NOTICE OF  
SAFETY AND HEALTH VIOLATIONS

DUCT VELOCITY DETERMINATIONS  
(Primary Data and Calculations)

PHOTOGRAPHS OF SELECTED PLANT OPERATIONS.

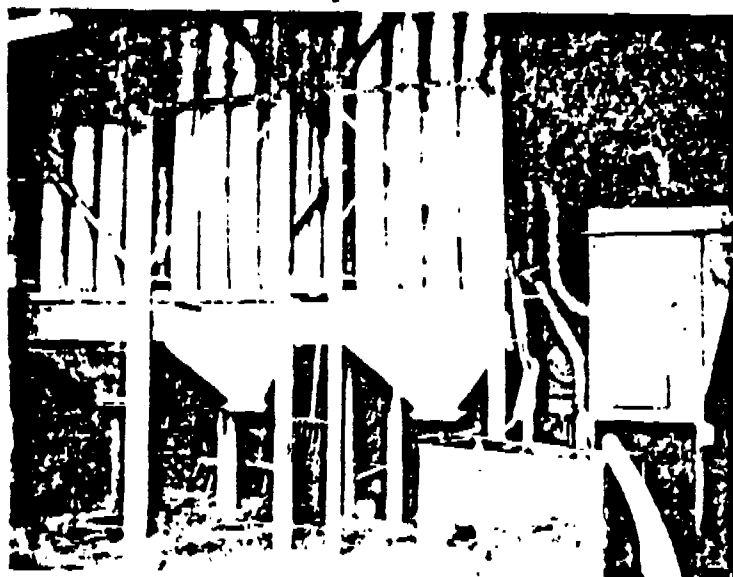
Scrap cutter hood and dust collector
