**Region 6 - Enforcement & Compliance Assurance Division**  
**INSPECTION REPORT**

| Inspection Date(s): | 08/27/2025 | | |
| Regulatory Program(s) | NPDES Stormwater/CWA 402 | | |
| Facility Name: | <b>Tierra Hermosa Subdivison Phase I &amp; II</b> | | |

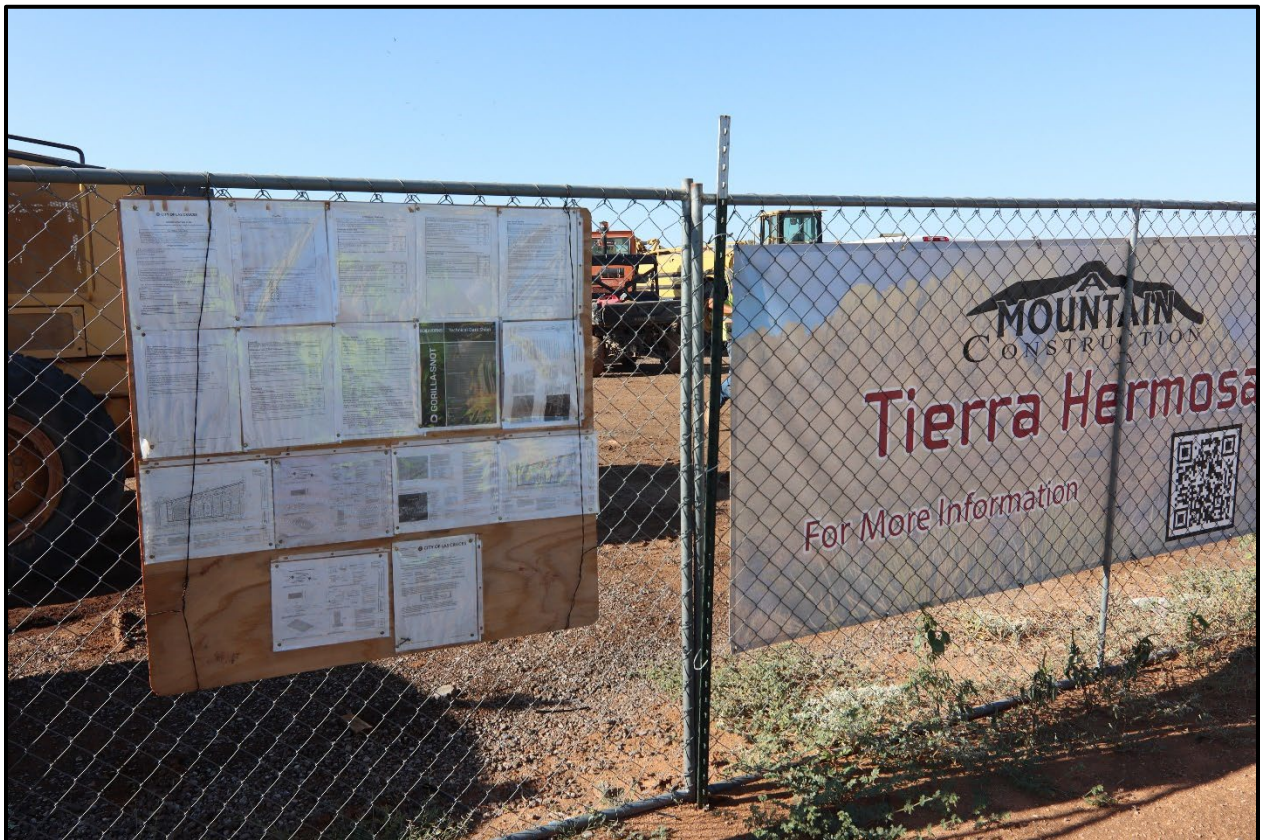
Photo No. 1

4. While there was a QR code link to the A Mountain Construction LLC company website near the construction trailer in the Phase II region across from Village Drive, the SWPPP Large Construction Site Notice was not posted as required by permit number NMR1006HZ (see Appendix 1, Photograph Log, Photo No 1.) **2022 CGP, Part 1.5**

Description: View of notice board with QR code link to the A Mountain Construction LLC company website, near the construction trailer at the Phase II region across from Village Drive

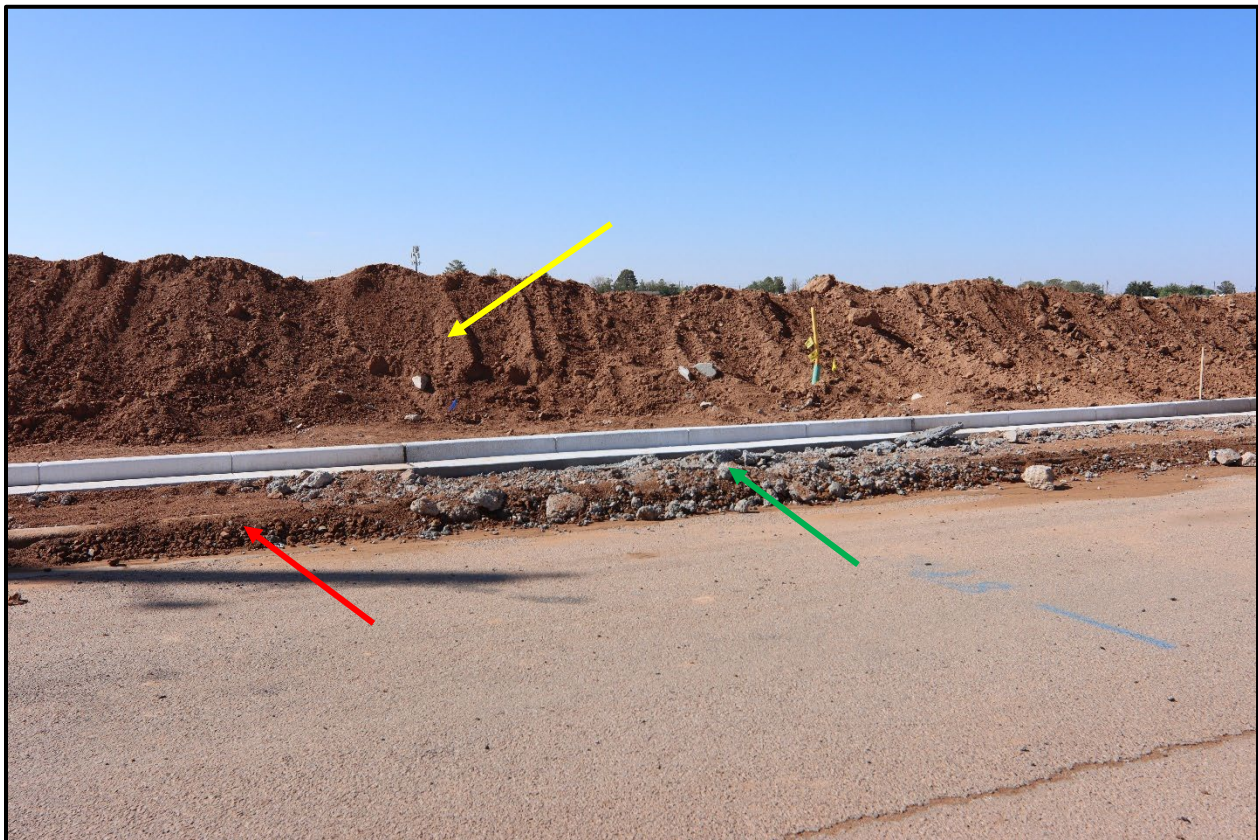
Photo No. 4

2. Earth berms were installed as a perimeter control BMP for the construction site however, the berms were not maintained and compacted to ensure that they continue to work effectively in accordance with (see Appendix 1, Photograph Log, Photo No 4, 5, 10, & 11) **2022 CGP, Part 2.1.4.**

3. The earth berms in place as a BMP were not effective and as a result, accumulations of sediment from the construction site were observed on the roadway and along the curb installations across from the intersection of Village Drive and Nunatak Place. In addition, concrete waste was observed at the curb installations and along the roadway the intersection of Village Drive and Nunatak Place (see Appendix 1, Photograph Log, Photos No 4 & 5). **2022 CGP, Part 2.2.3**

Description: View of an ineffective BMP (i.e., an unmaintained and uncompacted berm (yellow arrow) at the perimeter of the construction site at Village Drive). Sediment carryover (red arrow) was observed from the construction site onto the roadway along Village Drive. In addition, concrete waste (green arrow) was observed at the curb and along the roadway at Village Drive.

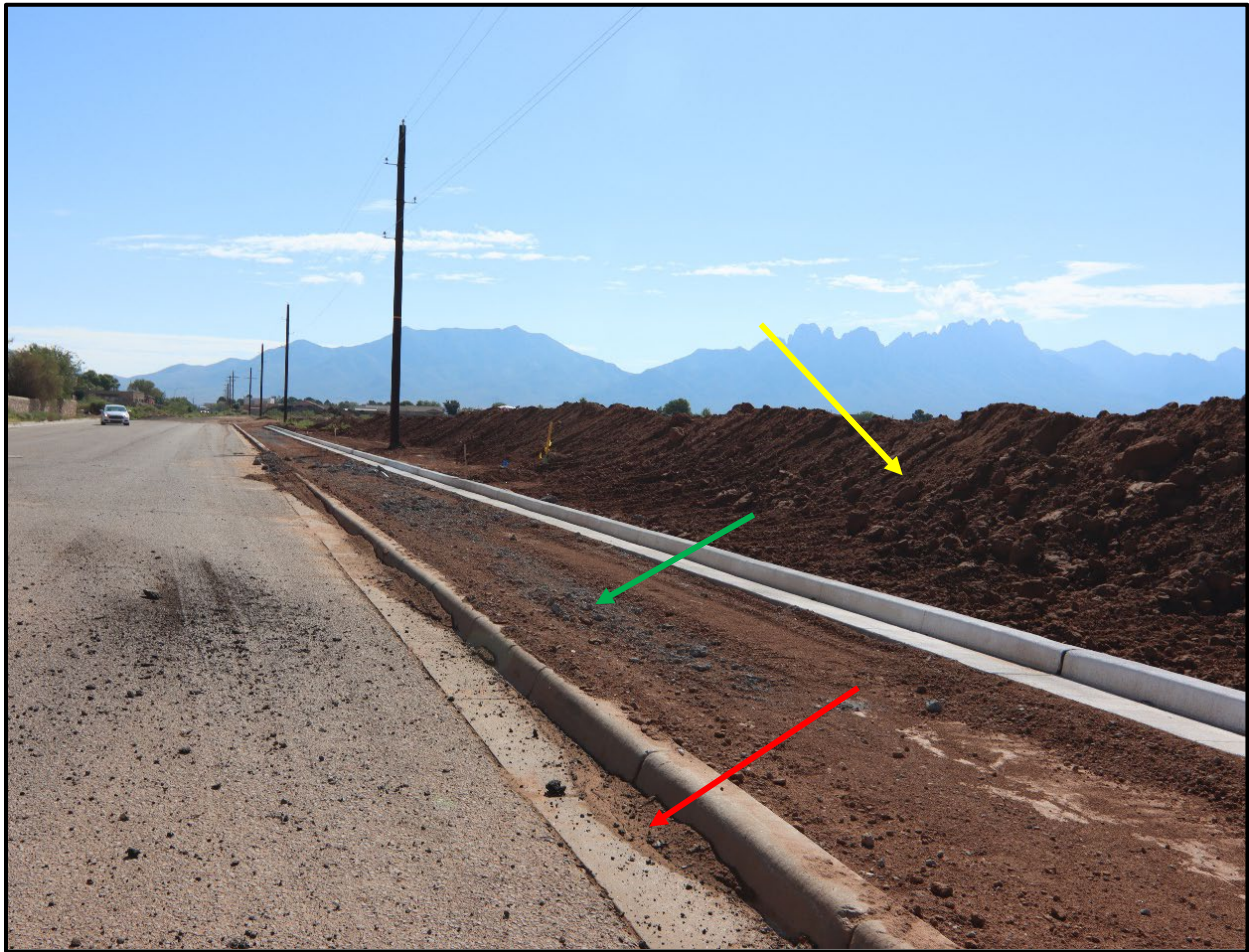
Photo No. 5

Description: A closer view of the unmaintained and uncompacted berm (yellow arrow) at the perimeter causing sediment carryover (red arrow) from the construction site onto the roadway along Village Drive. Concrete waste indicated by green arrow.

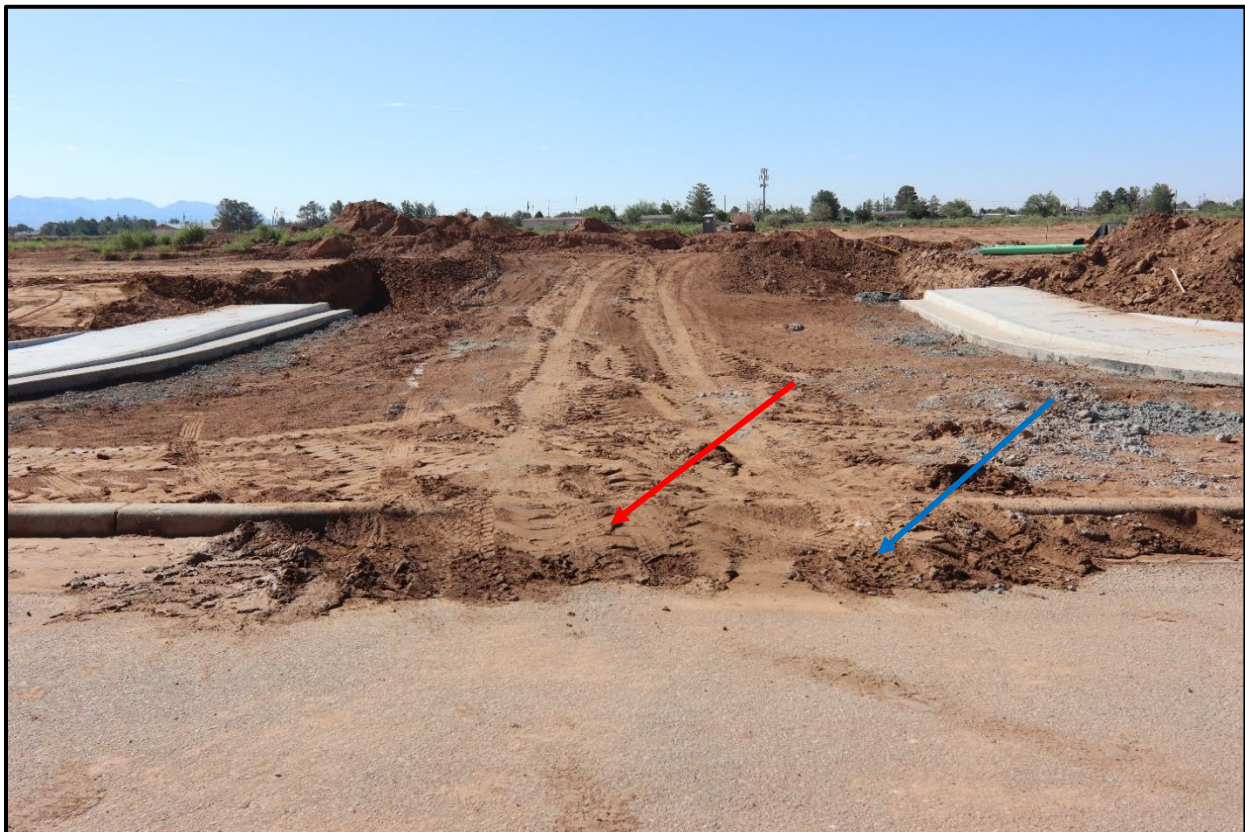
Photo No. 6

5. Stabilization techniques were not provided for the entrance and exit point of the construction site across from the intersection of Village Drive and Nunatak Place to minimize the track out of sediment onto the roadway despite the SWPPP detailing a vehicle track out pad as a stabilized construction entrance and exit at that location of the construction site. Sediment carryover and tire tracks were observed leading from the entrance and exit point of the construction site to the roadway (see Appendix 1, Photograph Log, Photo No 6). **2022 CGP, Parts 2.1.2 & 2.2.4**

Description: View of sediment carryover (red arrow) from the entrance and exit point of the construction site onto the access road along Village Drive. In addition, tire tracks were observed leading towards the access road from the construction area (blue arrow).

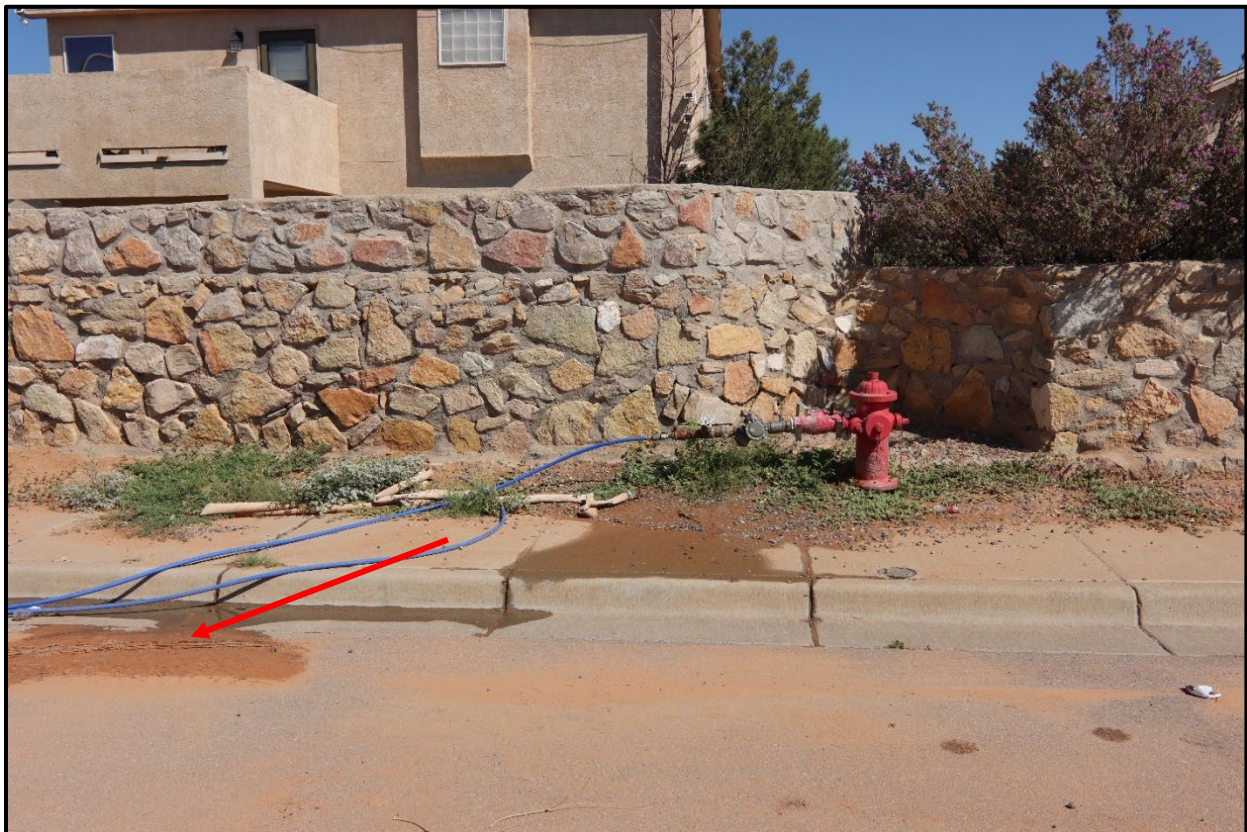
Photo No. 7

8. The fire hydrant near the intersection of Village Drive and Nunatak Place used to assist with dust control was observed leaking causing water to flow onto the road at Village Drive and commingle with visible accumulations of sediment from the construction site (see Appendix 1, Photograph Log, Photos No 7, 8 & 9). **2022 CGP, Part 1.2.2**

Description: View of the fire hydrant used for dust control leaking and causing water to flow onto the road at Village Drive and commingle with visible accumulations of sediment (red arrow) from the construction site.

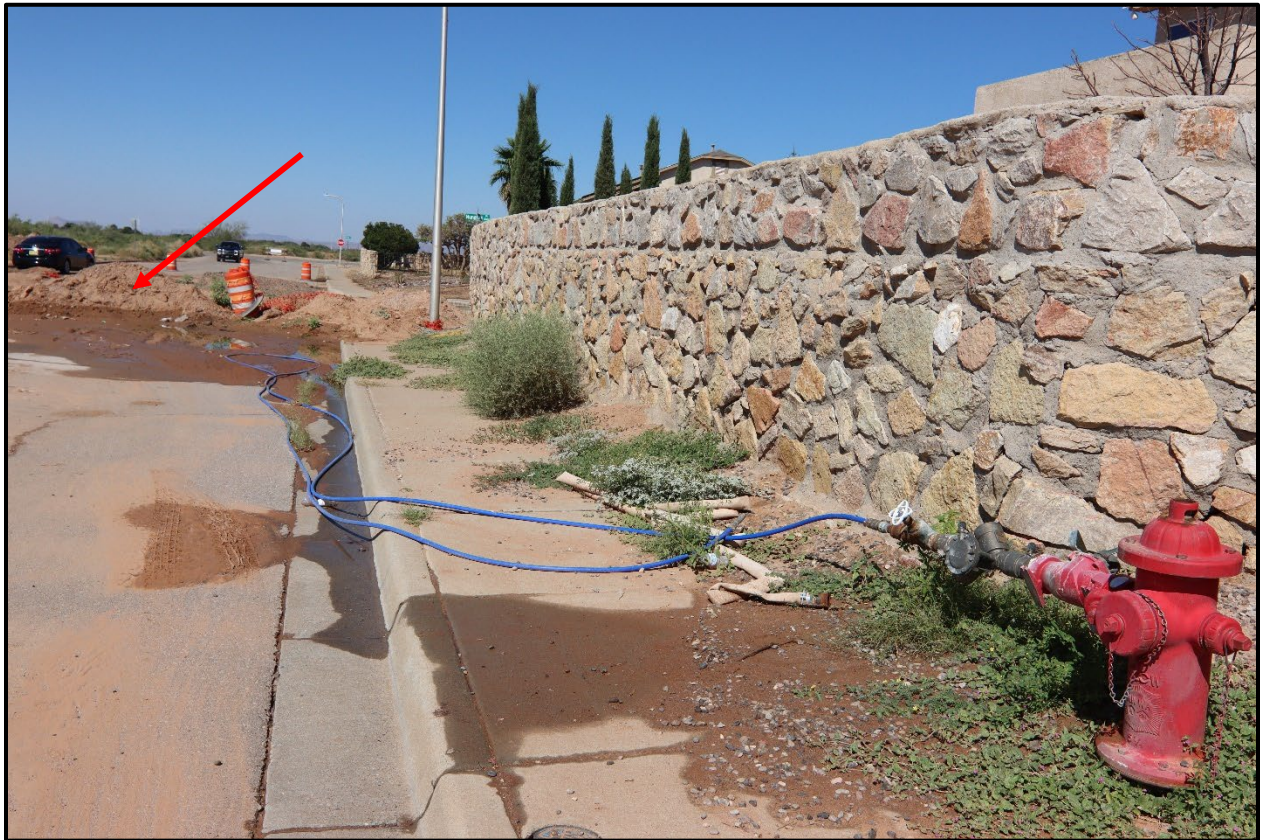
Photo No. 8

Description: View of the fire hydrant used for dust control leaking and causing water to comele with stockpiled sediment (red arrow) near the construction site at the intersection of Village Drive and Nunatak Place.

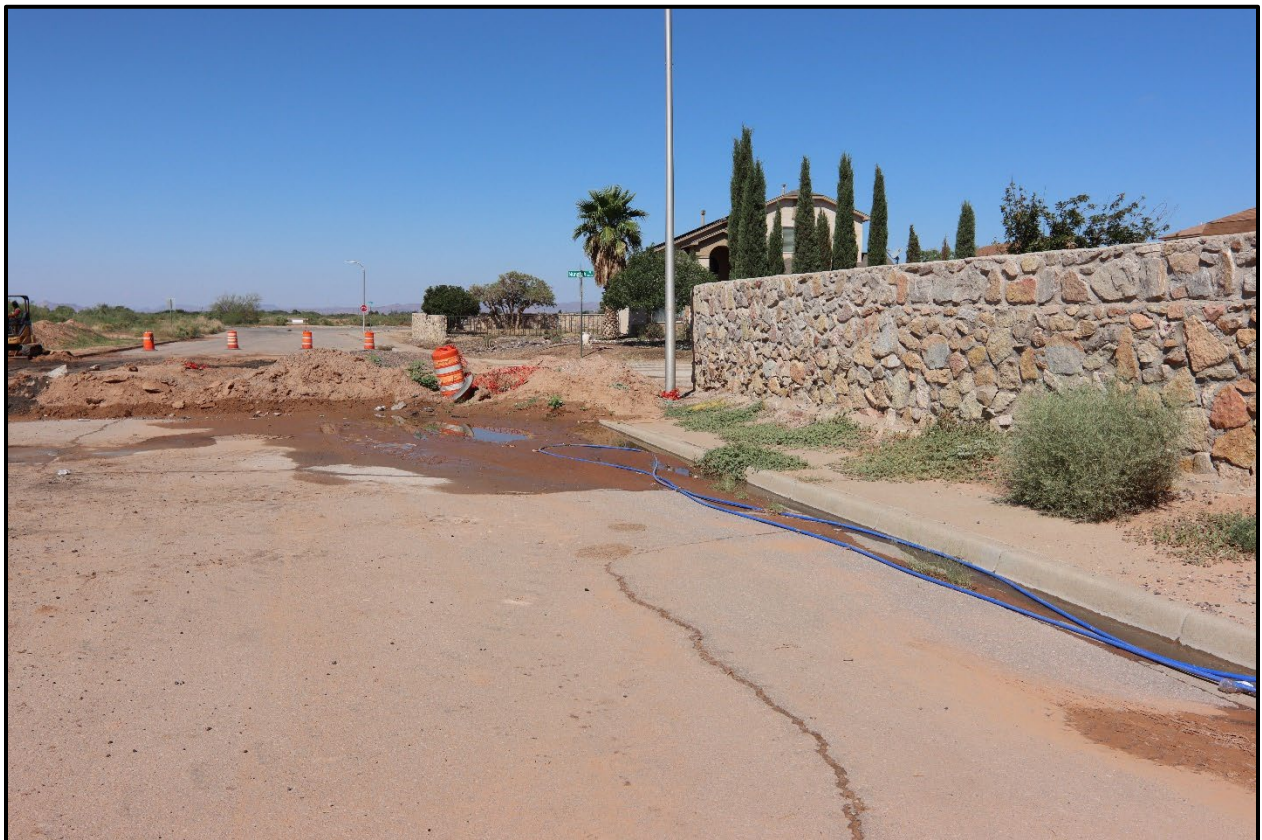
Photo No. 9

Description: A closer view of stockpiled sediment at the intersection of Village Drive and Nunatak Place comingling with water leaking from the fire hydrant.

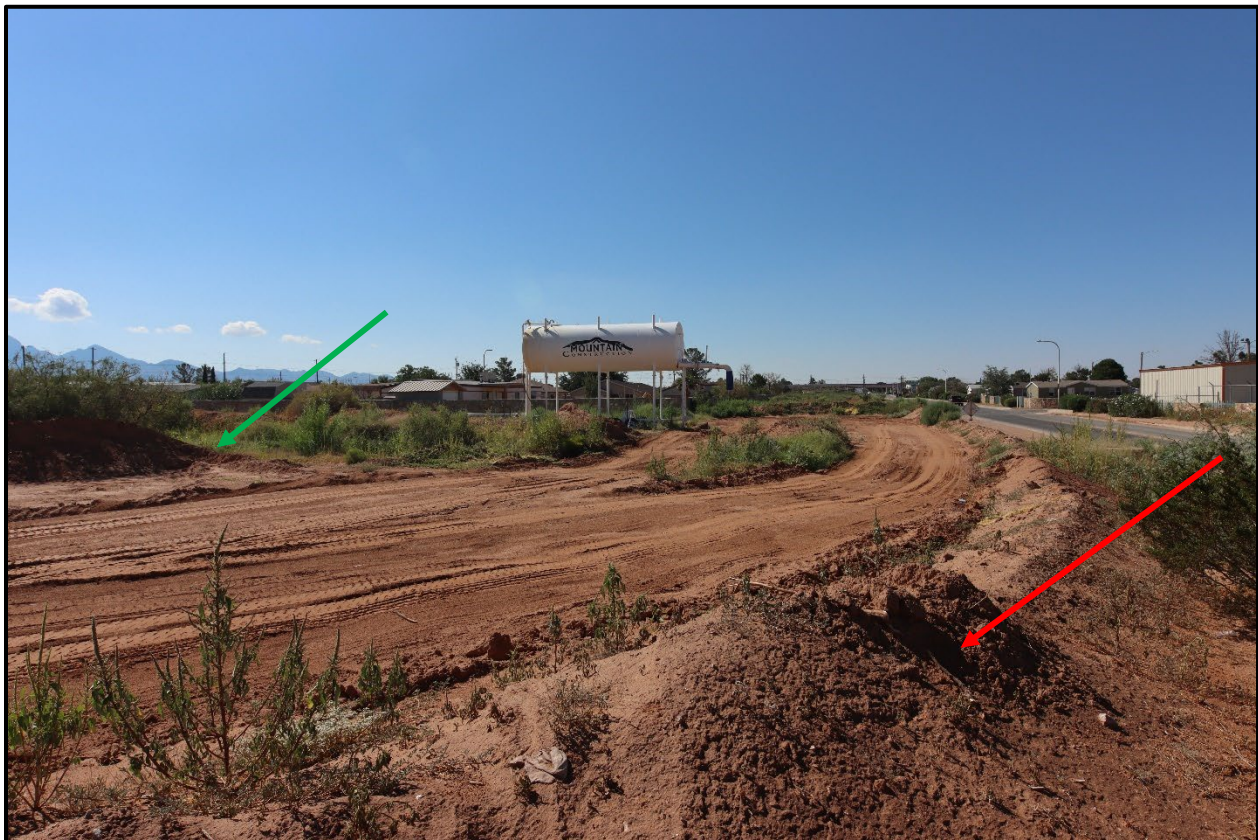
Photo No. 10

Description: View of an ineffective BMP (i.e., an unmaintained and uncompacted berm (red arrow) across from an arroyo (green arrow) on the construction site at Porter Drive and Central Avenue). When it rains, stormwater flows through the construction site via the noted arroyo: this stormwater washes away the perimeter berm, causing sediment to flow off-site onto the roadway.

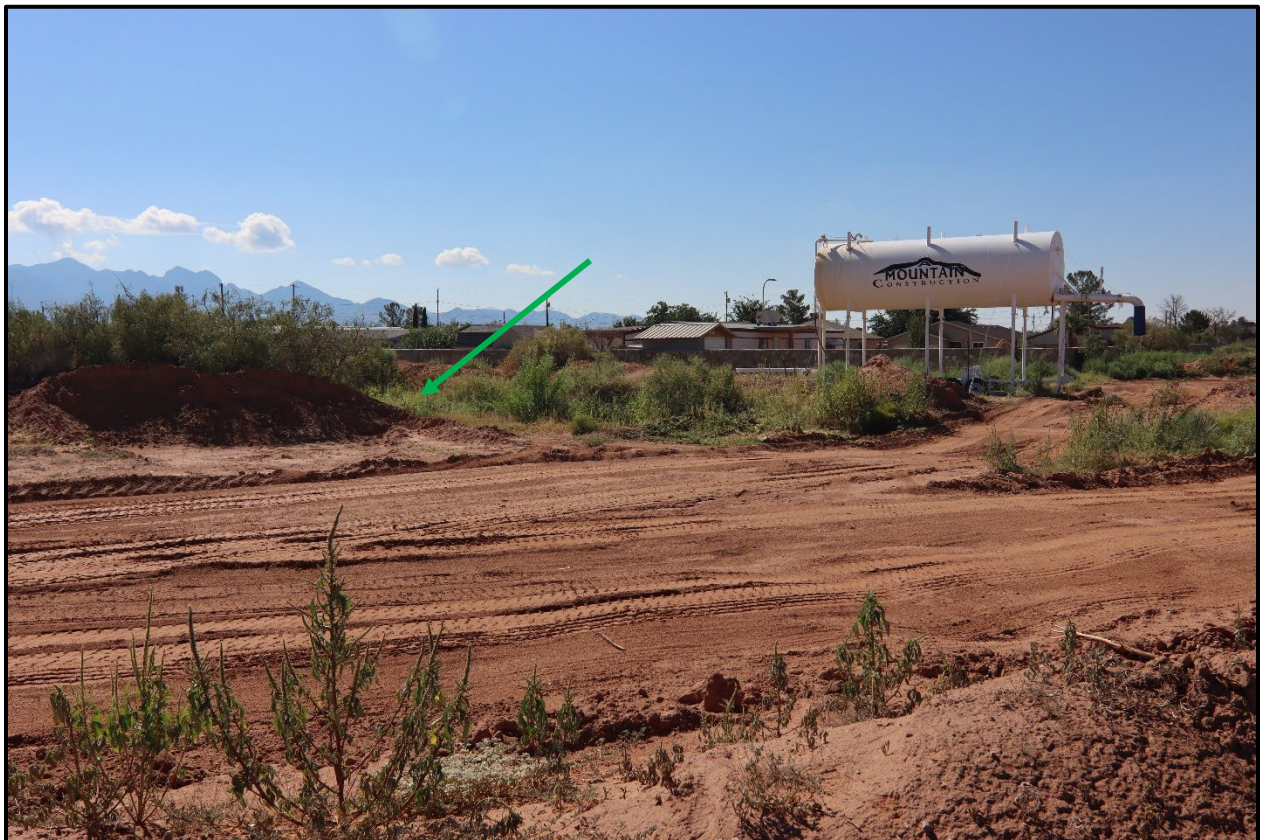
Photo No. 11

Description: A closer view of the location of the arroyo (green arrow) on the construction site at Porter Drive and Central Avenue.
