## Clean Water Act Section 404: Site Visit/Case Development

| Site Name | Kelly Branch | | | | | | |

Inspection Photographic Log  
Evarts, Kentucky  
May 7, 2024

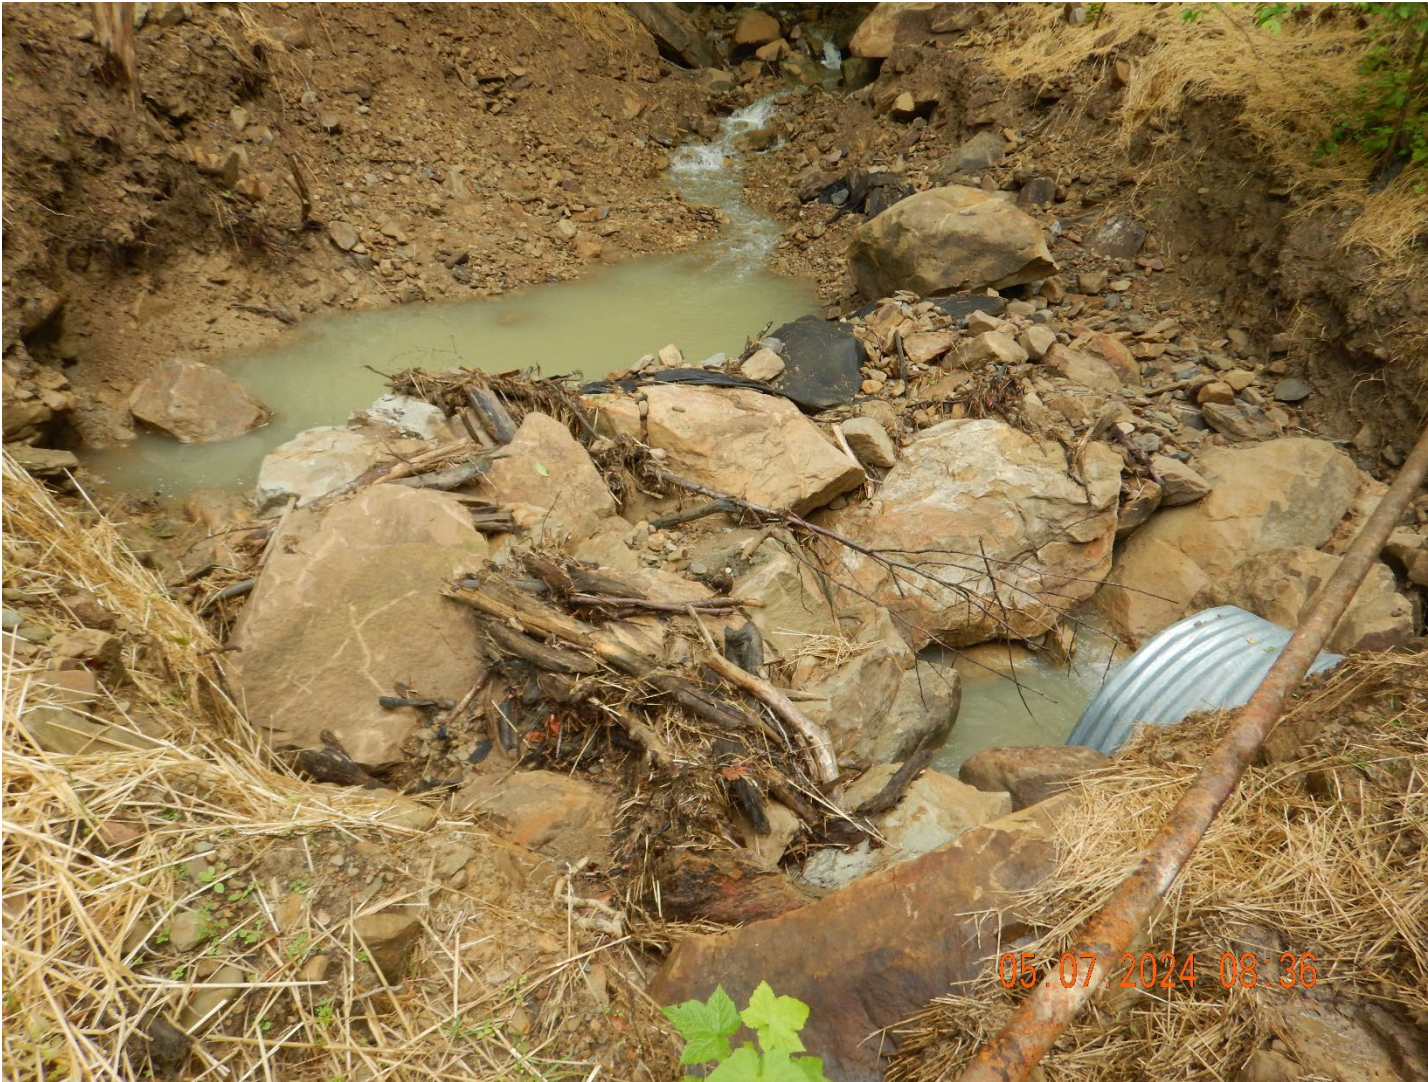
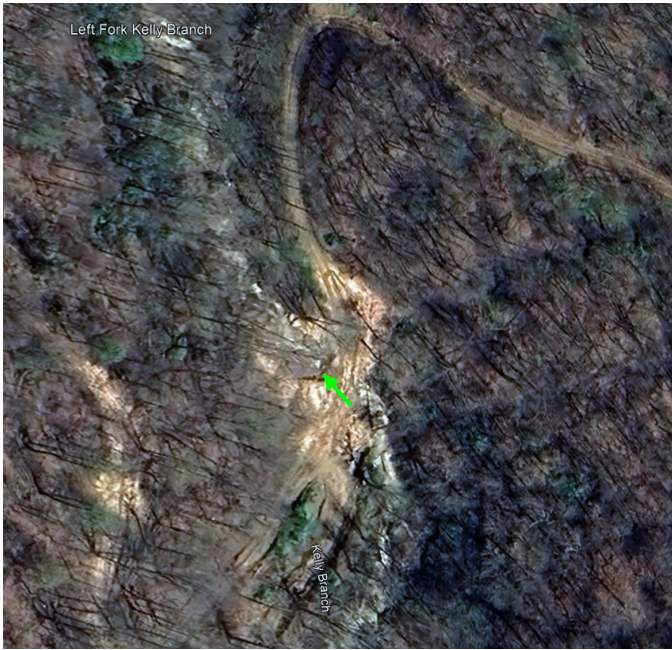
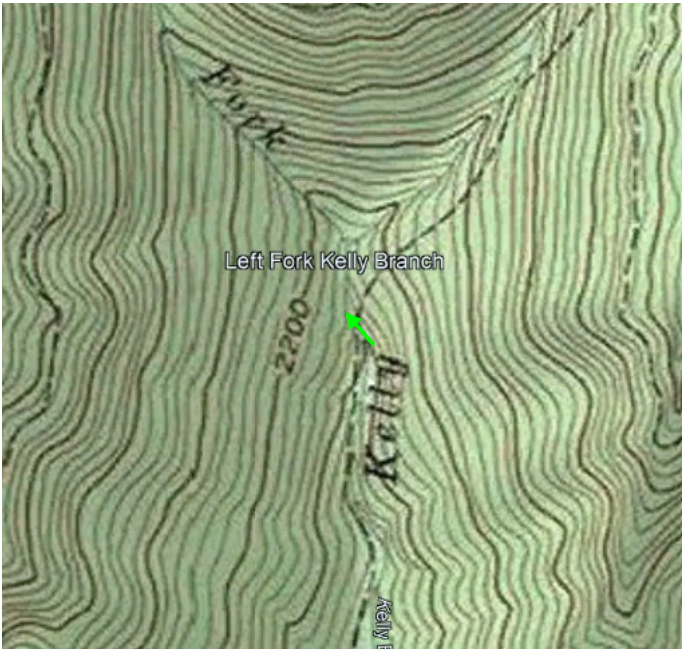
| Title | Photo 1 |

| Description | Photograph of rock check dam in Kelly Branch. |

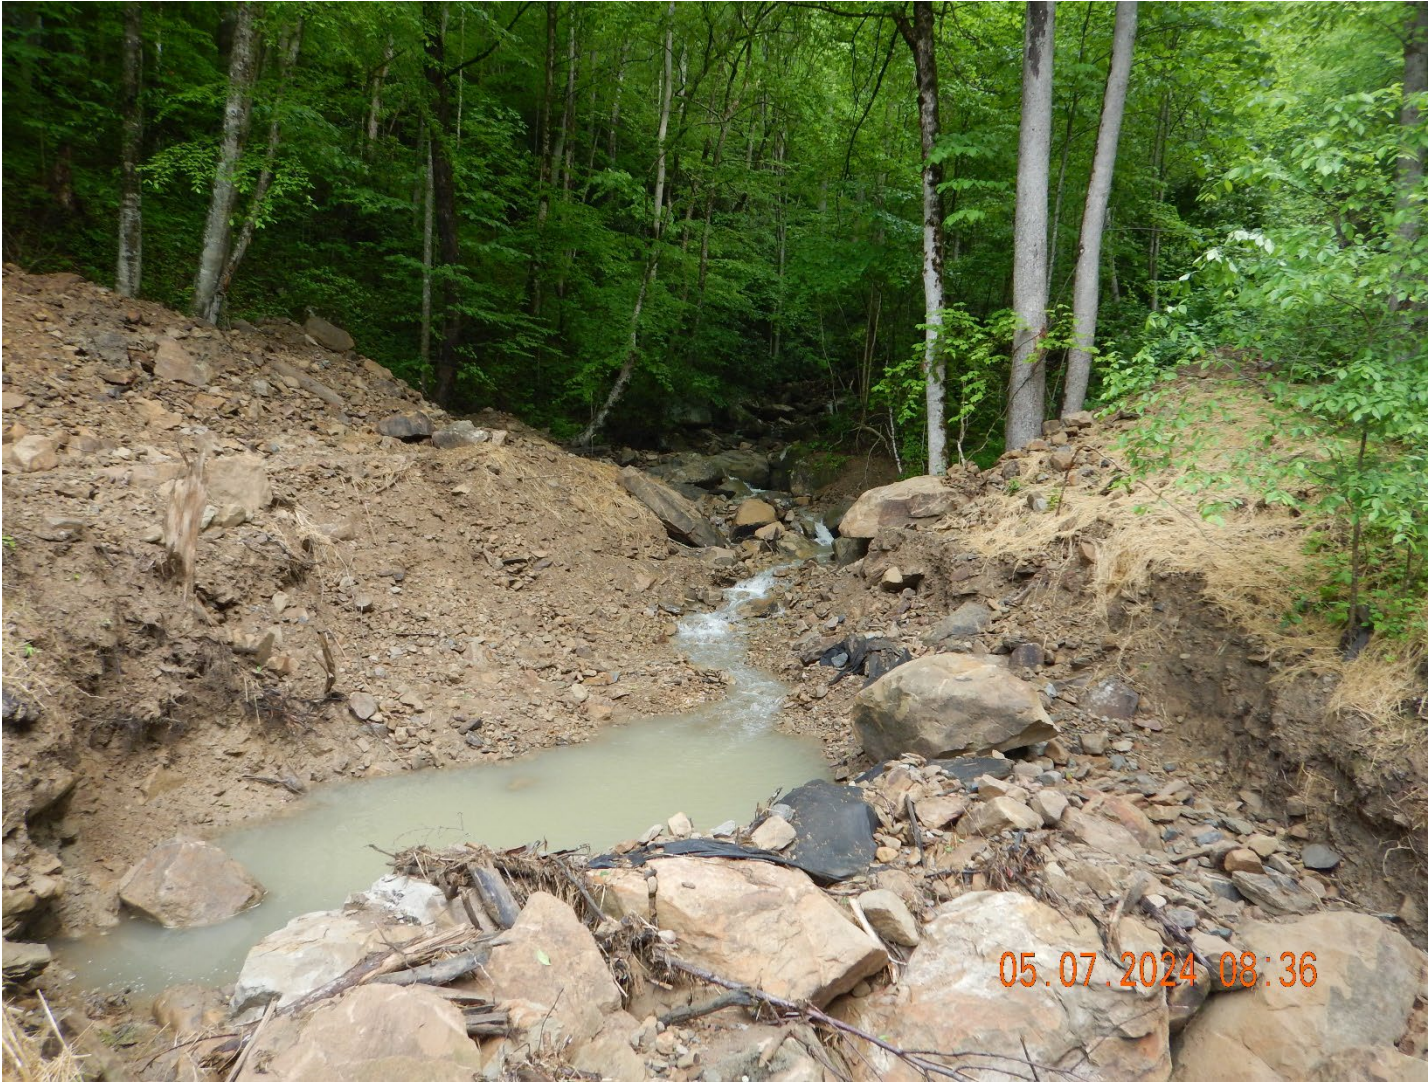
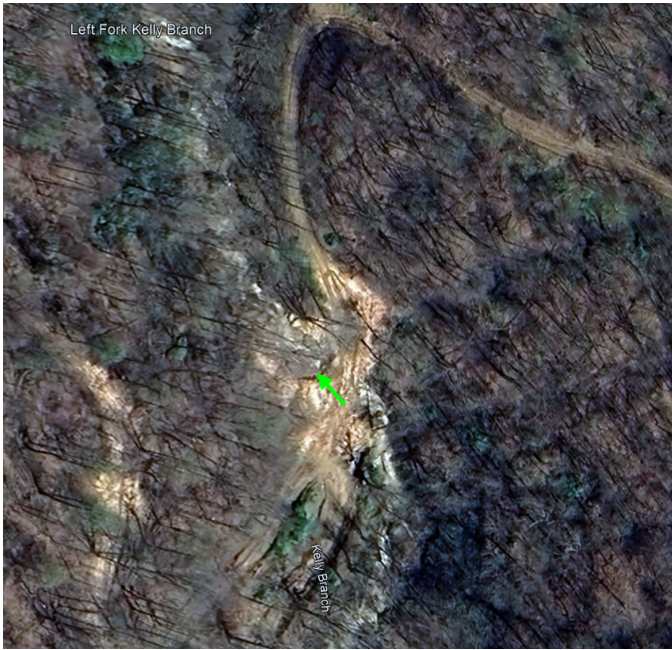
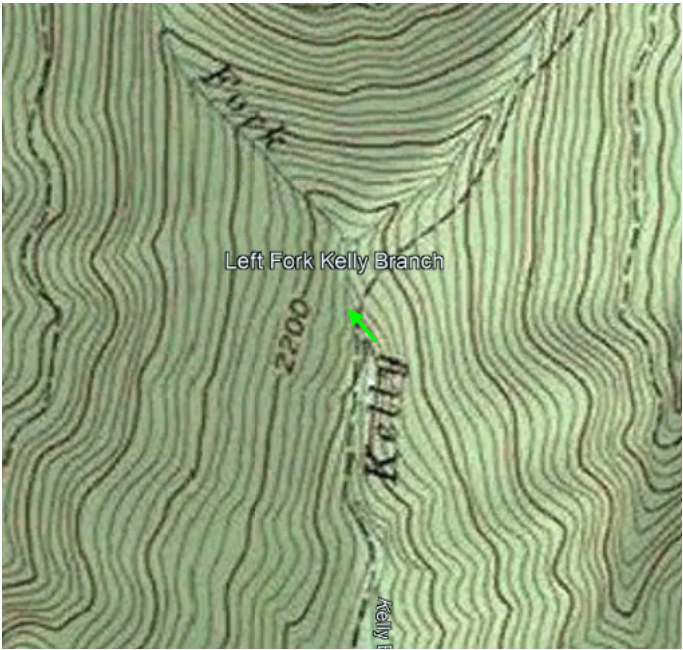
| Title | Photo 2 |

| Description | Photograph of rock check dam and Kelly Branch, facing upstream. |

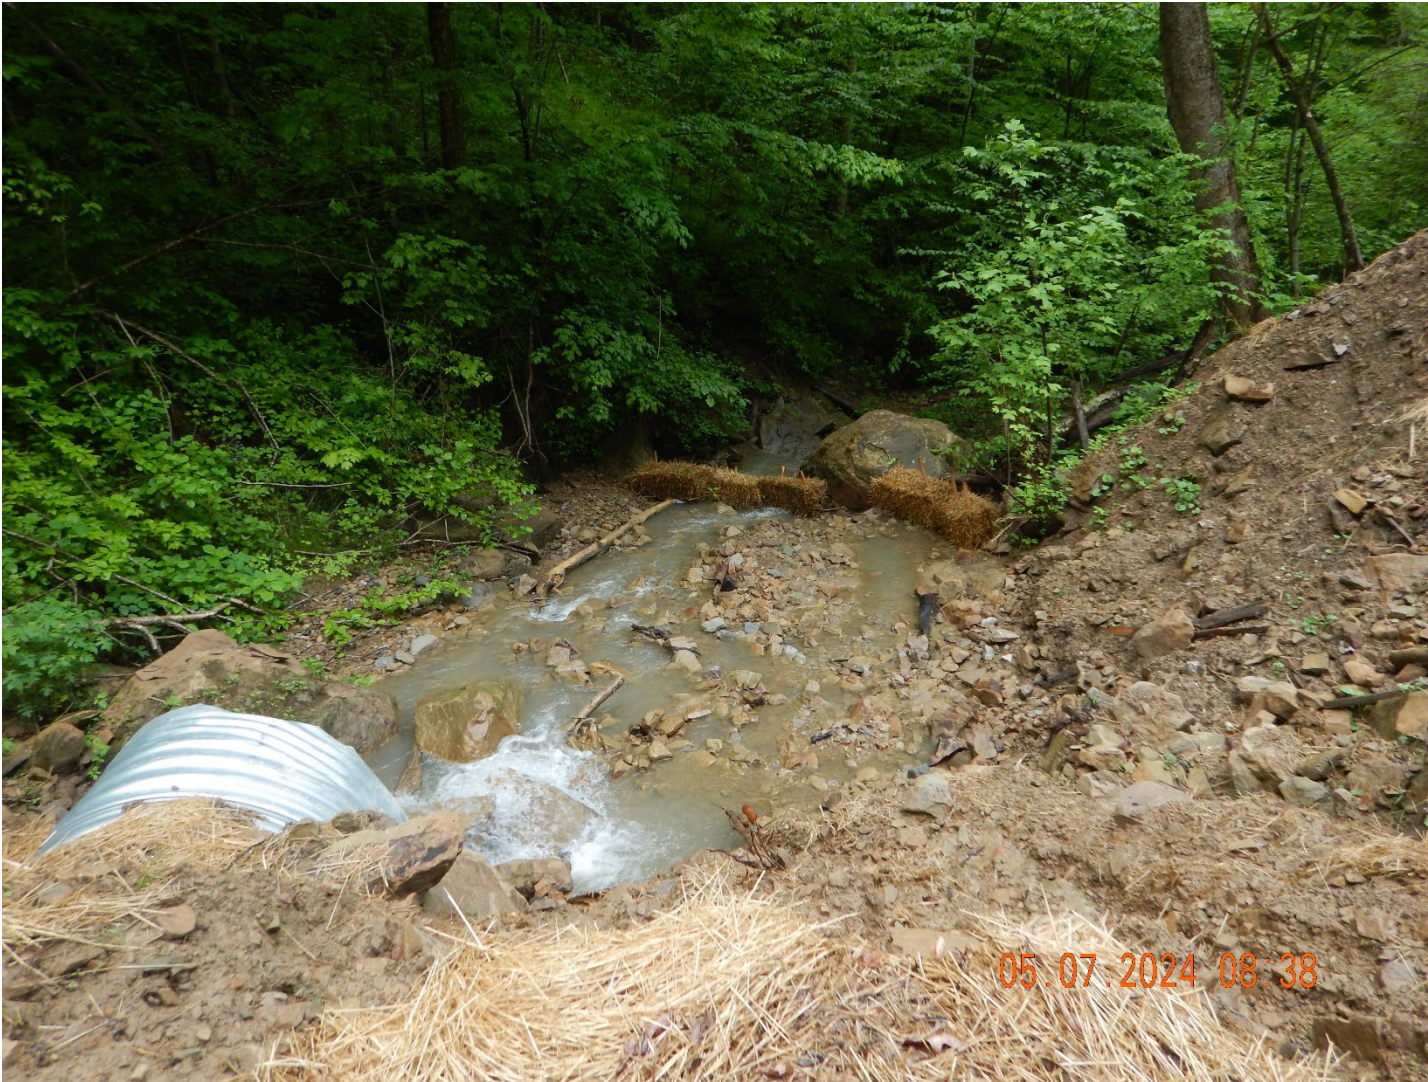
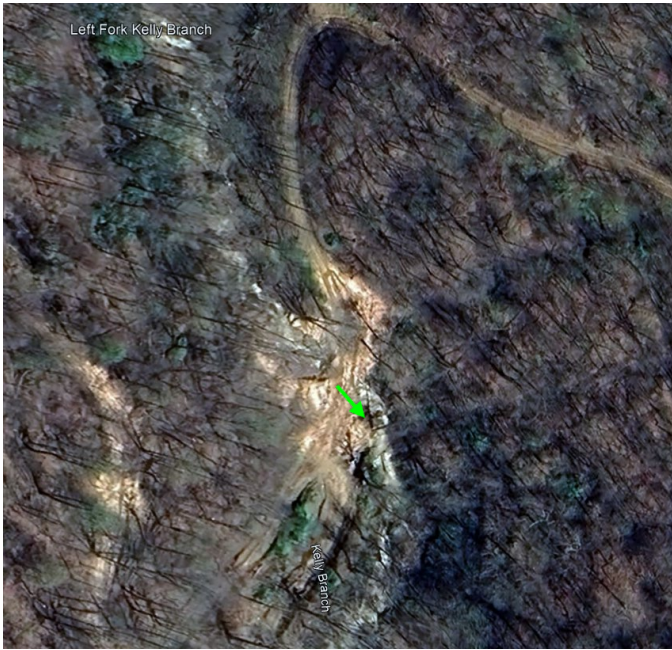
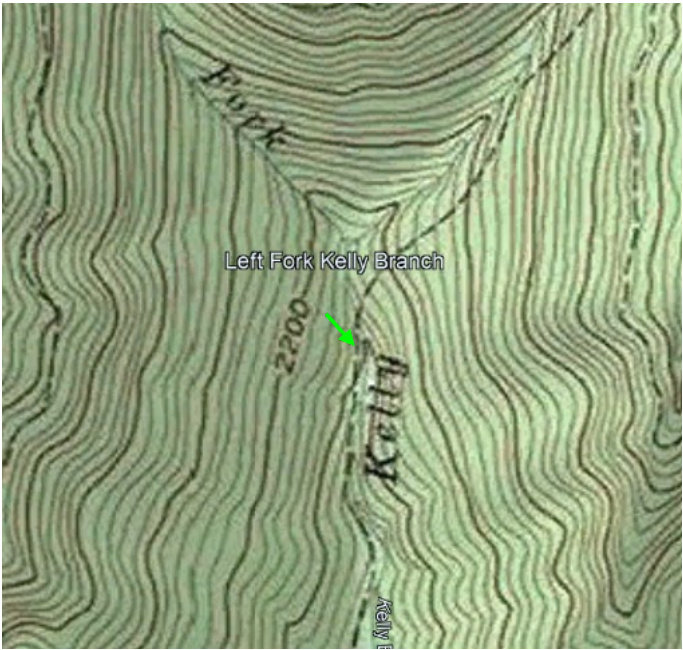
| Title | Photo 3 |

| Description | Photograph facing downstream of rock check dam in Kelly Branch. |

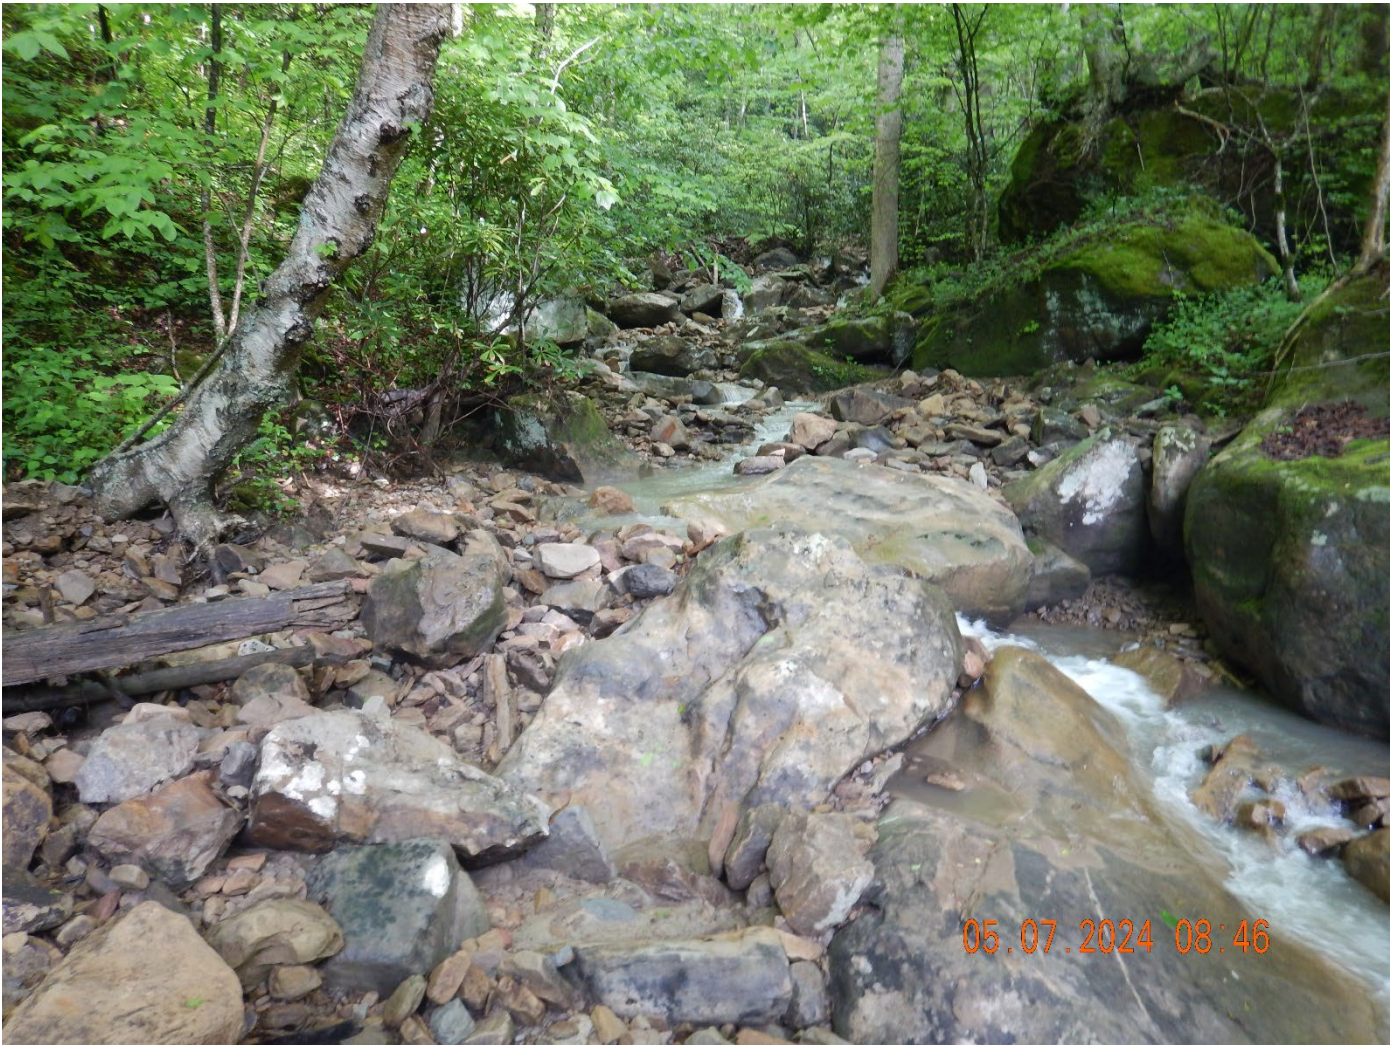
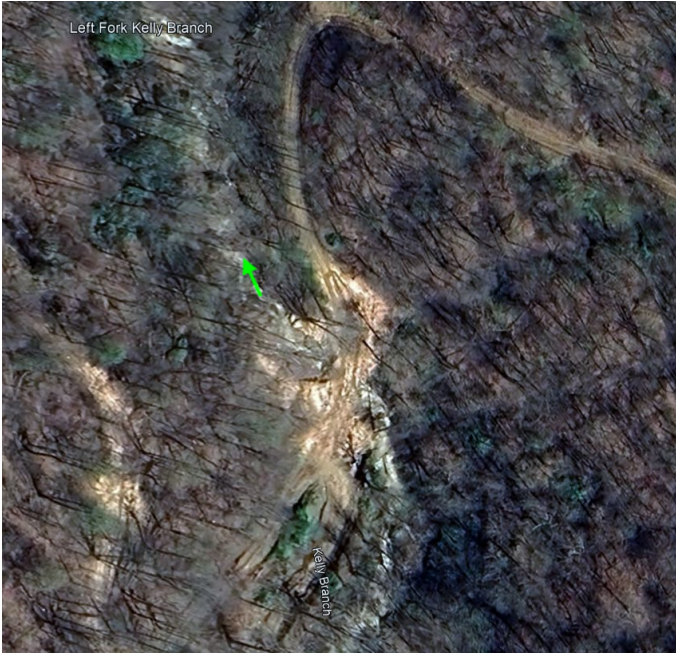
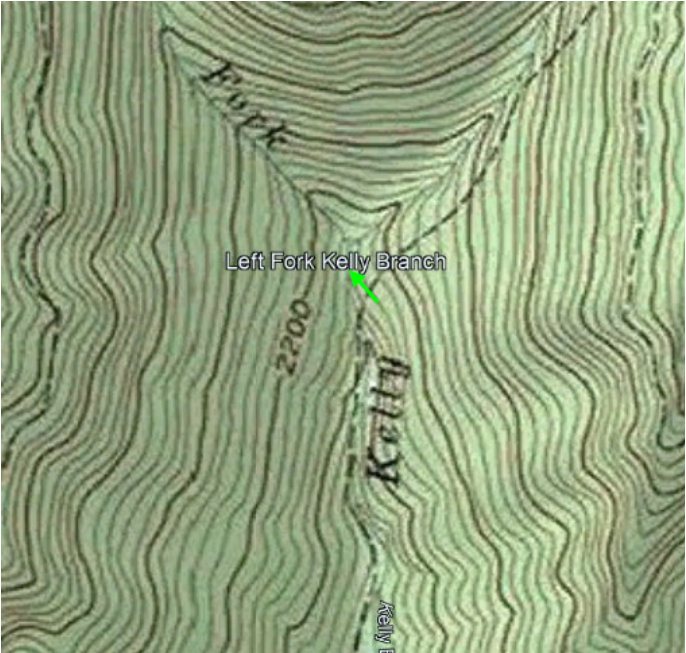
| Title | Photo 4 |

| Description | Kelly Branch facing upstream above the rock check dam. |

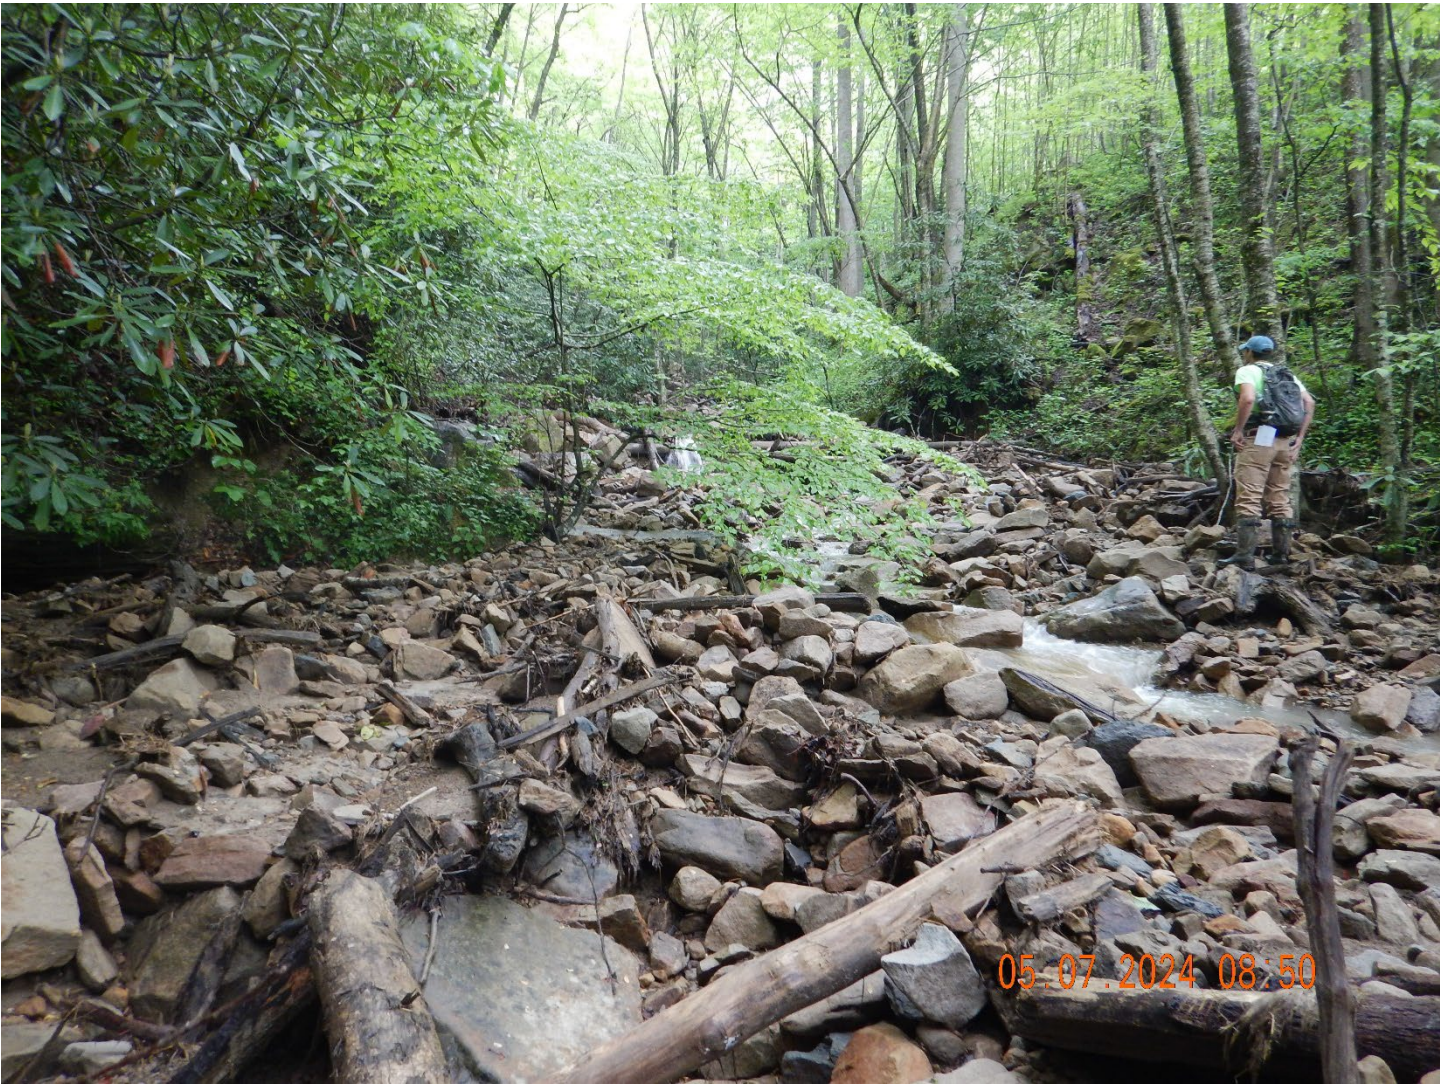
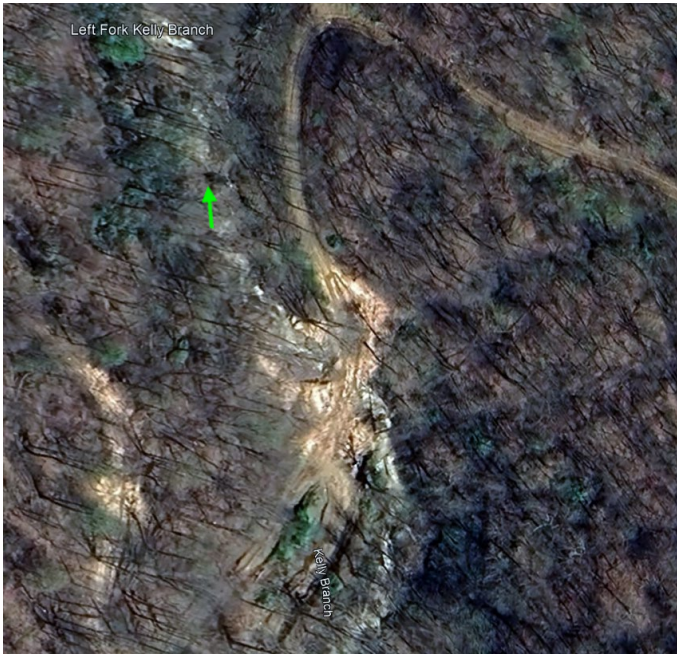
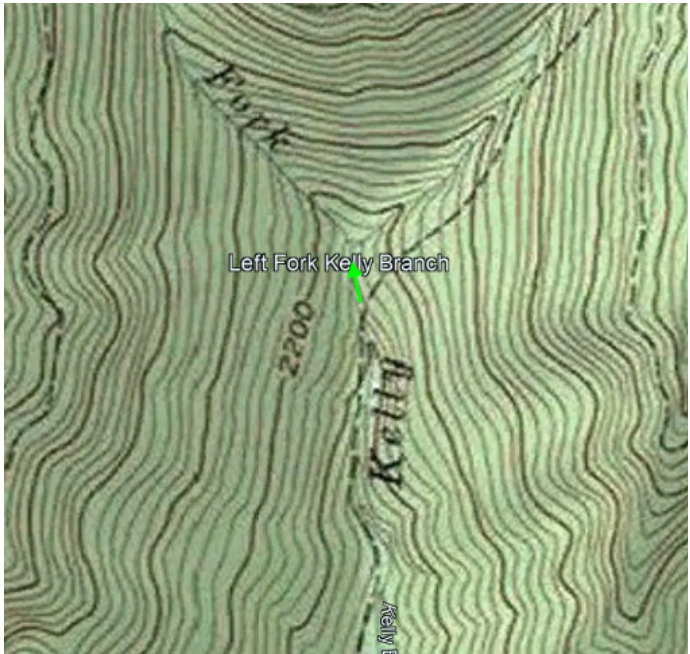
| Title | Photo 5 |

| Description | Photograph of Kelly Branch facing upstream approximately 75lf above rock check dam. |

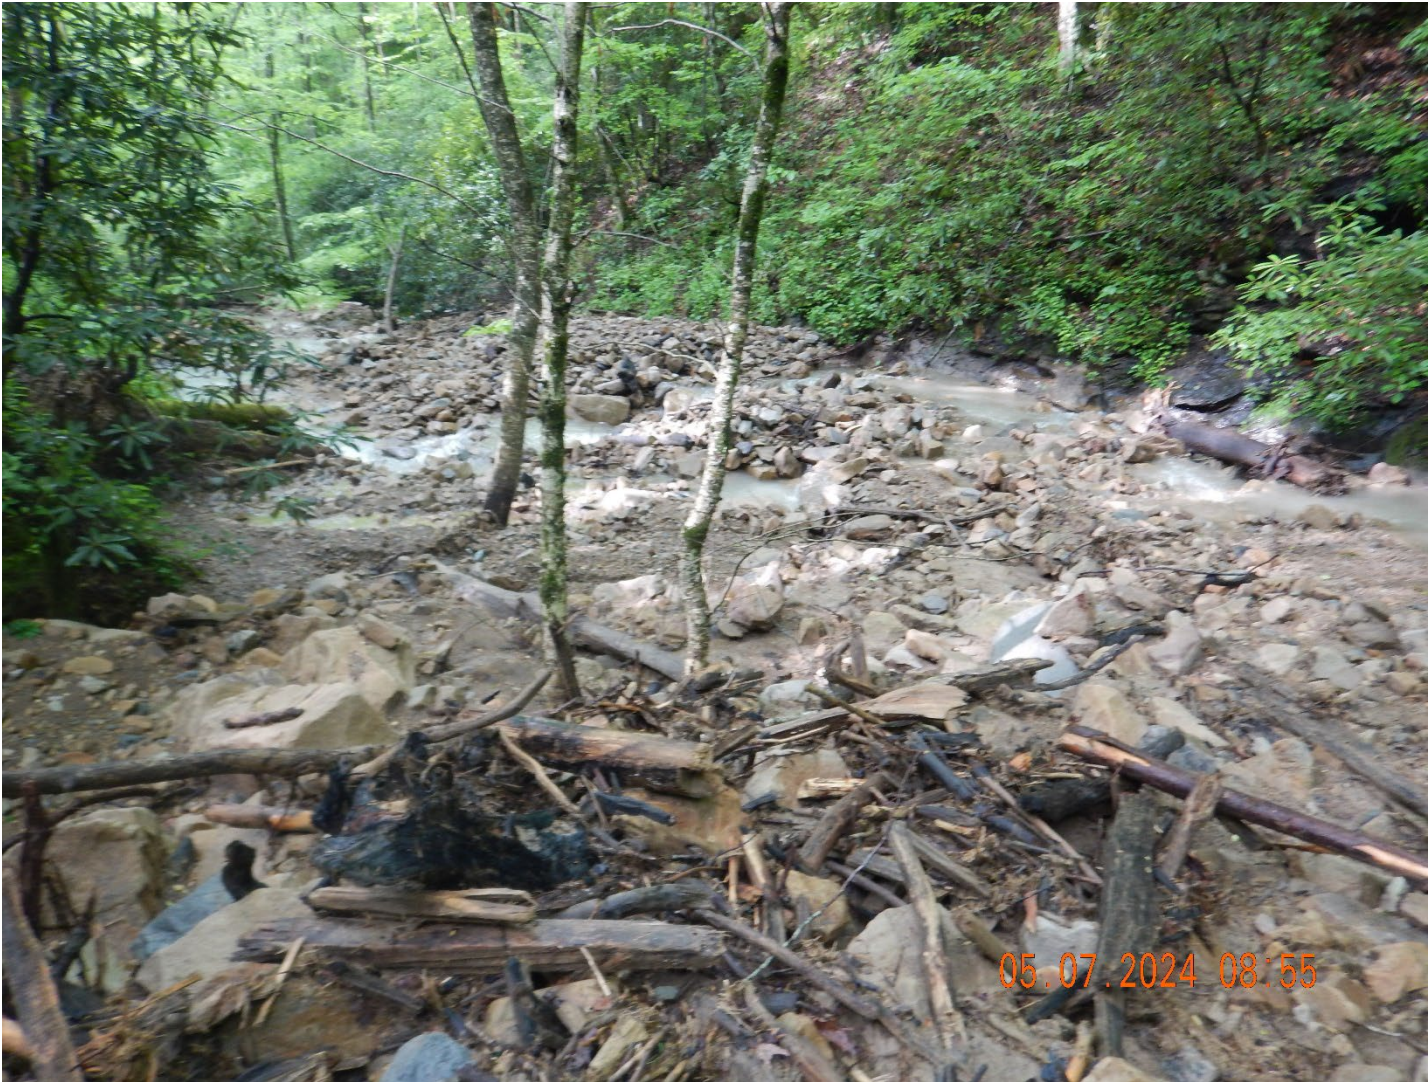
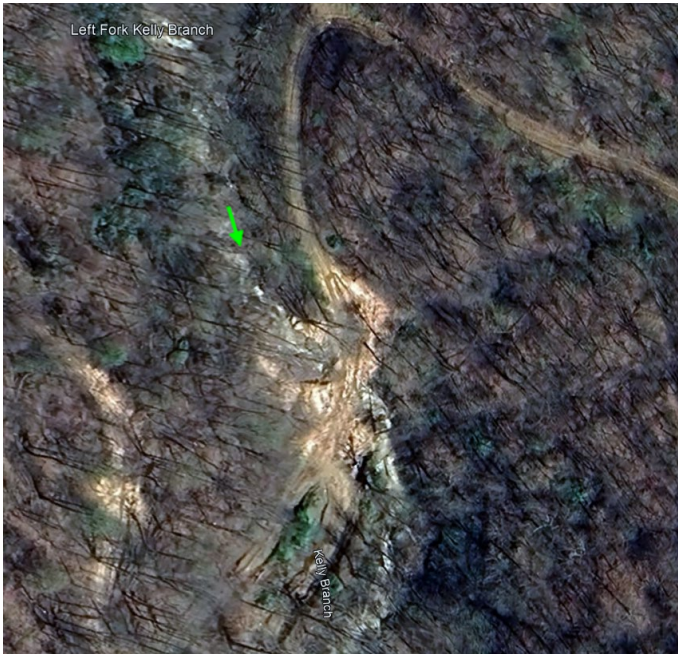
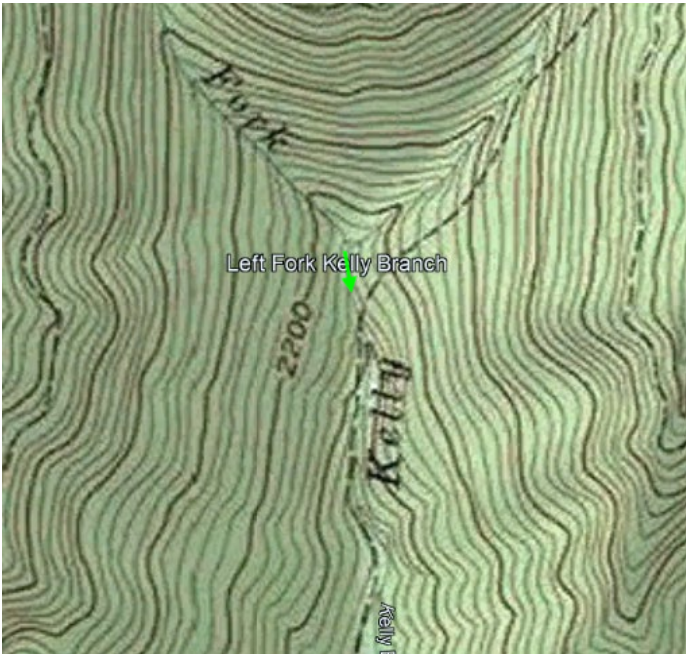
| Title | Photo 6 |

| Description | Kelly Branch facing downstream, same location as previous photograph. |

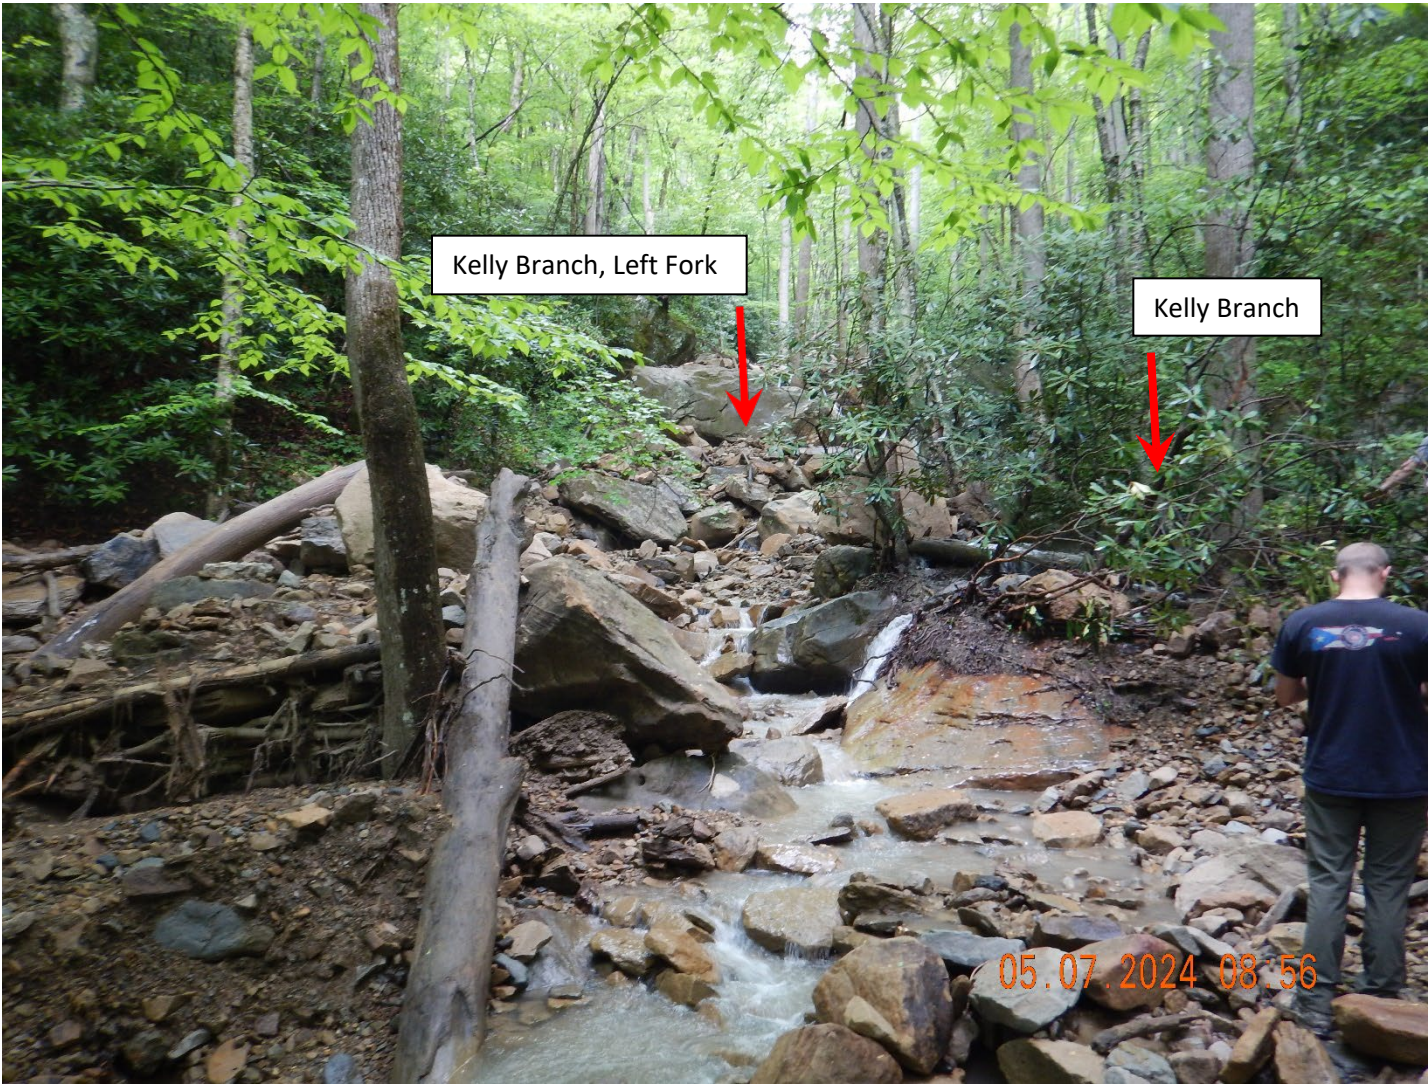
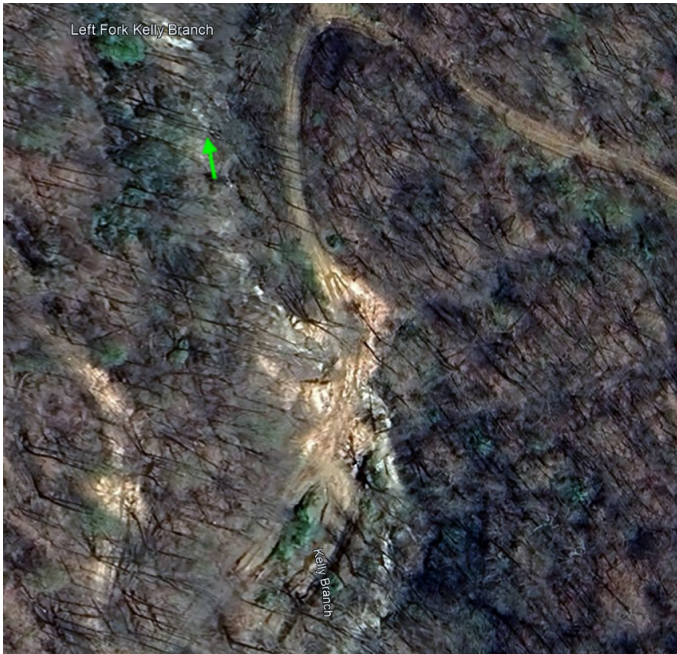
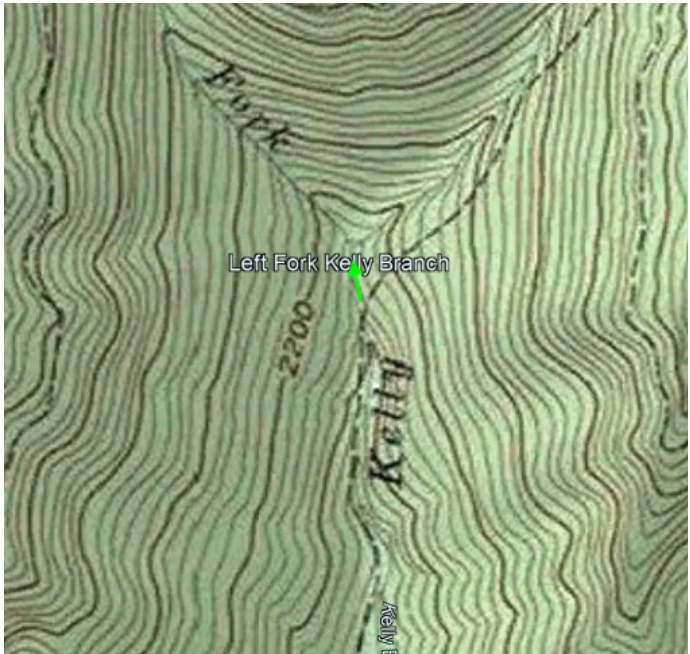
| Title | Photo 7 |

| Description | Kelly Branch facing upstream. Left Fork straight ahead and mainstem of Kelly Branch coming in from the right. |

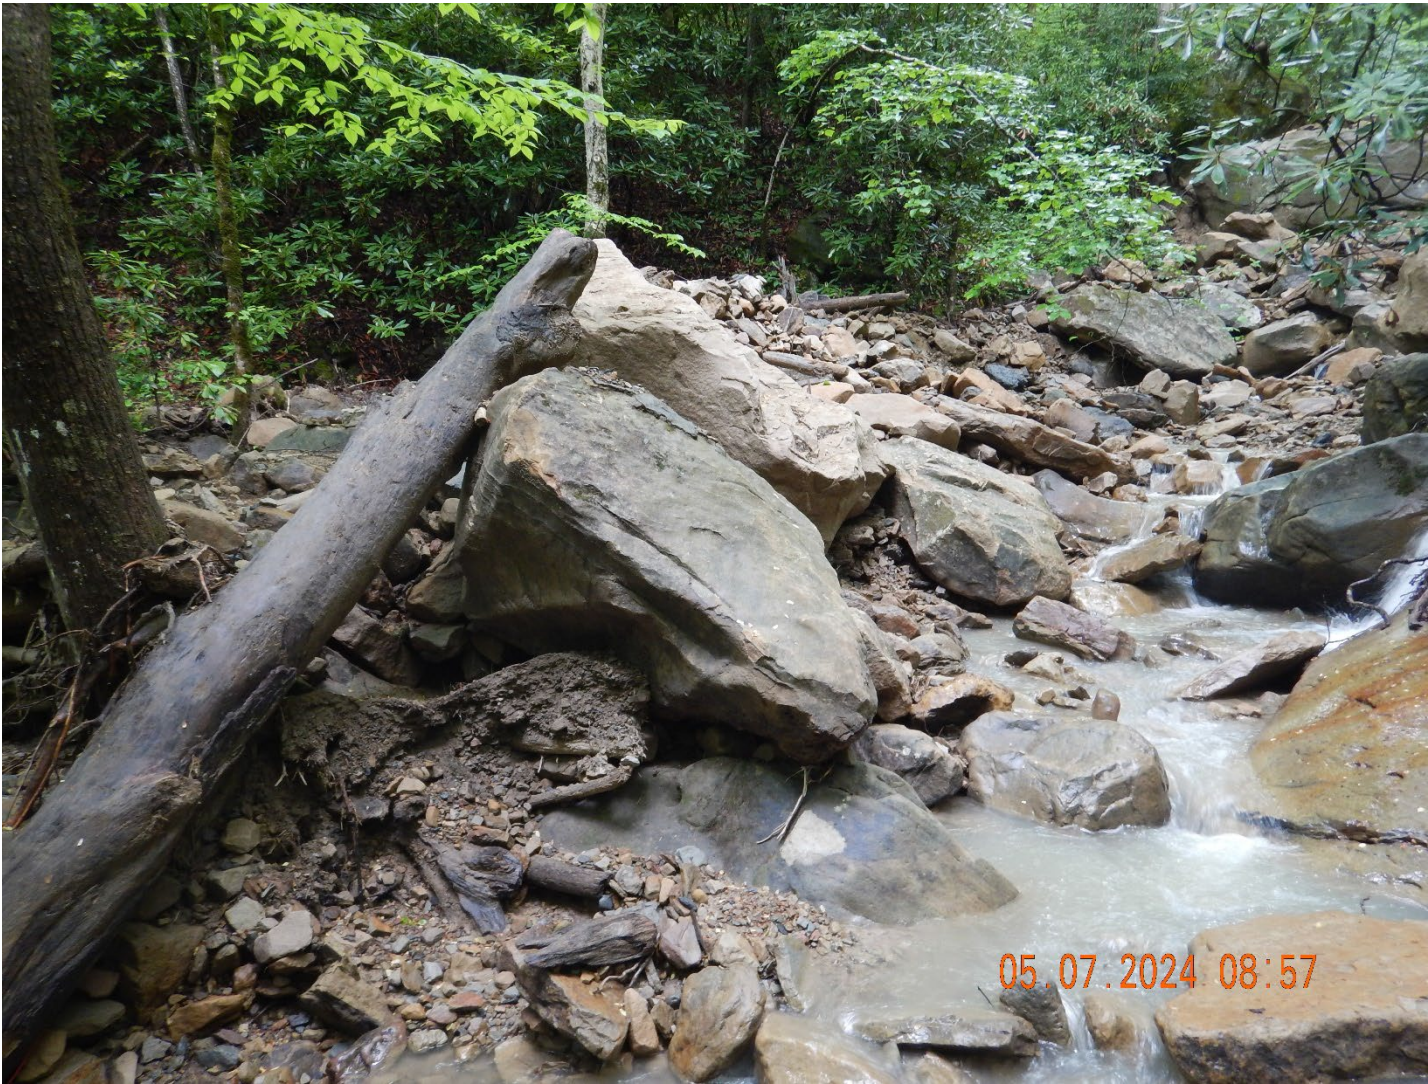
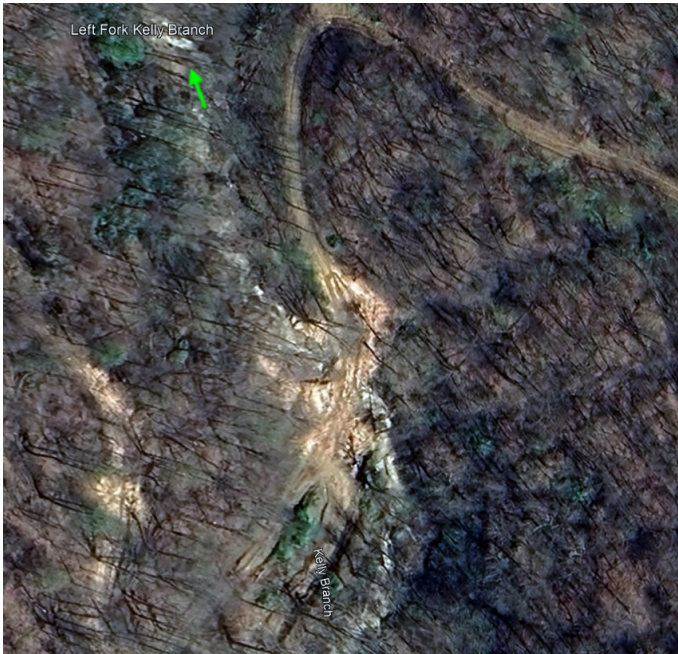
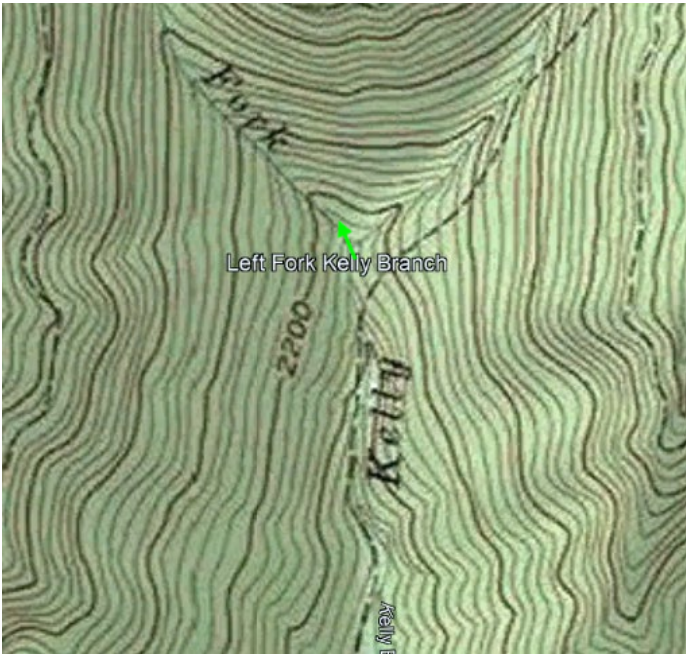
| Title | Photo 8 |

| Description | Left Fork of Kelly Branch facing upstream. Photograph is at the confluence of the left fork and the mainstem of Kelly Branch. |

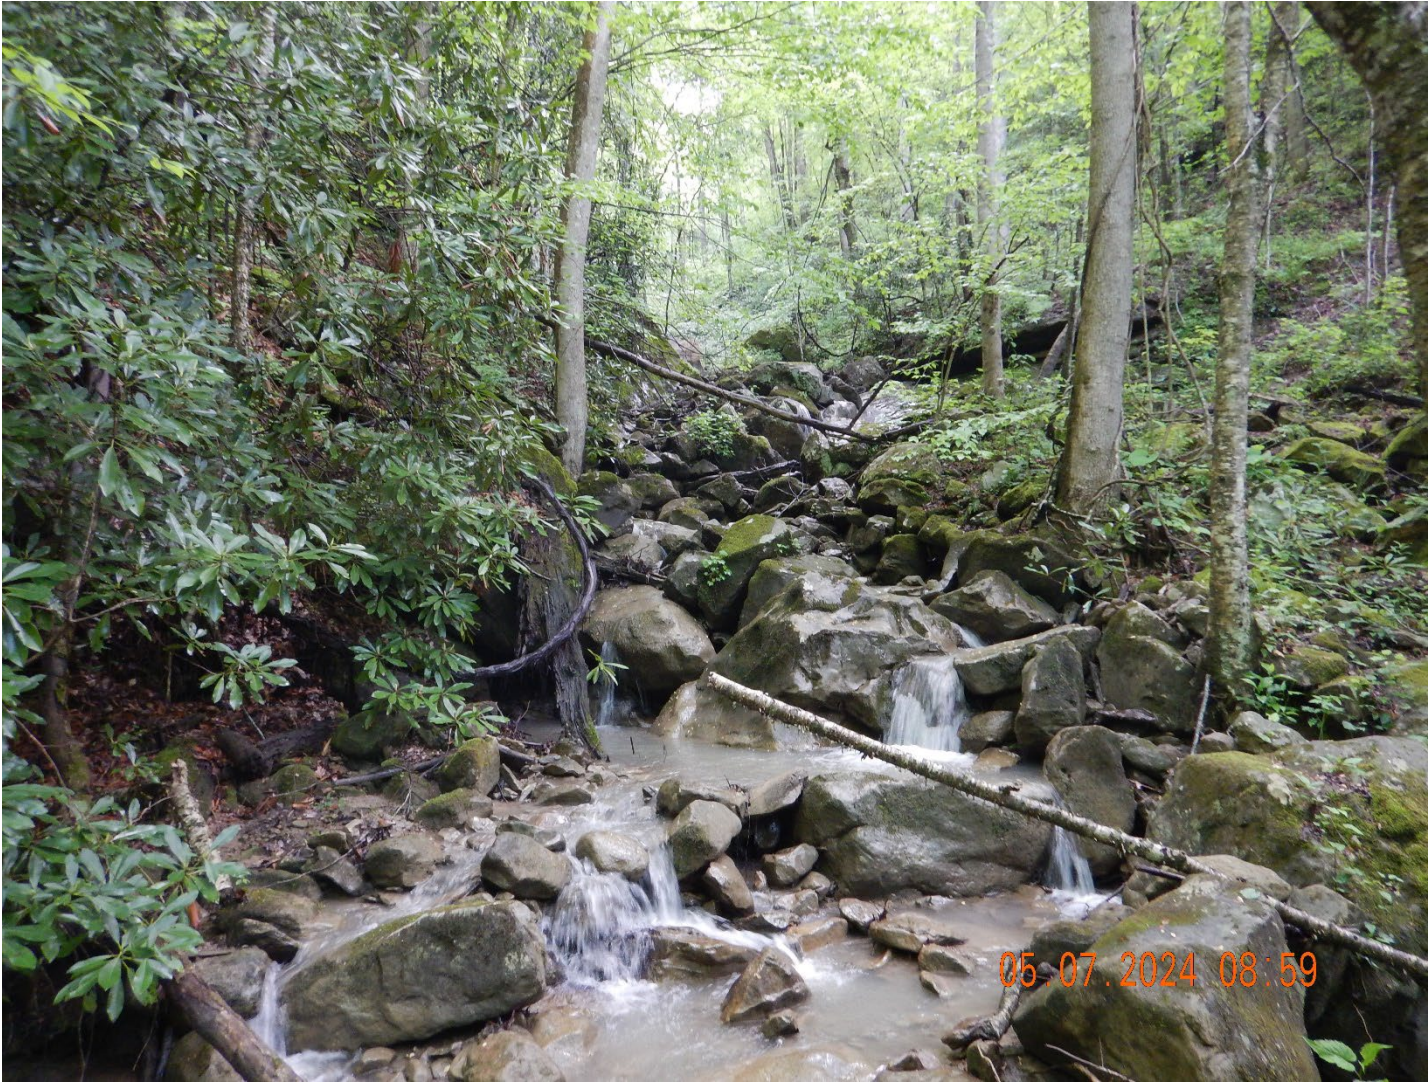
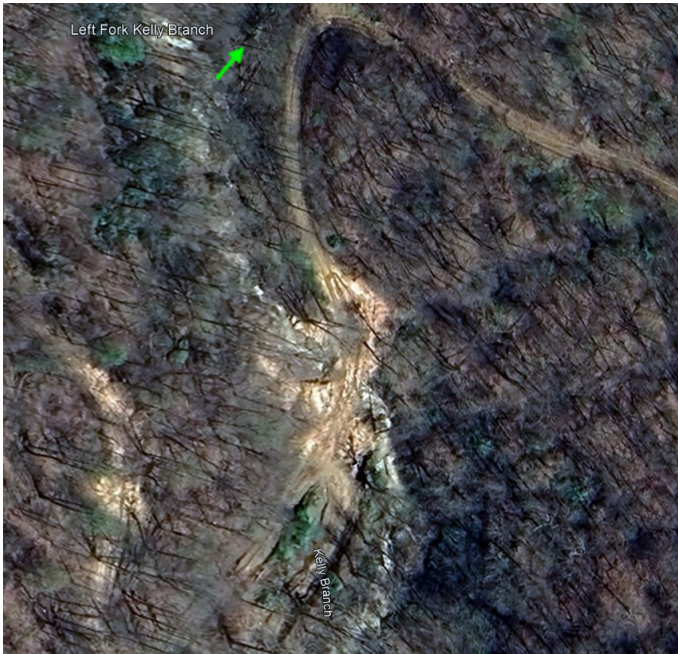
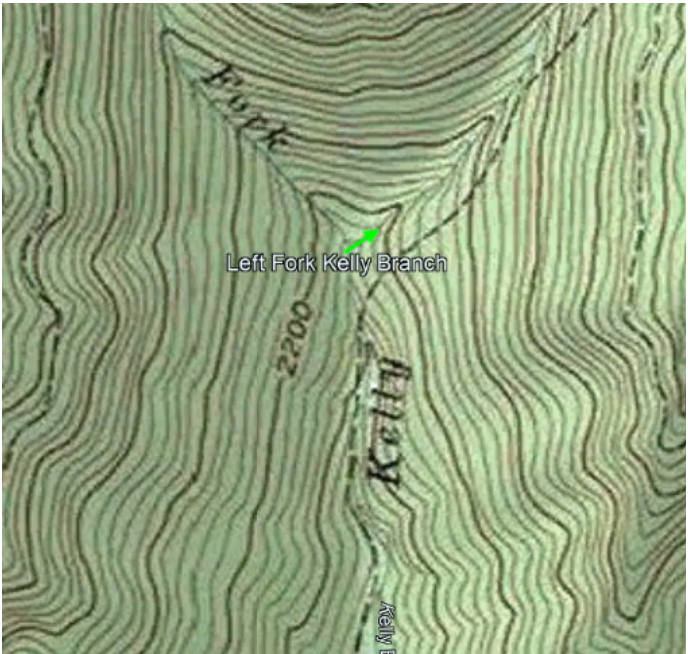
| Title | Photo 9 |

| Description | Mainstem of Kelly Branch facing upstream. |
