## Clean Water Act Section 404: Site Visit/Case Development

| Site Name | Kelly Branch | | | | | | |

Inspection Photographic Log  
Evarts, Kentucky  
May 7, 2024

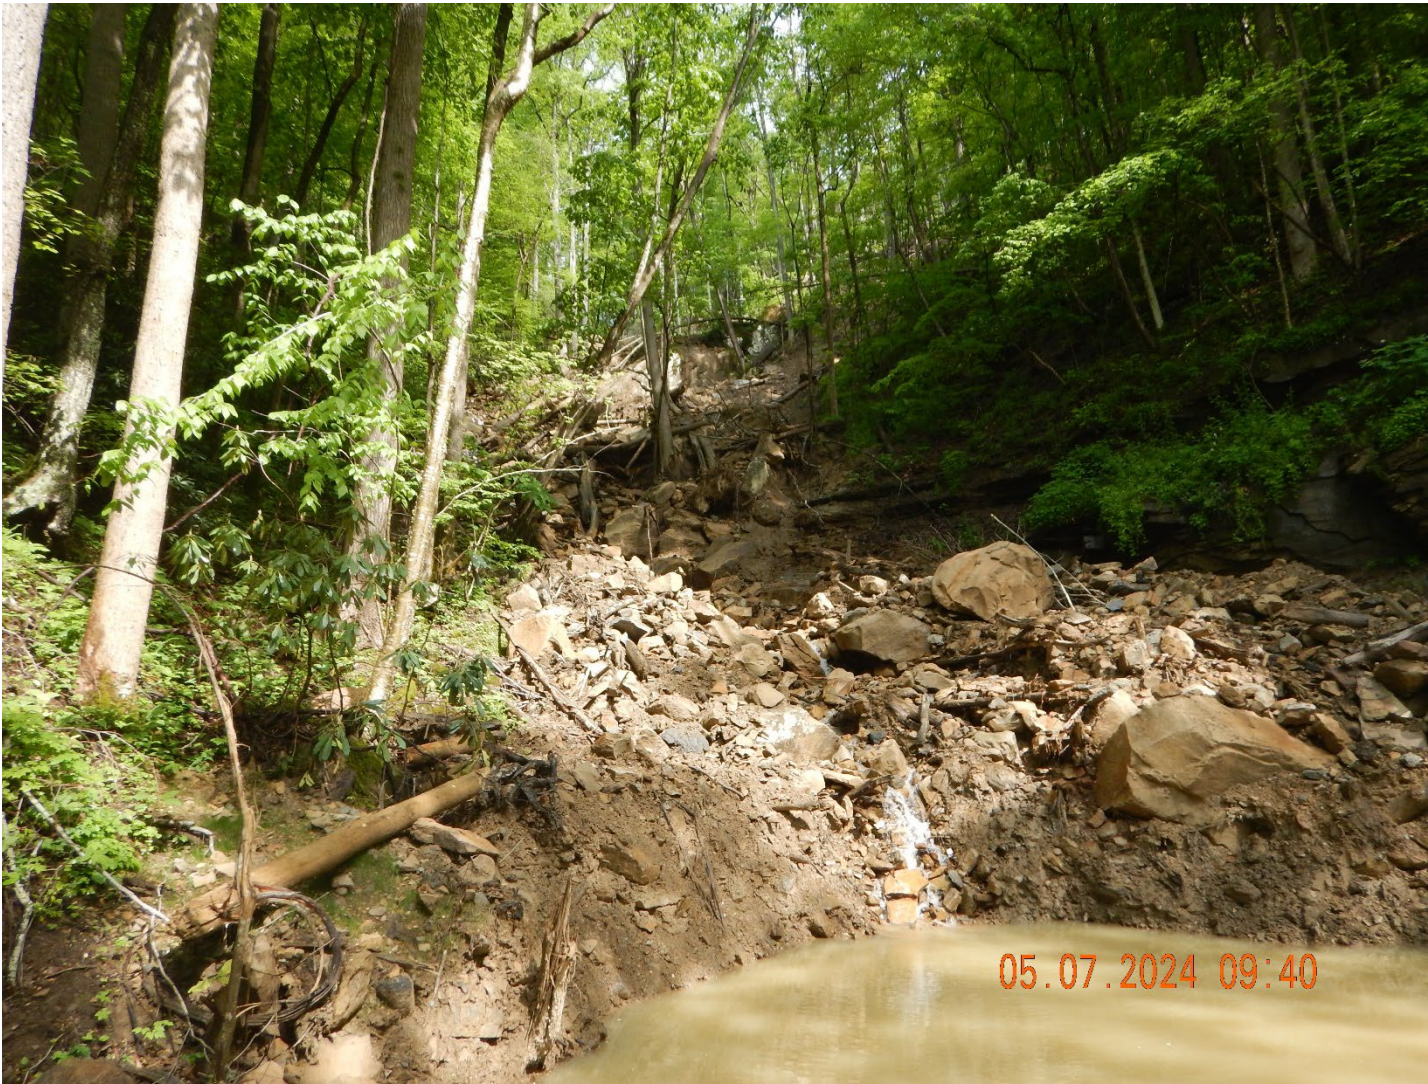
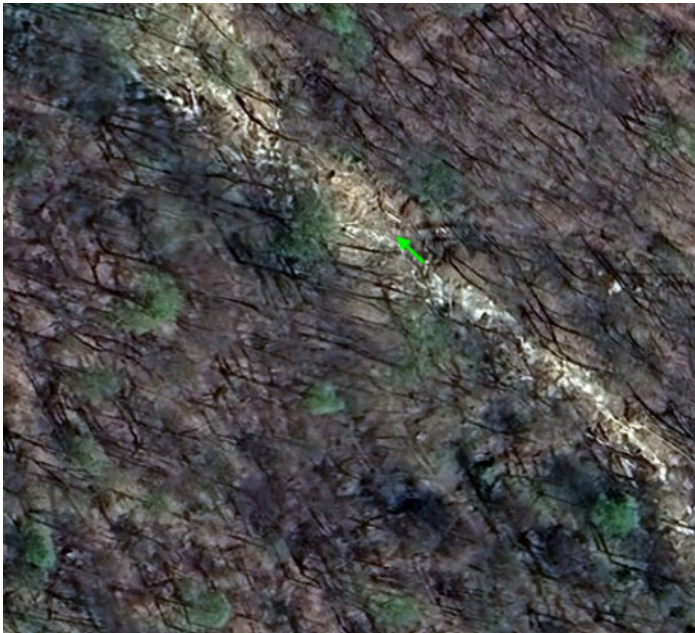
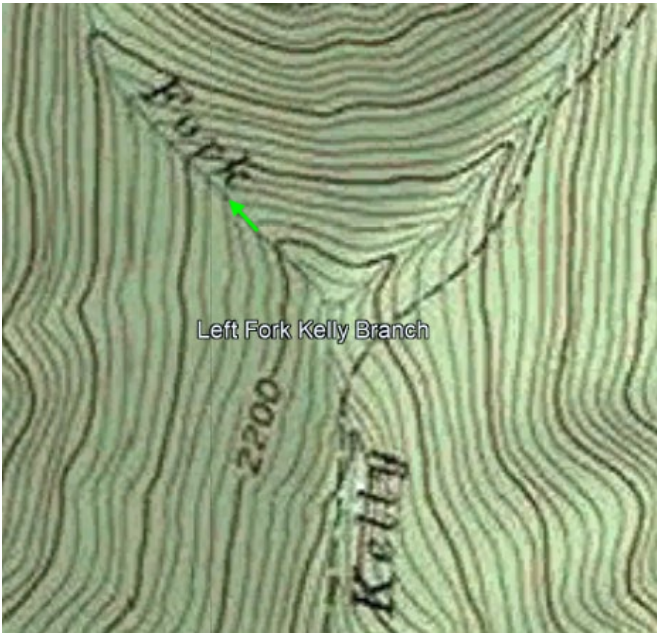
| Title | Photo 9 |

| Description | Left Fork of Kelly Branch, facing upstream. Photo taken at the location of the upper check dam. |

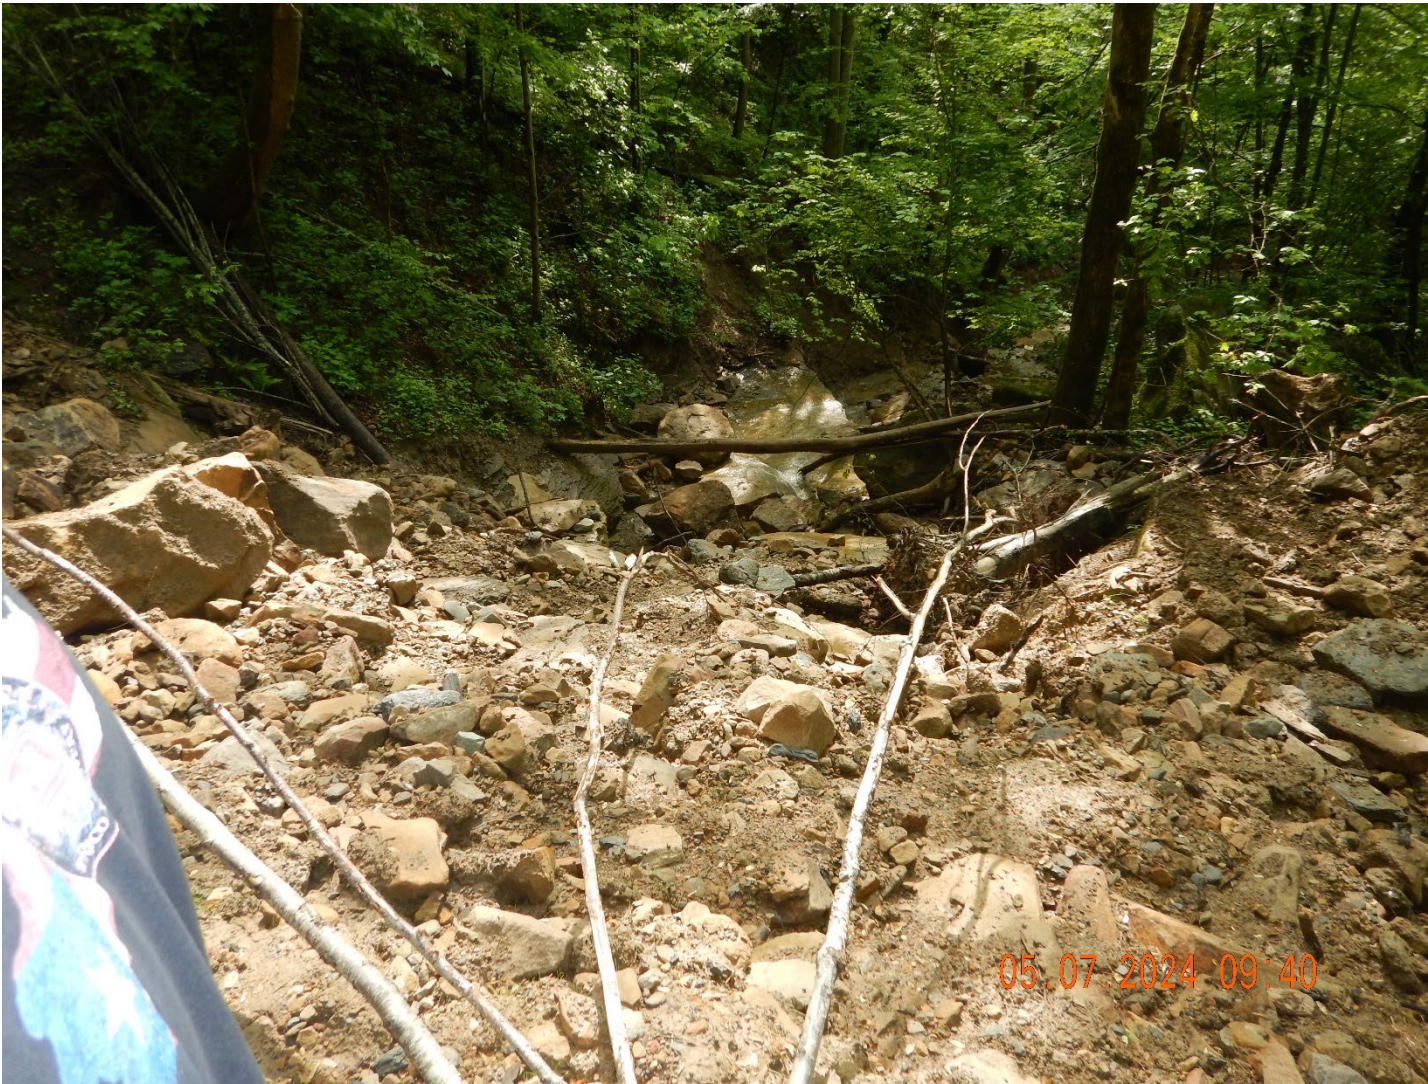
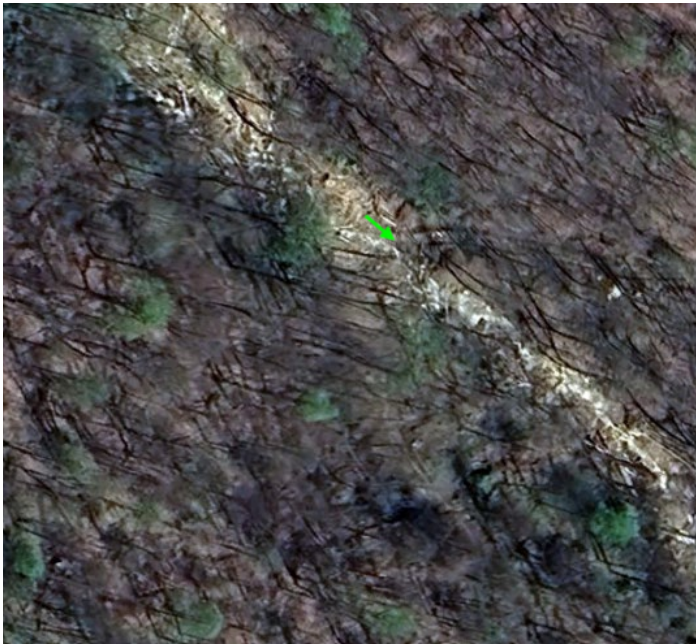
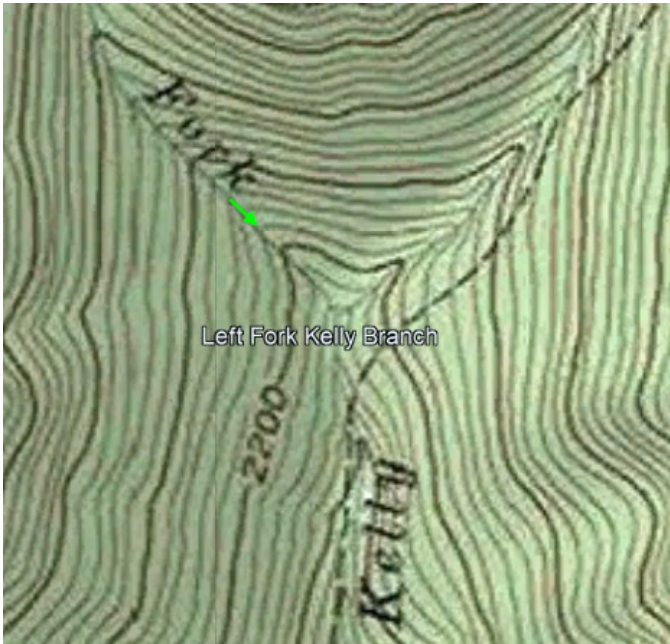
| Title | Photo 9 |

| Description | Same location as previous photo facing downstream. |

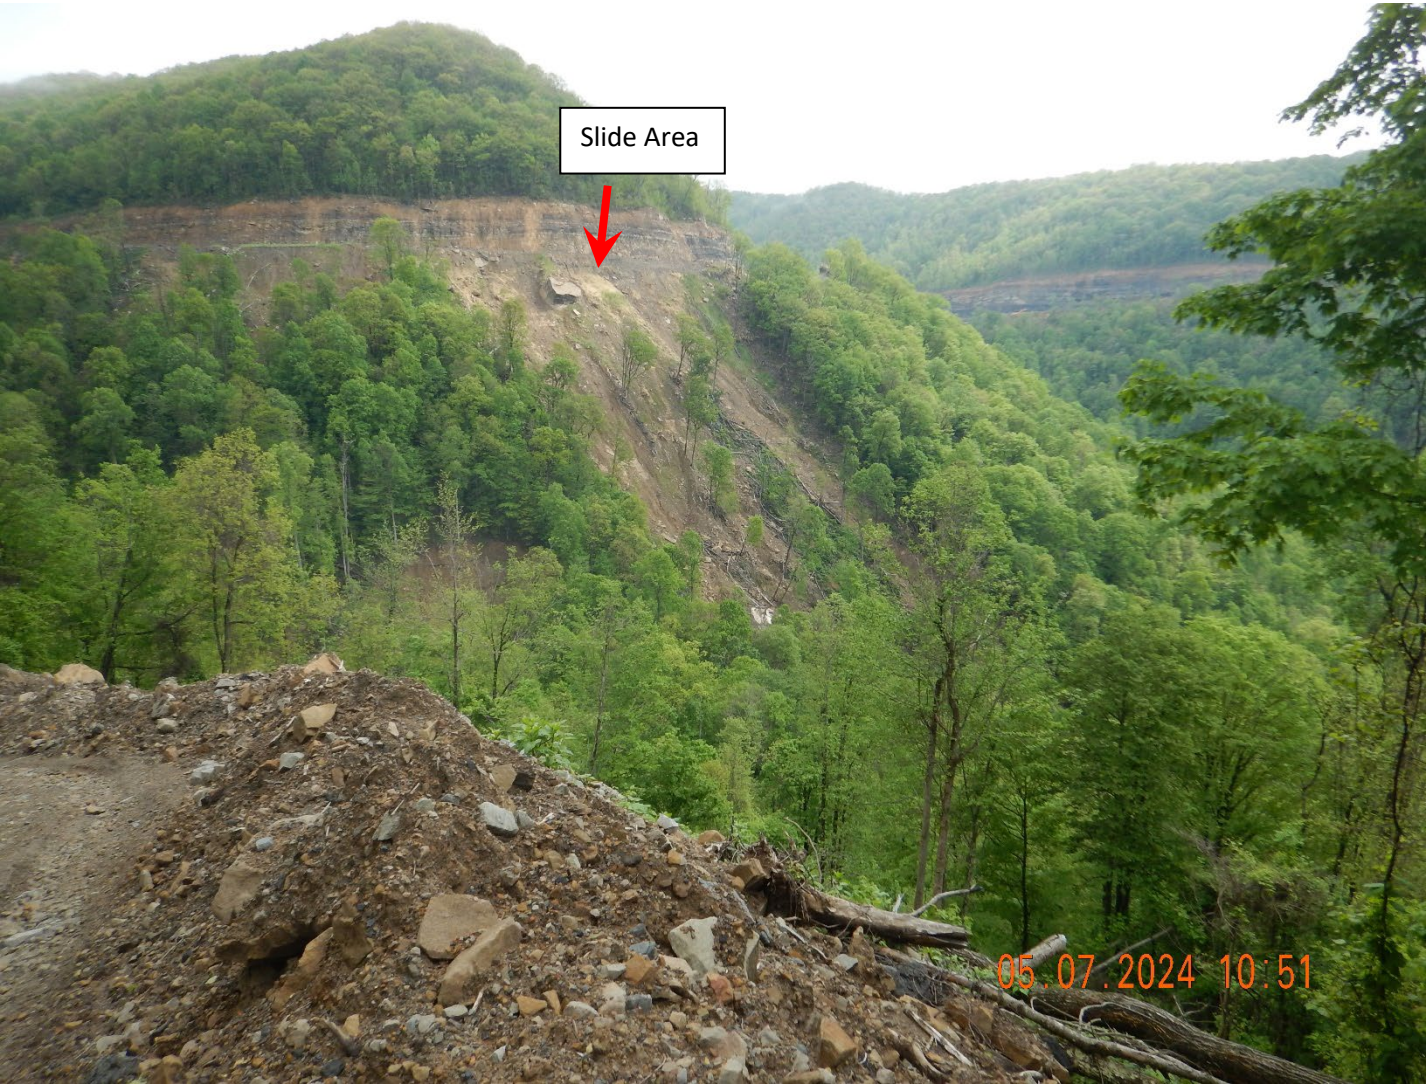
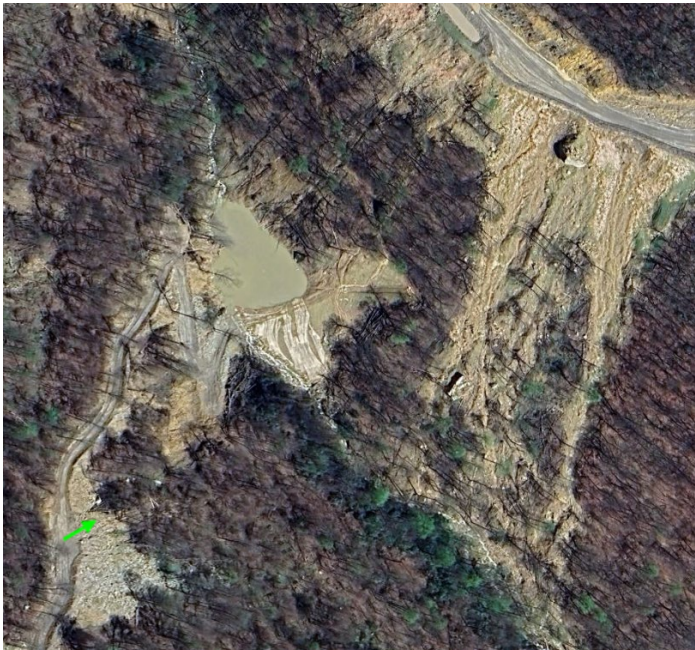
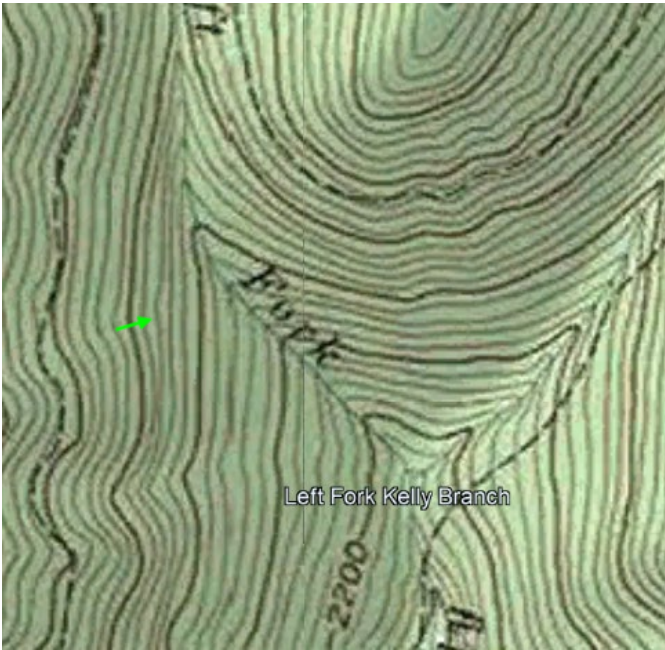
| Title | Photo 9 |

| Multiple landslides occurred on the Site during the mining operation. One slide area impacted the left fork and mainstem of Kelly Branch. Kelly Branch is a tributary of Clover Fork. The Site is located approximately 2.5 miles due east of Closplint, Kentucky (see Attachment A). | | | |

| Description | Photograph of slide area that went into the left fork of Kelly Branch. Photo taken from Pond 8 access road. |

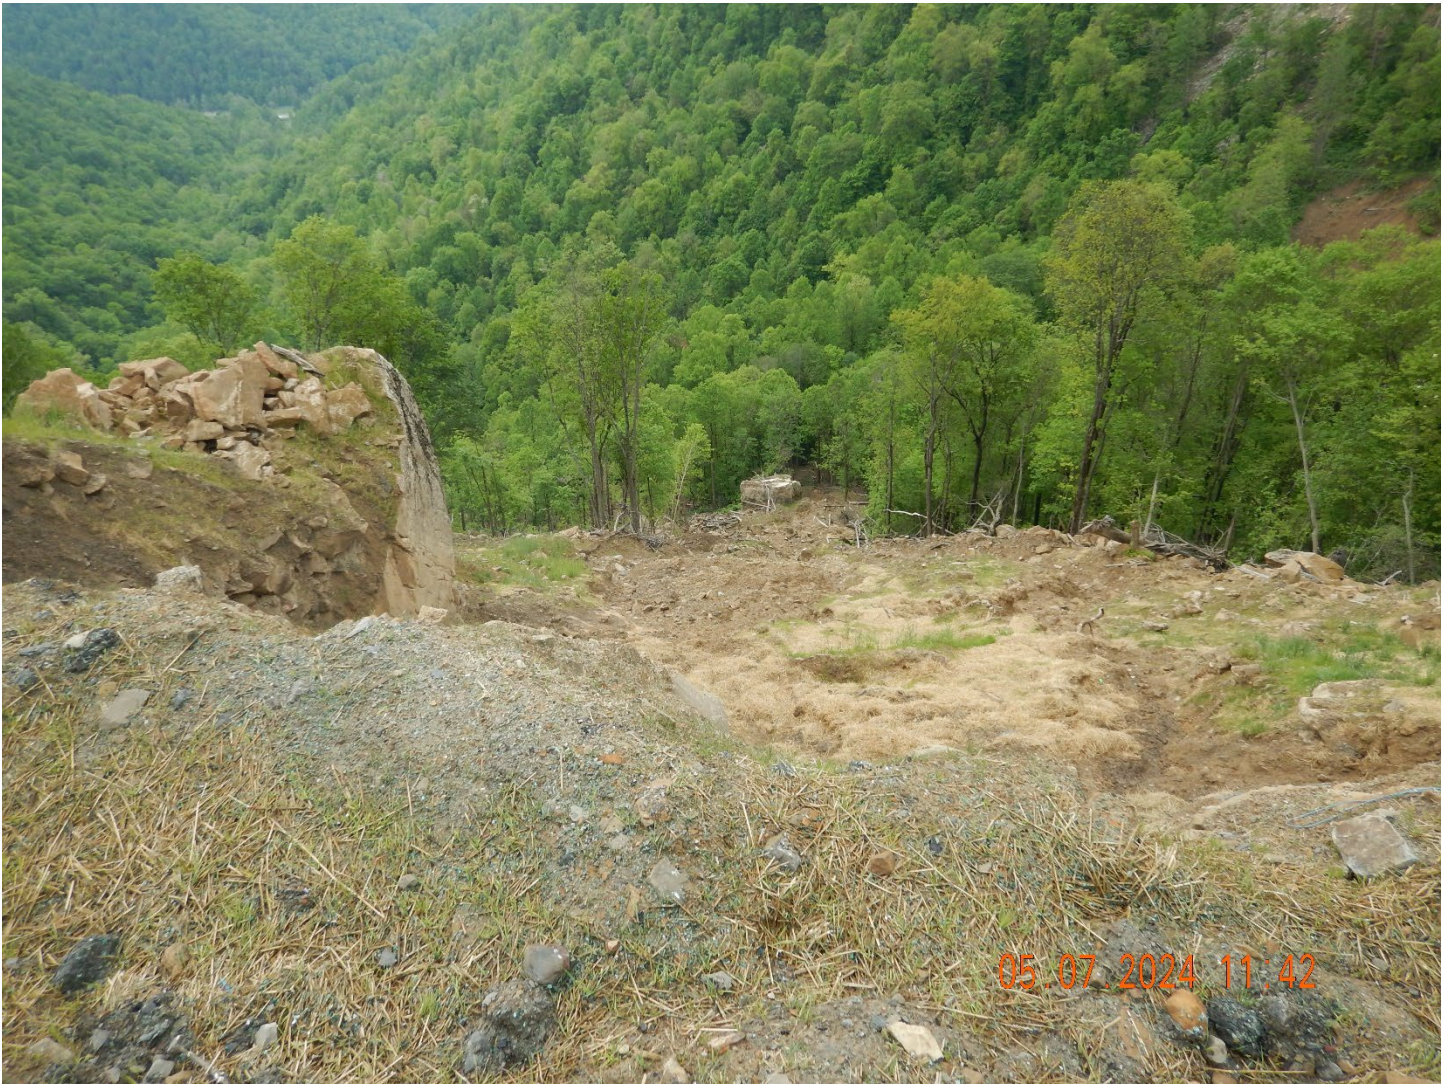
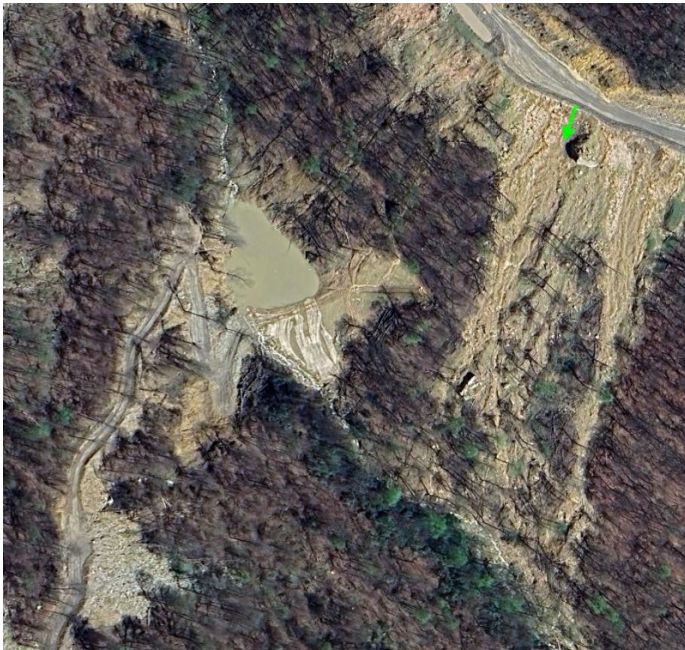
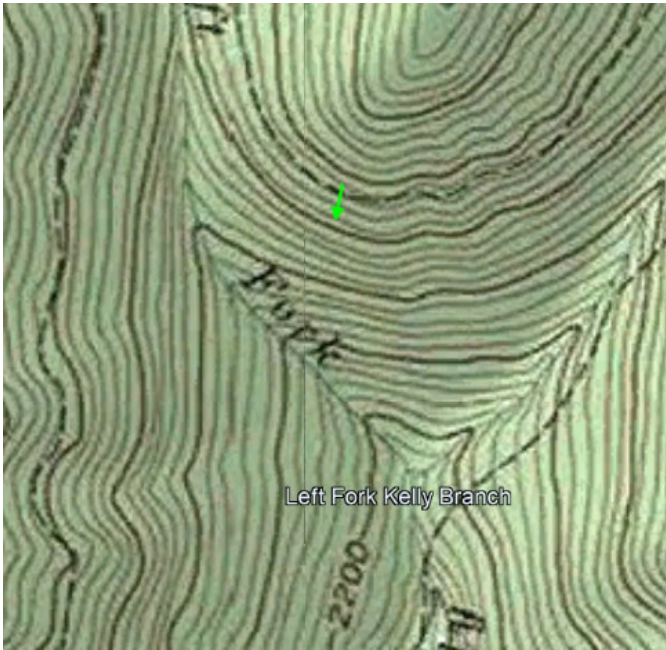
| Title | Photo 9 |

| Description | Photo of slide are from mine bench, facing toward the left fork of Kelly Branch. |

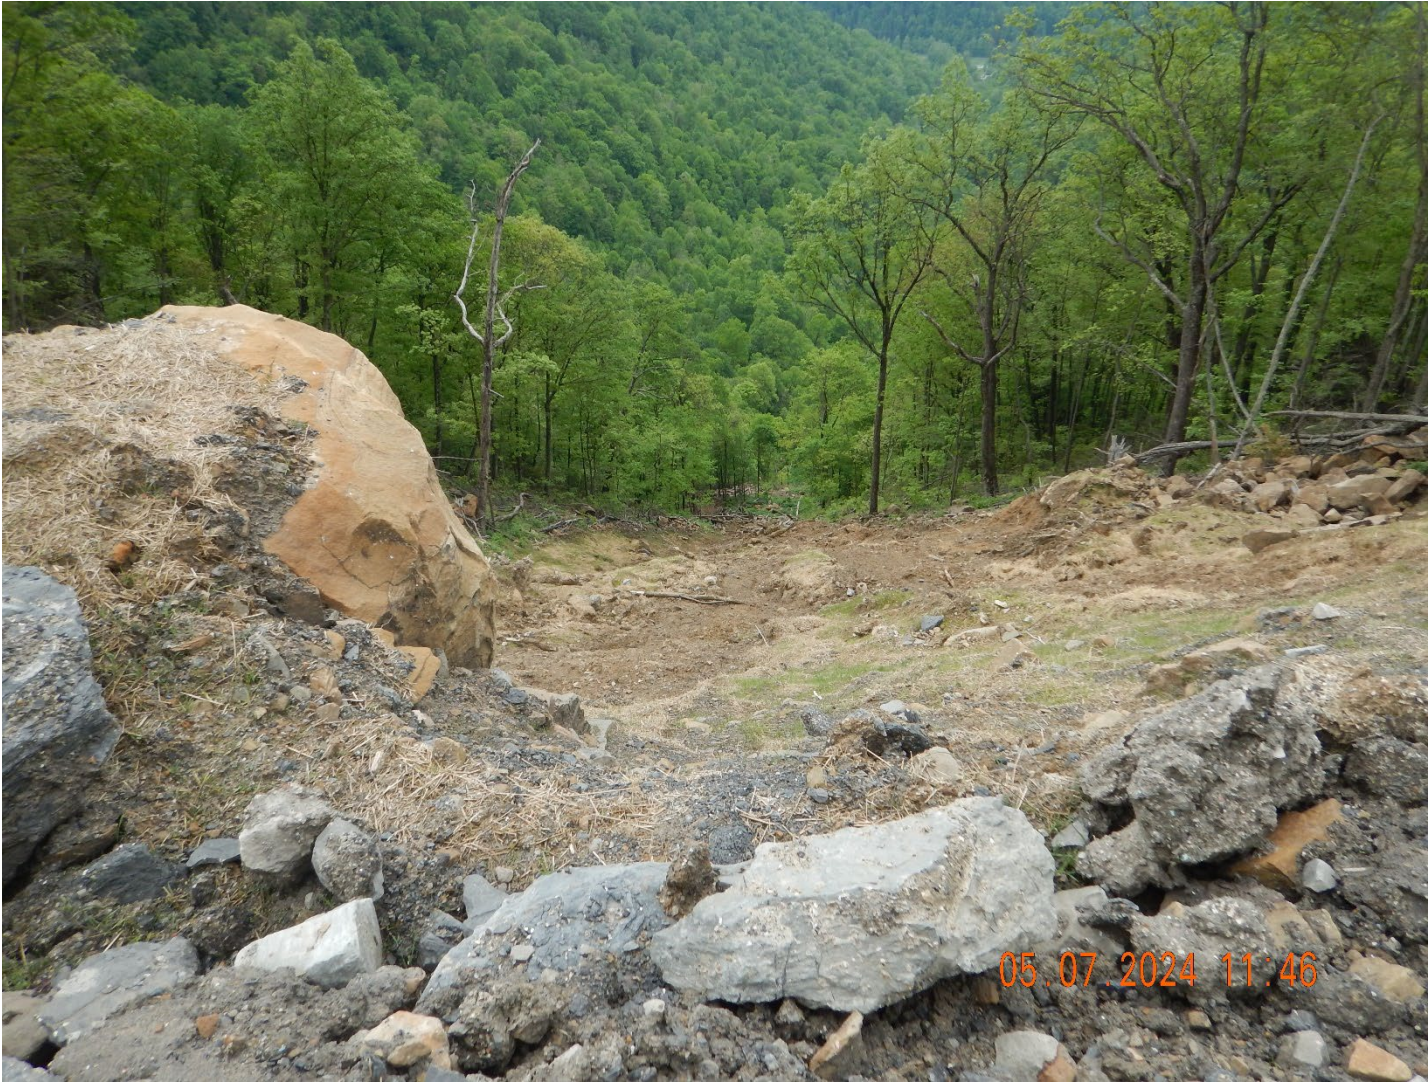
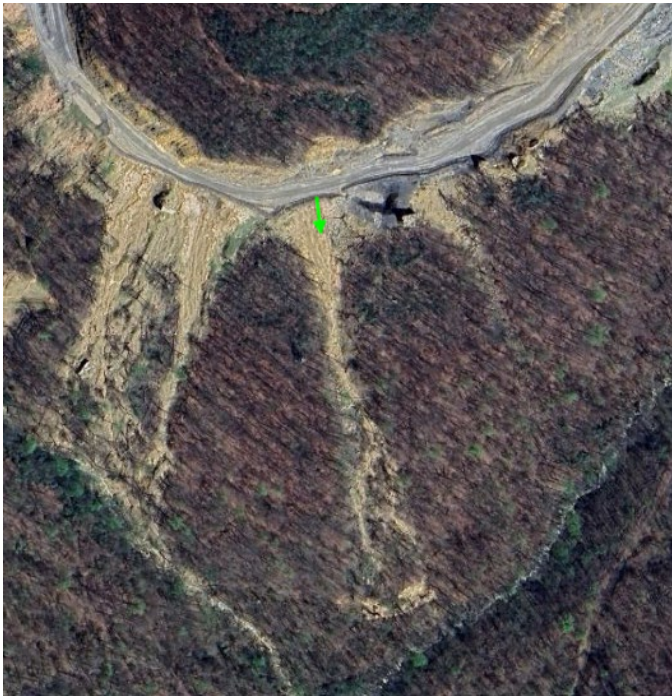
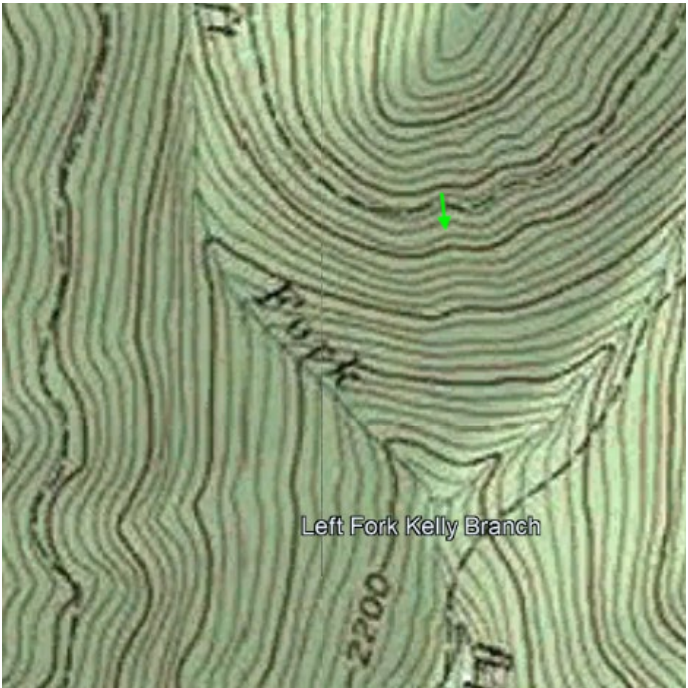
| Title | Photo 9 |

| Description | Looking down second slide that impacted the mainstem of Kelly Branch. |
