**UNION  
CARBIDE****INTERNAL CORRESPONDENCE****UNION CARBIDE CHEMICALS COMPANY**P. O. BOX 471, TEXAS CITY, TEXAS  
335

July 2, 1964

Failure of Spiral Wound Gaskets -  
H Gas Unit

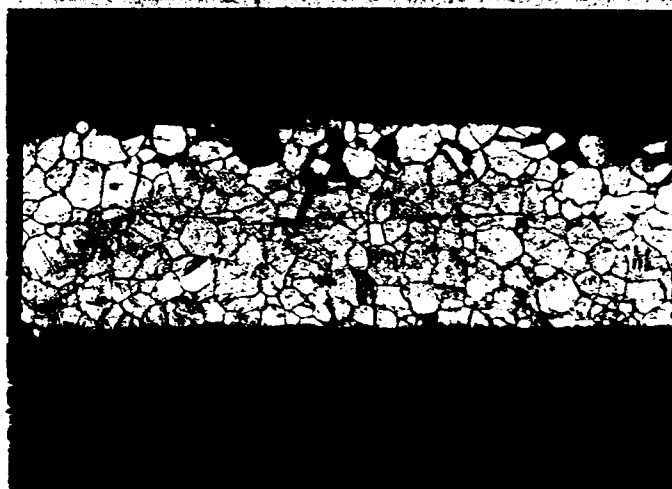
Close examination of the damaged gaskets revealed the type 304 stainless steel spiral material to be embrittled or cracked in a large number of places and the asbestos packing to be very hard, brittle, and shiny black. Metallographic examination of the stainless spiral revealed the attack to be intergranular corrosion of sensitized 304 stainless steel. An example of this corrosion may be seen in Fig. 2. With the temperatures involved, it appears that some decomposition of the asbestos packing and its filler material has taken place, releasing some corrosive constituent such as HCl. By comparison, the 3-inch gasket was found to be built of 316 stainless spirals and the asbestos packing was still soft and fibrous in nature. The three gaskets which failed were part of the original material ordered for the unit, while the 316 gasket was taken from the Brownsville plant stores.

A review of the Flexitallic catalog indicates that they have two types of asbestos which are supplied in their gaskets. One is the Canadian asbestos which is compounded with some filler material, and the second is a blue African asbestos. The 316 gaskets at the Brownsville plant use the blue African asbestos filler. Because of the difference in the appearance of the asbestos packing in the used gaskets, we have assumed that the 304 gaskets which failed contained the Canadian asbestos. The organic filler, or polymer material, which was used to bind the fibers together, is believed to have caused the corrosion of the stainless steel.

Fig. 2 A portion of the corroded 304 stainless steel spiral is shown in this photomicrograph. This intergranular attack is believed to have been caused by decomposition products of the filler in the asbestos packing.

150 X - Electrolytic Oxalic Acid Etch.

As a result of this investigation, we recommend that all the Flexitallic gaskets used in the hot zones of the H gas reaction system be specified as type 304 stainless steel with blue African asbestos. We surmise from the catalog and from discussions with Mr. W. S. Jackson, of our Purchasing Department, that when a Flexitallic gasket is ordered as "stainless steel with asbestos filler," one would receive 304 stainless and the Canadian asbestos. This is the standard run-of-the-mill gasket. If a particular stainless alloy, or more resistant asbestos material is required, it will be necessary to specify them individually.
