## **RCRA Inspection Report**

Safety-Kleen Systems, Inc.  
3700 La Grange Rd.  
Smithfield, Kentucky 40068

EPA ID#: KYD053348108  
NAICS #: 562211 – Hazardous Waste  
Treatment and Disposal

June 05, 2024, at 9:00 AM – 6:15 PM

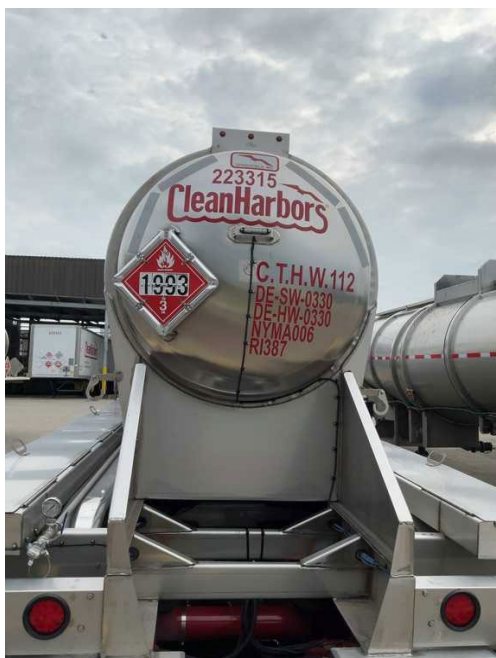
| Photo 03 | IMG-2024060509564556452293913.jpg |

This area is used to store tankers and box trucks carrying waste that are either waiting to unload waste or waiting to load waste to ship offsite (Photo 2). This area is covered under the RCRA permit as a solid waste management unit (SWMU). It was noted that a few tankers did

| Tanker# 223315 with no waste label and not empty. | 38.4334738, -85.23152284 |

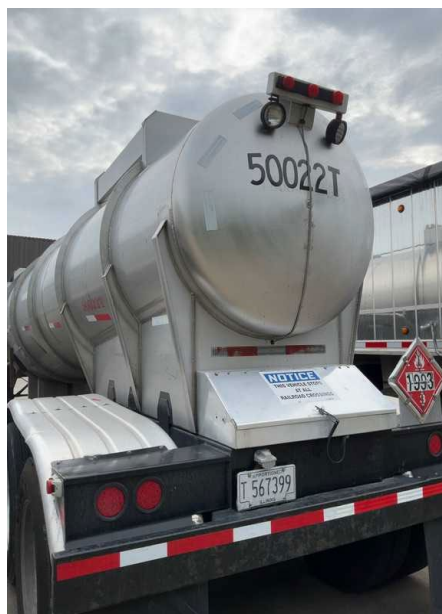
| Photo 04 | IMG-2024060509573757372306858.jpg |

| Tanker# 50022T with no waste label and not empty. | 38.43348312, -85.23151397 |

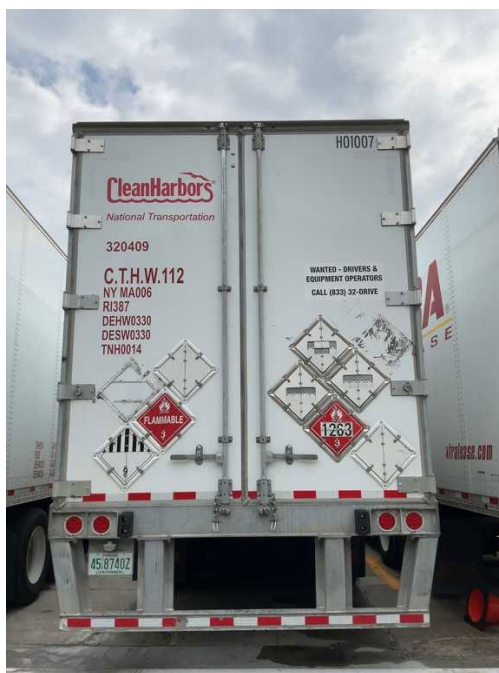
| Photo 05 | IMG-202406051004214212429511.jpg |

| Tanker# 320409 with no waste label and not empty. | 38.43348312, -85.23151397 |

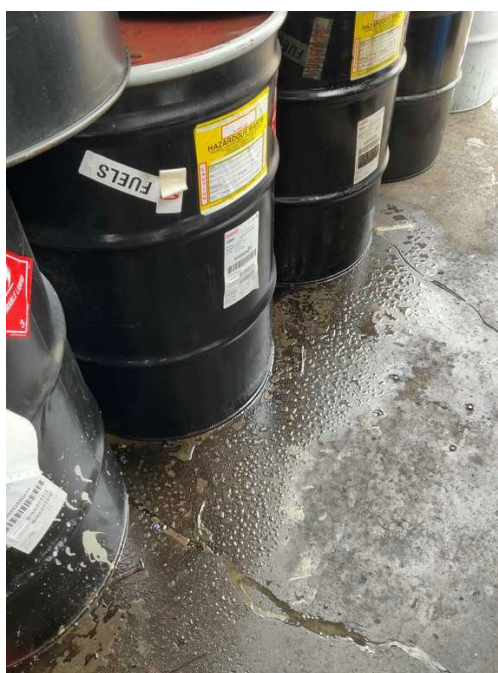
| Photo 08 | IMG-2024060510164516454252189.jpg |

appeared to be a leak coming from a container of waste (Photo 8). The facility representatives immediately placed absorbents around the area and began addressing the container that was leaking.

| Lower Dock – Leaking container. | 38.43348312, -85.23151396 |

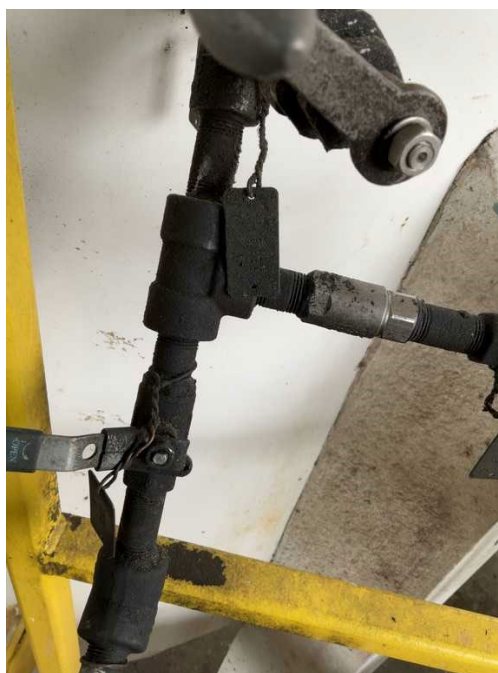
| Photo 11 | IMG-2024060510305130512429886.jpg |

The D-tank farm is covered under the RCRA permit and stores seven (7) 7,500-gallon aboveground storage tanks (Photos 9-10). The tanks are situated on concrete secondary containment which appeared to be in good condition and free of visible cracks. All the tanks were labeled “Hazardous Waste” and marked with an indication of the hazard of the contents. Tank system equipment such as pumps, valves, and flanges appeared to be tagged to identify each piece of equipment pursuant to Subpart BB Air Emission Standards for Equipment Leaks. However, approximately three tags appeared illegible (Photo 11).

| D-Tank Farm. Illegible tags on tank equipment. | 38.43348313, -85.23151395 |

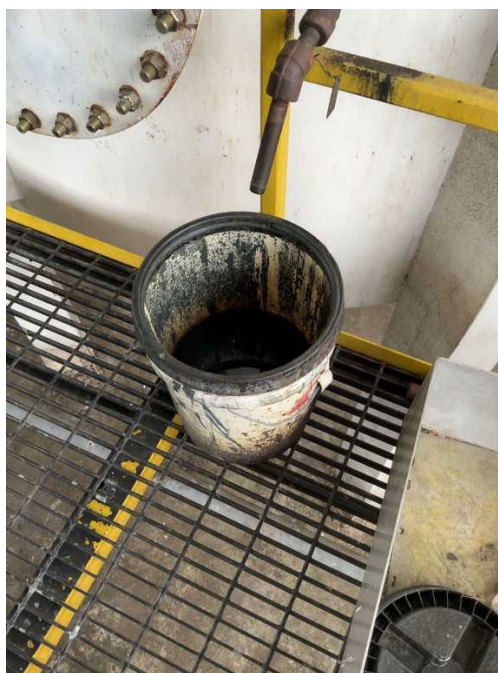
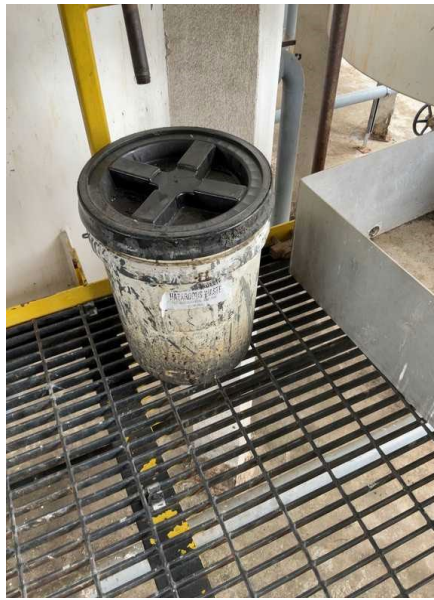
In front of tank 5104 the inspectors noticed an open 5-gallon bucket of an unknown liquid and a faded hazardous waste label on it (Photos 12-13). The facility representatives closed the bucket with a lid but could not determine the contents of the liquid.

| D-Tank Farm – Unknown liquid in 5-gallon bucket. | 38.43348311, -85.23151396 |

| D-Tank Farm – Unknown liquid in 5-gallon bucket. | 38.43314364, -85.23181949 |

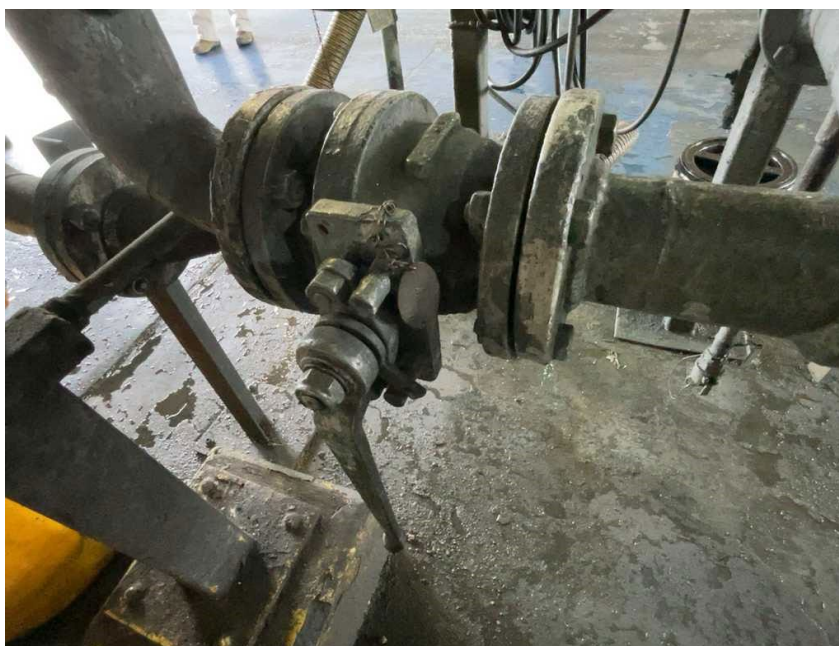
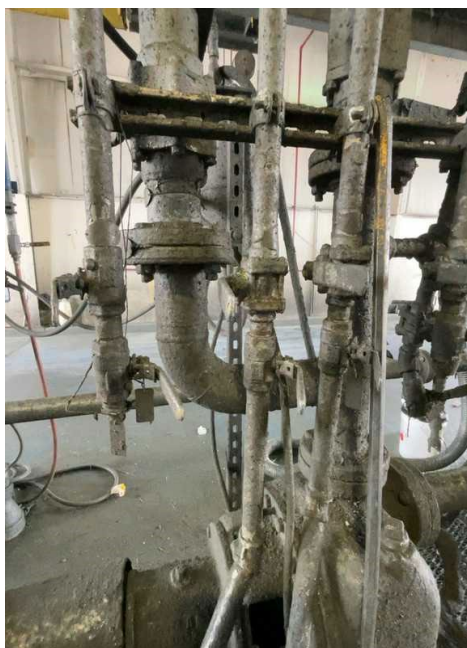
The Tanker Tunnel is covered under the RCRA permit as a SWMU and is used to unload liquids for fuel blending to designated tanks and load fuel onto tanker trucks from the tank farms that are ready to be shipped offsite for fuel burning (Photo 23). The tanker tunnel consists of four bays. Bays 1 and 2 are used to unload liquids from tankers while bays 3 and 4 are used to load liquid fuel that is ready to be shipped offsite. The tank tunnel is equipped with secondary containment sumps which are inspected daily and emptied if liquid is accumulating. Pumps and piping connections were marked with tags to identify each piece of equipment pursuant to Subpart BB Air Emission Standards for Equipment Leaks. The inspectors observed that several tags on equipment belonging to bays 1 and 2 were illegible (Photos 24-25).

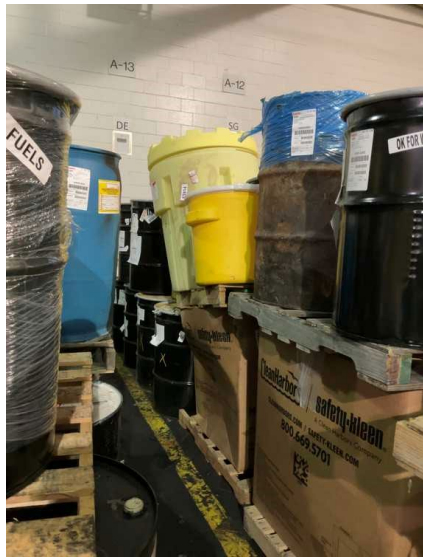
| Photo 35 | IMG-202406051205235232173009.jpg |

| Main Warehouse—Container Storage Area A.<br>Cubic yard box crushed from heavy containers<br>on top of it. | 38.43477622, -85.23107914 |

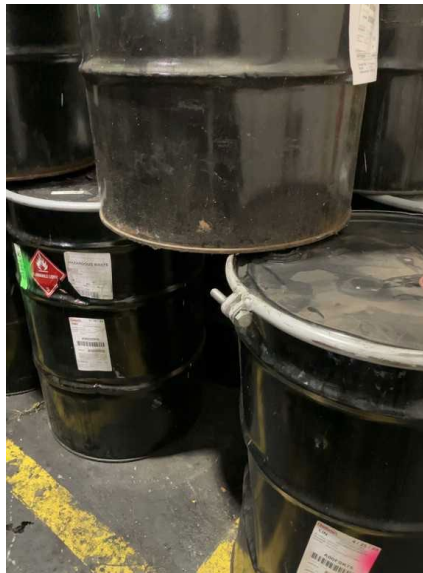
| Photo 35 | IMG-202406051205565562061211.jpg |

| Main Warehouse—Container Storage Area A.<br>Poorly stacked containers. | 38.43477628, -85.2310791 |

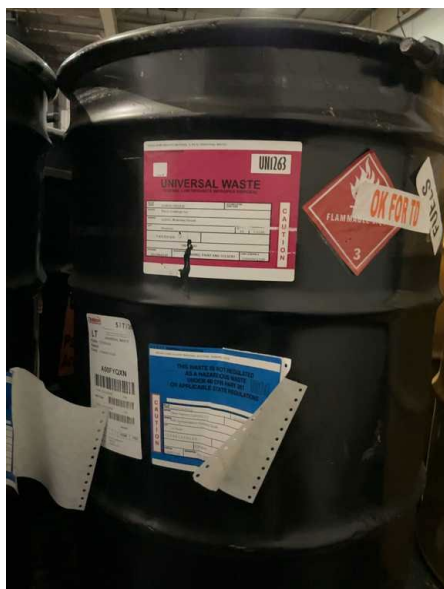
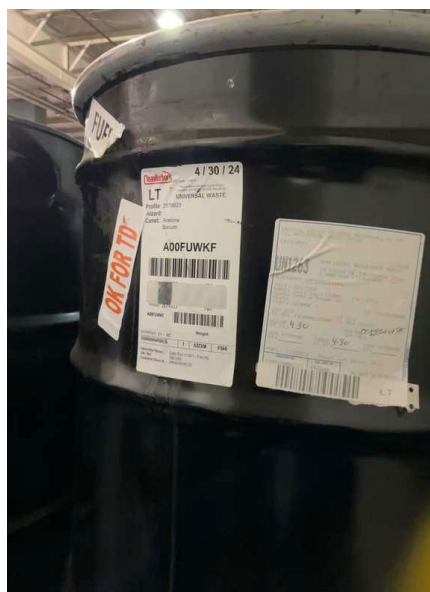
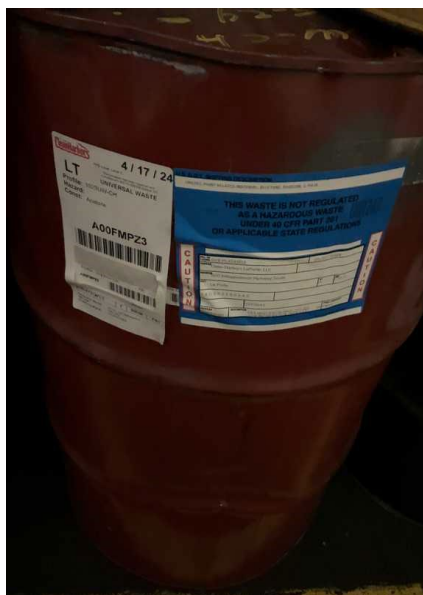
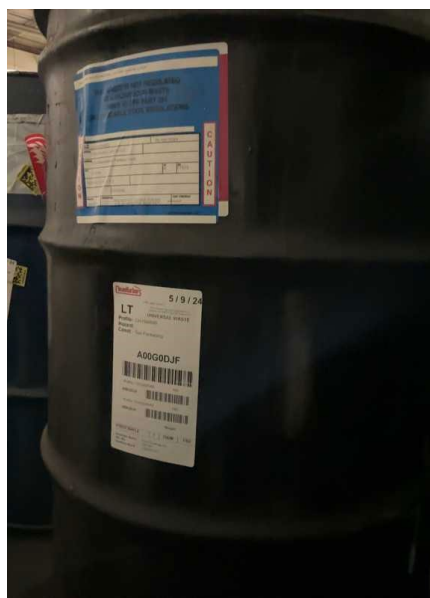
| Main Warehouse—Container Storage Area A.<br>Possible hazardous wastes labeled as universal wastes. | 38.43477656, -85.23107921 |

| Main Warehouse—Container Storage Area A.<br>Possible hazardous wastes labeled as universal wastes. | 38.43441274, -85.23091791 |

| Main Warehouse—Container Storage Area A.<br>Possible hazardous wastes labeled as universal wastes. | 38.43477894, -85.23108027 |

| Main Warehouse—Container Storage Area A.<br>Possible hazardous wastes labeled as universal wastes. | 38.43477629, -85.23107909 |

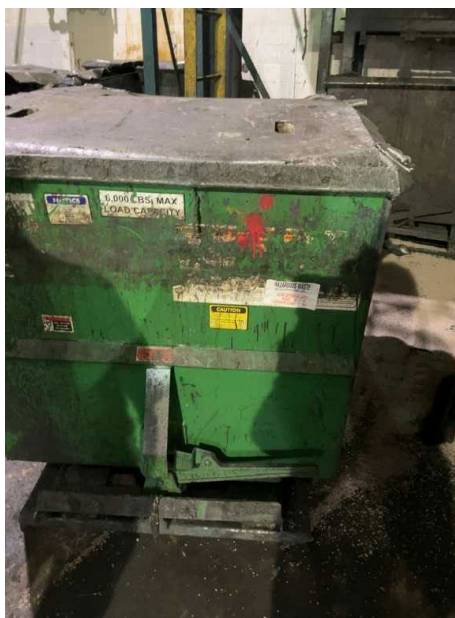
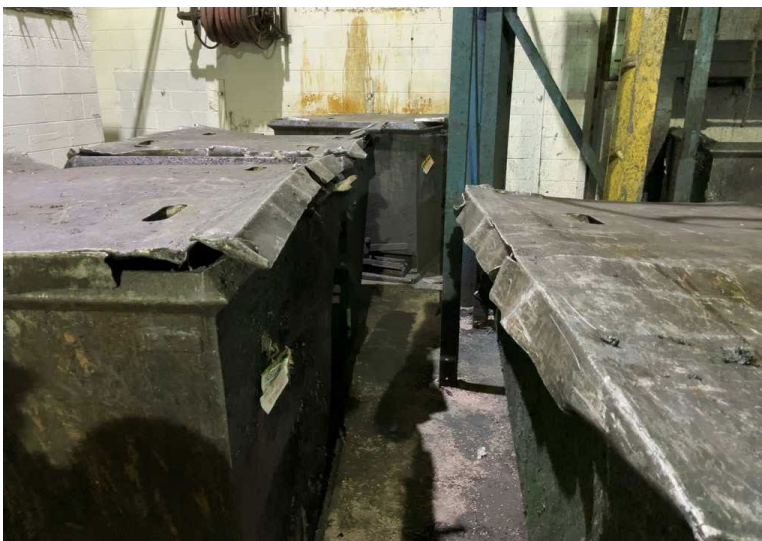
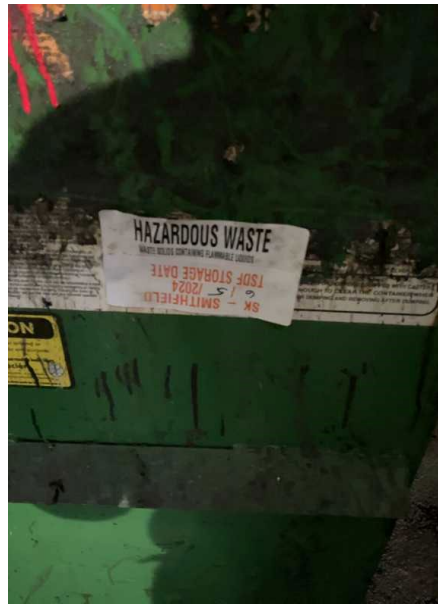
| Main Warehouse—6,0000-gallon hopper of hazardous waste with warped and damaged lid (not securely closed). | 38.43497148, -85.23097935 |

| Main Warehouse—6,0000-gallon hopper of hazardous waste with warped and damaged lid (not securely closed). | 38.43489766, -85.23100905 |

| Main Warehouse—6,0000-gallon hopper of hazardous waste with warped and damaged lid (not securely closed). | 38.43487691, -85.23102055 |
