# Clean Water Act Section 404: Site Visit/Case Development

Site Name	Dick's Concrete
-----------	-----------------

Site Address*	1053 County Road 37 (Pellets Island Road) and 1326 Co Route 12
---------------	--

CWA 404 Inspection Photolog  
Dick's Concrete  
1053 Co Rd 37 and 1326 Co Rt 12  
Orange County, NY

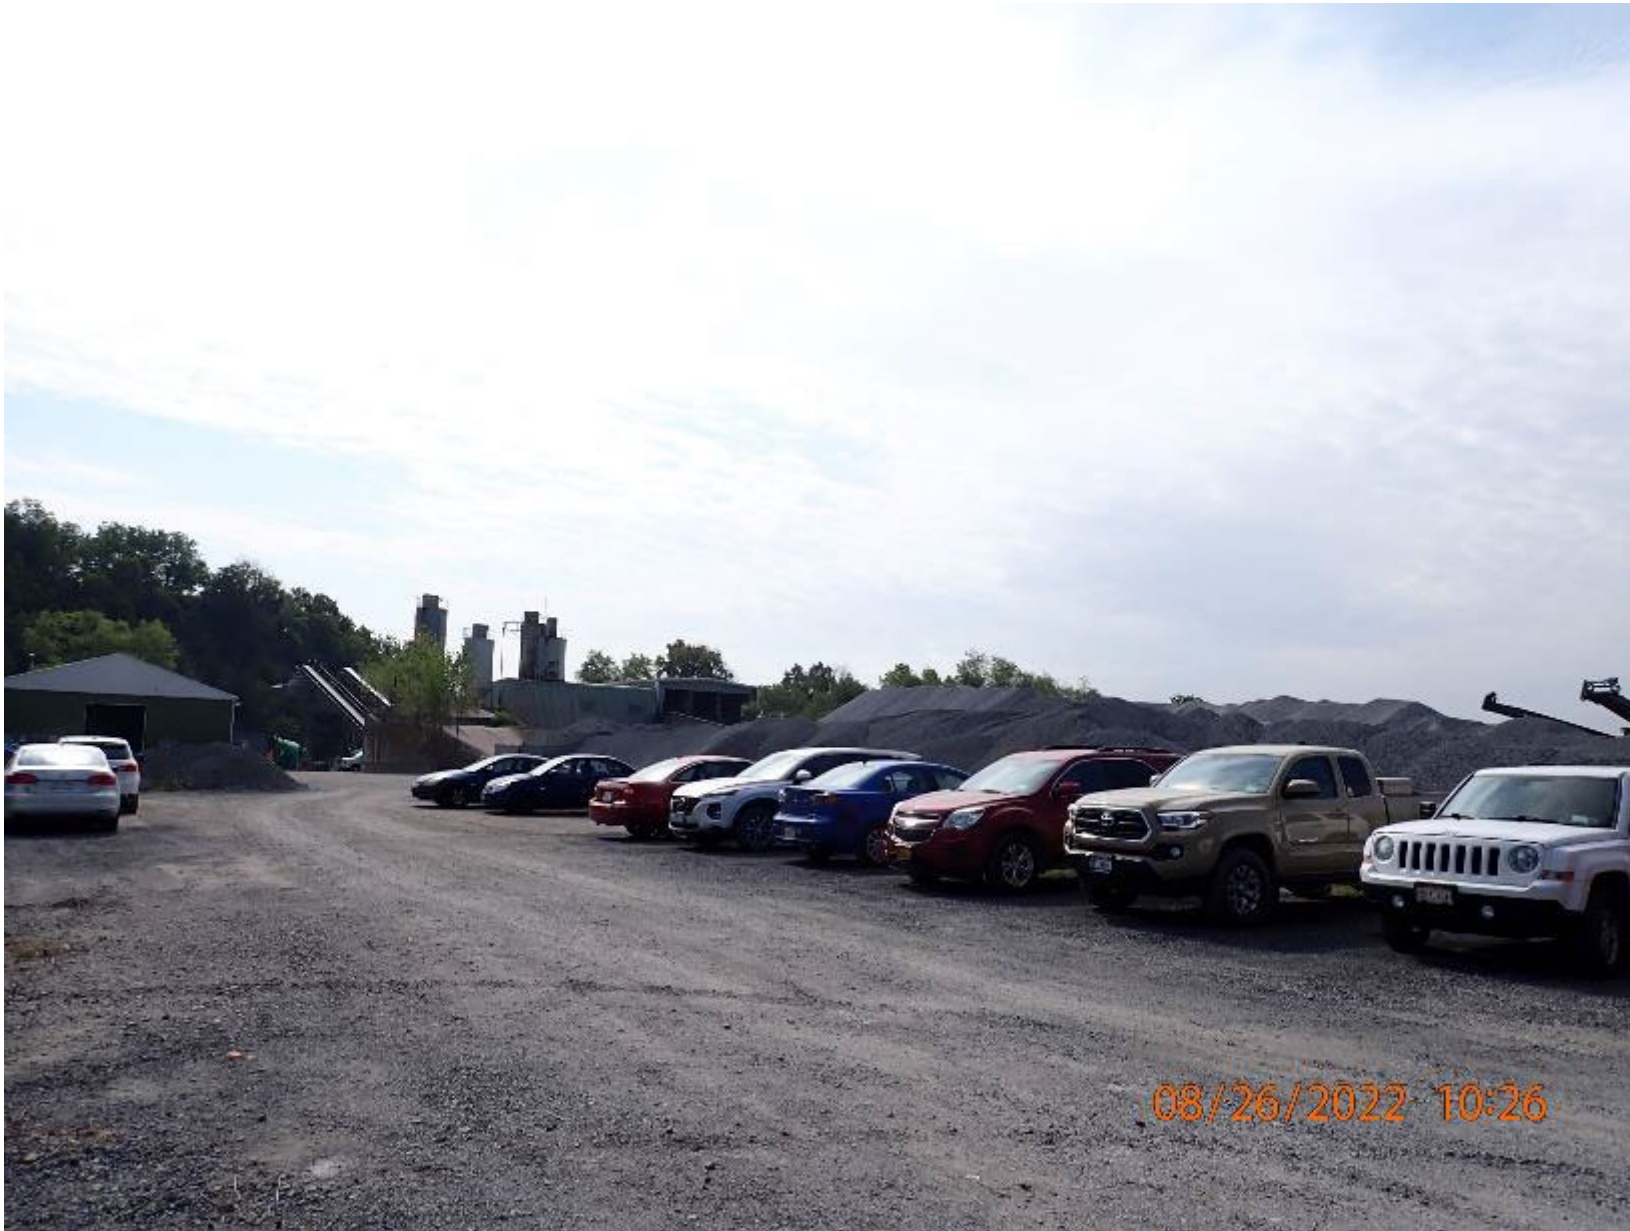
**Date:** 8/26/2022  
**Time:** 10:26 AM  
**Photographer:** SSA  
**Photo ID:** 1 – P8260369

Parking and entrance to Dick's  
Concrete facility

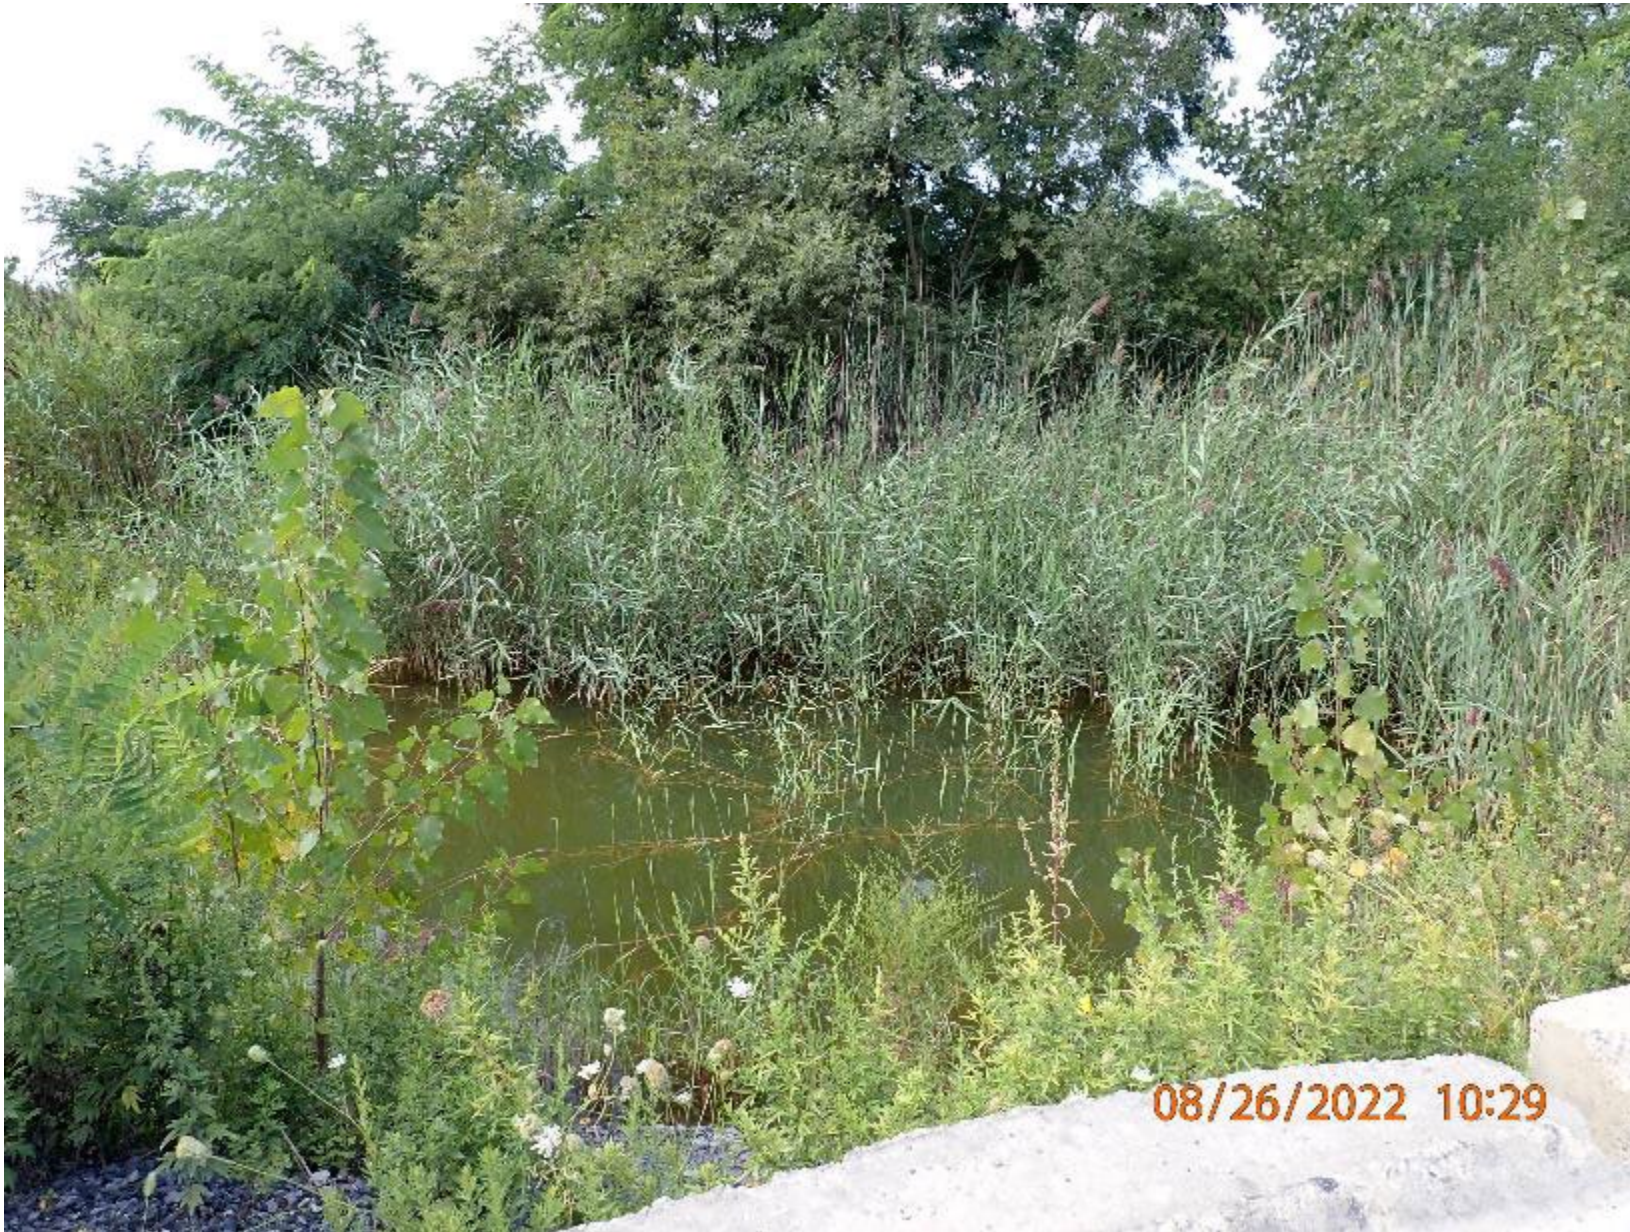
**Date:** 8/26/2022  
**Time:** 10:29 AM  
**Photographer:** SSA  
**Photo ID:** 2 – P8260370

EPA started the inspection at the Dick's Concrete parking lot off of Pellets Island Road/County Road 37. EPA observed basins surrounded by wetland vegetation along the western border of the property.

Man-made pond/basin on western edge of Dick's Concrete property

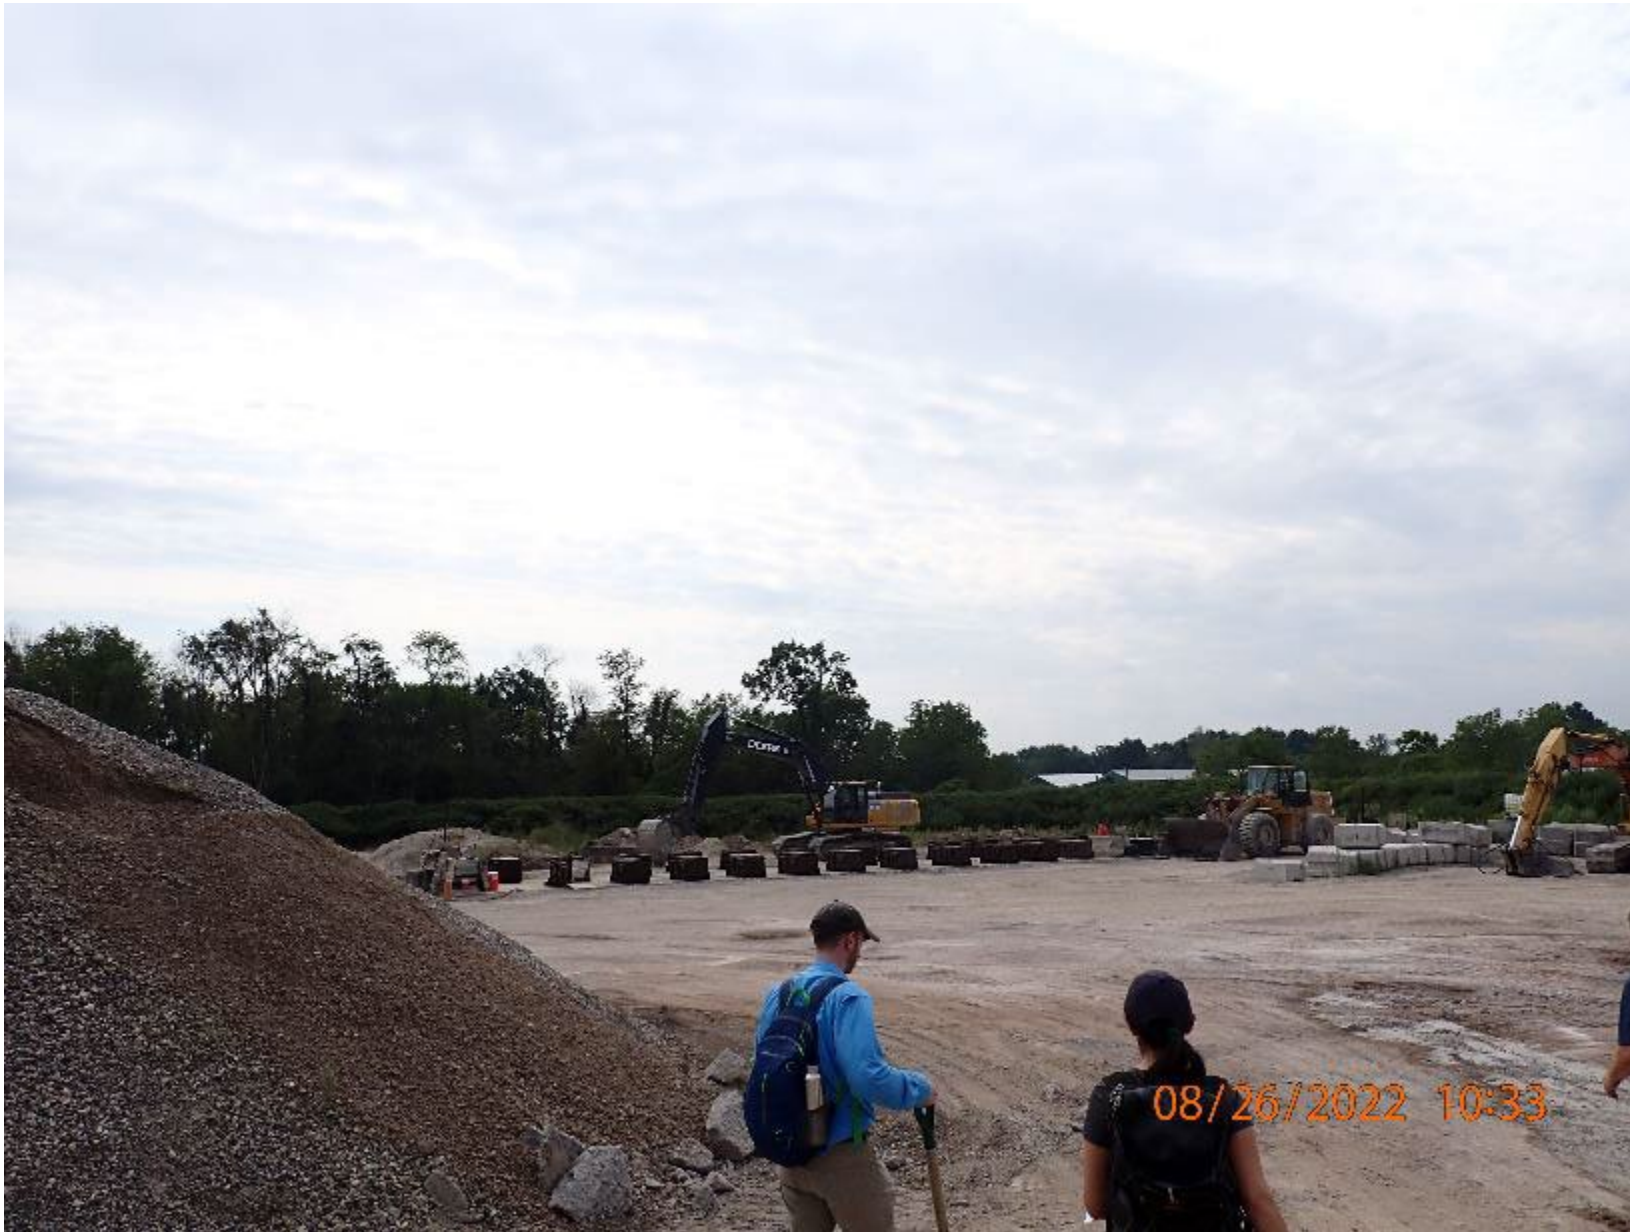
**Date:** 8/26/2022  
**Time:** 10:33 AM  
**Photographer:** SSA  
**Photo ID:** 3 – P8260371

EPA walked south to the Pena Farm, LLC parcel where fill material consisting of dirt and rock had been spread on the property to expand facility operations. The area was undeveloped and flat with the exception of piles of dirt, rock, and concrete. A berm measuring 15+ feet high surrounded the southwestern portion of the expansion area, separating it from agricultural channels to the south and west. Early successional plants had colonized portions of the area. Mr. Penaluna explained that the prior owner had constructed a berm several feet high to prevent runoff from entering the surrounding channels and that Dick's Concrete had added material to the top of the berm in some areas. EPA observed upland trees on and near the berm including, but not limited to, black walnut and staghorn sumac. Phragmites, an herbaceous wetland plant, was also observed between the berm and the agricultural channels.

Facility expansion area, disposal area for returned concrete

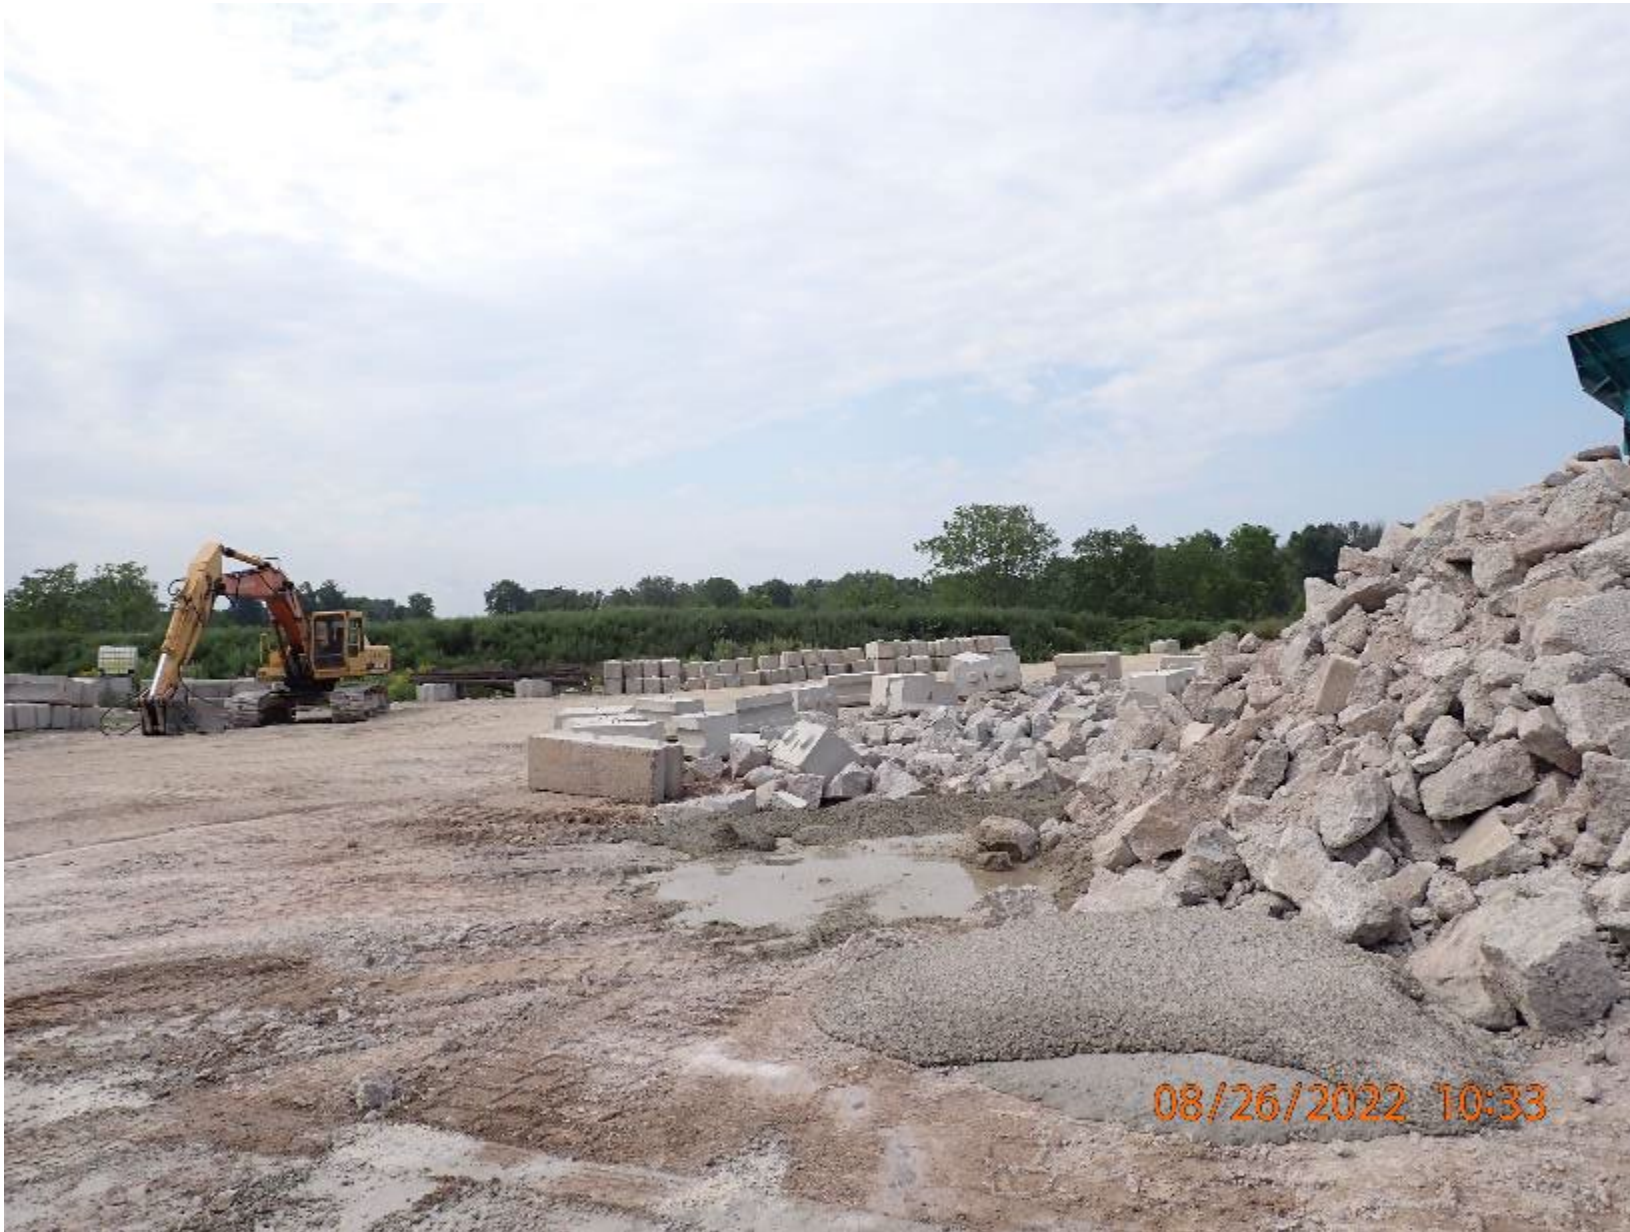
**Date:** 8/26/2022  
**Time:** 10:33 AM  
**Photographer:** SSA  
**Photo ID:** 4 – P8260372

Facility expansion area, disposal area for returned concrete

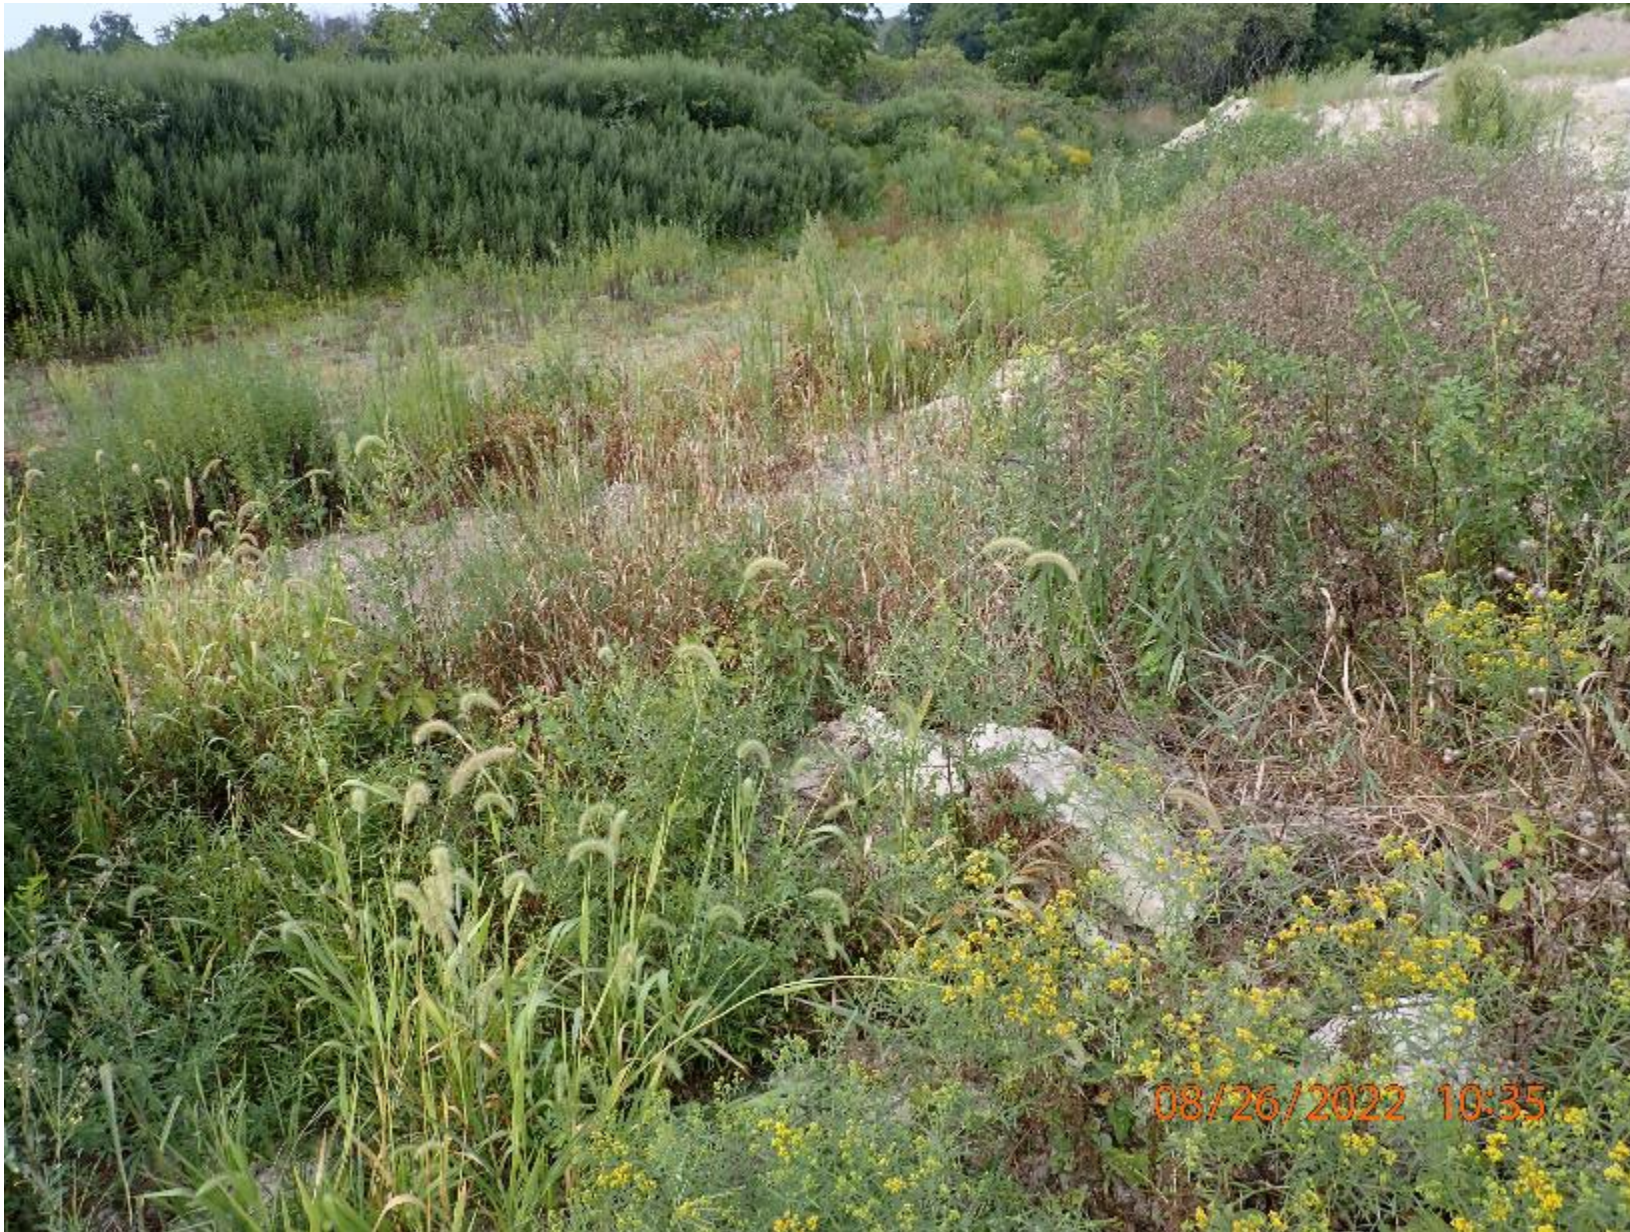
**Date:** 8/26/2022  
**Time:** 10:35 AM  
**Photographer:** SSA  
**Photo ID:** 5 – P8260373

Southern border of expansion area; berm in background

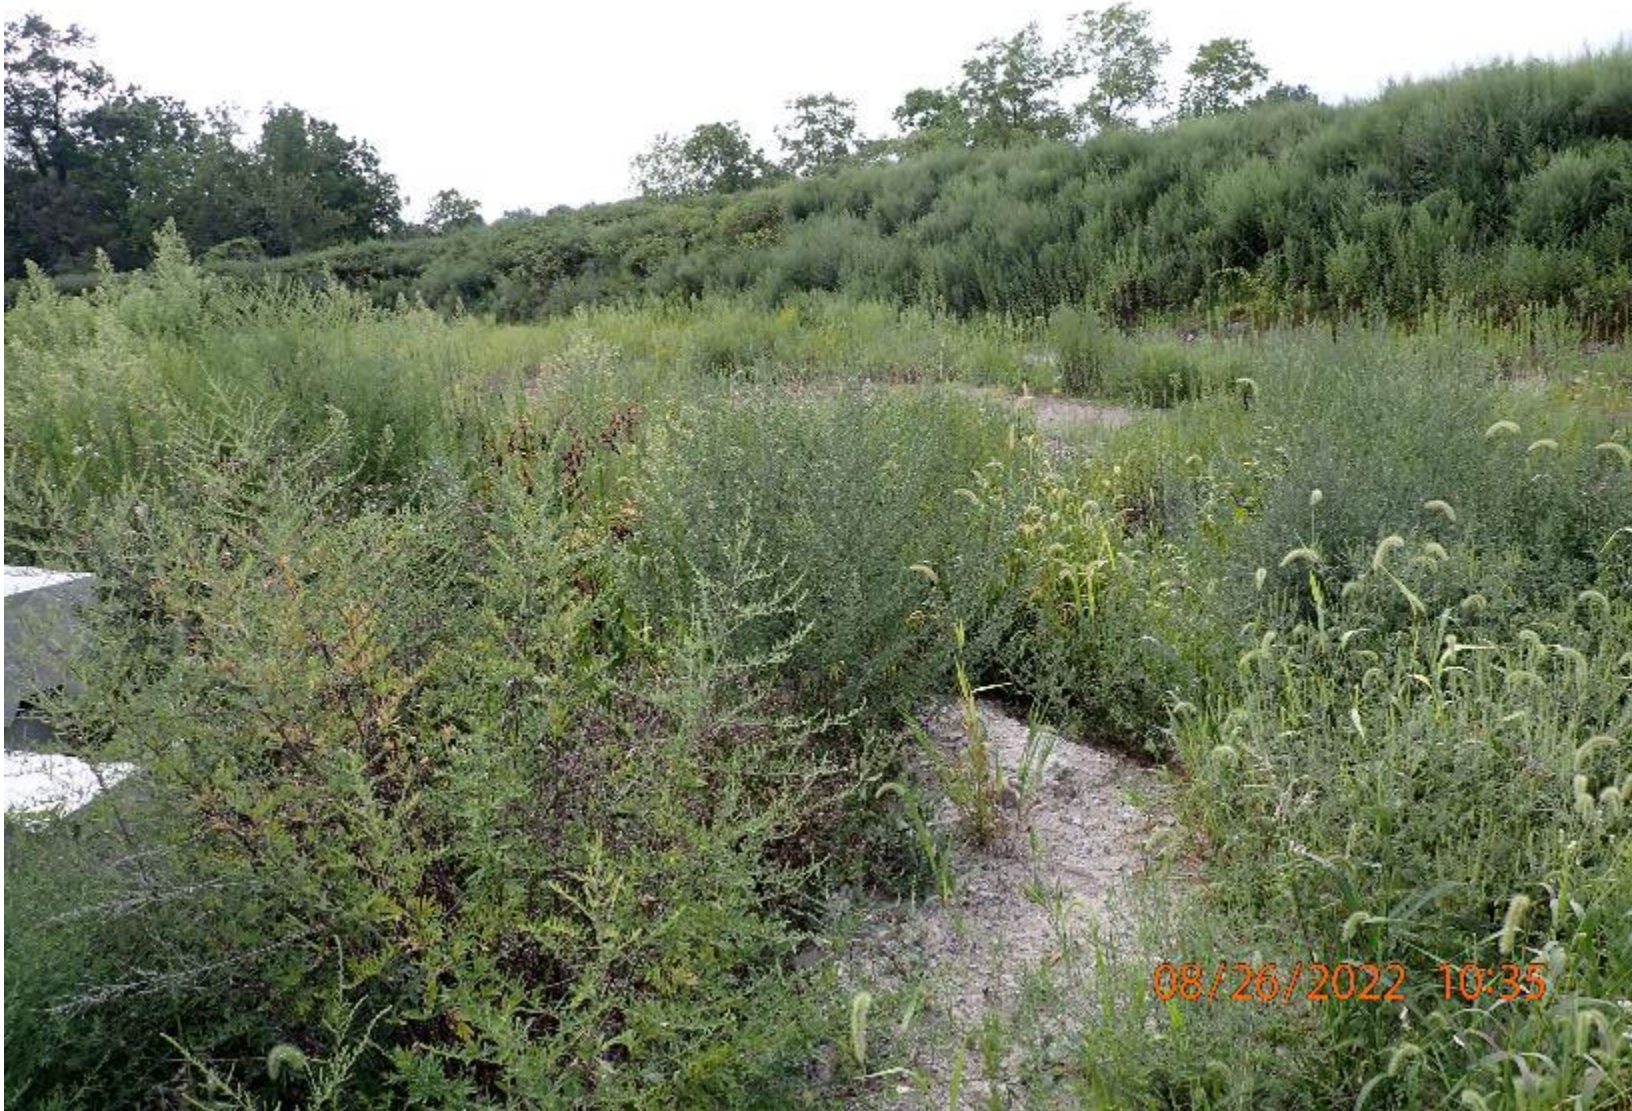
**Date:** 8/26/2022  
**Time:** 10:35 AM  
**Photographer:** SSA  
**Photo ID:** 6 – P8260374

Southern border of expansion area; berm in background

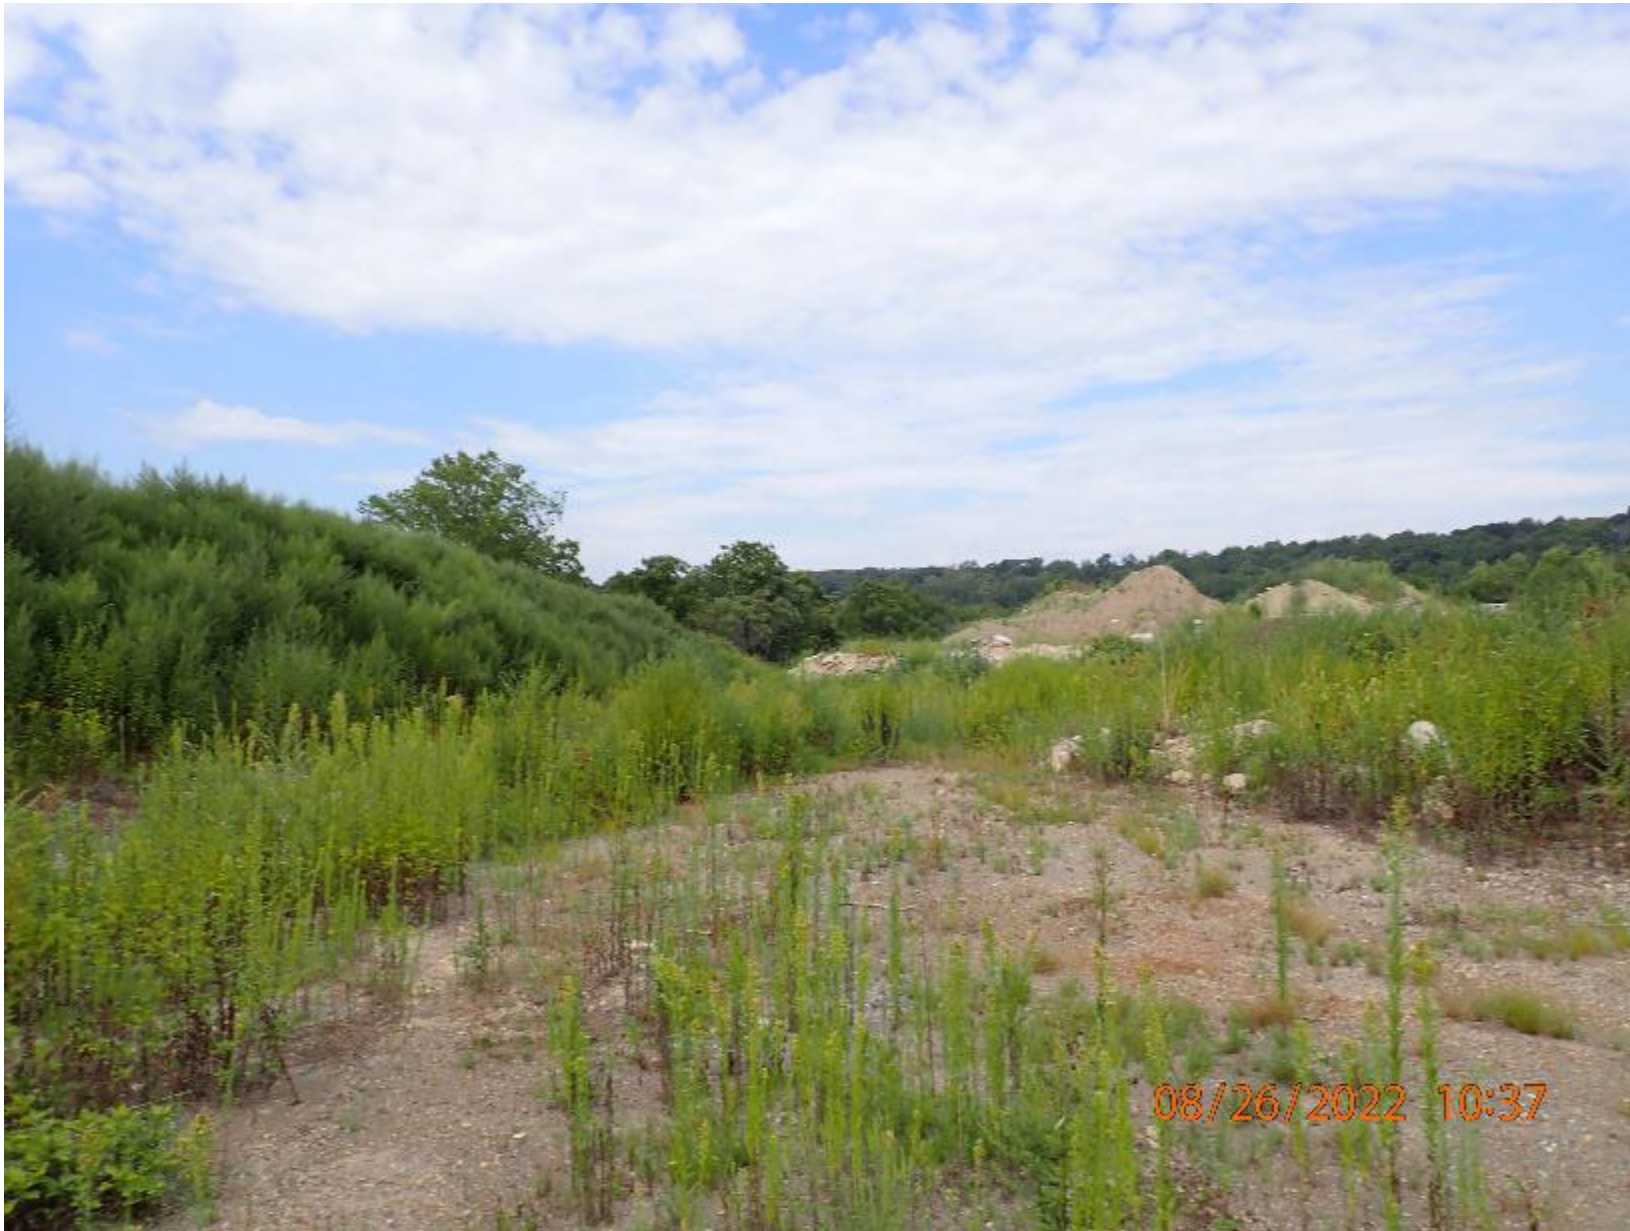
**Date:** 8/26/2022  
**Time:** 10:37 AM  
**Photographer:** SSA  
**Photo ID:** 7 – P8260375

**Description:**  
Border of facility expansion area

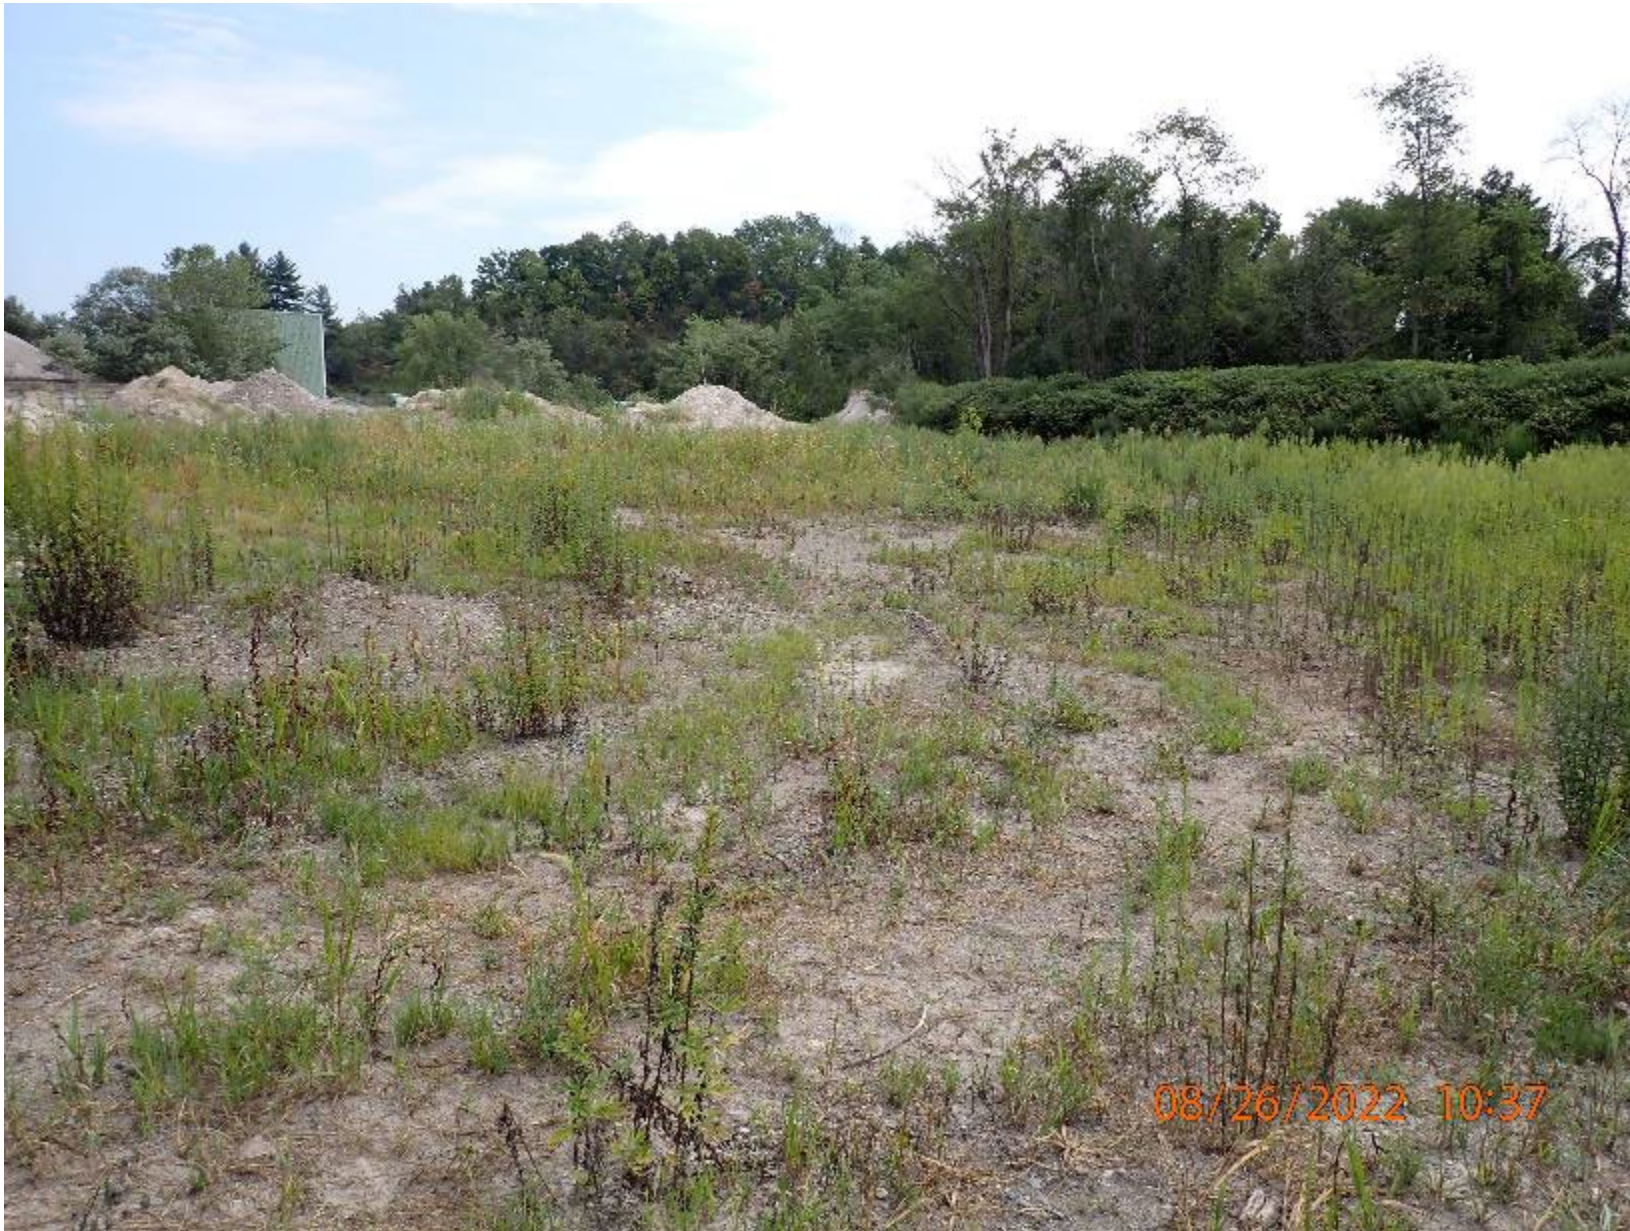
**Date:** 8/26/2022  
**Time:** 10:37 AM  
**Photographer:** SSA  
**Photo ID:** 8 – P8260376

Border of facility expansion area; berm in background

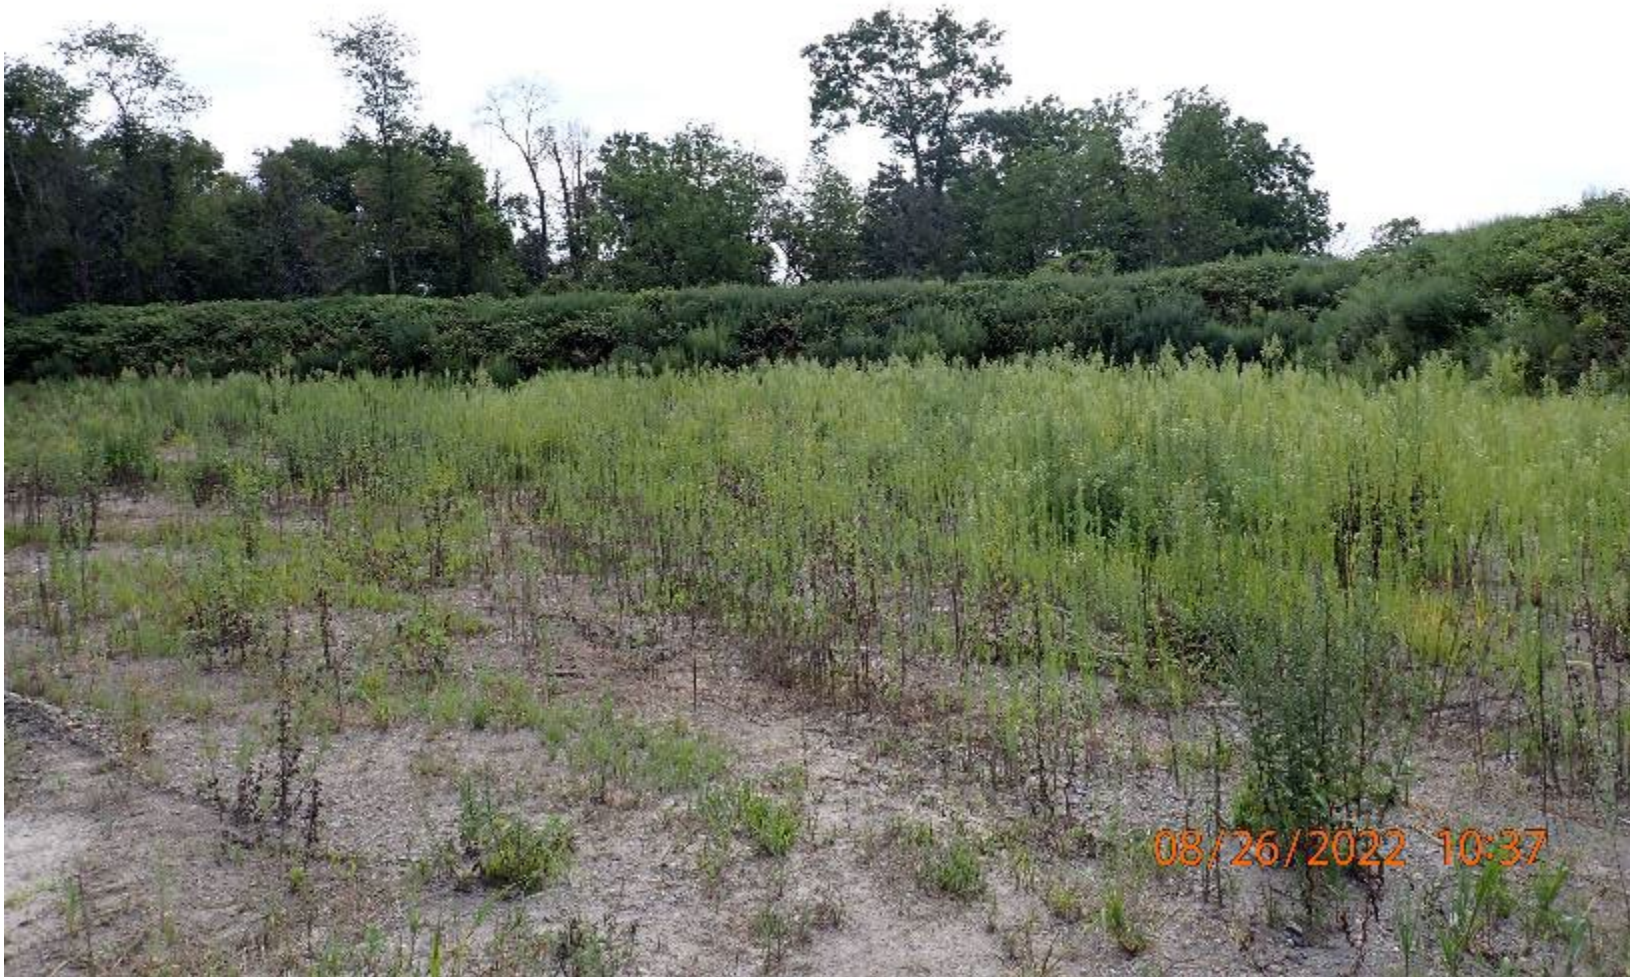
**Date:** 8/26/2022  
**Time:** 10:37 AM  
**Photographer:** SSA  
**Photo ID:** 9 – P8260377

Border of facility expansion  
area; berm in background

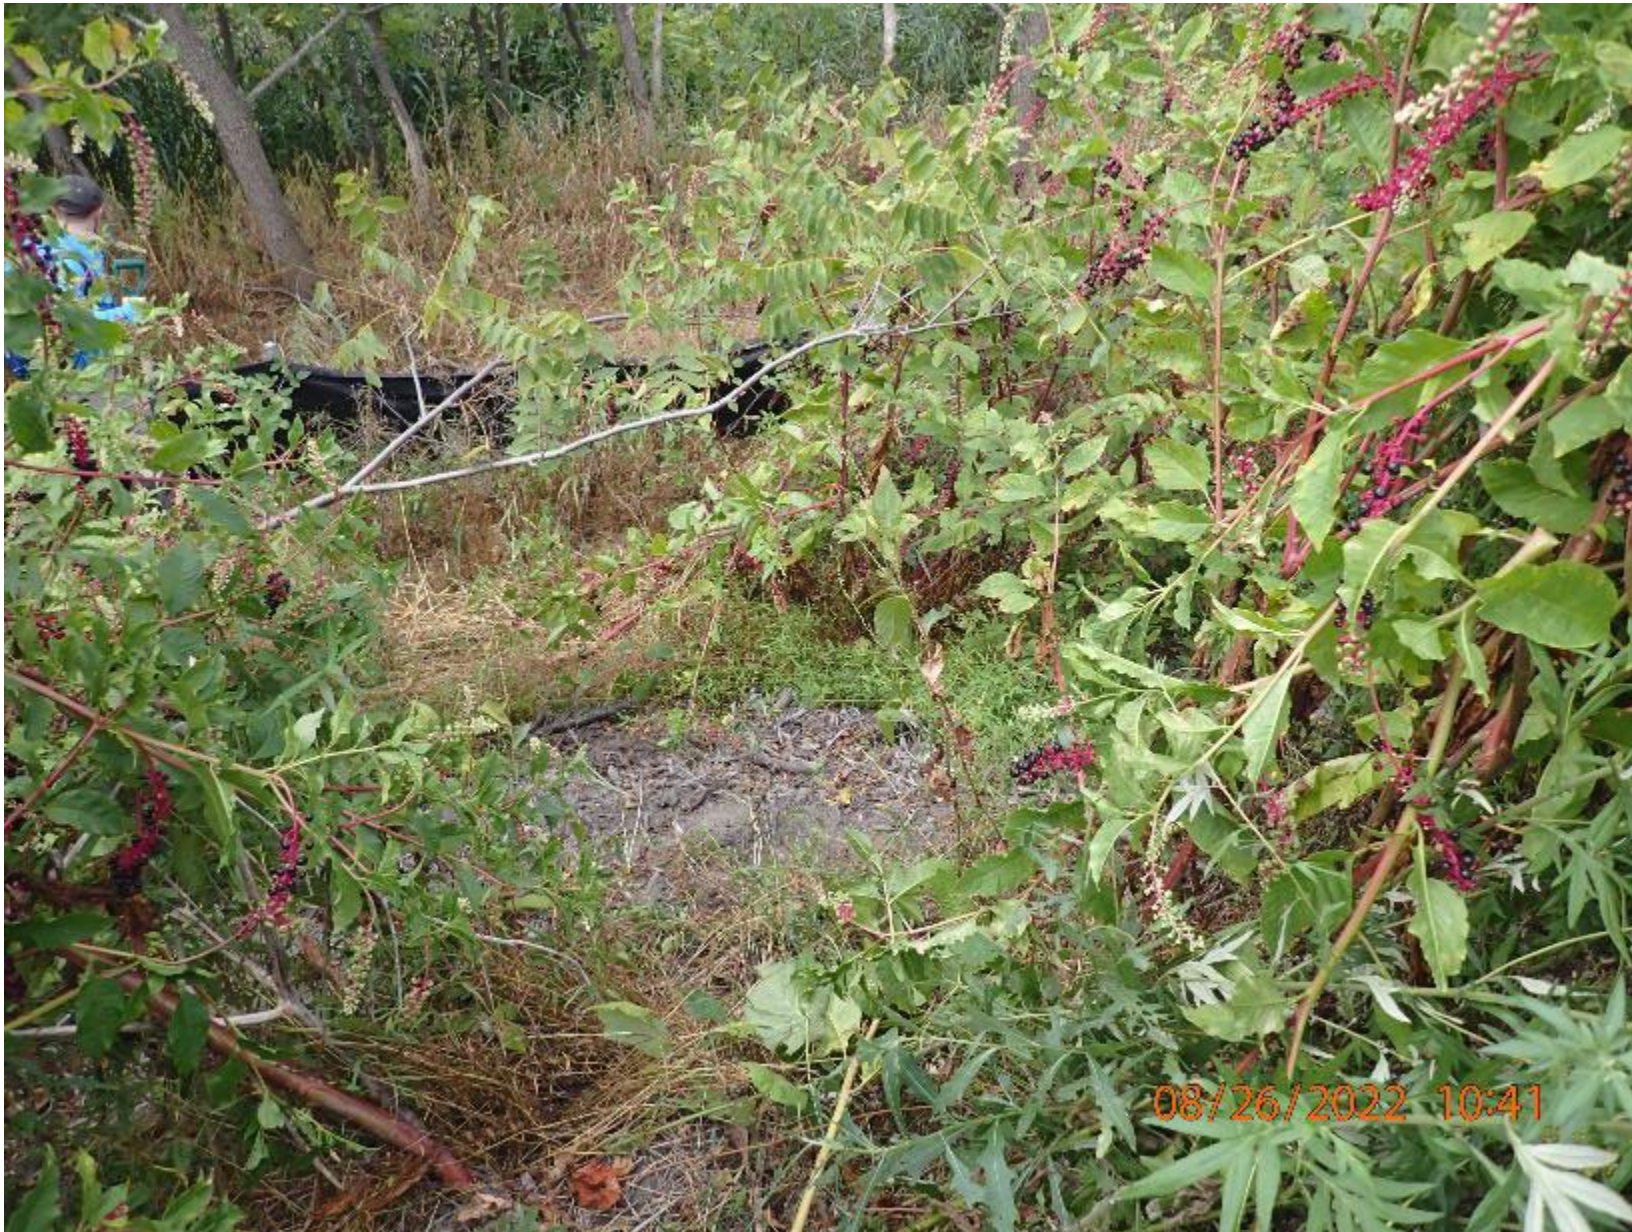
**Date:** 8/26/2022  
**Time:** 10:41 AM  
**Photographer:** SSA  
**Photo ID:** 10 – P8260378

Area adjacent to facility expansion area; area not impacted by expansion

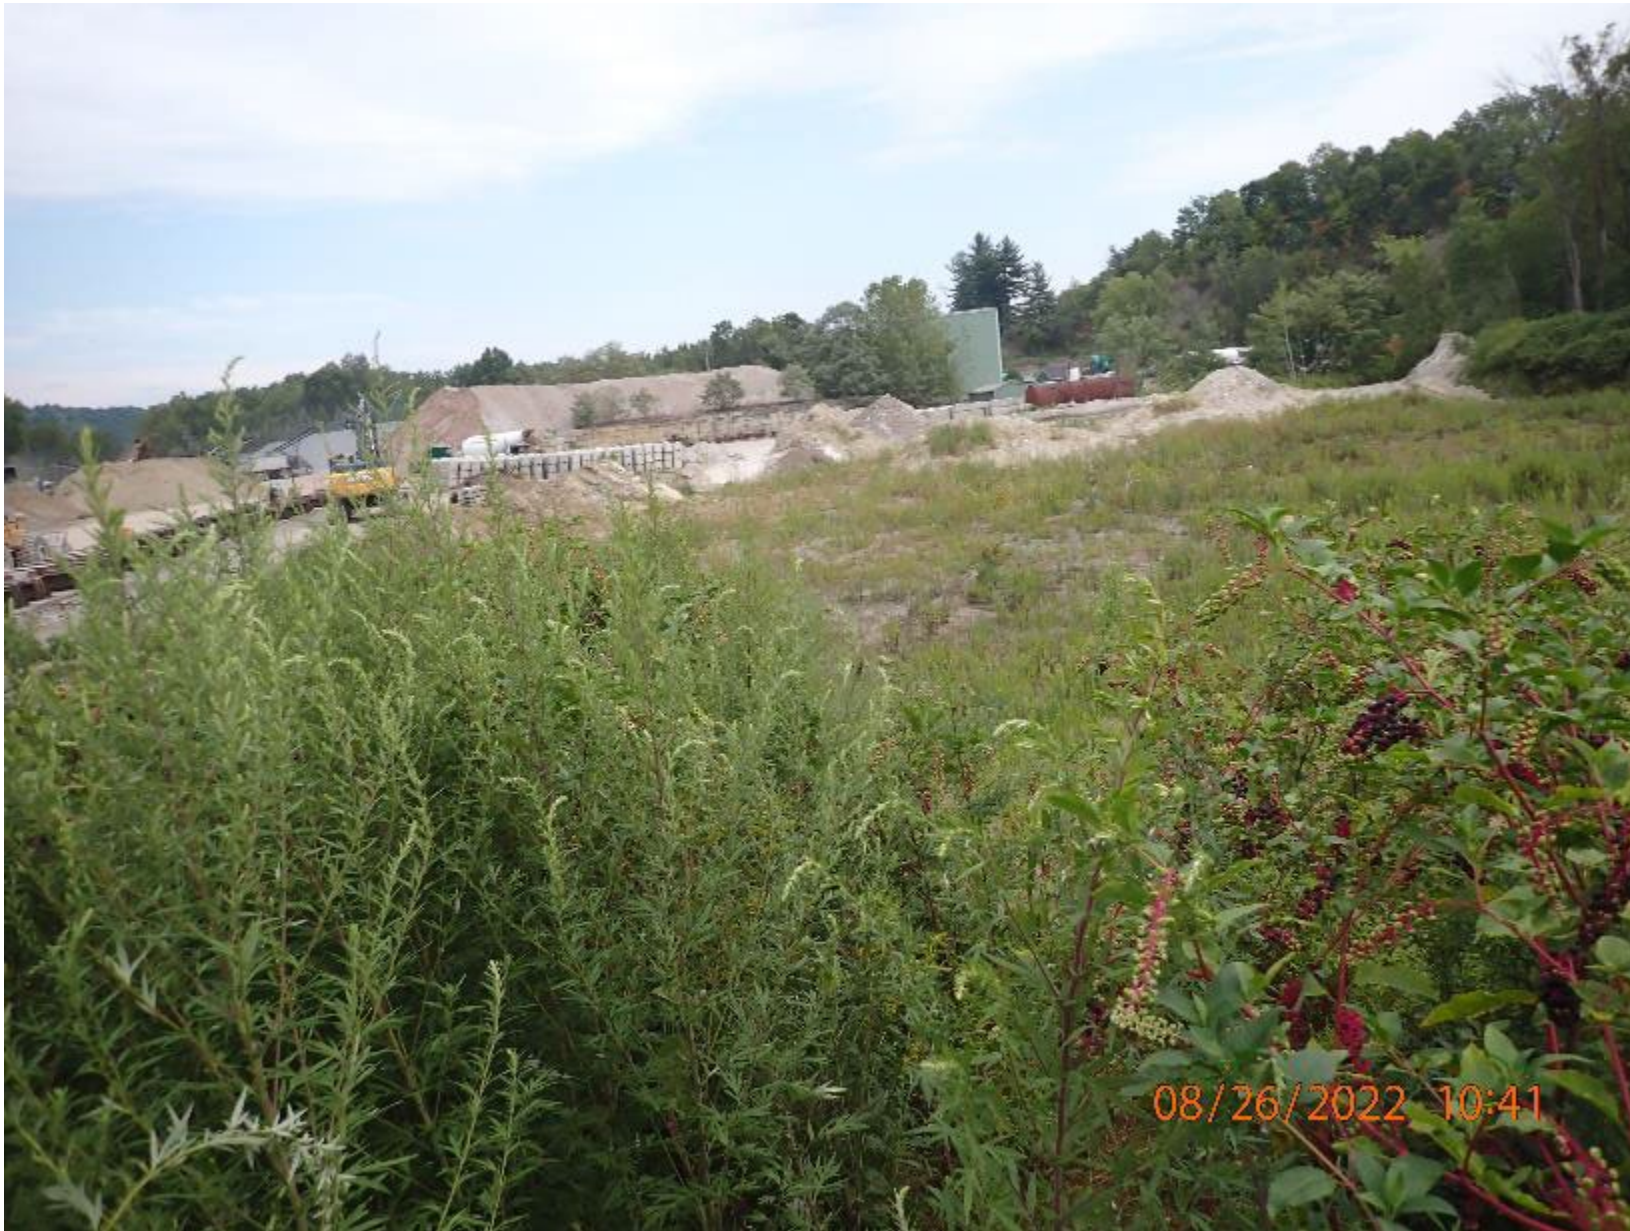
**Date:** 8/26/2022  
**Time:** 10:41 AM  
**Photographer:** SSA  
**Photo ID:** 11 – P8260379

Photo taken from top of berm facing facility
