# Clean Water Act Section 404: Site Visit/Case Development

Site Name	Dick's Concrete
-----------	-----------------

Site Address*	1053 County Road 37 (Pellets Island Road) and 1326 Co Route 12
---------------	--

CWA 404 Inspection Photolog  
Dick's Concrete  
1053 Co Rd 37 and 1326 Co Rt 12  
Orange County, NY

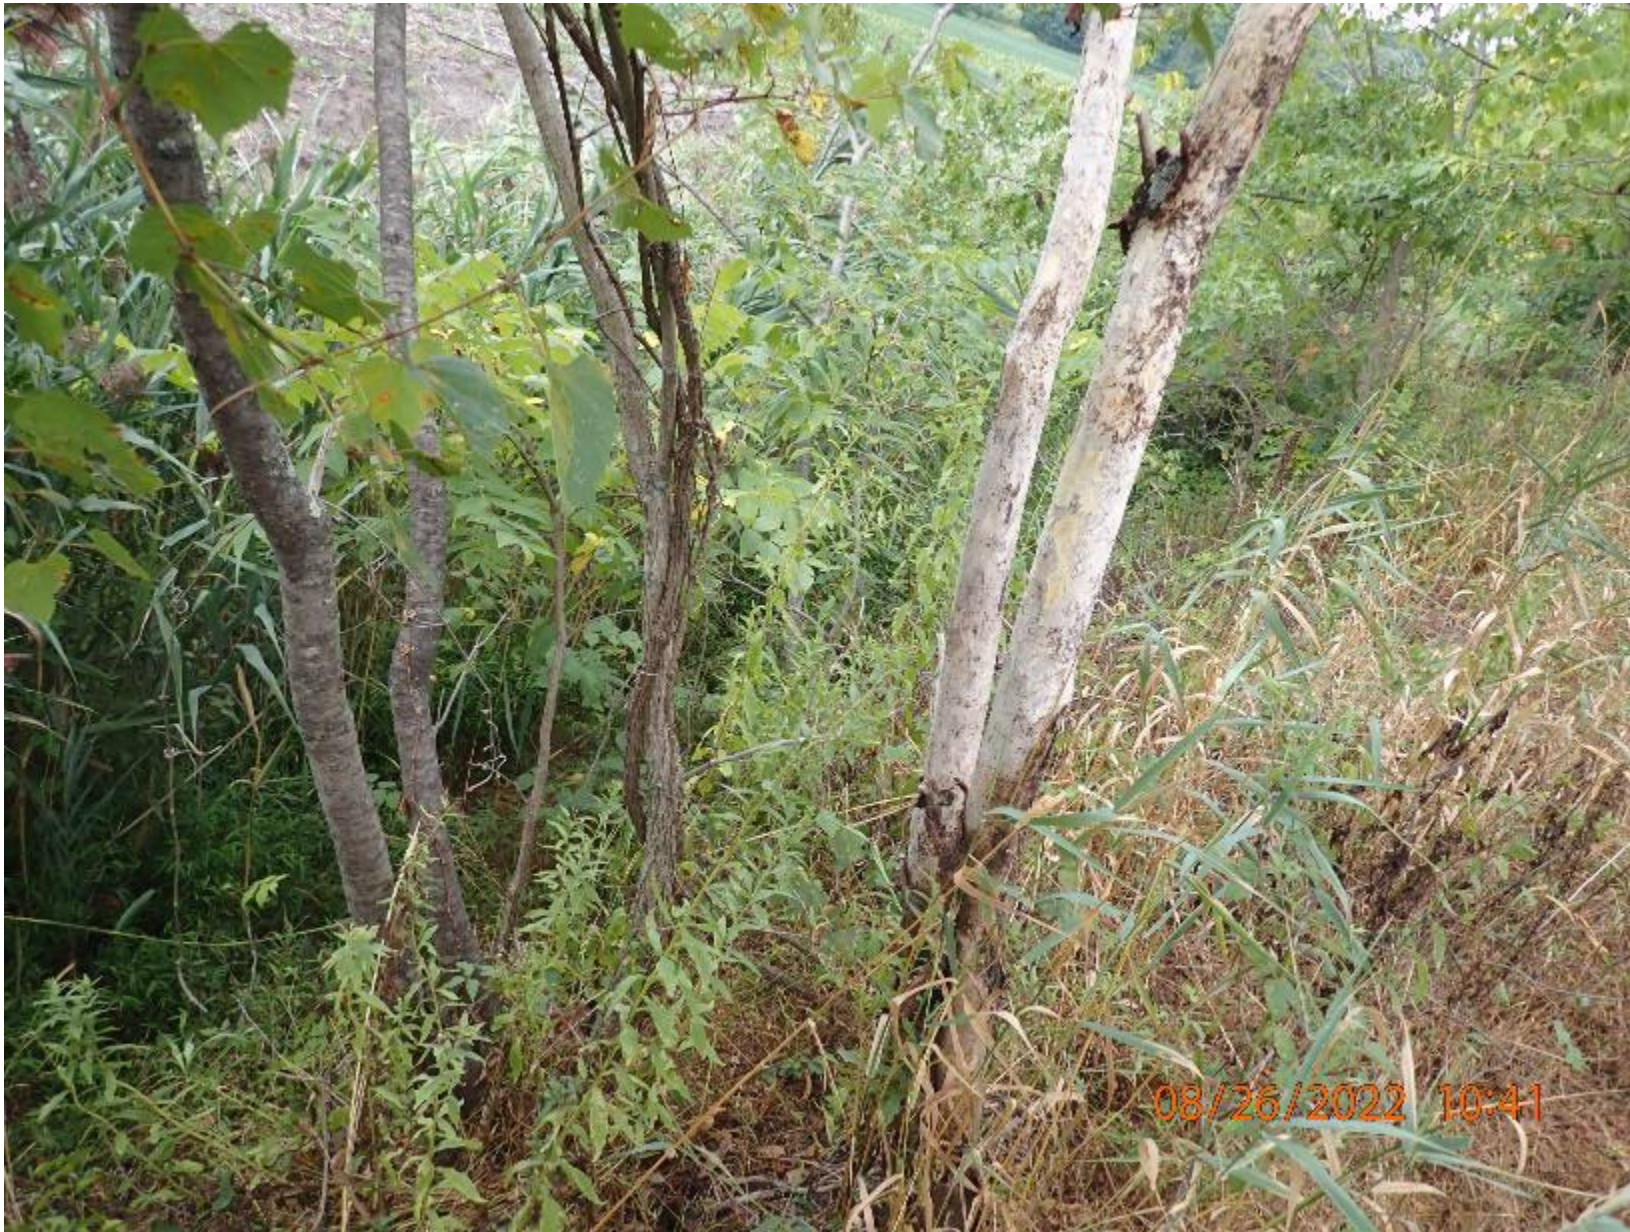
**Date:** 8/26/2022  
**Time:** 10:41 AM  
**Photographer:** SSA  
**Photo ID:** 12 – P8260380

**Description:**  
Photo taken from top of berm

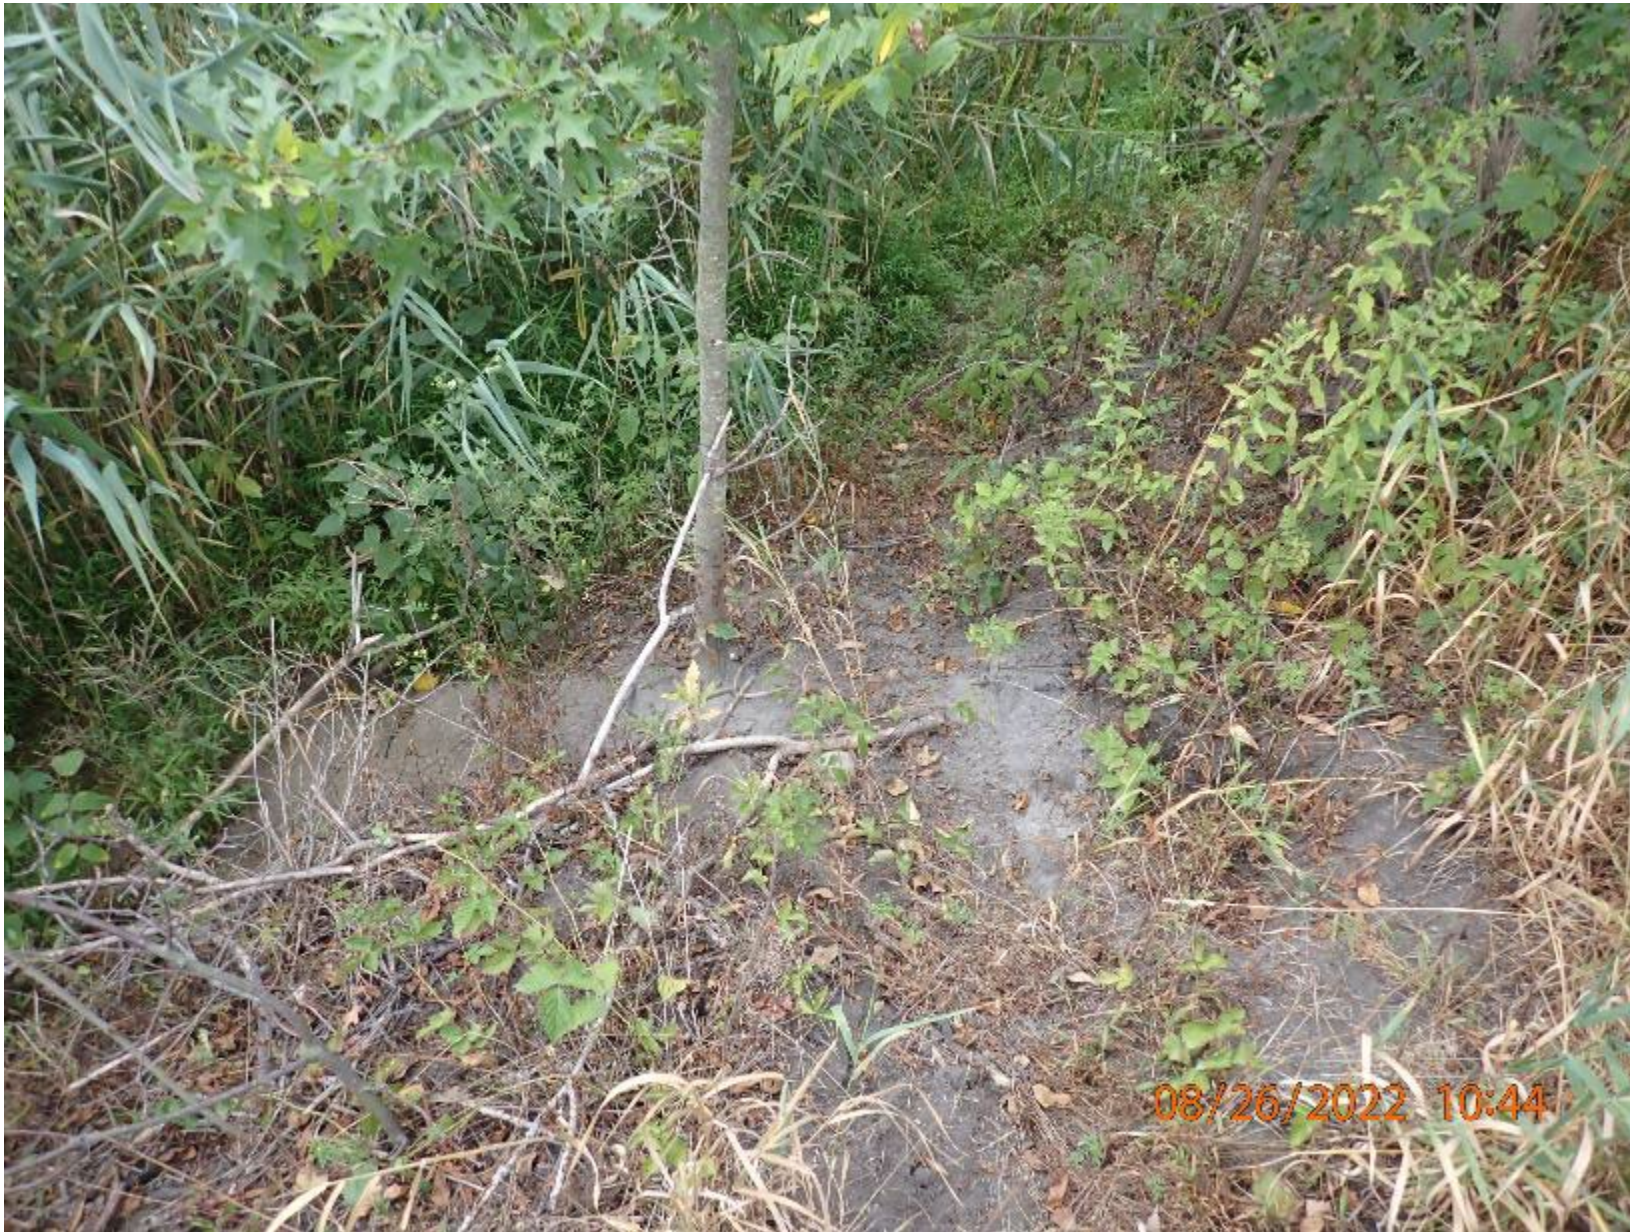
**Date:** 8/26/2022  
**Time:** 10:44 AM  
**Photographer:** SSA  
**Photo ID:** 13 – P8260381

Channel that runs along southern border of expansion area on other side of berm

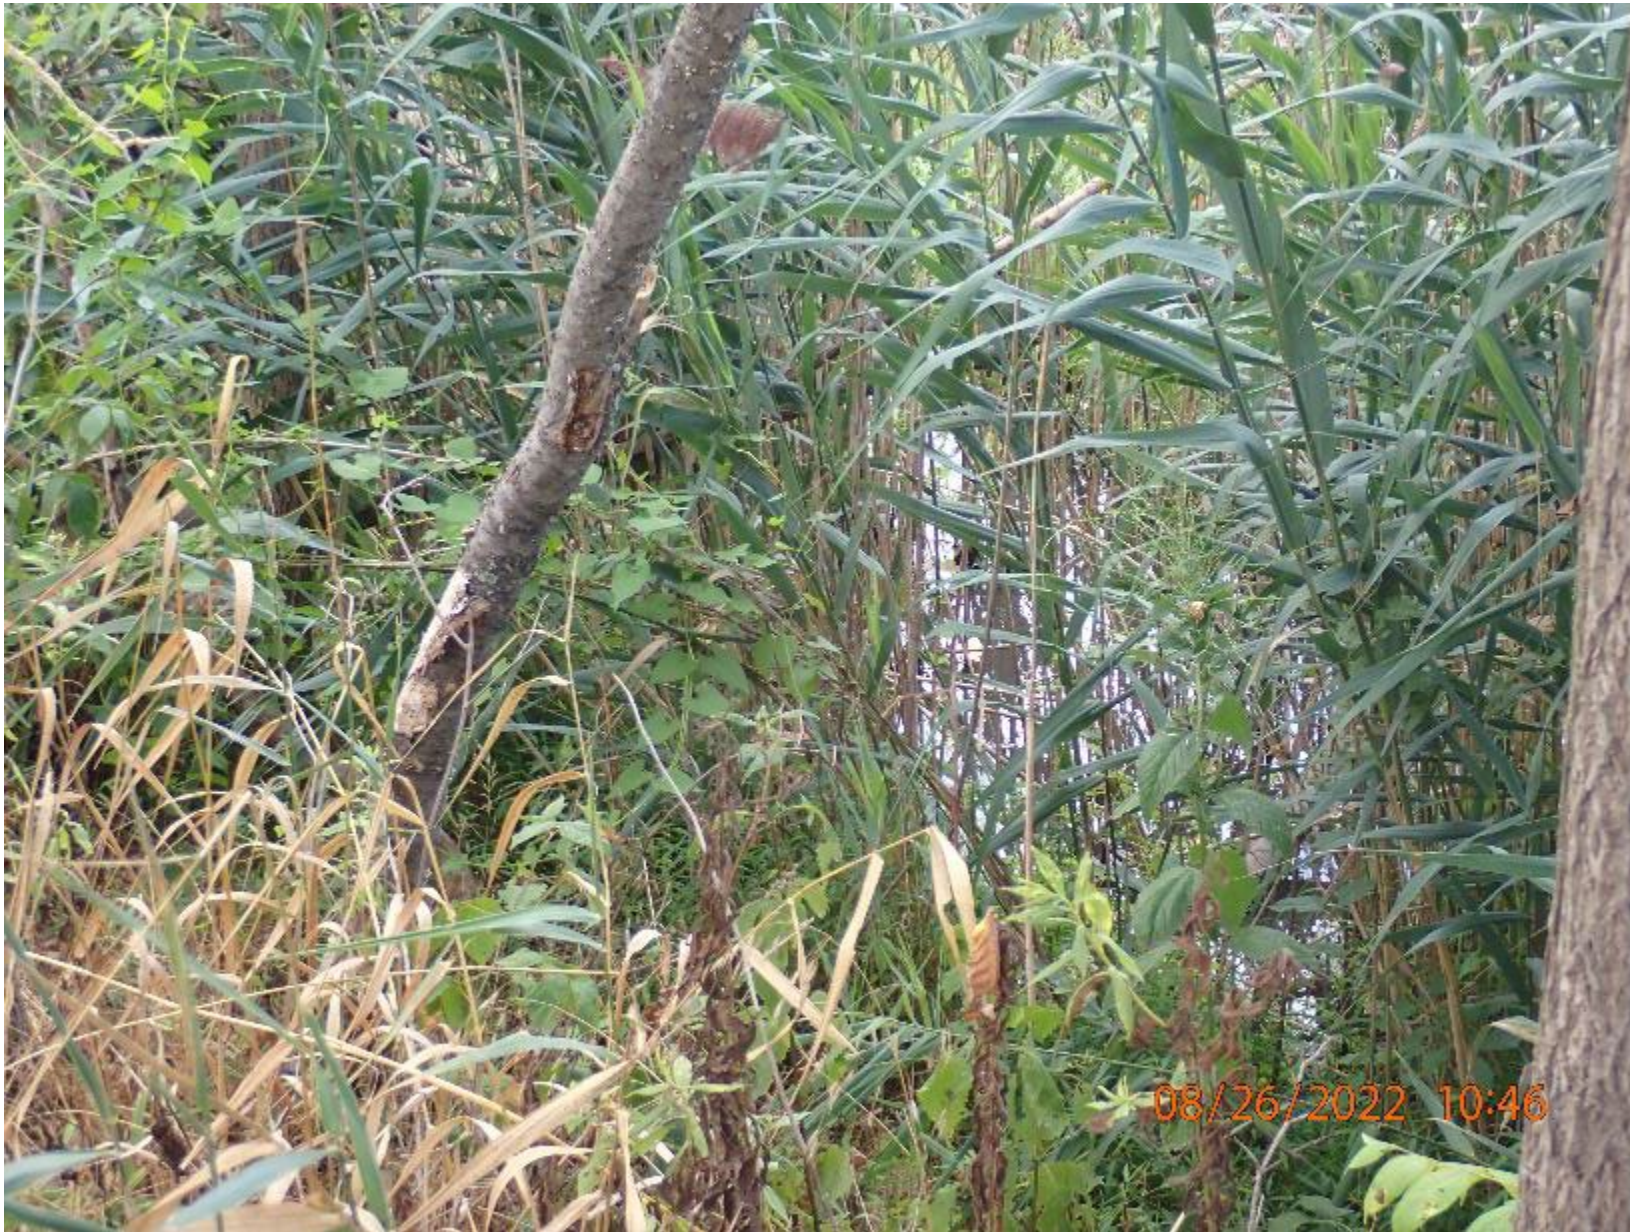
**Date:** 8/26/2022  
**Time:** 10:46 AM  
**Photographer:** SSA  
**Photo ID:** 14 – P8260382

EPA observed water in the agricultural channel south of the expansion area. The channel flows east to the Wallkill River.

Channel that runs along southern border of expansion area; surface water in channel

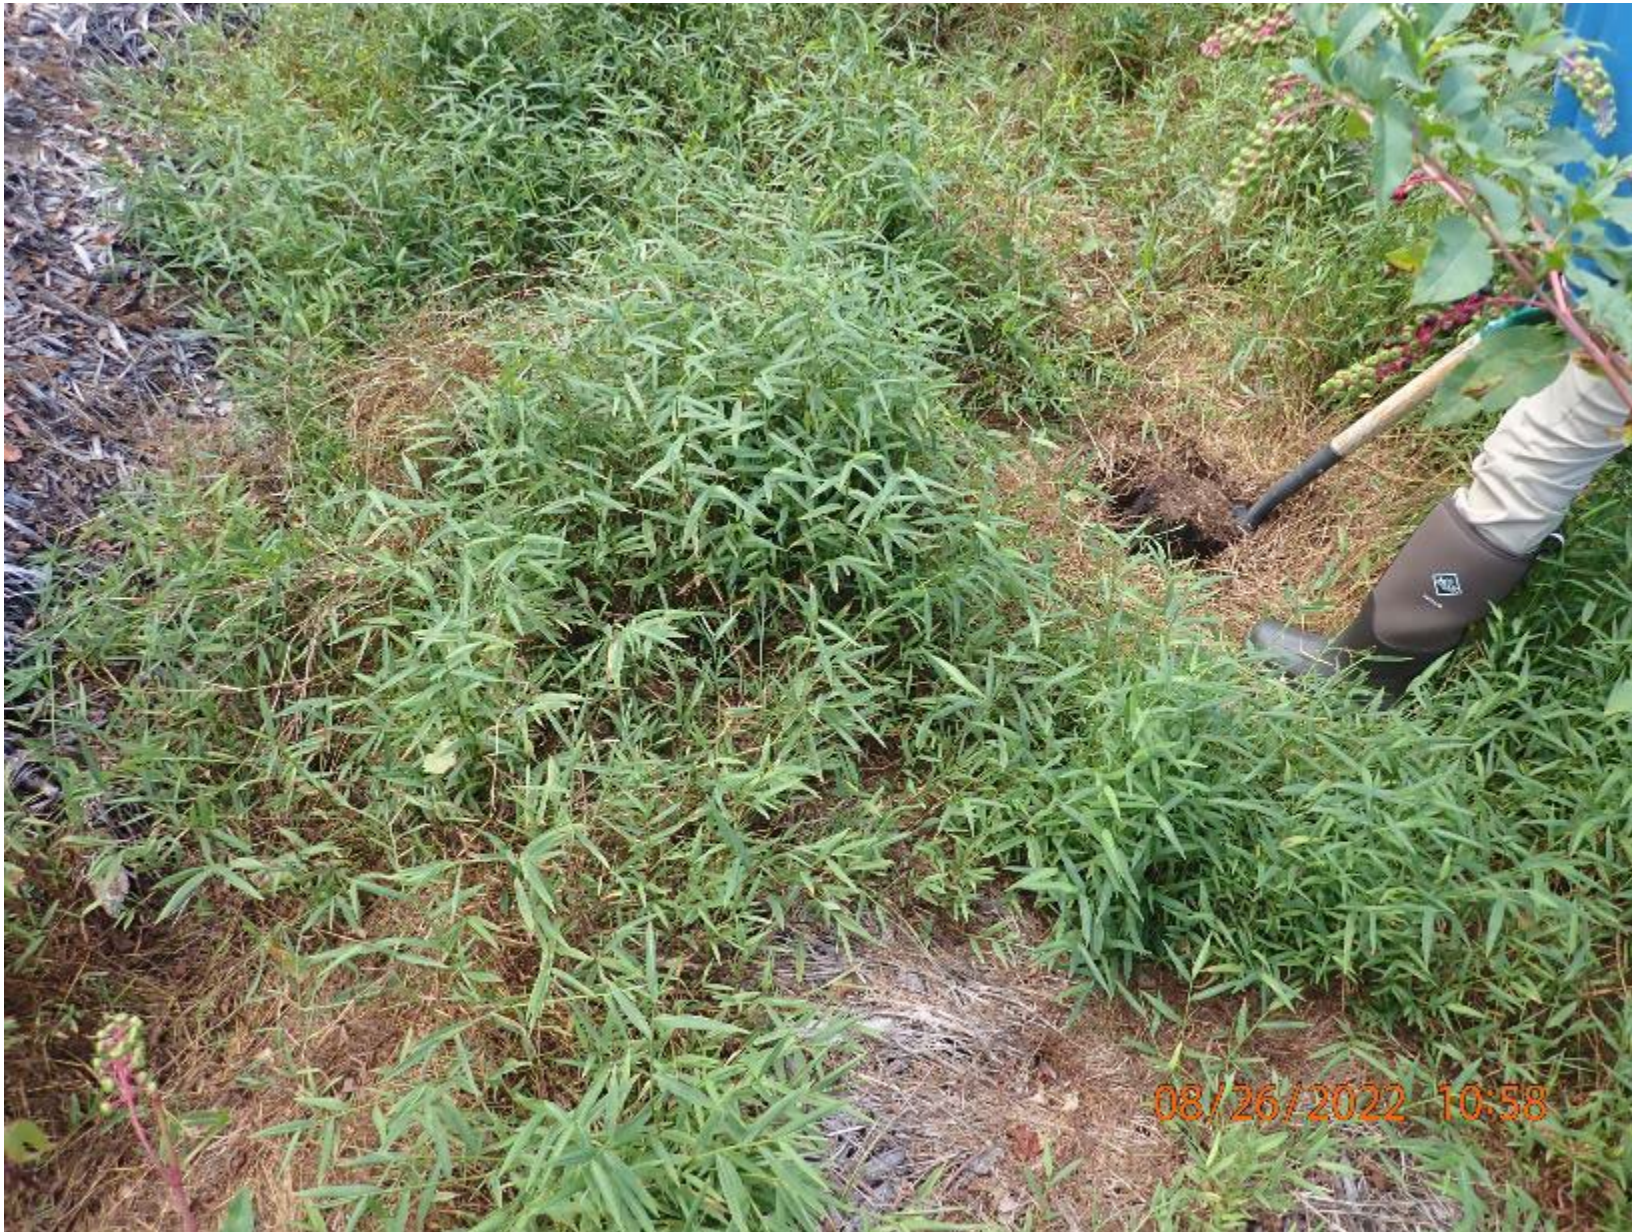
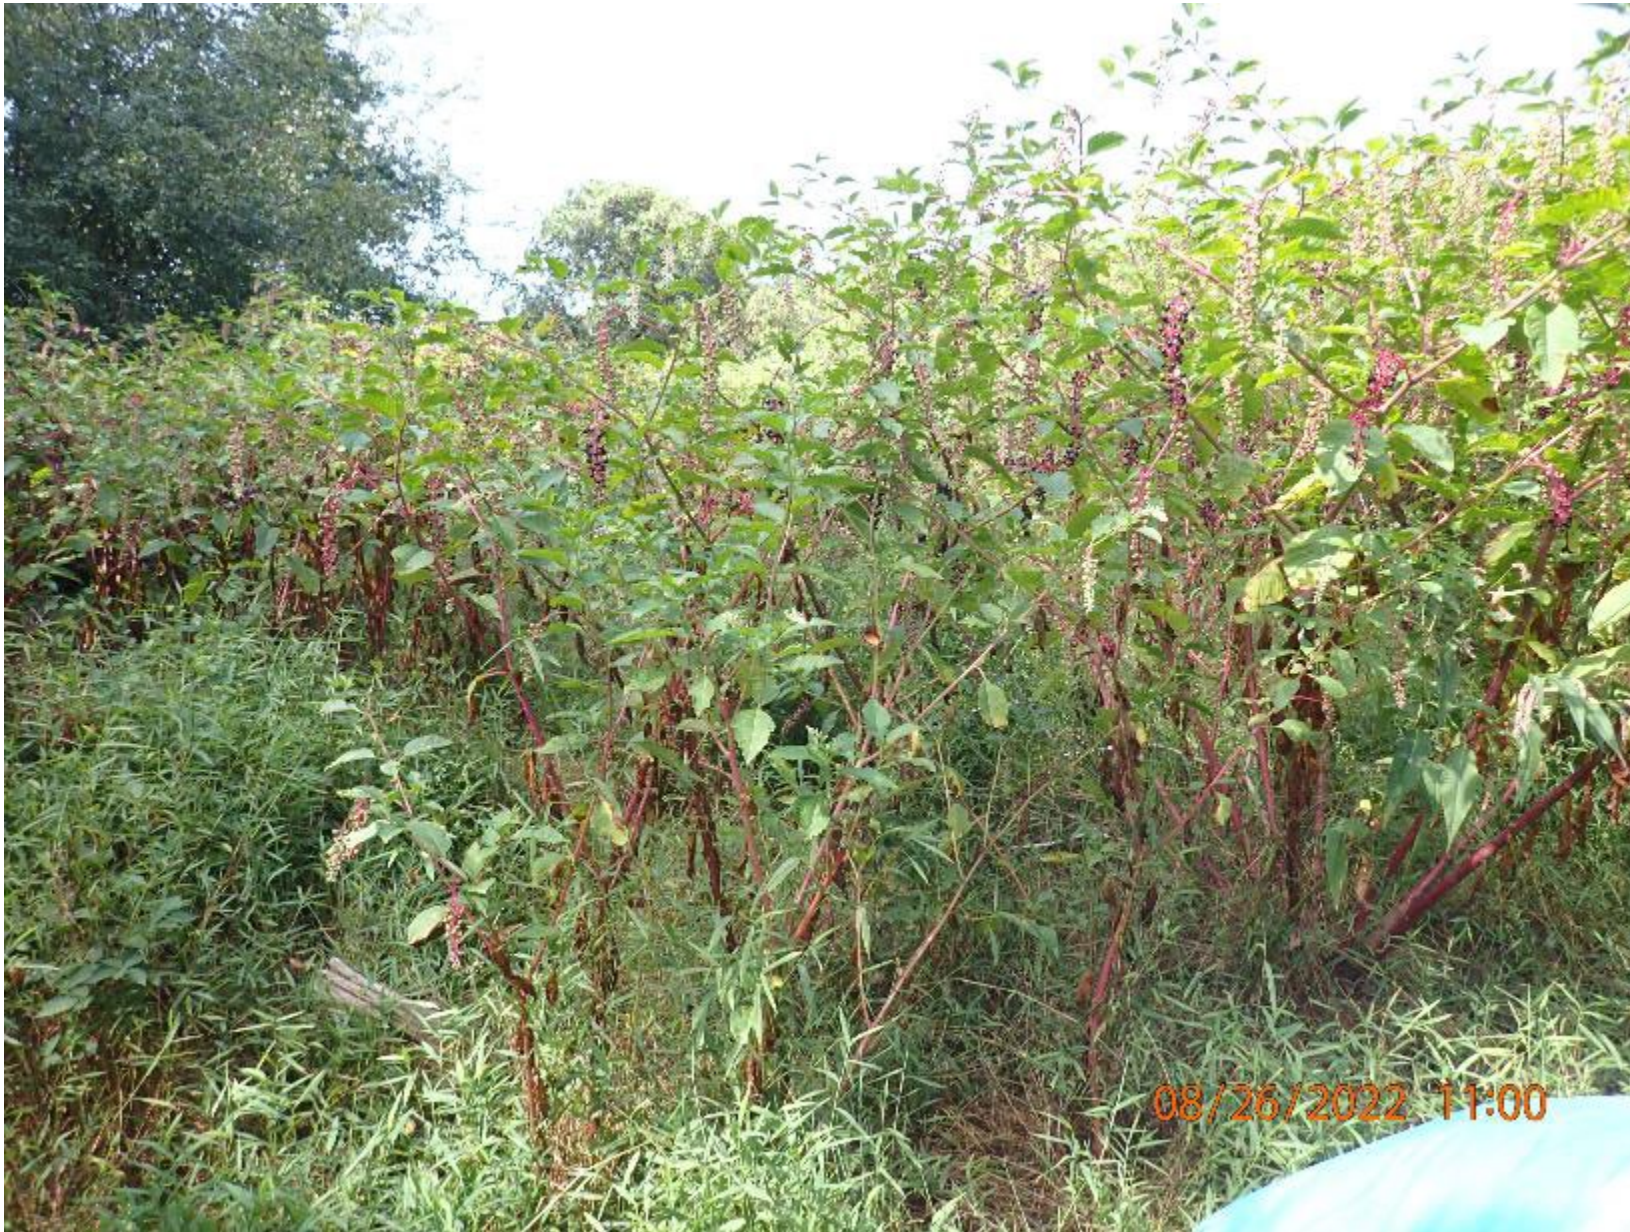
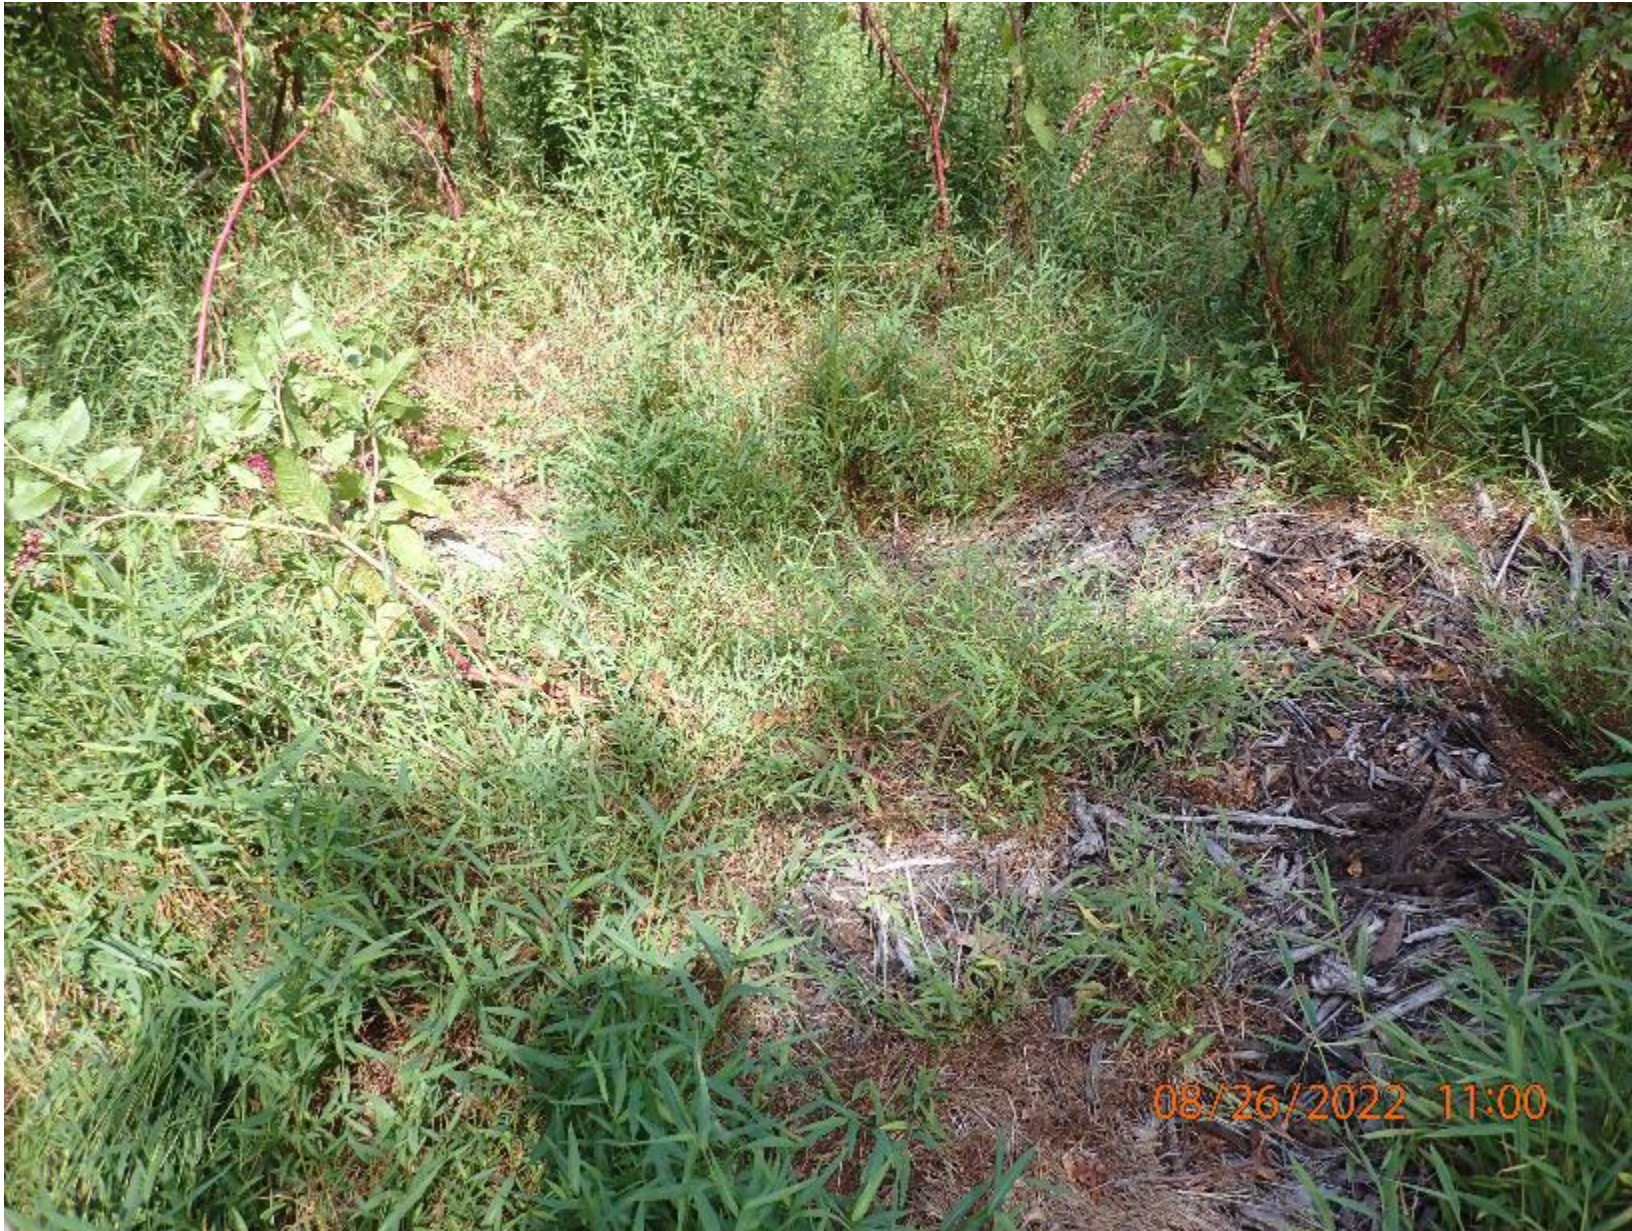
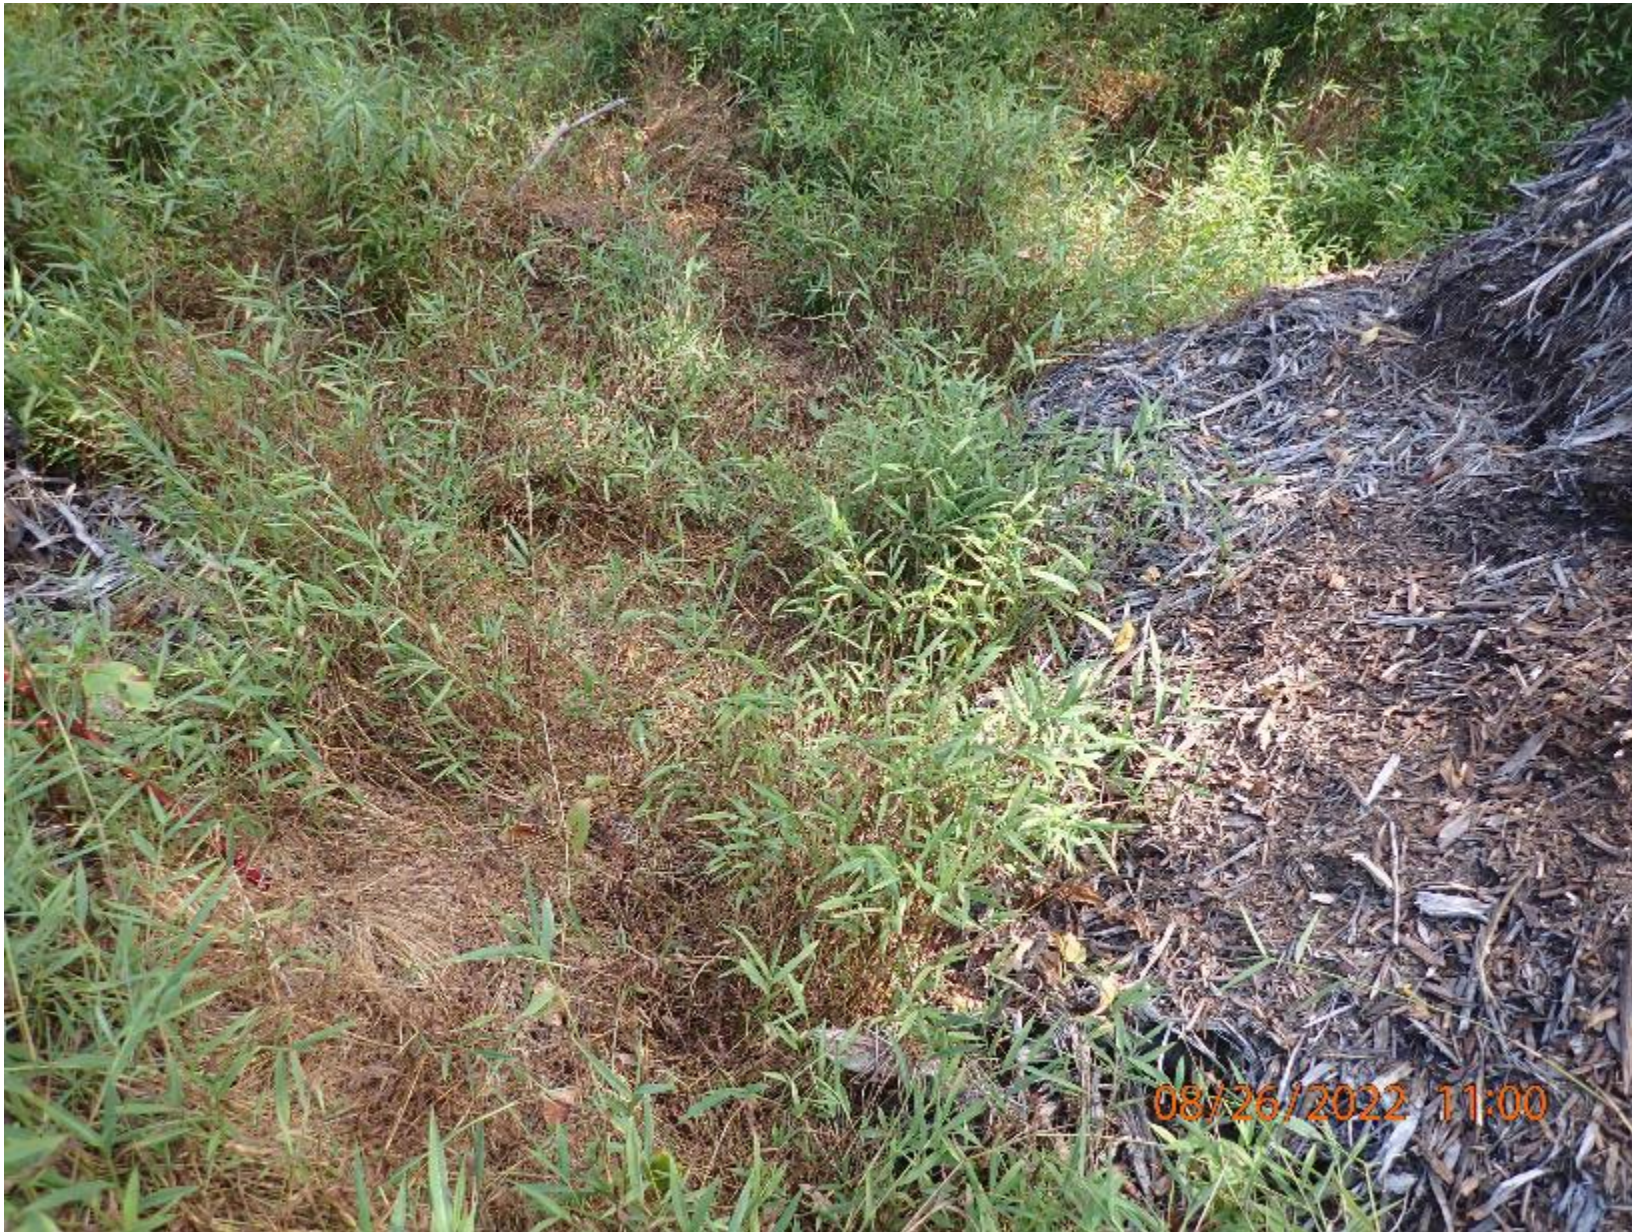
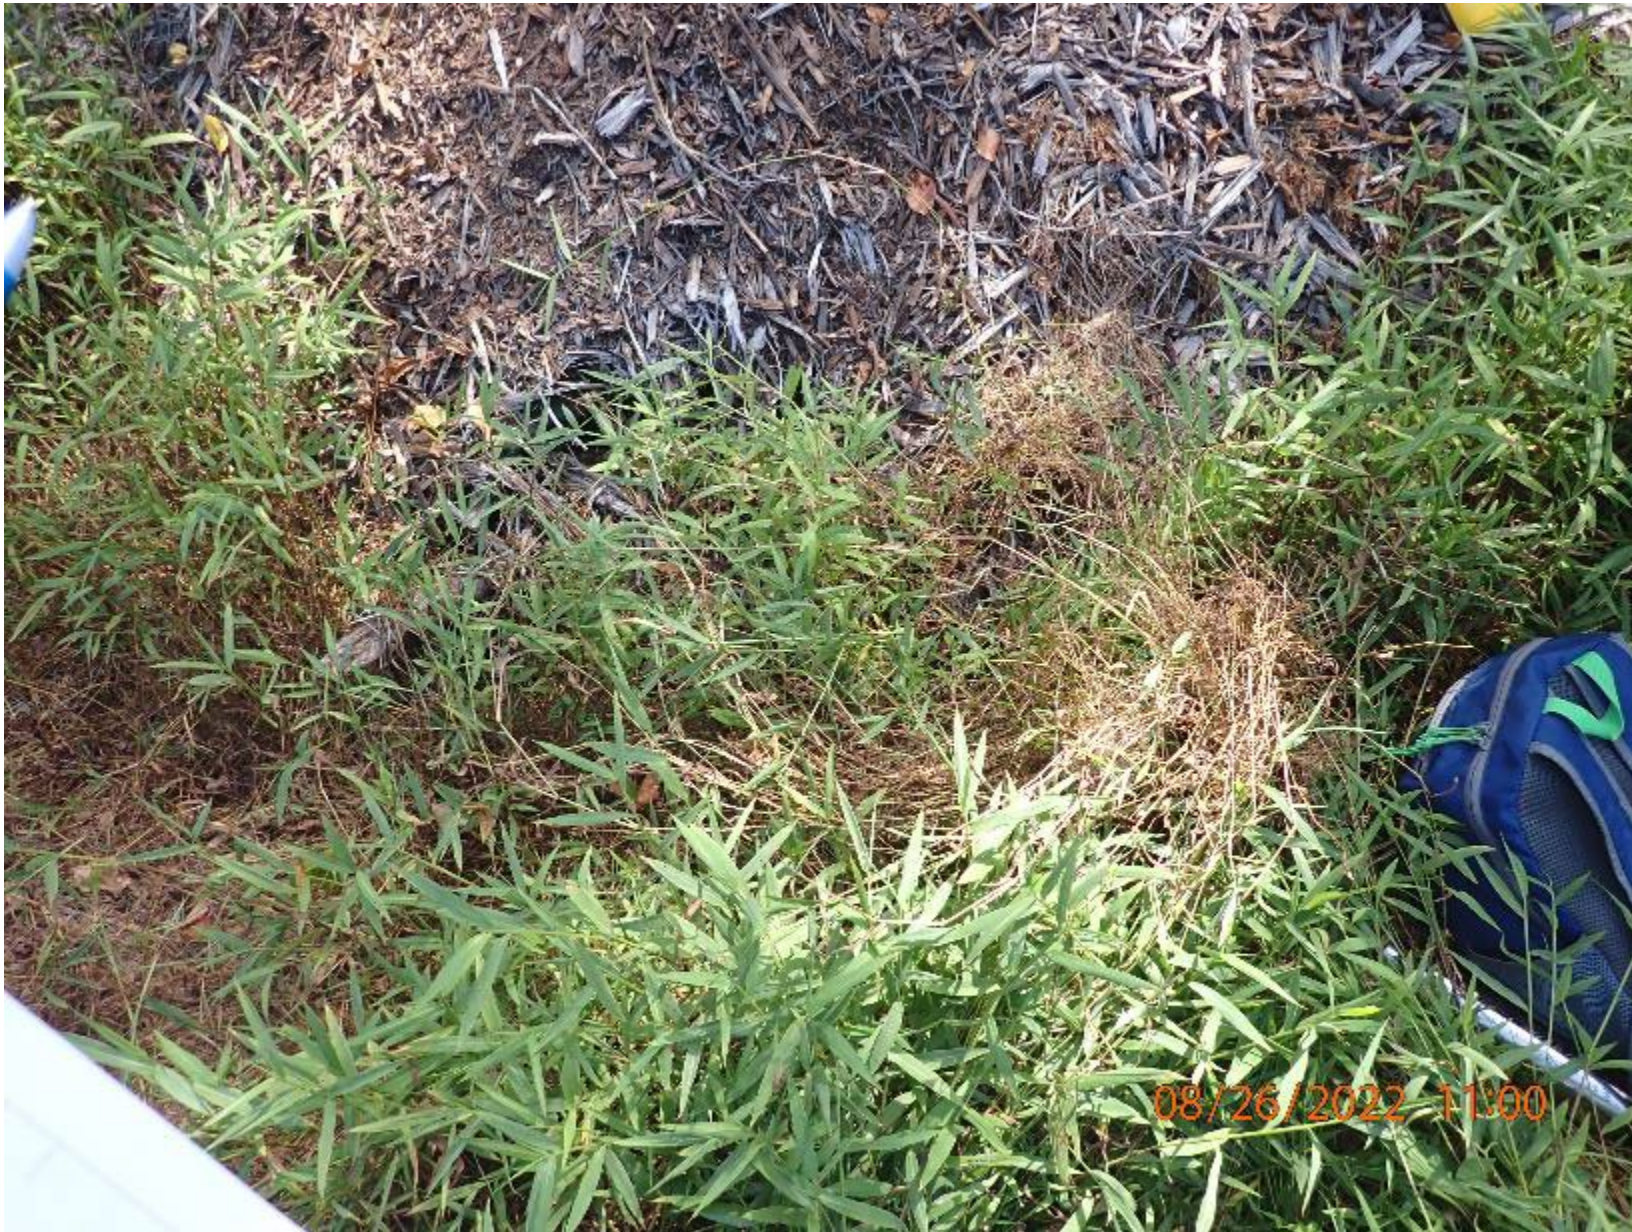
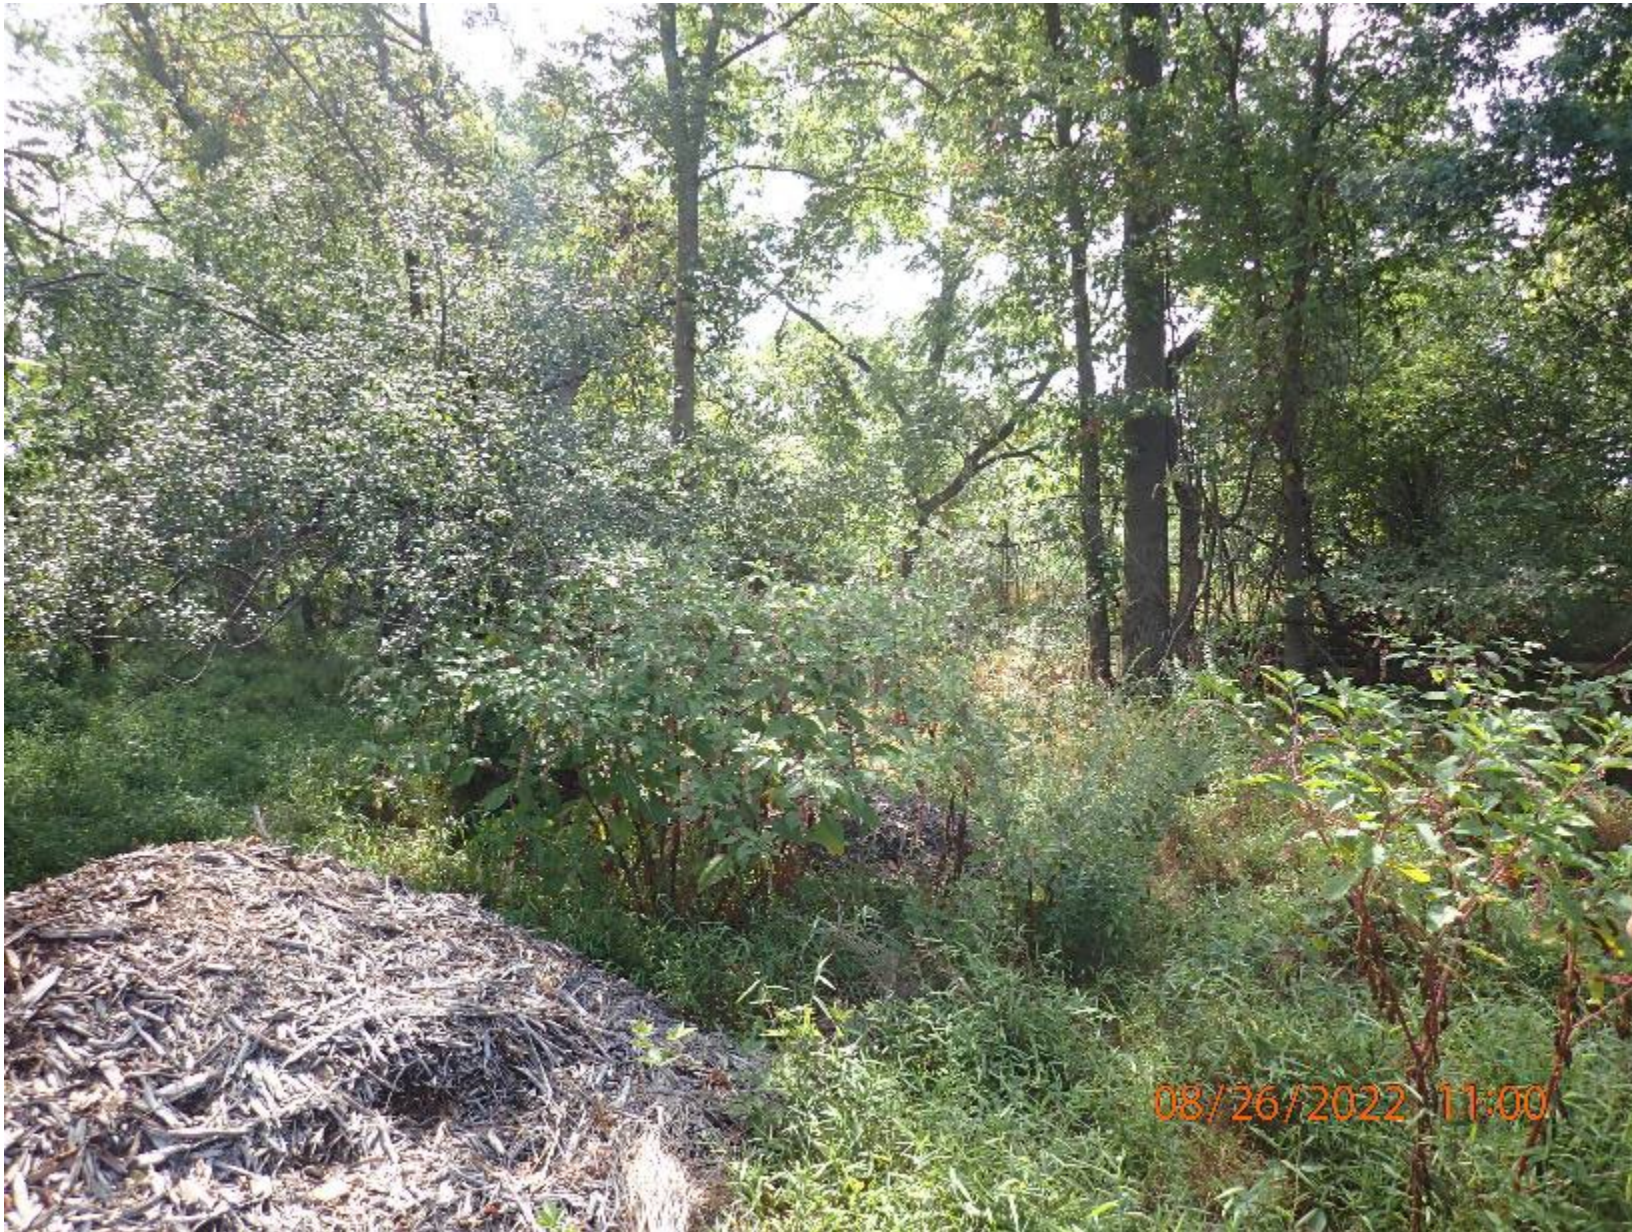
**Description:**  
Area around Soil Pit #1 (SS1)
