# Clean Water Act Section 404: Site Visit/Case Development

Site Name	Dick's Concrete
-----------	-----------------

Site Address*	1053 County Road 37 (Pellets Island Road) and 1326 Co Route 12
---------------	--

CWA 404 Inspection Photolog  
Dick's Concrete  
1053 Co Rd 37 and 1326 Co Rt 12  
Orange County, NY

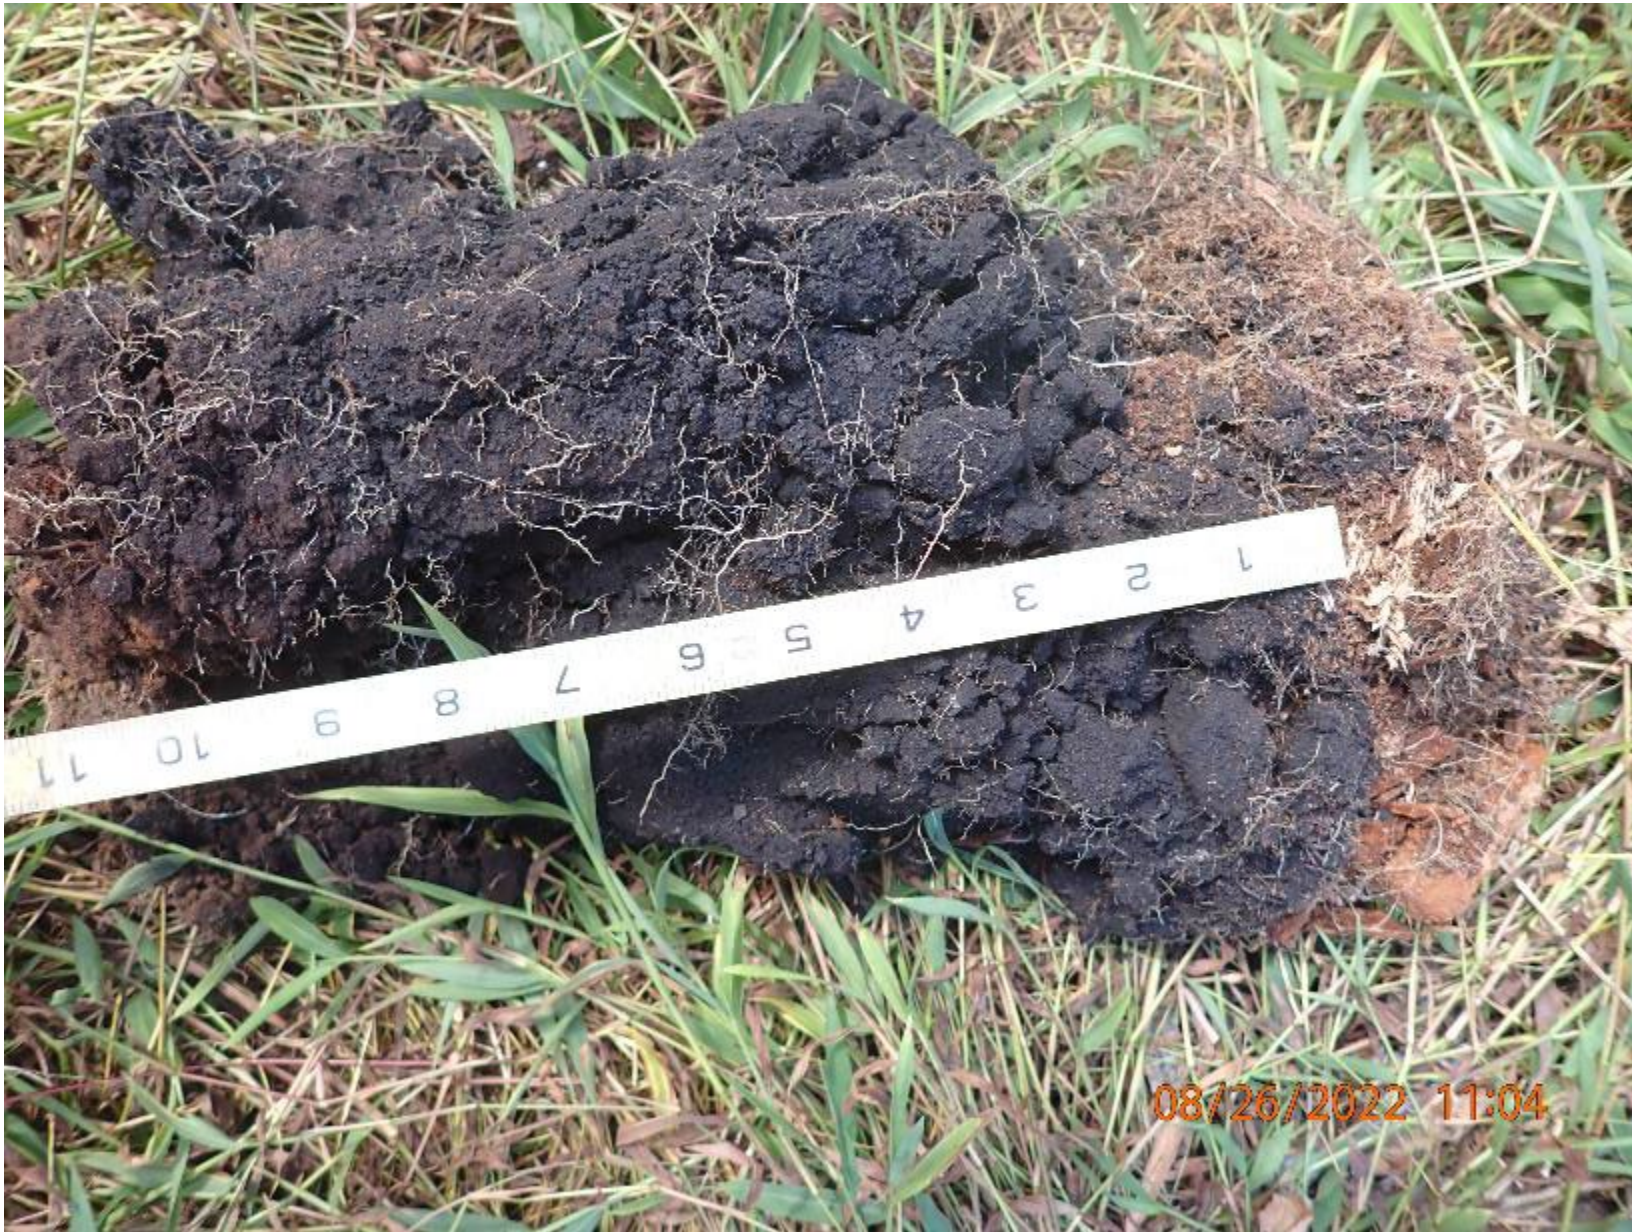
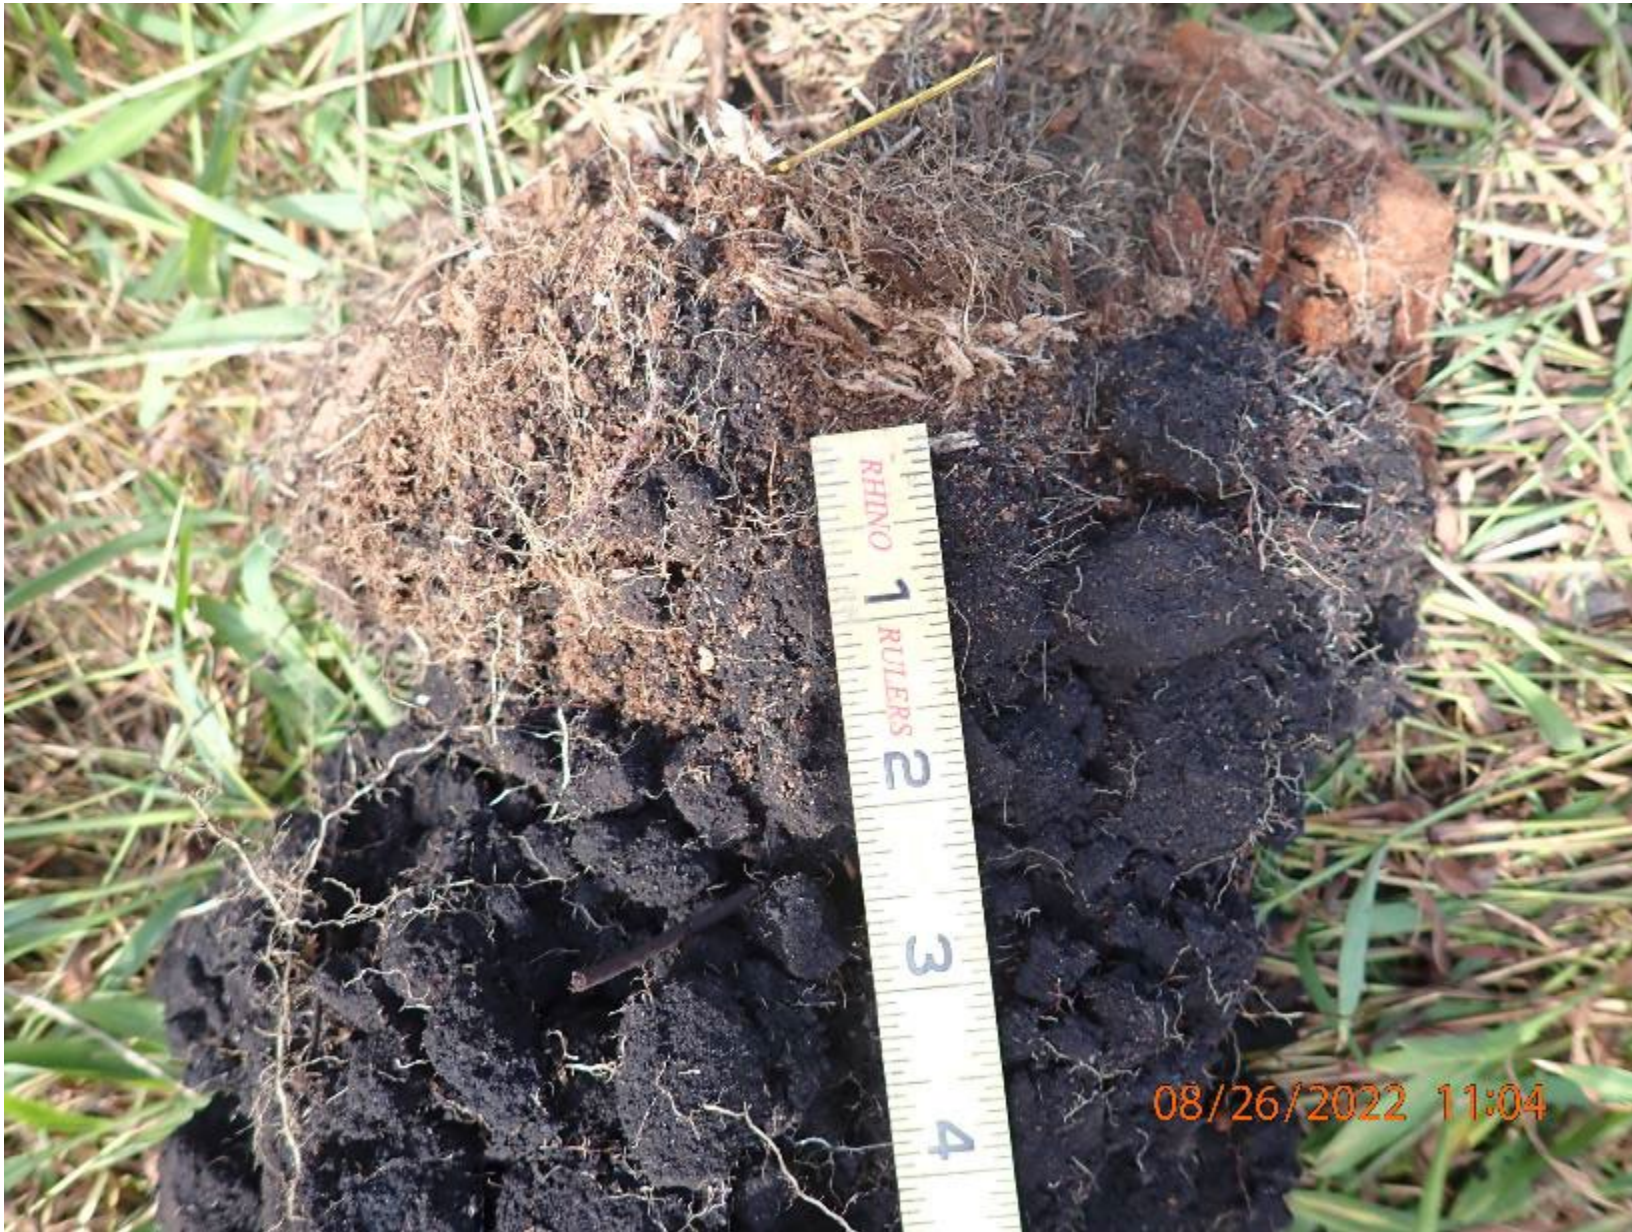
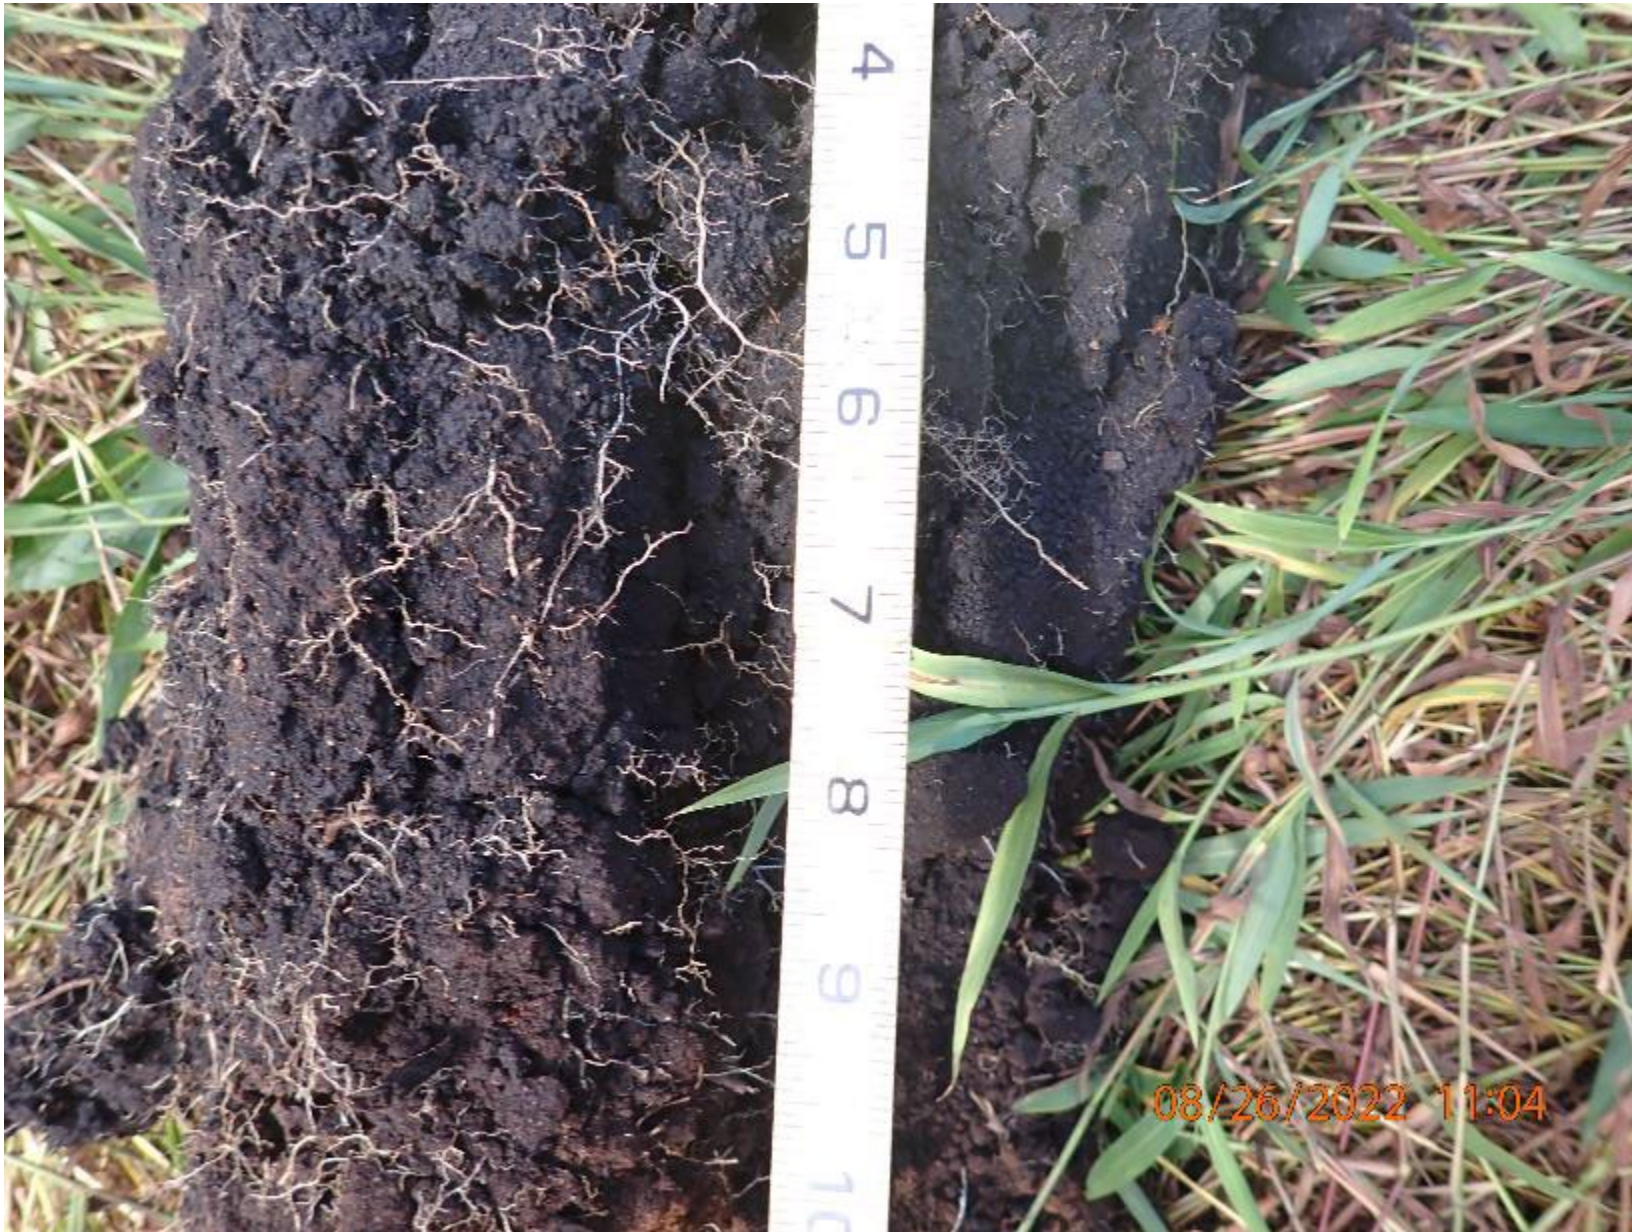
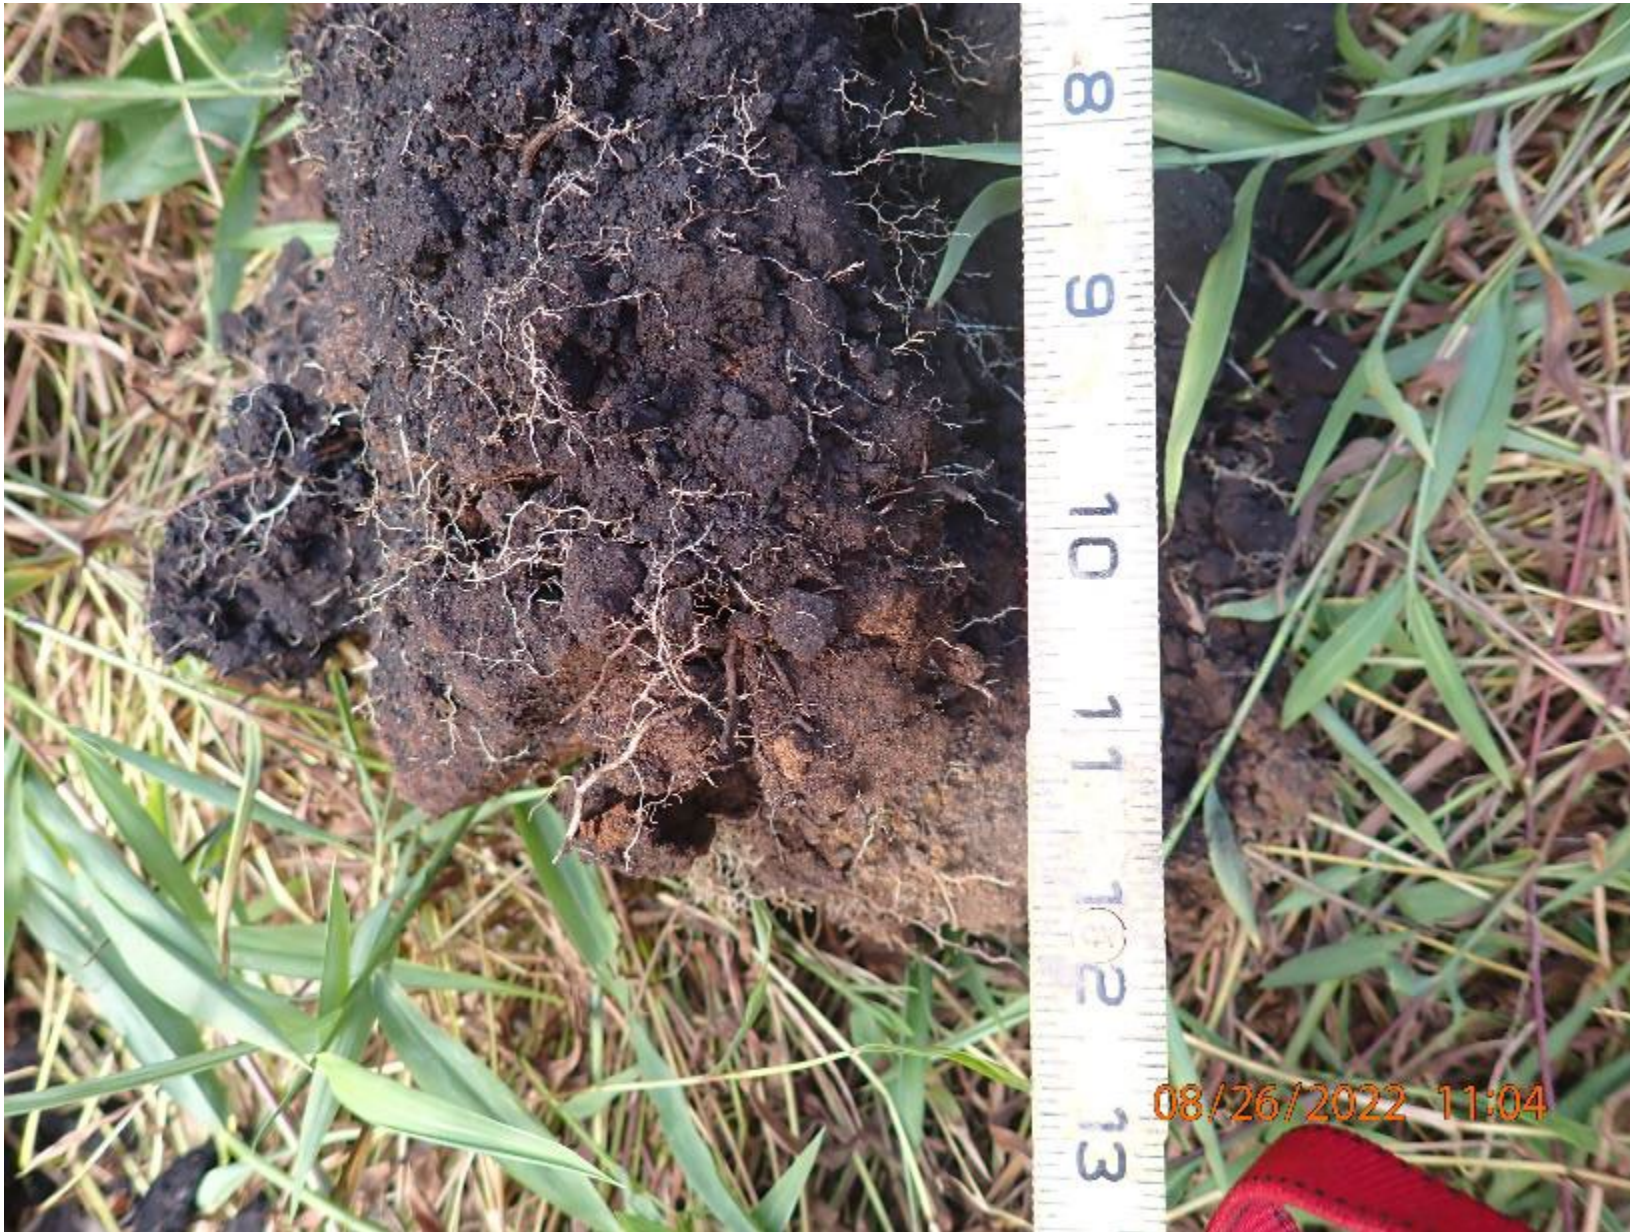
EPA took two soil samples. The first soil sample, located in a scrub-shrub/herbaceous area east of the expansion, was found to not be in a wetland due to a lack of hydrological indicators. The second soil sample, located between the berm and an agricultural channel south of the expansion area was also found to not be in a wetland.

**Description:**  
Soil Pit #1 (SS1) soil profile

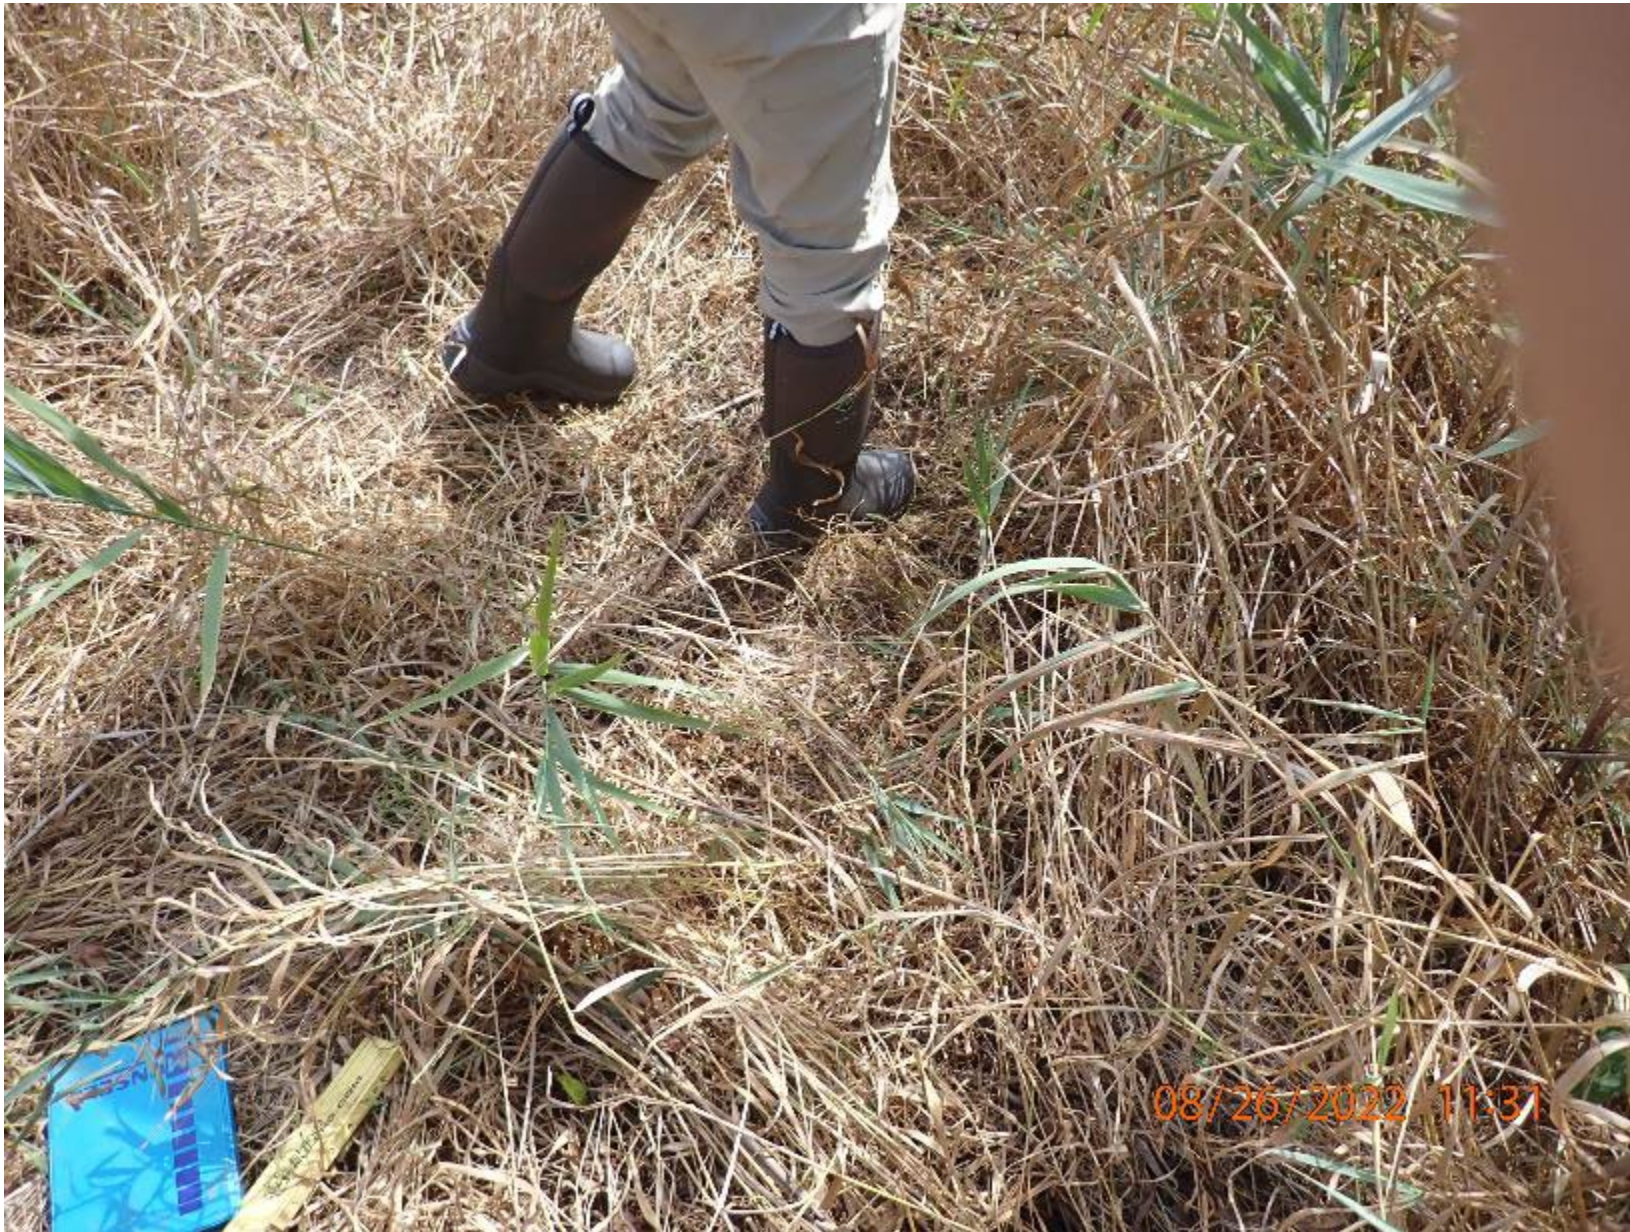
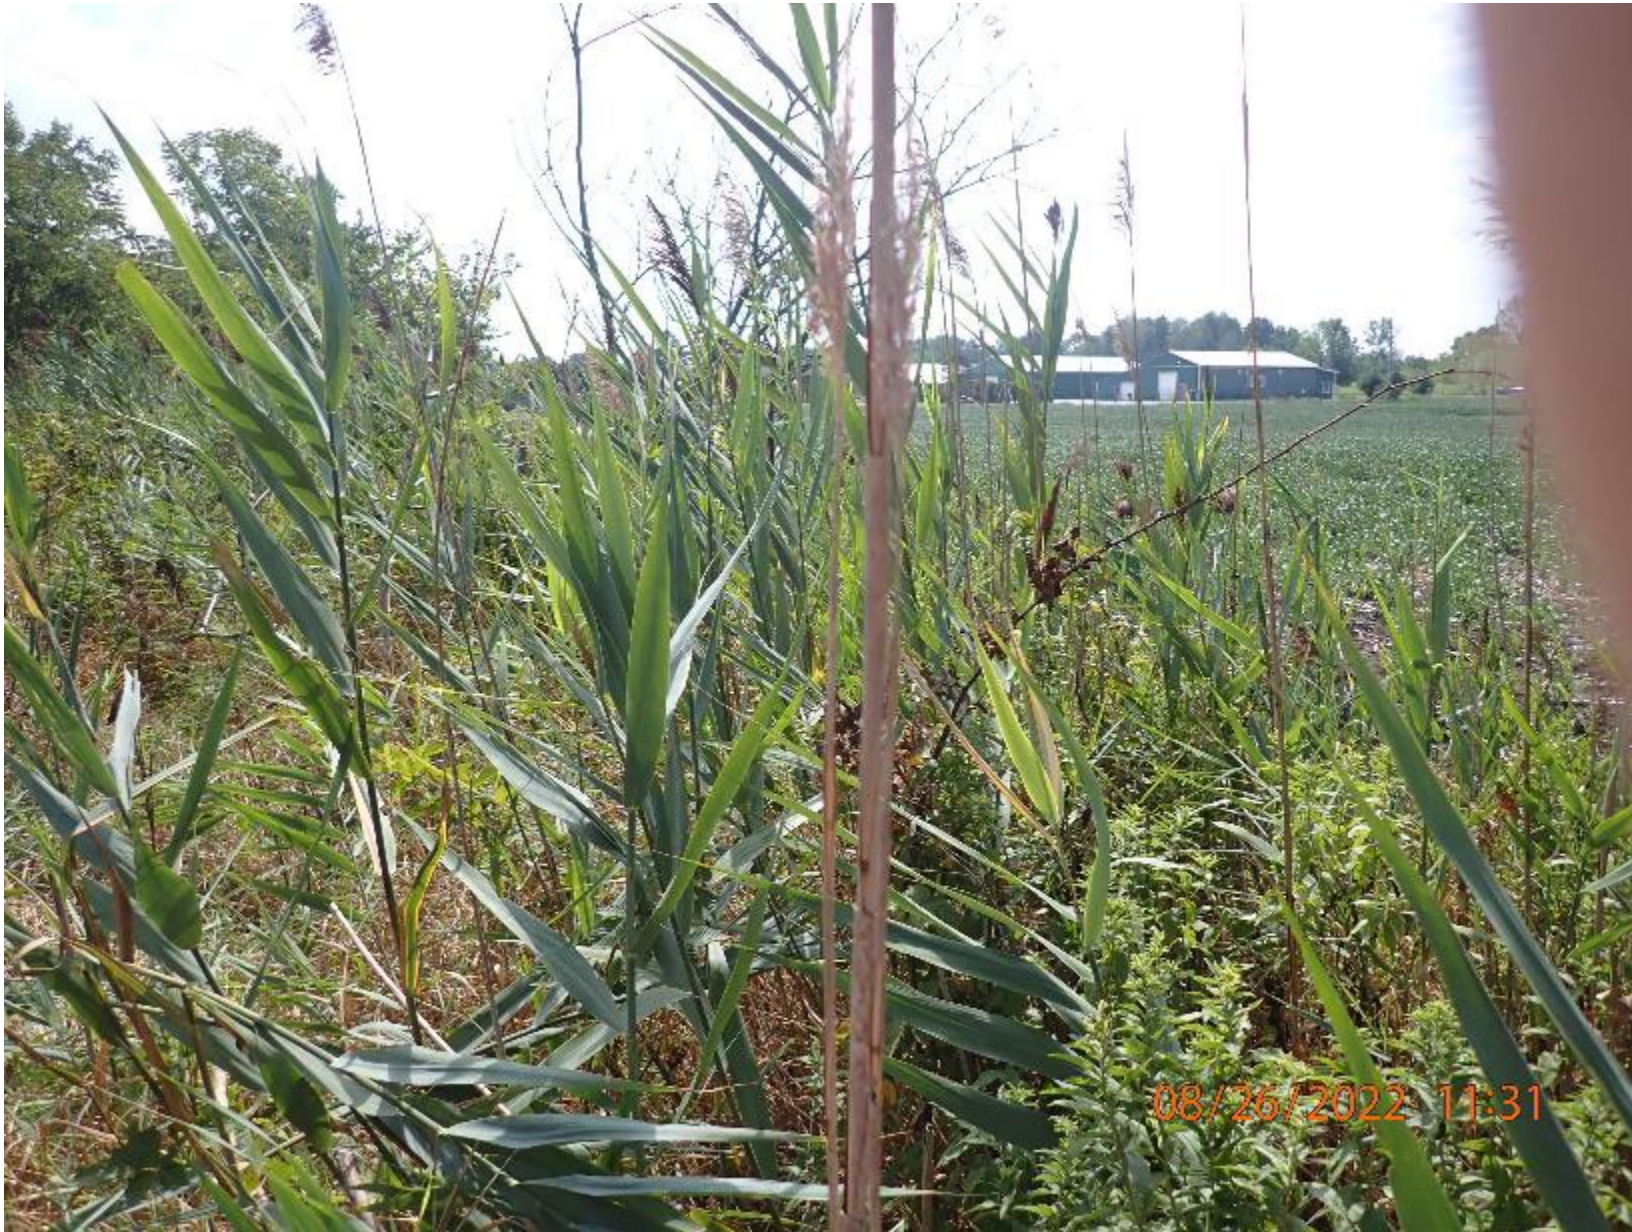
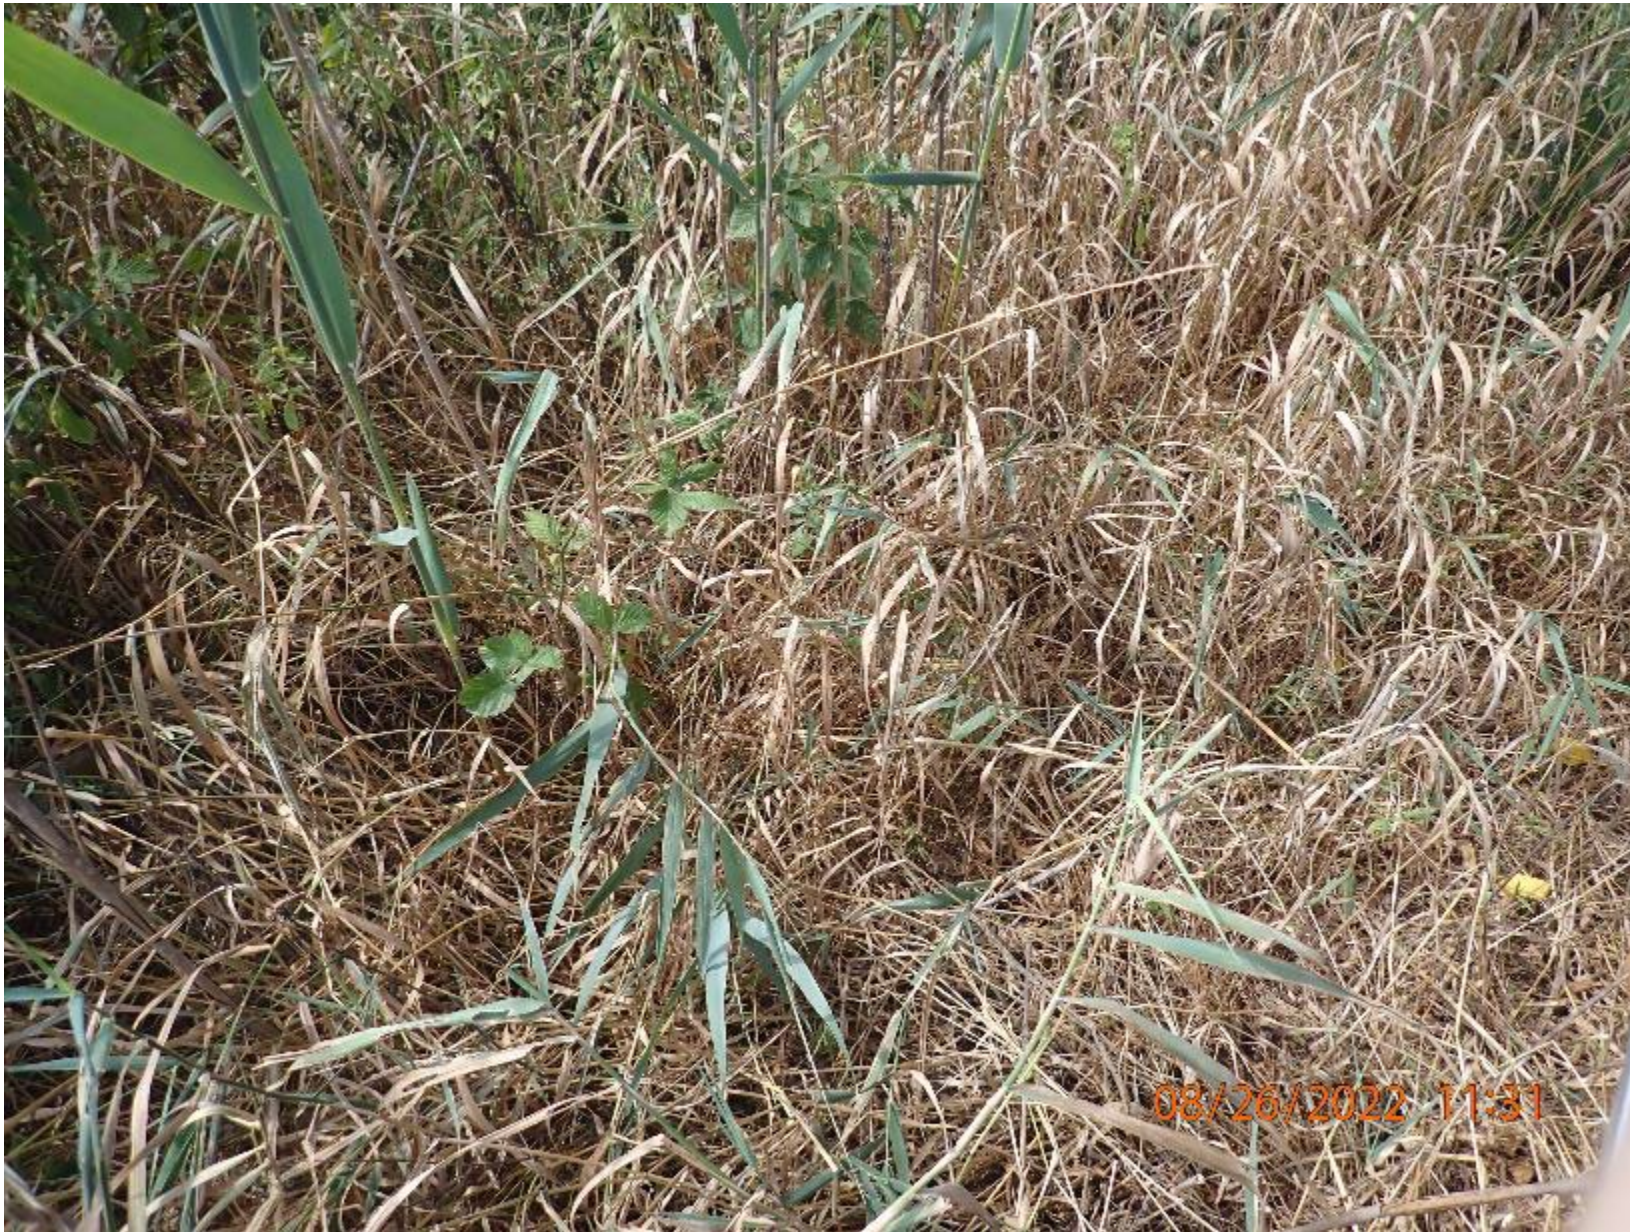
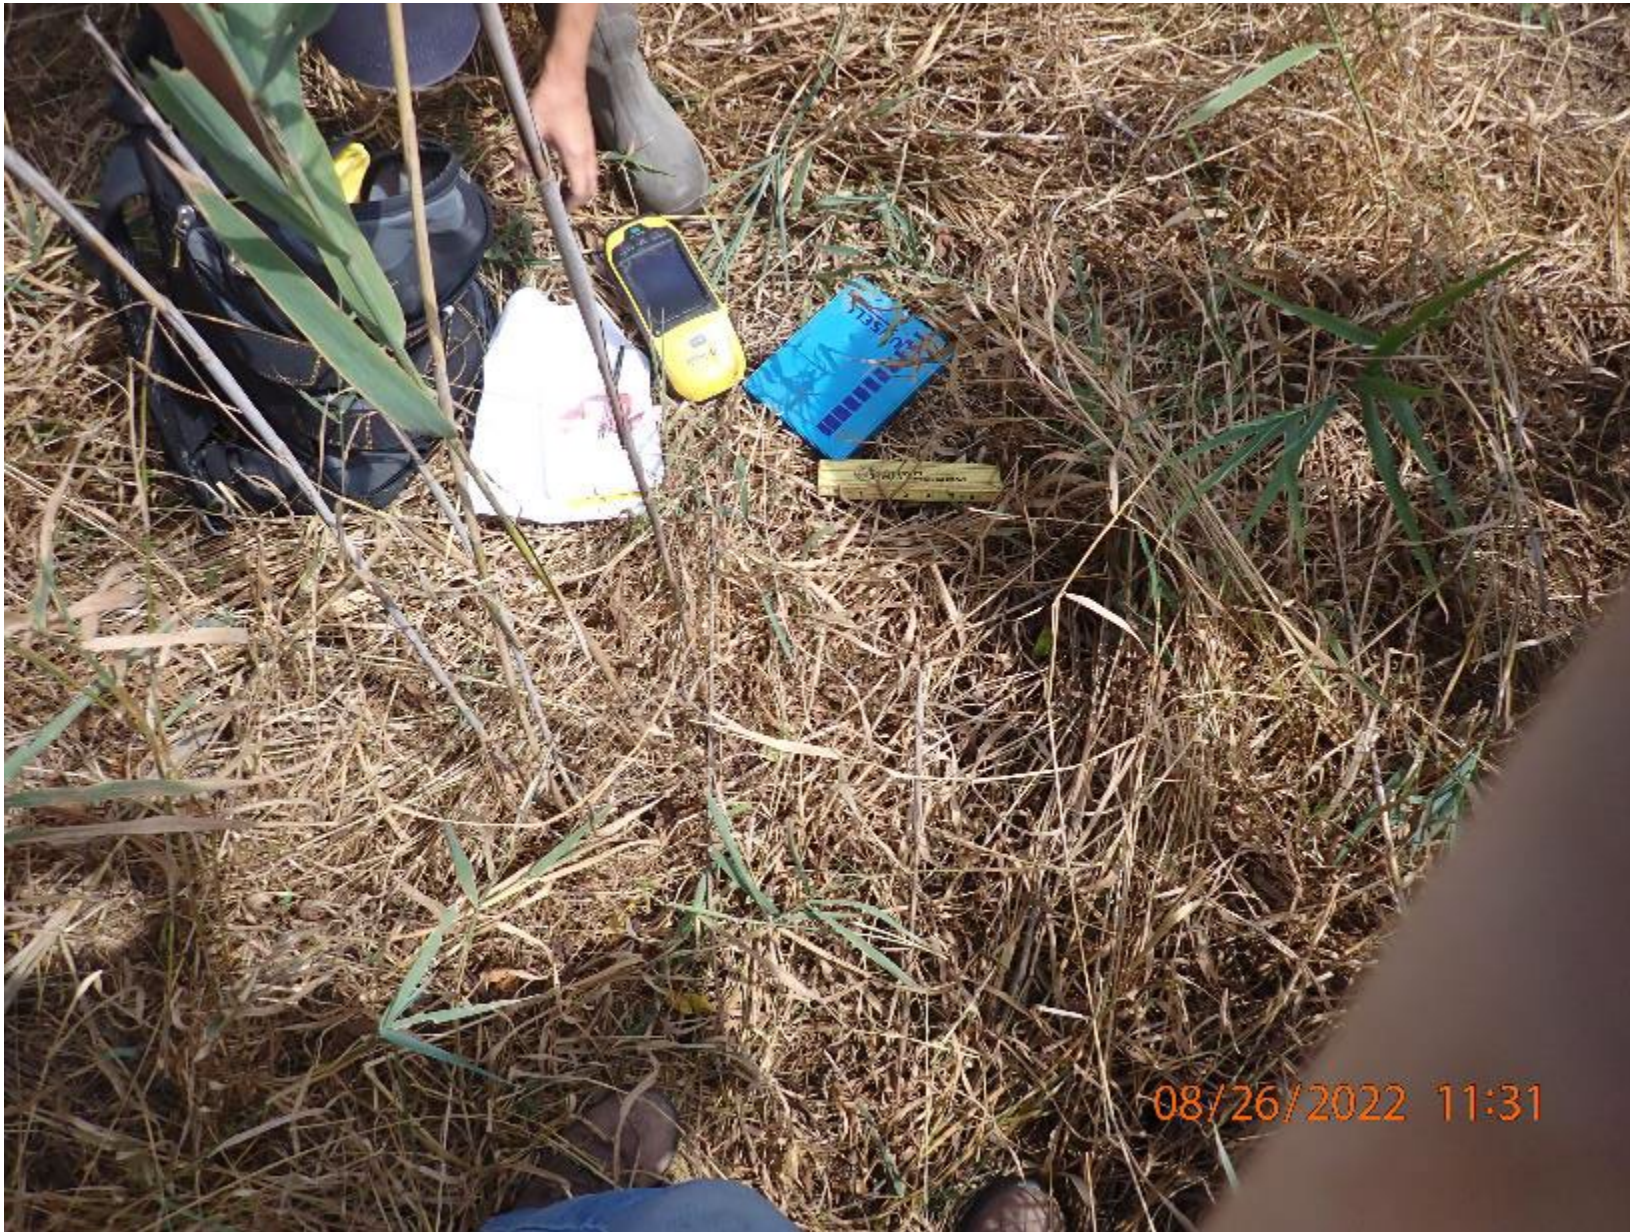
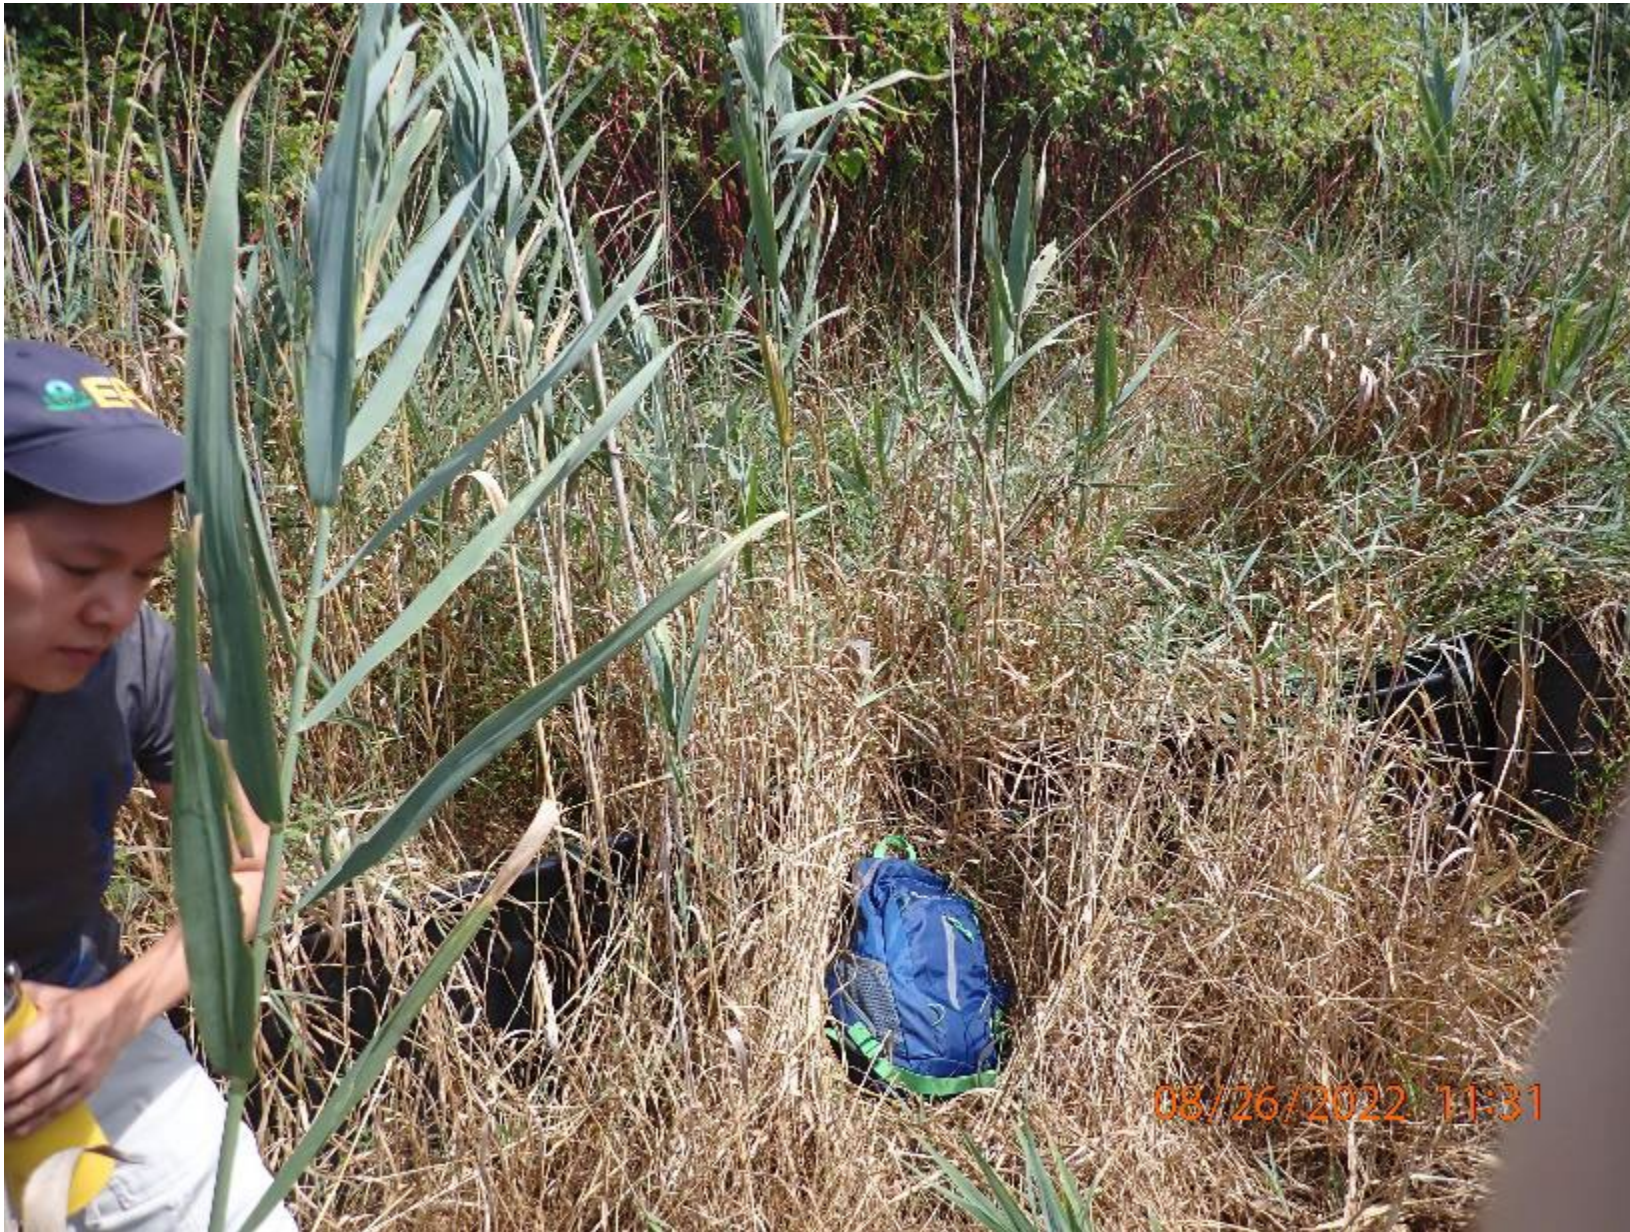
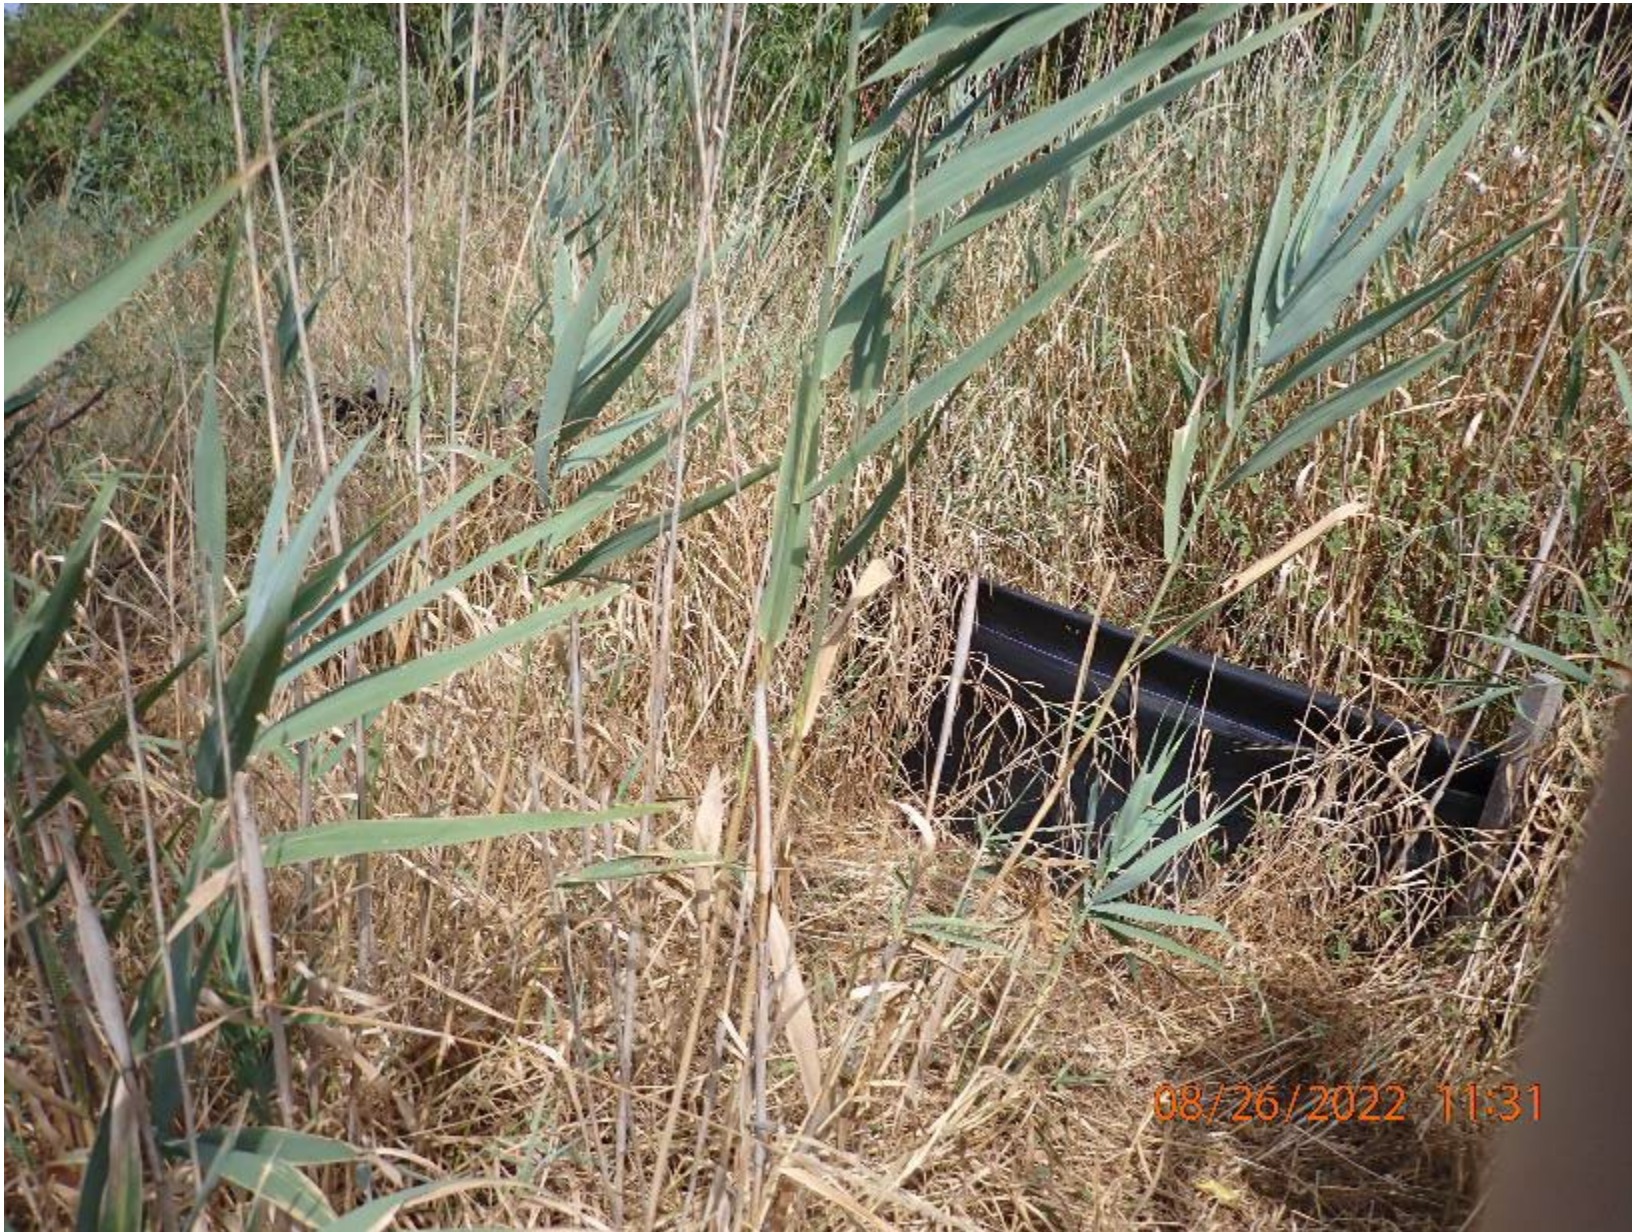
**Description:**  
Area around Soil Pit #2 (SS2)
