# Clean Water Act Section 404: Site Visit/Case Development

Site Name	Dick's Concrete
-----------	-----------------

Site Address*	1053 County Road 37 (Pellets Island Road) and 1326 Co Route 12
---------------	--

CWA 404 Inspection Photolog  
Dick's Concrete  
1053 Co Rd 37 and 1326 Co Rt 12  
Orange County, NY

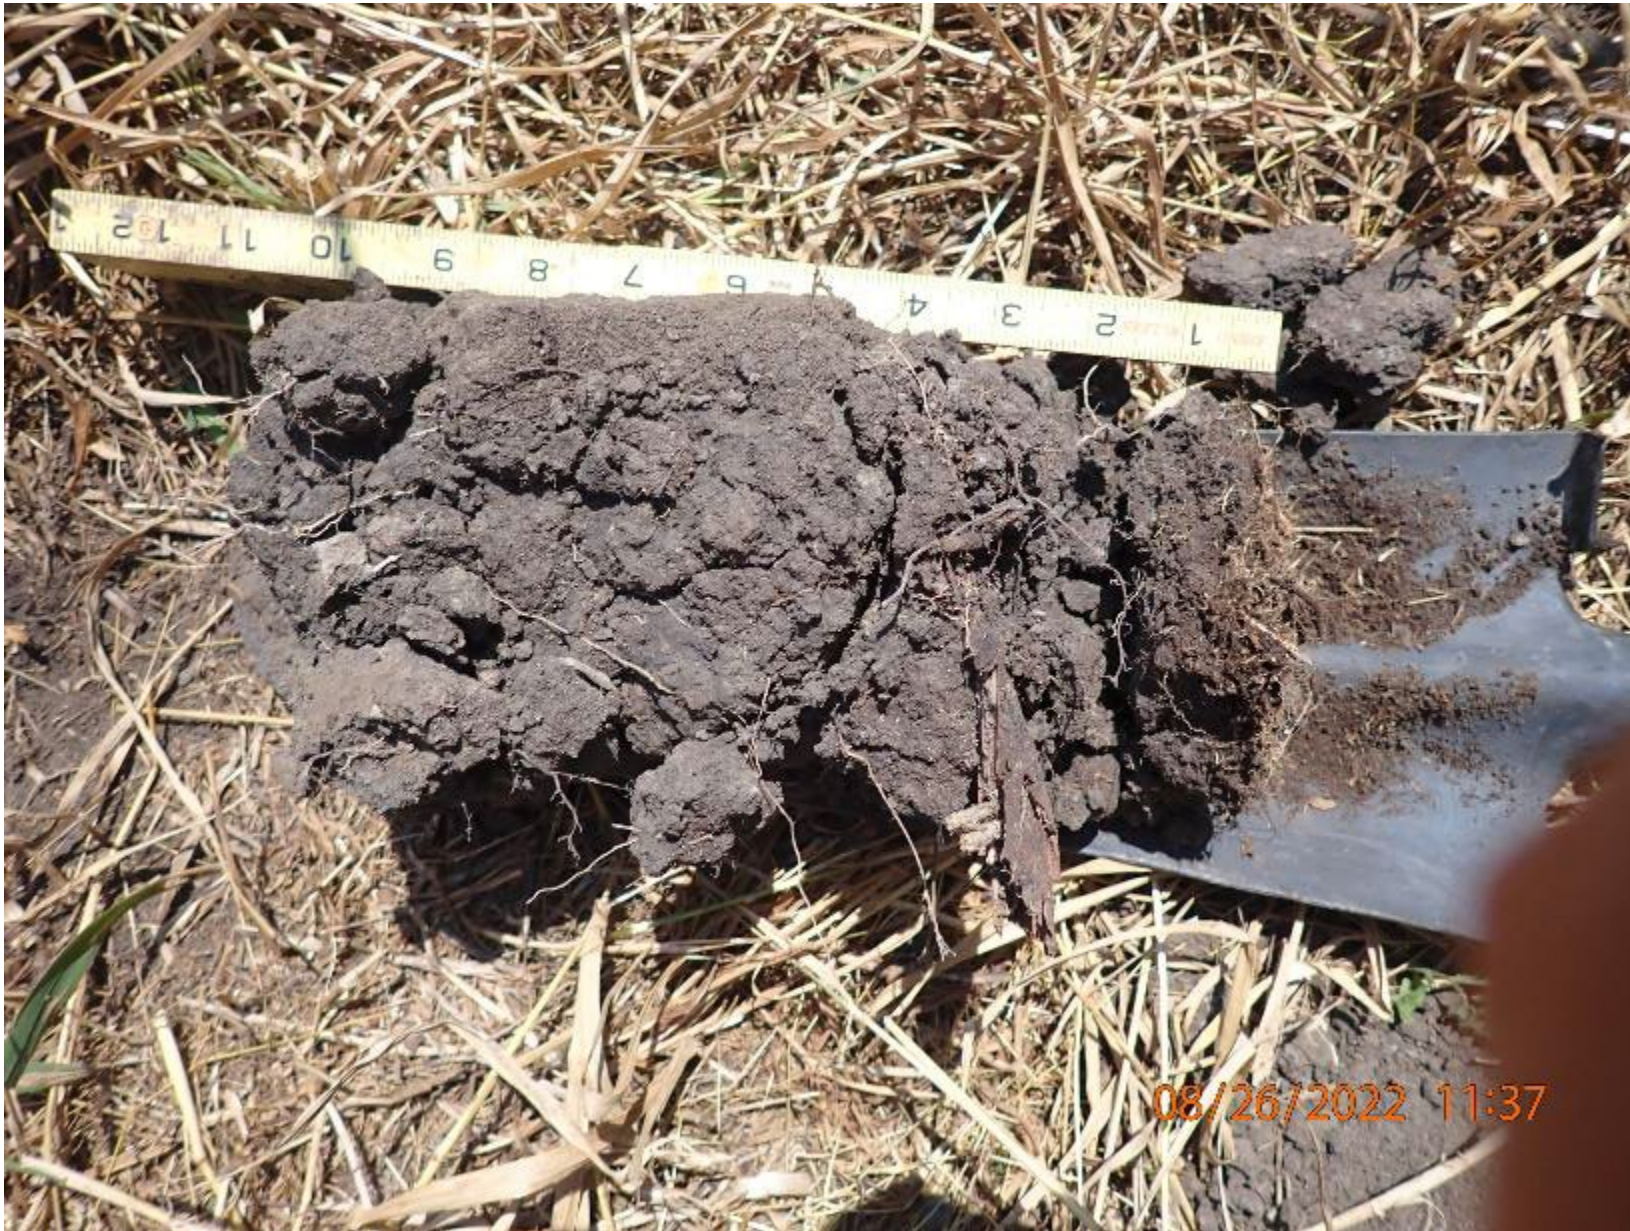
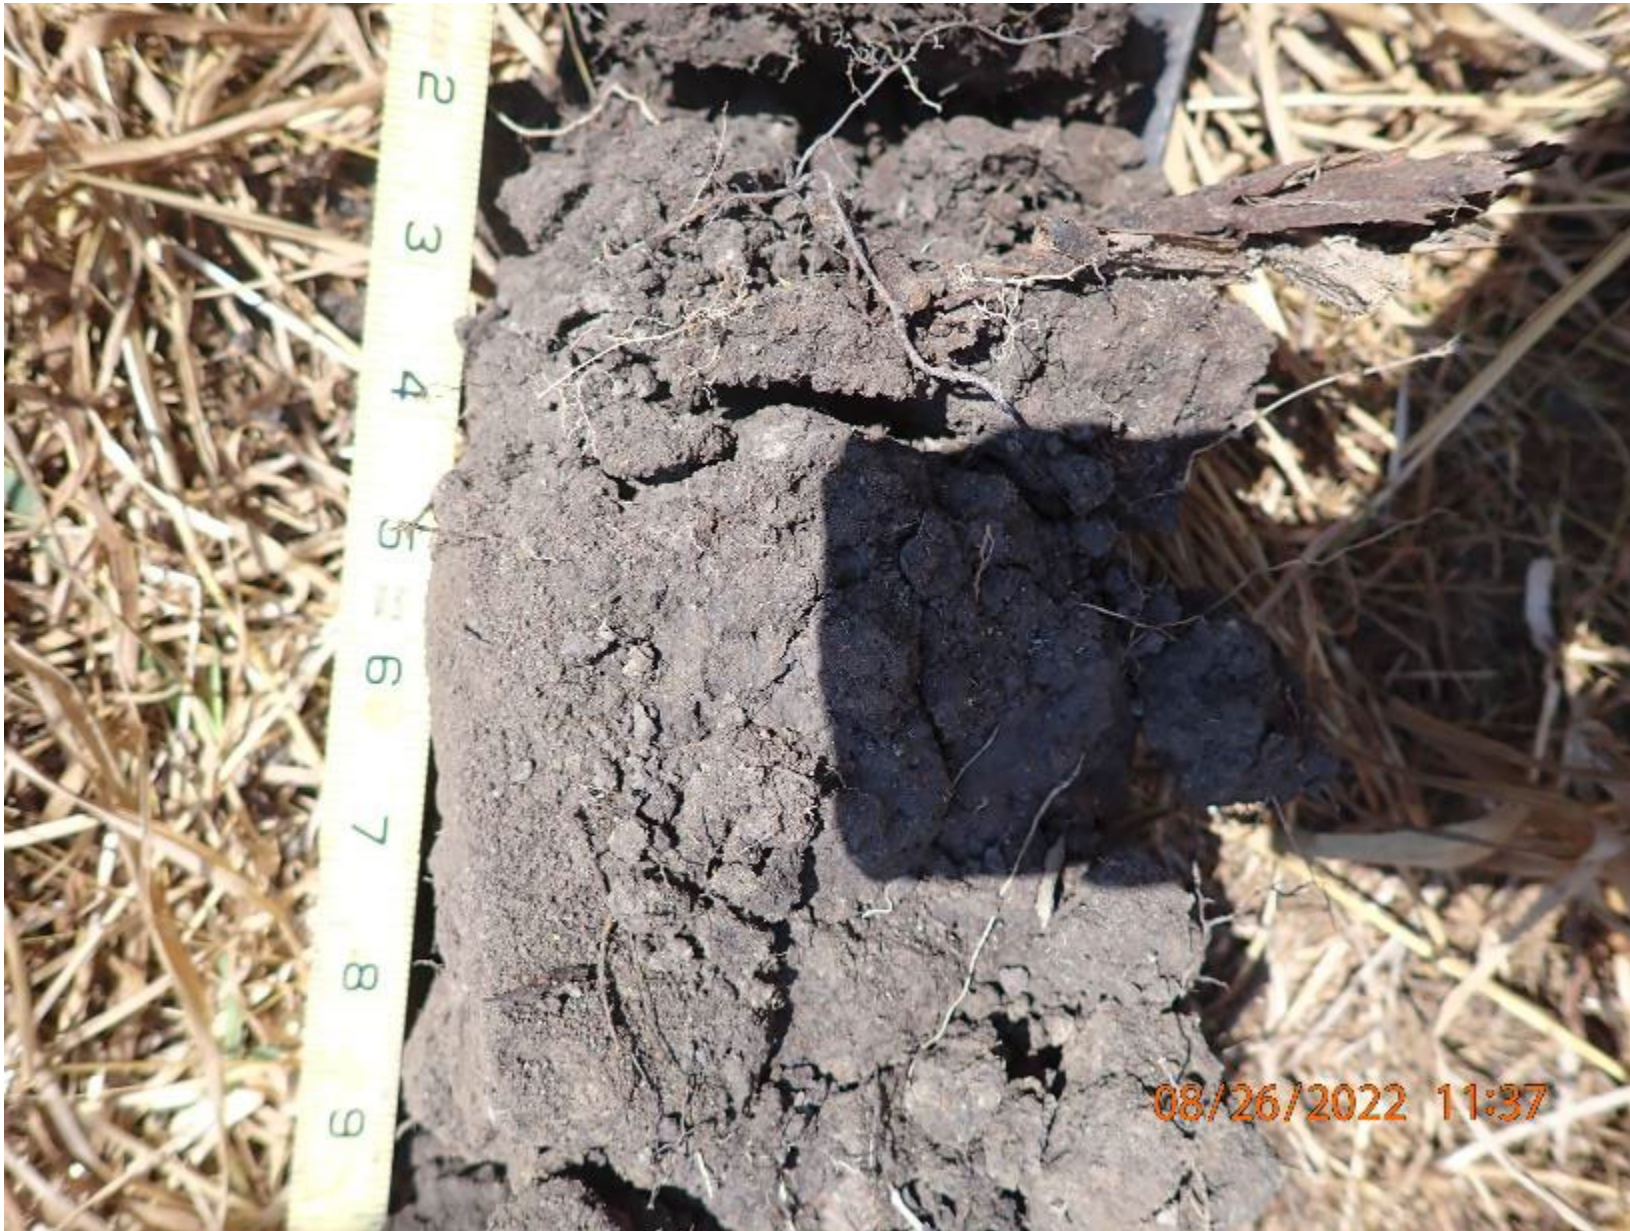
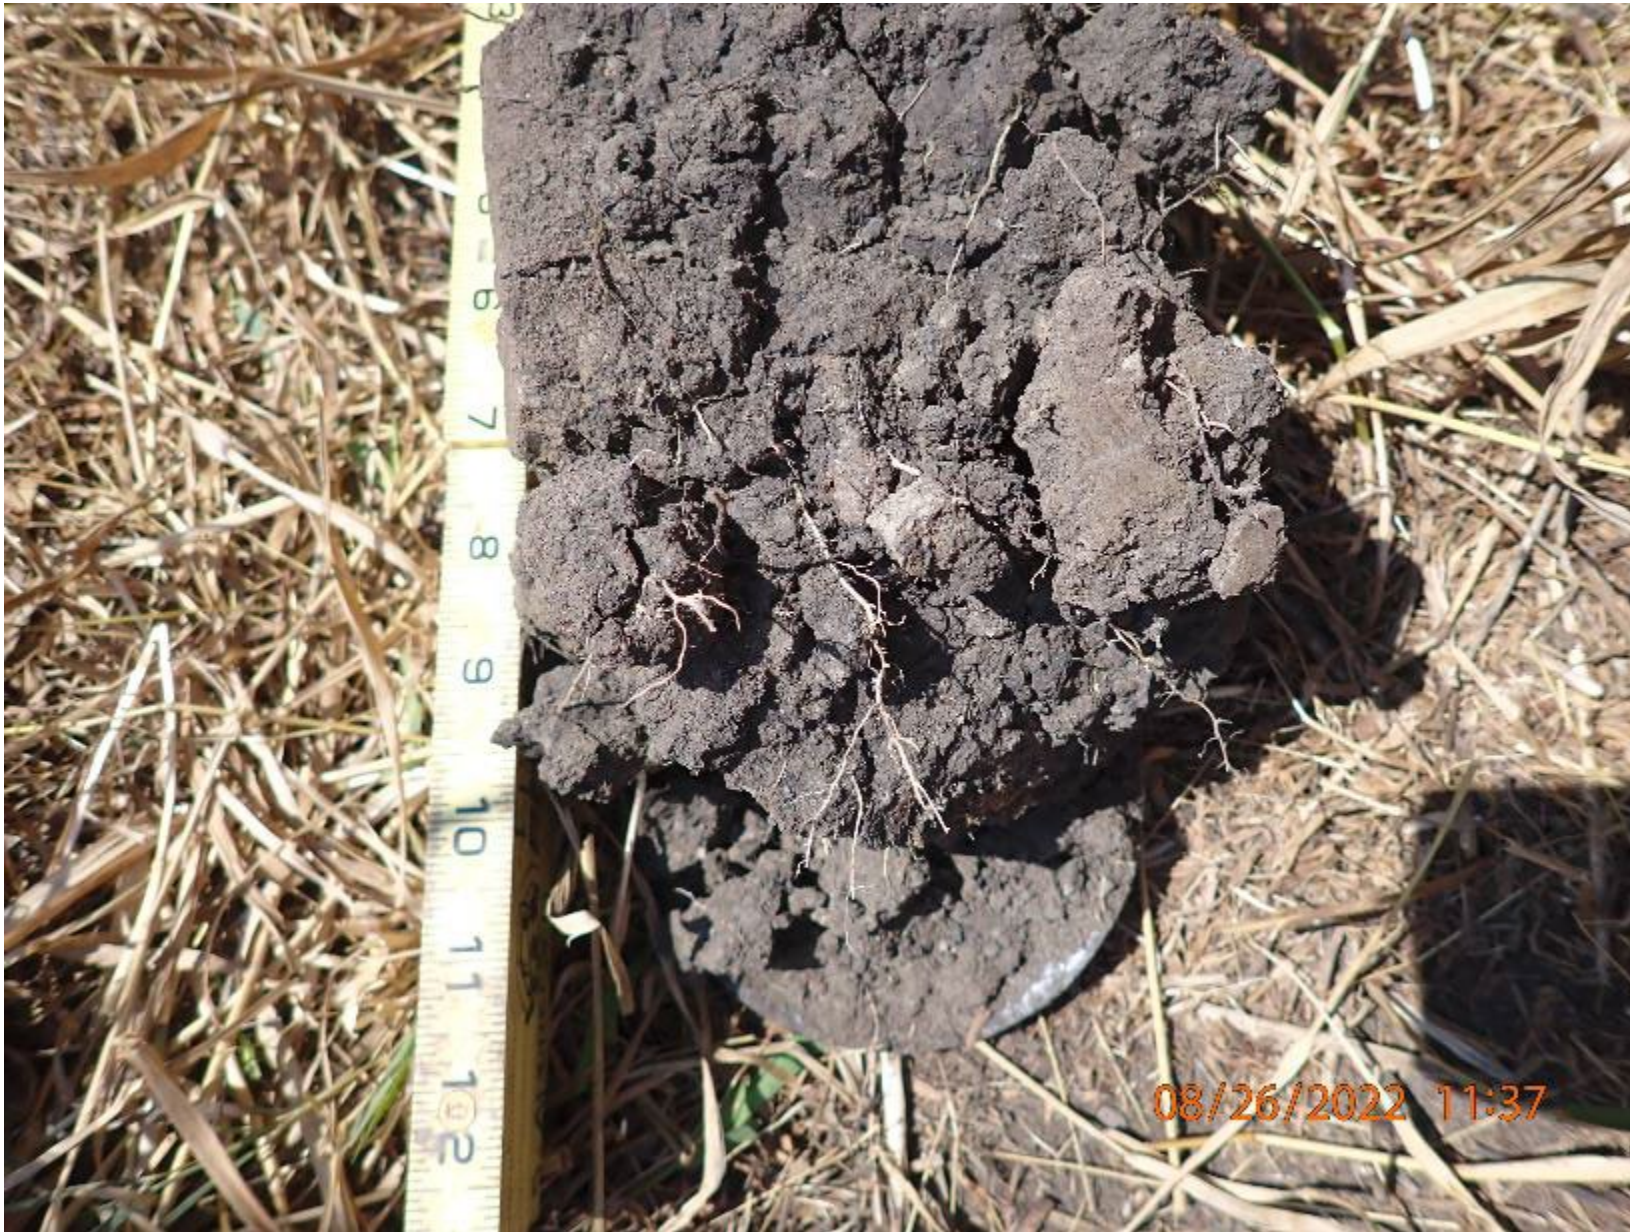
EPA took two soil samples. The first soil sample, located in a scrub-shrub/herbaceous area east of the expansion, was found to not be in a wetland due to a lack of hydrological indicators. The second soil sample, located between the berm and an agricultural channel south of the expansion area was also found to not be in a wetland.

**Description:**  
Soil Pit #2 (SS2) soil profile

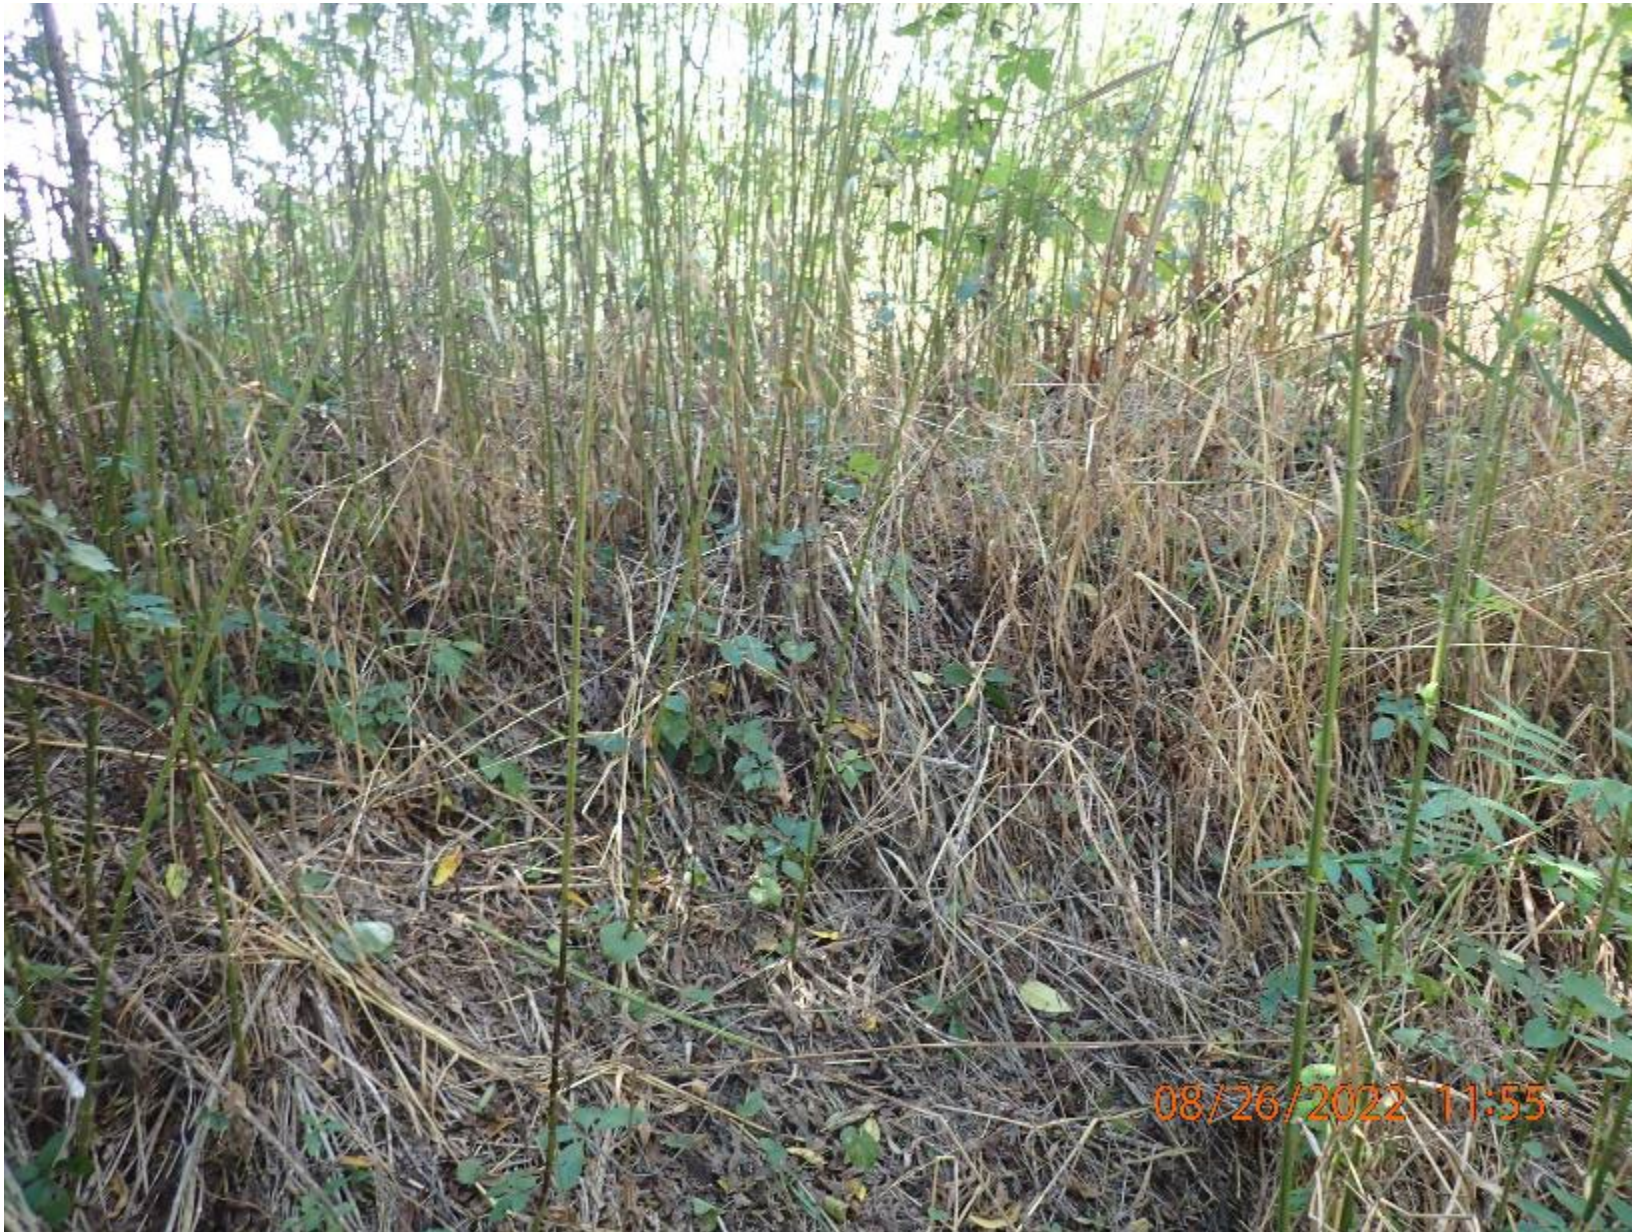
**Date:** 8/26/2022  
**Time:** 11:55 AM  
**Photographer:** SSA  
**Photo ID:** 34 – P8260402

**Description:**  
Area near berm

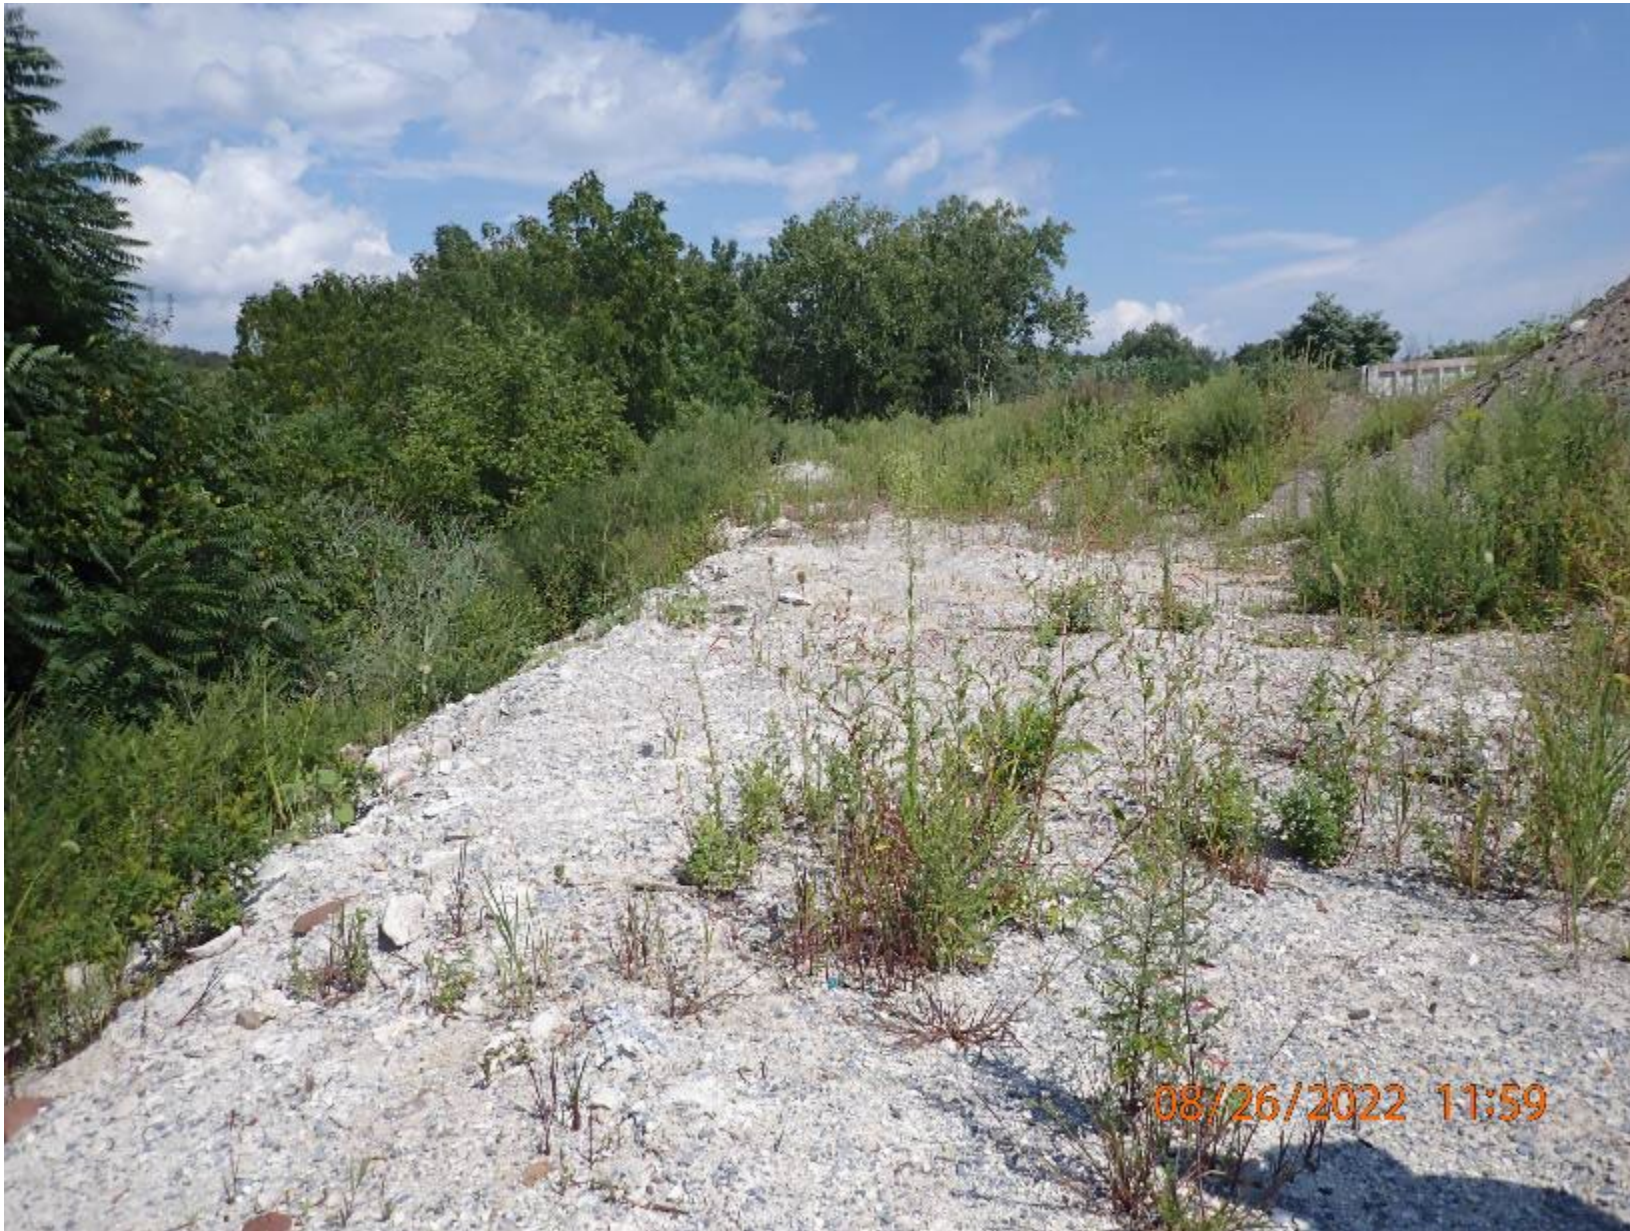
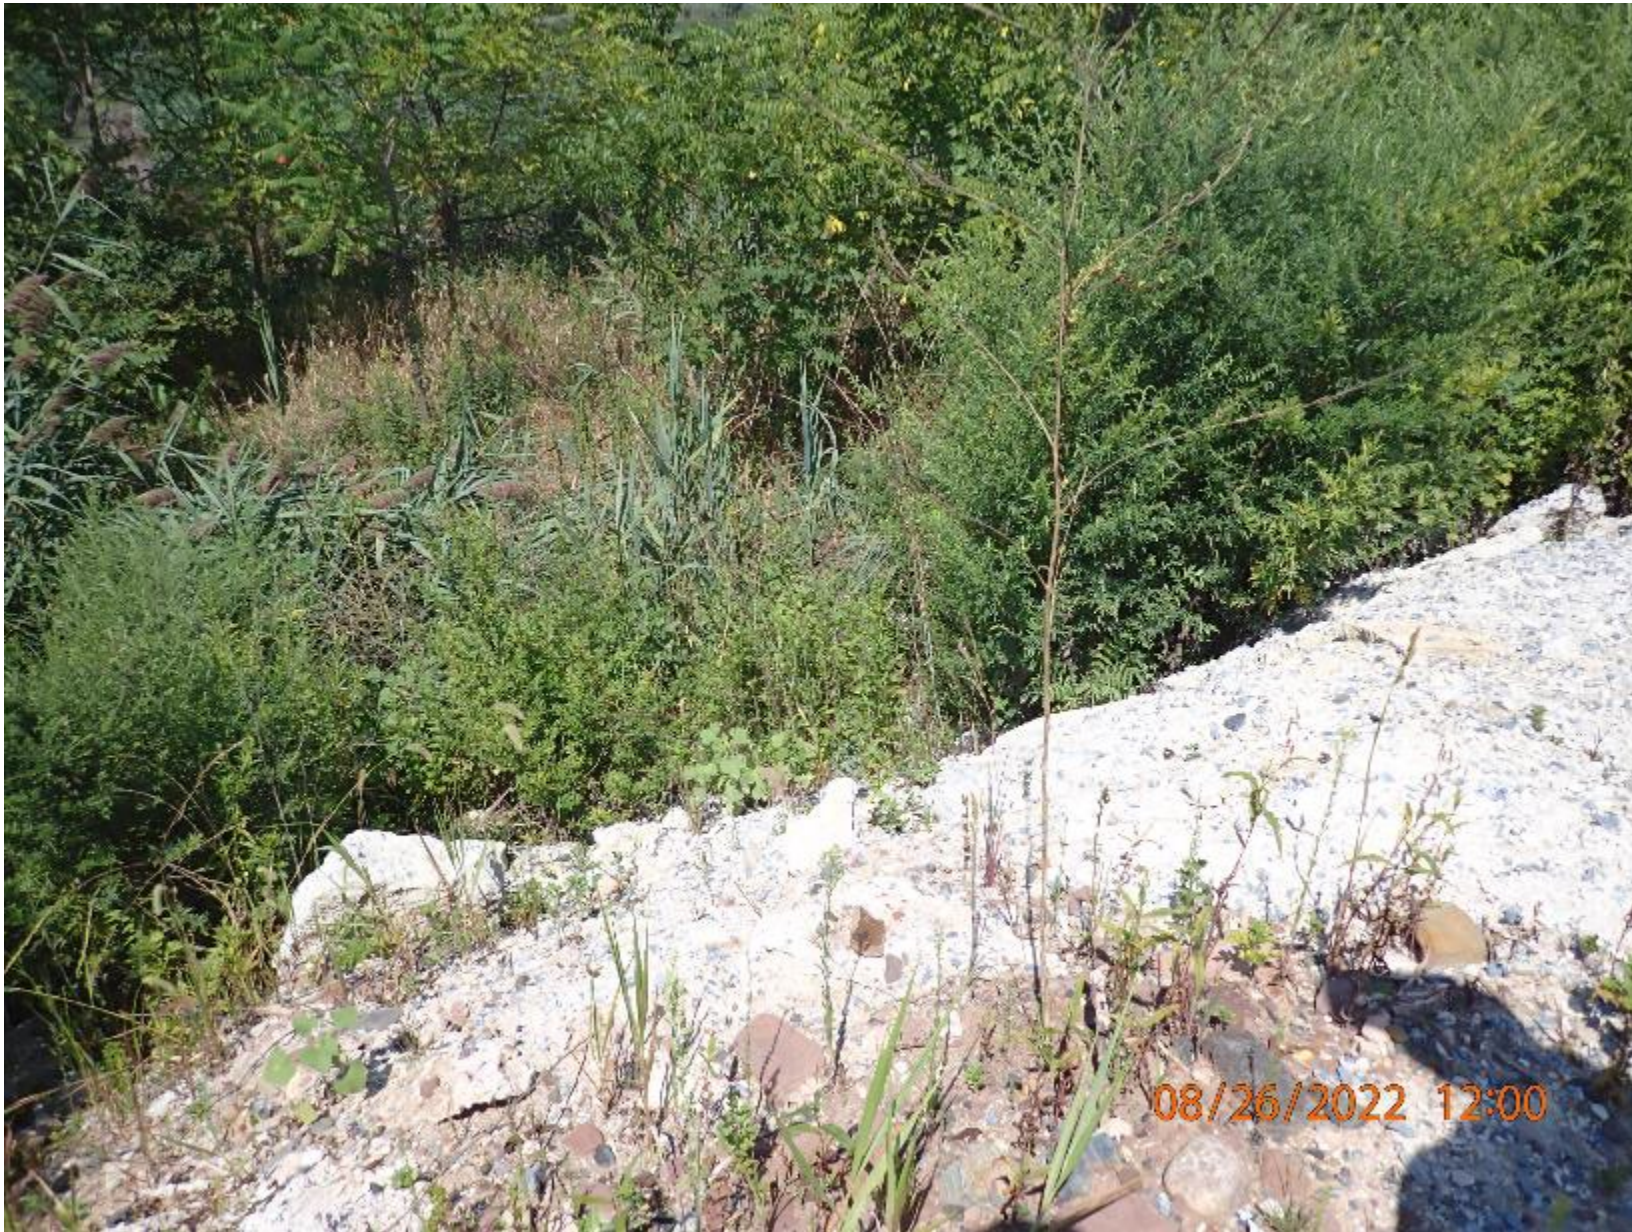
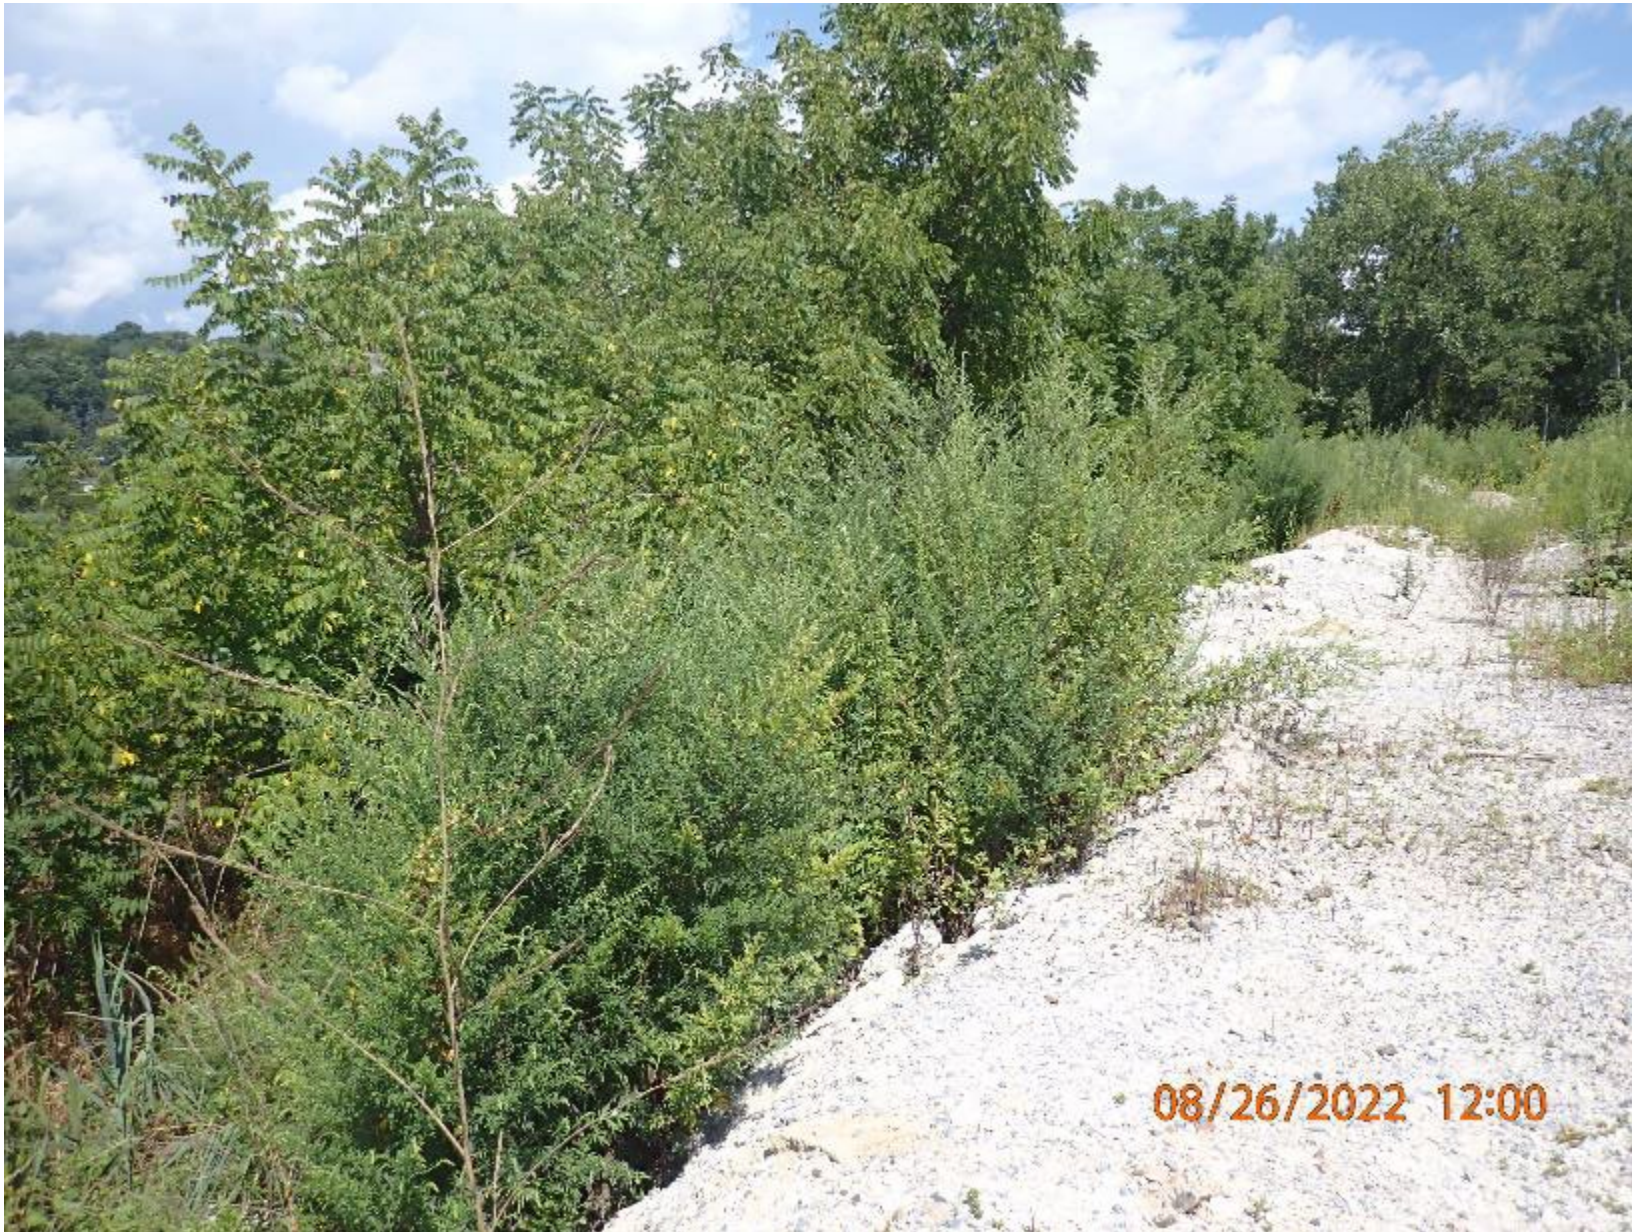
SW corner of expansion area;  
area on top of berm
