**Well Inspection**  
**Osage DNR / Environmental Protection Agency**  
**1201 Elm Street, Suite 500**  
**Dallas, Texas 75270**

| | | <b>Well ID</b> | 22-03 | | |
| <b>Inspection Reason</b> | MIT | <b>Responsible Company at Time of Inspection</b> | CapturePoint, LLC | | |

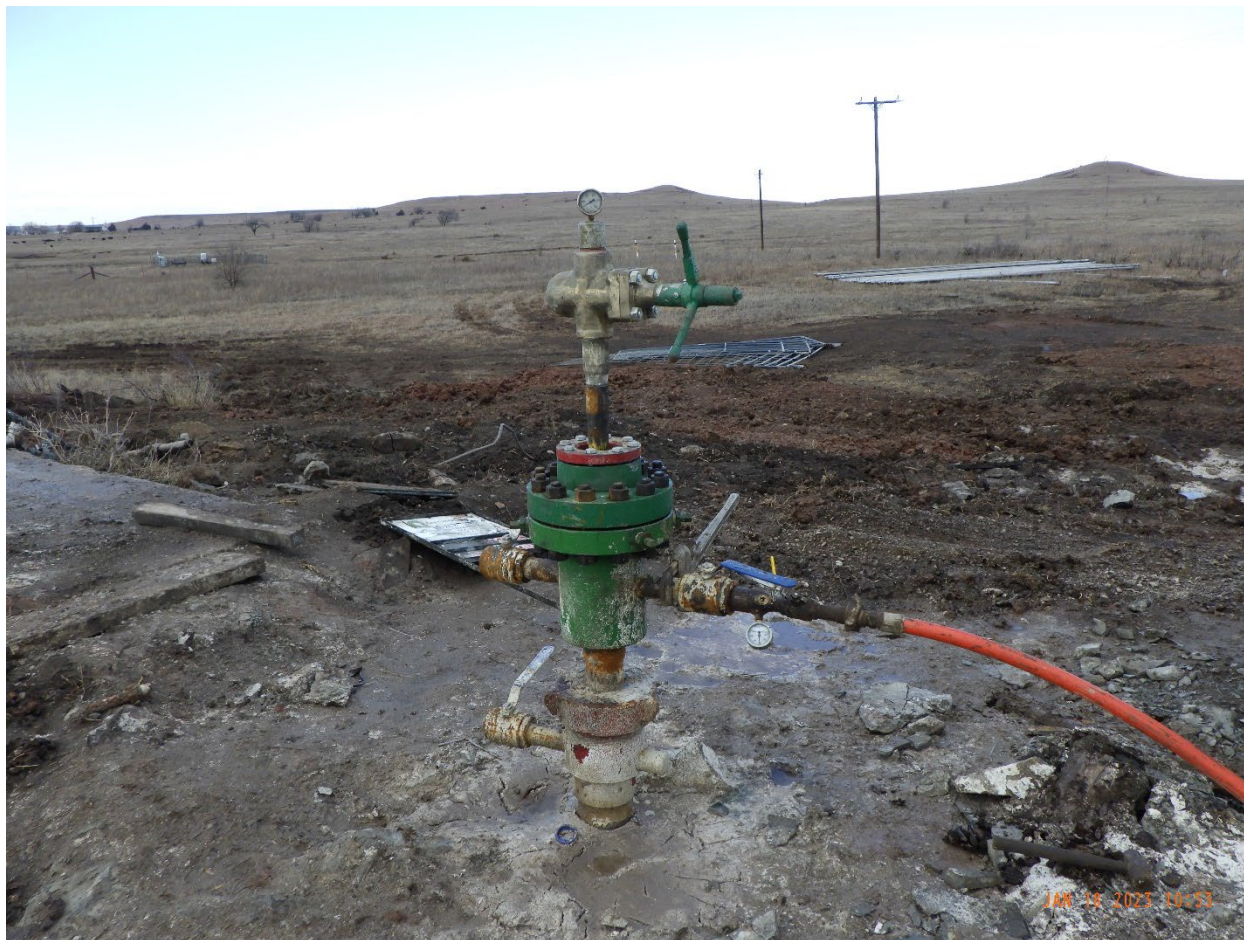
Photo No. 1

**Description:** This was well OS6273134 at the time of inspection.
