## Region 6 - Enforcement & Compliance Assurance Division

### INSPECTION REPORT

| Facility Name: | City of Rio Rancho Wastewater Treatment Plant #2 | |
| Identification/Permit Number: | NM0027987 | |

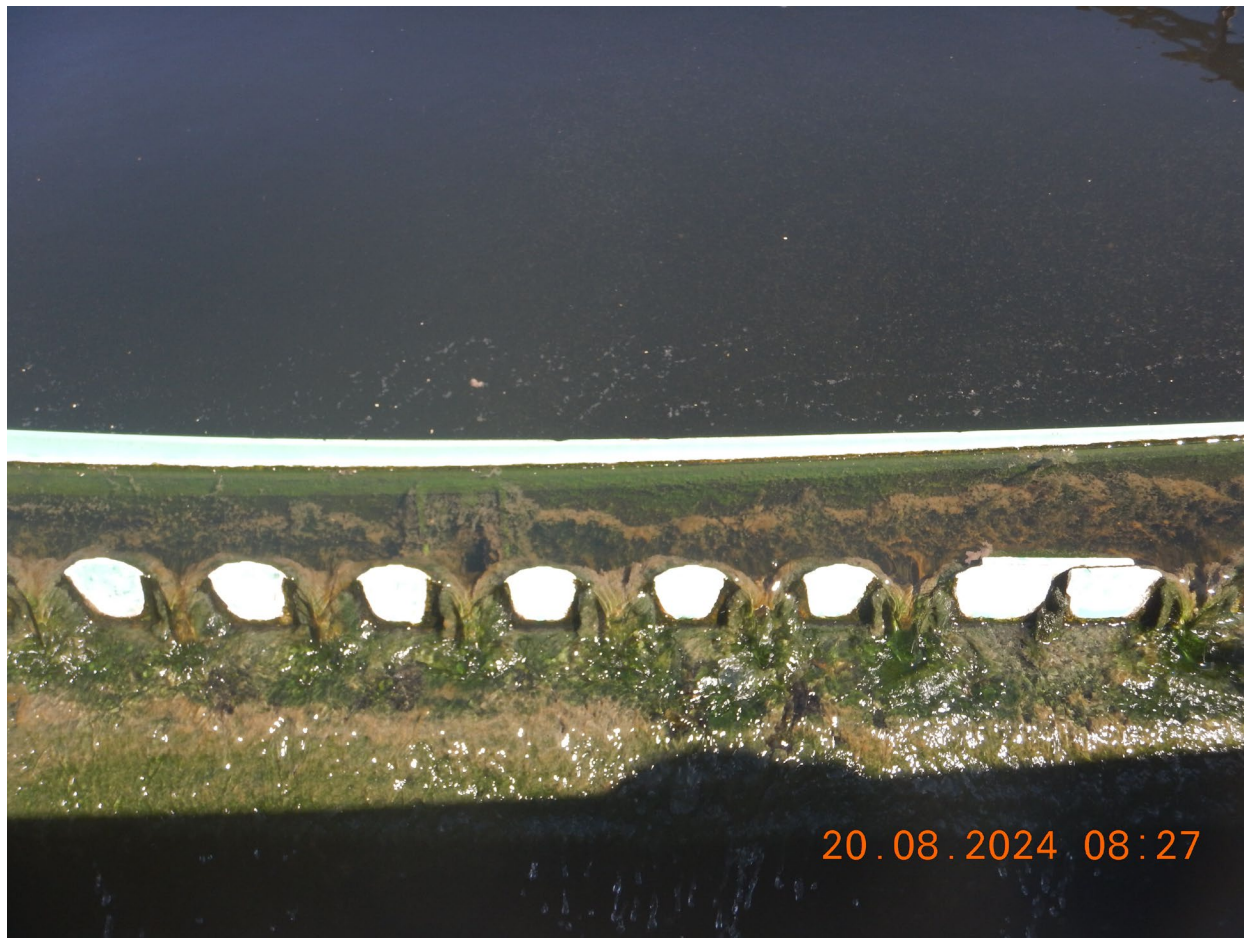
Photo No. 1

- The clarifiers exhibited excessive algae growth along the weirs and the consultants stated they are washed and/or cleaned approximately once per month.

View of the excessive algae growth on the clarifiers along the weirs. **Note:** the consultants stated they are washed and/or cleaned approximately once per month. (DSCN2711). Photographed by E. Yurk

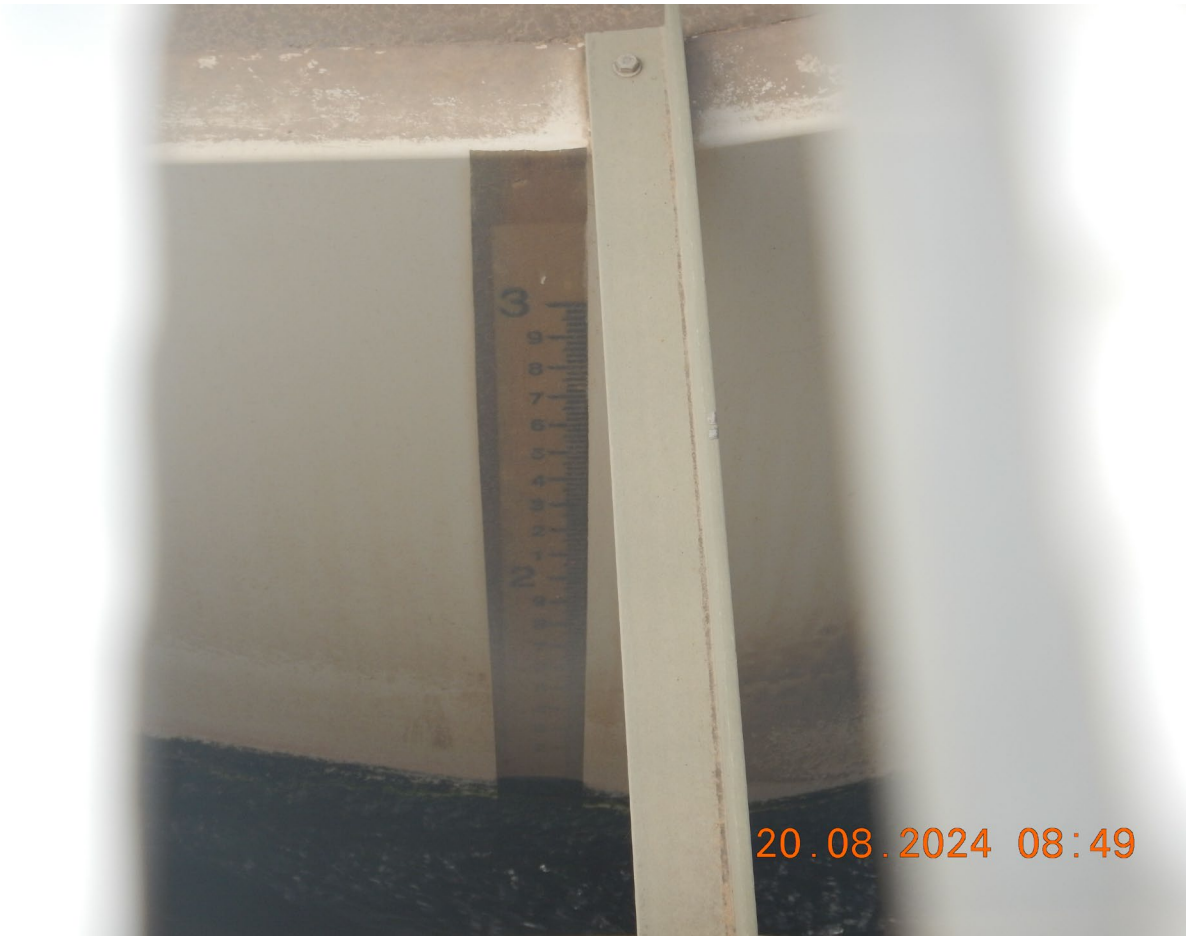
Photo No. 2

- Rio Rancho utilizes a sonic meter for flow measurement within a Parshall flume after UV disinfection and staff gauge as confirmation. However, the staff gauge was difficult to read and required cleaning.

Rio Rancho utilizes a sonic meter for flow measurement within a Parshall flume after UV disinfection and staff gauge as confirmation. However, the staff gauge was difficult to read and required cleaning. (DSCN2714). Photographed by E. Yurk

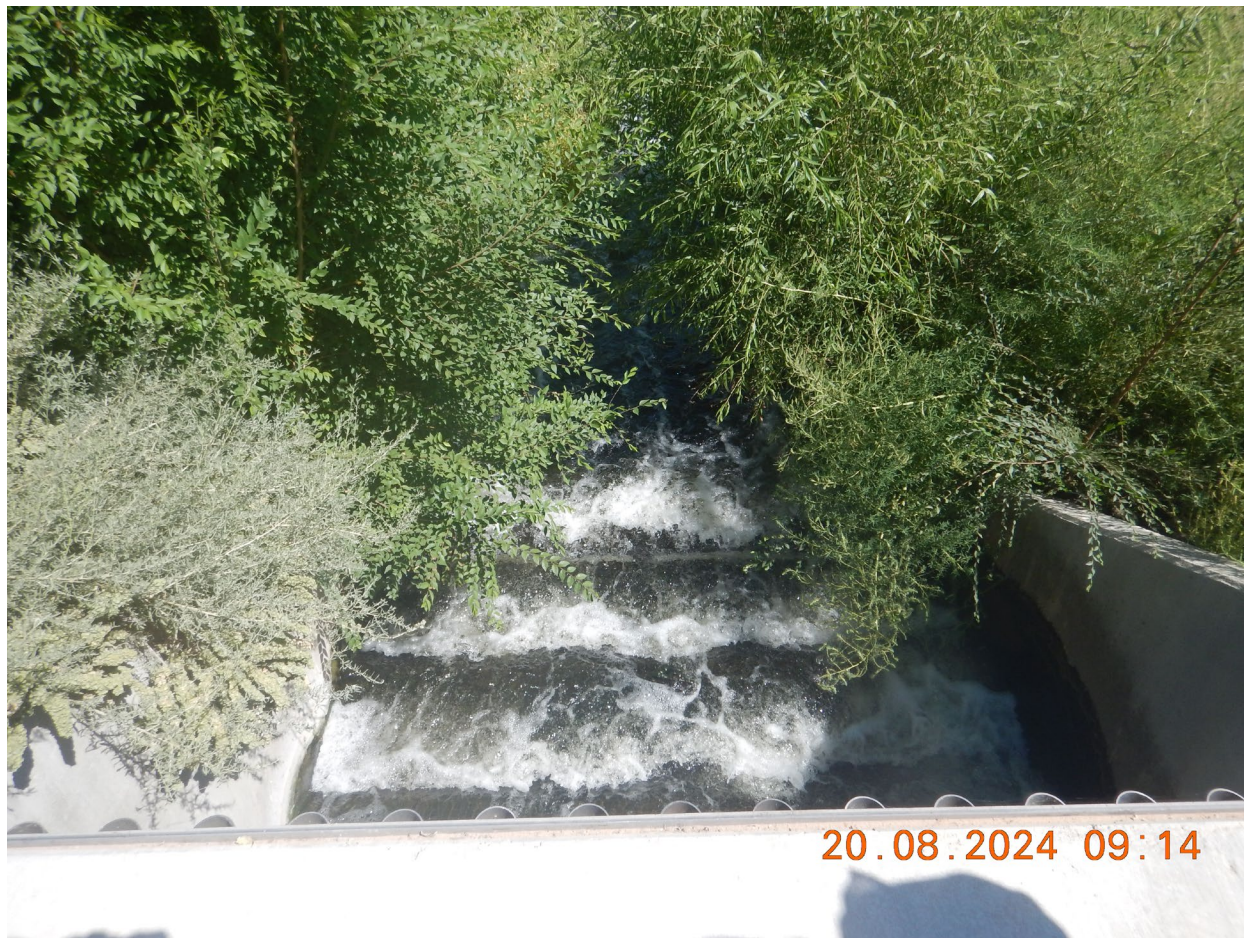
Photo No. 3

View of Outfall 001 downgradient toward the Rio Grande. (DSCN2716) Photographed by E. Yurk

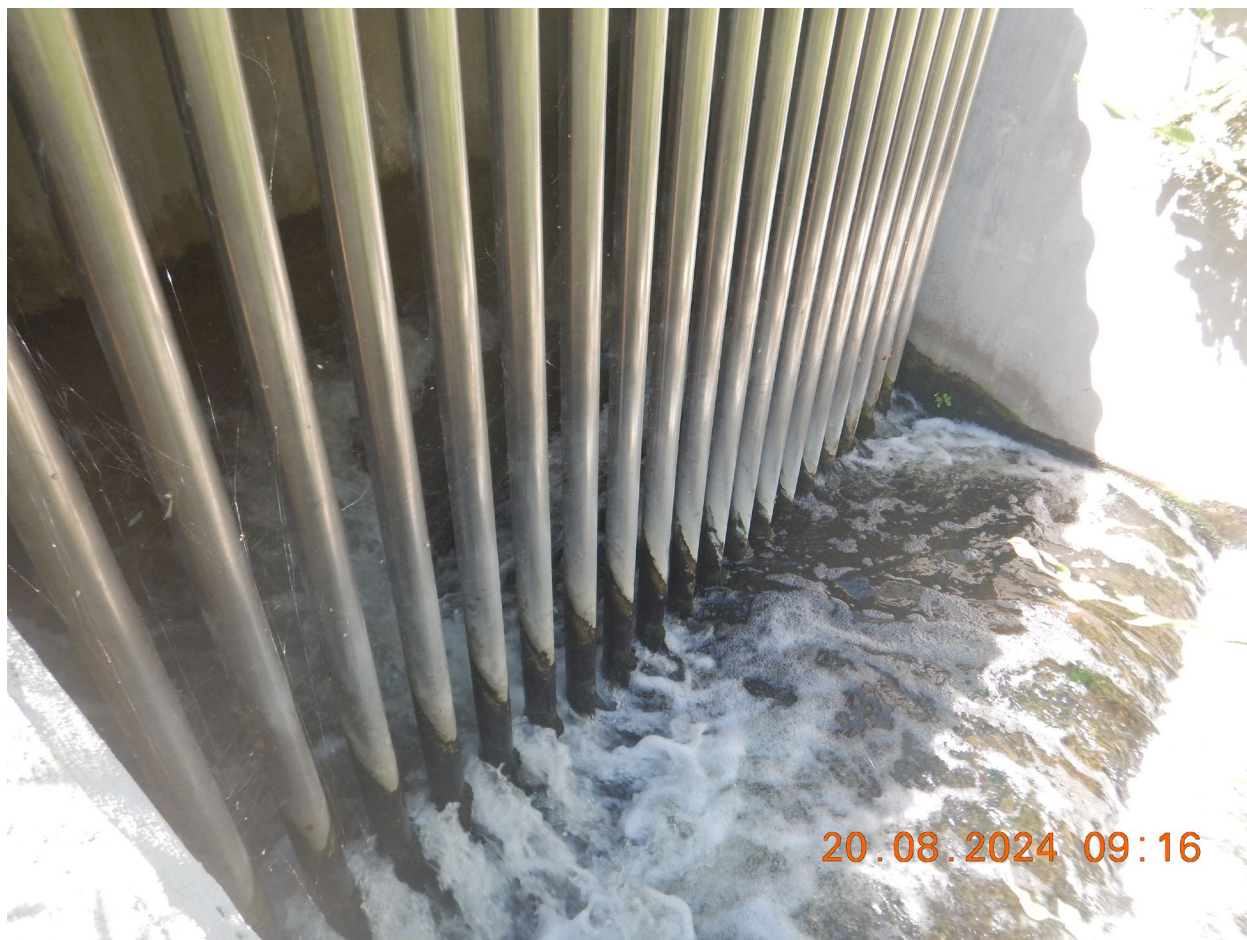
Photo No. 4

View of Outfall 001 at the discharge orifice. Note: there was no evidence of aromatics, stressed vegetation, or staining (sheen). (DSCN2718) Photographed by E. Yurk

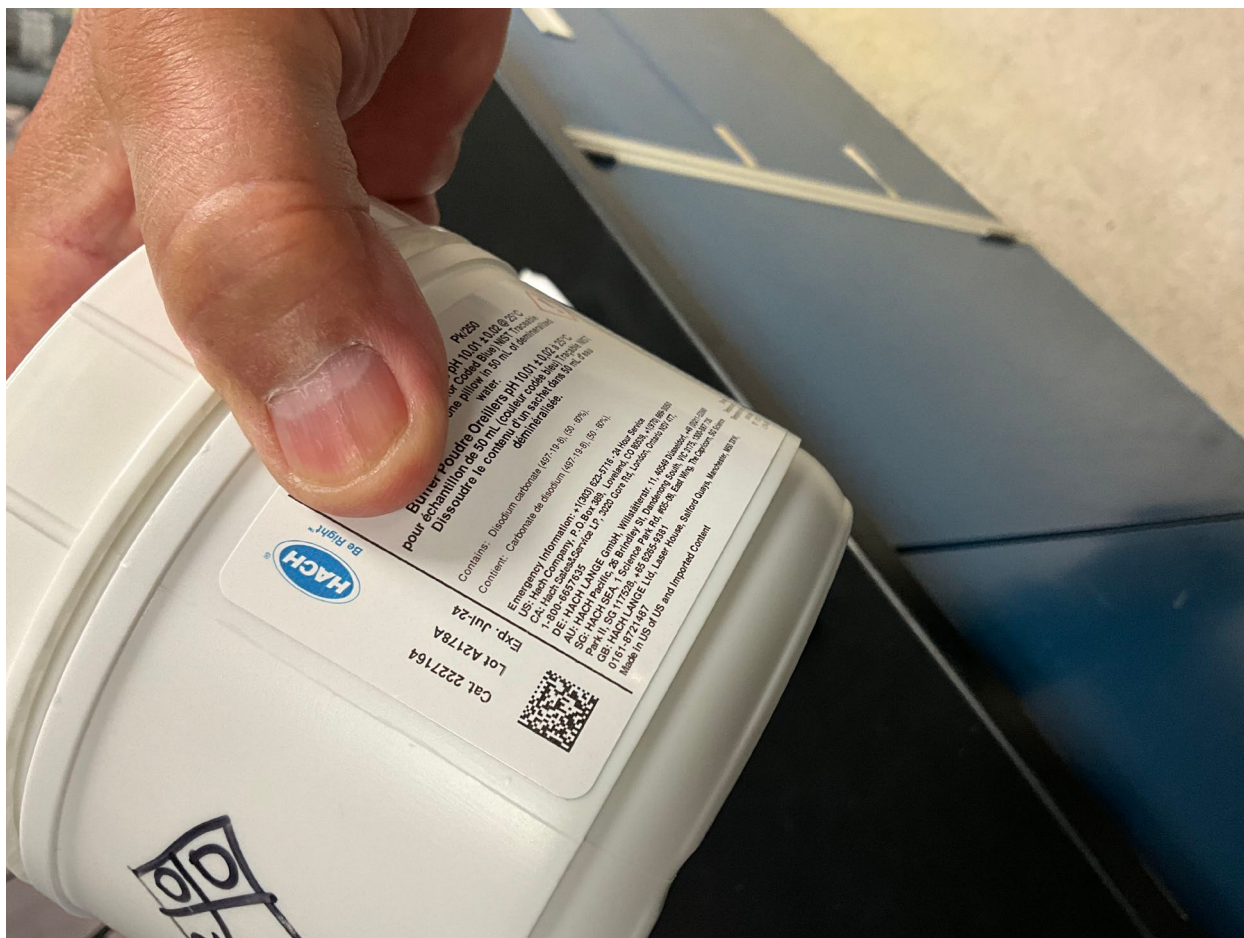
Photo No. 5

- The on-site laboratory pH-10 buffer had expired (July 2024).
- Rio Rancho consultants stated the sludge blanket within the treatment basins is approximately 1-foot thick and the basins were last cleaned in 2013.

View of the on-site laboratory pH-10 buffer that had expired (July 2024). (IMG\_0010). Photographed by D. Esparza
