**Purpose:** City of East St. Louis CSO Inspection

**Facility:** City of East St. Louis, IL

**NPDES Permit:** IL0033472

**Dates of Inspection:** March 31, 2021 – April 1, 2021

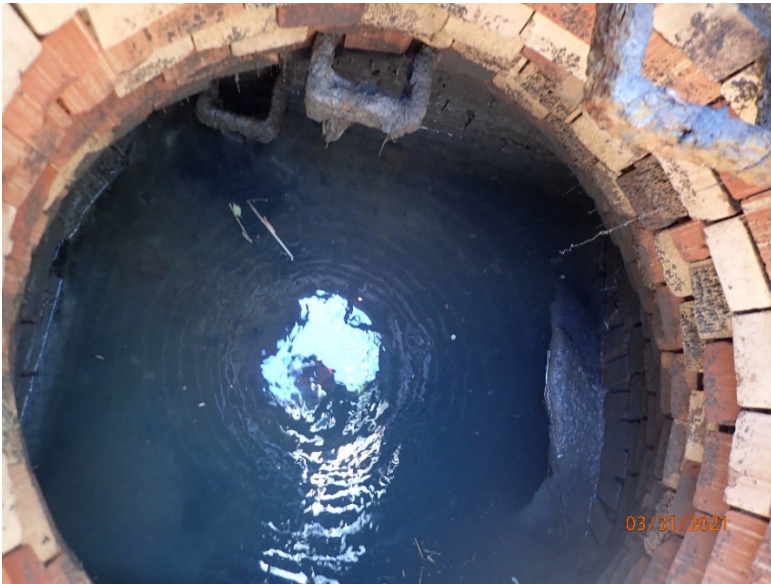
1: P3310004

Description: Looking down into the manhole that is the second manhole downstream of the flow from Centreville on 82<sup>nd</sup> Street. The manhole had standing water which was clear. There was some flow movement, but the level of the water did not recede.

Location: Manhole #15 in East St. Louis. Northwest of intersection of North 82<sup>nd</sup> Street and Ridge Avenue.

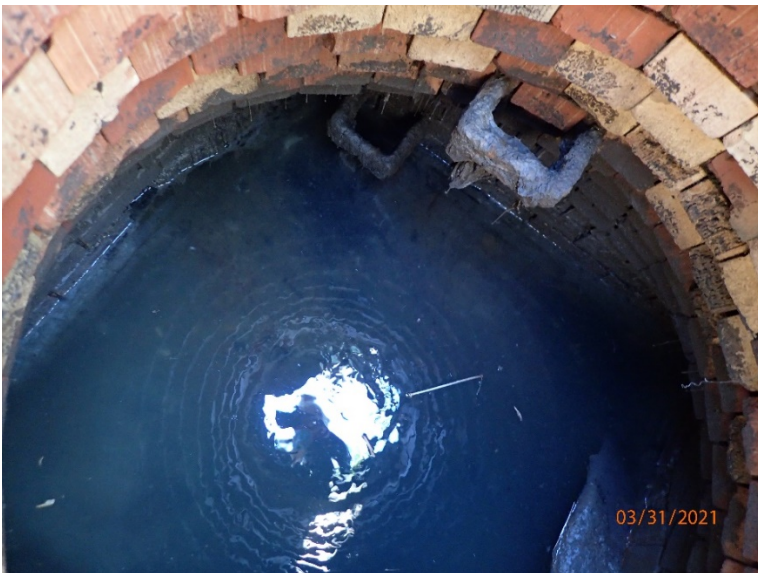
2: P3310005

Description: There was standing water with some flow into and out of manhole #15.

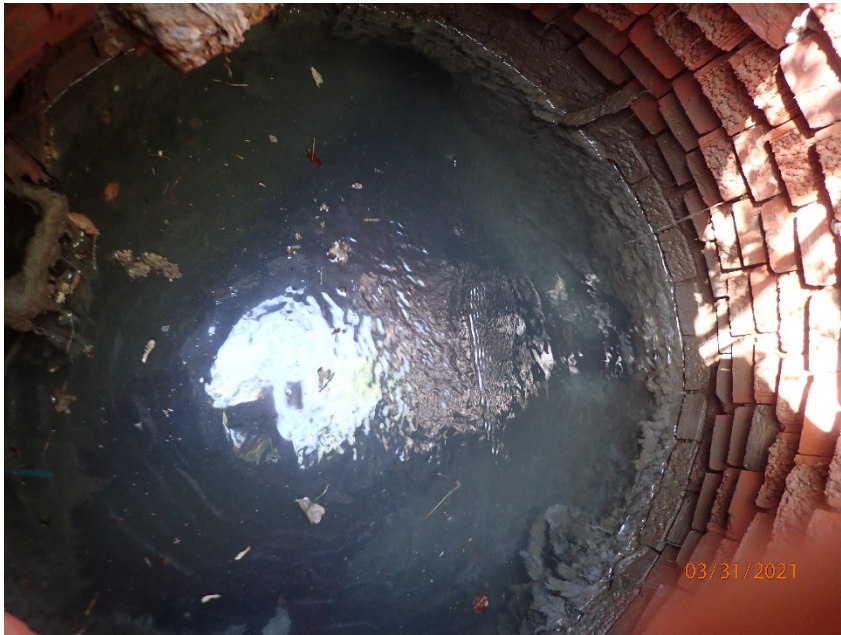
3: P3310007

Description: There was standing water in the first manhole downstream of Centreville in the East St. Louis collection system. There was some flow in and out, but the level of water did not recede.

Location: Manhole #42, southeast of North 82<sup>nd</sup> Street and Ridge Avenue.

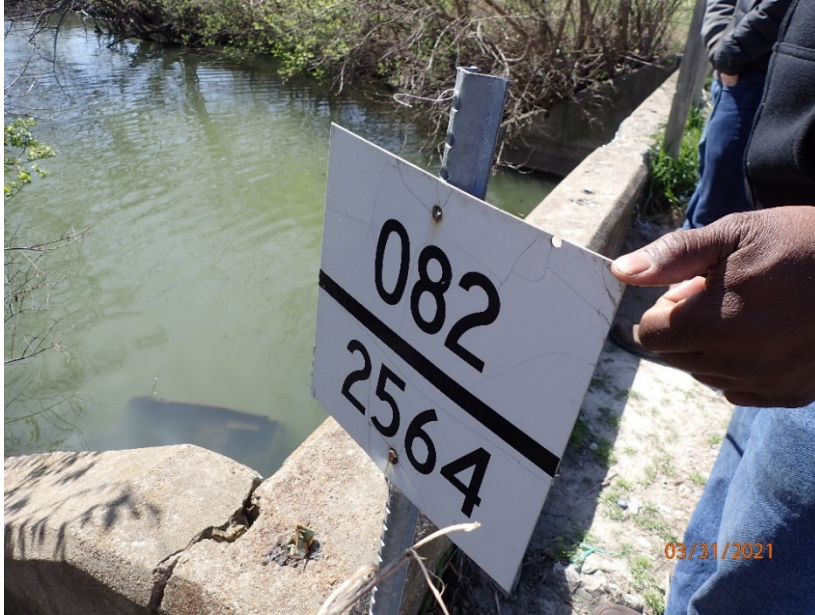
5: P3310009

Description: The sign marking at East St. Louis' Outfall 003, which flows to the Frank Holten State Park Lake.

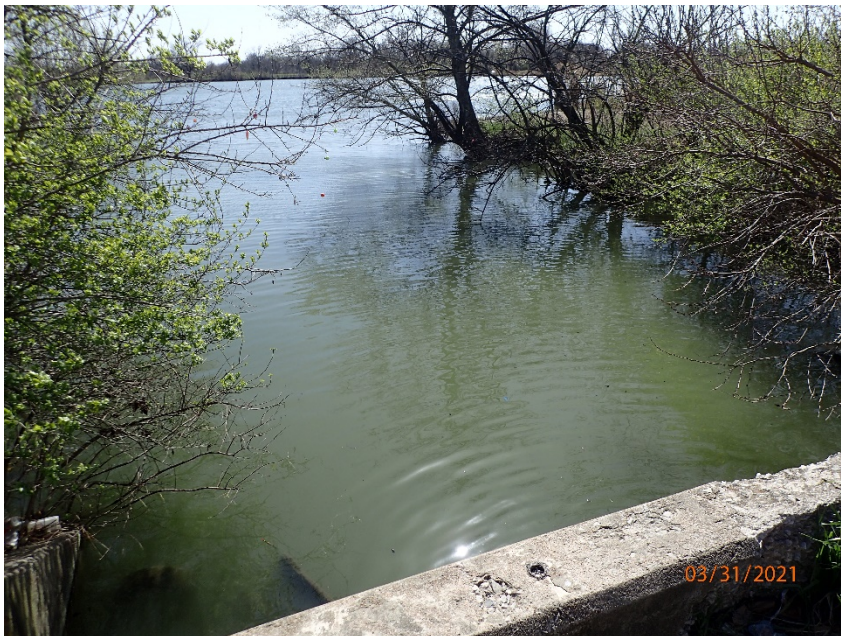
6: P3310010

- The State of Illinois has determined that Outfall 003 discharges to a sensitive area and the City was required to submit a plan to eliminate or relocate the outfall within three months of the effective date of the Permit.

Description: East St. Louis' Outfall 003 flows into the Frank Holten State Park Lake.

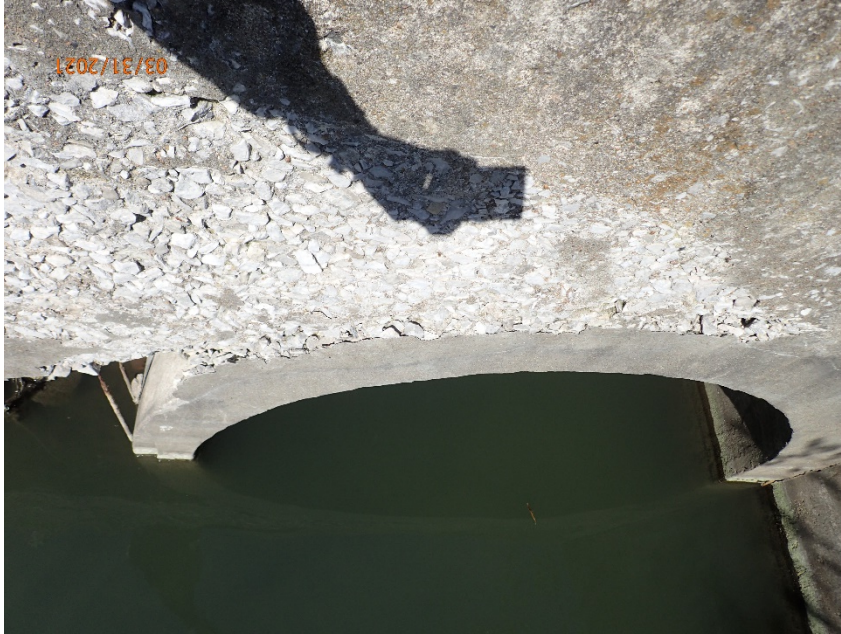
7: P3310011

Description: Looking down at one of the three pipes that make up Outfall 003.

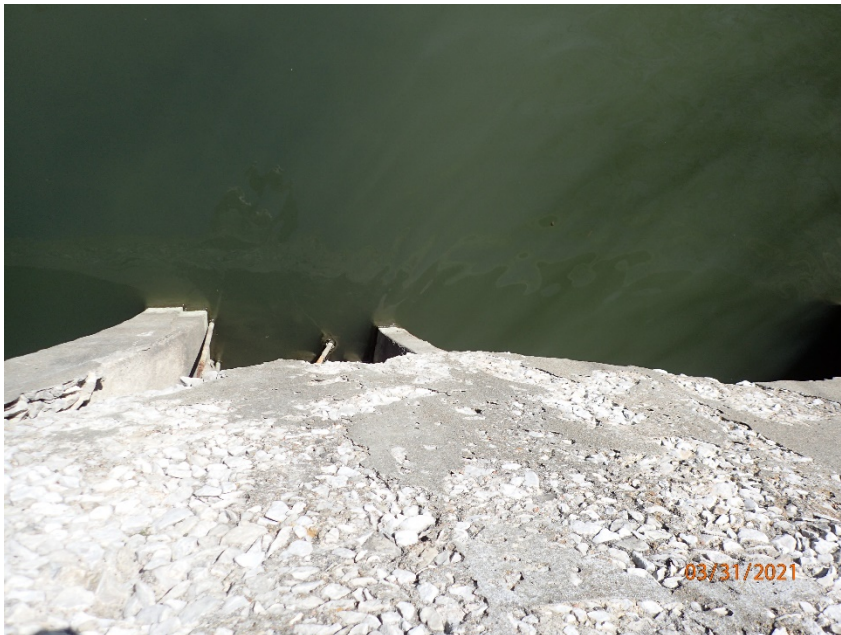
8: P3310012

Description: Looking down at Outfall 003 from above.

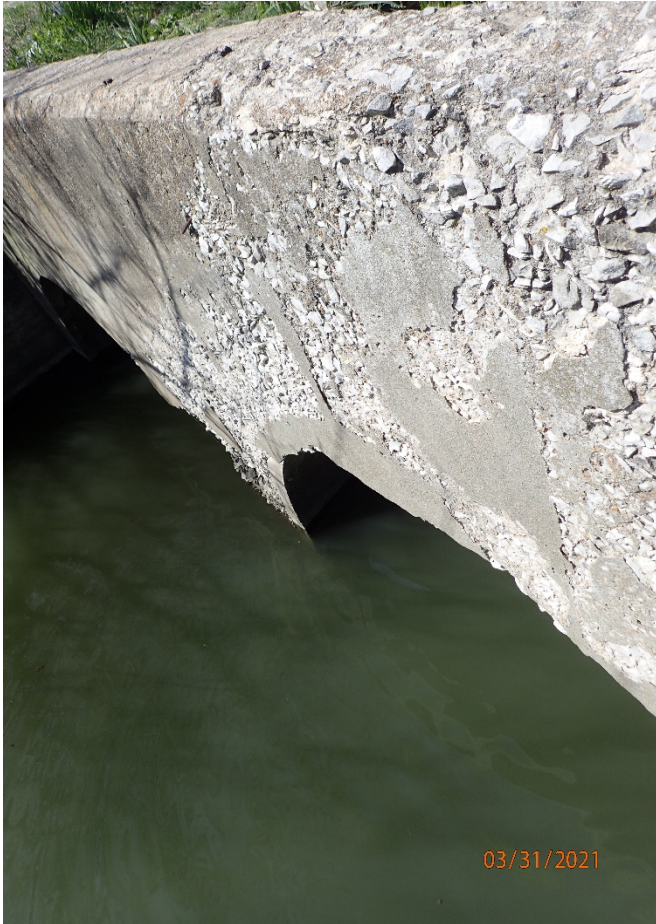
9: P3310013

Description: Looking down at one of the three pipes that make up Outfall 003.

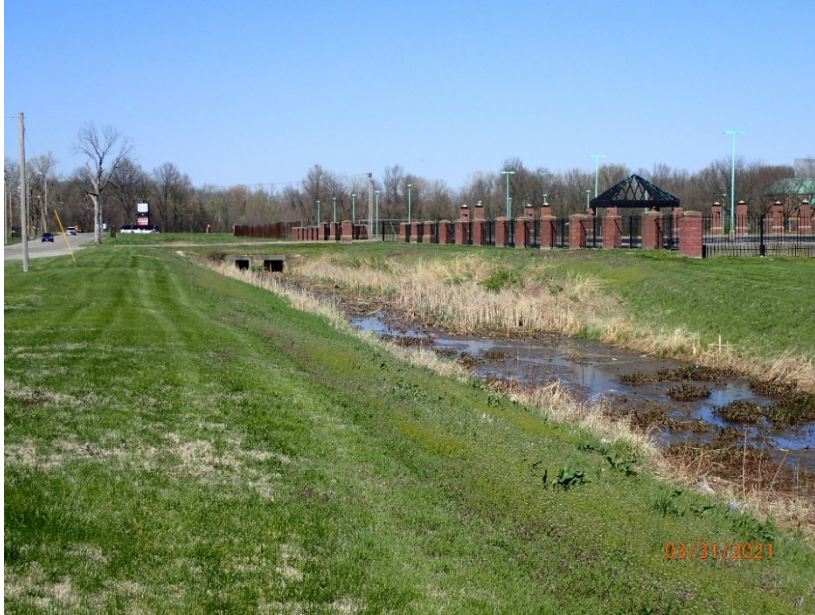
11: P3310015

Description: The ditch next to the pump station on North 47<sup>th</sup> Street north of State Street. Flow from the ditch flows south toward State Street.

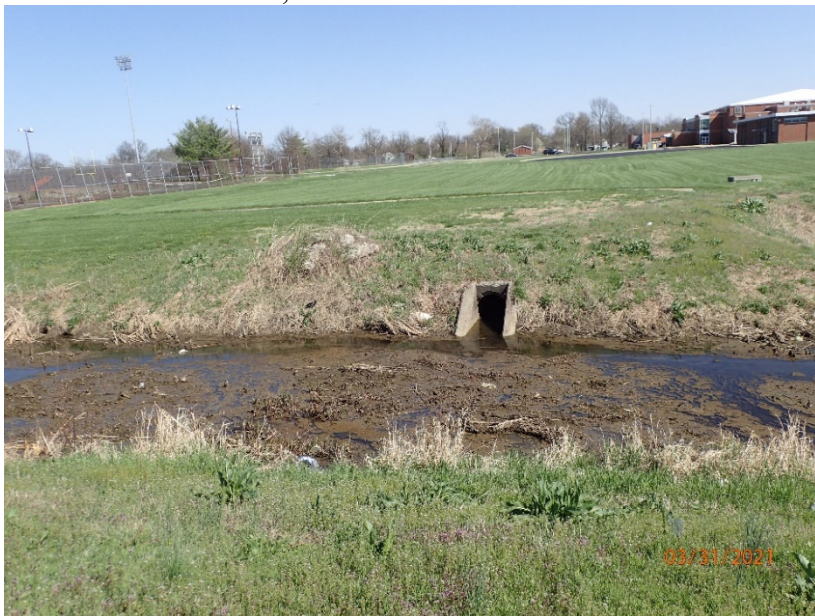
12: P3310016

Description: There are outlets on the east side of the ditch. There was no flow coming from the outlets on the day of the inspection and Mr. Swanson did not know where the flow would originate.

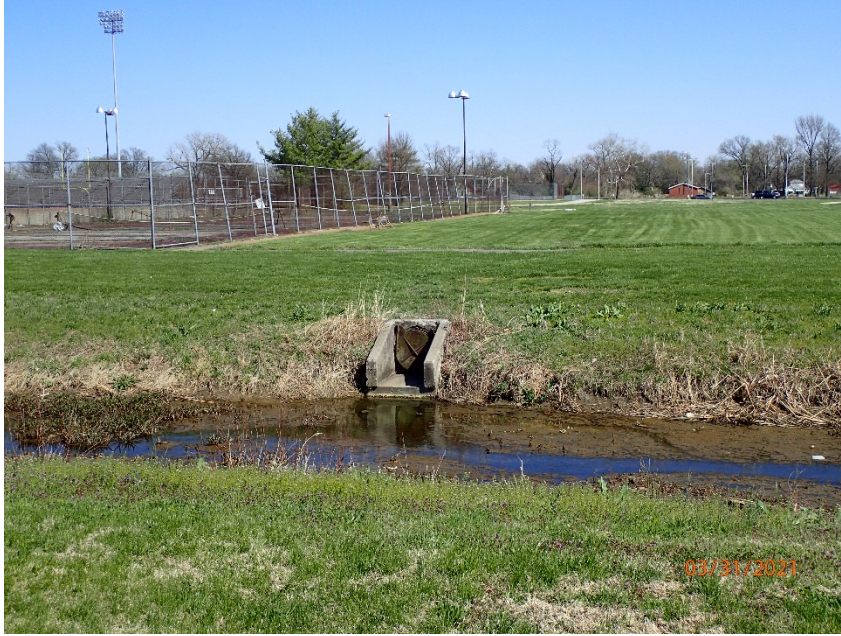
13: P3310017

Description: One of the outlets to the ditch has a backflow cover on the pipe. There was no flow coming from the outlets on the day of the inspection and Mr. Swanson did not know where the flow would originate.

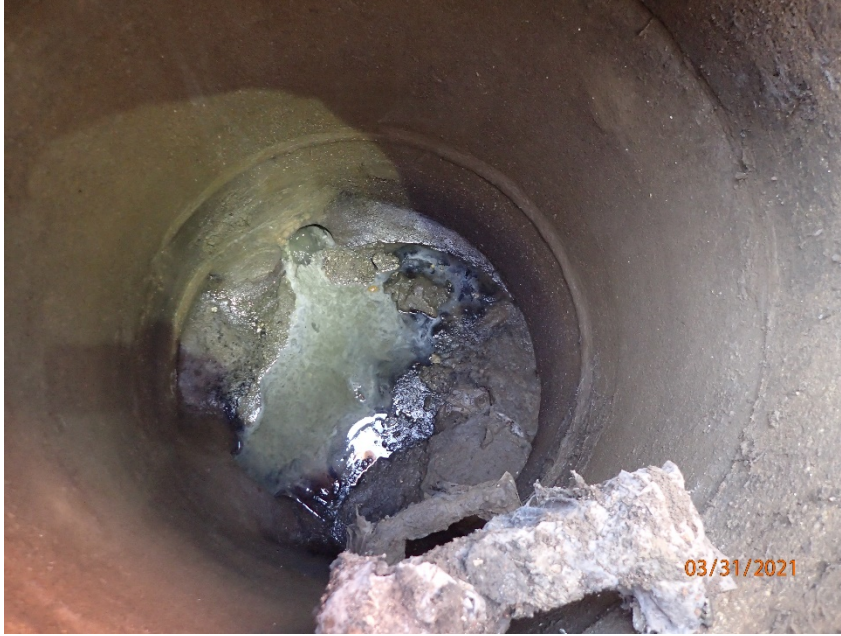
14: P3310018

Description: The manhole at 63<sup>rd</sup> Street.

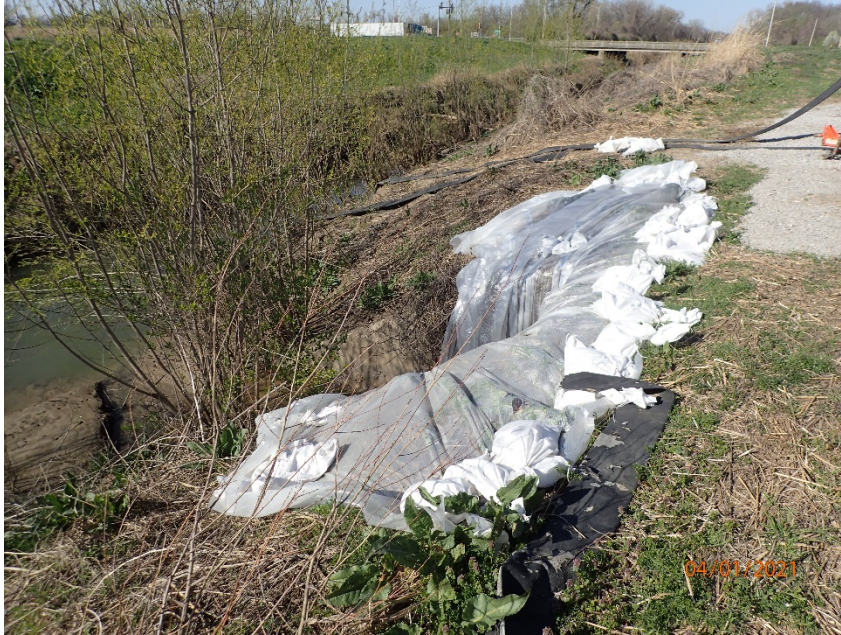
16: P4010023

Description: Large storm water outfall has been sandbagged and poly lined.

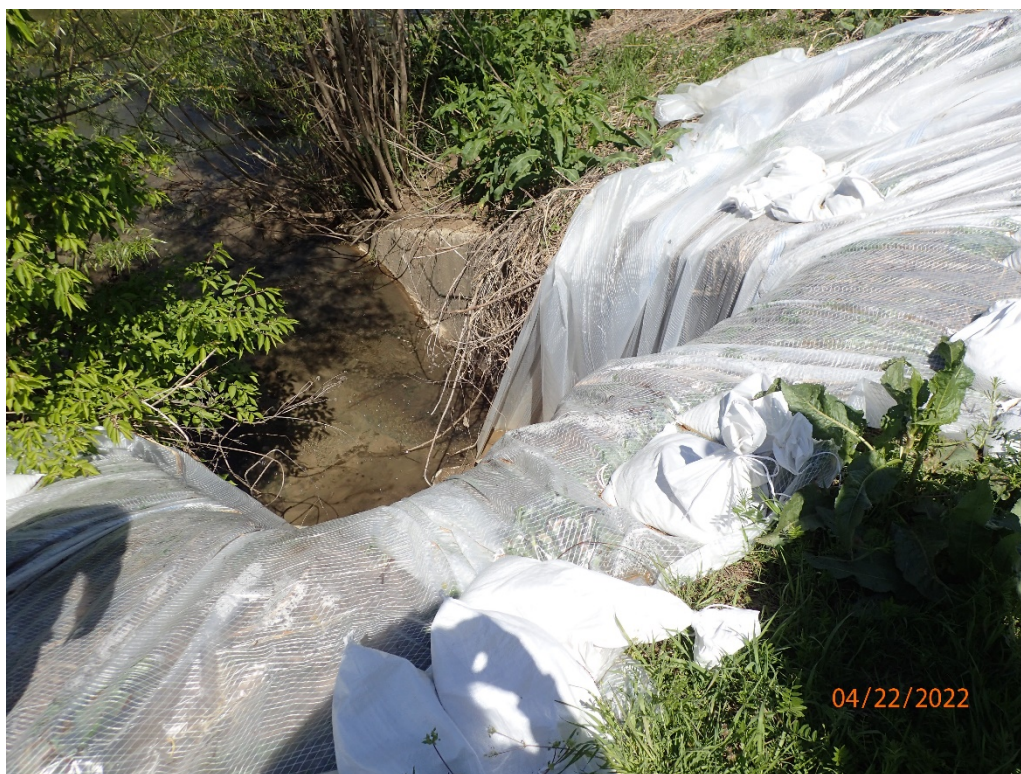
P4220019.JPG

Description: Plastic Sheeting to prevent flow from entering the outlet pipe is held in place by sandbags.

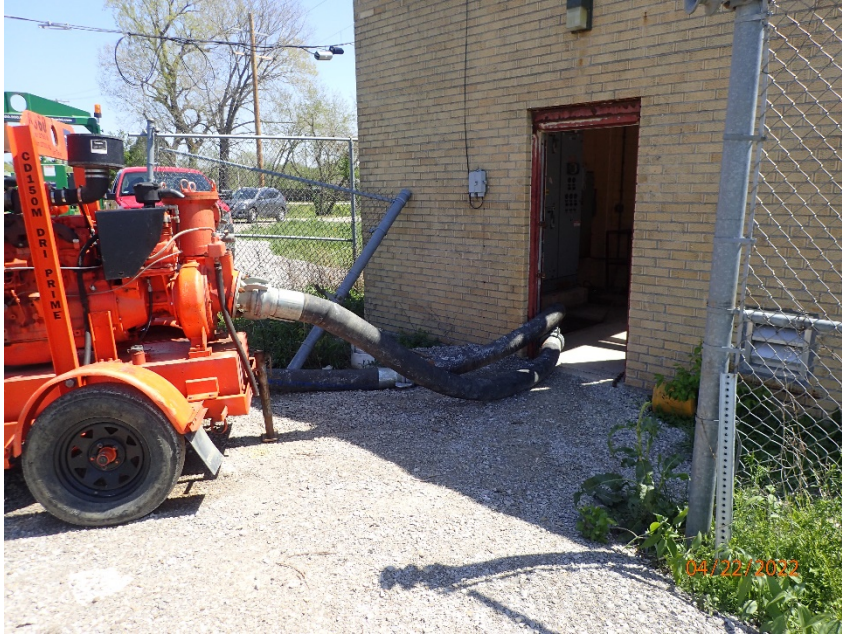
P4220020.JPG

Description: Pump station is being bypassed. Gate cannot be closed and pump station door is open.

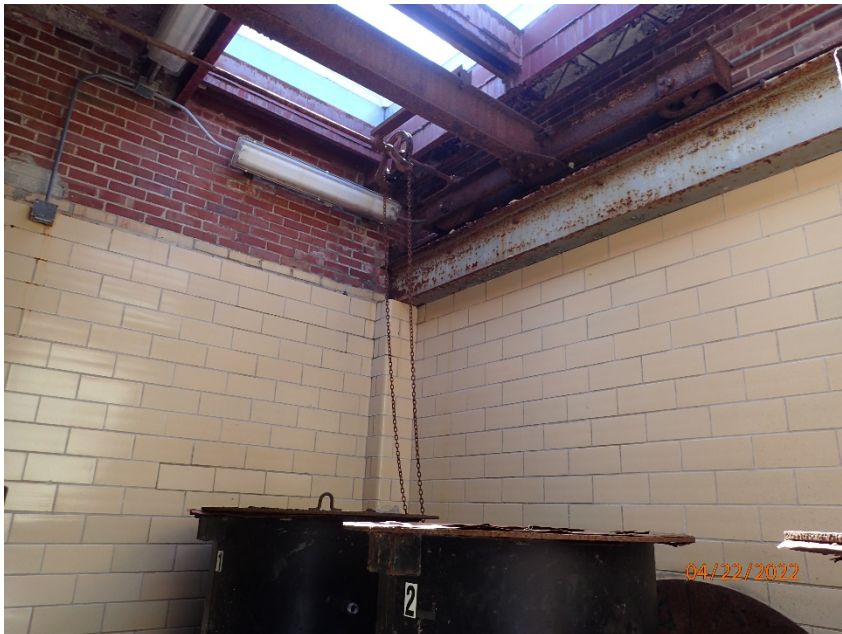
P4220021.JPG

Description: Roof is damaged and open to the elements.

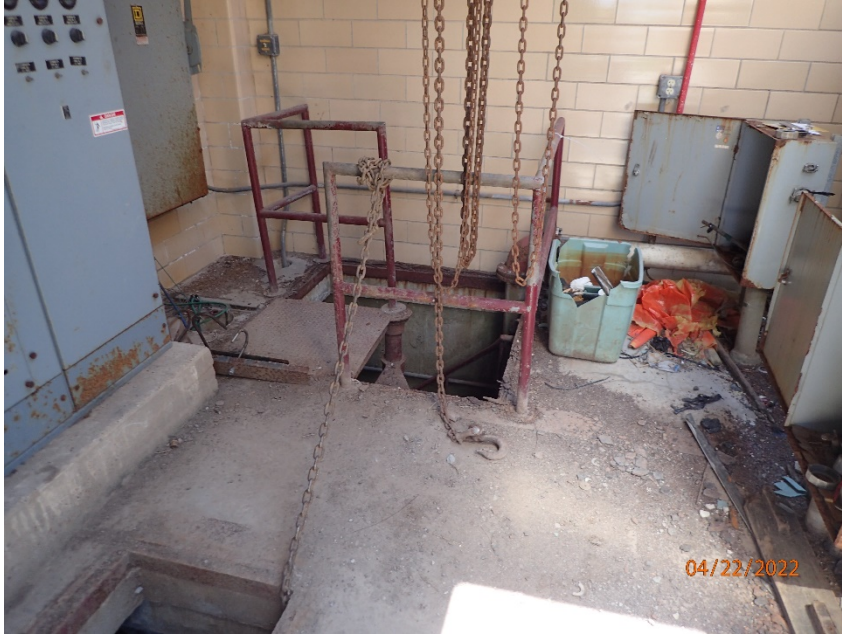
P4220022.JPG

Description: Wet well is open to the public.

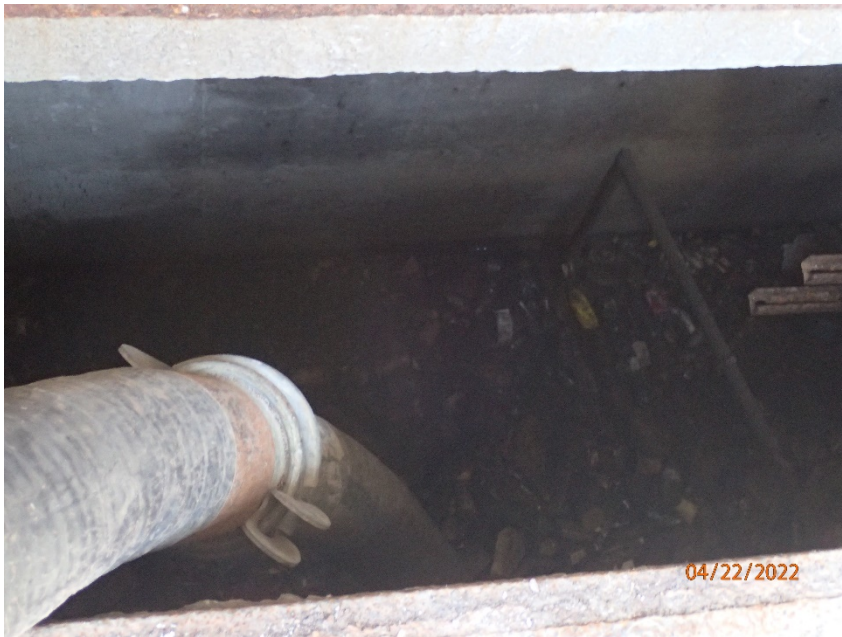
P4220023.JPG

Description: Wet well is not covered and is open to the public.

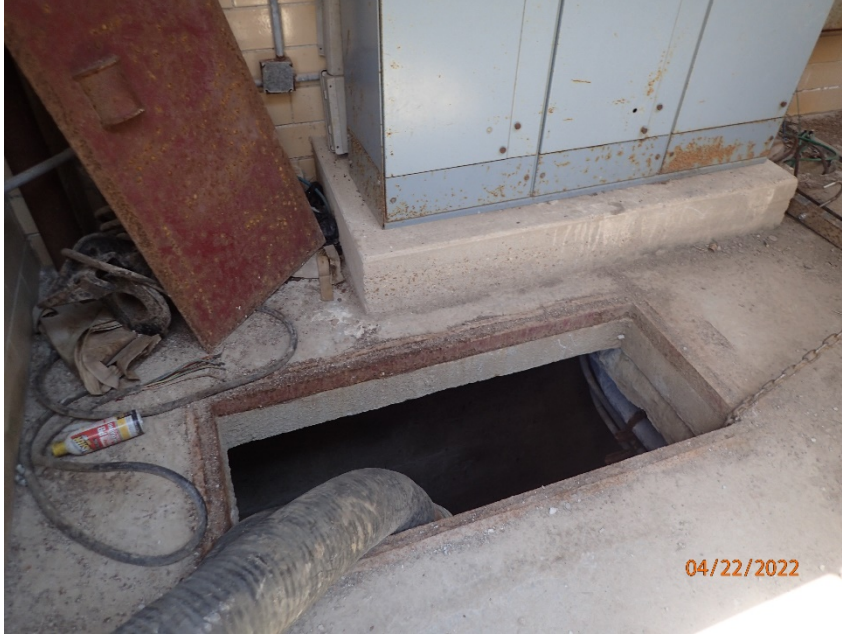
P4220024.JPG

Description: Wet well is not covered and is open to the public.

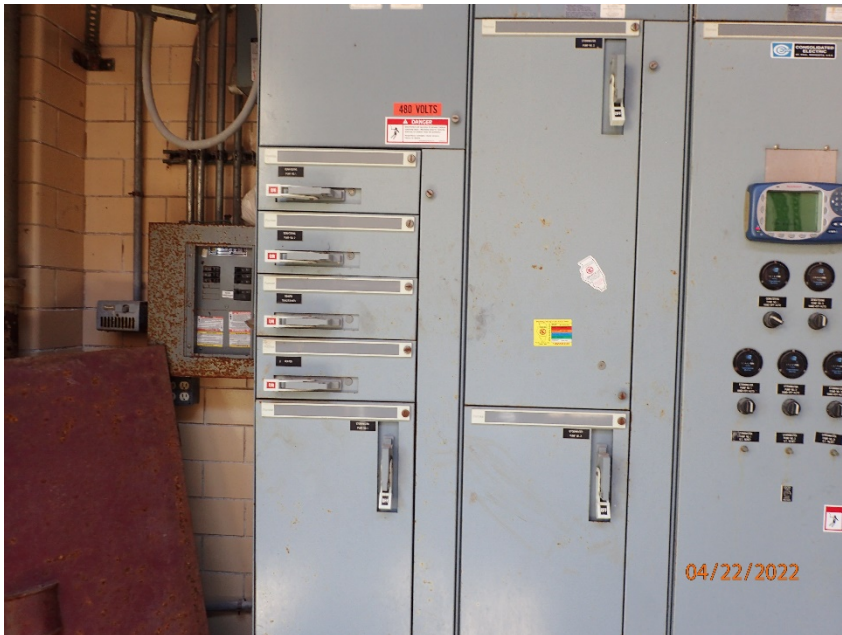
P4220025.JPG

Description: There is still power going to the pump station.

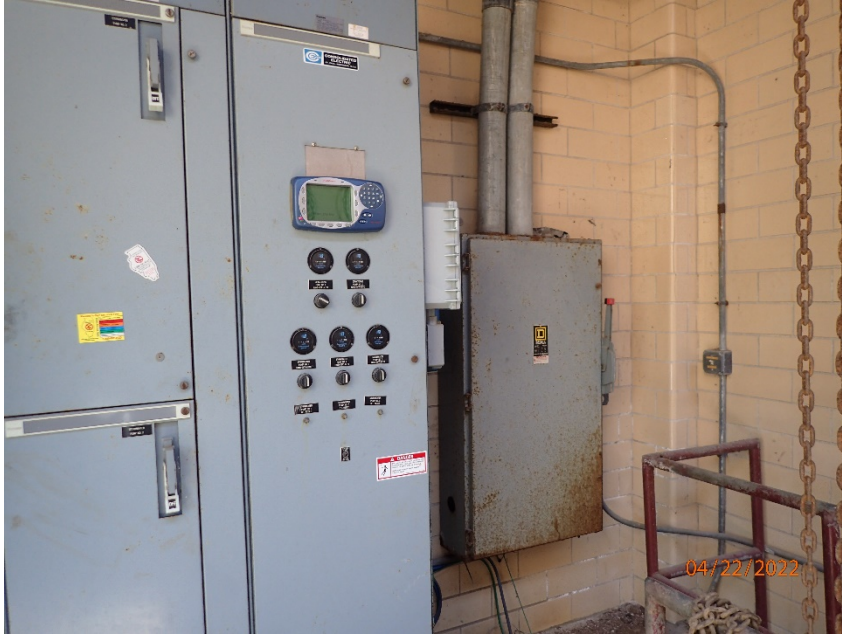
P4220026.JPG

Description: Electric feed is still on.
