## Region 6 - Enforcement & Compliance Assurance Division

### INSPECTION REPORT

| Company Name: | <b>LBOC, LLC</b> | |
| Facility Name: | <b>IPRC Tank Battery</b> | |

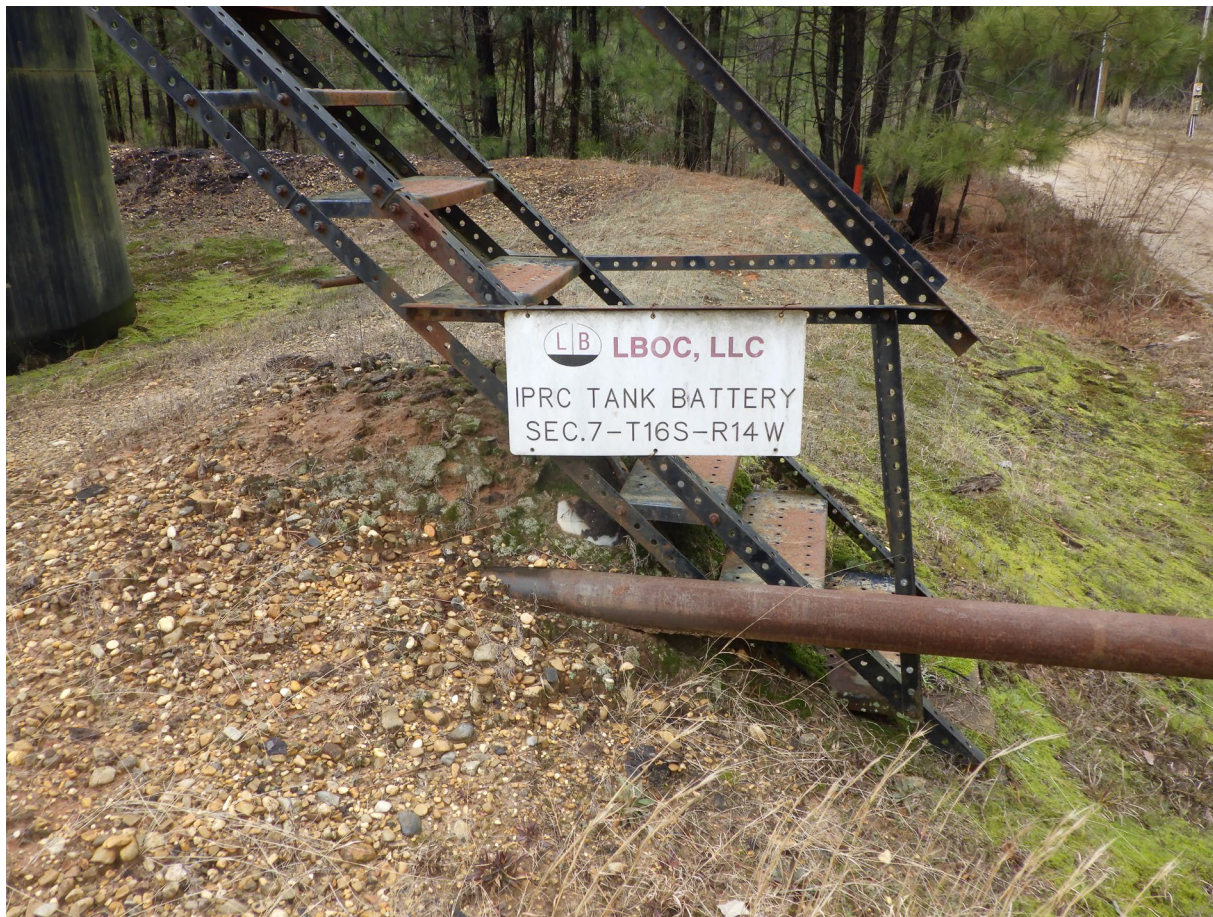
Photo No. 1

**Description:** This photo was taken looking northwest showing the facility sign.

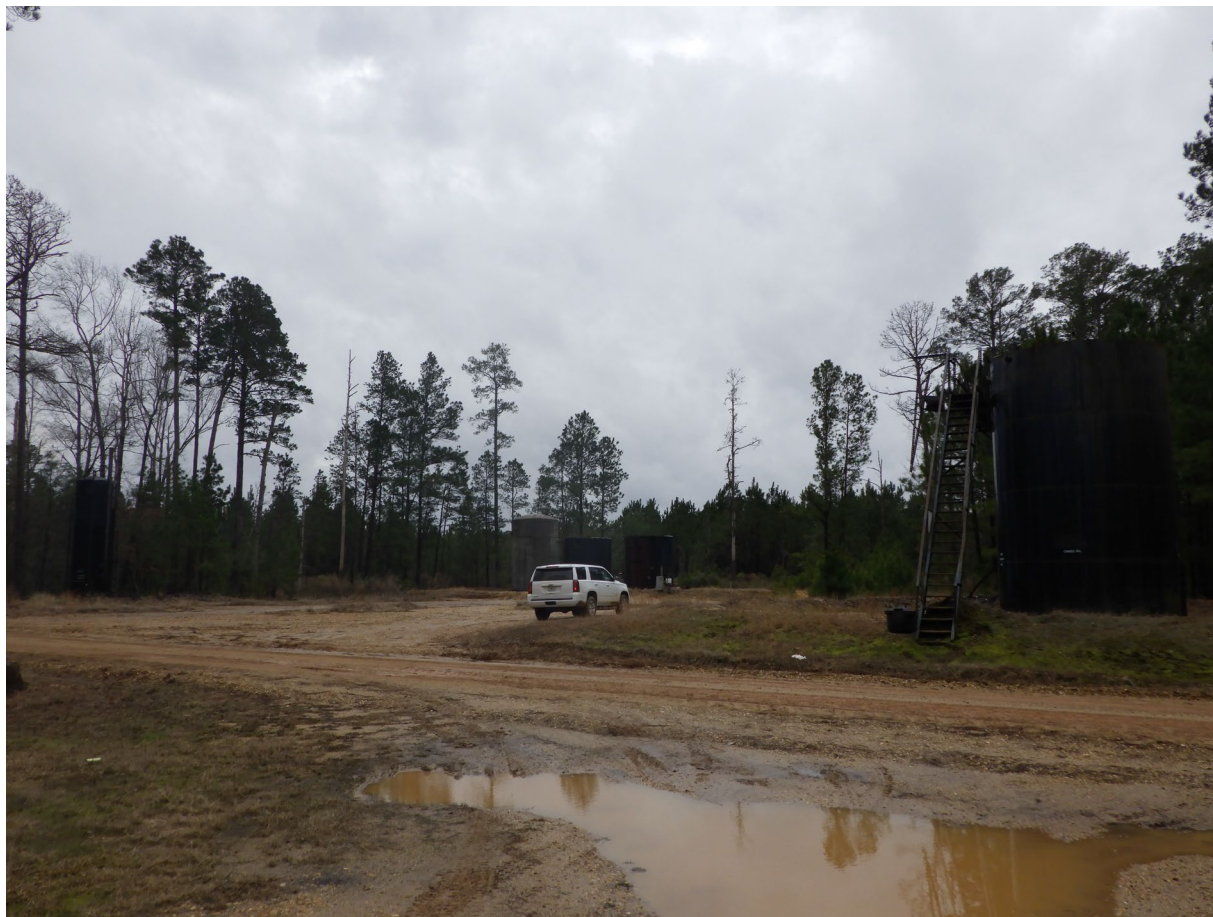
Photo No. 2

**Description:** This photo was taken looking south showing an overview of the facility.

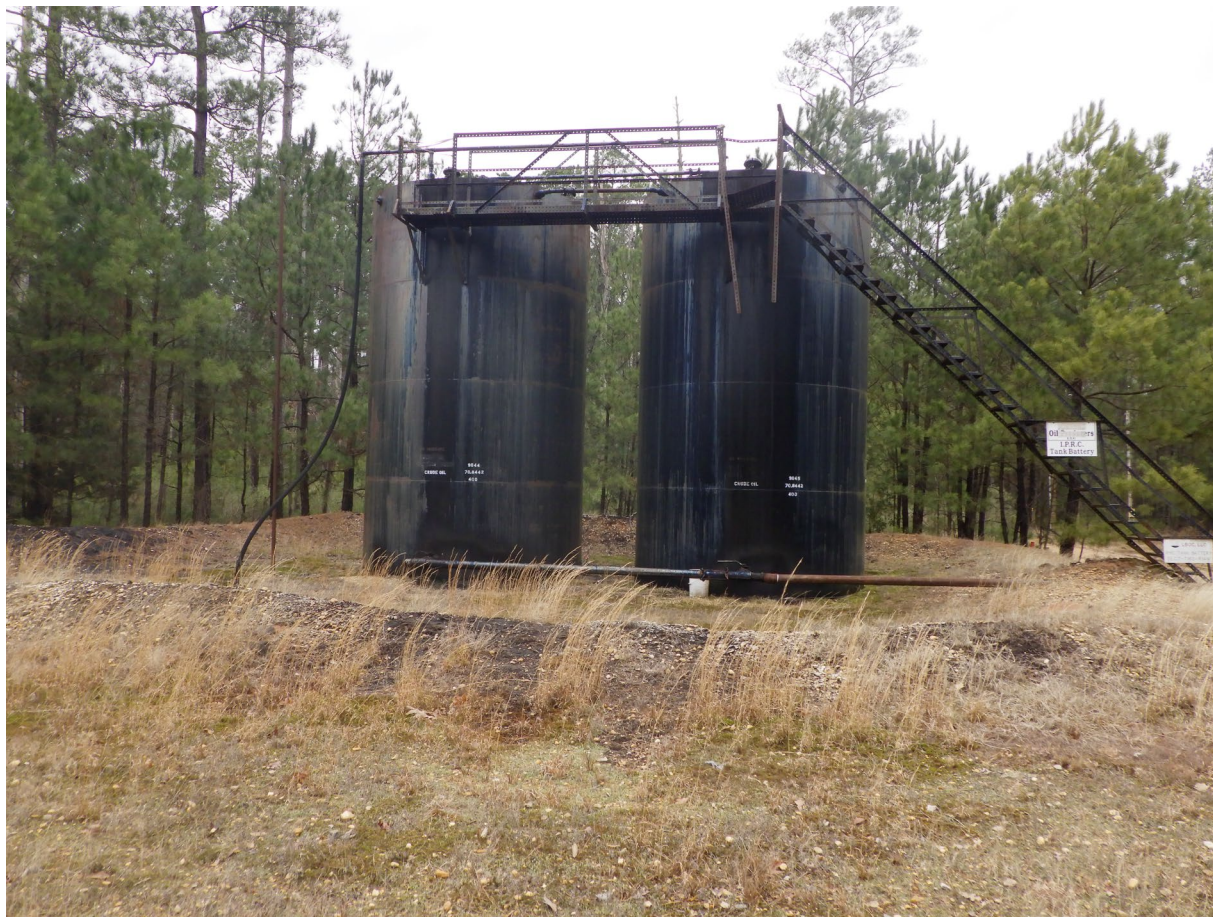
Photo No. 3

**Description:** This photo was taken looking west showing an overview of the facility.

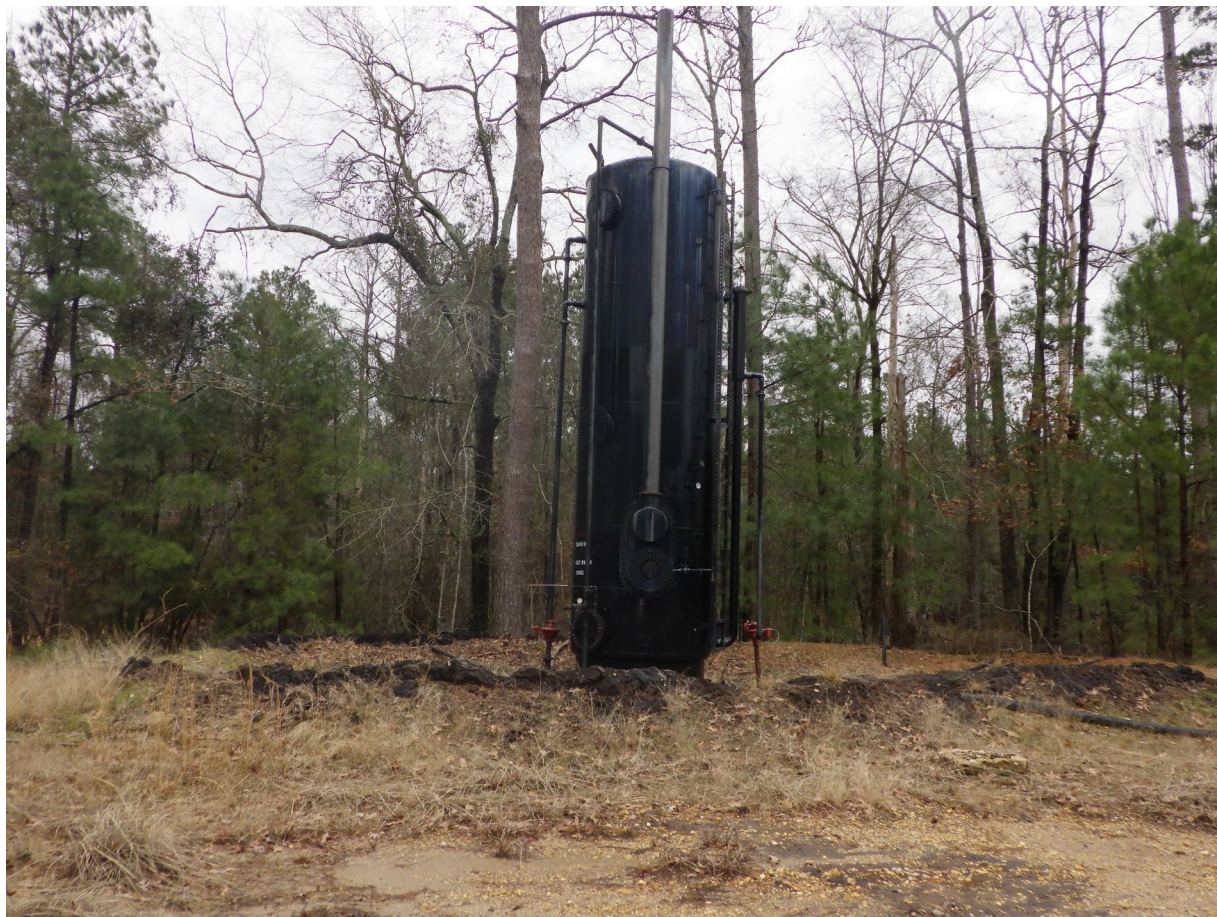
Photo No. 4

**Description:** This photo was taken looking east showing an overview of the facility.

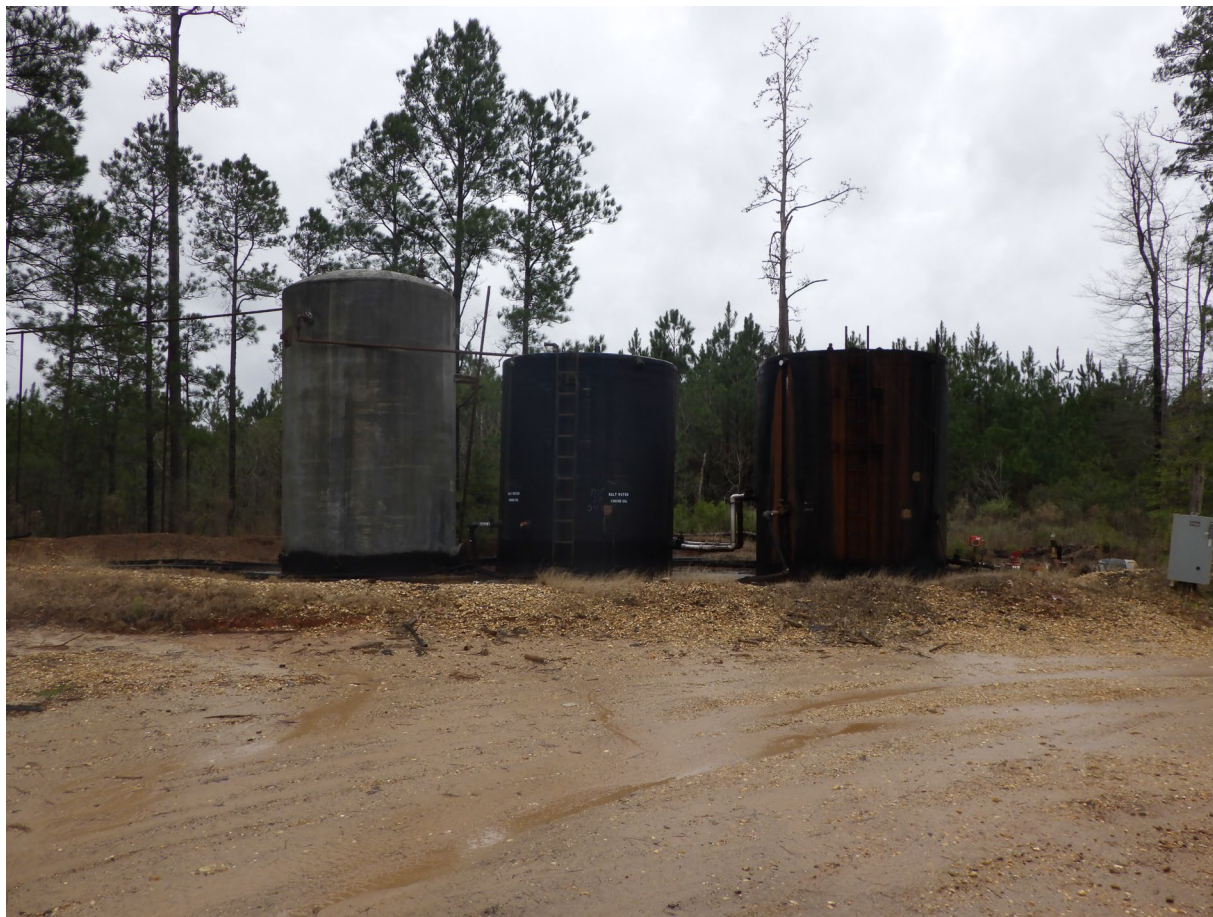
Photo No. 5

**Description:** This photo was taken looking south showing an overview of the facility.

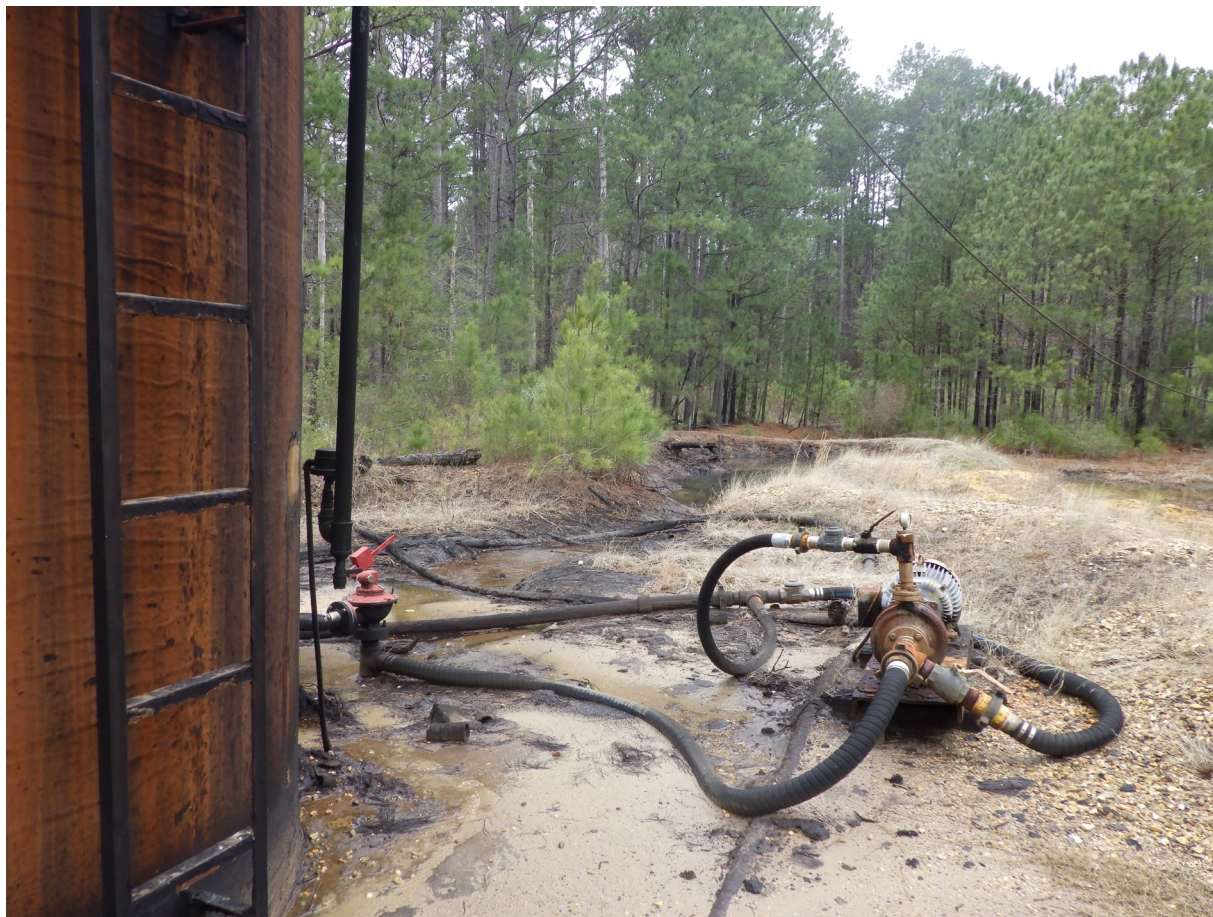
Photo No. 6

I observed loose oil and produced water inside of secondary containment, see photo No. 6 and No. 7.

**Description:** This photo was taken looking west showing the produced water and loose oil inside of secondary containment.

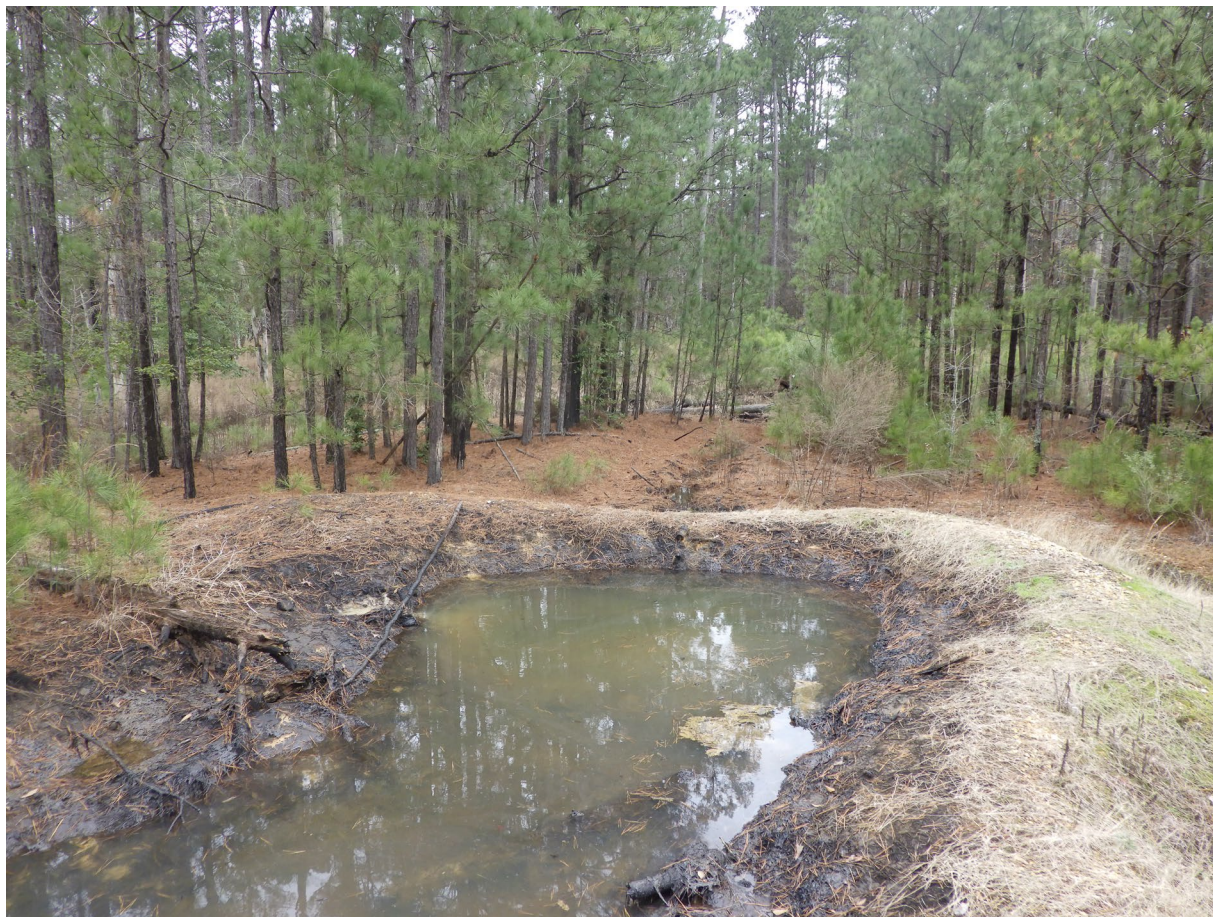
Photo No. 7

**Description:** This photo was taken looking west showing the loose oil and produced water in secondary containment.

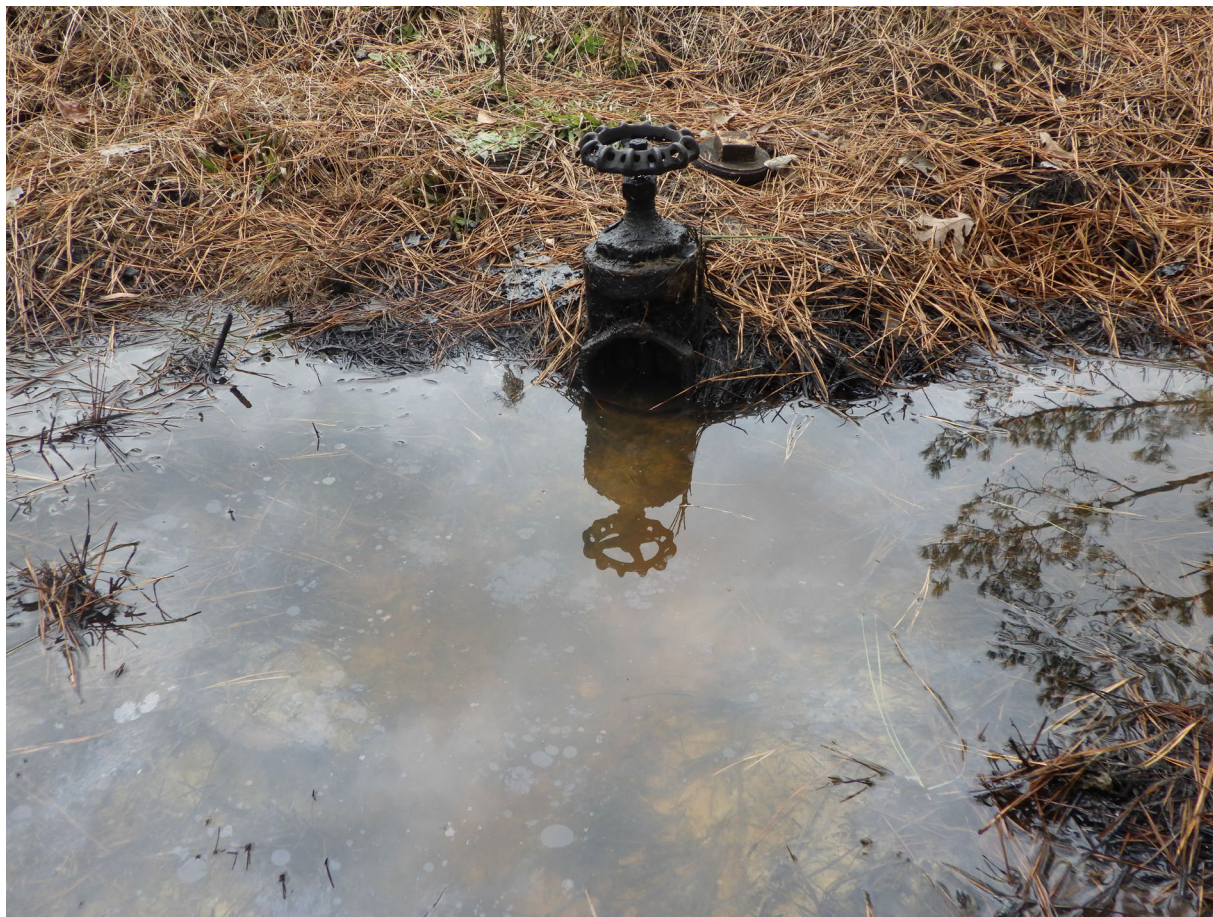
Photo No. 8

I observed an open drain valve releasing the loose oil and produced water from inside secondary containment and the contaminated flow path outside of secondary containment, see photo No. 8 and No. 9.

**Description:** This photo was taken looking east showing the open secondary containment drain valve open with a sheen on the discharged water.

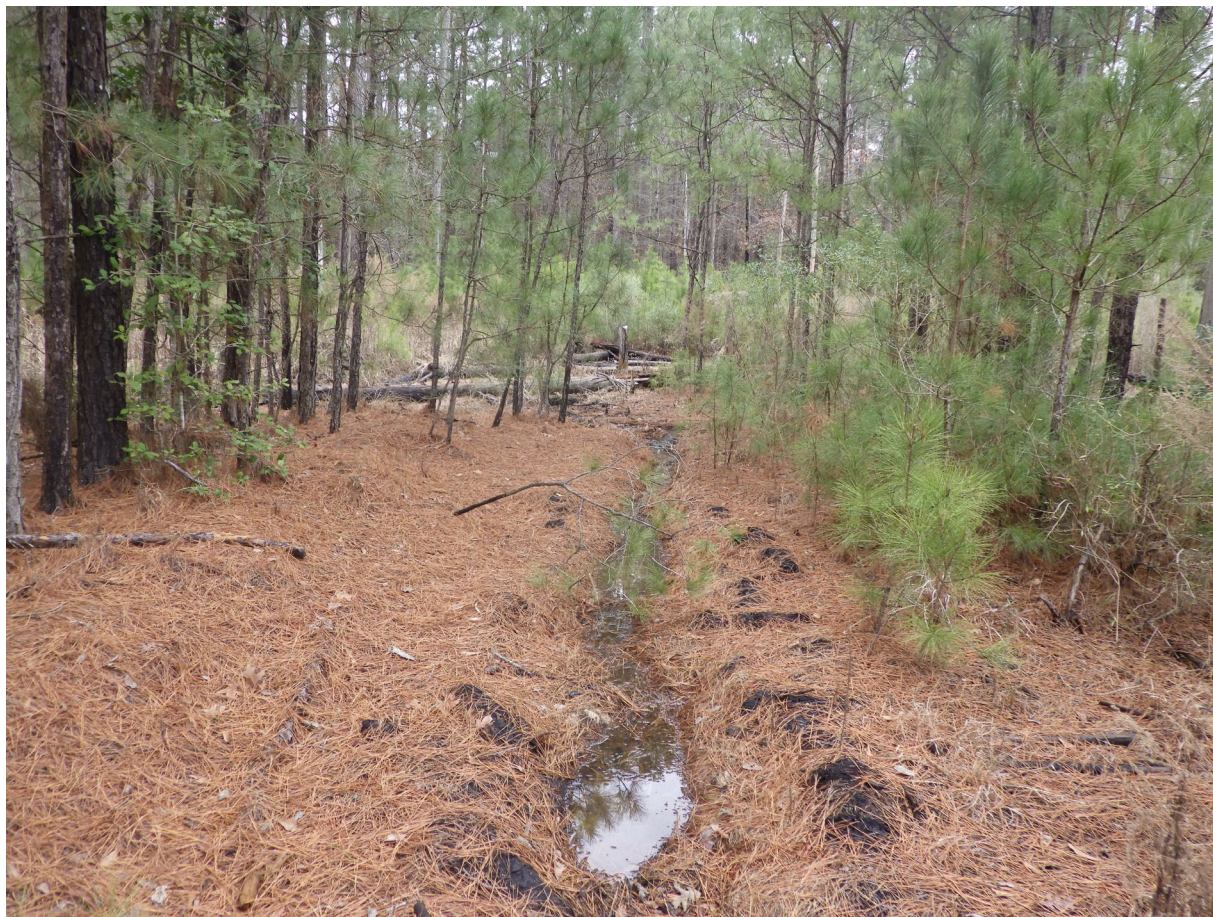
Photo No. 9

**Description:** This photo was taken looking west showing the impacted flow path.

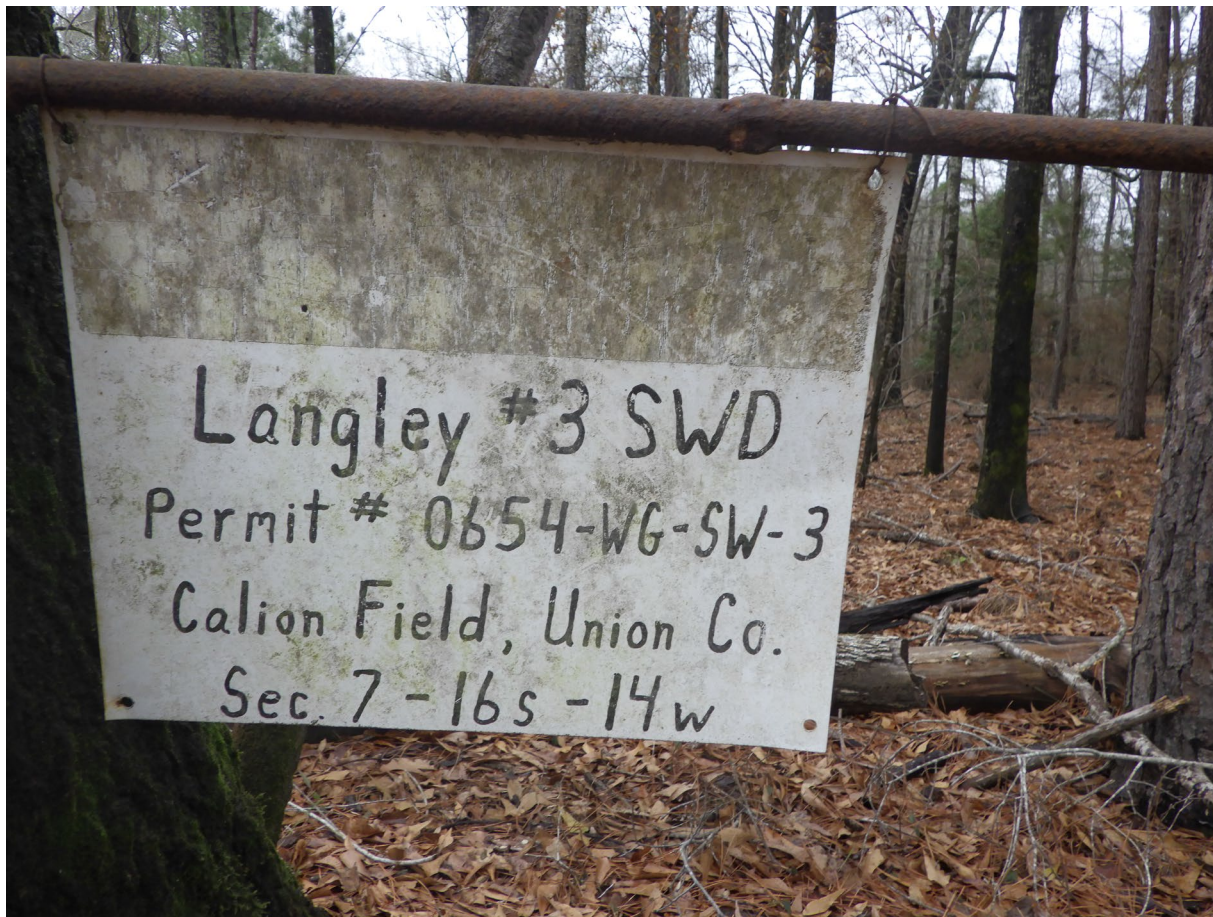
Photo No. 10

**Description:** This photo was taken looking W at the facility showing the facility sign.

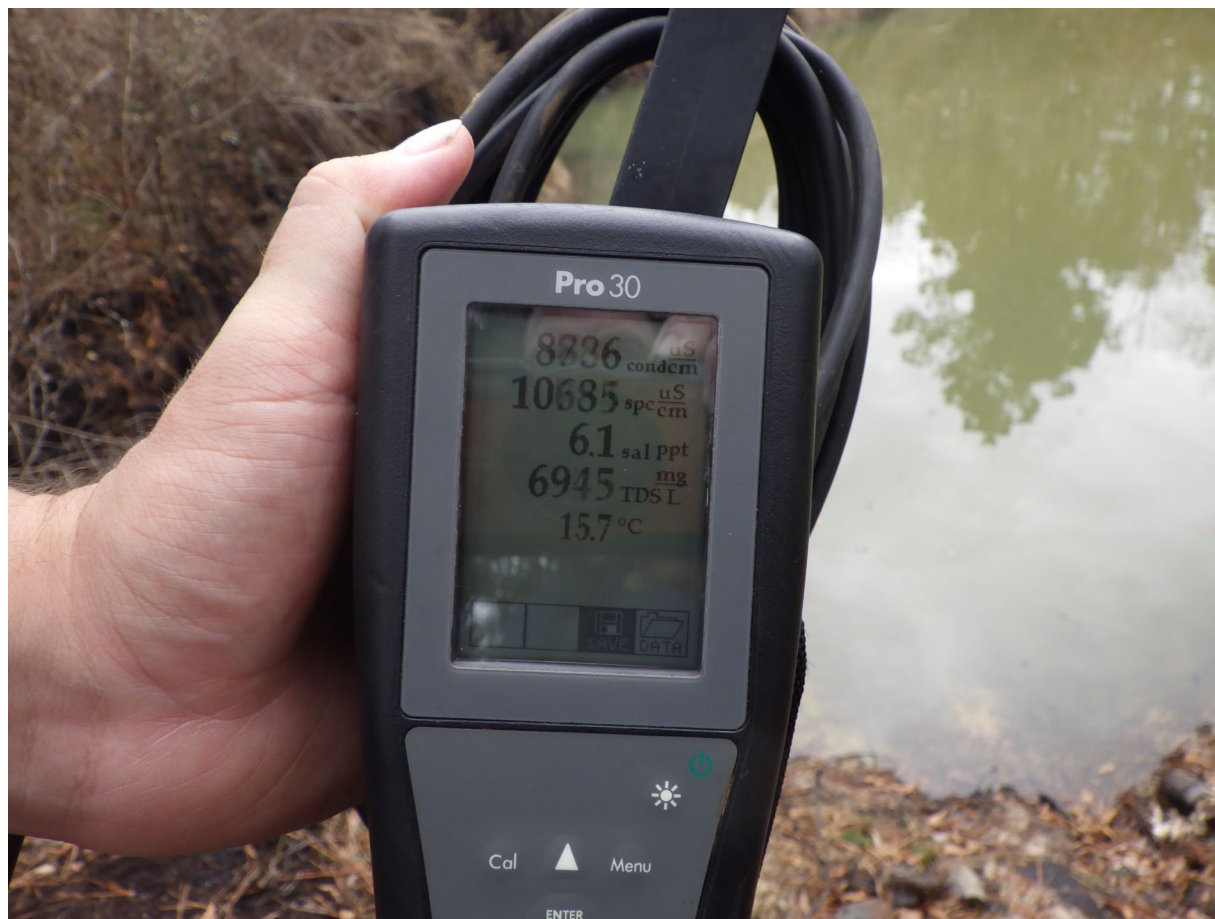
Photo No. 11

I observed the Langley #3 SWD behind the IPRC Tank Battery containing a pit with a Total Dissolved Solids reading of 6,945 mg/L, see photo No. 10 through photo No. 12.

**Description:** This photo was taken showing a Total Dissolved Solids (TDS) reading of 6,945 mg/L at the pit near the Langley #3 SWD.

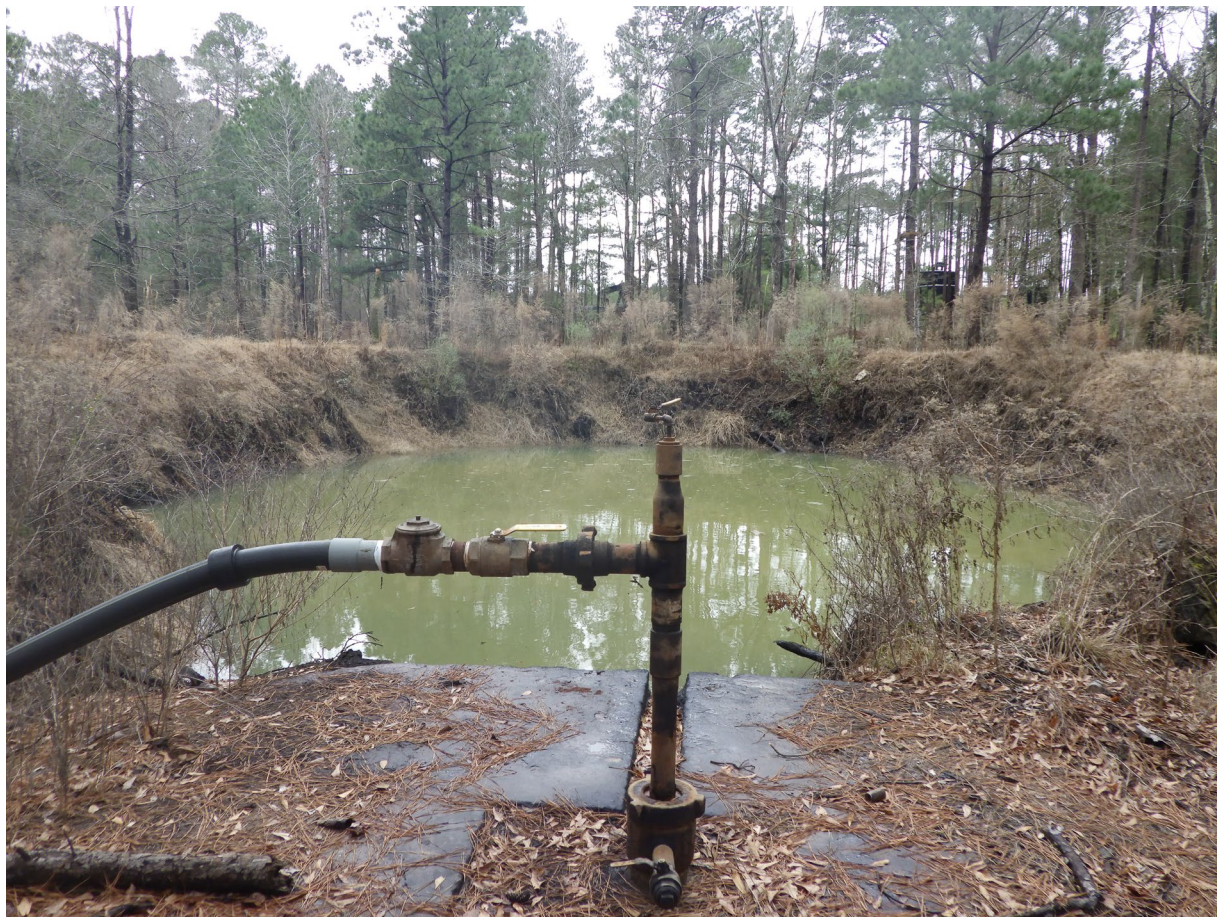
Photo No. 12

**Description:** This photo was taken looking south showing the well and pit at the Langley #3 SWD.
