**Region 6 - Enforcement & Compliance Assurance Division**  
**INSPECTION REPORT**

| Inspection Date(s): | 03/2/2023 | |
| Company Name: | Hudson Water Supply Corporation (WSC) | |
| Facility Name: | Hudson - WSC | |

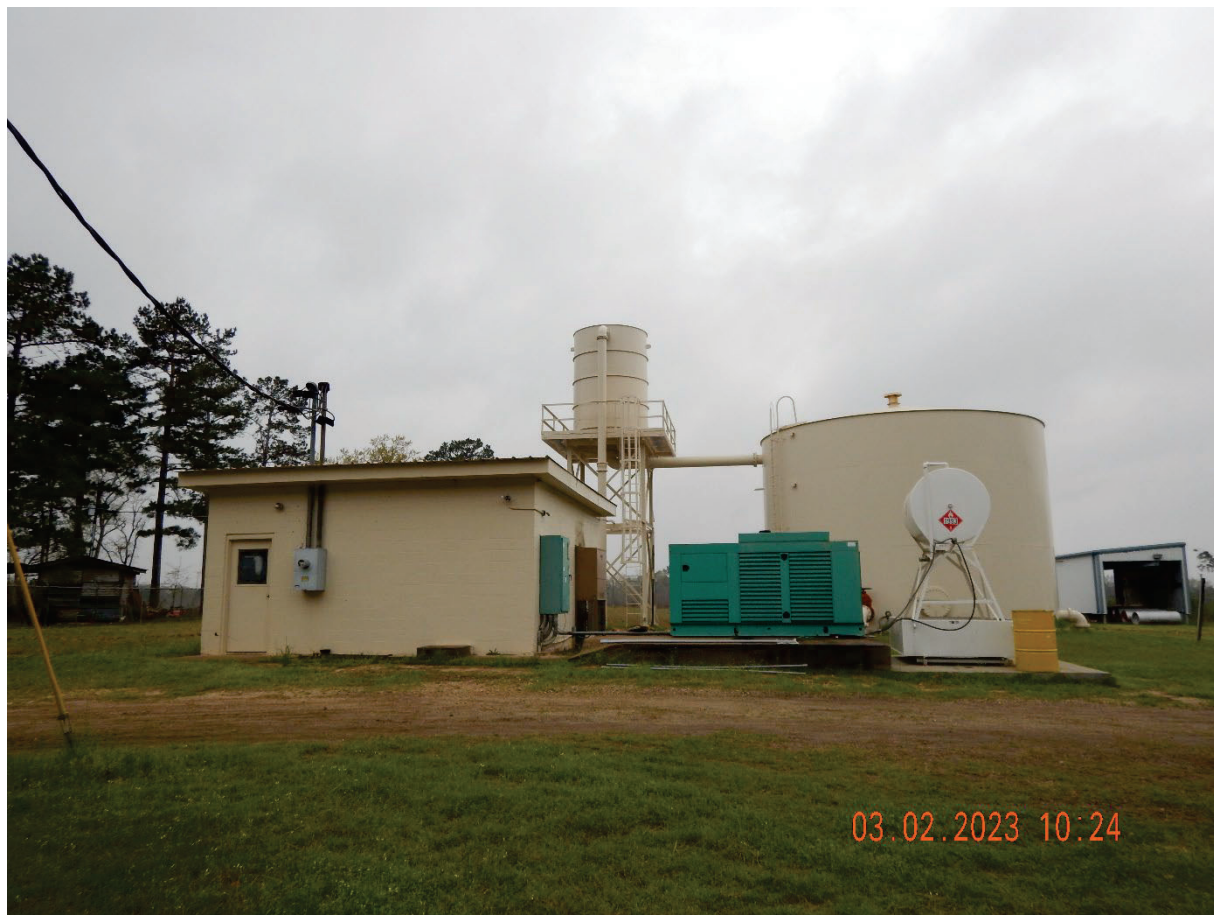
Photo No. 1

- At the time of inspection Plant 4 was receiving water solely from the remote Well No. 7
- The plant is located near the smaller ground storage tank with the aeration unit on the top (Photo 1)
- Well No. 5 was having casing replaced at the time of inspection (Photo 2)

Description: Plant number 4, aeration tank, and ground storage tank.

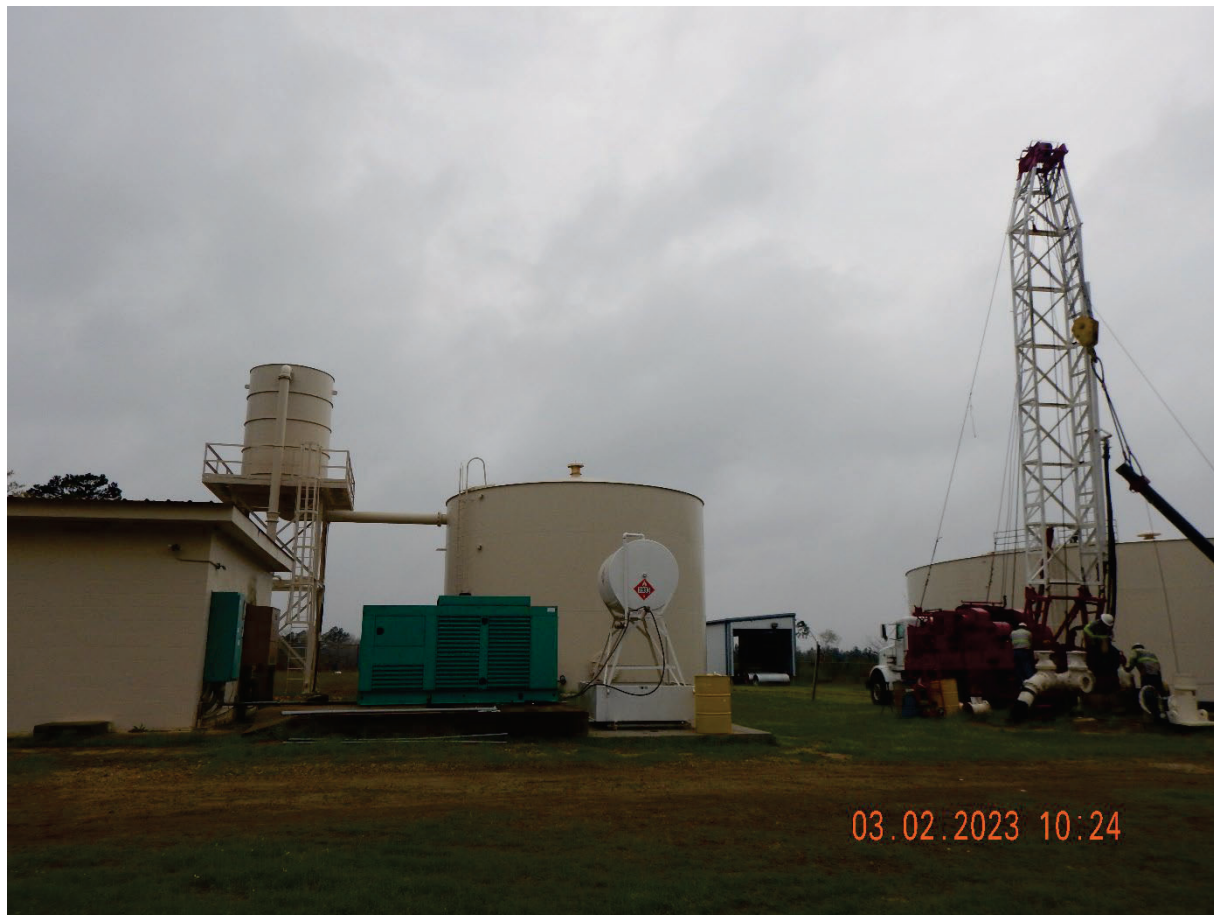
Photo No. 2

Description: Water plant 4, aeration and ground storage tank, large ground storage tank, well casing work.

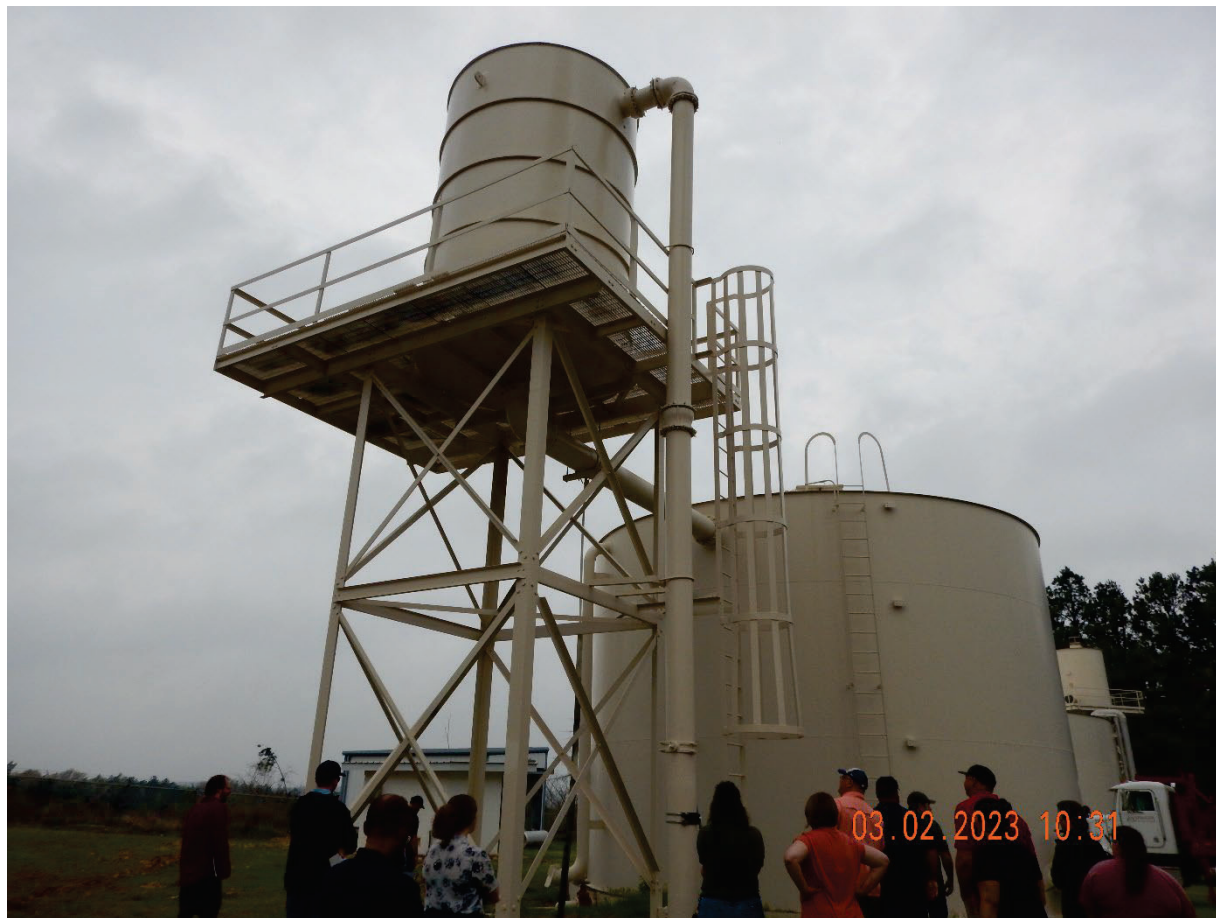
Photo No. 3

- Water from Well No. 7 enters aeration tank before entering ground storage tank, which is top filled (Photo 3)
- Chlorine can be injected both before and after aeration (Photos 4 and 12- 13)

Description: Aeration setup entering ground storage tank.

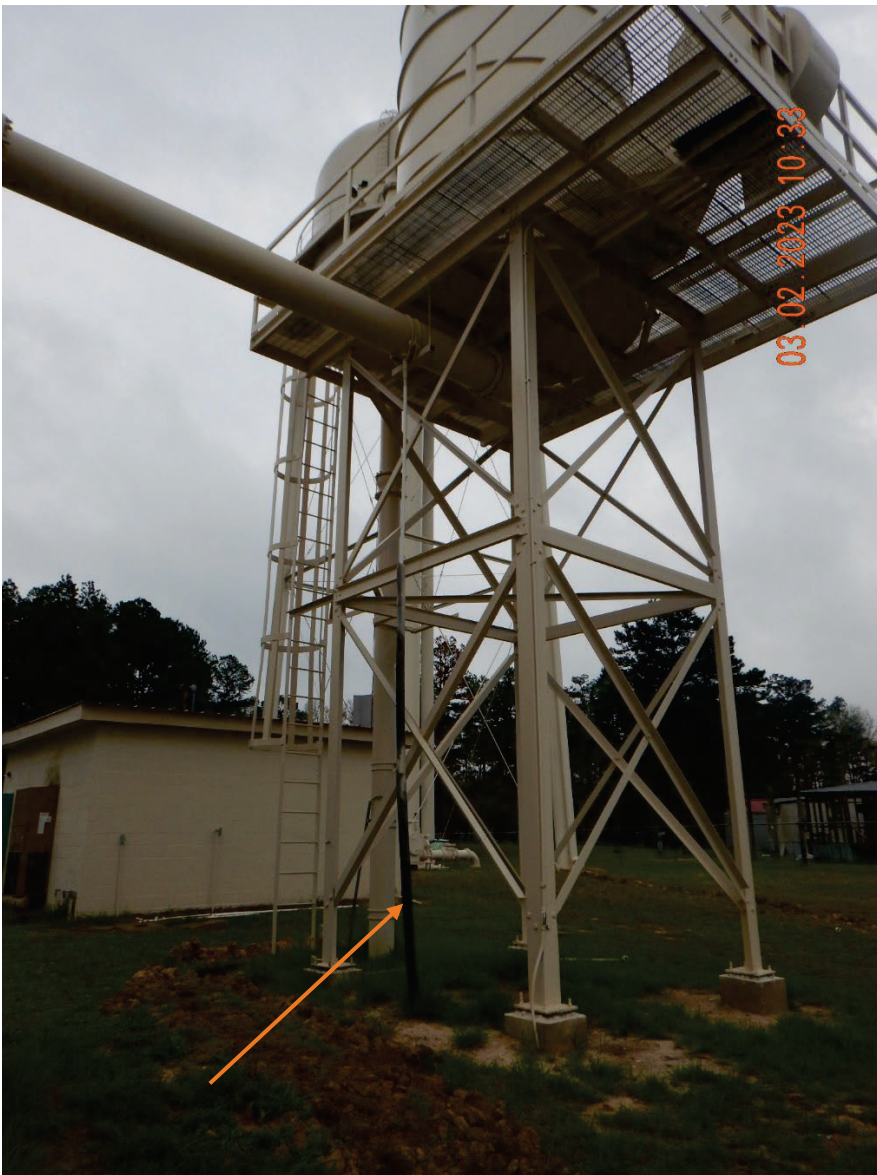
Photo No. 4

Description: Chemical injection before aeration at Plant 4, arrow added for clarity

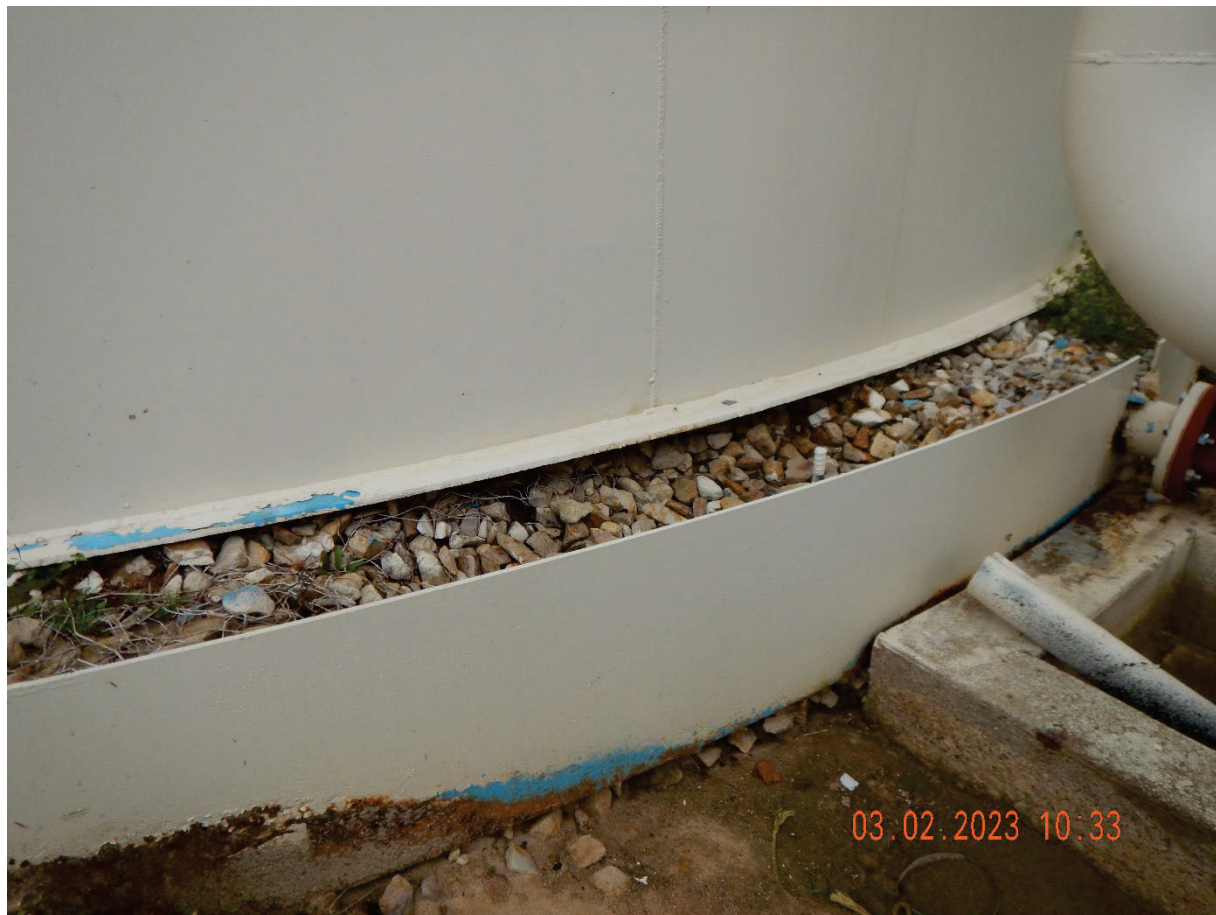
Photo No. 5

- Gravel from the base of the 0.1 MG ground storage tank was settling or missing in some locations (Photo 5)
- Overflow outlet on 0.1 MG ground storage tank had flap closure with small amount of rust observed (Photo 6)

Description: Gravel eroding beneath ground storage tank foundation

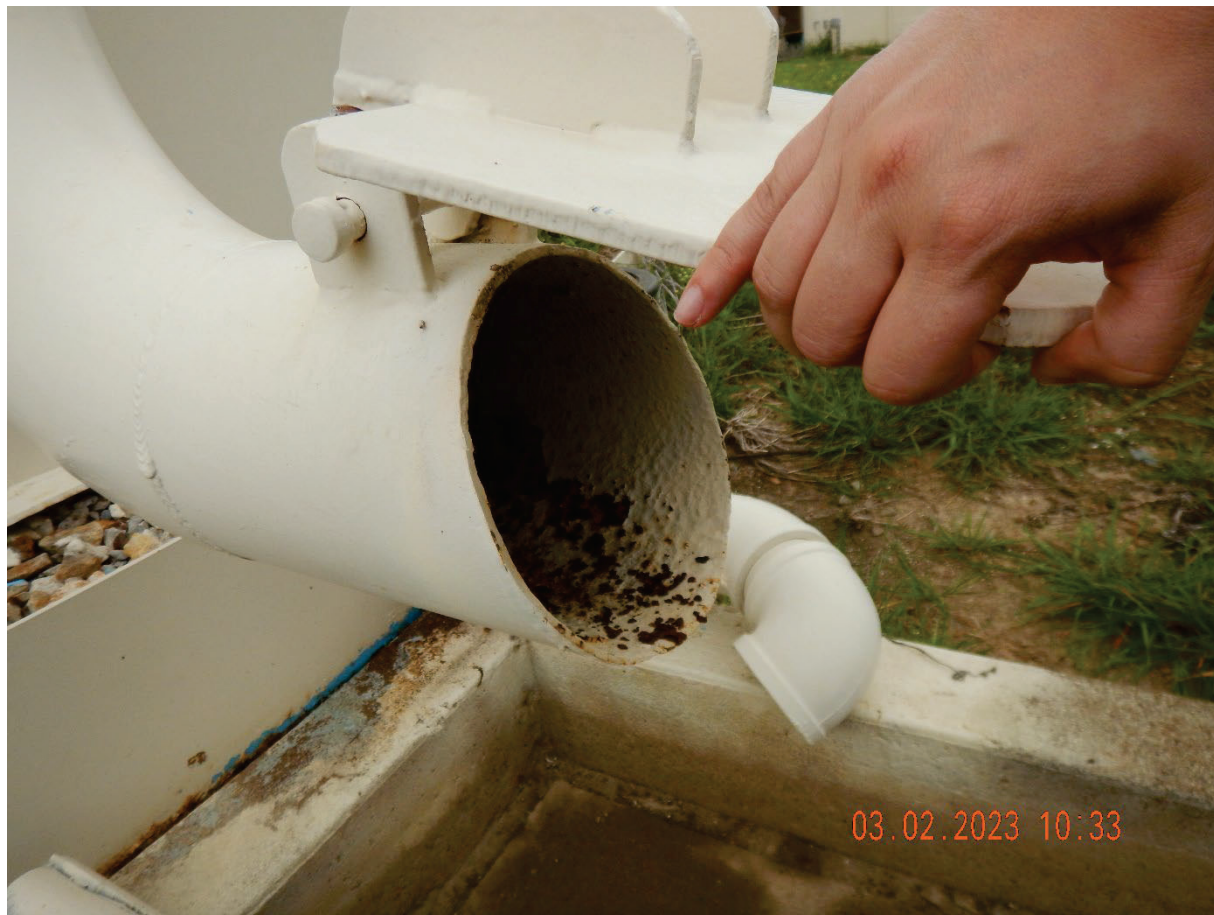
Photo No. 6

- Plant 4 was receiving water from remote well No. 7 while Well No. 4 was repaired. Remote well may not have capacity to fully supply demand in summer/high demand season
  - Aeration tank on 1 MG had a loose mesh screen
  - Overflow outfalls from both ground storage tanks at Plant 4 had small amounts of rust
  - Overflow outfall at Plant 5 had large amount of rust present at flap closure which may cause flap closure to fail to provide full seal - recommend screening outfall if flap not providing full seal
- The ERP and RRA were observed to be incomplete

Description: Overflow outlet with small amount of rust and flap closure

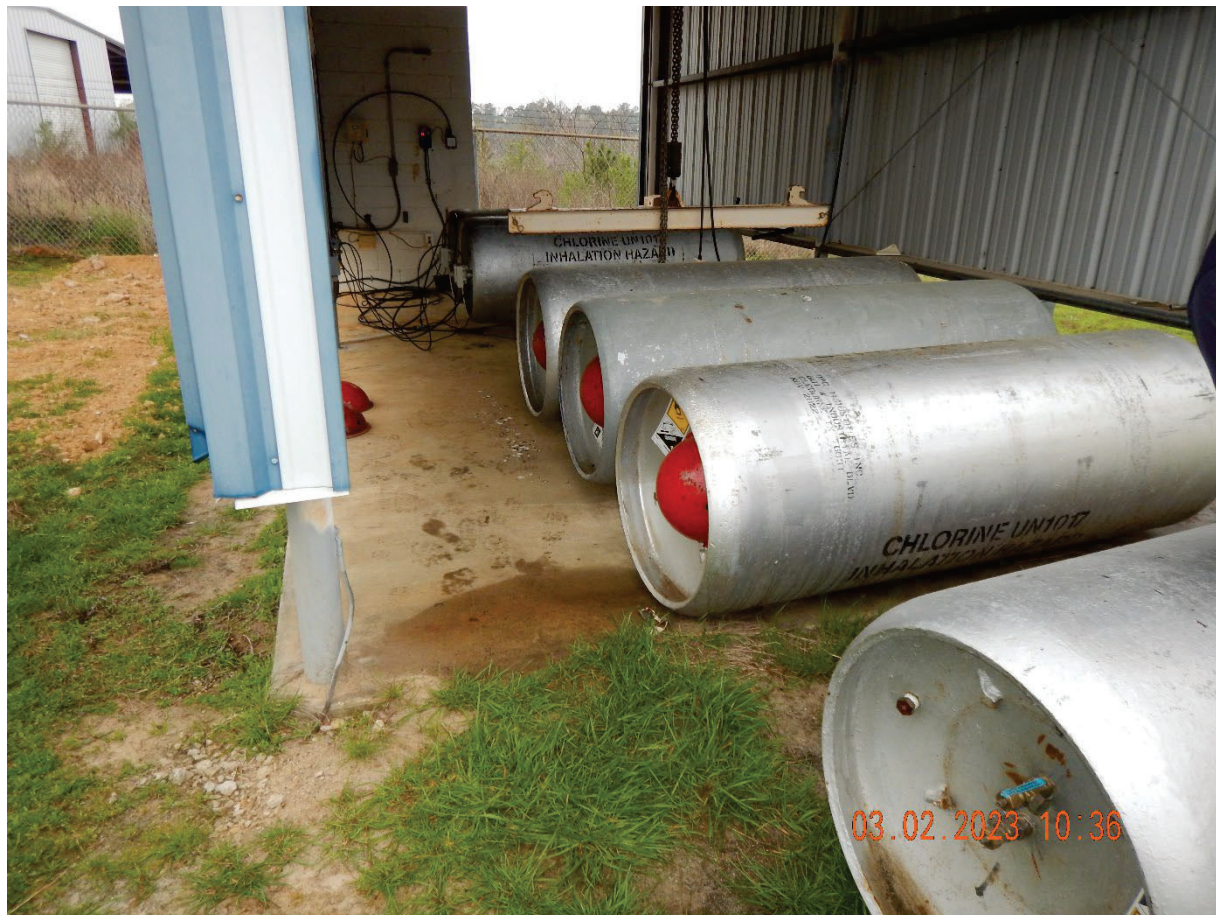
Photo No. 7

- Gas chlorine cylinders stored in shed behind ground storage tank, one rotameter requires dosing shift depending on well supplying water (Photo 7)
- Unlabeled Chemical storage tank without secondary containment (Photo 8)

Description: Chlorine cylinder storage

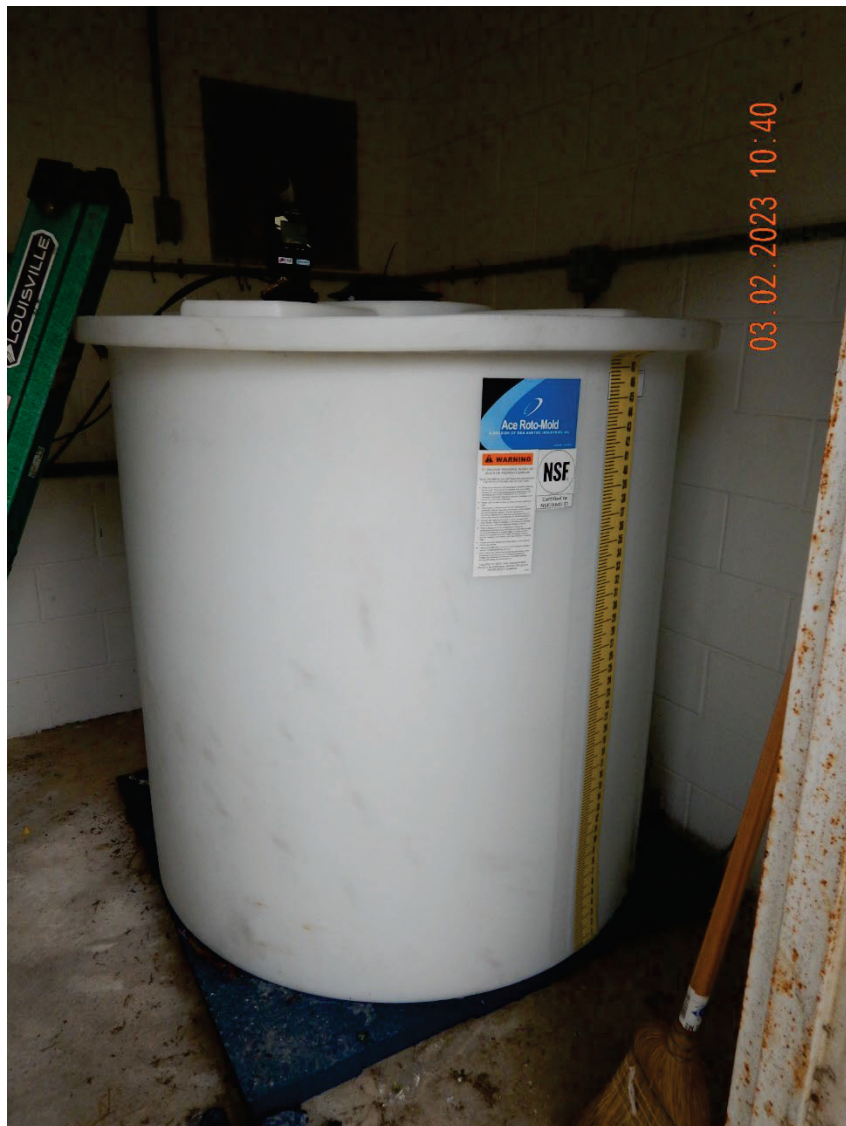
Photo No. 8

Description: Unlabeled chemical container

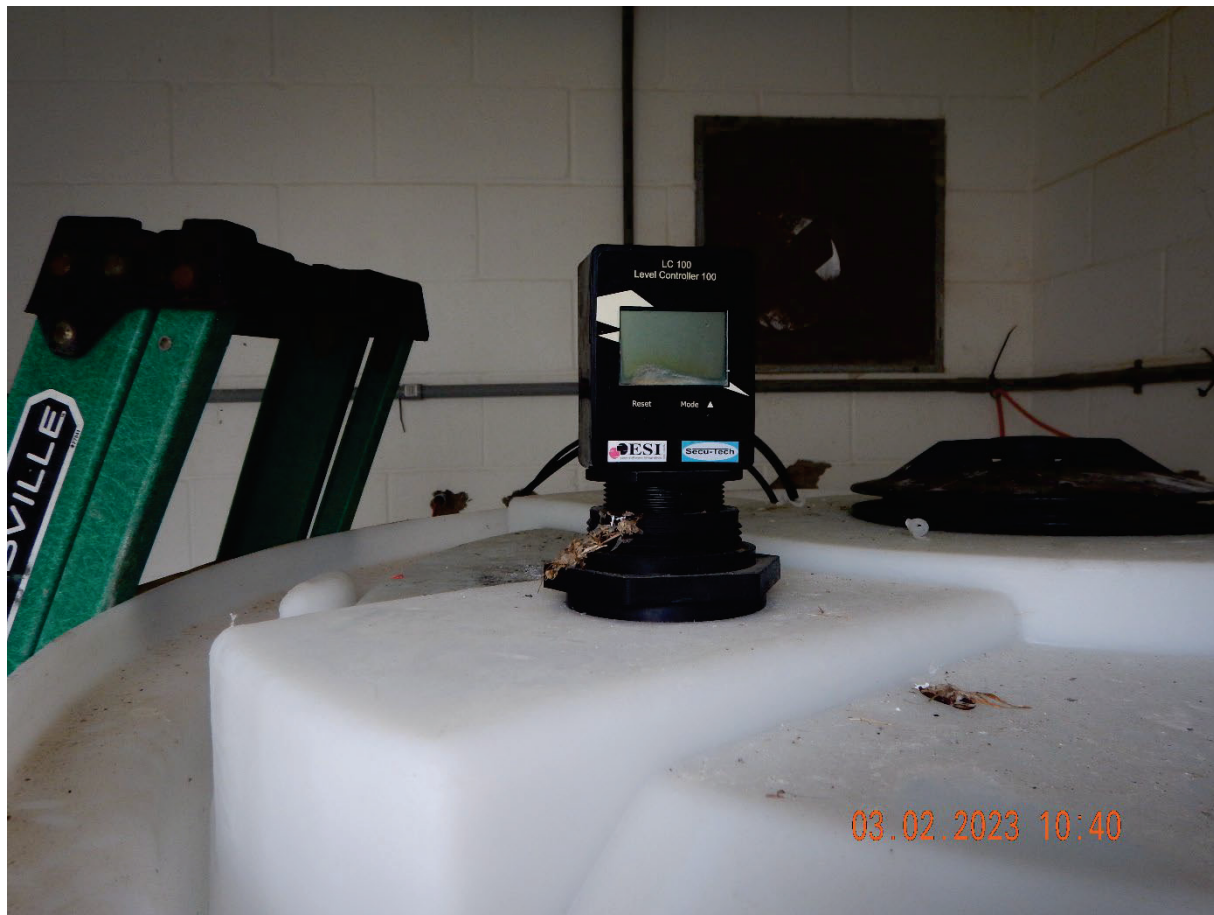
Photo No. 9

- The level gauge was observed to be in non-working condition on the chemical storage tank (Photo 9)
- Water from groundwater tank pumped to elevated storage using two high service pumps (Photo 10)

Description: Level gauge broken on chemical storage

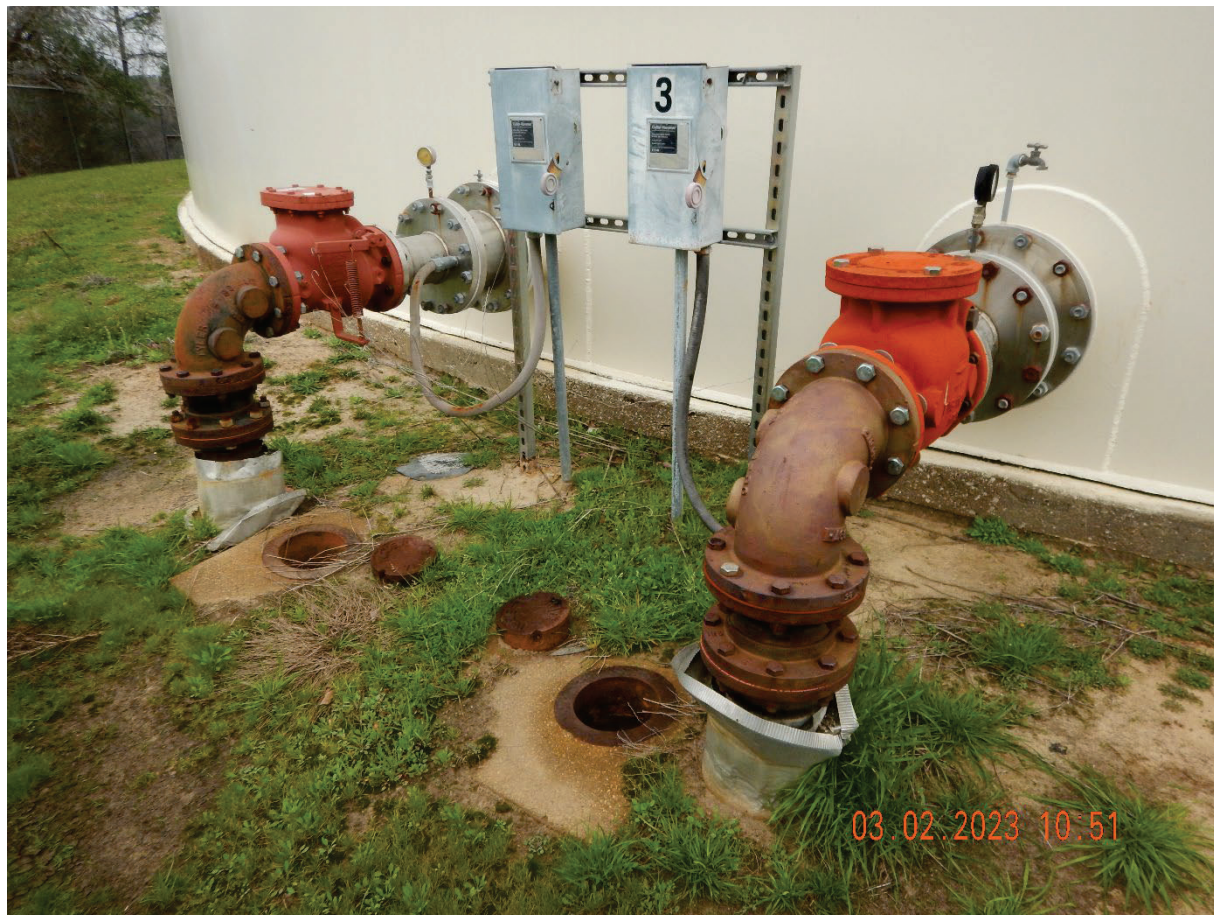
Photo No. 10

Description: Pumps for water leaving ground storage tank

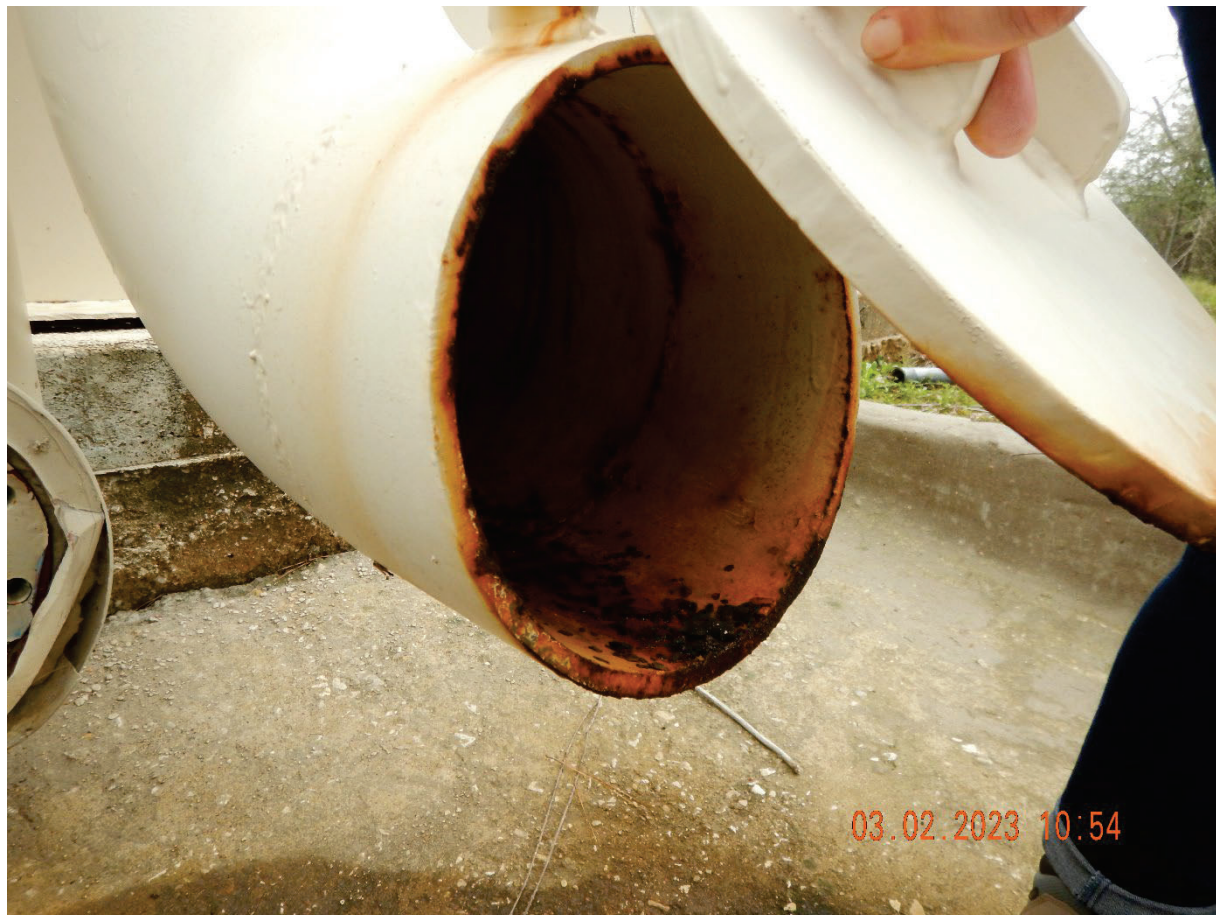
Photo No. 11

- Overflow outlet from 1 MG ground storage tank has flap closure and some rust present (Photo 11)
- Pre-aeration chlorine injection at 1 MG ground storage tank (Photo 12)

Description: Overflow outlet with small amount of rust on large ground storage tank at Plant 4

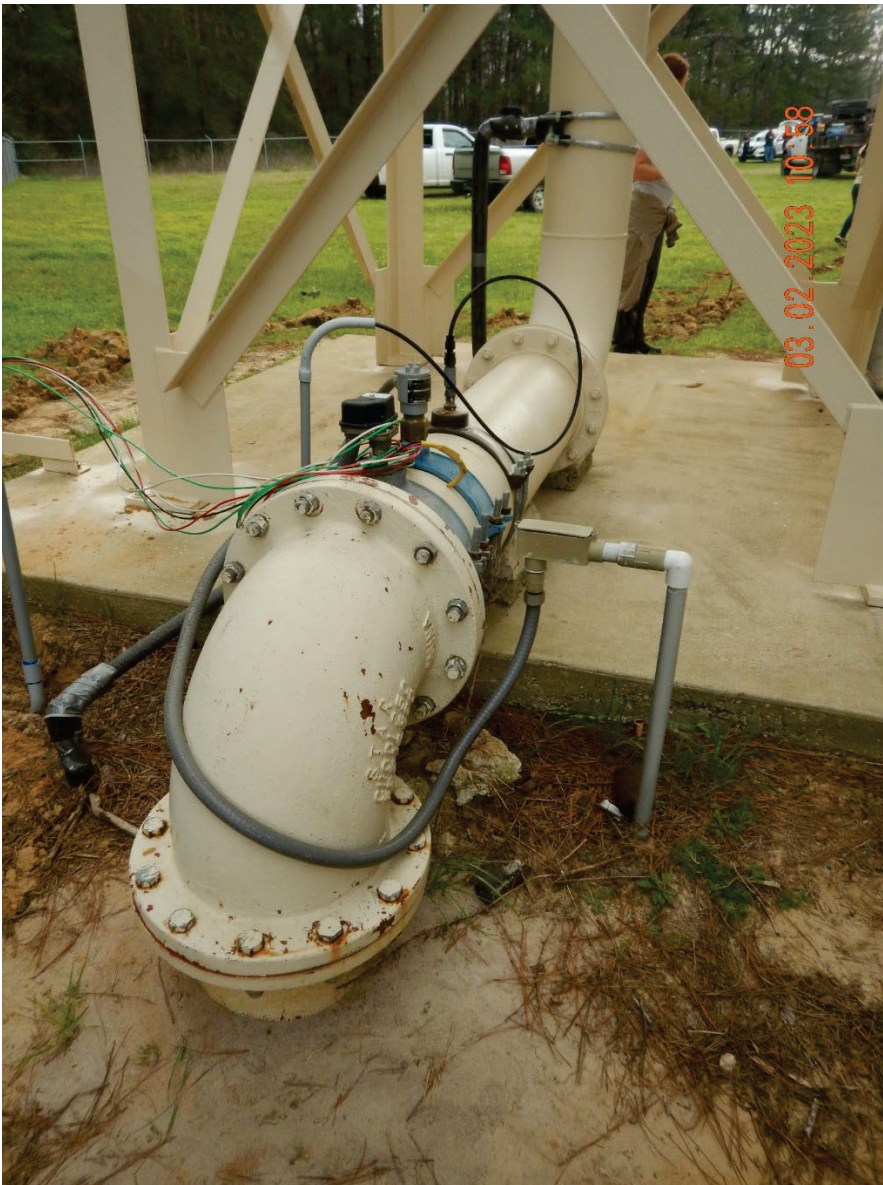
Photo No. 12

Description: Chlorine injection location at Plant 4

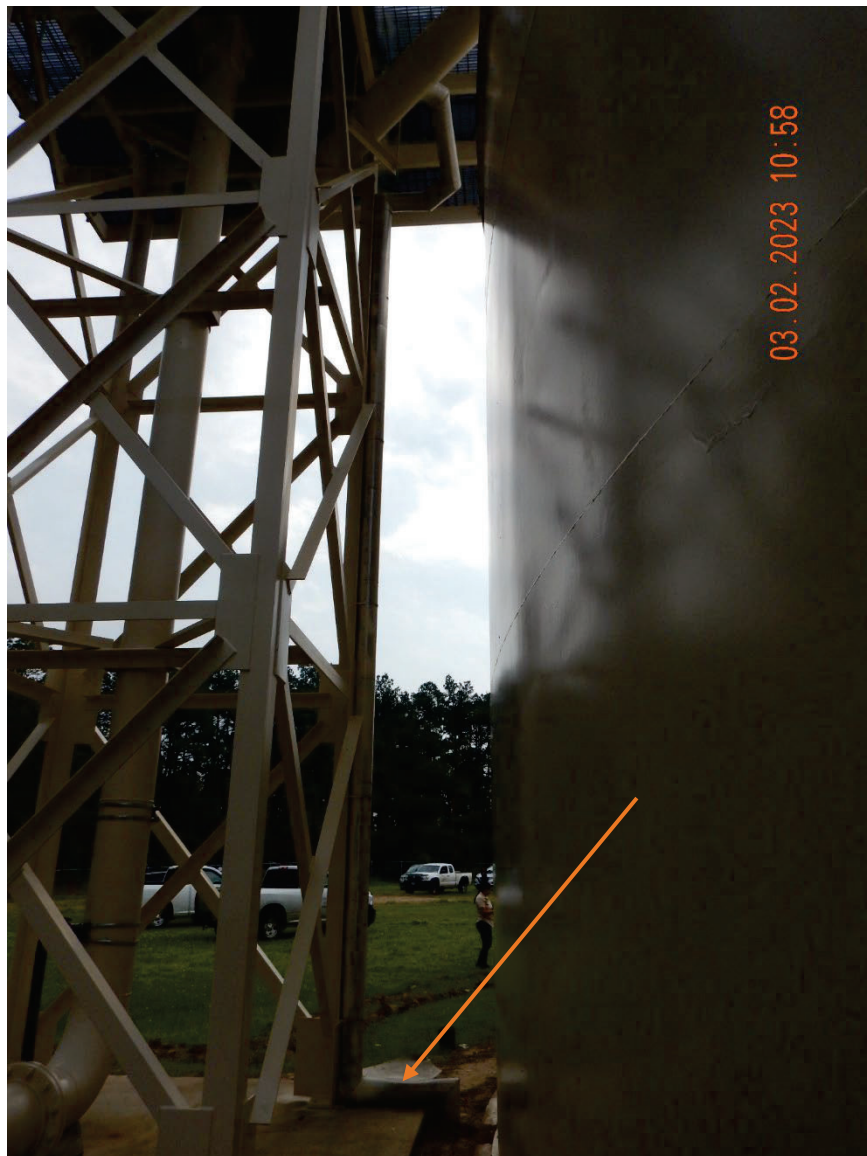
Photo No. 13

Description: Chlorine injection location on 1 MG ground storage tank, arrow added for clarity

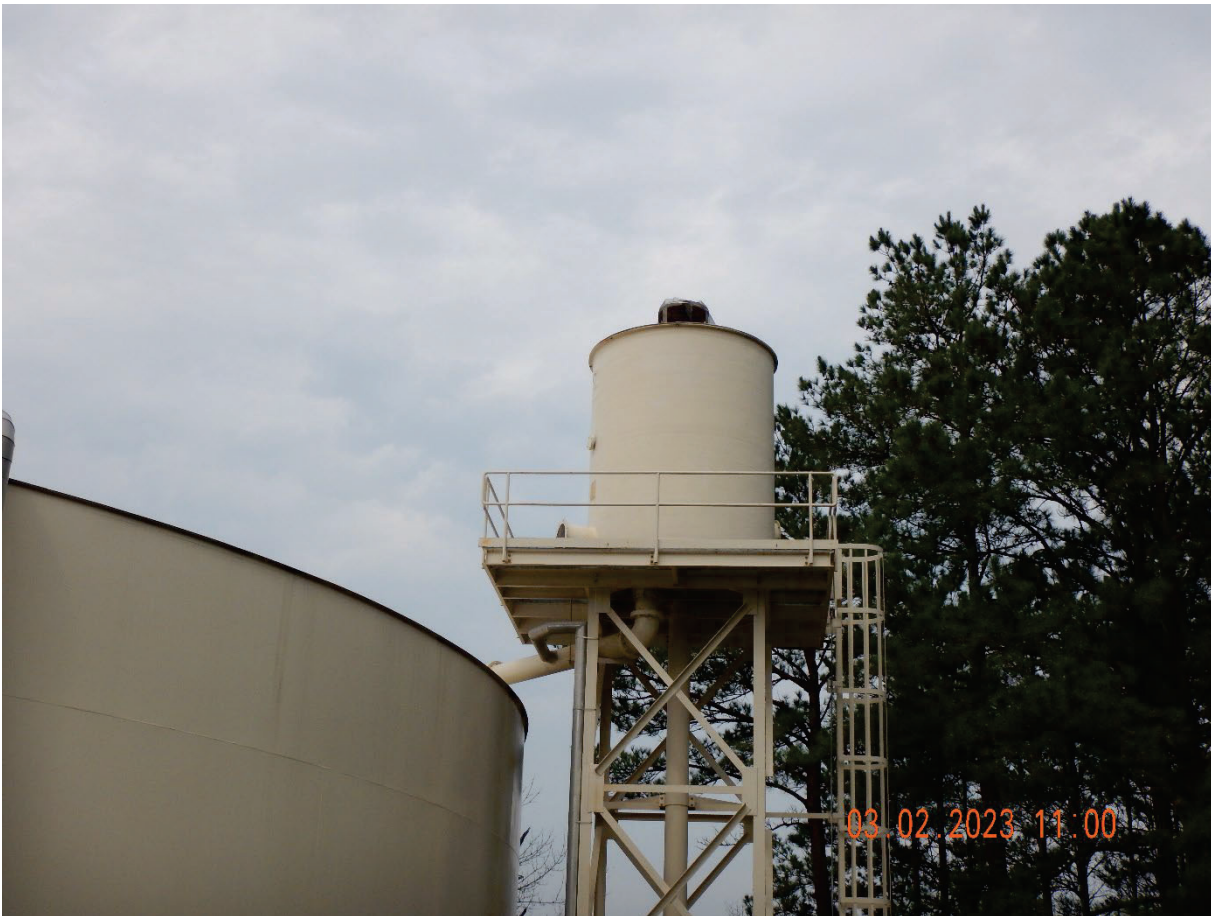
Photo No. 14

- Screening on hatch observed to be loose on aeration unit for 1 MG ground storage tank (Photo 14 & 15)

Description: Loose screen at top of aeration tank at Plant 4

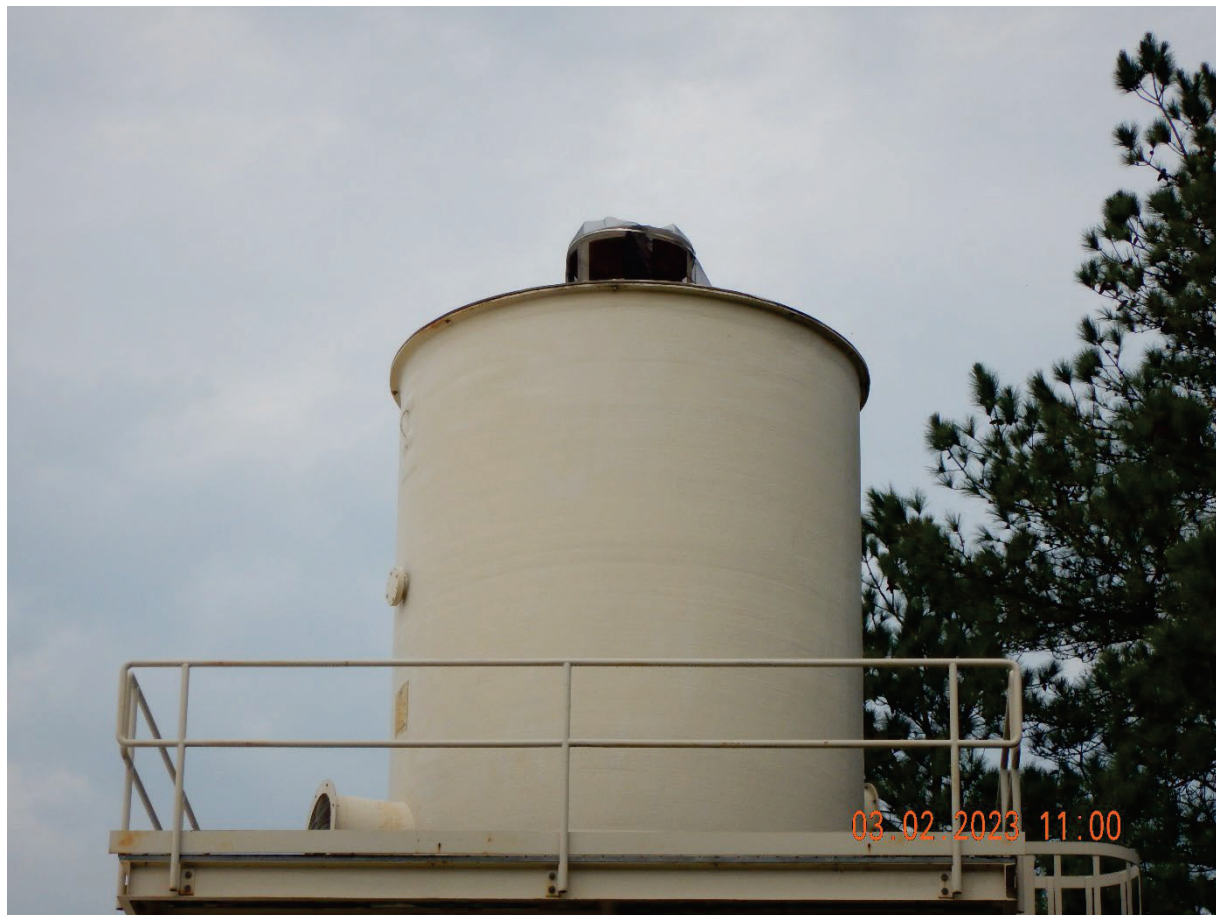
Photo No. 15

Description: Loose screen on aeration tank at Plant 4

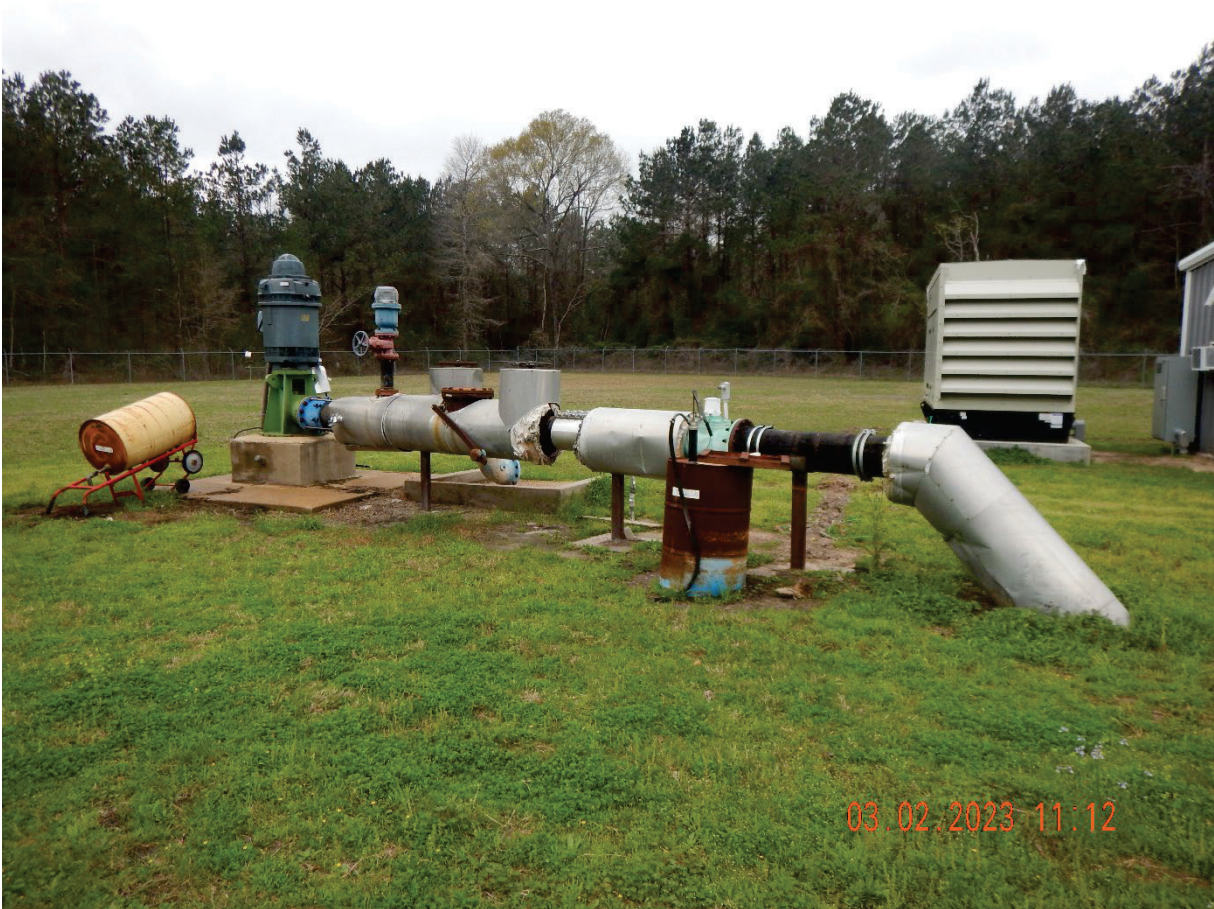
Photo No. 16

- Well 6 recently repaired where oil fed to lubricate well (Photo 16)
- Level gauge on ground storage tank observed to be in non-working condition (Photo 17)
- Overflow outfall had flap closure and large amount of rust present (Photo 18 & 19)

Description: Well No. 6 at Plant 5

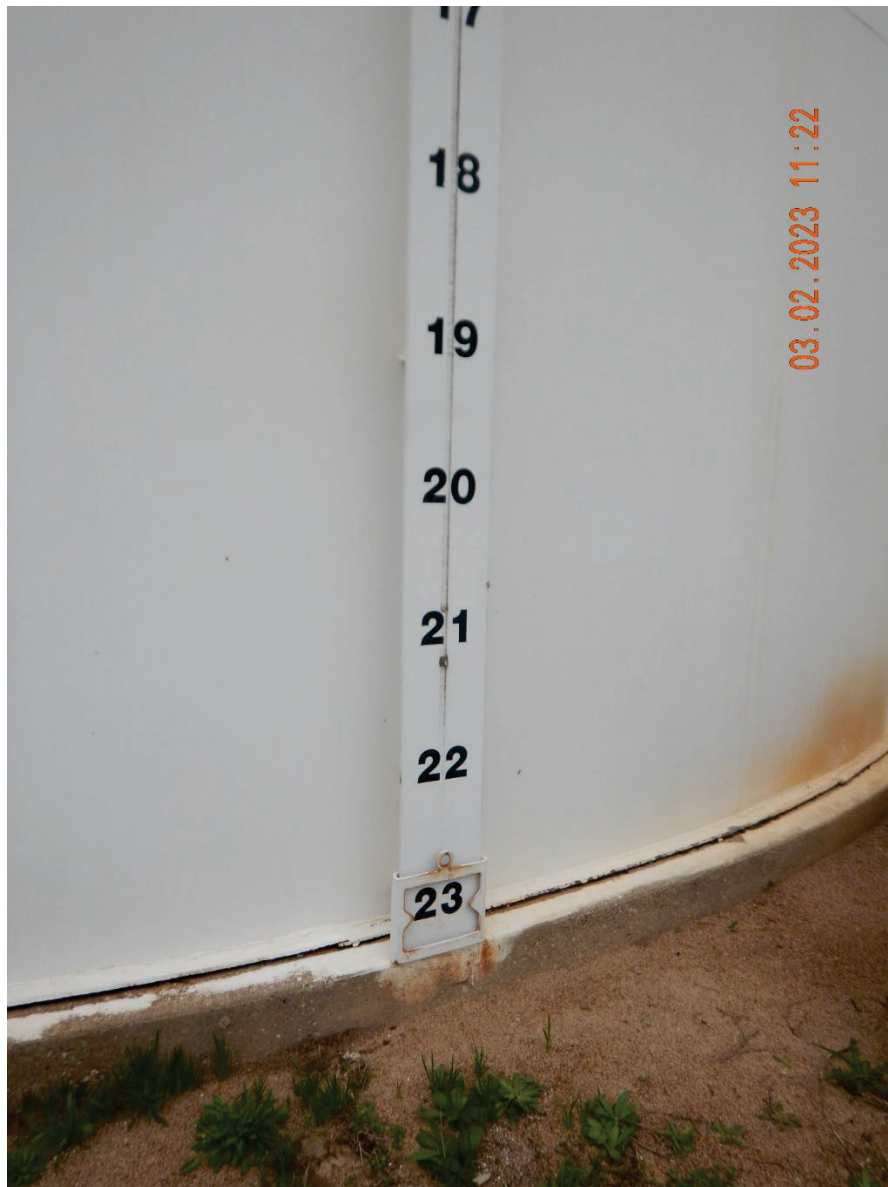
Photo No. 17

Description: Water level indicator on ground storage tank in non-working status

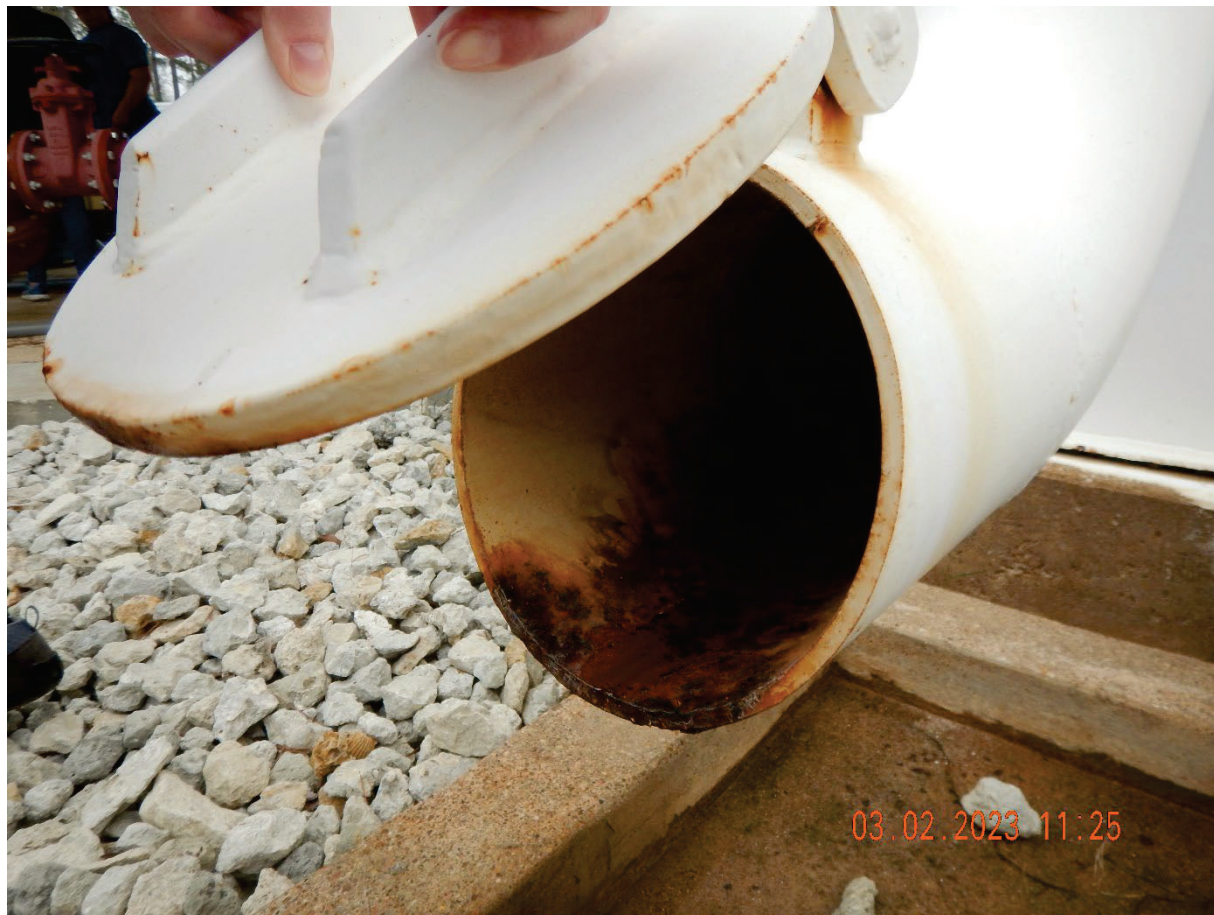
Photo No. 18

Description: Overflow outfall with flap closure and rust

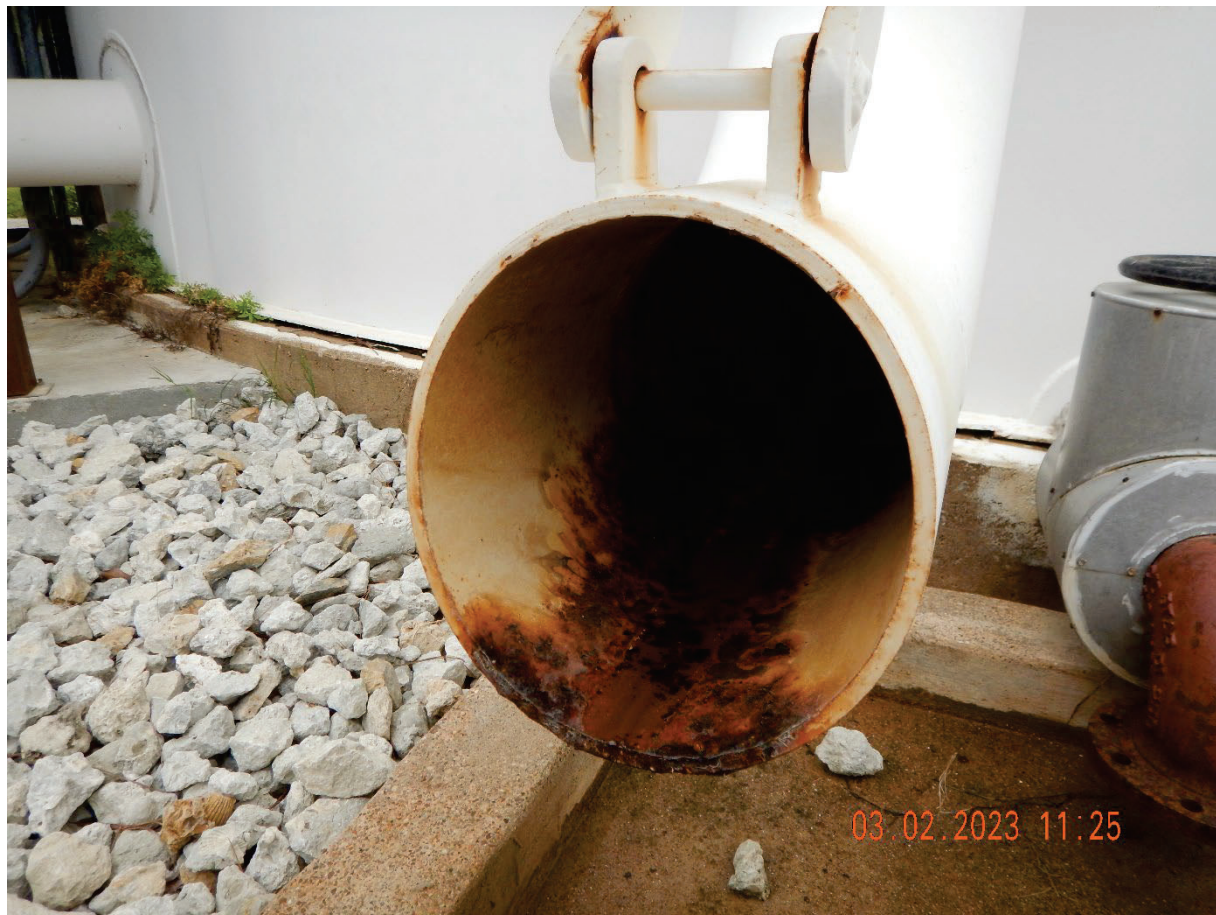
Photo No. 19

Description: Overflow outfall with flap closure and rust
