**Region 2 Enforcement & Compliance Assurance Division**  
**Air Compliance Branch**  
**CAA Inspection Report**

**Inspection Date:** 7/24/2024  
**Facility Name:** 49 Gingerbread Castle Rd  
**Facility Address:** 49 Gingerbread Castle Rd, Hamburg NJ  
**ICIS-Air ID #:** 3601694258  
**EPA Lead Inspector:** Christopher Collins, Collins.Christopher.W@epa.gov  
**EPA Asst. Inspector:** Victor Tu, tu.victor@epa.gov  
**Facility Contact:** Joseph Park, Owner, joseph@selininy.com  
**State Inspector(s):** James Harris, NJDOL, james.harris@dol.nj.gov  
**State Inspector(s):** Ray Djurin, NJDOL, radovan.djurin@dol.nj.gov  
**State Inspector(s):** Frank Cuomo, NJDOL, frank.cuomo@dol.nj.gov  
**State Inspector(s):** Jim Vermeychuk, NJDOH, james.vermeychuk@doh.nj.gov

40 CFR Part 61 Subpart M – Asbestos NESHAPs

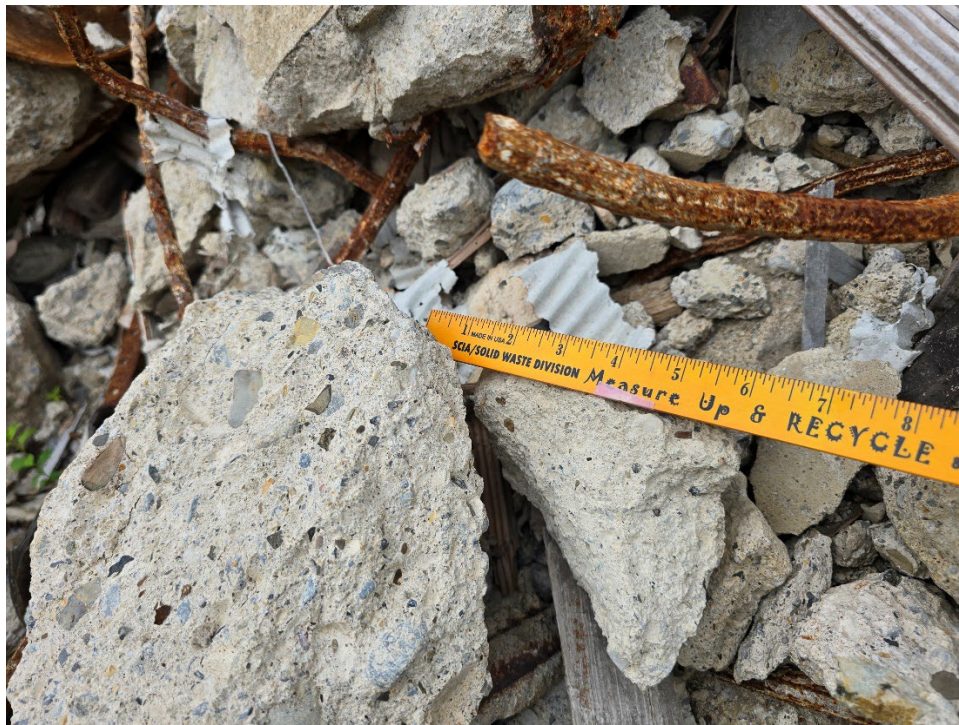
Frank Marino and Ray Djurin identified several materials that had been previously tested positive for asbestos during a prior DOL inspection (Figures 3-6):

*Figure 3: Corrugated insulation.*

The inspection team noted there was no signage on the gates, and no visible wetting of materials. They explained to the Owner that all materials need to be kept wet and documented with a logbook and photos demonstrating wetting. They also explained that signage should be present on the gates warning of asbestos, and that all waste is considered asbestos-contaminated. The inspection team further explained that all waste generated is considered asbestos containing waste material.

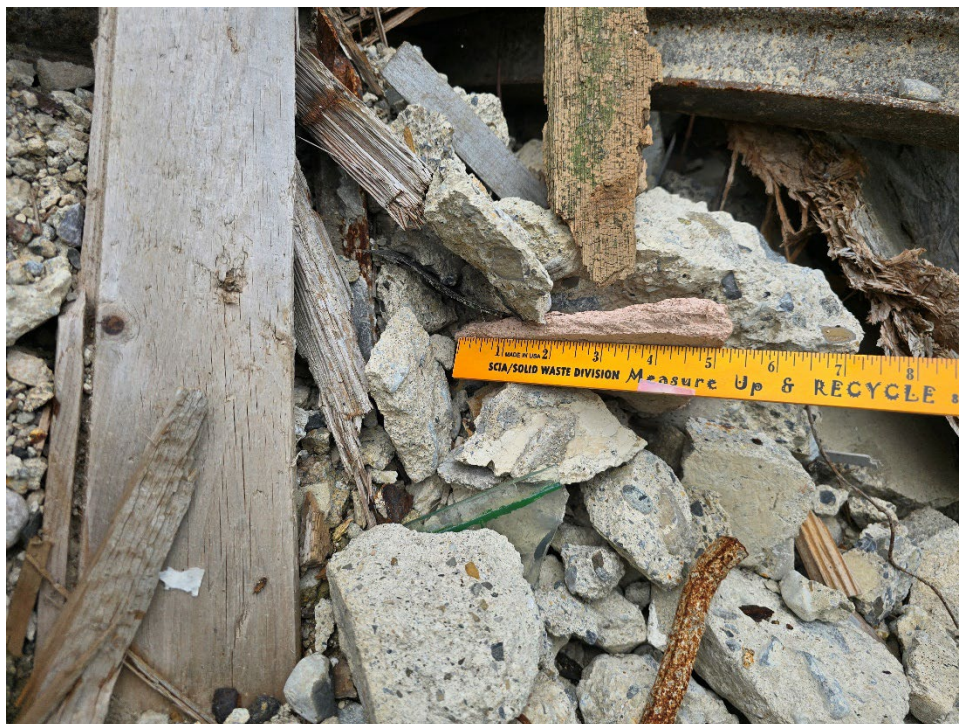
*Figure 4: Pink Cementous Material*

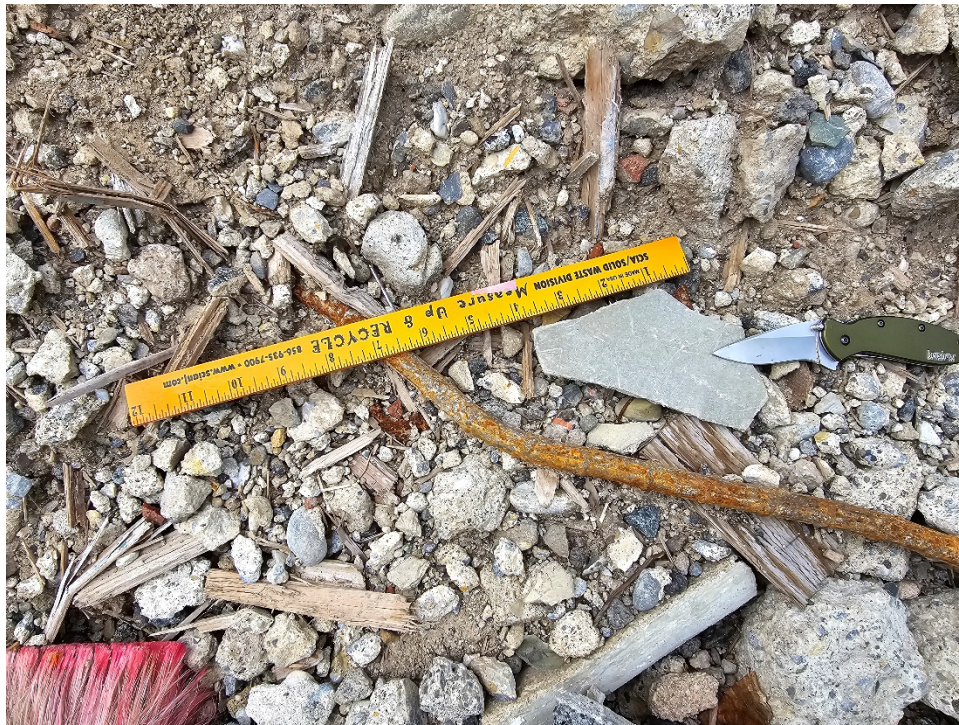
Figure 5: Transite material.

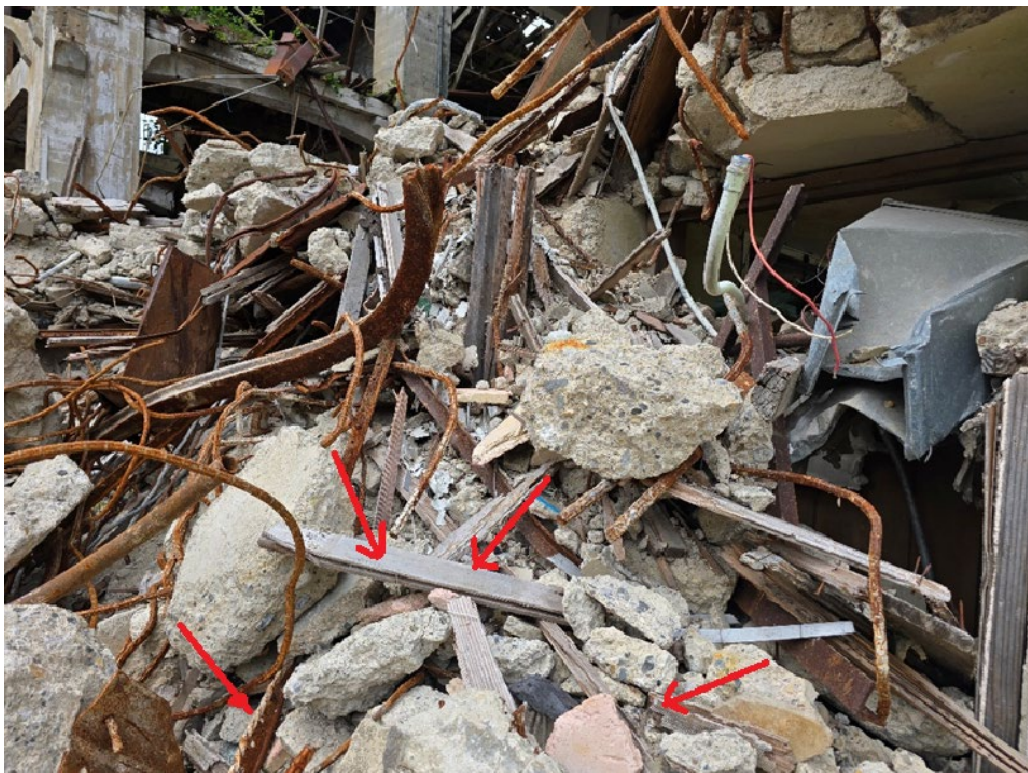
Figure 6: ACM laying in debris pile from Figure 4.

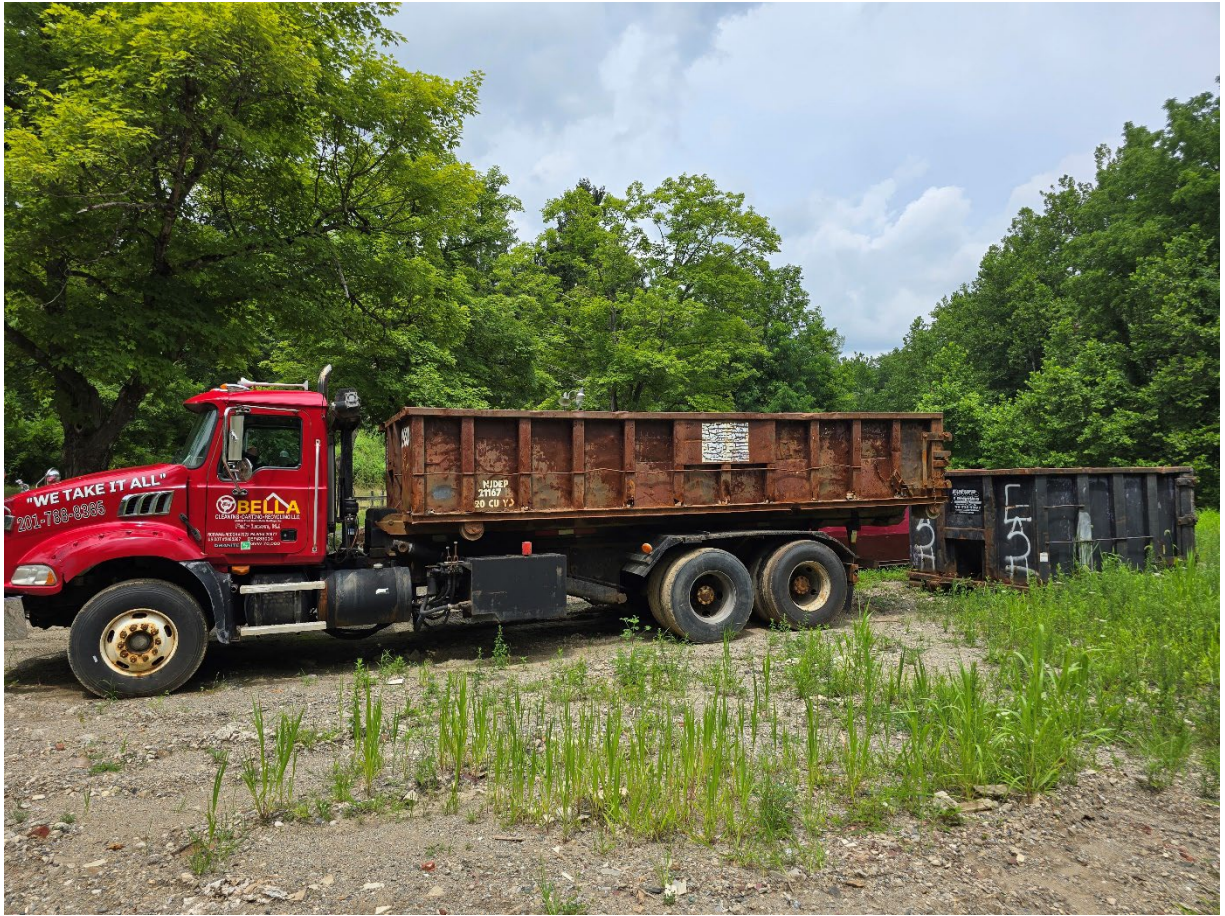
The tour continued to the debris field across the street, owned by Winners Property LLC (30 Gingerbread Castle Rd), an entity owned by the Owner's family. At this site, inspectors found Bella vehicles, containers with waste, and demolition waste laying on the ground and seemingly buried in the ground (see figure 7, 8 and 9).

*Figure 7: Bella Truck with 20 cubic ft container.*

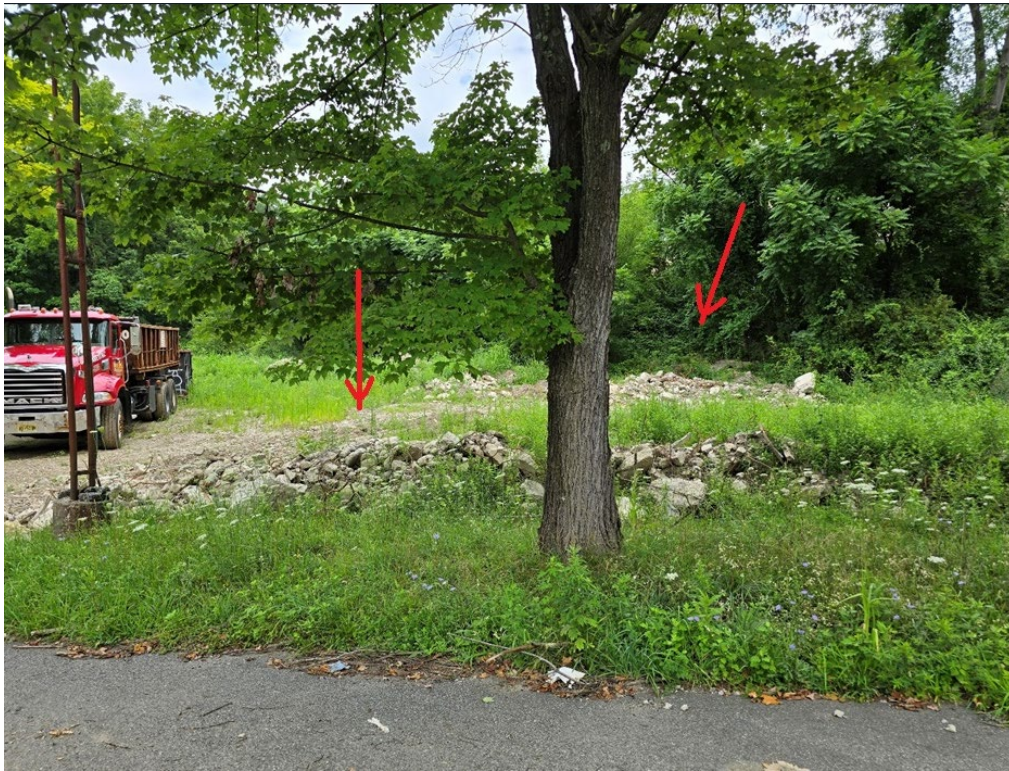
*Figure 8: Demolition Debris.*

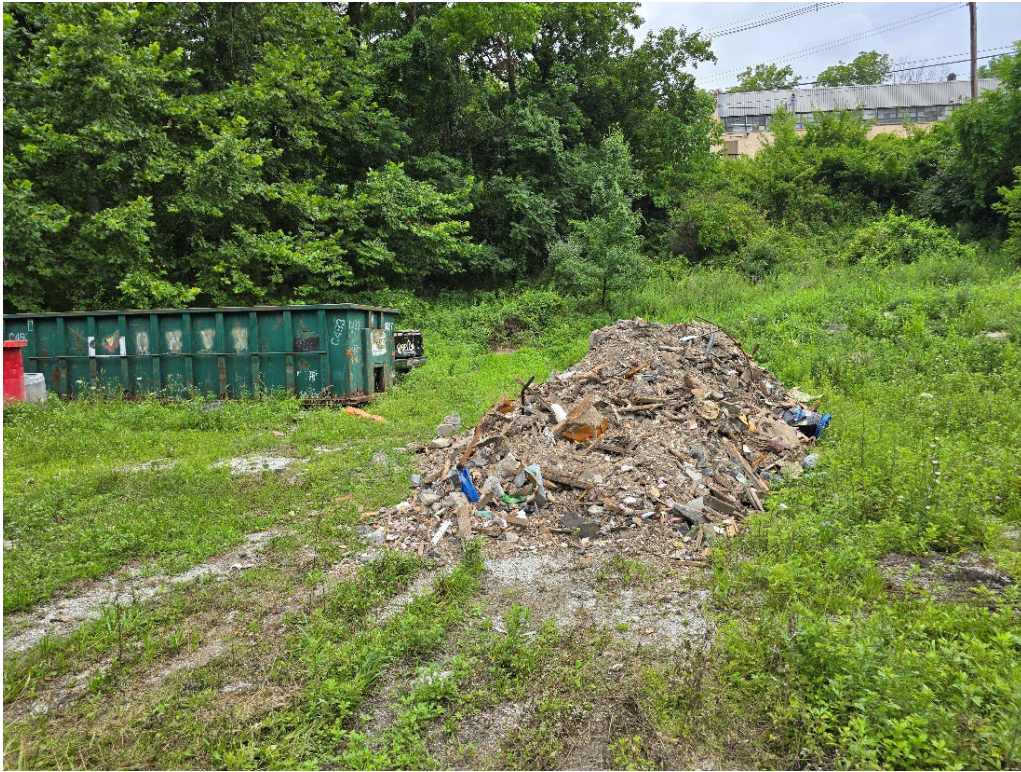
Numerous mounds of debris, what appears to be C&D debris, was observed on the site (Figure 10, 11 and 12). The Owner stated he does not believe that these debris pile are from the demolition project and had not seen this waste prior to the inspection. He also stated that he has only authorized Bellas to dump debris from this demolition project and nothing else.

*Figure 10: Pile of waste which included non-construction waste.*

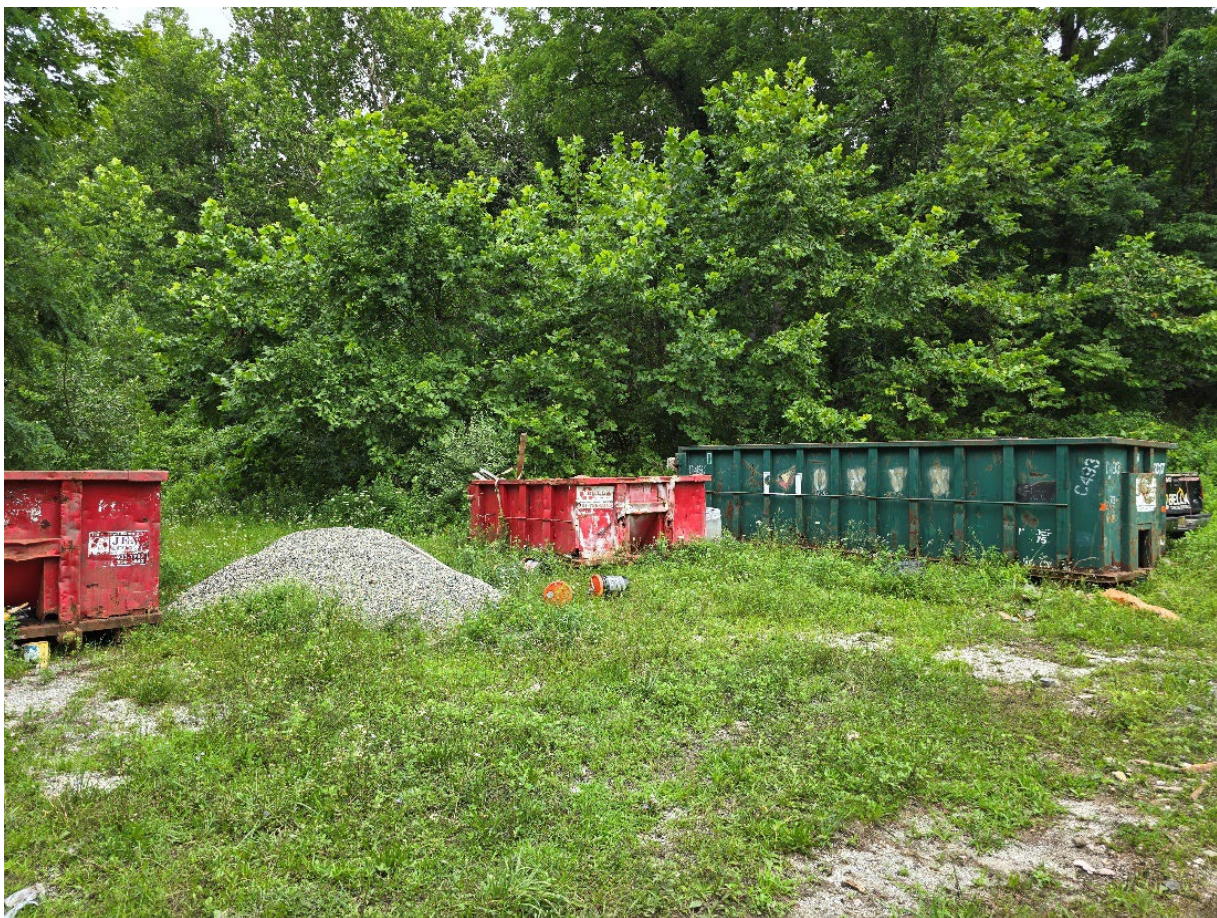
*Figure 11: Pile of waste material and "Bella" labeled containers.*

Possible black tar was observed in the debris.

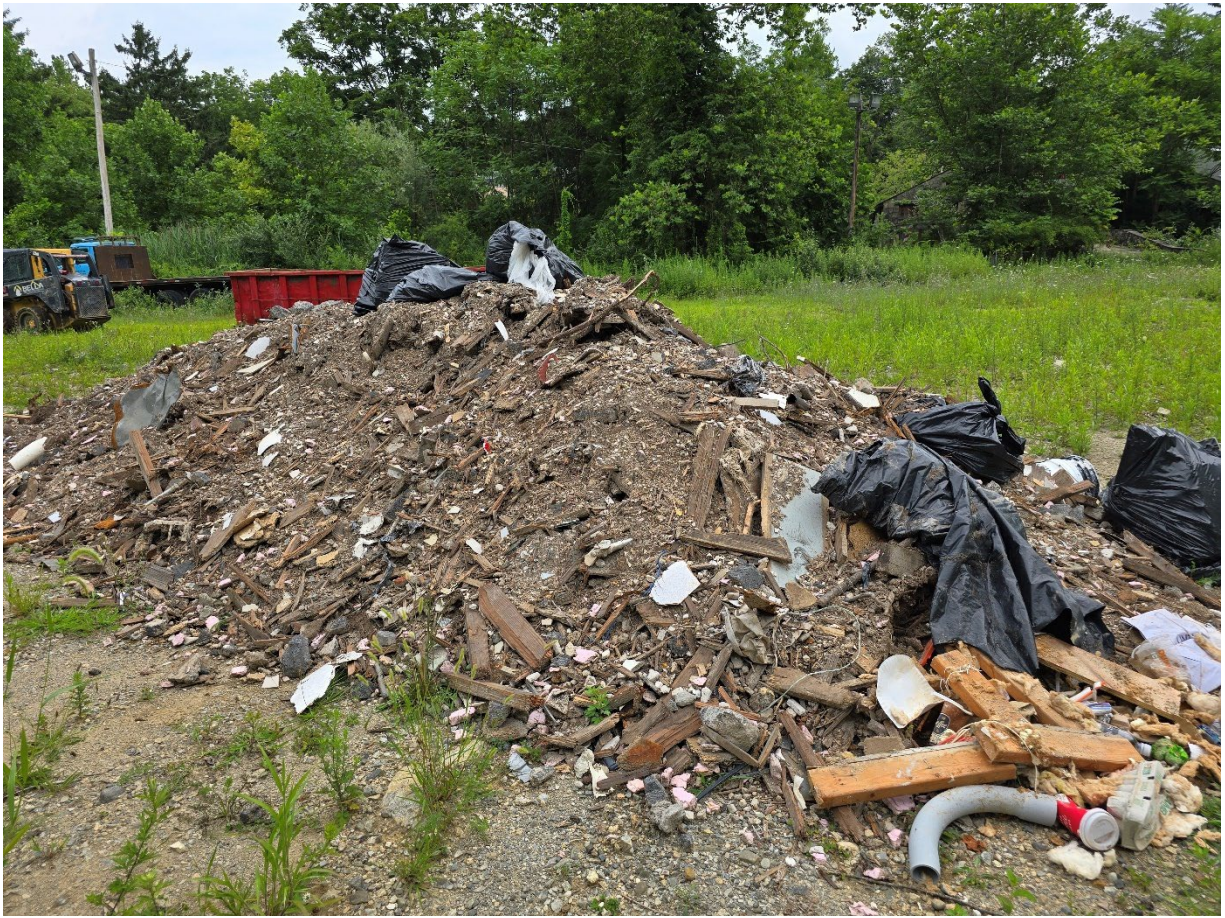
A second pile of debris was found further into the property, which appeared to contain non-construction waste (Figure 12). The Owner stated he had not seen this waste prior to the inspection and was unaware of its presence.

*Figure 12: Pile of debris with non-construction waste.*

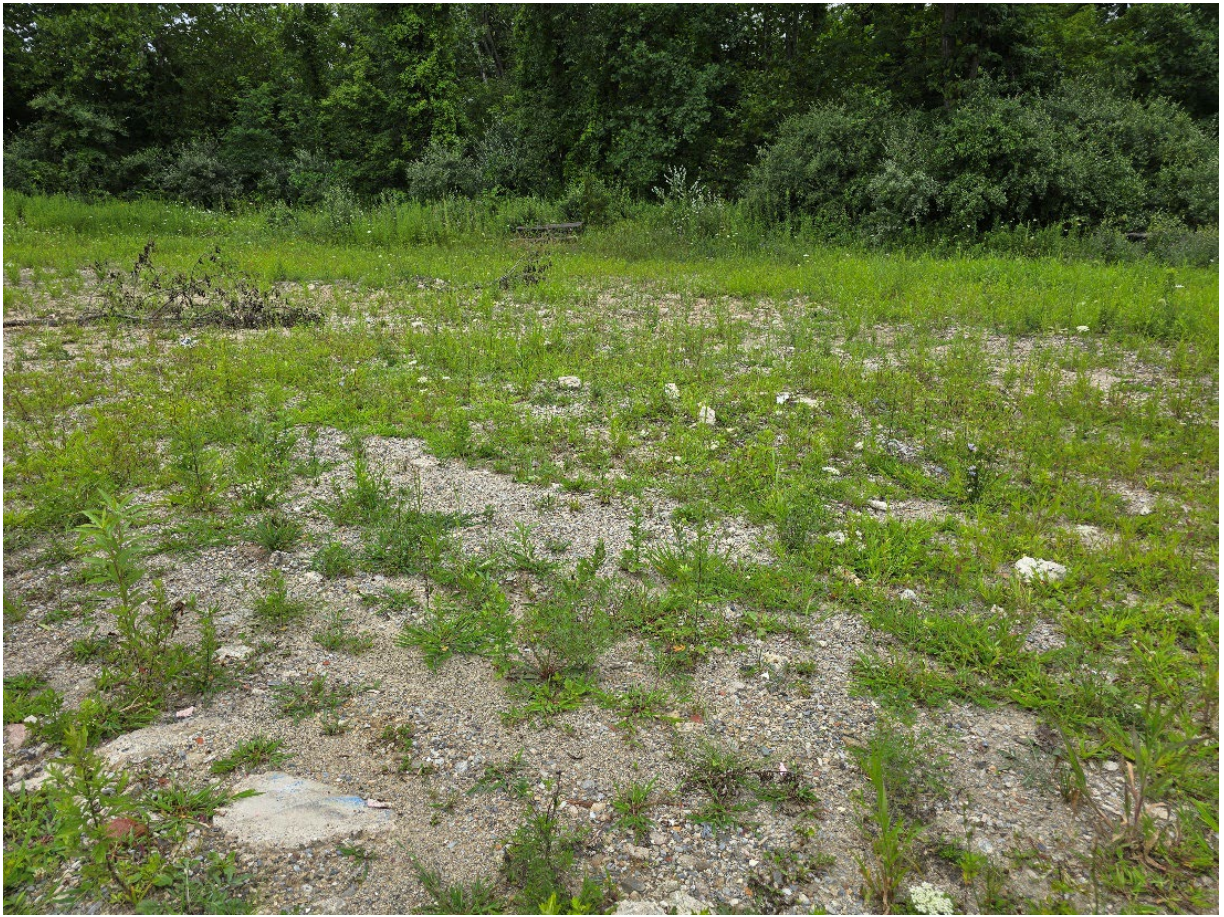
The owner stated that the construction debris was originally placed in this area (see figure 13) of the property, until he instructed Bella to move the waste to where it is currently.

*Figure 13: Site where construction debris was originally placed, before being moved to final site. Remanent of the demolition debris was still present on the ground.*

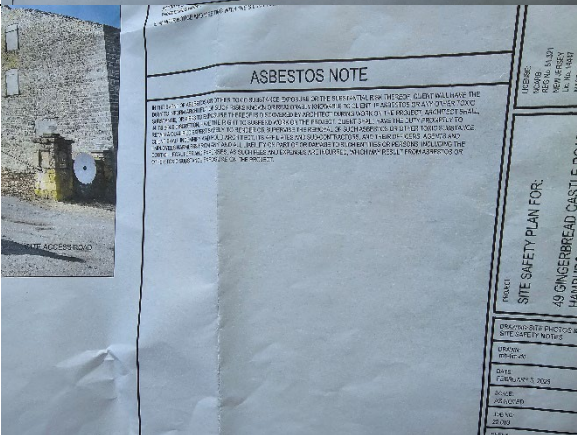
| 20240724_121615.jpg | "Asbestos Note" in Site Safety Plan, shown by Joe Butto during the inspection. | |

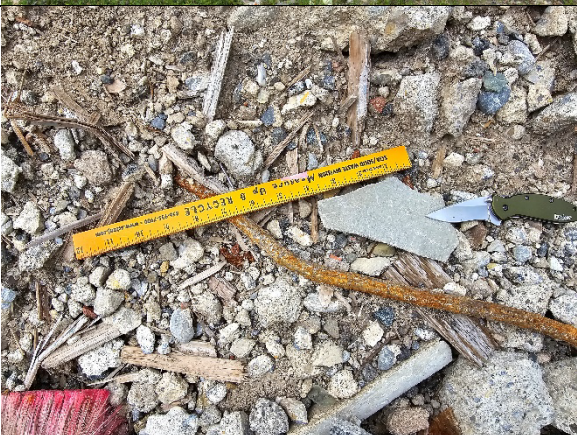
| 20240724_124048.jpg | Asbestos transite material, Identified as ACM during prior DOL inspection | |

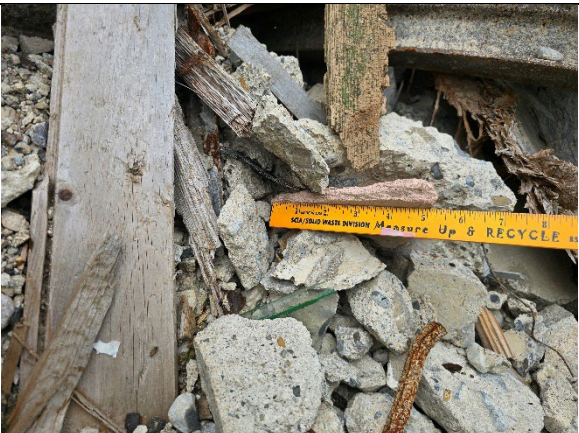
| 20240724_124143.jpg | Asbestos pink material, Identified as ACM during prior DOL inspection | A close-up photograph of a pile of debris, including concrete chunks, wood, and a piece of pink material. A yellow ruler is placed horizontally across the debris for scale. The ruler has text that reads "KOLBOLD WASTE DIVISION Measure Up & RECYCLE". |

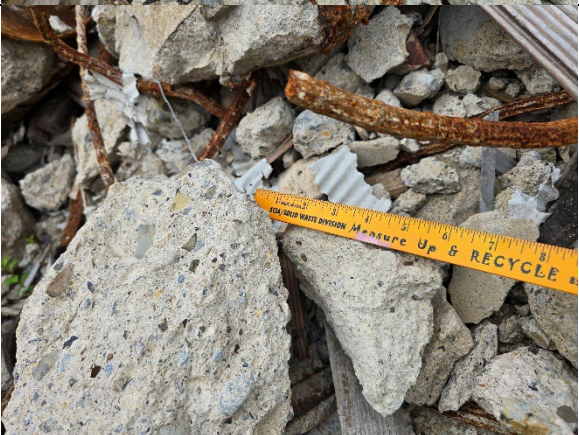
| 20240724_124203.jpg | Asbestos corrugated paper material, Identified as ACM during prior DOL inspection | A close-up photograph of a pile of debris, including concrete chunks, wood, and a piece of corrugated paper. A yellow ruler is placed horizontally across the debris for scale. The ruler has text that reads "KOLBOLD WASTE DIVISION Measure Up & RECYCLE". |

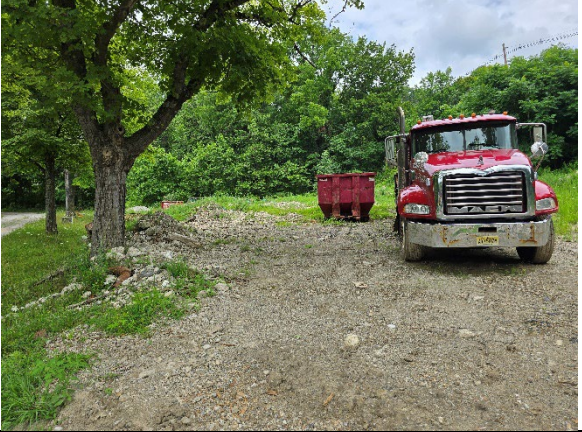
| 20240724_132338.jpg | Bella Truck and debris, alternate angle. The red container was filled with metal at the time of inspection. | |

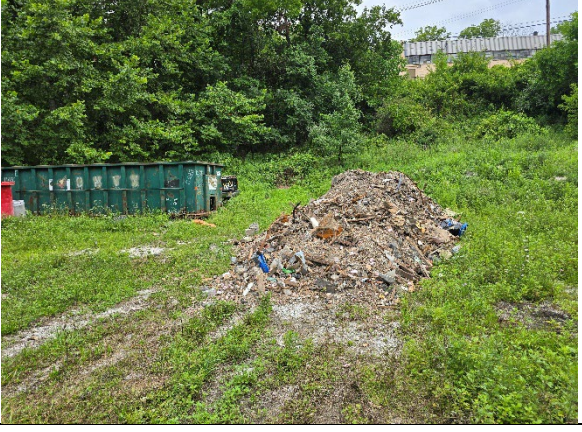
| 20240724_132620.jpg | Pile of waste which included C&D waste. | |

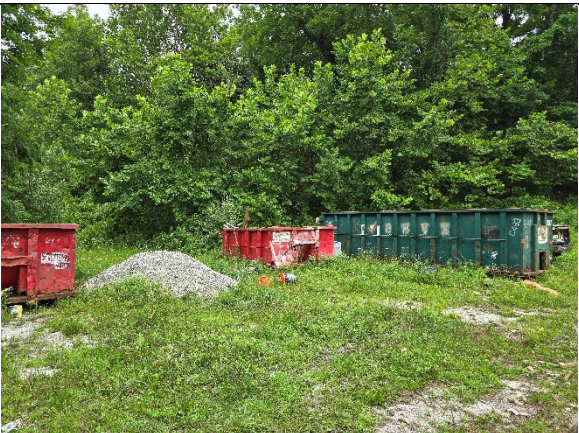
| 20240724_132642.jpg | Pile of waste material and "Bella" labeled containers. | |

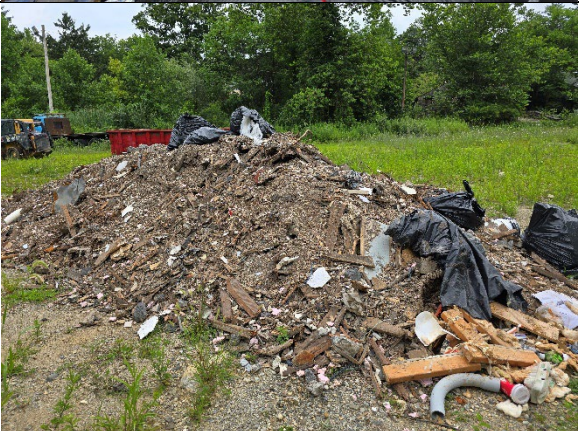
| 20240724_134031.jpg | Pile of debris with C&D waste. | |

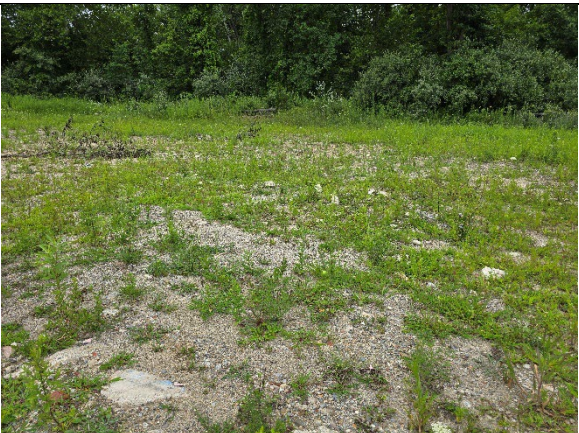
| 20240724_134539.jpg | Site where construction debris was originally placed, before being moved to final site. | |
