**SUBJECT:** CLEAN AIR ACT INSPECTION REPORT  
Clark-Floyd Landfill, Borden, Indiana

**Date of Inspection:** November 13, 2024

**Purpose of Inspection:** Landfill Monitoring Inspection

**Facility Type:** Municipal Solid Waste Landfill

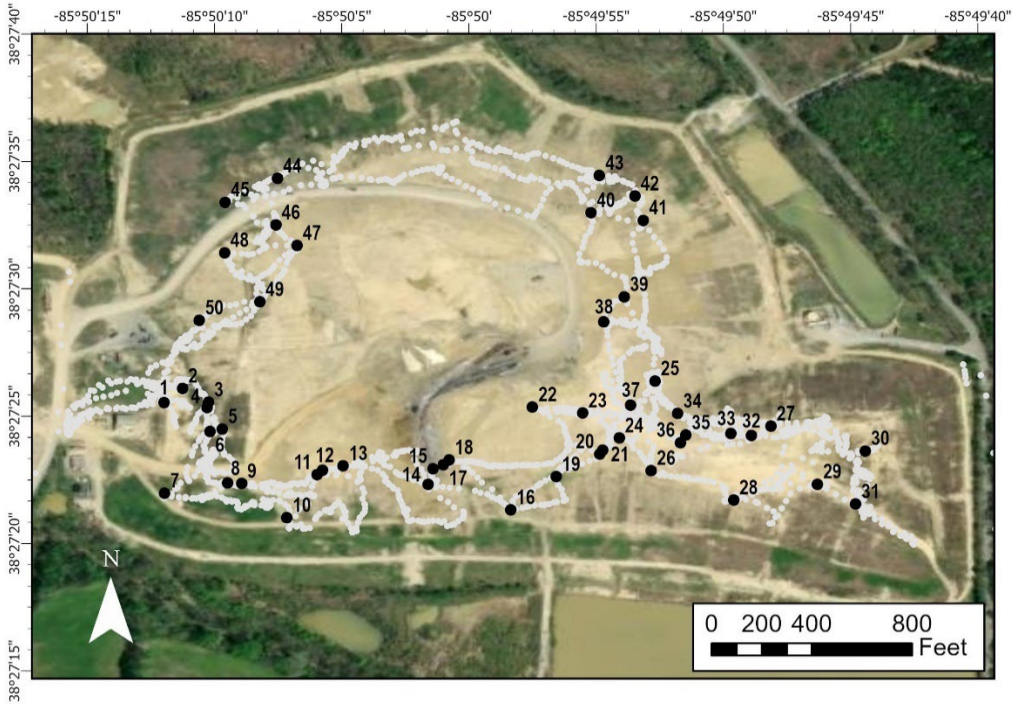
EPA inspectors detected and documented 50 points on the Landfill surface with concentrations of methane above 500 ppm. Some of the documented points involved areas where there were numerous exceedances, particularly in eroded areas, but only one point was recorded for each location. Of the 50 SEM hits found, 21 were found in areas of erosion, 27 were at the base of wellheads, and 2 were found near header seams. All SEM photos and locations/concentrations are documented in Appendices A and B, respectively, with visual maps shown in Appendix C. Cover integrity issues were noted over most of the non-vegetative slopes on the East hill during SEM including large erosion reels and exposed trash, with some locations having leachate breakouts. See Appendix A for photos. Additionally, elevated levels of landfill gas above background were seen over a large portion of the SEM path taken. See Appendix C for a concentration map of all continuous 10 second readings taken during SEM.

Recorded highest SEM hit locations are mapped on top of satellite imagery with the approximate monitoring path. The numbers correspond to MAP IDs that are presented in Appendix B.

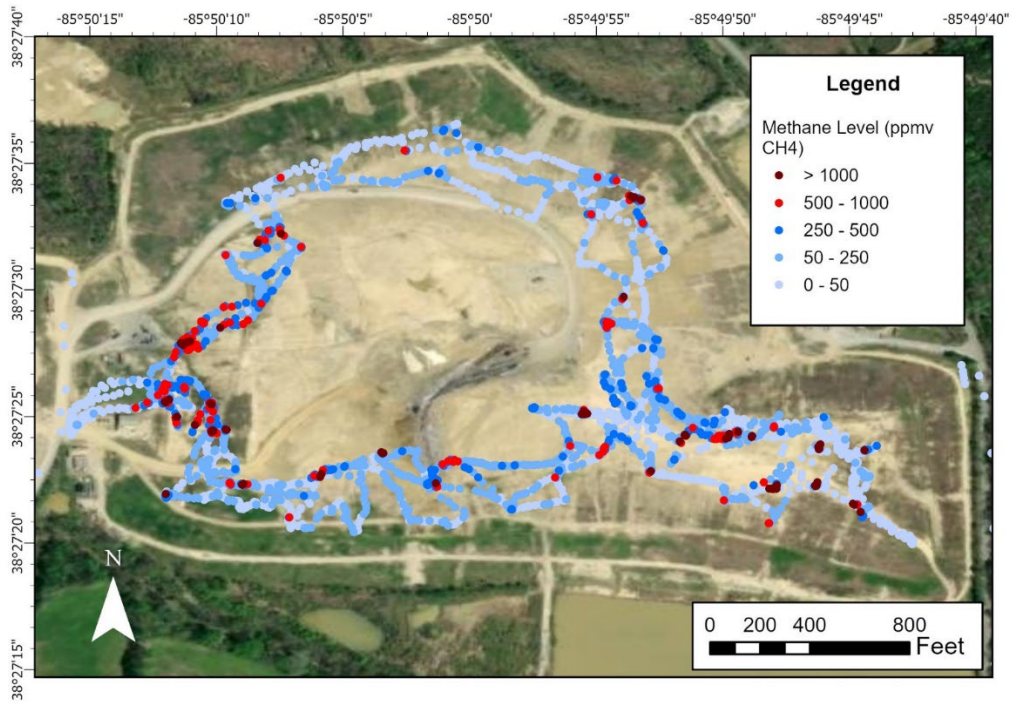
Integrated GPS monitoring points collected every 10 seconds during SEM are mapped over satellite imagery of the landfill. Concentrations of methane (ppmv) are shown using a color scale. The 10 second readings stop when recording a max reading, leading to some variation relative to hits above.
