**Region 6 - Enforcement & Compliance Assurance Division**  
**INSPECTION REPORT**

| Inspection Date(s): | 02/08-09/2024 | |
| Facility Name: | <b>Ineos Calabrian Facility</b> | |

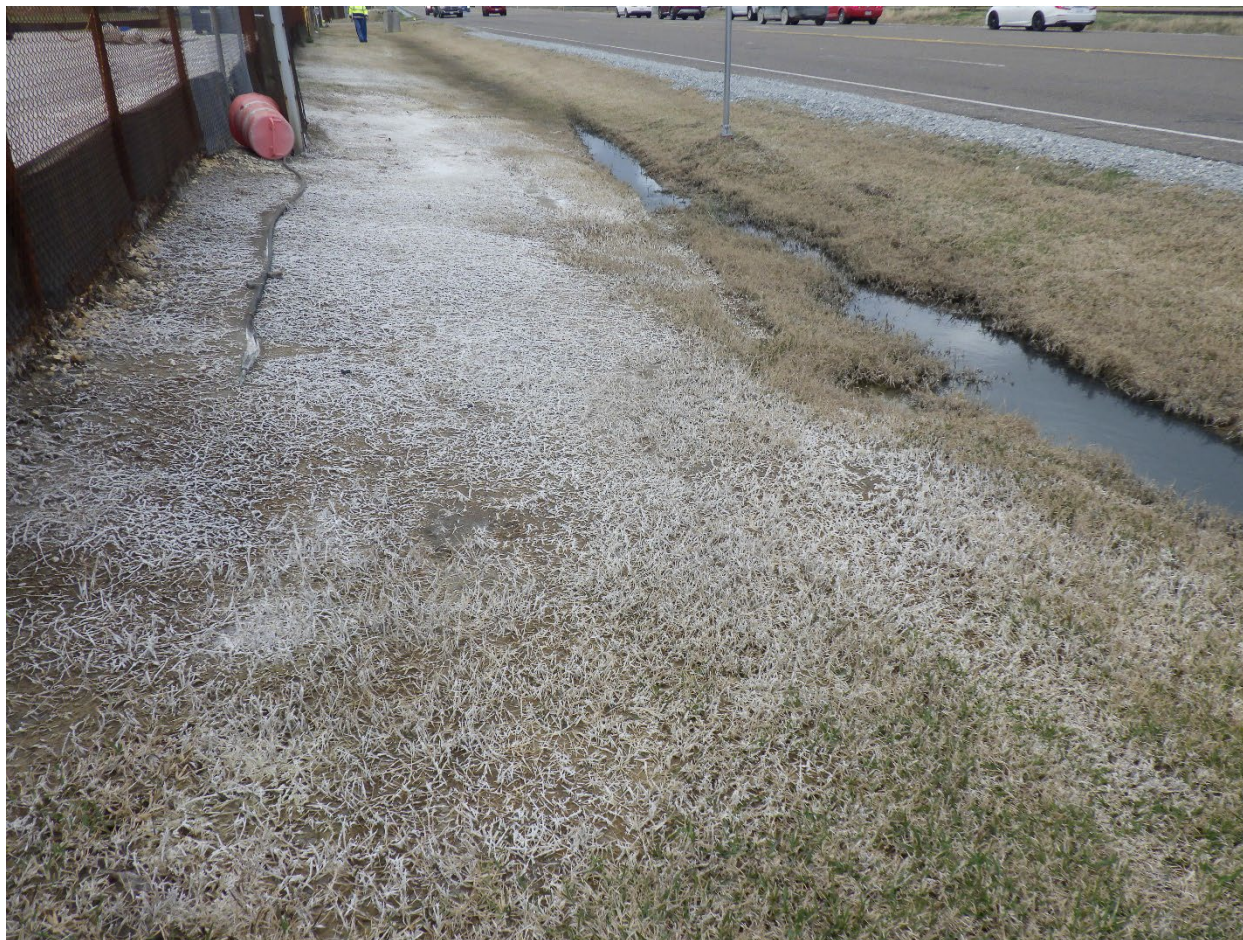
Photo No. 9

At 3:00PM, the inspection team used the GF77 to observe emissions being released from the Meta Bisulfite Unit while outside the property of the facility. At the fence line near the Meta Bisulfite Unit, we observed that the grass was dead and was covered with a white powdery substance (Appendix 1, Photos 9-10). At 3:15PM, the inspection team made entry to the facility and met with Leslie Pitre for the opening conference for the follow up inspection.
