# **REPORT OF COMPLIANCE EVALUATION INSPECTION**

Greene County - Kansas Expressway Extension Phase 2  
Right of Way Corridor from Plainview Road to Farm Road 190  
Springfield, Missouri, 65810  
Greene County

NPDES Permit # MOR100040

August 12 and 13, 2024

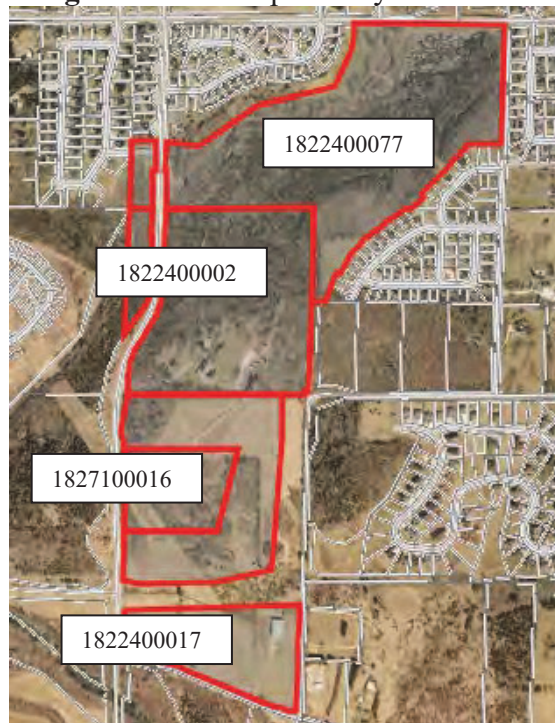
**Image 1.** Greene County-owned properties

The legal description provided is Section 22, Township 28N, Range 22 W and Section 27, Township 28 N, Range 22 W. The construction site is bordered on the north by West Farm Road 182/Plainview Road. The east side is bordered by South Fork Subdivision in the north portion, private property in the middle portion, and an active construction stormwater site, Lions Gate Phase V permitted under MORA26033, in the south portion. Along the southern boundary, the site is bordered by West Farm Road 190. To the west the site is bordered by South Farm Road 141/Cox Avenue. The site is located on portions of four parcels owned by Greene County as listed below in Table 1 and as seen in Image 1.

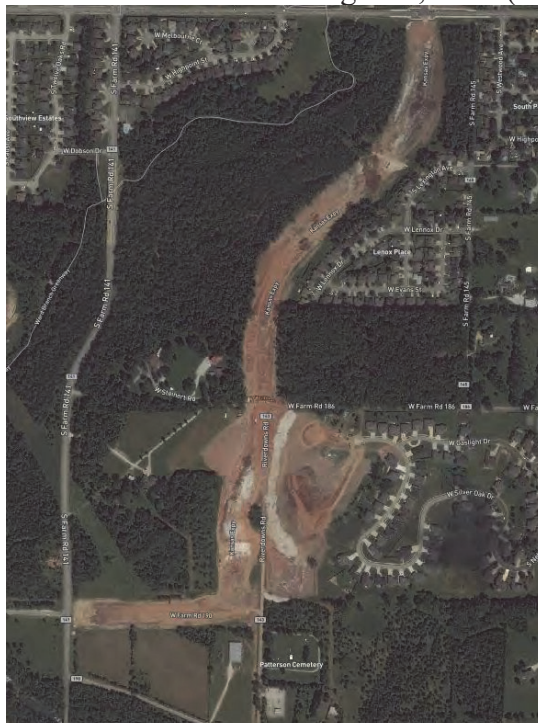
**Image 2.** Kansas Expressway Extension Phase 2 disturbed area on August 3, 2024 (G-EDG)

**Location.** This construction site is located in unincorporated portions of Greene County south of Springfield, Missouri. The disturbed area is the right of way corridor from Plainview Road to Farm Road 190, as provided in quarterly reports. The site is approximately 1.1 miles long. Based on site observations and analysis of aerial imagery from August 3, 2024, the disturbed area ranges from approximately 150 feet wide to 350 feet wide and a total of 28.7 acres. See Image 2 for aerial imagery of the disturbed area.
