**INSPECTION REPORT**

**LARCHMONT ESTATES SUBDIVISION**

**SAVANNAH, GEORGIA**

March 17, 2022

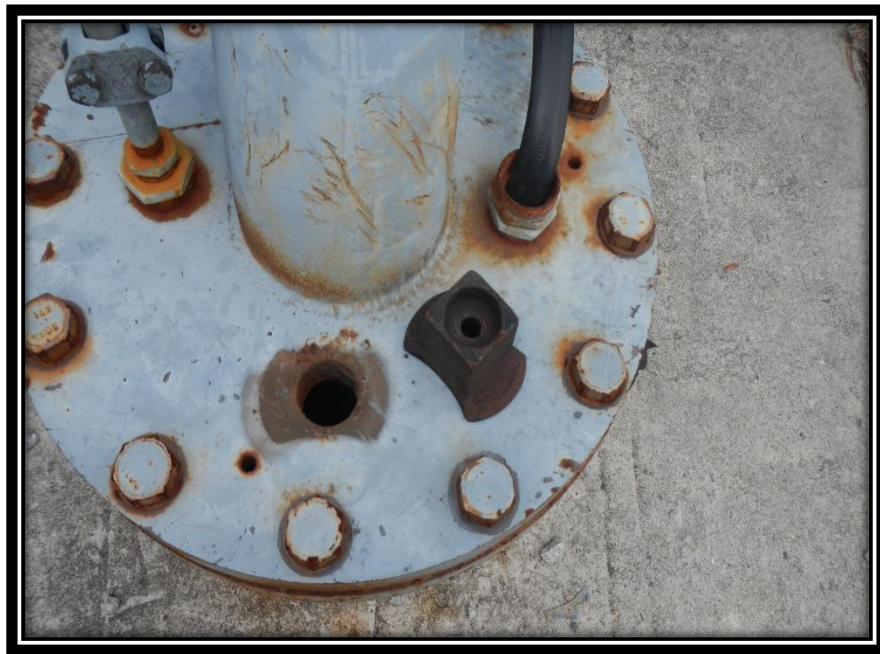
6. **Findings:** In Well Number 109 the EPA inspector observed openings in the casing of the well pump and in the well the pad. (Refer to Appendix A, Image 1 & 2)

**Comments:** Pursuant to 40 C.F.R. § 141.723 (Requirements to respond to significant deficiencies identified in sanitary surveys performed by EPA). *“A significant deficiency includes a defect in design, operation, or maintenance, or a failure or malfunction of the sources, treatment, storage, or distribution system that EPA determines to be causing, or has the potential for causing the introduction of contamination into the water delivered to consumers”*. Unprotected access points to the water source provide a pathway for contaminants to enter the water source and pose a risk to public health. The system must seal the openings.

*Image 1 Opening in the casing of the well pump*

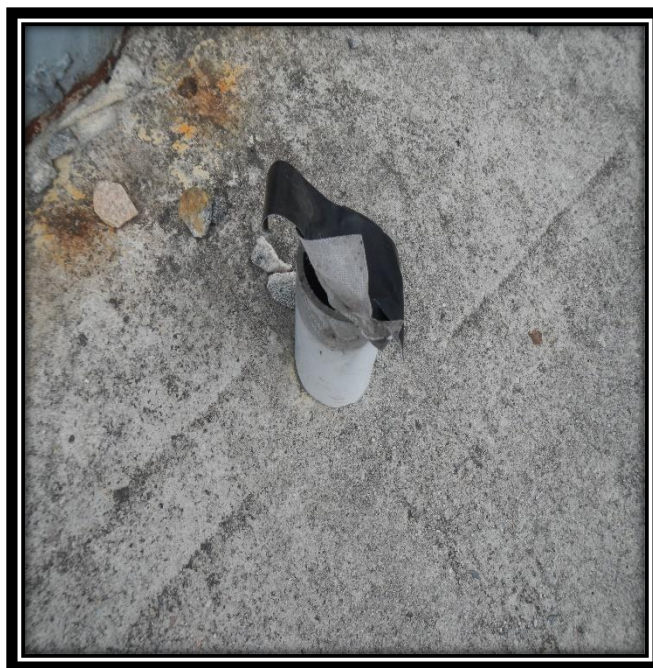
*Image 2 Opening in the well pad*

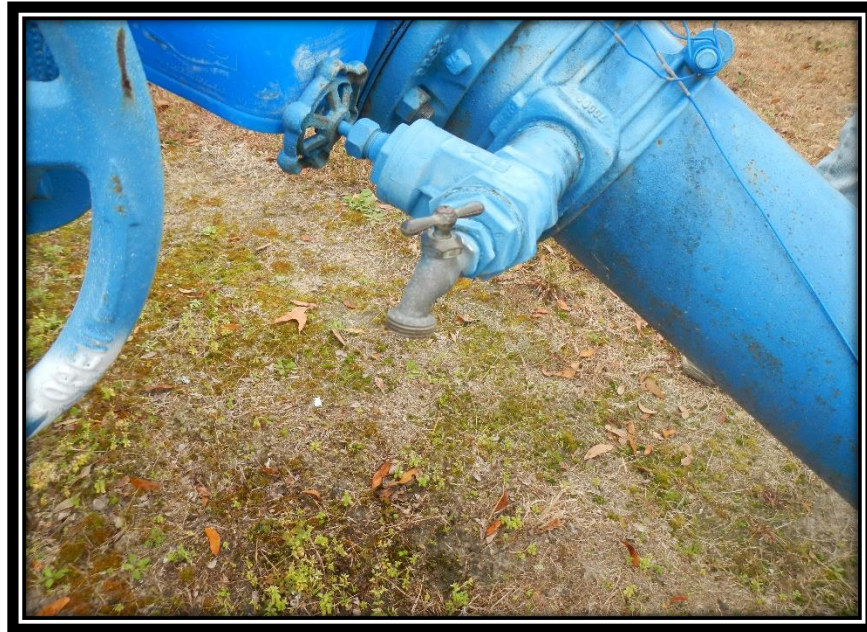
9. **Findings:** The EPA inspection team observed threaded samplings taps in the following wells: Well 109, Well 106, Well 104, Well 5, Well 8, Well 10, Well 2, Well 3, Well 101. (Refer to Appendix A, Image 3)

**Comments:** Pursuant to Georgia Rules For Safe Drinking Water 391-3-5-.13. Cross Connections “No person shall construct, maintain or operate a physical arrangement whereby a public water system is or may be connected directly or indirectly with a non-potable water system or non-permitted water system, sewer, drain, conduit, pool, storage reservoir, plumbing fixture, or other device which contains or may contain contaminated water, liquid, gasses, sewage or other waste of unknown or unsafe quality, which may be capable of imparting contamination to the public water system as the results of backflow, bypass arrangements, jumper connections, removable sections, swivel or changeover devices, or other temporary, permanent or potential connections through which or because of which back-flow or back-siphonage could or would occur”. The System must install a back-flow protection device or remove the threading from the taps.

*Image 3 Threaded sampling taps*

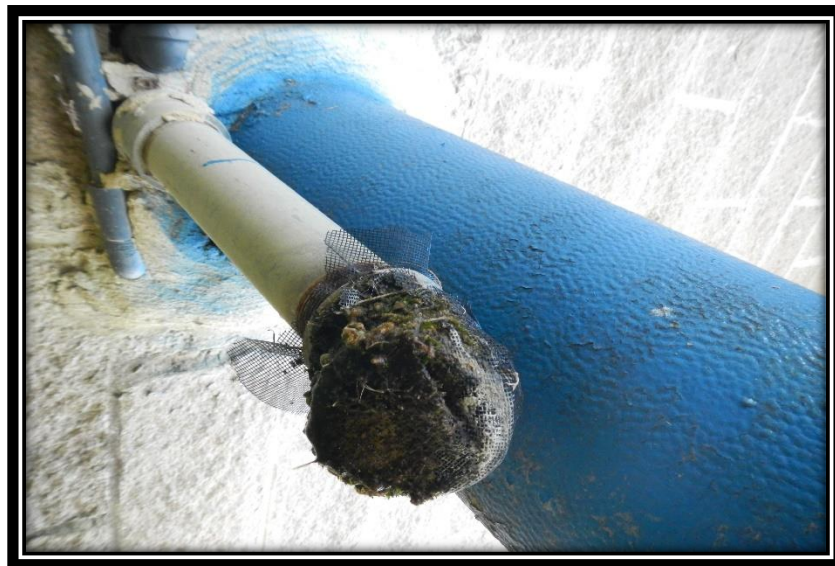
**Observation:** The EPA inspection team observed air vents without 24-mesh in the following locations: Well 109, Well 106, Well 104, Well 5, Well 8, Well 10, Well 2, Well 3, Well 101, Elevated storage tank and all Hydropneumatic Tank. (Refer to Appendix A, Photographs 4-6)

*Image 4 Well air vent*

**Comments:** Air vents & overflows must be screened with 24- mesh to prevent the entry of contaminants.

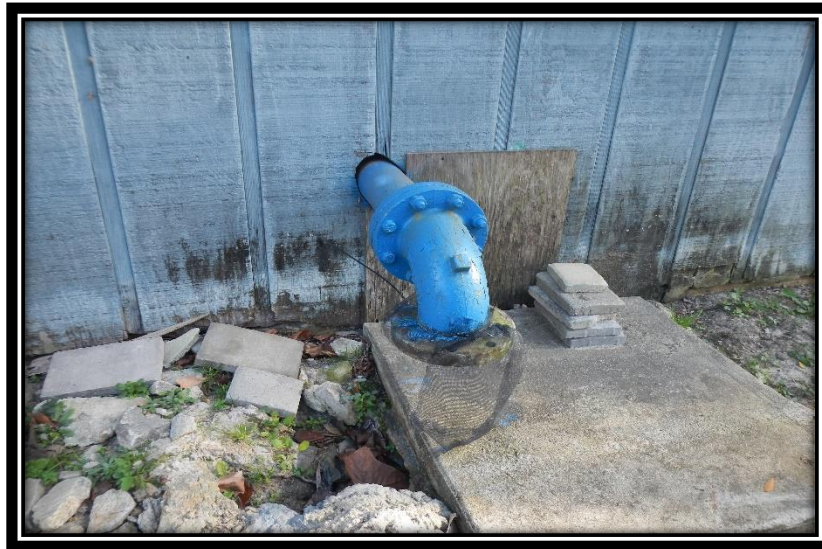
*Image 5 Well air vent*

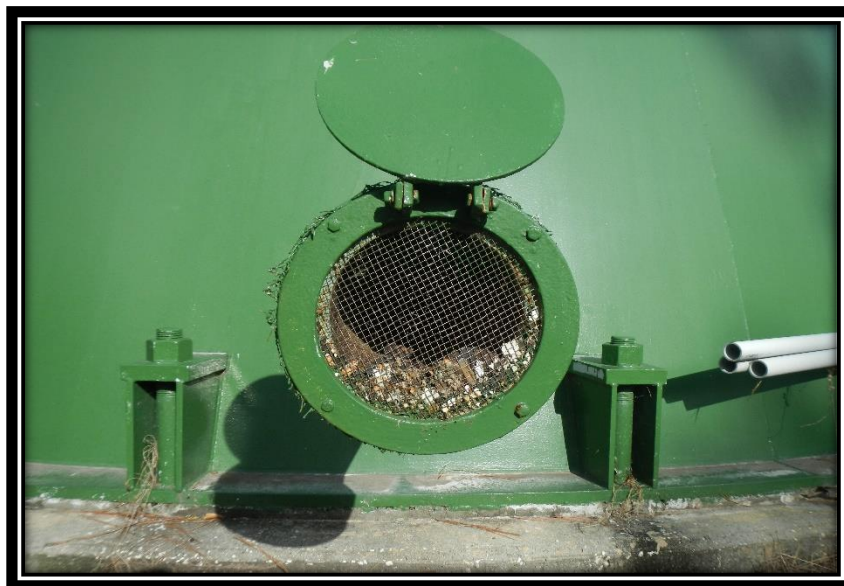
*Image 6 Storage tank overflow*
