**UNITED STATES ENVIRONMENTAL PROTECTION AGENCY**  
**REGION 5**  
**77 WEST JACKSON BOULEVARD**  
**CHICAGO, ILLINOIS 60604**

**SUBJECT:** CLEAN WATER ACT INSPECTION REPORT  
*Miba Bearings US LLC*

**Facility Name:** Miba Bearings US LLC

**Date(s) of Inspection:** May 6 and 7, 2025

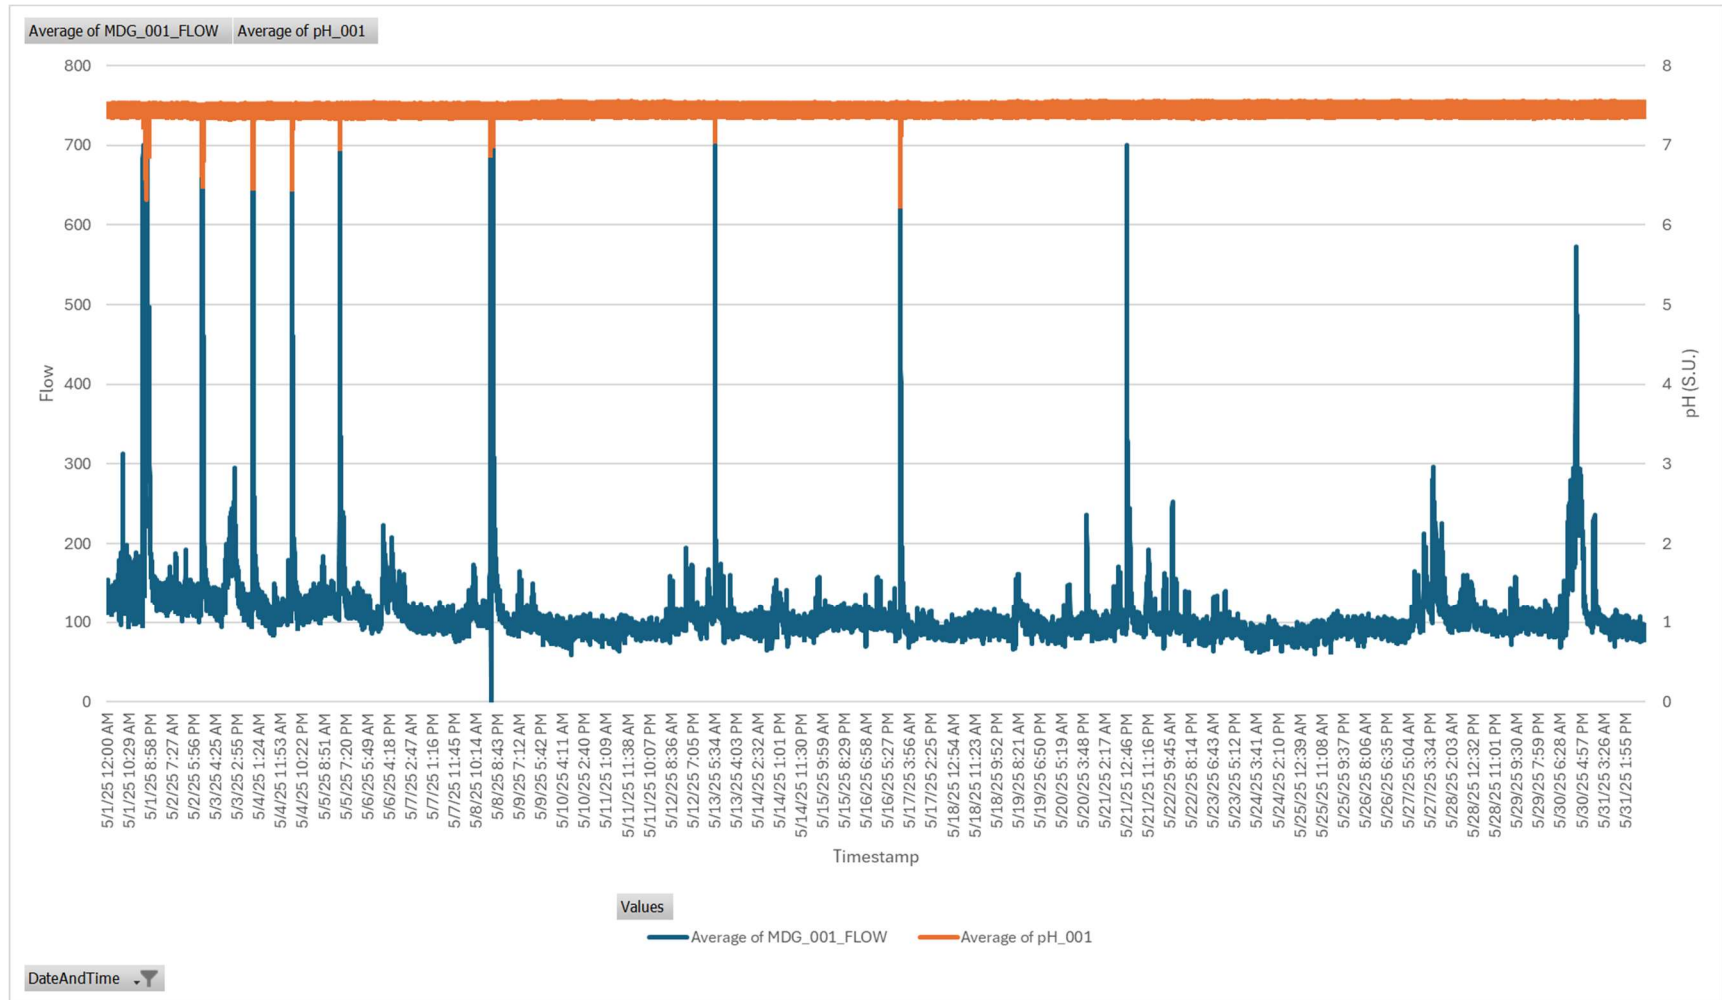
Chart of Continuous Measurements at Outfall 001:

range as 6.5 to 9.0. A measurement is collected each minute for flow and pH. There were 8 measurements below 6.5 and no measurements over 9.0. Each pH excursion was associated with a sharp increase in flow at Outfall 001. Data for Outfall for 601 could not be provided.

- 5. NPDES Permit No. OH0048372, PART I, A. Final Effluent Limitations and Monitoring Requirements Table – Final Outfall – 001- Final d. pH Range Excursions – the pH range for compliance is 6.5 to 9.0. With continuous pH monitoring, a violation is established if an excursion event continuous uninterrupted for more than 60 minutes and/or the total minutes of excursion for a month exceeds 7 hours and 26 minutes.**

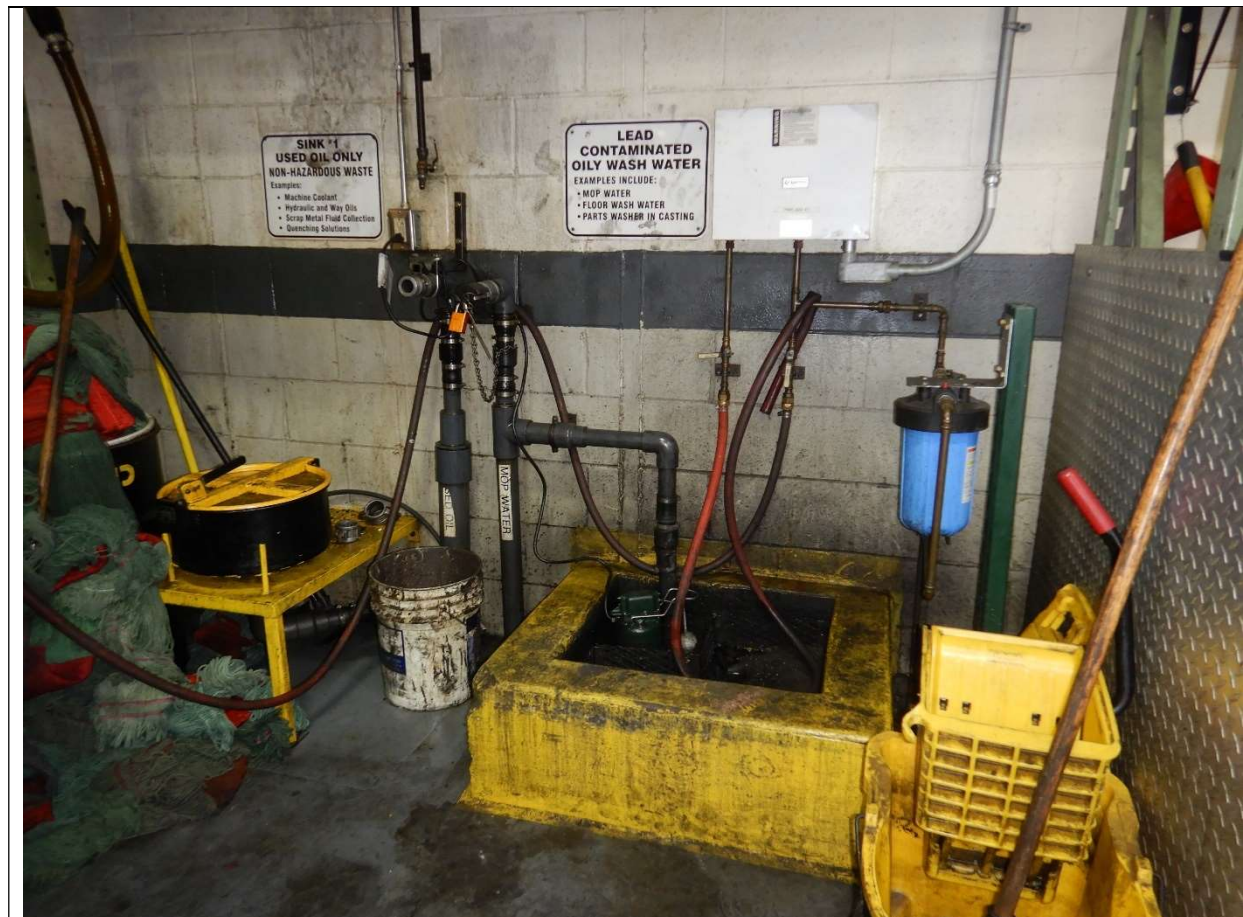
1: DSCN2658.JPG

On May 6, 2025, at 8:39 AM EPA observed the oily wash dump (Photo 1), which is where floor wash water and oily parts wash water are dumped into a sump, being pumped to an oil water separator prior to a drain (Photo 41)

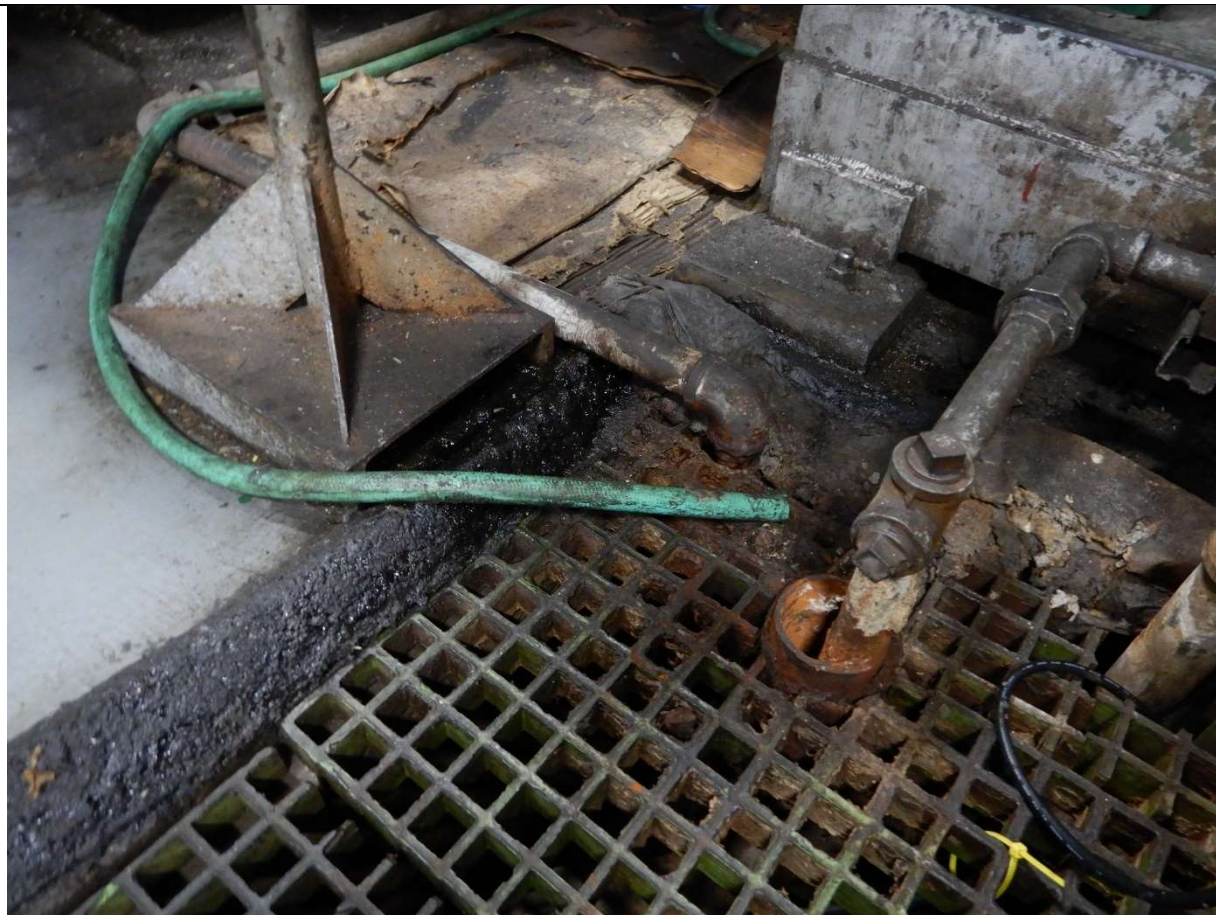
**37: DSCN2694.JPG**

Description: Close up of the sump in the boiler room. There was a foam containment around the sump, but the containment was deteriorated and did not appear to be liquid tight.

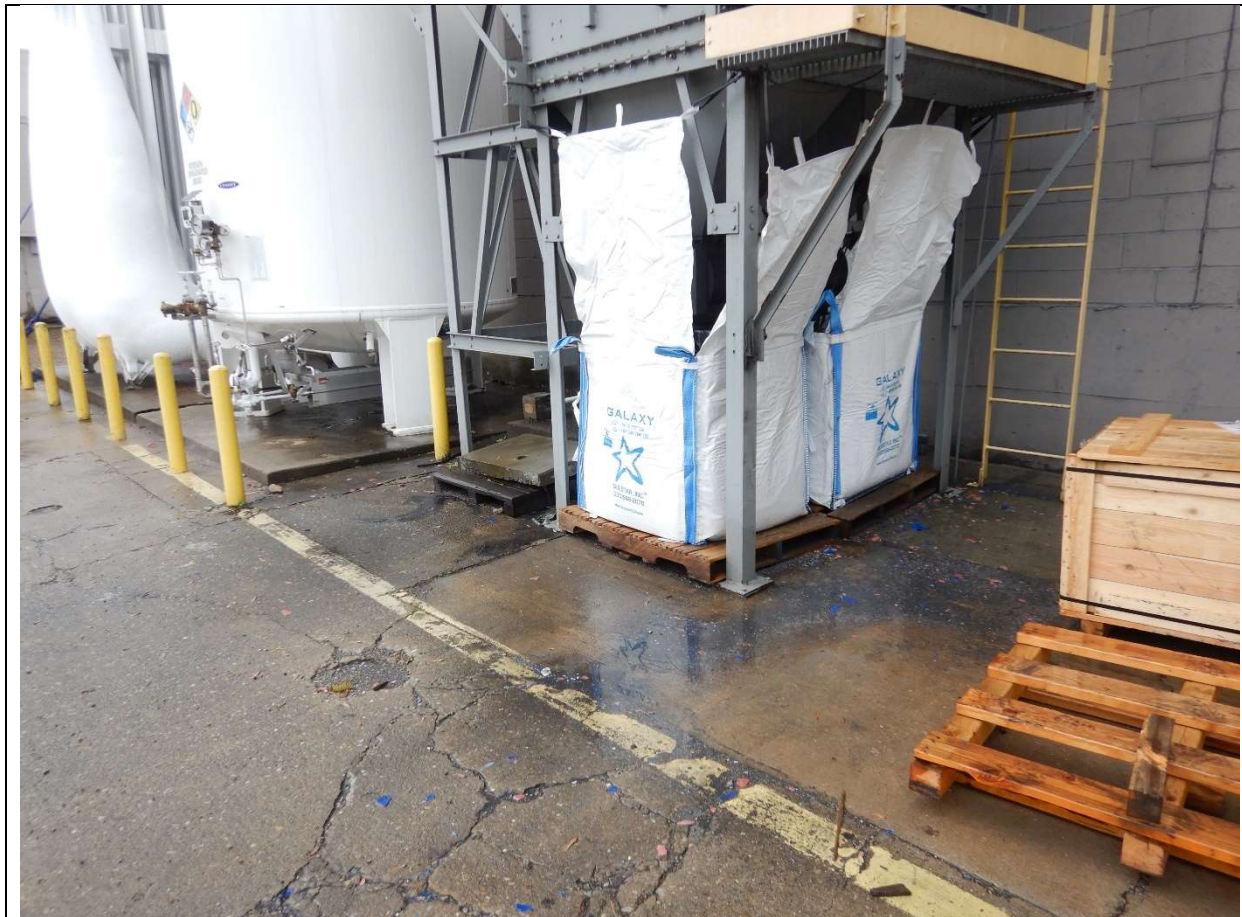
**58: DSCN2715.JPG**

At 2:30 PM EPA observed the exterior portions of the facility. The facility stores metal tubes or bearing pipes outdoors on racks and wood pallets. This condition is shown in Photos 49 through 99. The dust collector for the foundry is located outdoors and shown in Photo 56. The foundry dust collector particulate is collected in a sealed drum. At the same location there is a second dust collector for a carbon machining operation. The carbon dust collector particulates are collected in an open sack shown in Photo 58, and there was a dark granular material on the pavement near the collector.

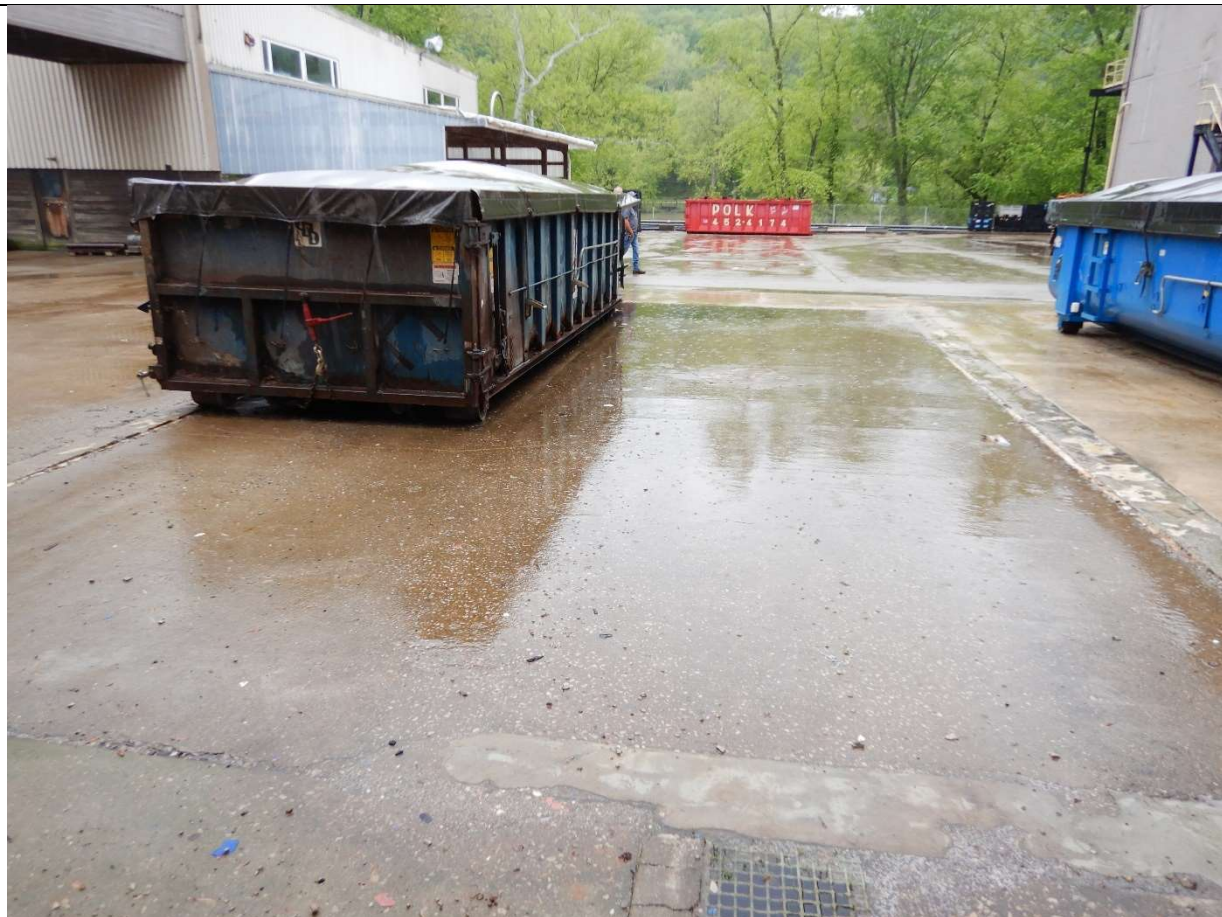
62: DSCN2719.JPG

There were two large roll-off boxes storing hazardous waste as shown in Photos 62 through 67. One container held wastewater treatment sludges/filter cake (F006) and the other held cadmium (D006) and lead (D008) solids.

- Hazardous waste roll-off boxes stored outside (potential material handling activity) (photos 62 through 67).
- Uncovered roll off boxes with non-hazardous waste (photos 68-70, 93, 99)

Description: Roll off boxes storing hazardous waste.

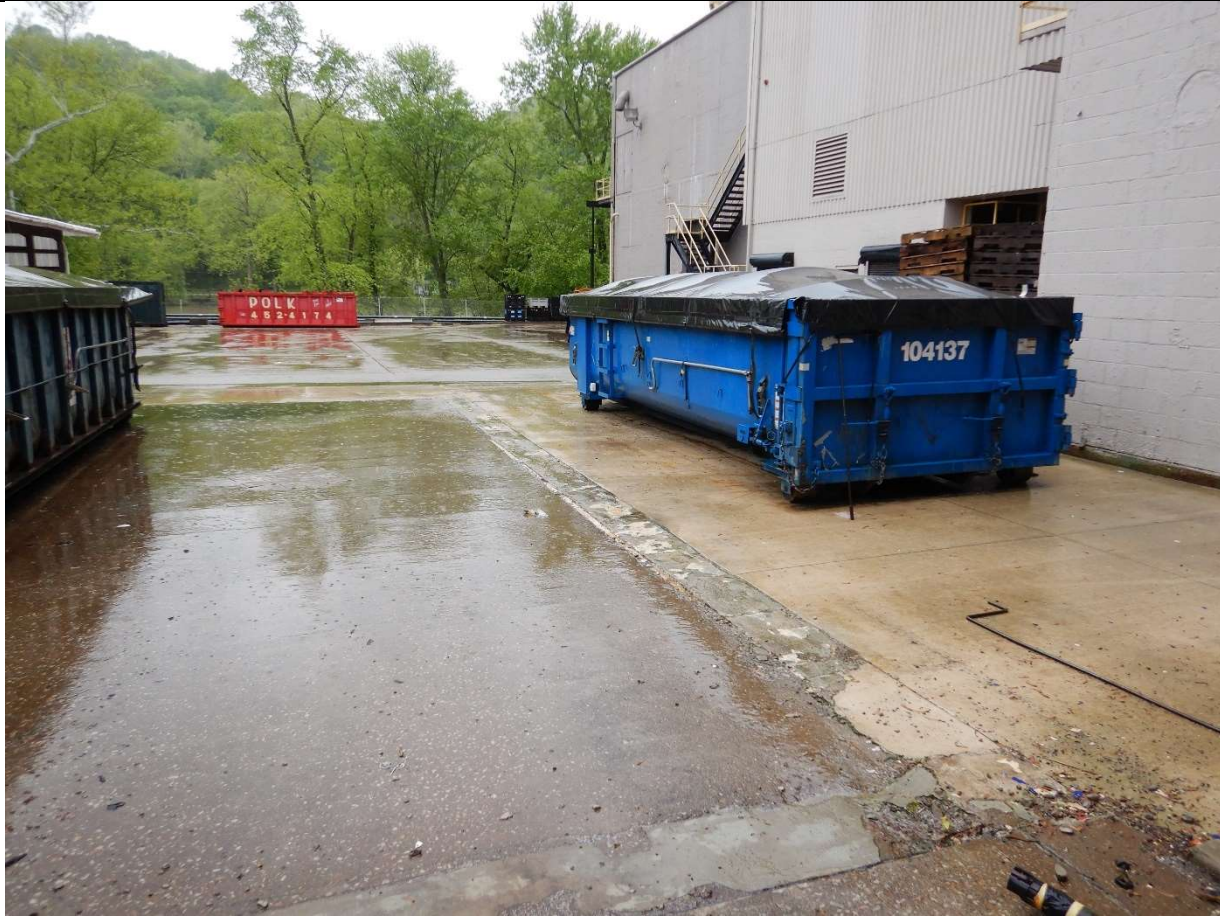
**63: DSCN2720.JPG**

Description: Roll off boxes storing hazardous waste.

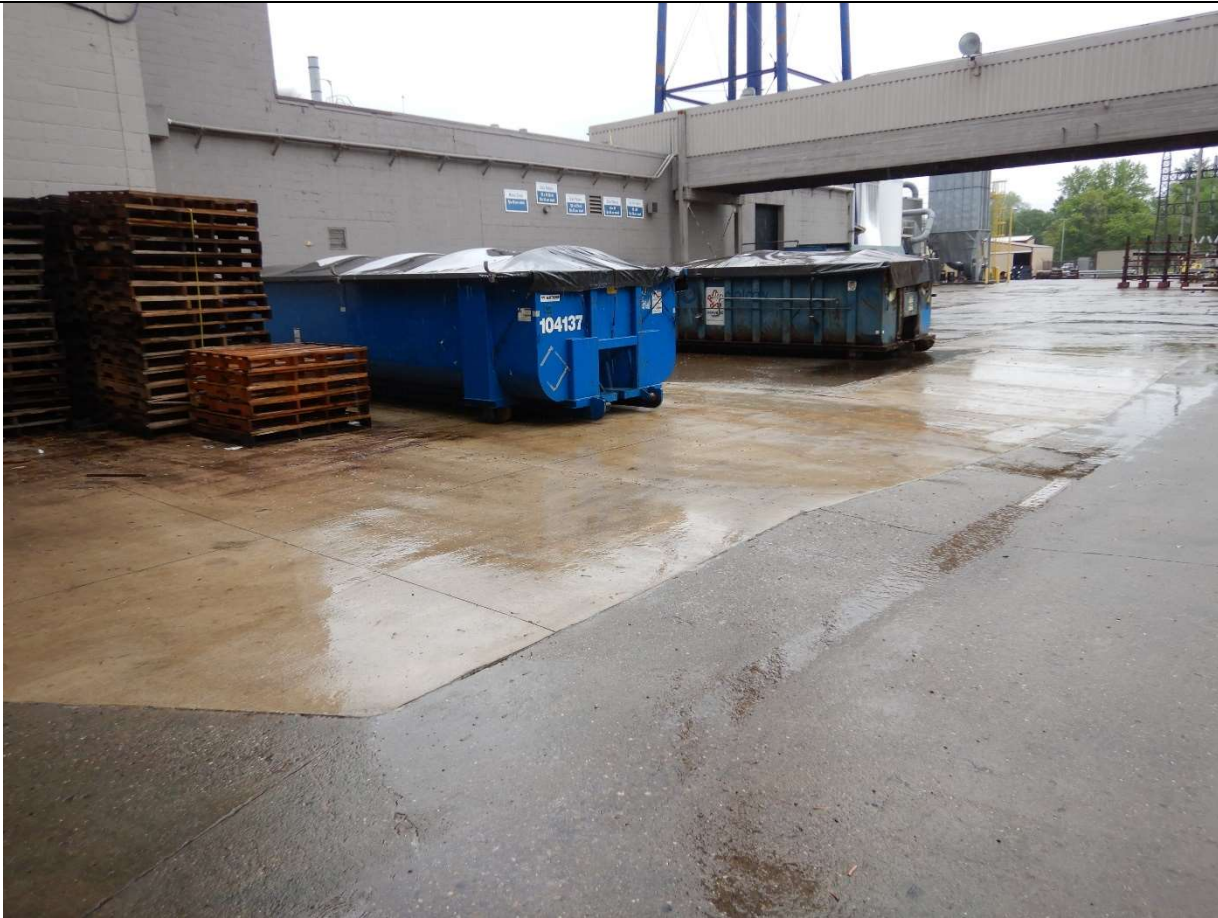
**66: DSCN2723.JPG**

**Description:** Hazardous waste label on one of the roll-off boxes. This was D006 and D008.

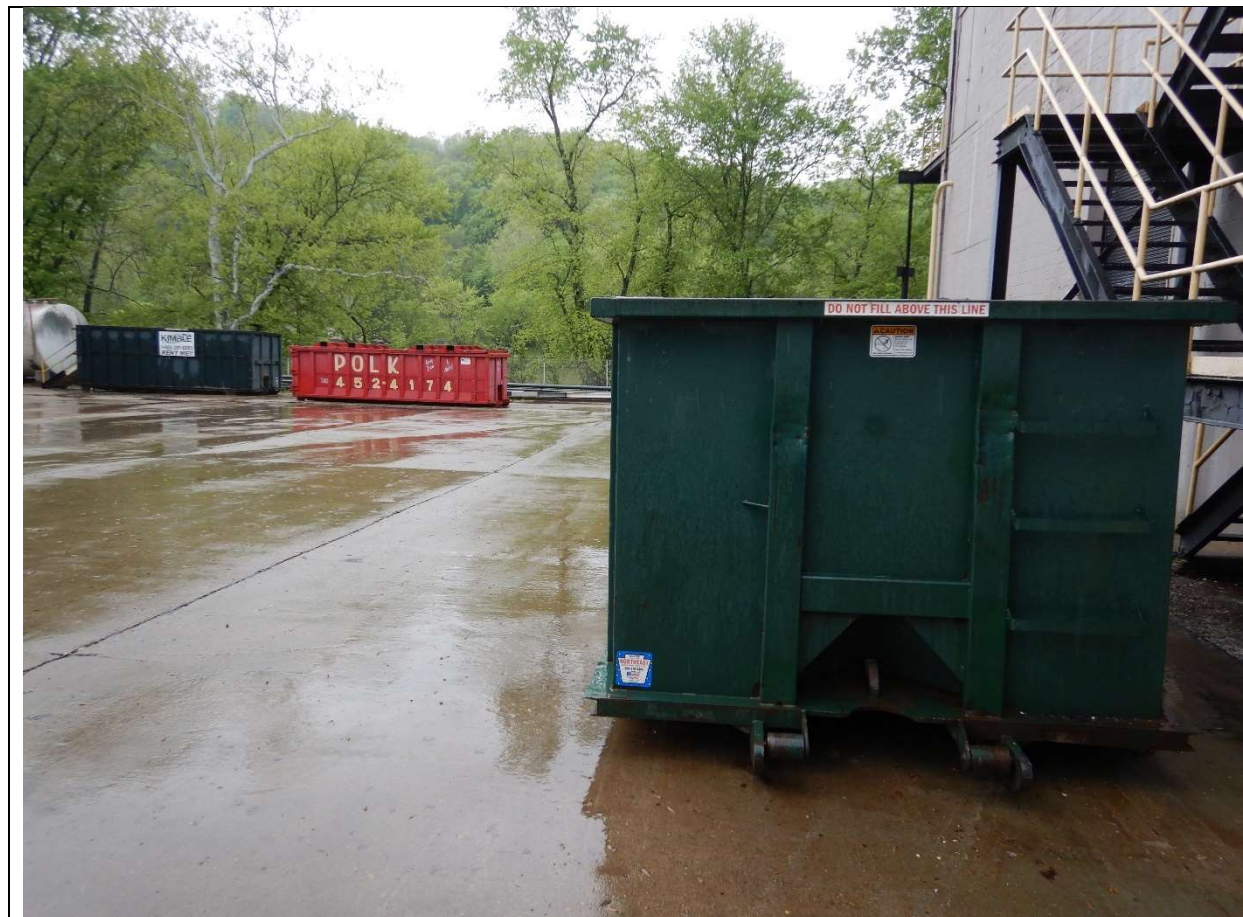
68: DSCN2725.JPG

There were three other roll-off boxes containing non-hazardous waste as shown in photos 68 through 70 and 99.

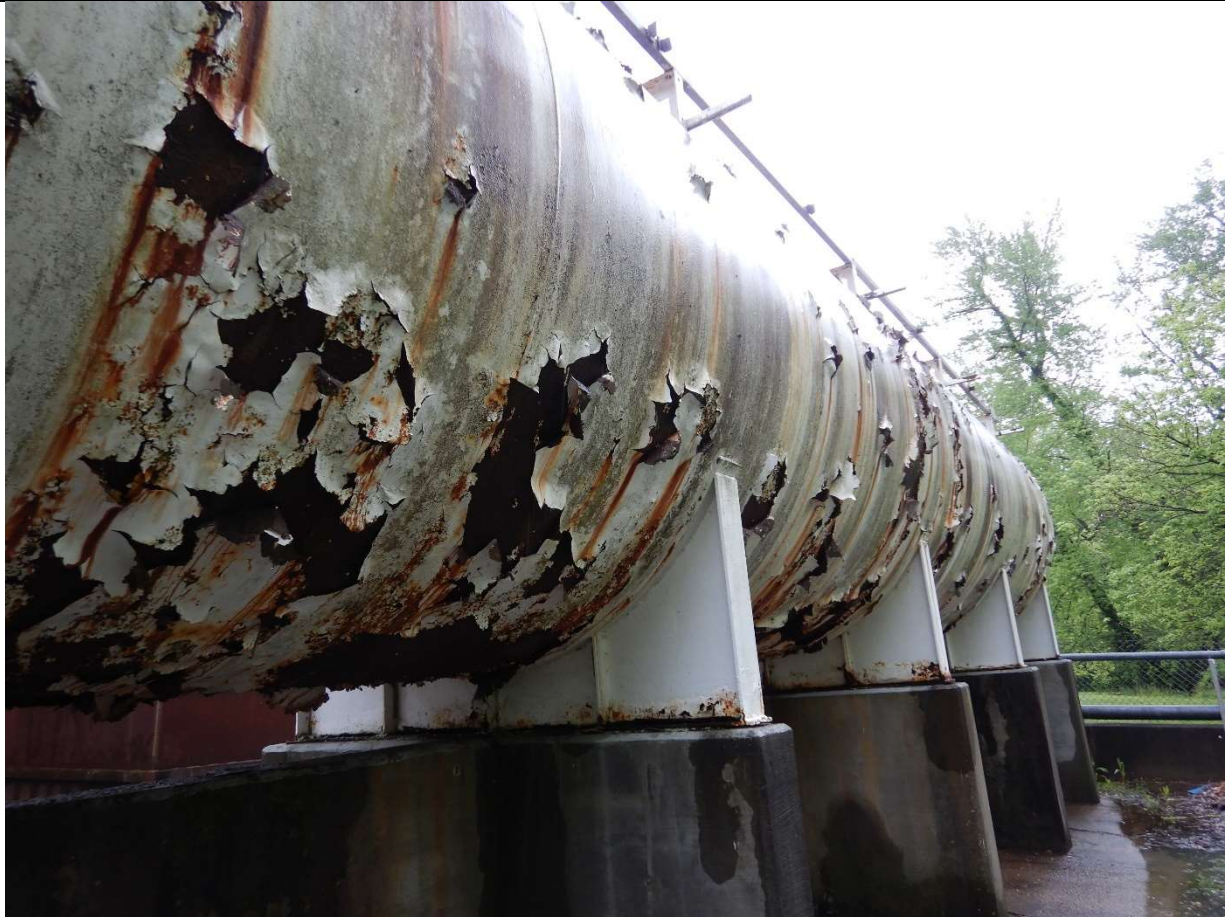
[92: DSCN2749.JPG](#)

There were two above-ground tanks in containment and one elevated tank along the south edge of the wastewater treatment building. The containments for both tanks were full of water and overflowing. These conditions are documented in photos 67 through 91, The elevated tank had large chips of peeling paint as shown in Photo 92.

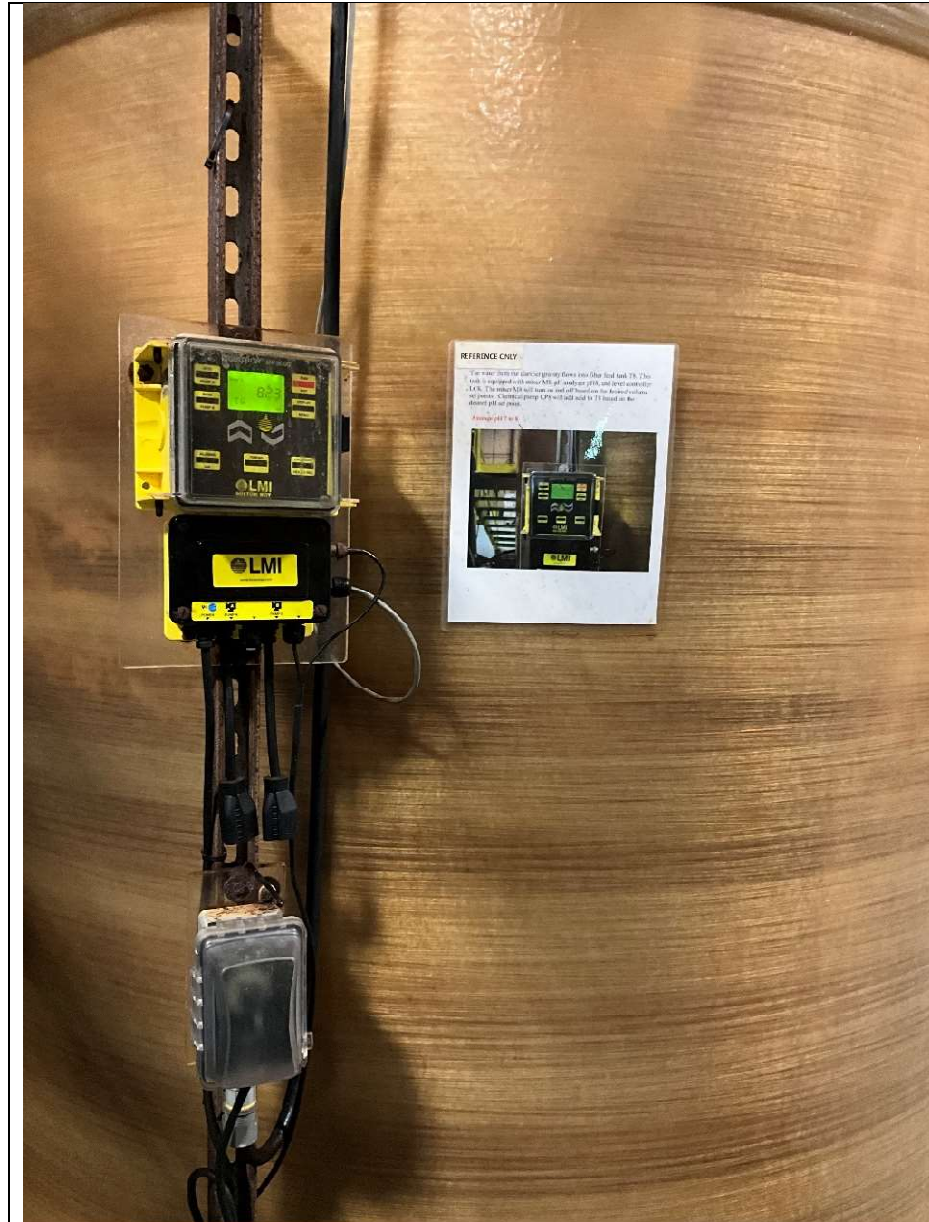
[112: IMG\\_0088.jpeg](#)

At 9:25 AM EPA observed the pH readout/controller located at tank T8. The readout was also displaying an E6 error for Pump A 'LOCKOUT'. The documentation for the Liquidtron DP5000 controller calls Pump A the acid pump. At the time of the inspection the reading pH reading was 8.23. The instruction sheet affixed to tank T8 included a statement "Average pH 7 to 8" (112)

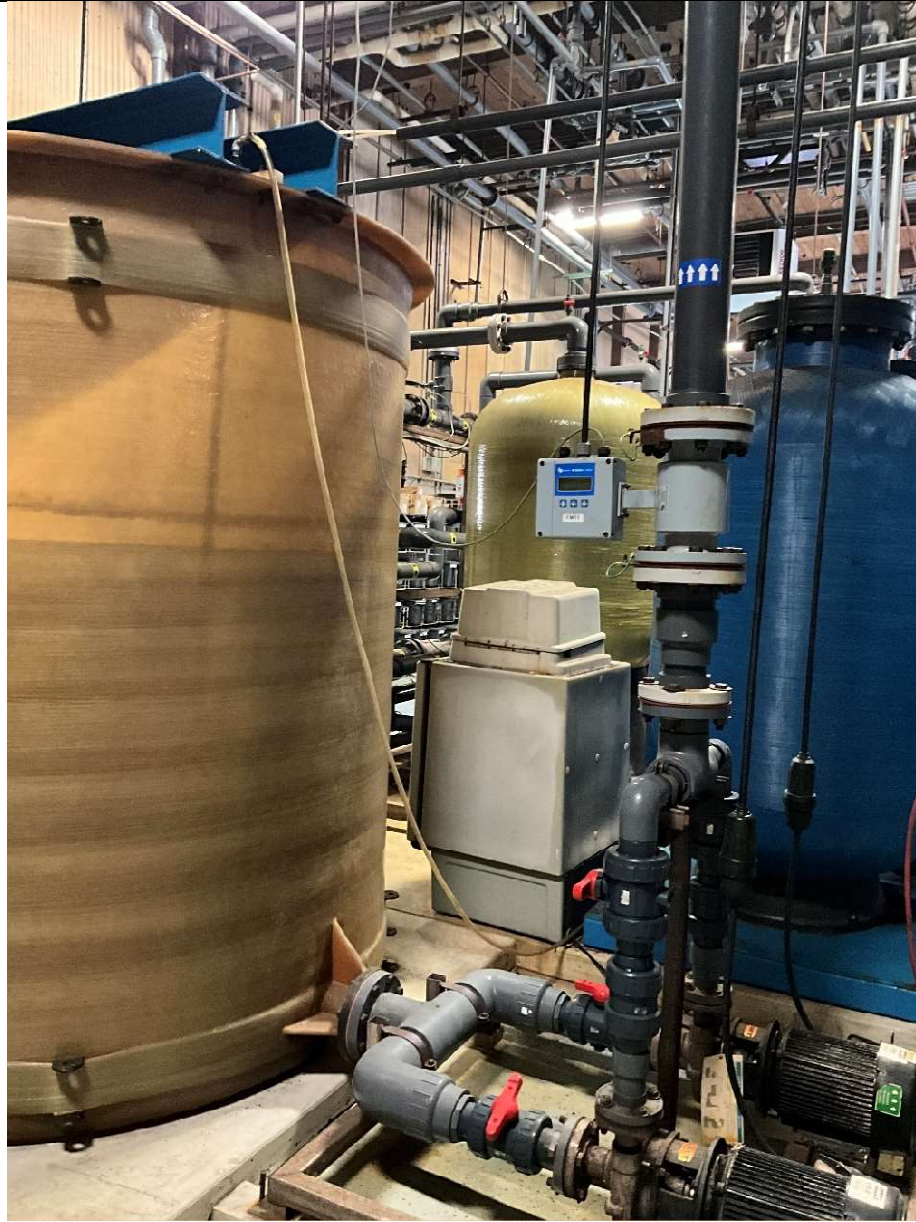
[119: IMG\\_0095.jpeg](#)

At 10:00 AM EPA observed the sample collection line for the composite sampler at tank T11. The line had a sag or low spot where water can collect between sample draws (Photo 119).
