**Region 6 - Enforcement & Compliance Assurance Division**  
**INSPECTION REPORT**

| Regulatory Program(s) | Clean Water Act – National Pollution Discharge Elimination System (Brine) | |
| Company Name: | Northcote Cleveland LLC | |
| Facility Name: | Osage B Lease | |

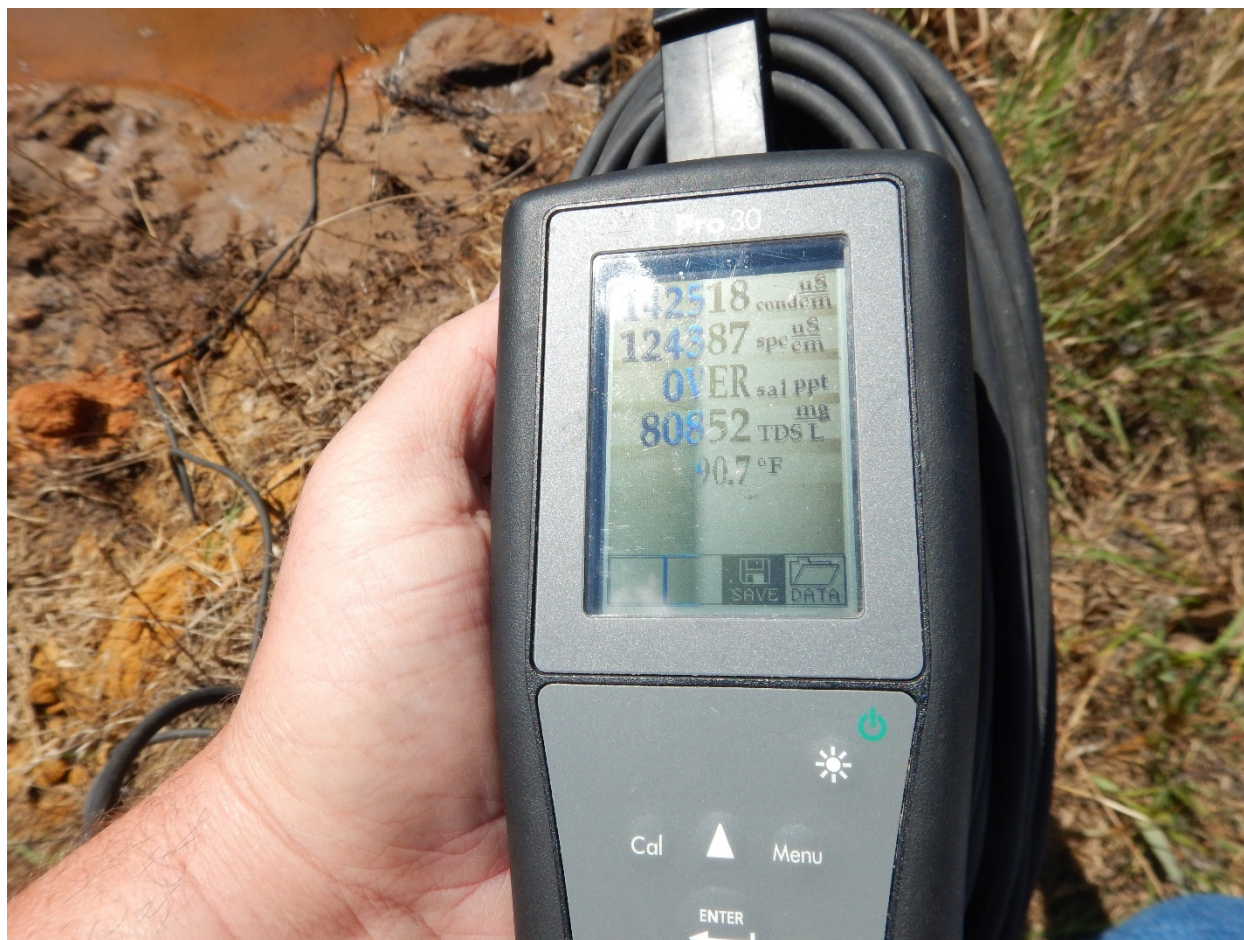
Photo No. 1

**Description:** This was an elevated TDS field reading of 80,852 mg/L taken at the Point of Entry (POE) into the impacted, unnamed tributary. Cleanup crews removed this water from the tributary immediately after this reading was observed.

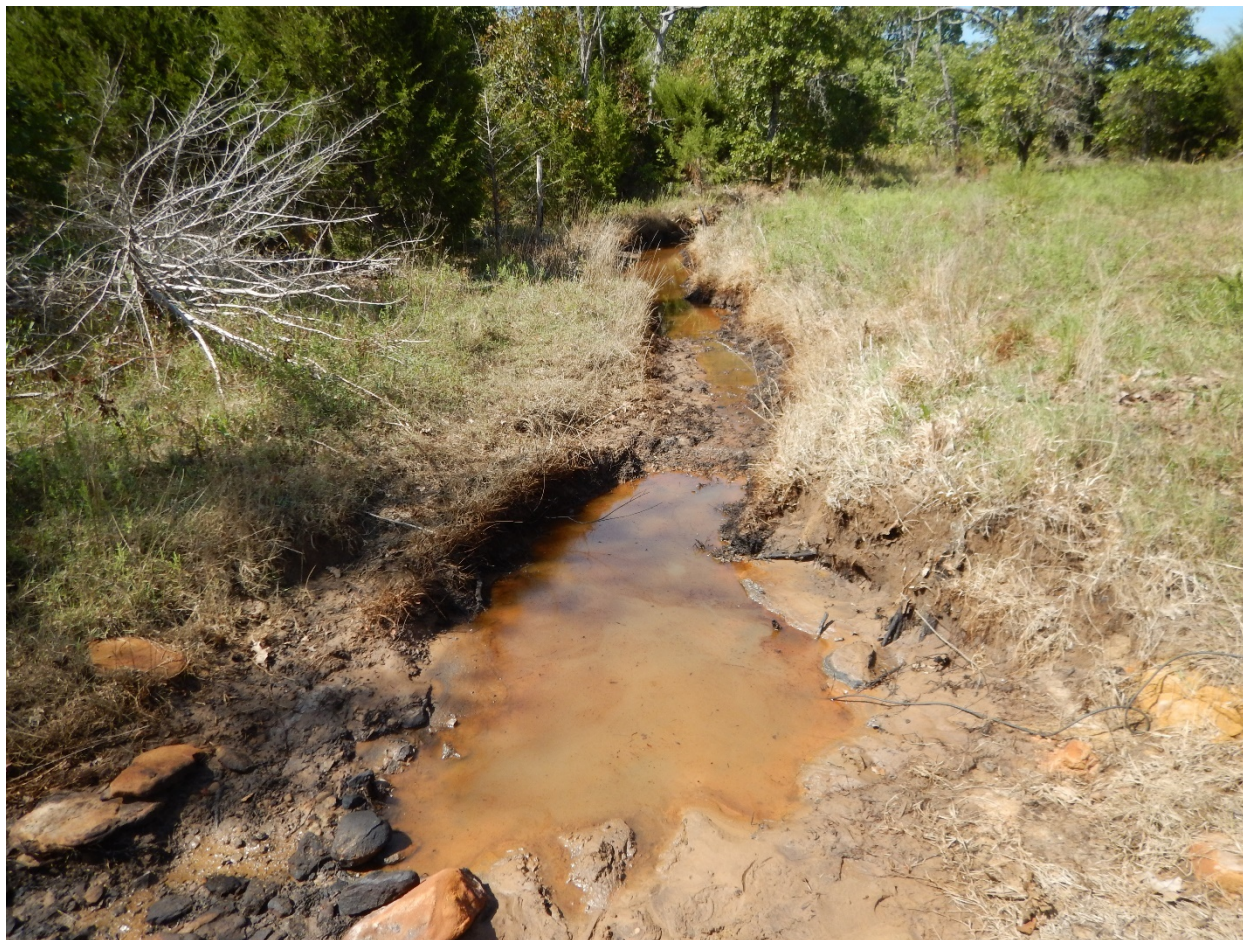
Photo No. 2

**Description:** This was a view looking from the POE downstream or southwest. The high-water mark is evidenced by the dark brown band of oil stained vegetation along the right hand bank of the tributary.

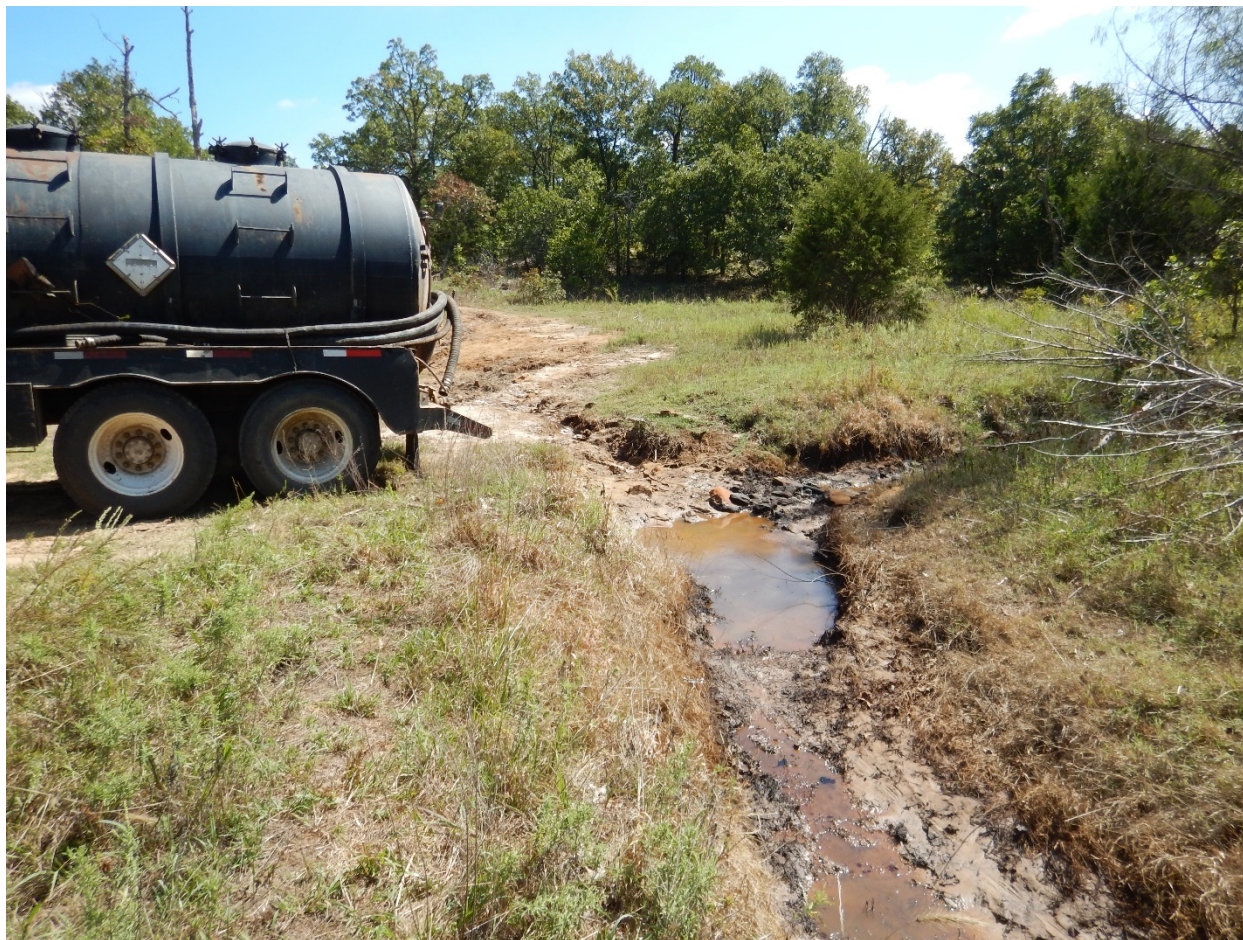
Photo No. 3

Initial observations confirmed there had been no cleanup or remediation efforts completed at or near the release point of the spill, there was also no change observed along the flowpath from the release point to the Point of Entry (POE) from the initial spill inspection. During the inspection I observed an elevated TDS field reading of 80,852 mg/L at the POE into the impacted tributary which is documented in Appendix 1 (photo log) photo No. 1 (GPS 36.259417, -96.226174). A few minutes after observing the elevated TDS reading at the POE, I observed cleanup crews use a vacuum truck to remove the impacted water from the tributary, the start of that operation is evidenced in photo No. 3.

**Description:** This was the vacuum truck that emptied the impacted water from the pool of water in the main channel of the tributary at the POE.

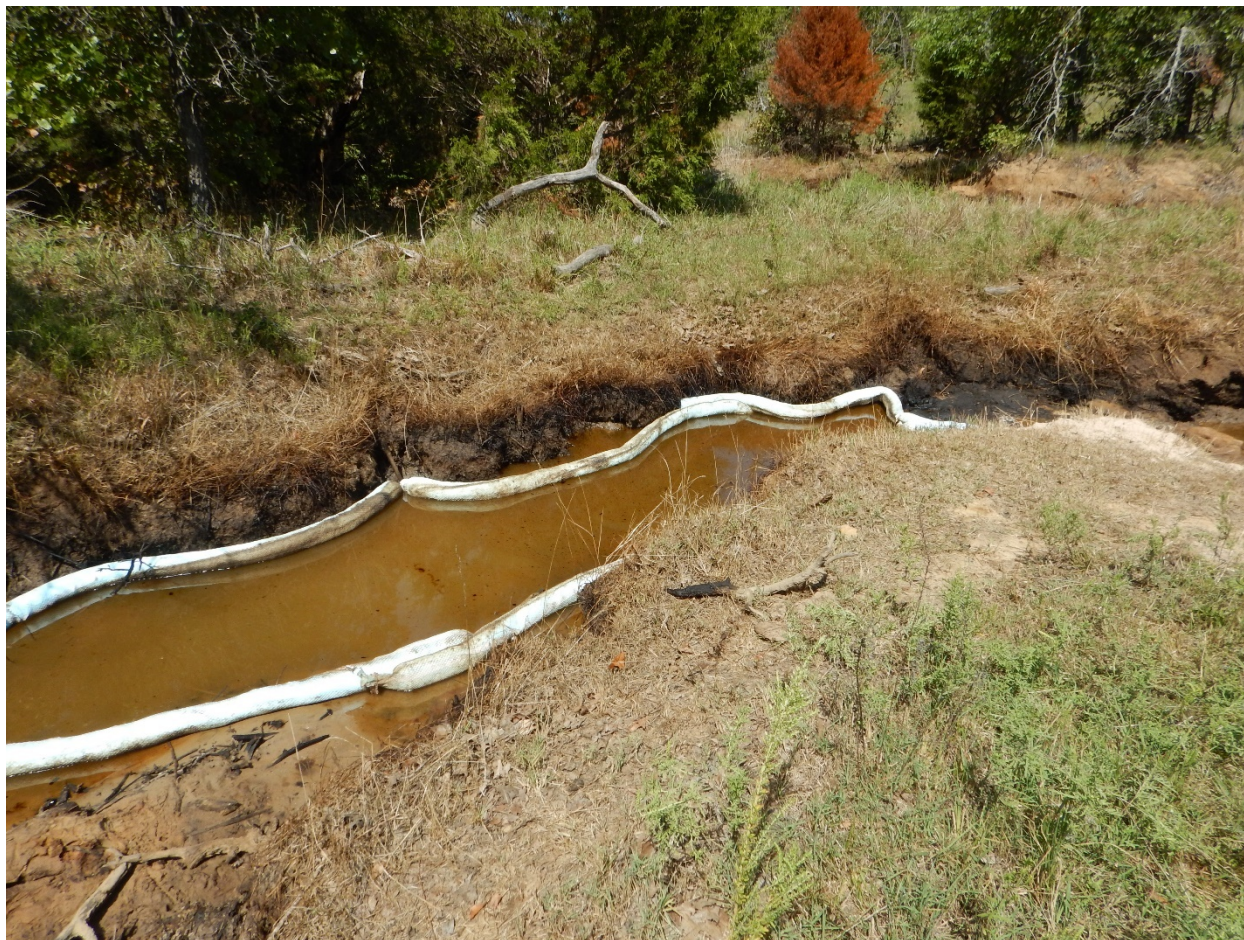
Photo No. 4

I observed floating, oil absorbent booms on the impacted tributary. These booms were located on a pool of water which was covered with oil at the time of the initial inspection, the operator had made significant progress in removing oil from the impacted tributary at this location. Oil staining on the vegetation and along the banks of the tributary was still prominent at the time of the inspection. I also observed an elevated TDS field reading of 10,145 mg/L TDS at the same location. I conveyed the need to remove the impacted water from the tributary to the operator. All these impacts were documented in photos 4, 5, 6, and 7.

**Description:** This was a photo showing oil absorbent floating booms floating on the surface of the impacted tributary. This location had been 99% covered with oil at the time of the initial inspection on 09/03/2022. Significant cleanup progress was observed. Oil-stained vegetation can still be seen along the banks of the tributary.

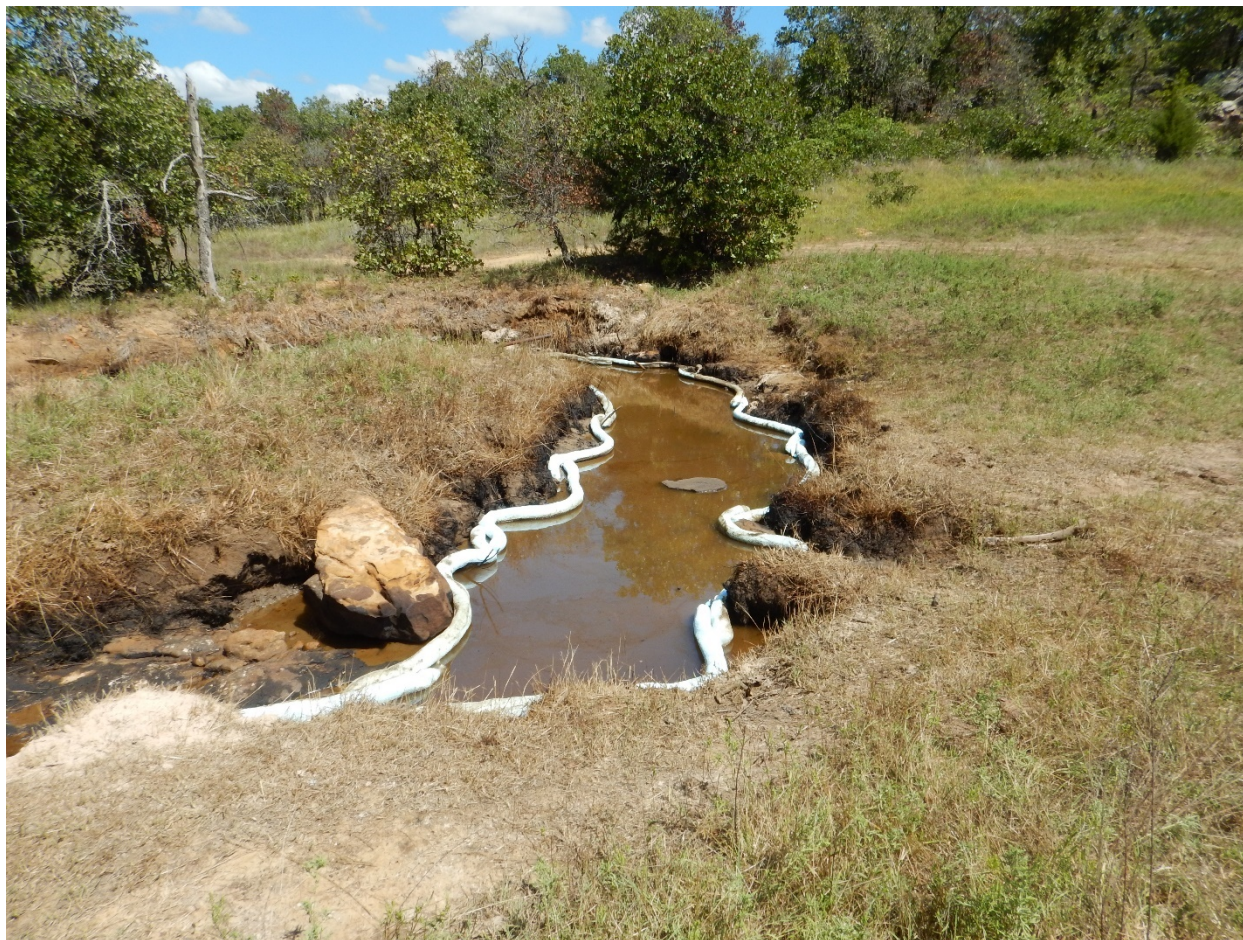
Photo No. 5

**Description:** This is the same pool of water as shown in photo No. 4, just a wider view.

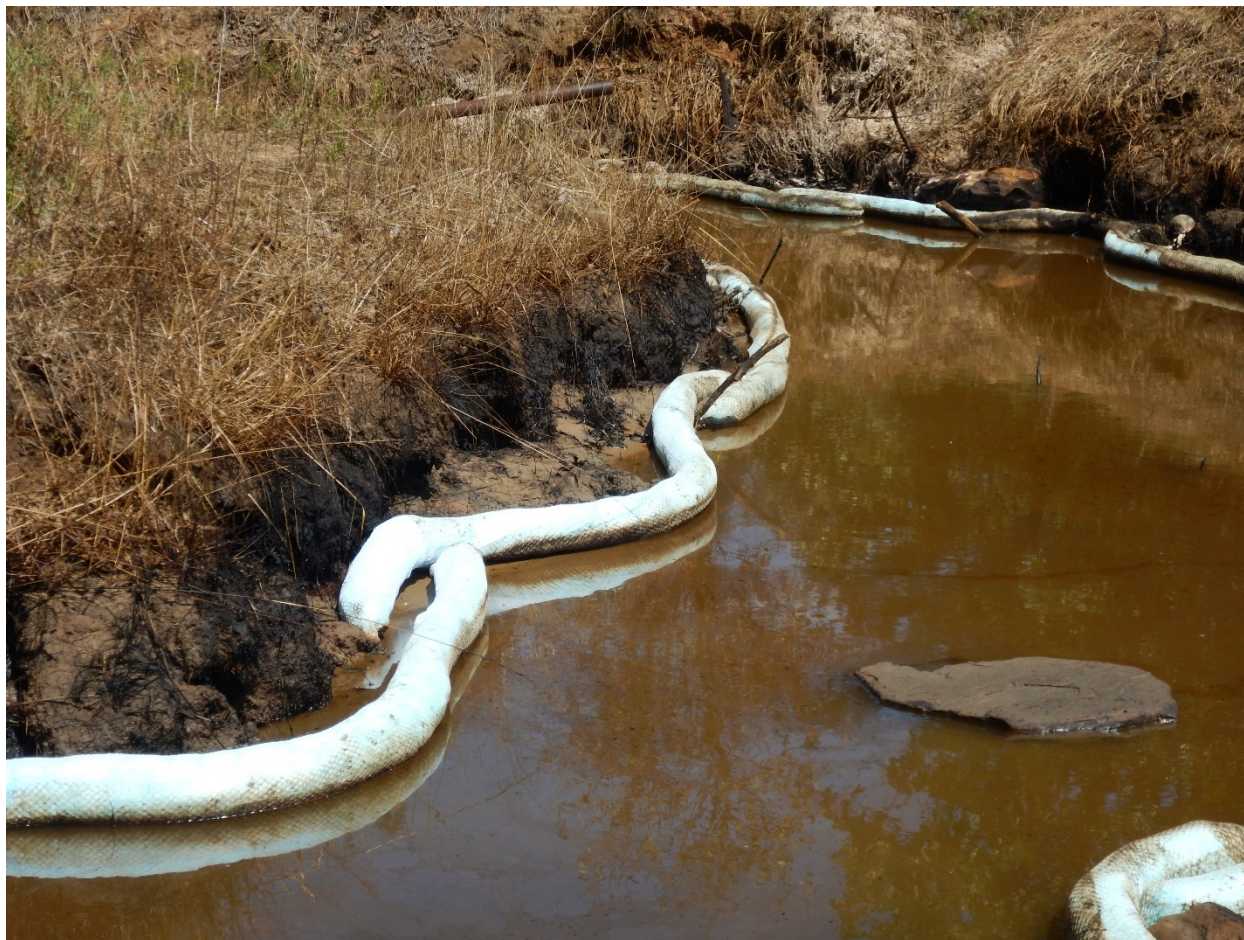
Photo No. 6

**Description:** This photo showed the impacted vegetation along the banks of the tributary as well as the high-water mark as indicated by the dark brown/black ring along the bank. The dark colored soil/vegetation is a result of oil staining.

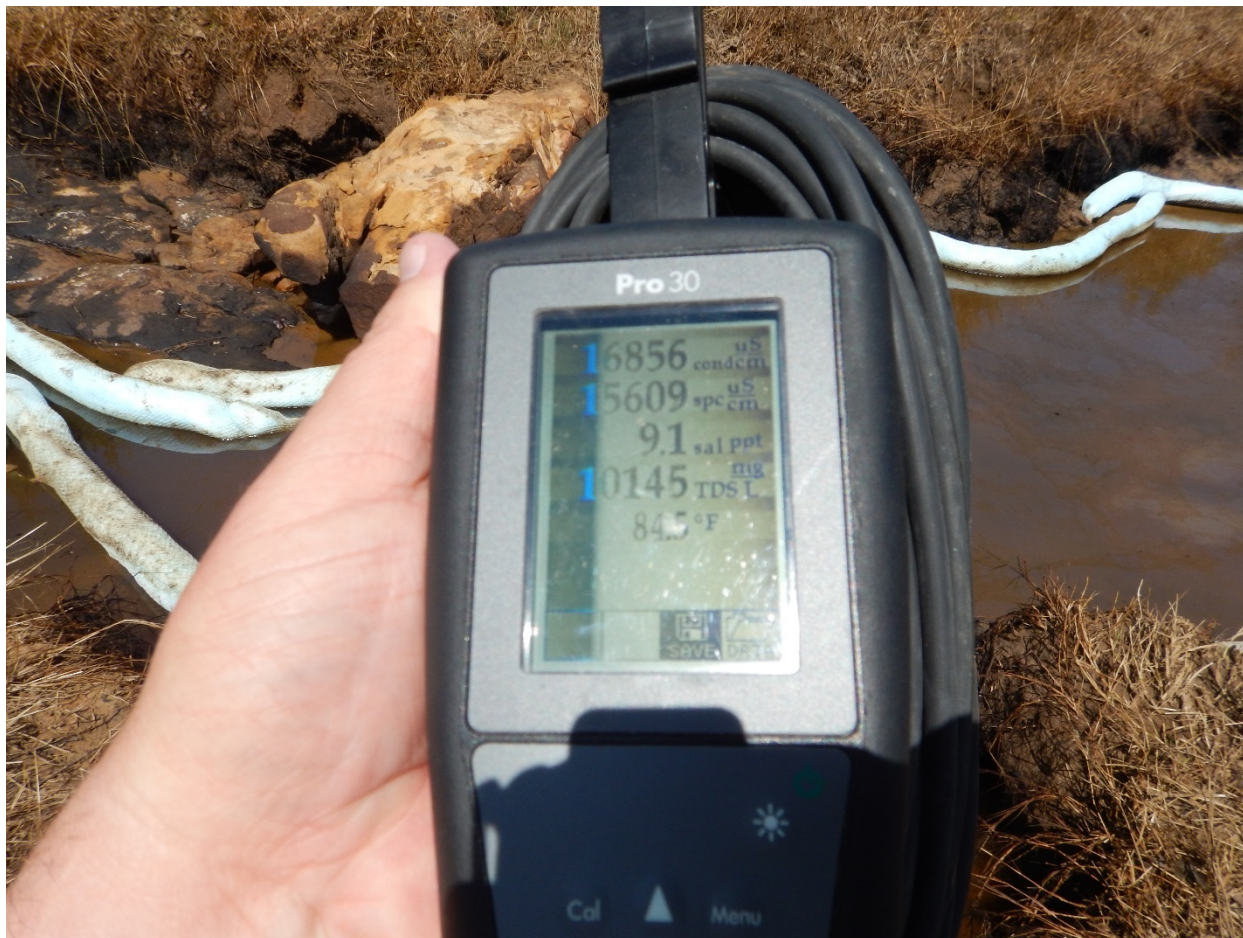
Photo No. 7

**Description:** This was an elevated TDS field reading of 10,145 mg/L taken from the same pool of water shown in photos No. 4, 5, and 6.

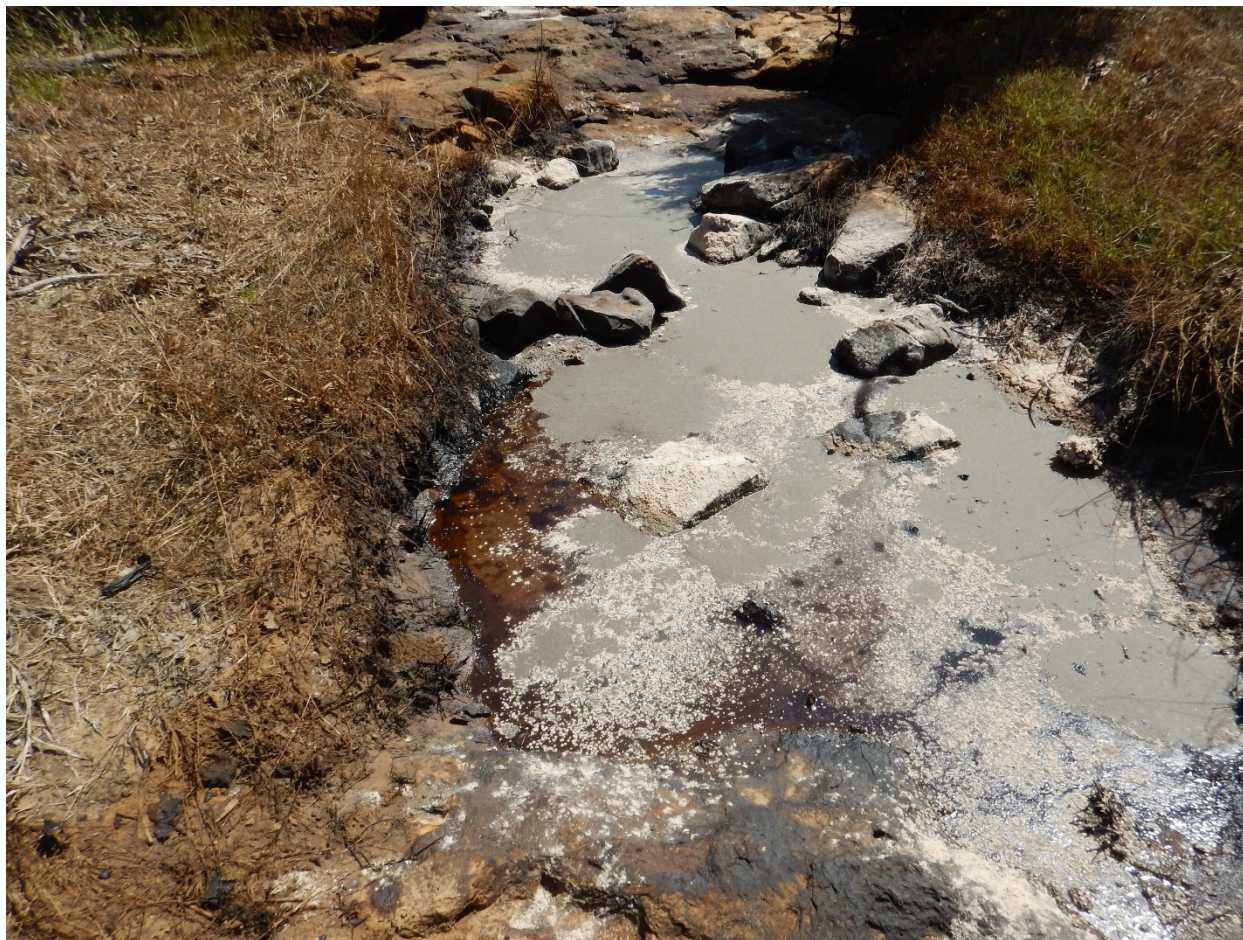
Photo No. 8

I observed oil floating on the surface of the tributary, oil staining on the rocks, vegetation, and banks. The white powdery substance observed was identified by the operator as "Clean B" an industrial absorbent. These impacts were documented in photo No. 8.

**Description:** Oil floating on the surface of the tributary, oil staining on the rocks, vegetation, and banks. The white powdery substance was identified by the operator as "Clean B" an industrial absorbent.

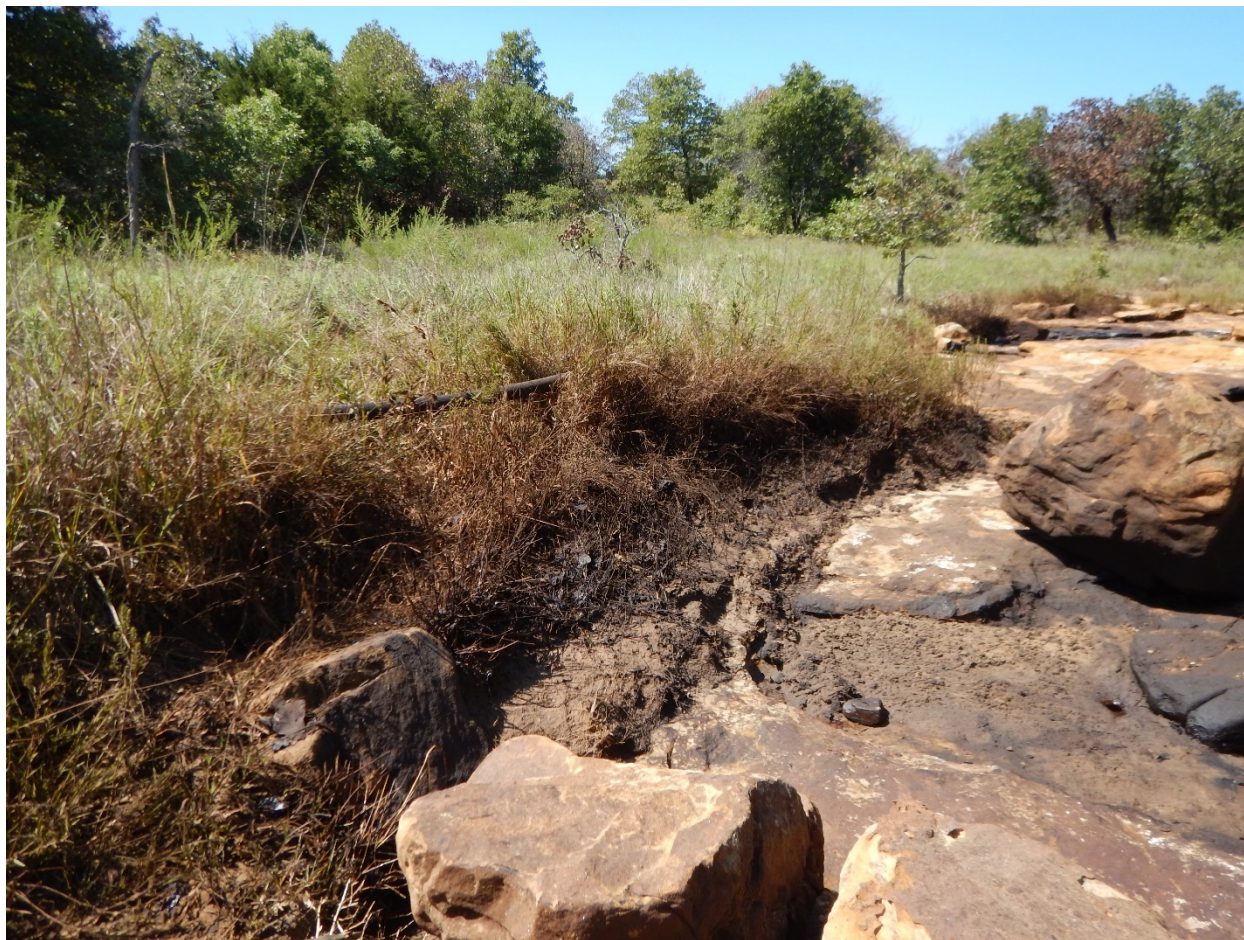
Photo No. 9

**Description:** This was a photo of the high-water mark and oil-stained rocks and vegetation along the impacted tributary, with a view looking downstream or south. The operator had removed the free-floating oil and impacted water from this section of the tributary.

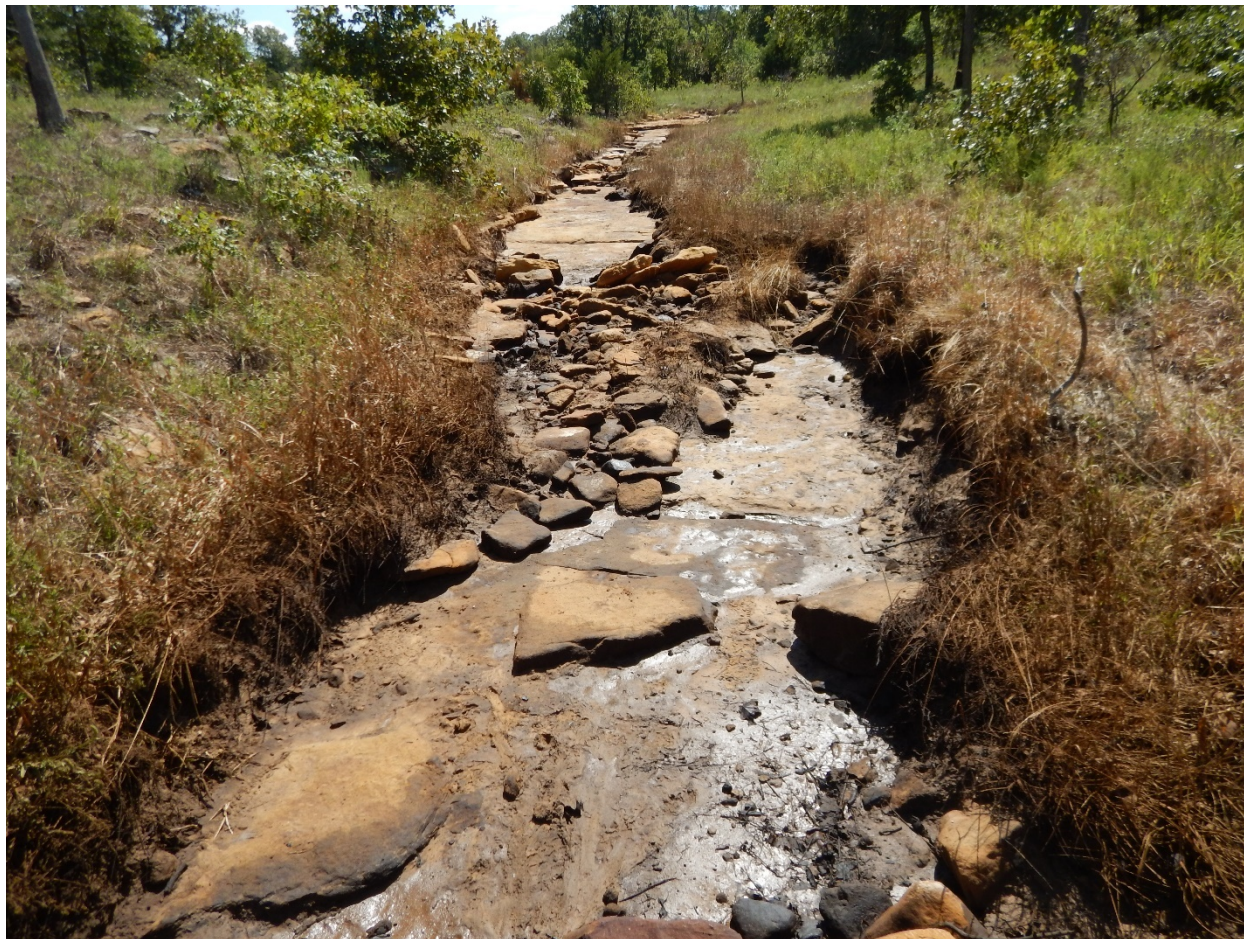
Photo No. 10

**Description:** This photo shows the oil and brine impacted vegetation as well as the bed and bank features of the impacted tributary. The operator has removed the free-floating oil and impacted water from this portion of the tributary.

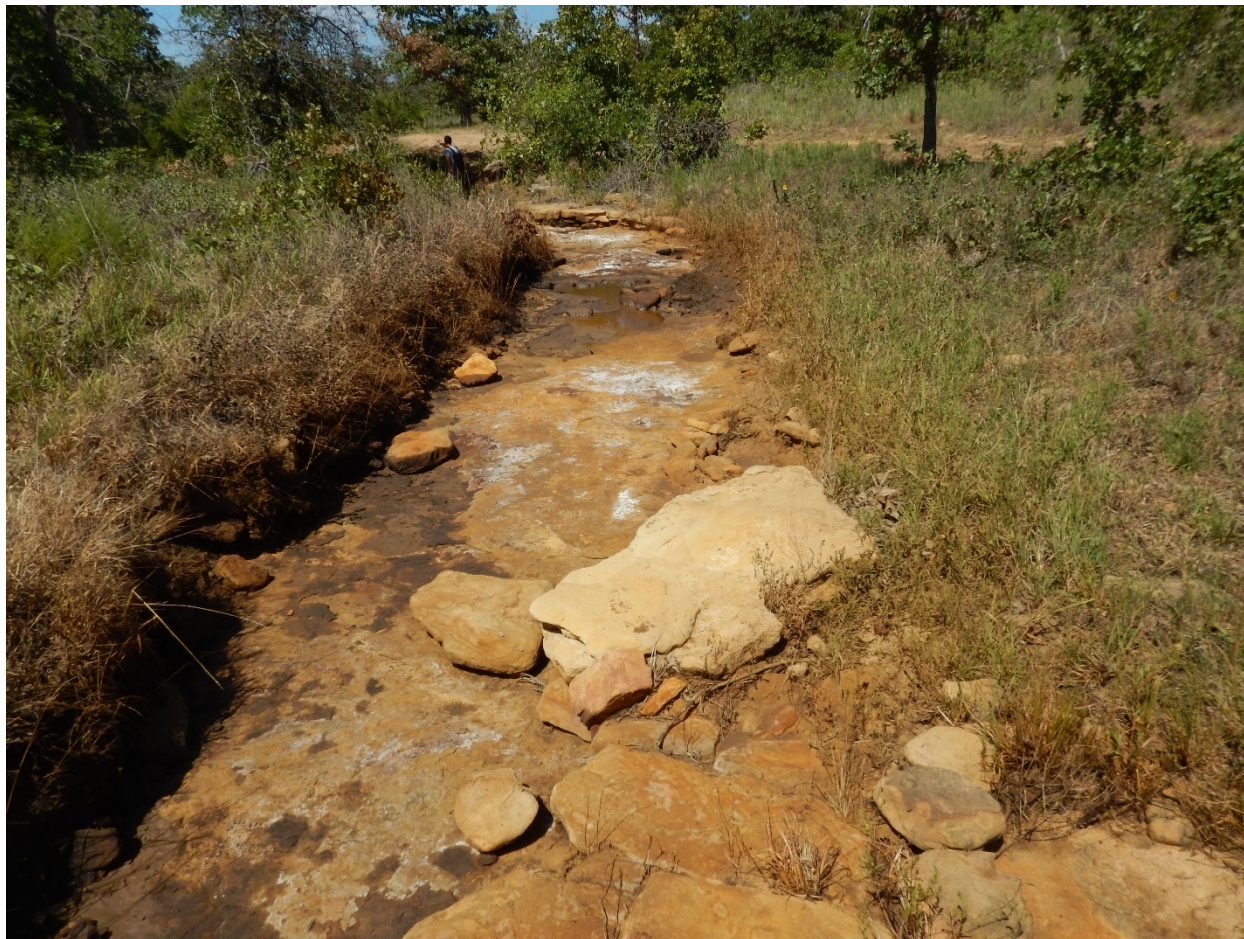
Photo No. 11

**Description:** This was a photo showing impacted vegetation along the tributary and the bed and bank features of the impacted tributary. As with the majority of the impacted tributary, the operator has removed the impacted water along with most of the free floating oil.

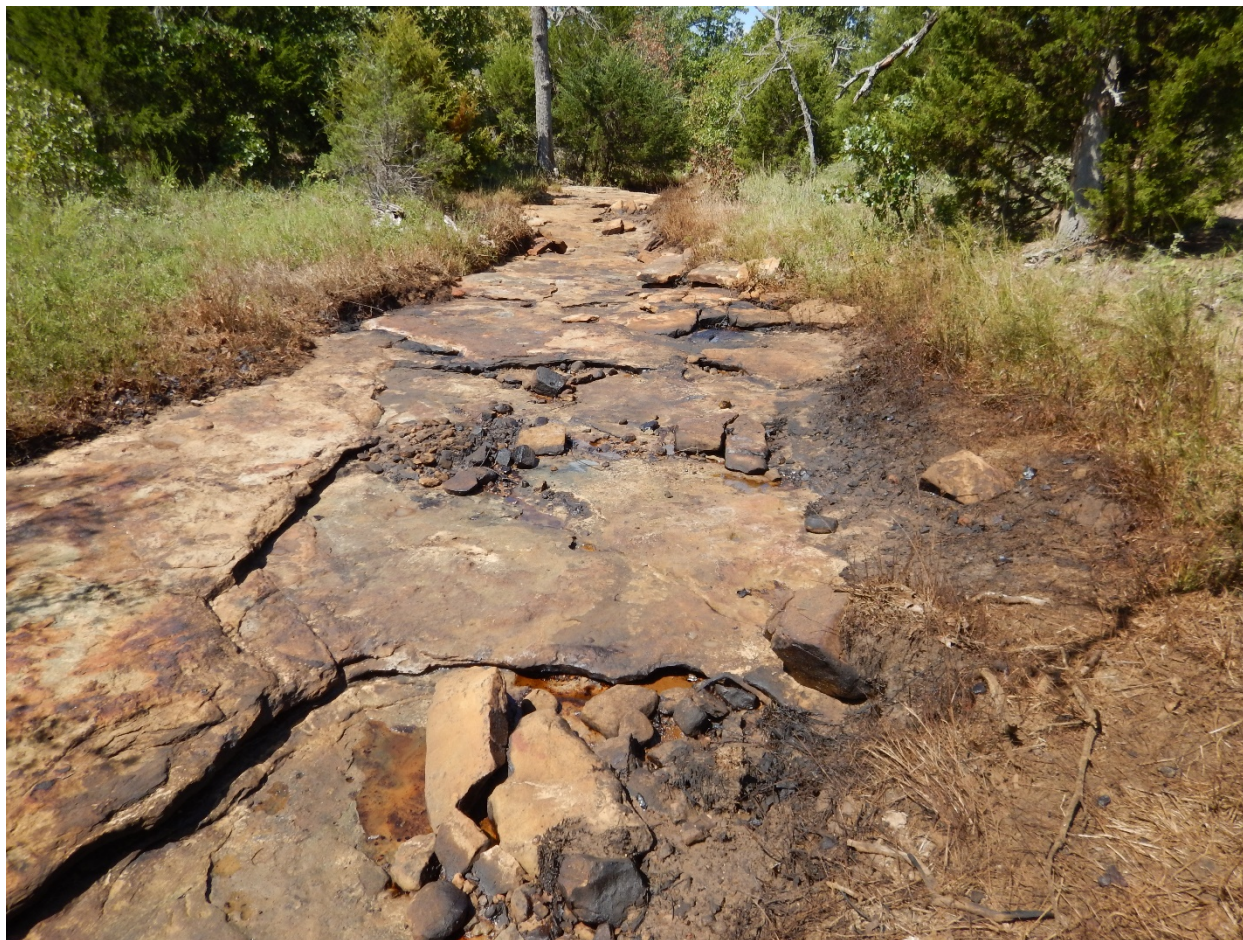
Photo No. 12

**Description:** This photo showed the impacted vegetation along the tributary's banks, as well as oil-stained rocks along the streambed. The operator has removed the free floating oil and impacted water from the tributary.

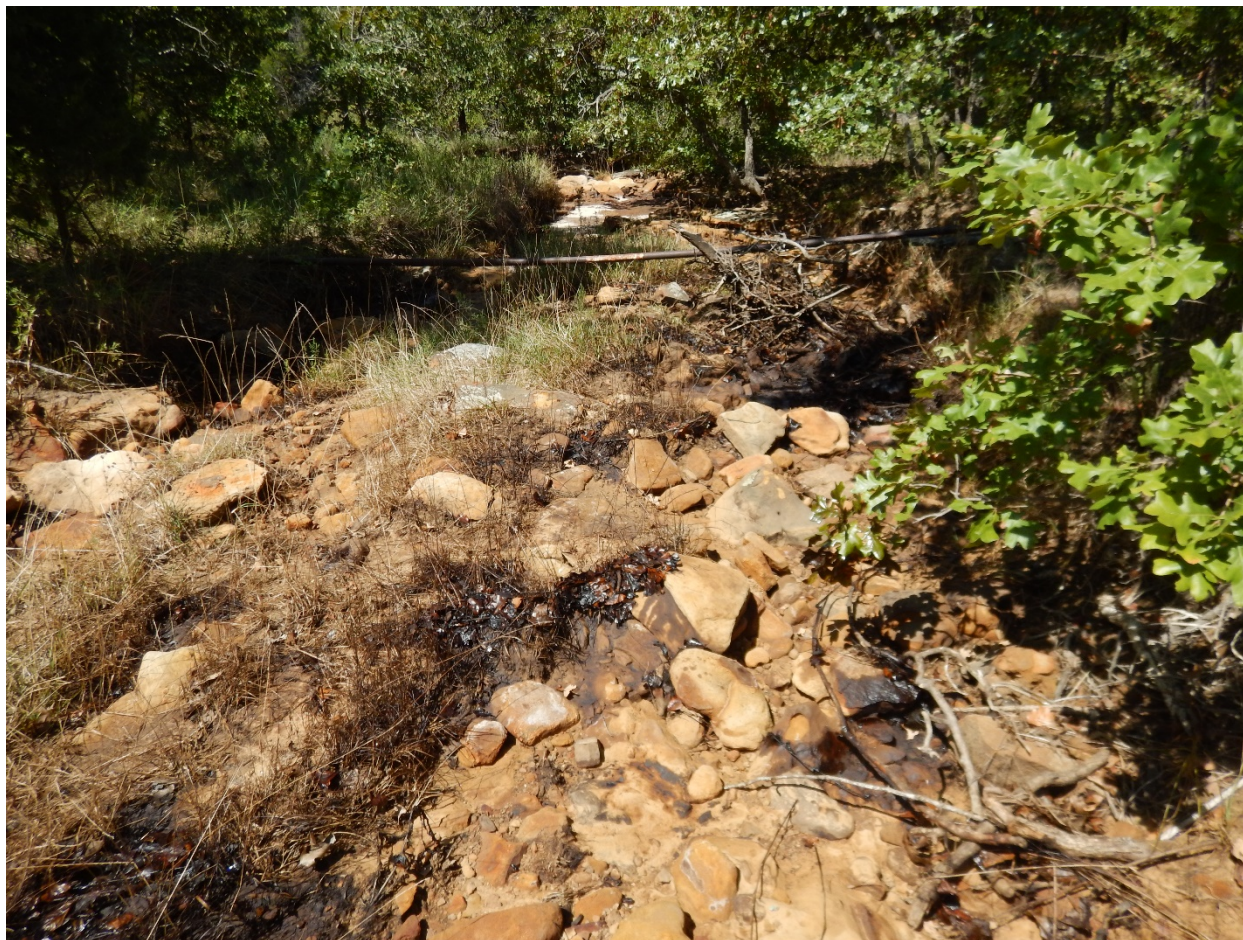
Photo No. 13

**Description:** This was a photo of oil-stained natural debris in the bed of the tributary. This should be removed as part of the cleanup operation.

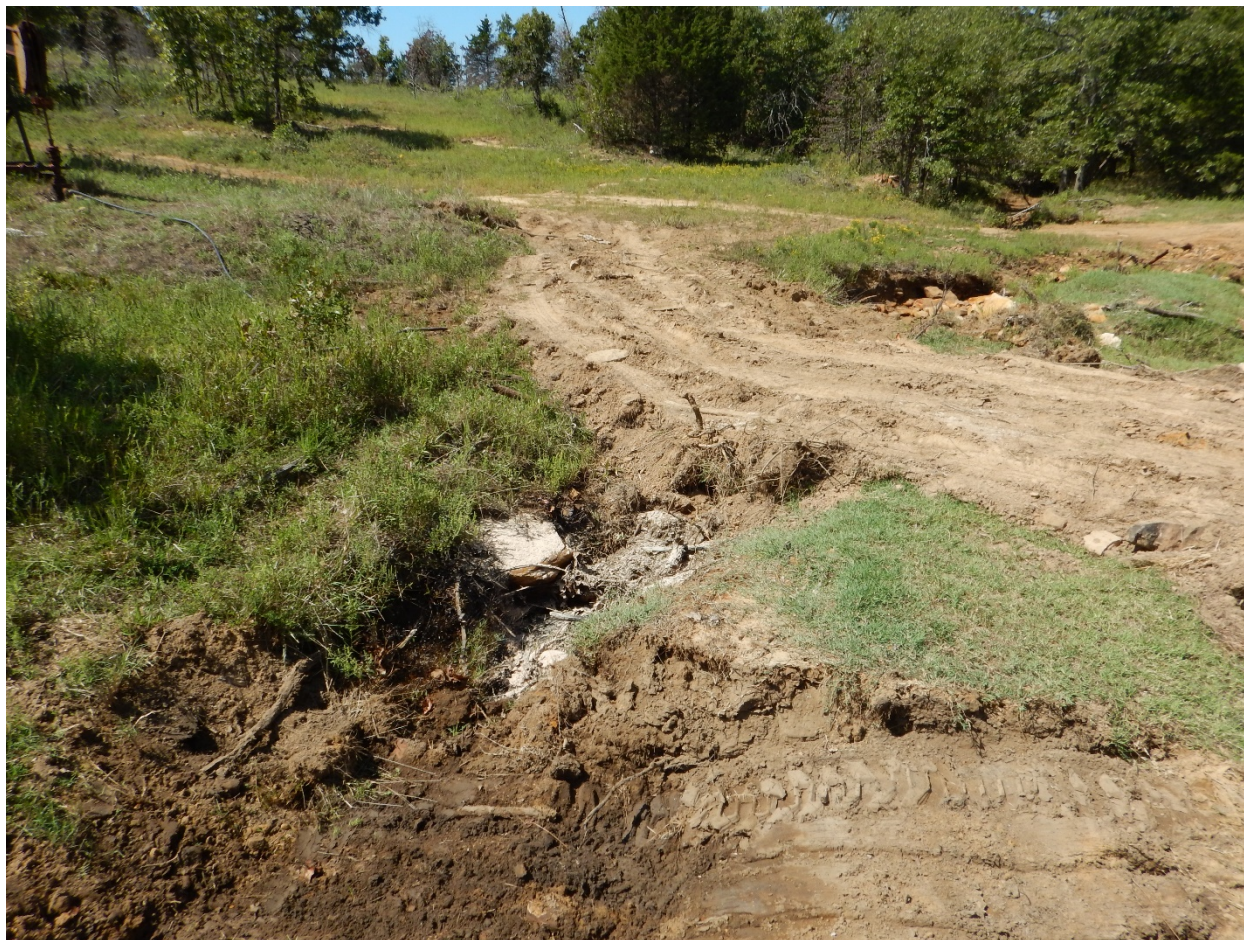
Photo No. 14

I observed a temporary containment dam at (GPS 36.261170, -96.229526) which is documented in photo 14. This dam was not present during the initial inspection conducted 09/03/2022.

**Description:** This was a temporary containment dam installed by the operator to prevent further downstream migration of impacted waters and oil. This dam was not present during the initial inspection which was conducted on 09/03/2022.

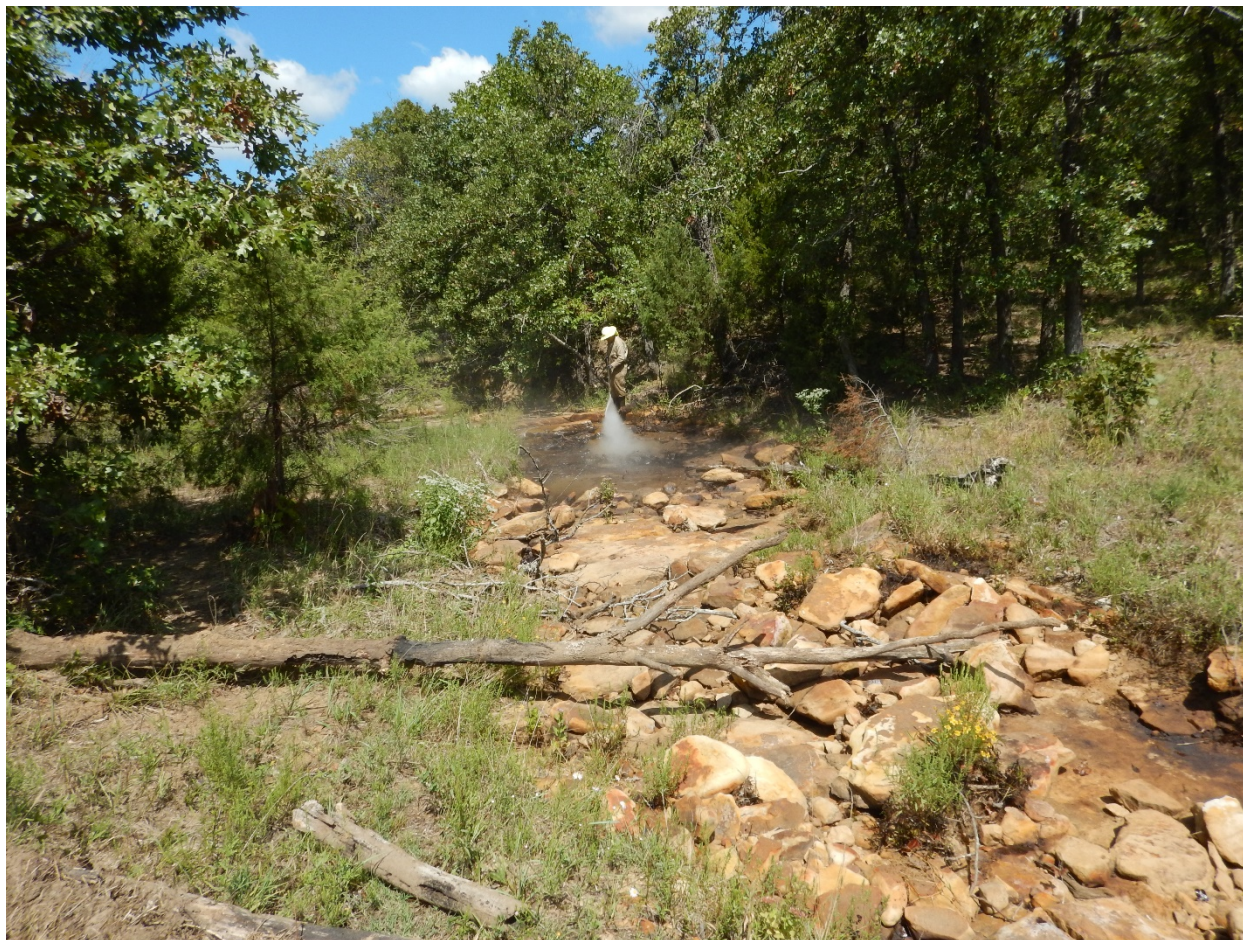
Photo No. 15

**Description:** This was a photo of an ACME Environmental employee power washing the oil stains from the streambed and rocks along the impacted tributary.

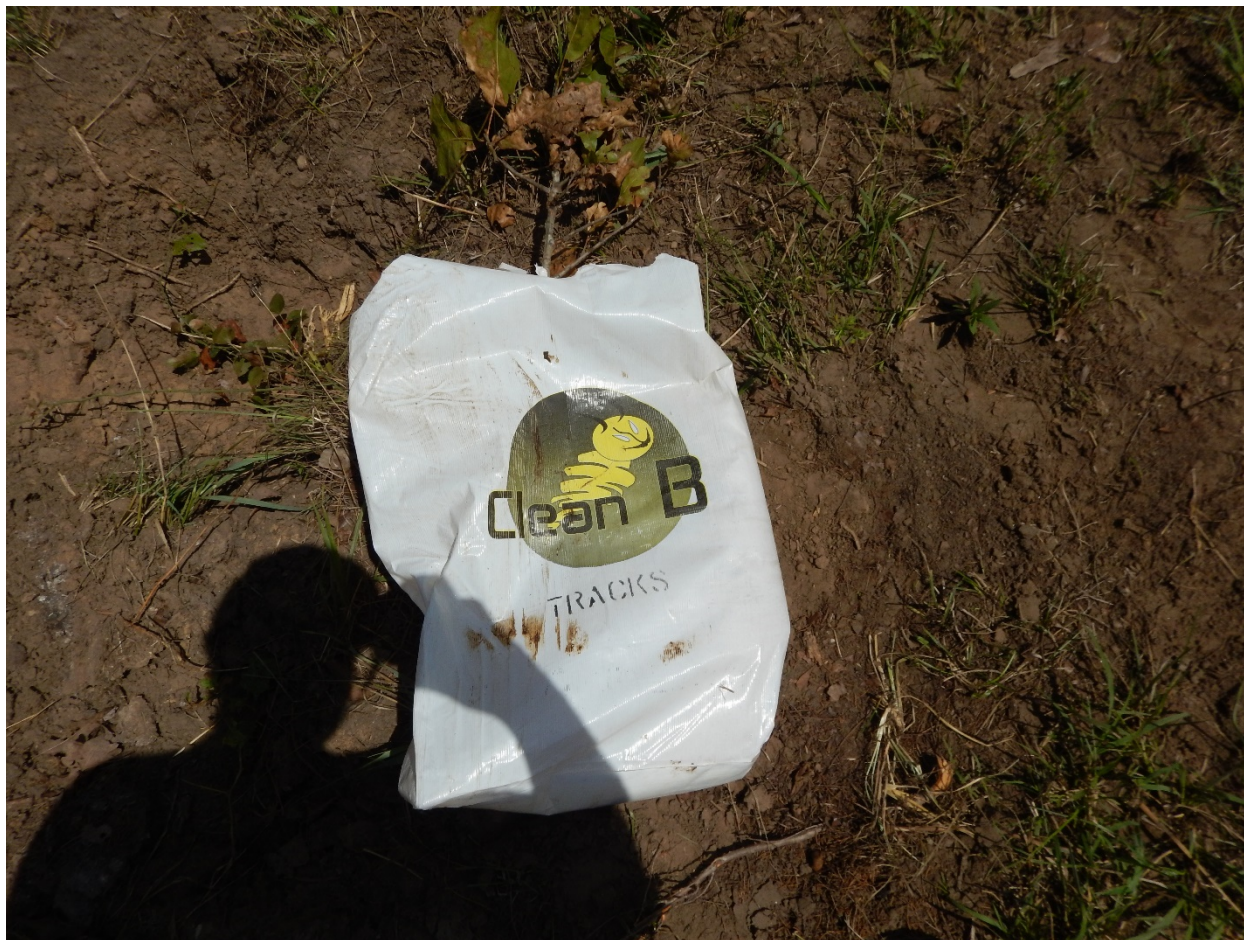
Photo No. 16

**Description:** This was the bag of "Clean B" industrial absorbent which had been applied to the oil in the tributary in photo No. 8 of this photo log.

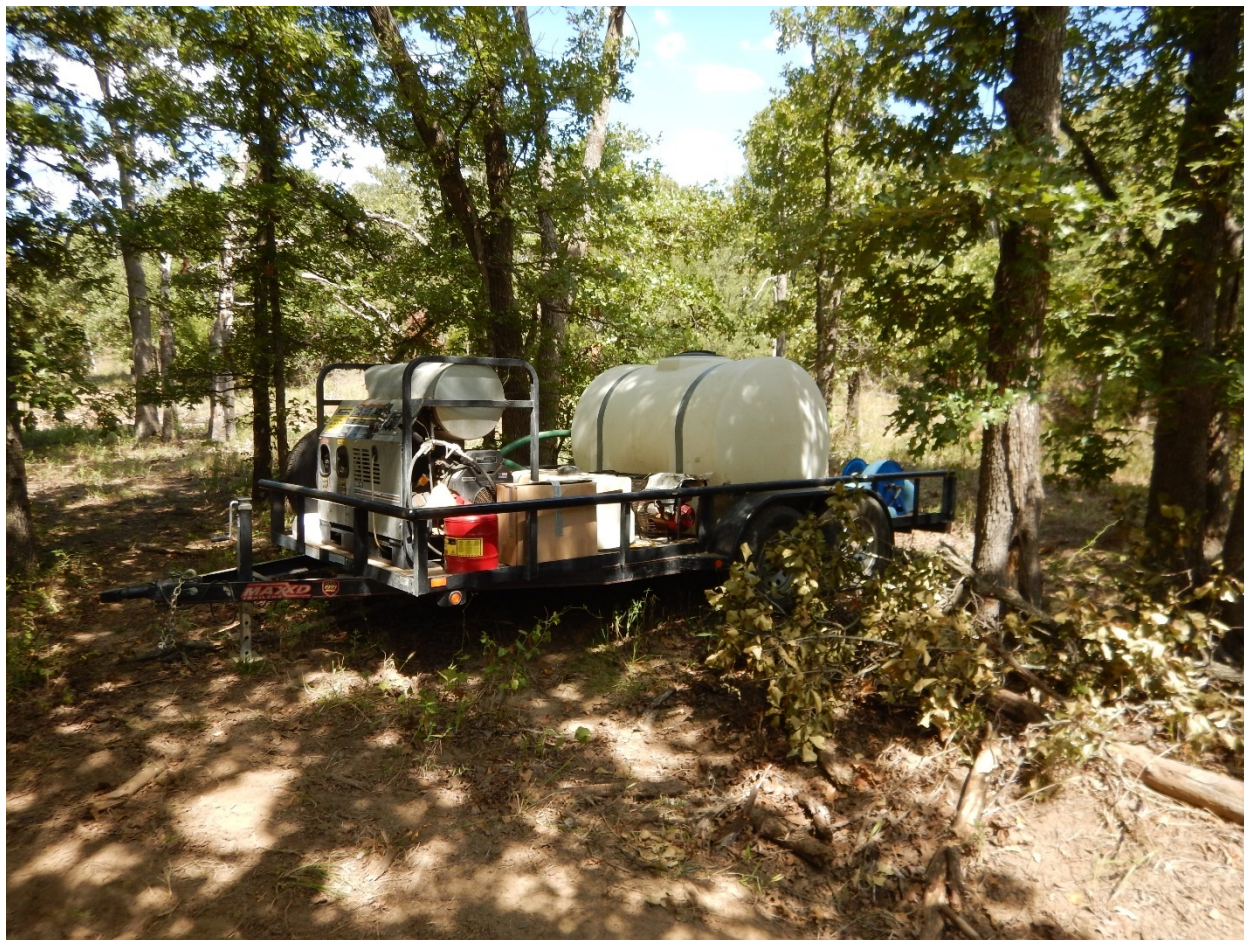
Photo No. 17

**Description:** This was the power washing rig used to power was oil stains from the impacted tributary.

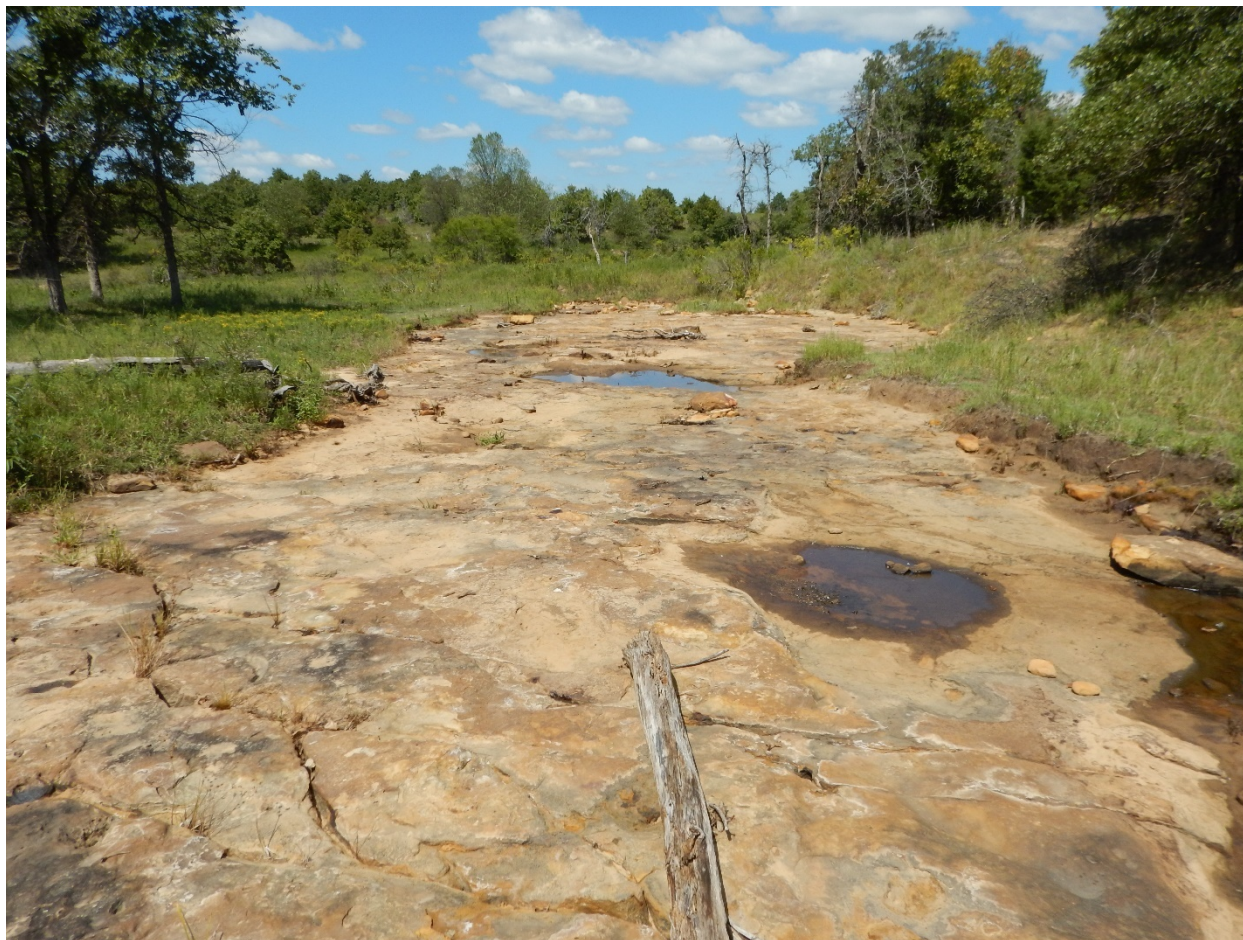
Photo No. 18

I observed a section of the impacted tributary where power washing had already occurred, there was no oil staining present in this area at the time of the inspection. This area had been sufficiently cleaned.

**Description:** This was a section of the impacted tributary where power washing had already occurred, there was no oil staining present in this area at the time of the inspection. This area had been sufficiently cleaned.
