**Region 6 - Enforcement & Compliance Assurance Division**  
**INSPECTION REPORT**

| Regulatory Program(s) | Clean Water Act – National Pollution Discharge Elimination System (Brine) | |
| Company Name: | Northcote Cleveland LLC | |
| Facility Name: | Osage B Lease | |

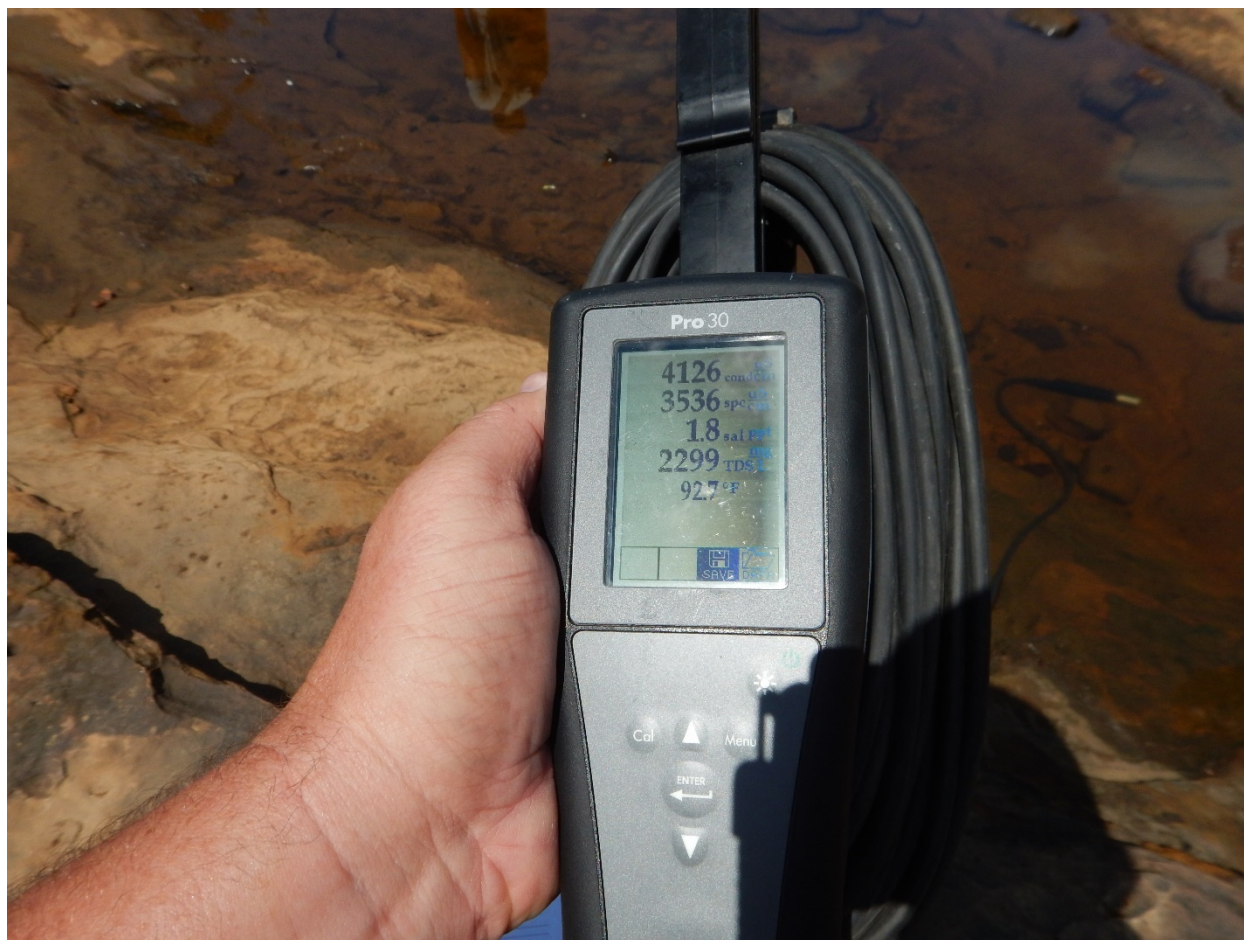
Photo No. 19

I observed an elevated TDS field reading of 2,299 mg/L (photo 19) taken along the impacted tributary. While this was an elevated reading, it shows significant improvement over the initial readings observed on 09/03/2022. The operator was instructed to empty this pool of water from the impacted tributary.

**Description:** This was an elevated TDS field reading of 2,299 mg/L taken along the impacted tributary. While this was an elevated reading, it shows significant improvement over the initial readings observed on 09/03/2022. The operator was instructed to empty this pool of water from the impacted tributary.

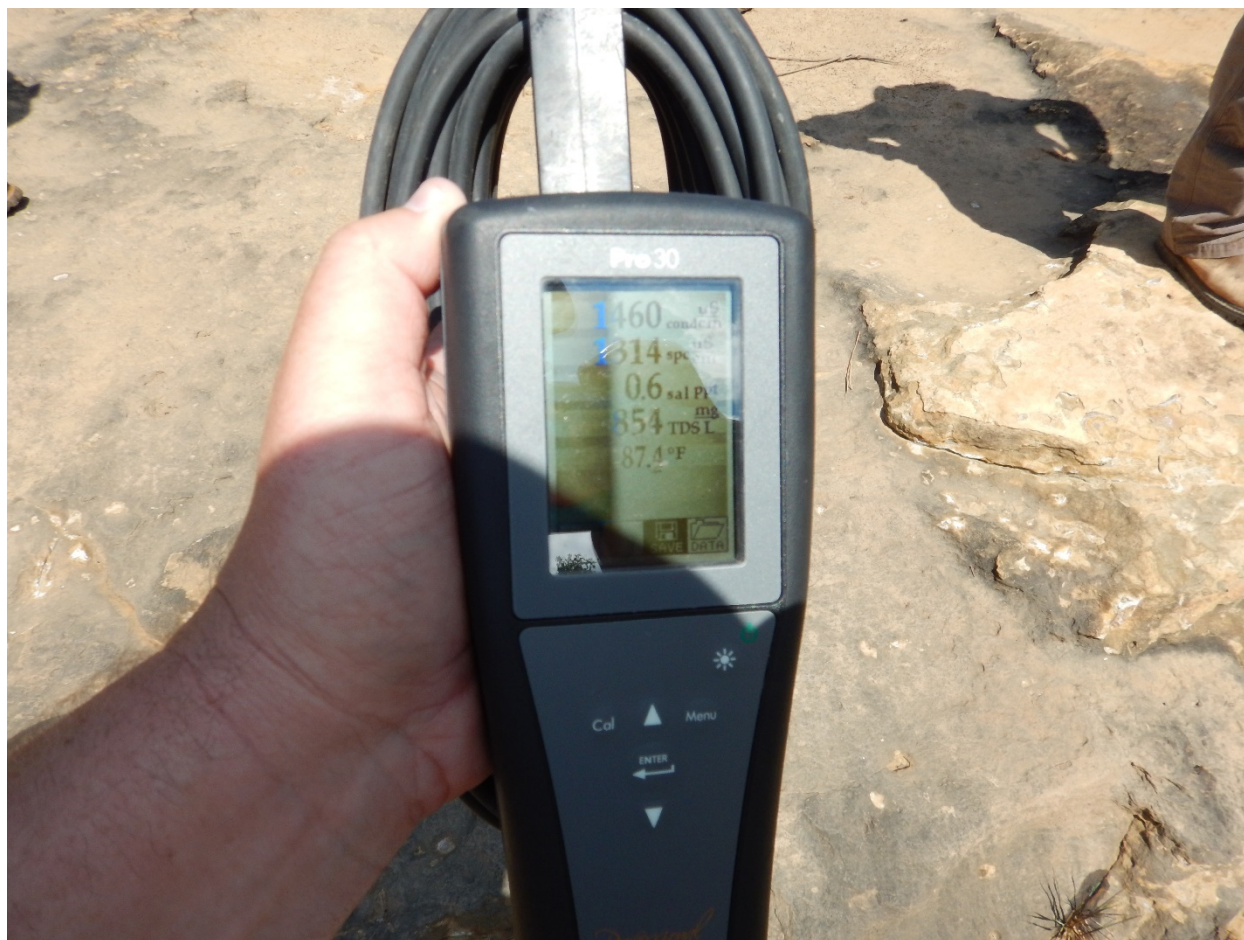
Photo No. 20

**Description:** This was an elevated TDS field reading of 854 mg/L taken in the last pool of water along the impacted tributary before it entered the waters of Mud Creek/Keystone Lake.

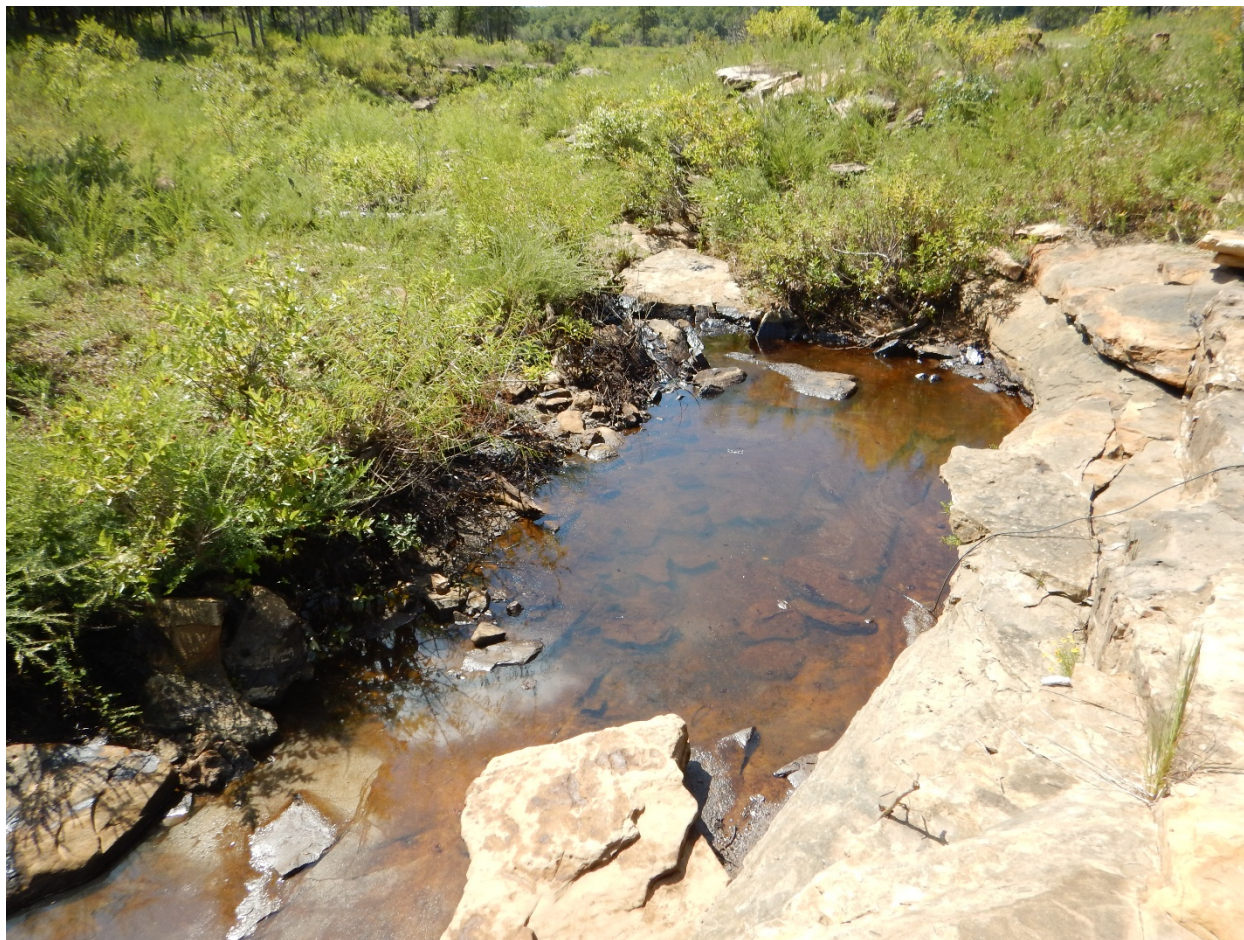
Photo No. 21

I observed an elevated TDS field reading of 854 mg/L taken in the last pool of water along the impacted tributary before it entered the waters of Mud Creek/Keystone Lake. I observed oil on the pool of water as well as oil staining on the rocks and vegetation around the pool. At the time of the inspection, this area had not been impacted by cleanup activities. These observations were documented in photos 20 and 21.

**Description:** This was the pool of water where the TDS field reading of 854 mg/L was taken. There was a small amount of oil on the pool and oil-stained rocks and vegetation we present around the pool. Cleanup efforts had not yet reached this portion of the tributary at the time of the inspection.

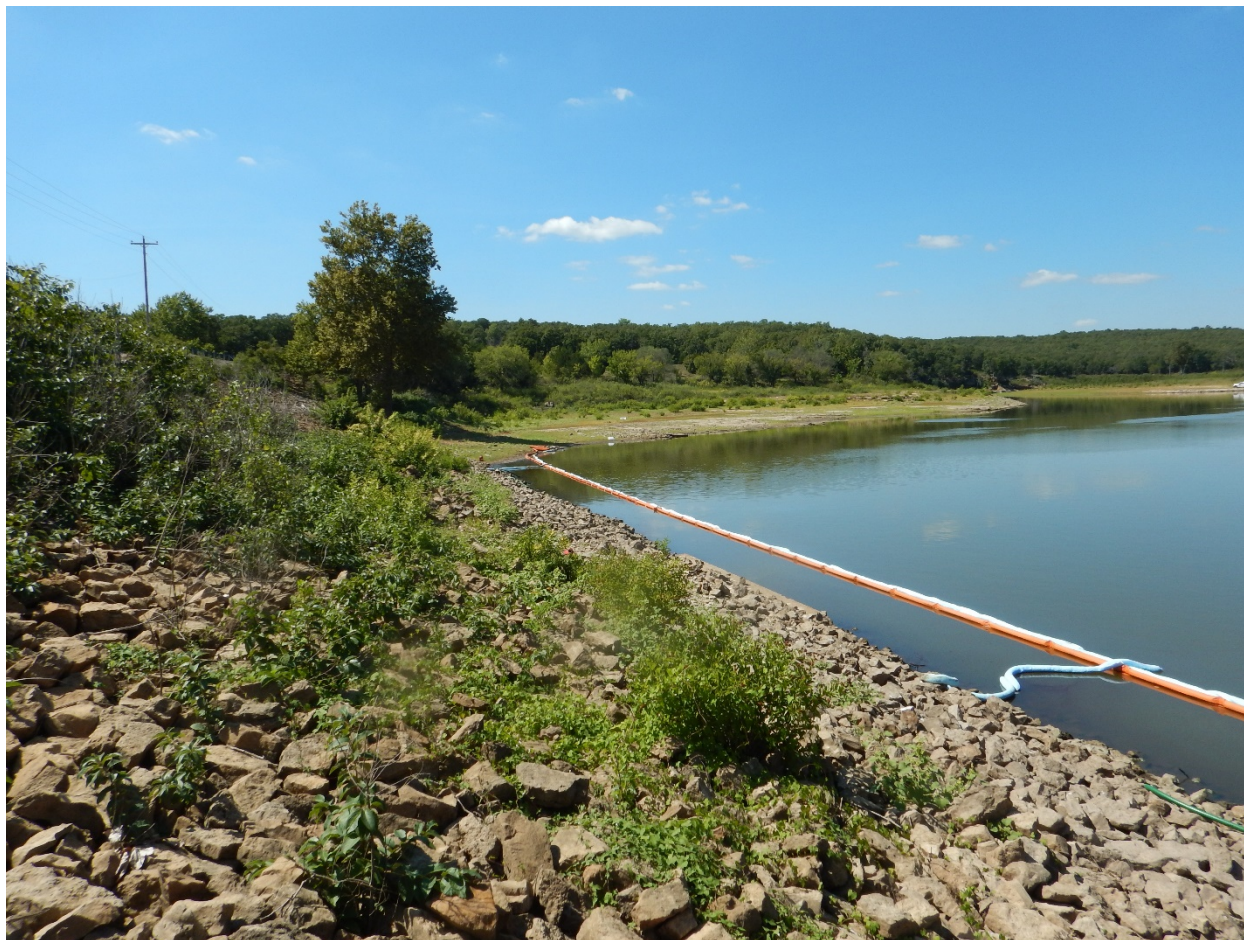
Photo No. 22

I observed floating oil containment booms and oil absorbent booms installed on Mud Creek/Keystone Lake. At the time of the inspection the booms had the oil captured primarily along the rip rap at the base of the earthen bridge which carried New Prue Road across Mud Creek/Keystone Lake. (See photos 22 and 23).

**Description:** This was a wide-angle view of the containment and absorbent booms installed on Mud Creek/Keystone Lake.

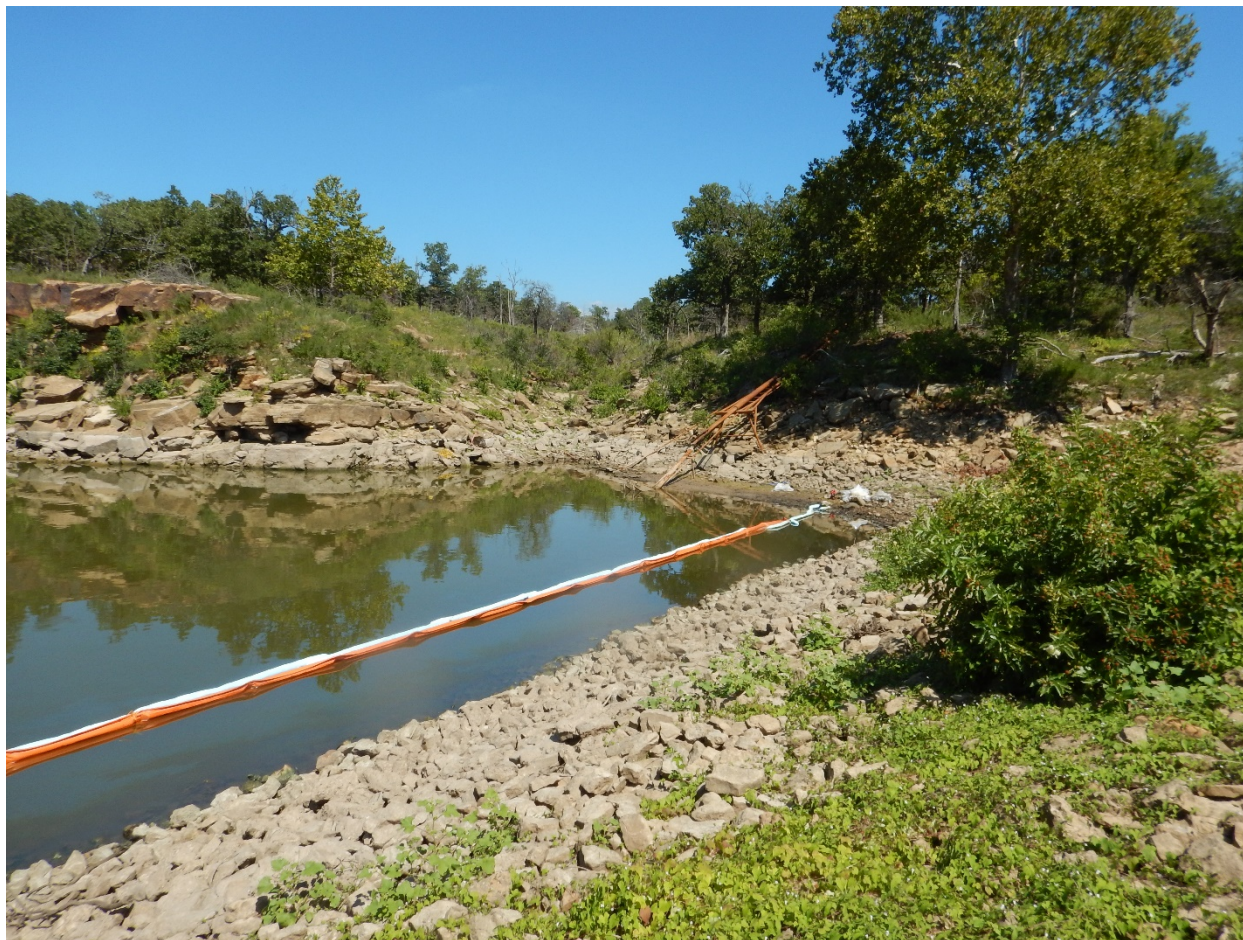
Photo No. 23

**Description:** This was a wide angle view of the containment and absorbent booms installed on Mud Creek/Keystone Lake.

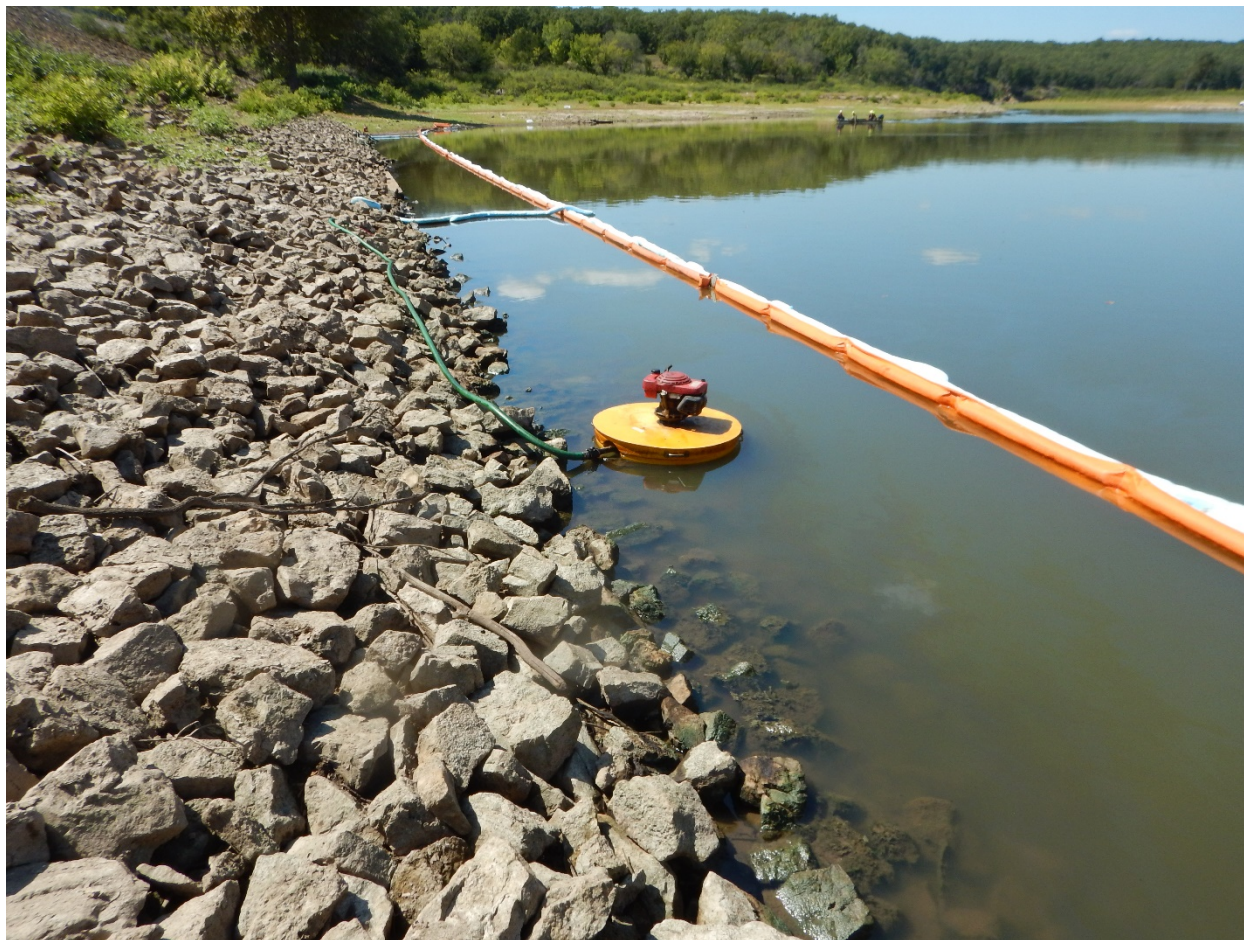
Photo No. 24

**Description:** This was a photo of the floating oil containment boom, floating oil absorbent boom and a gasoline powered wash pump floating on Mud Creek/Keystone Lake. The oil, sheen and contaminated area was located between the booms and rip rap (rocks). This is the area where ACME Environmental had trapped the oil and was conducting cleanup and removal operations. At the time of the inspection, Cody Mather stated 11 gallons of oil had been removed from Mud Creek/Keystone Lake.

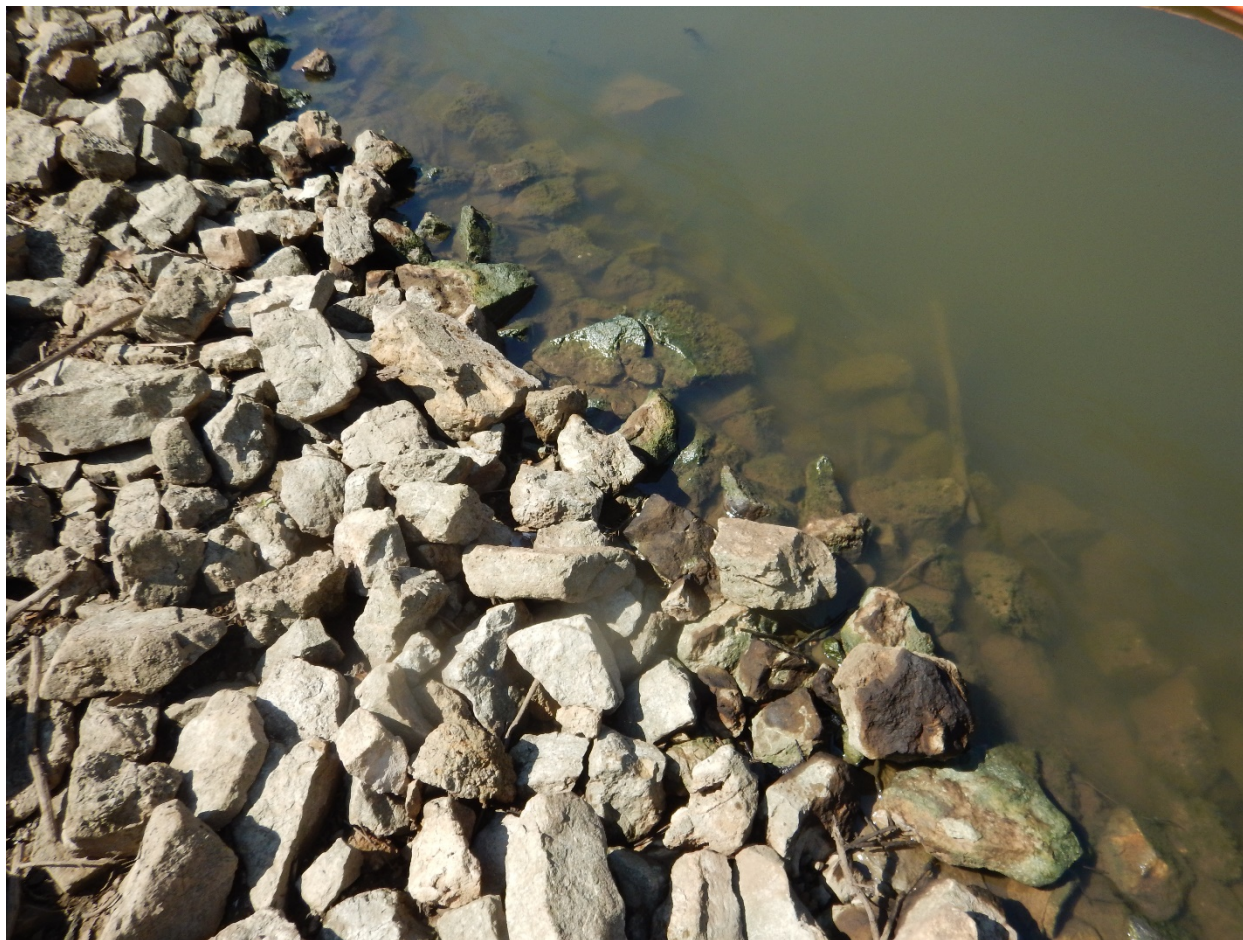
Photo No. 25

**Description:** This was an area that was being clean by ACME Environmental. There were a few rocks which still had oil staining present but most of the rocks had been cleaned at the time of the inspection. ACME Environmental was using a pressure wash pump to clean the oil from the rocks.

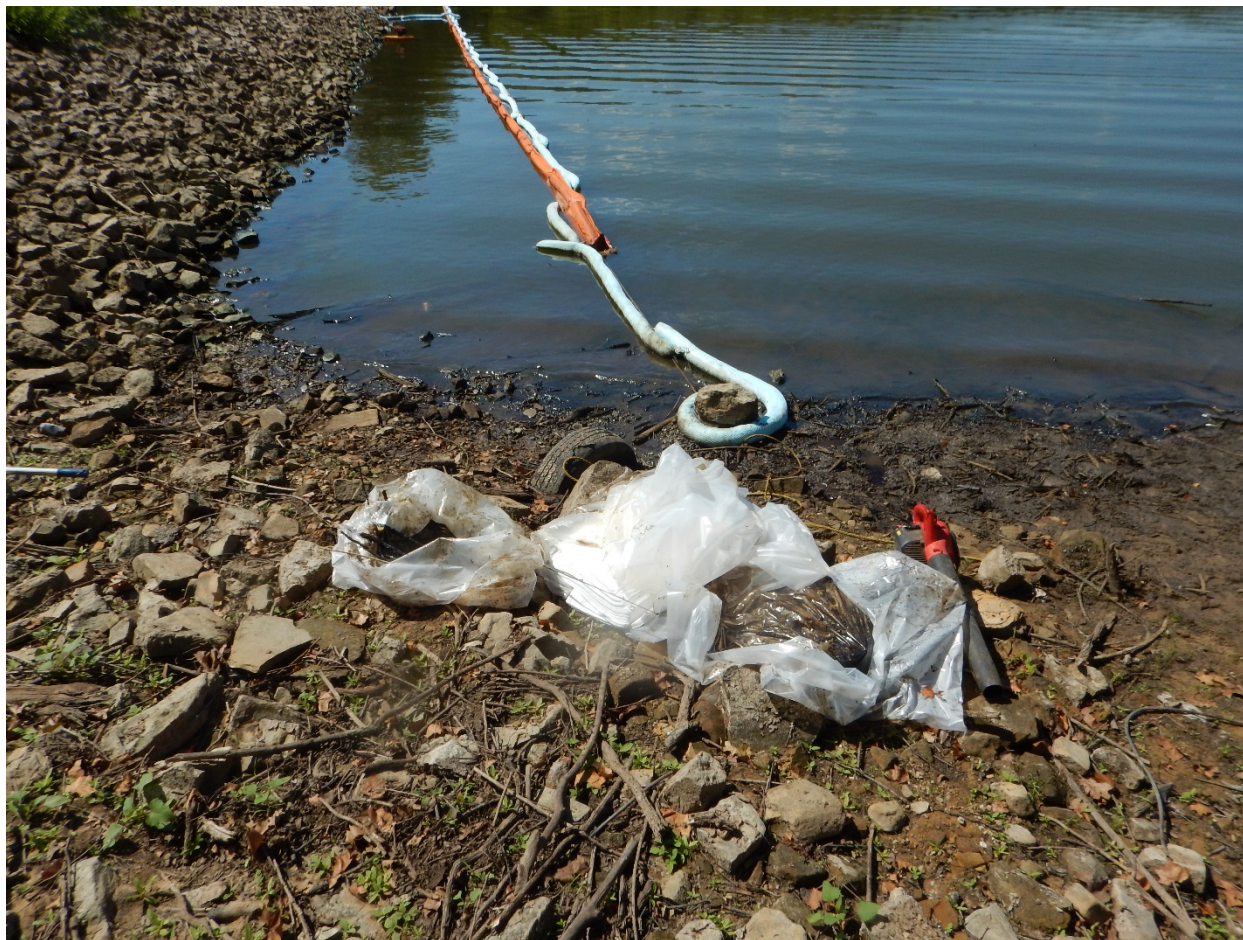
I observed trash sacks containing oil-soaked debris and oil-soaked cleanup materials near the shoreline along Mud Creek/Keystone Lake (photo 26).

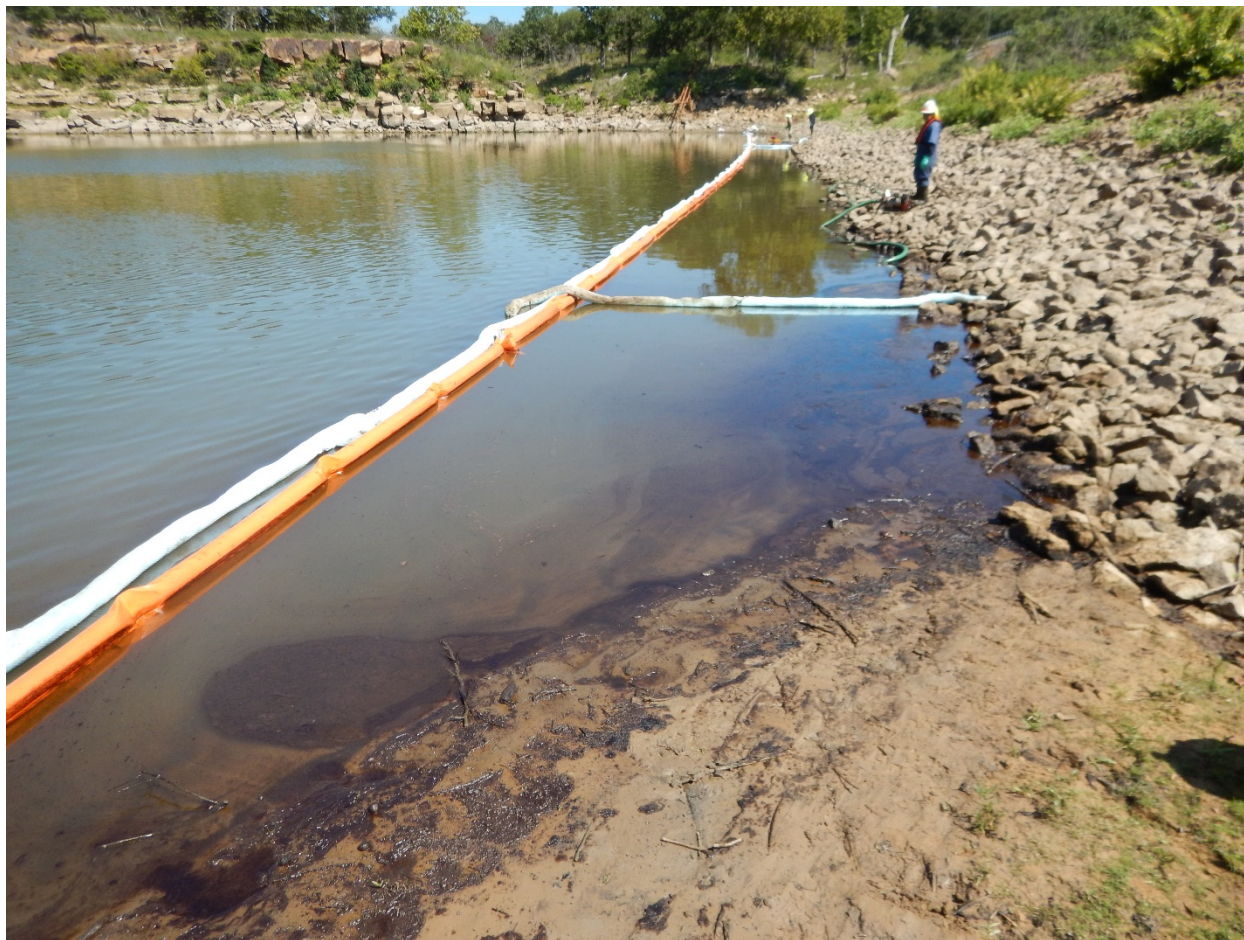
I observed oil trapped against the shore by the containment and absorbent booms (photo 27). This area had not yet been cleaned. ACME Environmental cleanup personnel can also be seen working in the photo. The rip rap along the right side of the picture is located at the base of the earthen bridge which carried New Prue Road across Mud Creek/Keystone Lake. I observed additional booms and cleanup materials available for use at the cleanup area (photo 28). (GPS 36.258135, -96.233195).
