# WASTEWATER TREATMENT SYSTEM COMPLIANCE EVALUATION INSPECTION REPORT

**Purpose:** NPDES Compliance Evaluation Inspection

**Facility:** Big Sand Lake/West Hertel Wastewater Treatment Plant  
St. Croix Chippewa Indians of Wisconsin Reservation  
P.O. Box 67  
Hertel, Wisconsin 54893  
(NW ¼ of Section 2, T38N, R15W)

**Date of Inspection:** October 27, 2020

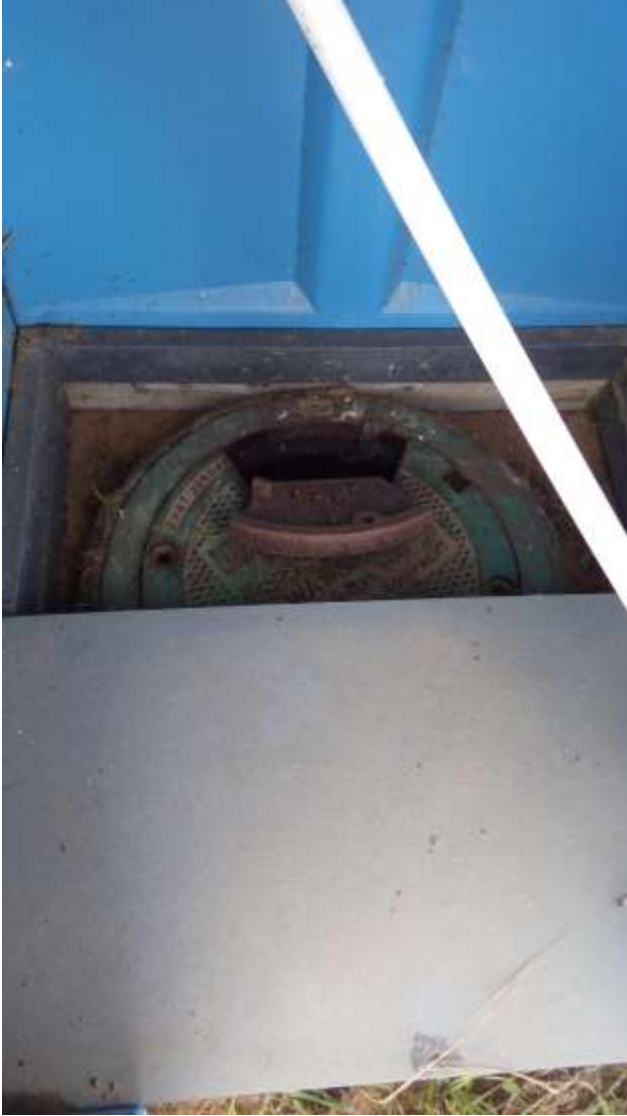
1: STWH0001

We began the inspection at the influent vault (Photograph 1; STWH0001.jpg) before the headwork septic tanks. We then viewed the headworks area, including septic tanks 1 and 2 (Photograph 2; STWH0002.jpg) and septic tank 3 and the diverter tank (Photograph 3; STWH0003.jpg). Photograph 4 shows the inside of the headwork diverter tank, including diversion weirs (STWH0004.jpg). Next, we viewed treatment wetlands 1-3 (Photograph 5; STWH0005.jpg; noted cattails in the offline treatment wetlands 1 and 2), treatment wetland 4 (Photograph 6; STWH0006.jpg), treatment wetland 5 (Photograph 7; STWH0007.jpg), and treatment wetland 6 (Photograph 8; STWH0008.jpg). We walked to the effluent sampling shed (Photograph 9; STWH0009.jpg) and viewed the ISCO effluent composite sampler (Photograph 10; STWH0010.jpg) and the system process control panels (Photograph 11; STWH0011.jpg, and Photograph 12; STWH0012.jpg). Next, we viewed the effluent vault, which contained the effluent flume, effluent composite sampler tubing, and sonic flow meter. I observed worms along the bottom of the effluent flume, and Ms. Dooling noted that the composite sampler tube inlet was covered by a screen (Photograph 13; STWH0013.jpg). Mr. Buck stated that the screen was in place to keep worms from being drawn into the composite sampler.

Description: Influent vault prior to first septic tank.

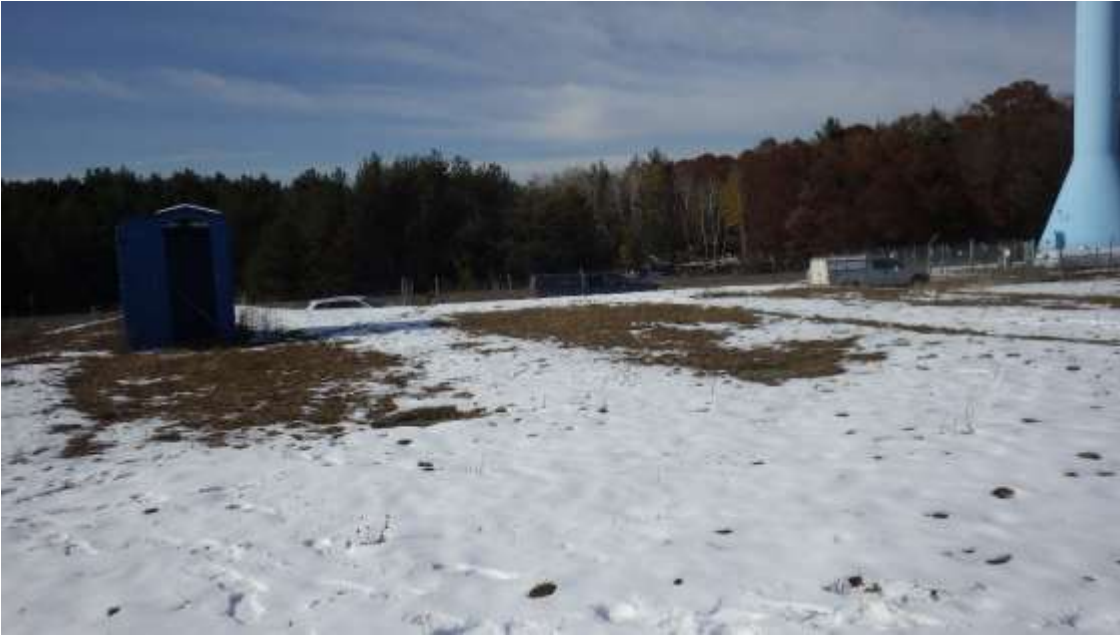
2: STWH0002

Description: Area of septic tanks 1 and 2, and influent vault shed (small blue shed on the left of photo).

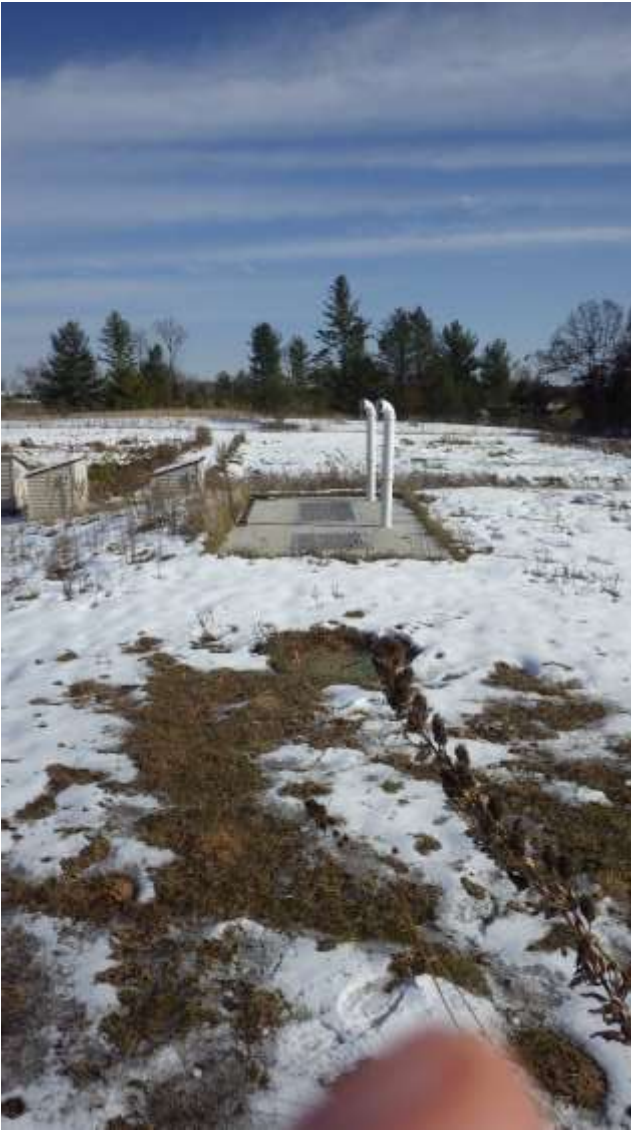
3: STWH0003

Description: Area of septic tank 3 (foreground), and diverter tank vault doors (adjacent to white vent pipes) in background.

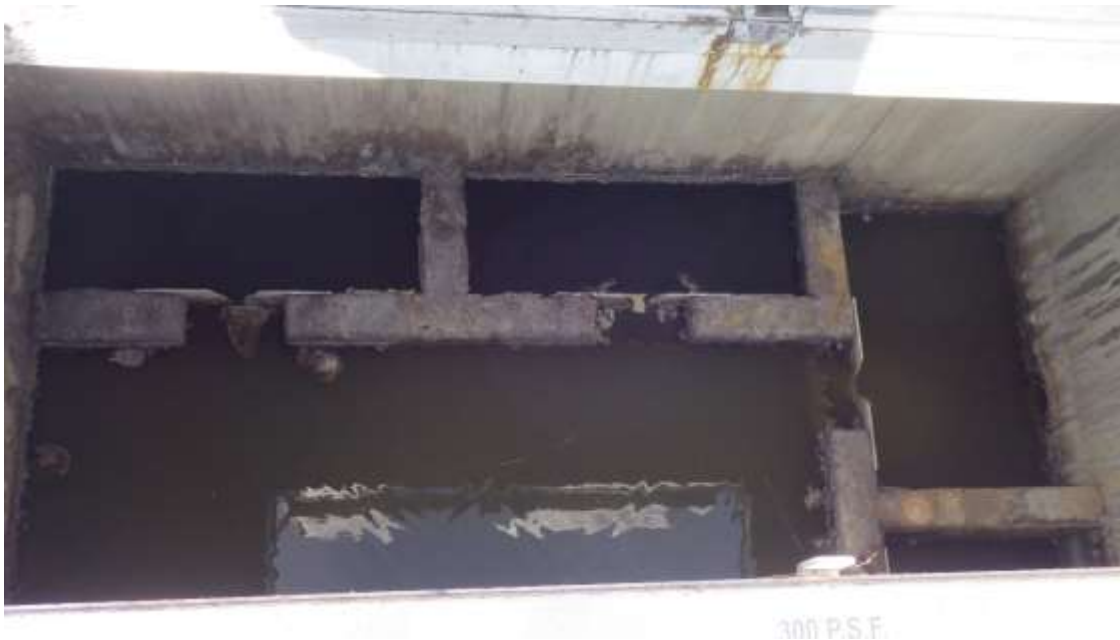
4: STWH0004

Description: Diverter tank with diversion weirs visible.

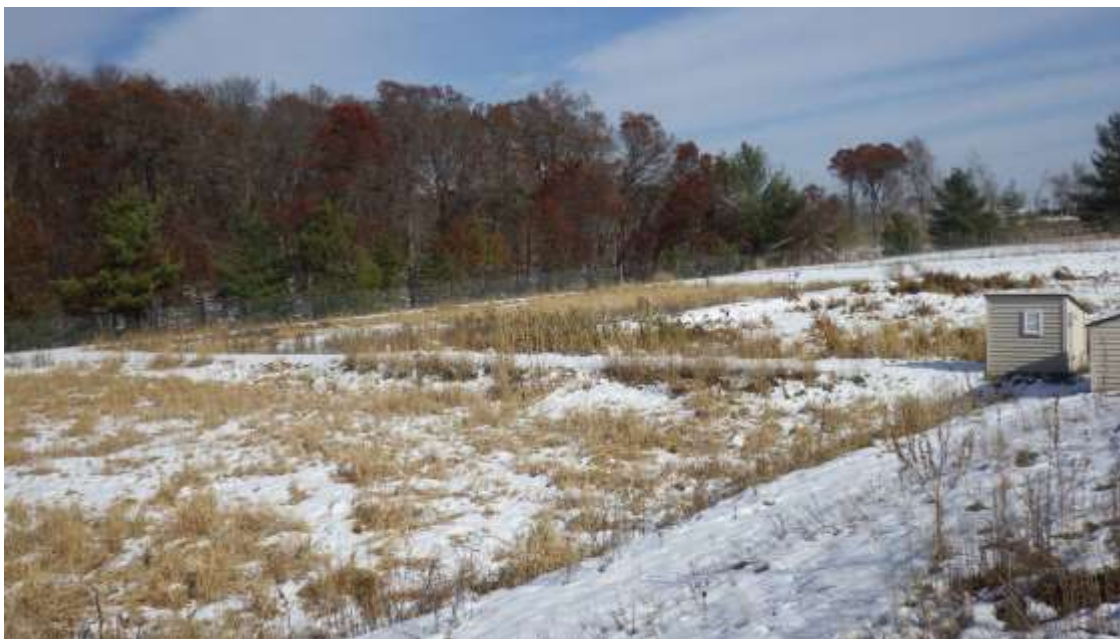
5: STWH0005

- Two treatment wetlands have been offline for two years due to invasive grass and vines, and worms were observed in the effluent flume. Pursuant to Permit Part I.C.3 and Part II.B.1, the Tribe shall at all times properly operate and maintain all facilities and systems of treatment and control;

Description: Treatment wetlands 1-3 (in order left to right). Note cattails growing in offline treatment wetlands 1 and 2.

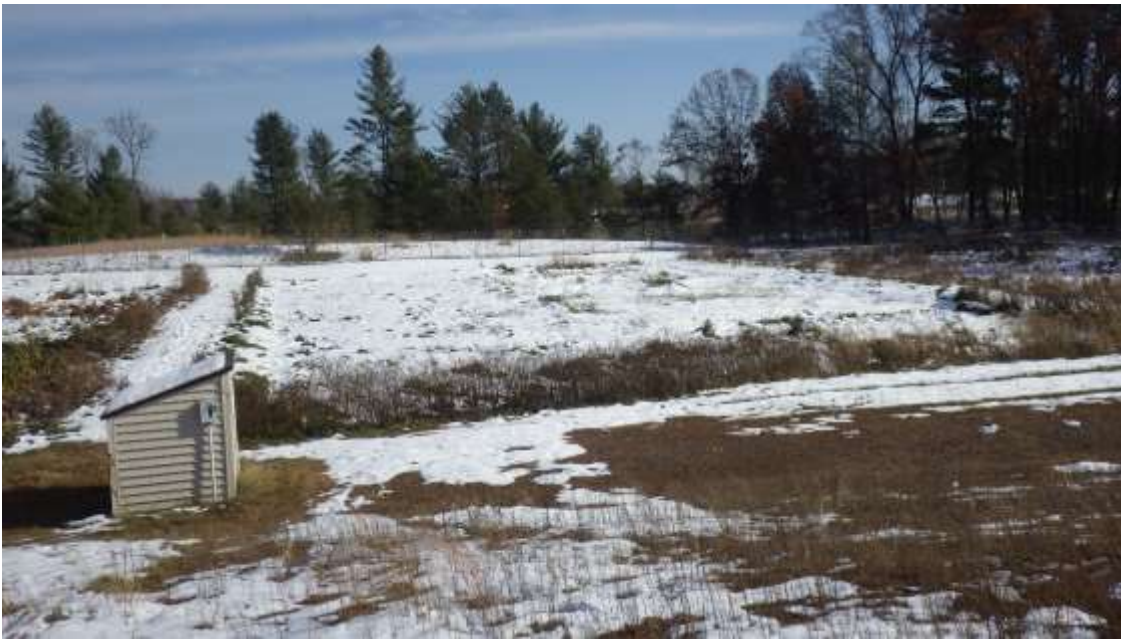
6: STWH0006

Description: Treatment wetland 4.

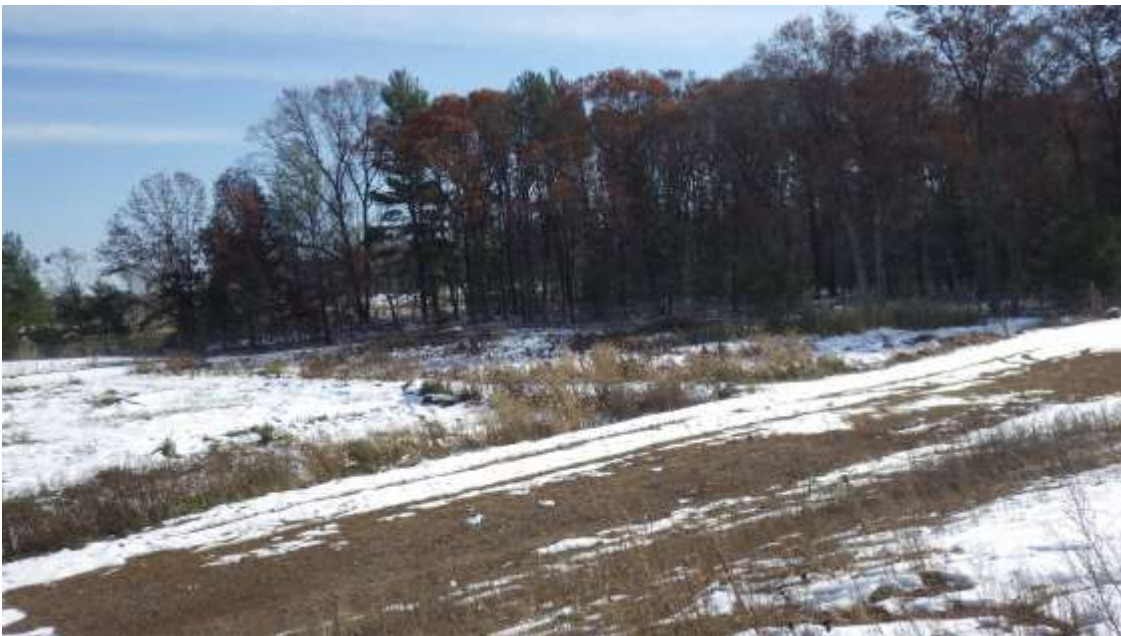
7: STWH0007

Description: Treatment wetland 5.

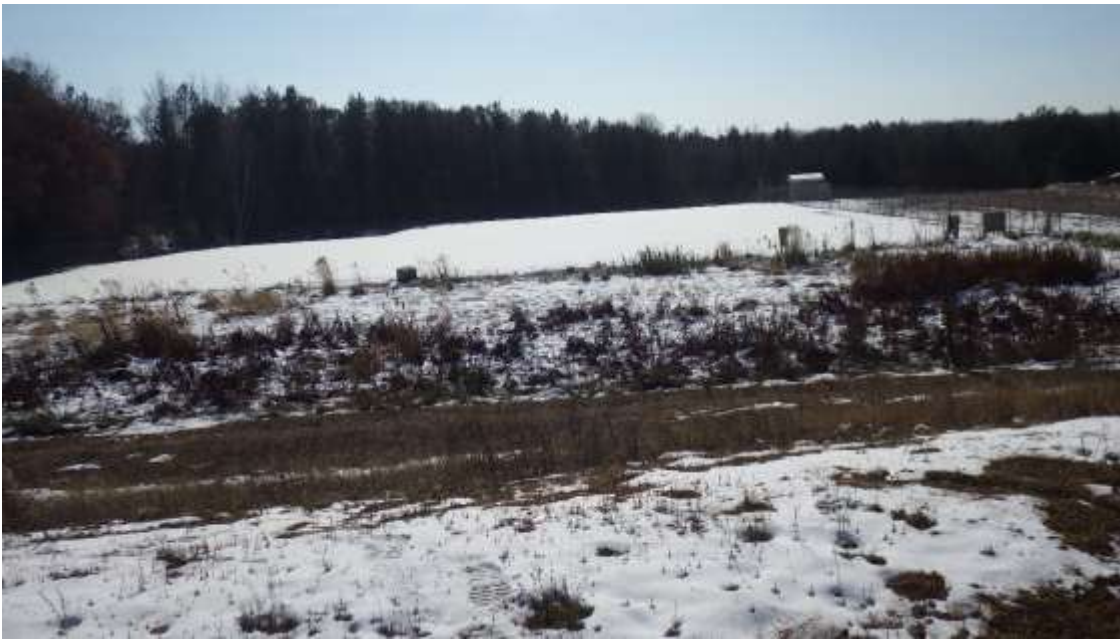
8: STWH0008

Description: Treatment wetland 6.

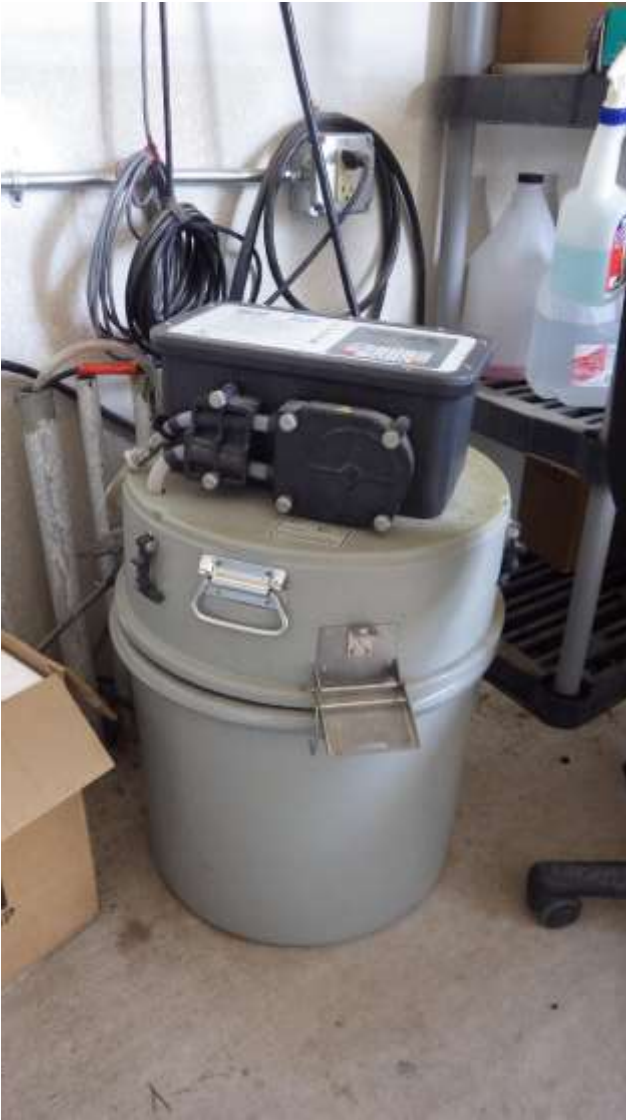
9: STWH0009

- Influent samples are collected as grab samples. Composite samples are required for BOD<sub>5</sub>, copper, and total phosphorus. [Permit Part I.B];
- Effluent samples collected via 24-composite sampler must be preserved (e.g., refrigerated) in accordance with 40 CFR Part 136;

Description: Effluent ISCO composite sampler.

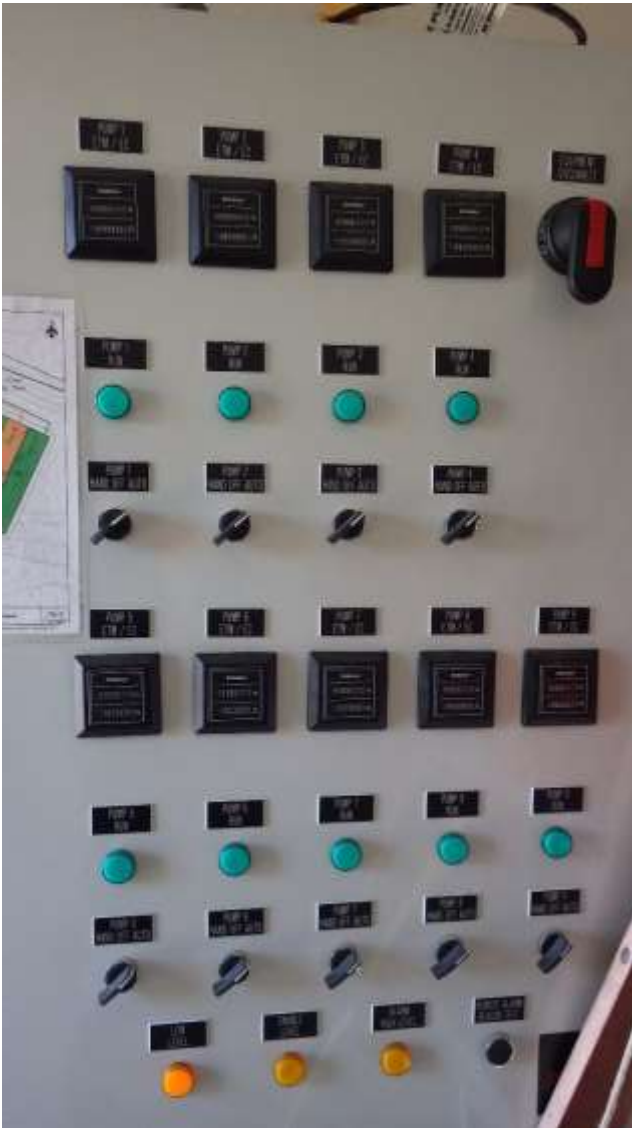
11: STWH0011

Description: Process pump control panel.

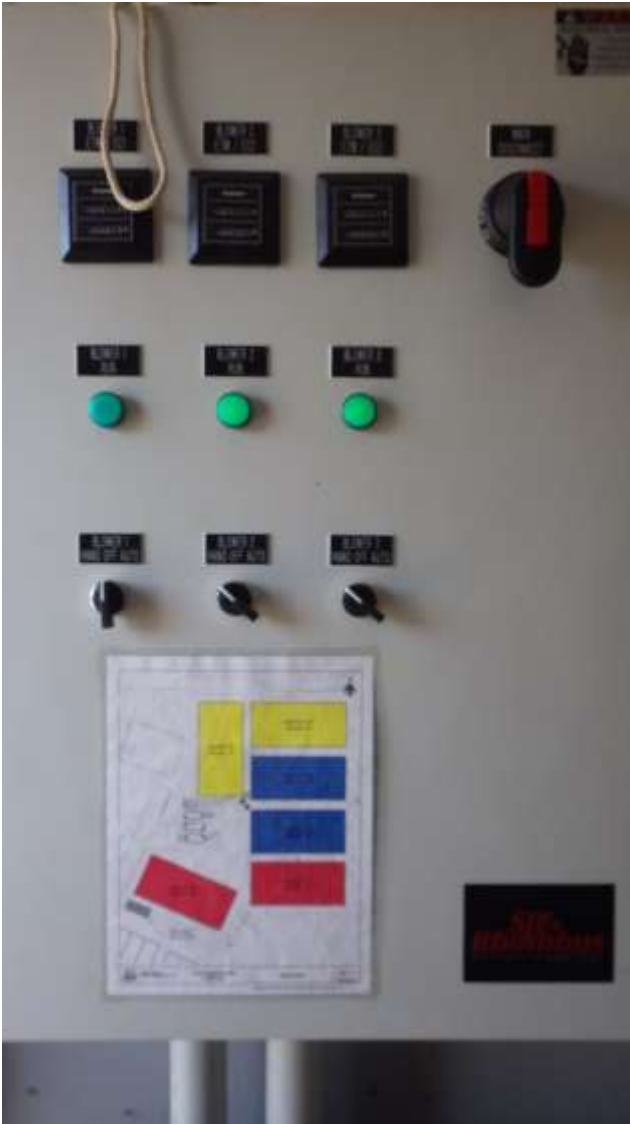
12: STWH0012

Description: Process blower control panel.

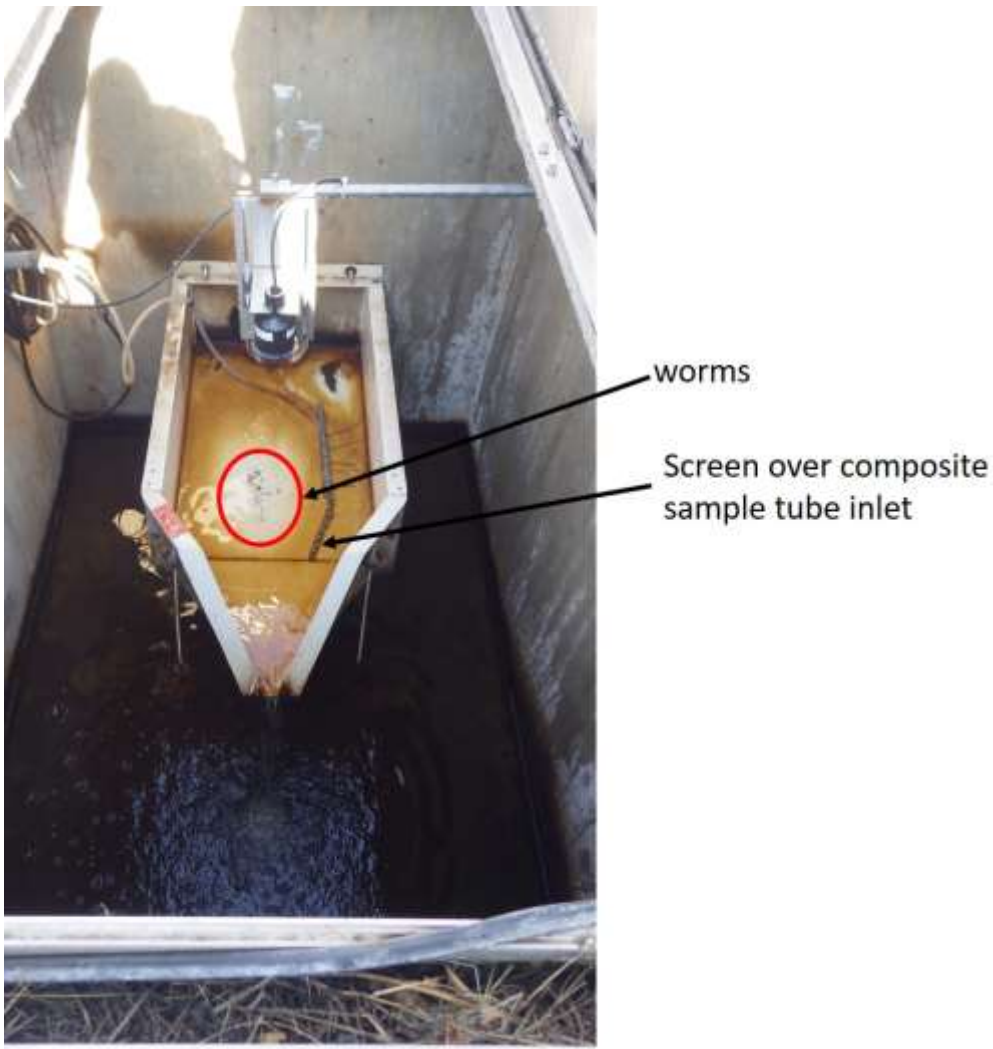
13: STWH0013

- Effluent composite sampler tube inlet was covered by a screen to keep worms from being drawn into the composite sampler. Pursuant to Permit Part I.A.b, representative samples shall be collected in the effluent line after the single-pass filter effluents combine;

Description: Effluent parshall flume. Note worms along the bottom of the flume, and screen covering composite sampler tube inlet.

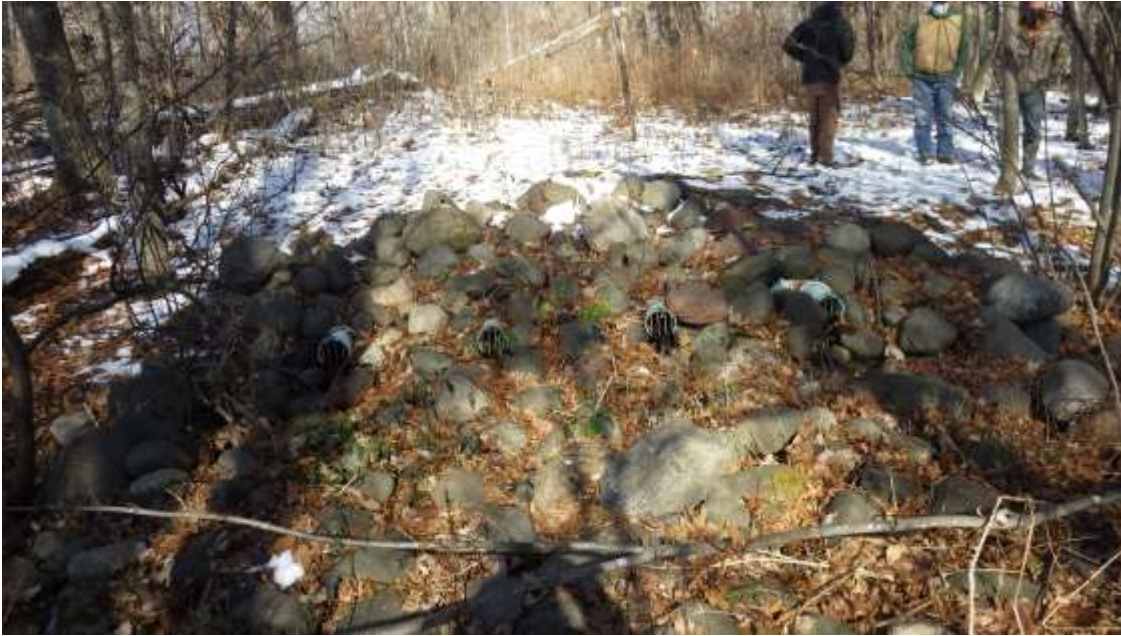
14: STWH0014

The group then drove across Rt. 70 to the final effluent Outfall 001. Effluent Outfall 001 is distributed through four outfall pipes to reduce channeling at the head end of the unnamed wetland (Photograph 14; STWH0014.jpg). The effluent was clear, and no issues were observed in the receiving water. On the way back to the Utility Garage, we stopped to observe main Lift Station 5 (Photograph 15; STWH0015.jpg) and the backup power generator for Lift Station 5 (Photograph 16; STWH0016.jpg).

Description: Diffused outlets to final effluent Outfall 001.

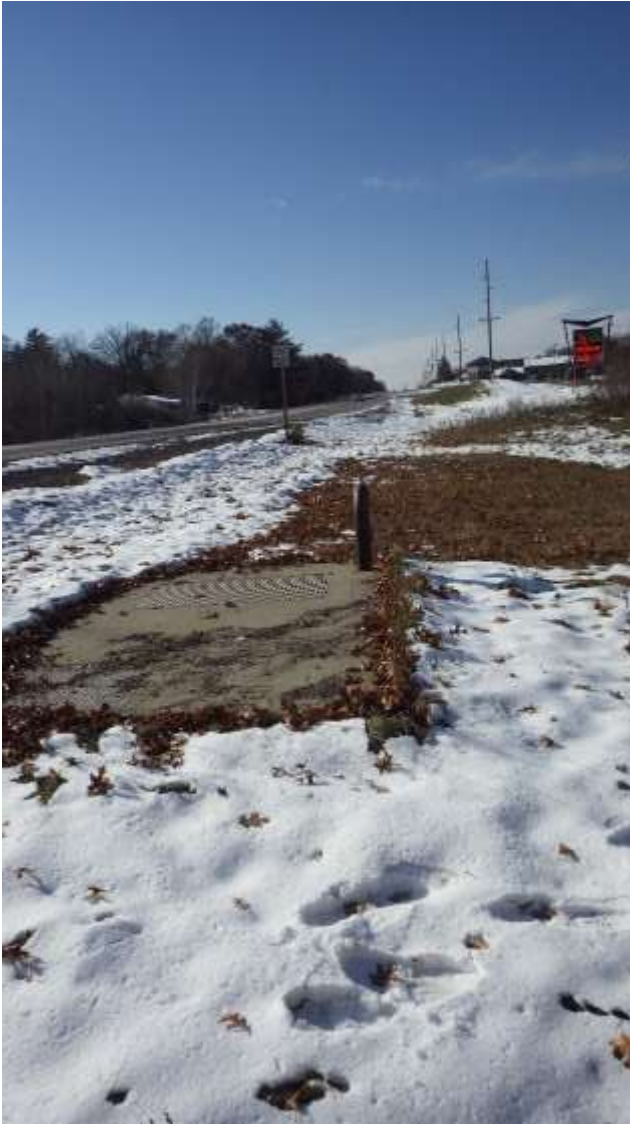
15: STWH0015

Description: Lift station 5 vault and vent.

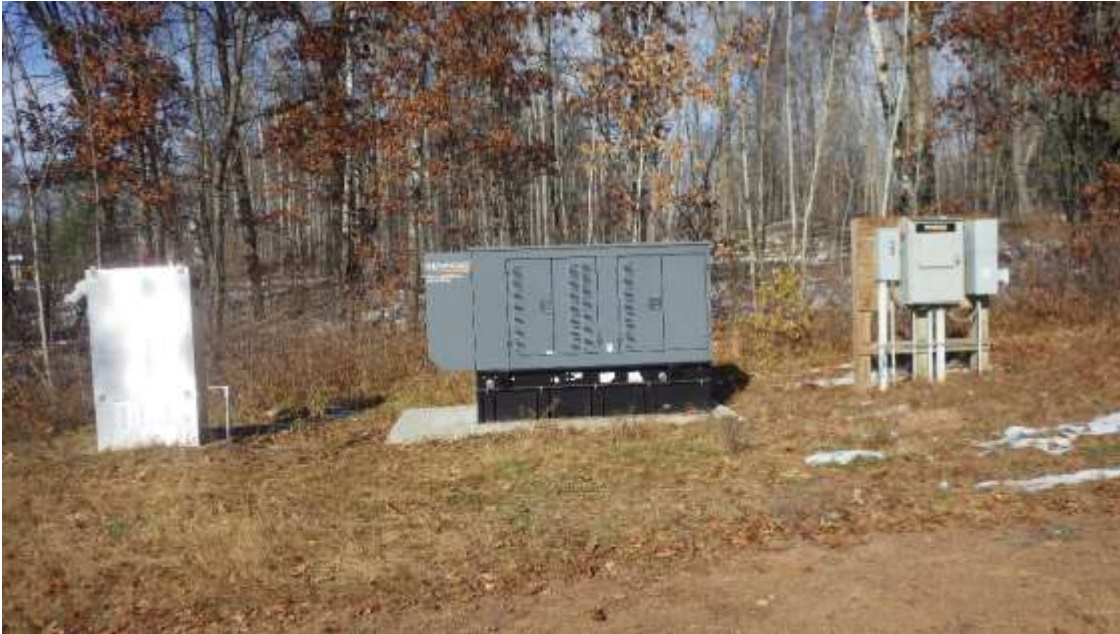
16: STWH0016

Description: Lift station 5 backup generator and controls.
