**Region 6 Compliance Assurance and Enforcement Division  
INSPECTION REPORT**

| Inspection Date(s): | 08/21-22/2024 | | |
| Company Name: | International Paper Co | | |
| Facility Name: | Mansfield Mill | | |

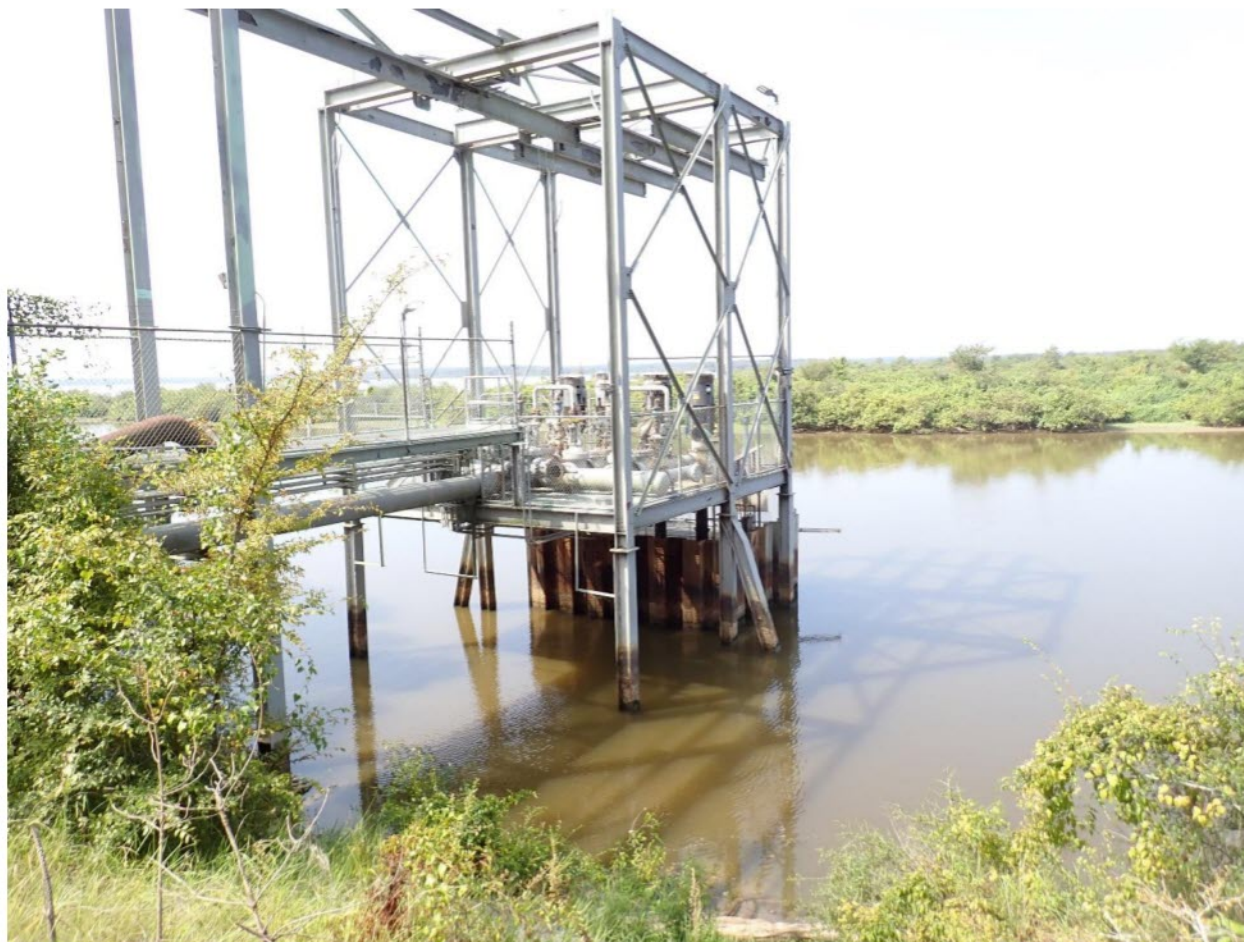
Photo No. 2

This image shows the Water Intake Structure that intake fresh water from Toledo Bend Reservoir for the cooling and industrial processes at the facility. The design intake flow of the system is 18.8 MGD and the actual intake flow is 17.1 MGD.

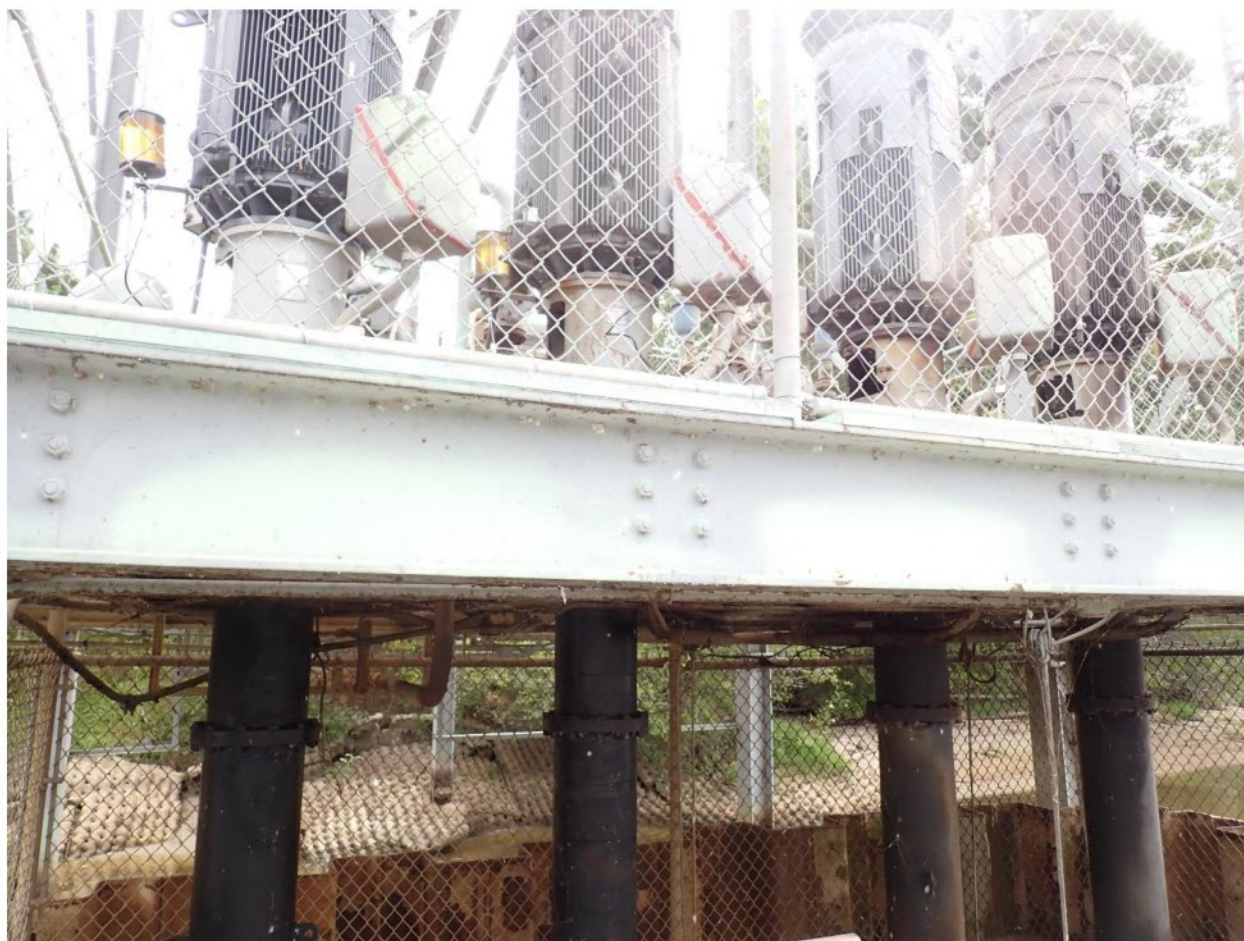
Photo No. 3

This image shows four pumps with trash racks that are used to intake fresh water from Toledo Bend Reservoir. The bottoms of the trash racks are approximately 25 to 30 feet below the reservoir surface water level.

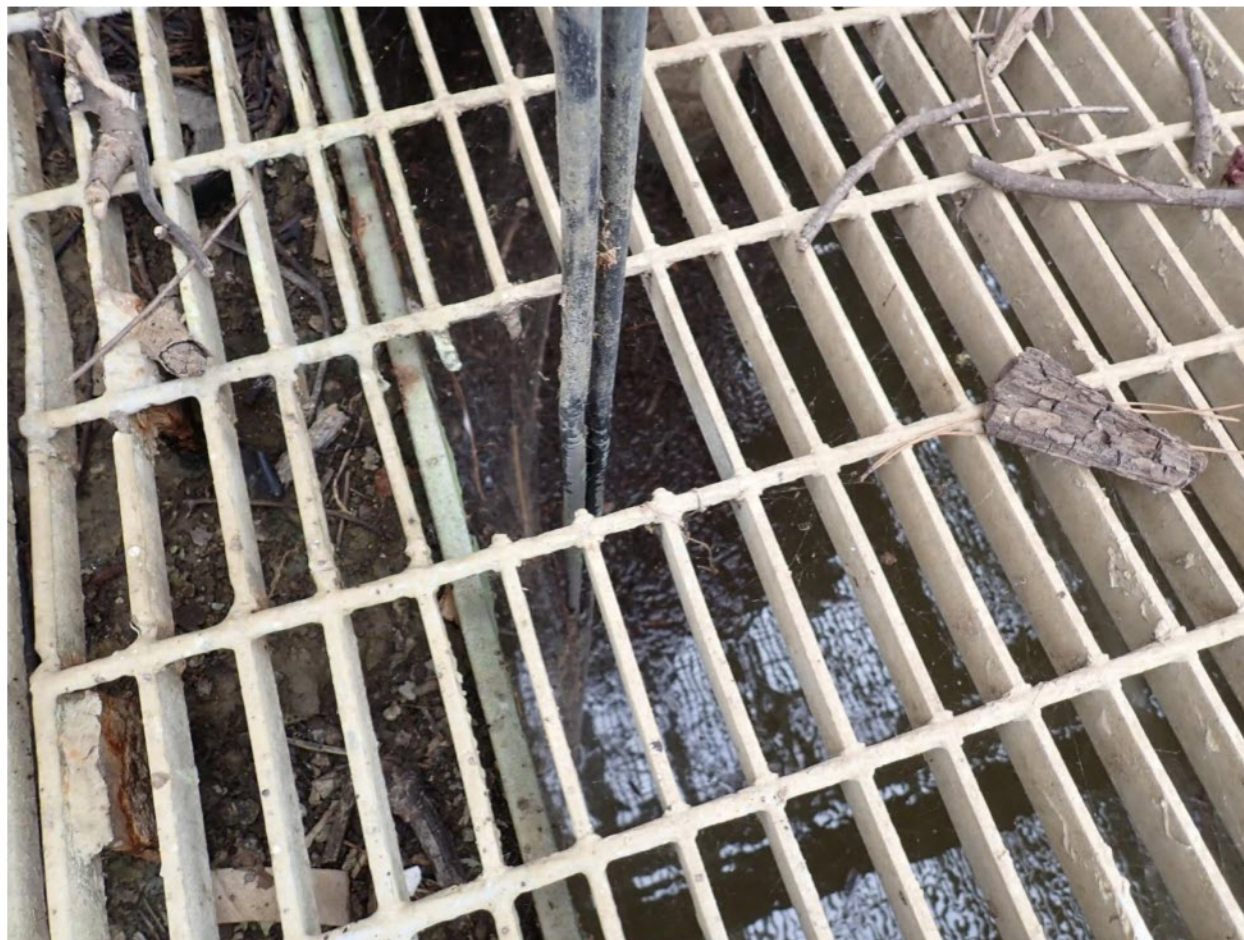
Photo No. 4

Photograph File Name: P8220132.JPG  
Date of Photograph: 08/22/2024  
Latitude and Longitude: 31.892353 -93.897206  
Orientation: SW  
Map Datum: WGS-84  
Time of Photo: 9:39 AM  
Photographer: Jack Arias  
Description: This image shows debris inside the stainless-steel trash rack box.

1. Facility should provide the 316b application file that includes information about the integrity and maintenance of the cooling water intake structure (CWIS). This file should include intake structure dimensions, maintenance records in case of corrosion (stainless-steel trash rack wall structures) and others, drawings and maintenance records of screened caisson structure that prevent large organism or debris from entering the system, drawings and maintenance records of smaller mesh screened structure that reduce impingement of small organism or further restrict smaller debris manual backflush.

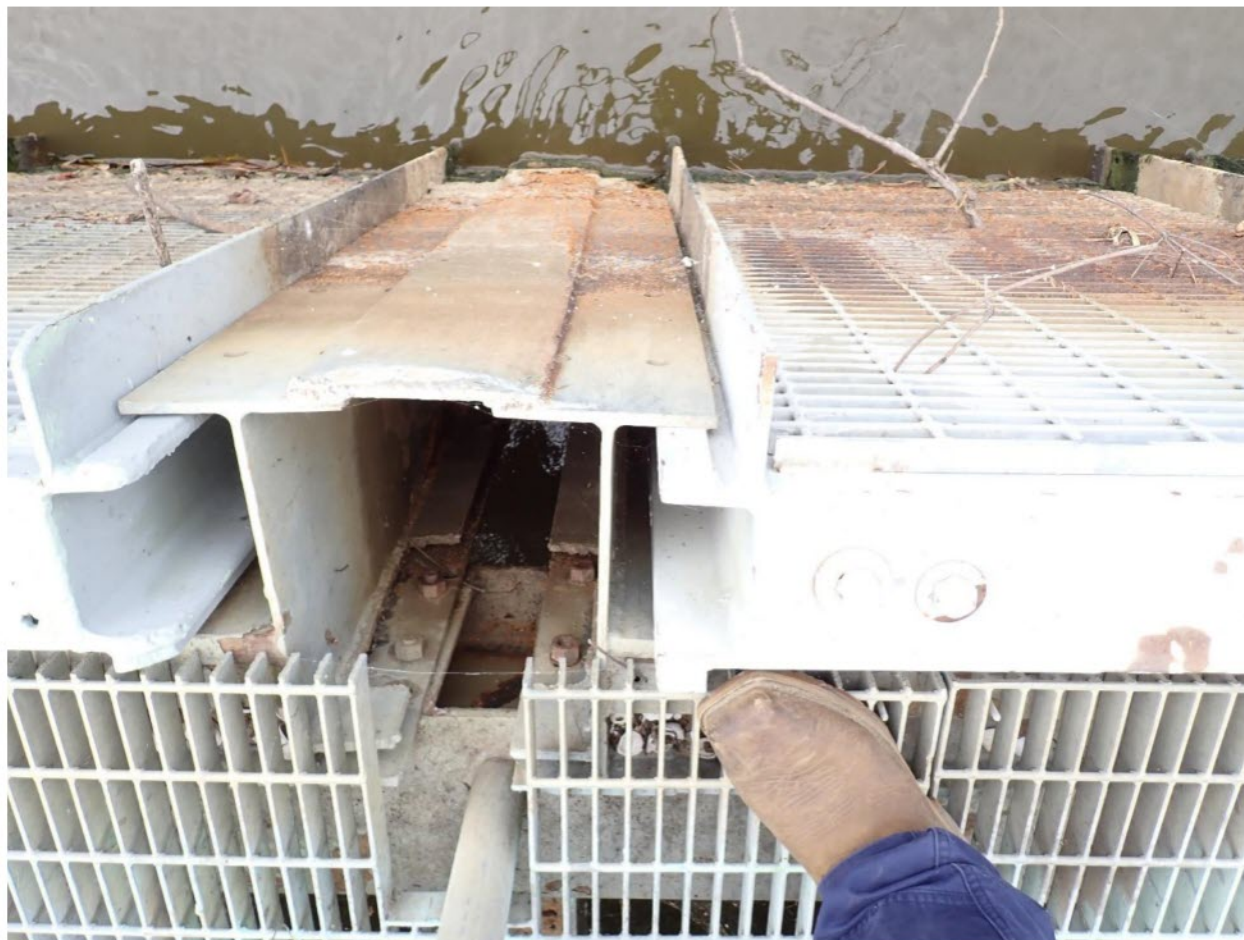
Photo No. 5

This image shows corrosion on the stainless-steel trash rack wall structures that contain and protect the intake pipes connected to the pumps.

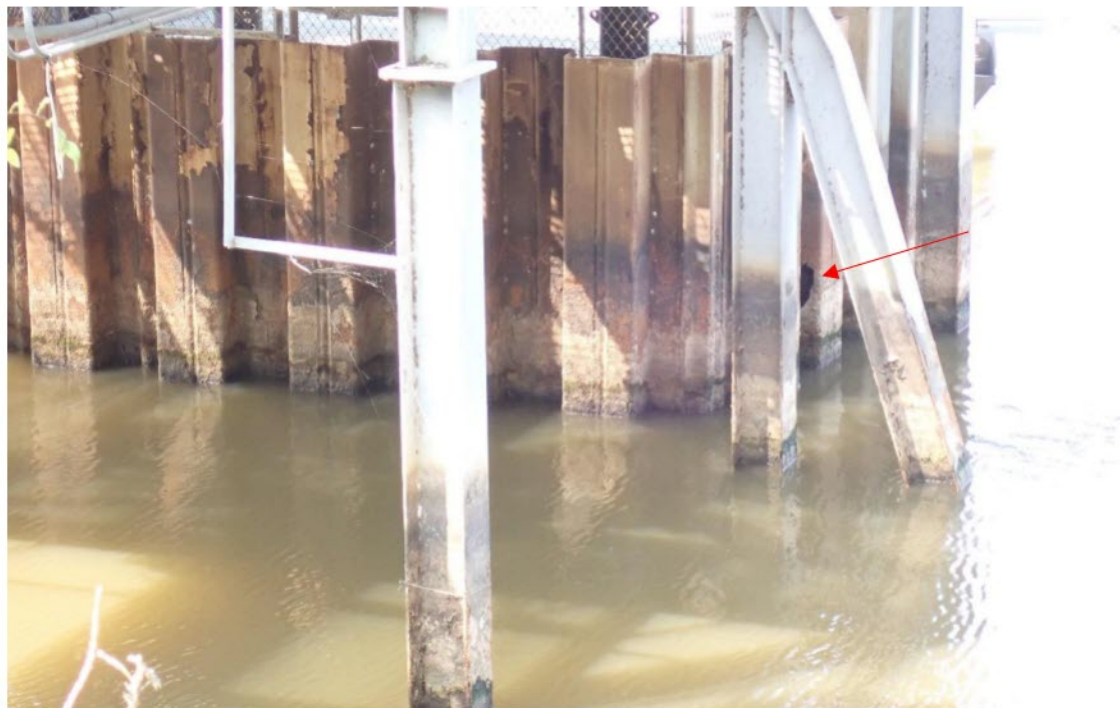
Photo No. 6

This image shows a large hole (red arrow) on the stainless-steel trash rack wall structures that contain and protect the intake pipes connected to the pumps.

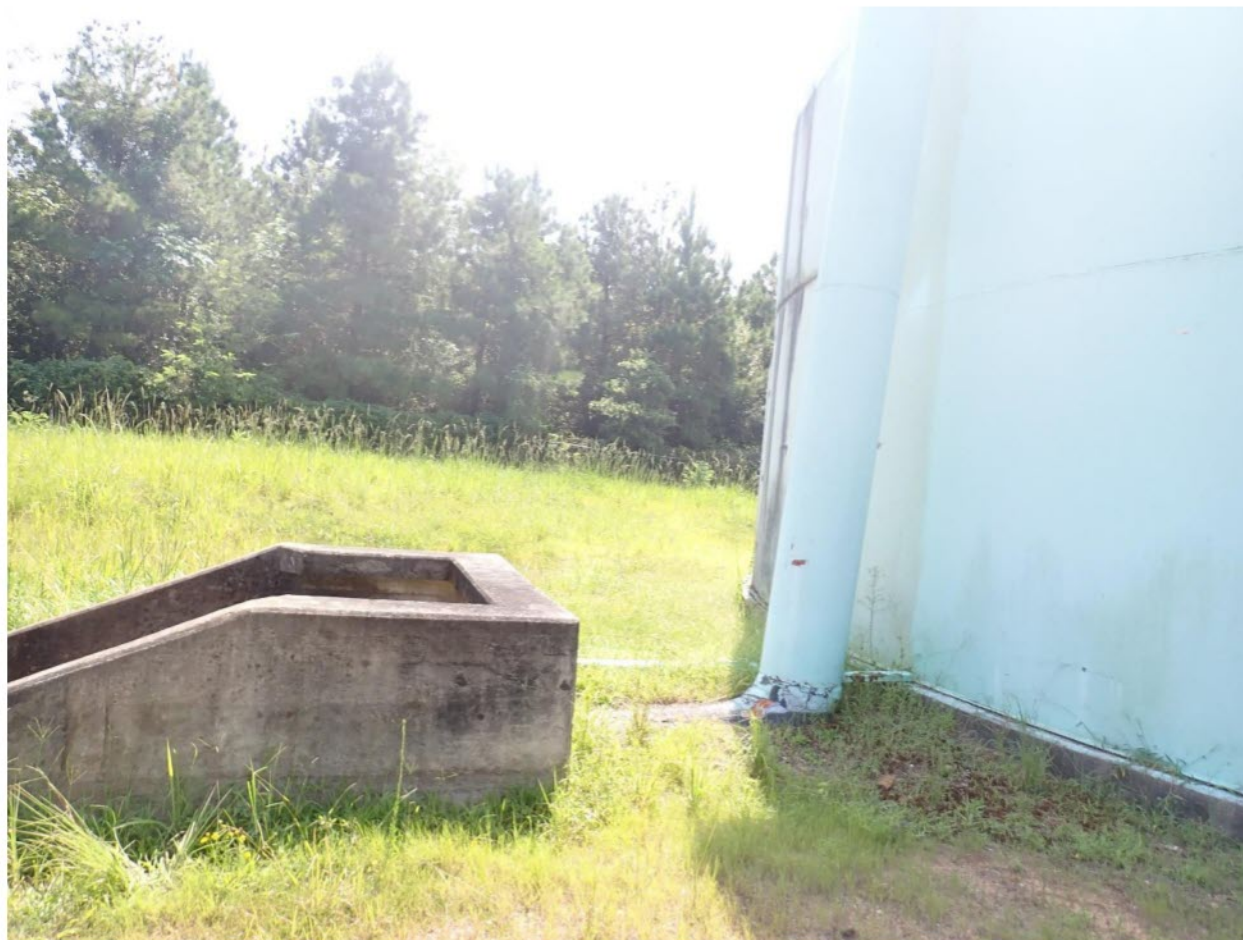
Photo No. 7

This image shows the head tank which is part of the water intake structure system (CWIS). Its purpose is to store water and provide capacity water to maintain facility operations for specific period of times.

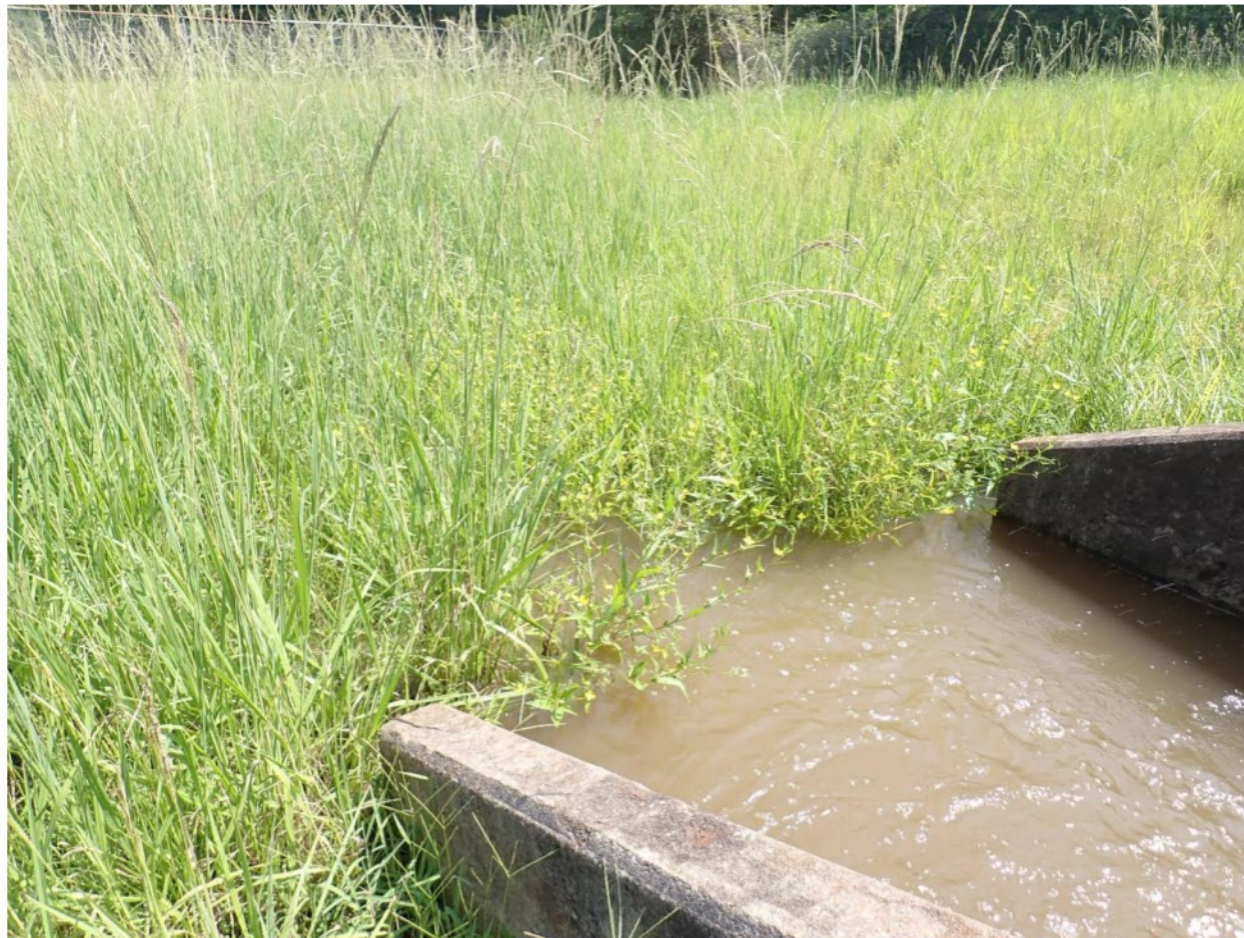
Photo No. 8

The head tank is part of the water intake structure system (CWIS). Its purpose is to store water and provide capacity to maintain facility operations for specific periods of time. Intake water is stored at this location and transferred to the mill. The tank is connected to nine pumps prior to the mill (four intake pumps at Toledo Bend Reservoir, two push pumps between Toledo and Head Tank, and three push pumps between head tank and the mill). At the time of the inspection, we observed intake water overflowing from the tank to ground surface next to the tank (See Photo Nos. 7 – 8 in Appendix 1).

Description: This image shows the intake water overflowing from the tank to ground surface next to the tank.

2. Facility needs to provide information about a permit that allows them to release water from the head tank into the surface area next to the tank. Also, the facility needs to explain how they will control the volume and flow rate of water going to the head tank and discharge into the surface.

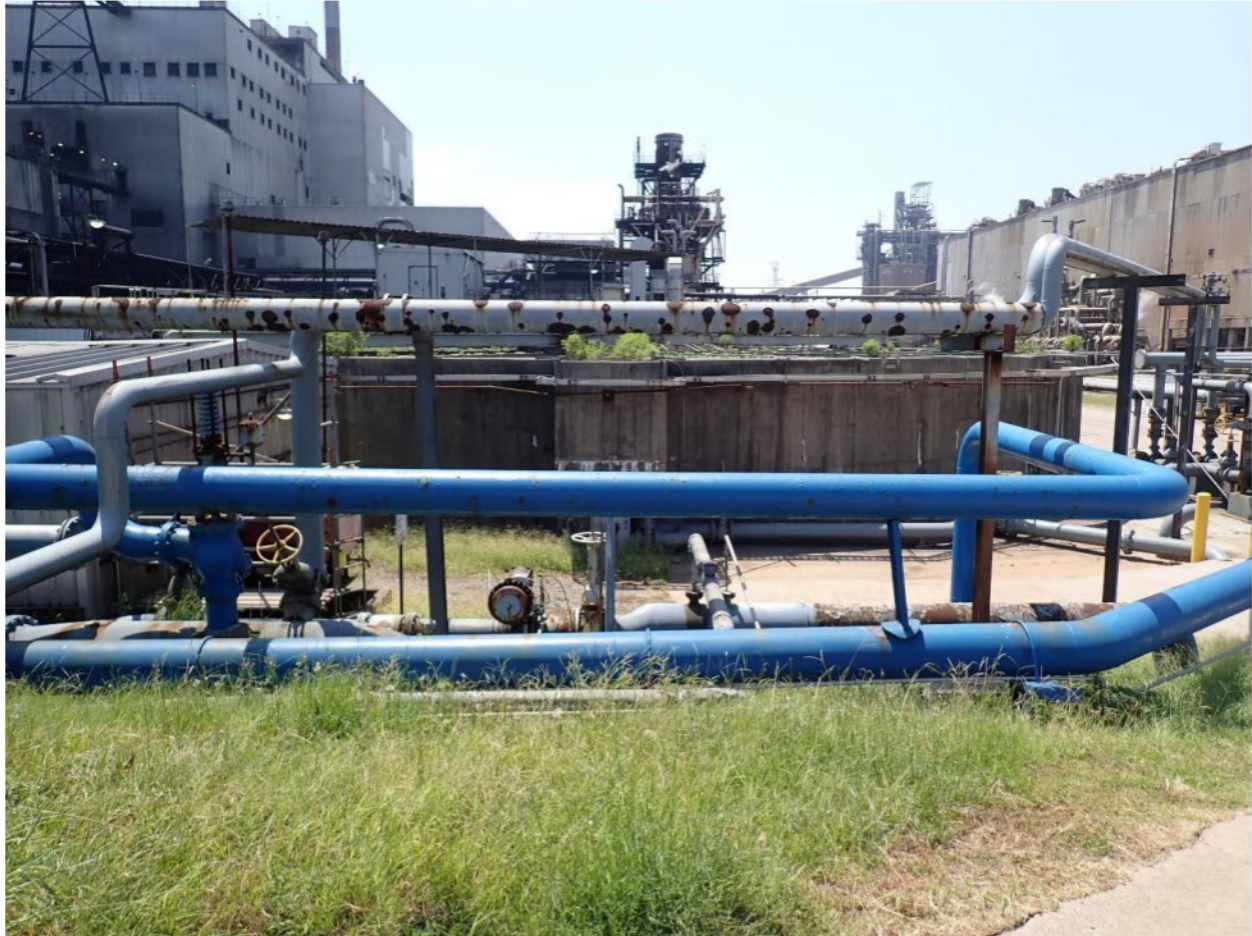
Photo No. 9

Photograph File Name: P8210061.JPG  
Date of Photograph: 08/21/2024  
Latitude and Longitude: 32.1592963 -93.5568618  
Orientation: E  
Map Datum: WGS-84  
Time of Photo: 11:29 PM  
Photographer: Jack Arias  
Description: This image shows the south clarifier that received and treated water from the intake water from Toledo Bend Reservoir prior to being routed to the treated water reservoir for use in utilities and mill process units.

3. Facility needs to control the plants and algae growth inside the south and north clarifier systems and further explain how the plants and algae potentially impact the treatment process and integrity of the clarifier systems.

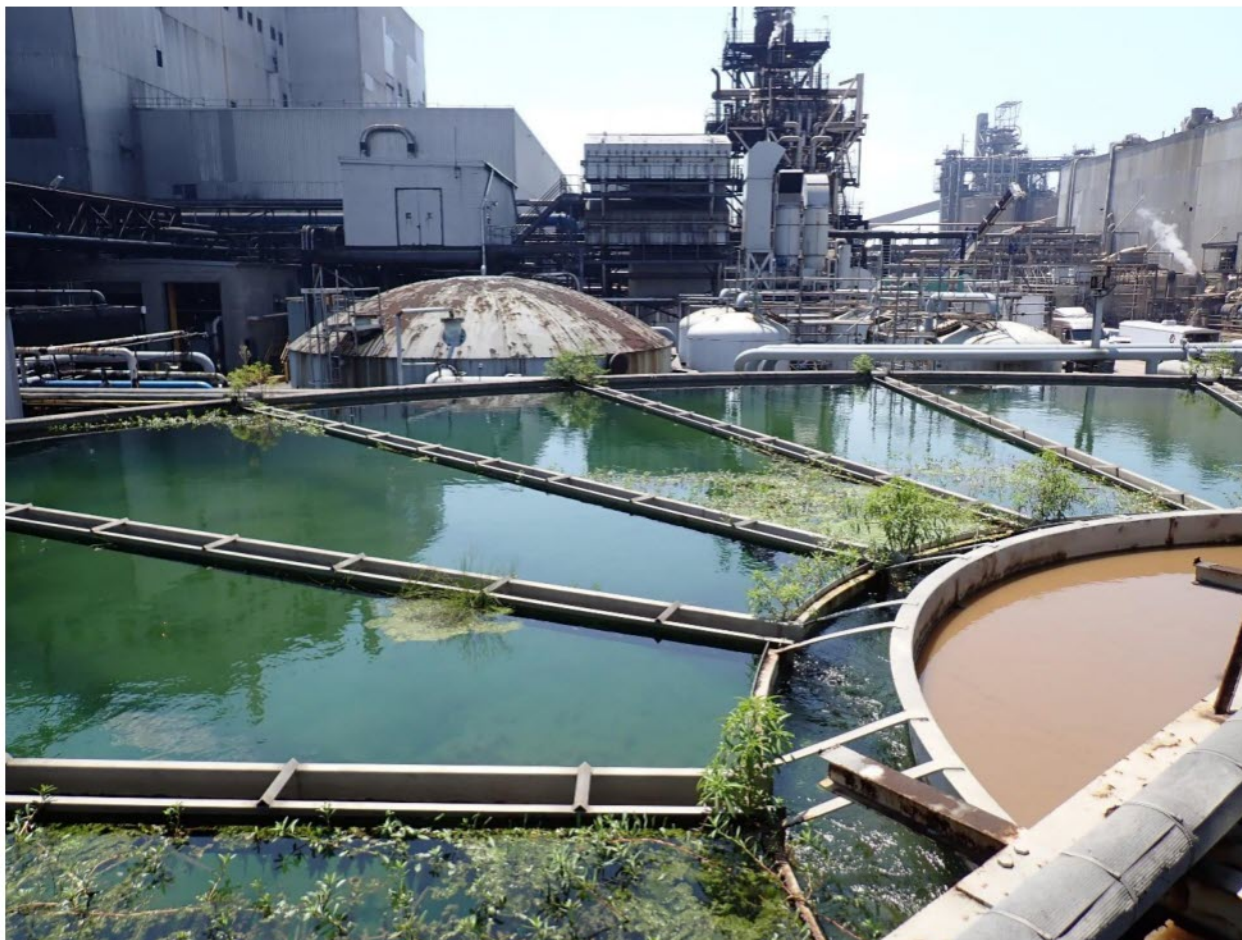
Photo No. 10

Photograph File Name: P8210065.JPG  
Date of Photograph: 08/21/2024  
Latitude and Longitude: 32.1592963 -93.5568618  
Orientation: E  
Map Datum: WGS-84  
Time of Photo: 11:39 AM  
Photographer: Jack Arias  
Description: This image shows plants and algae beds inside the south clarifier system. These plants and algae layers could potentially impact the treatment process and integrity of the clarifier system.

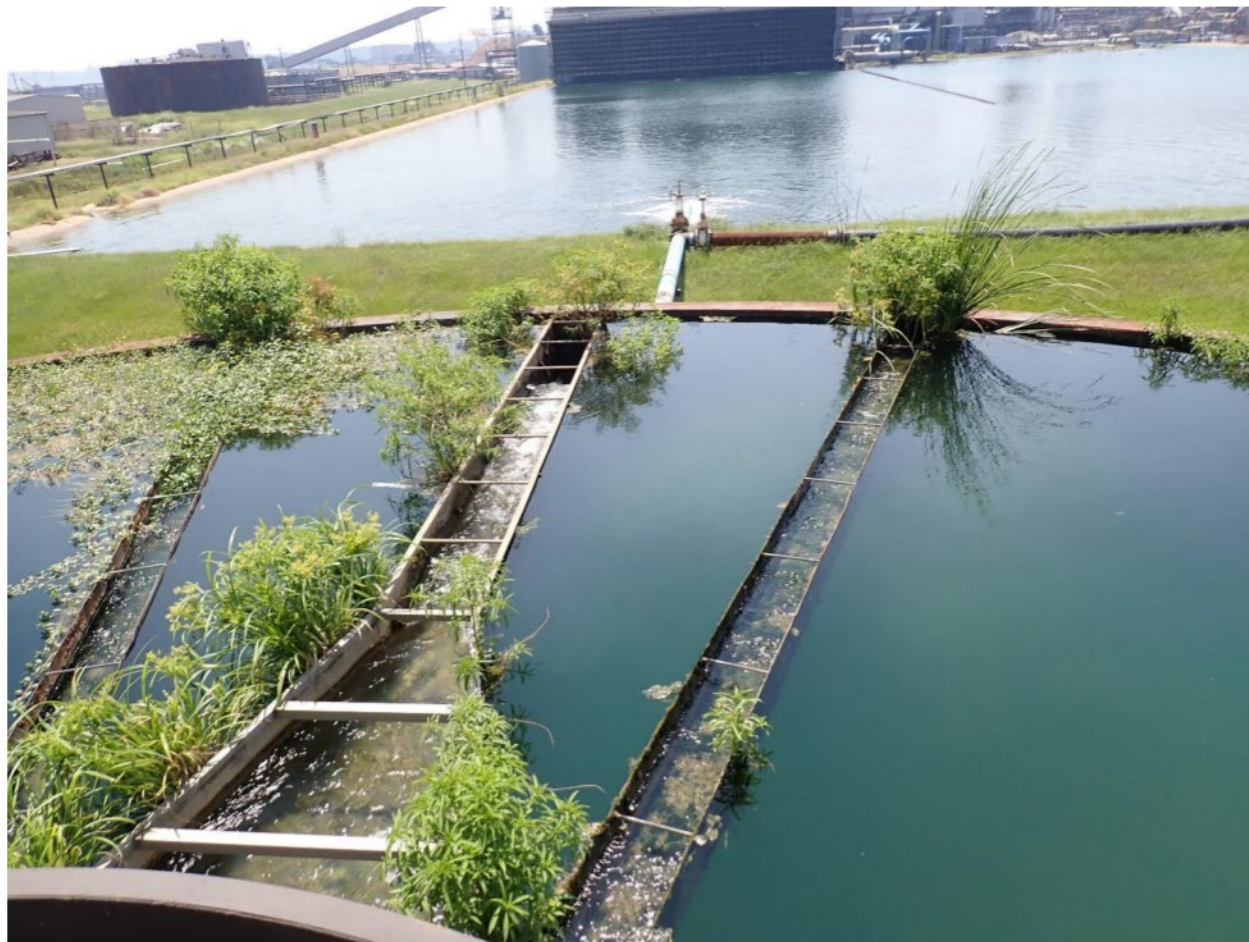
Photo No. 11

This image shows plants and algae beds inside the north clarifier system. These plants and algae beds could potentially impact the treatment process and integrity of the clarifier system.

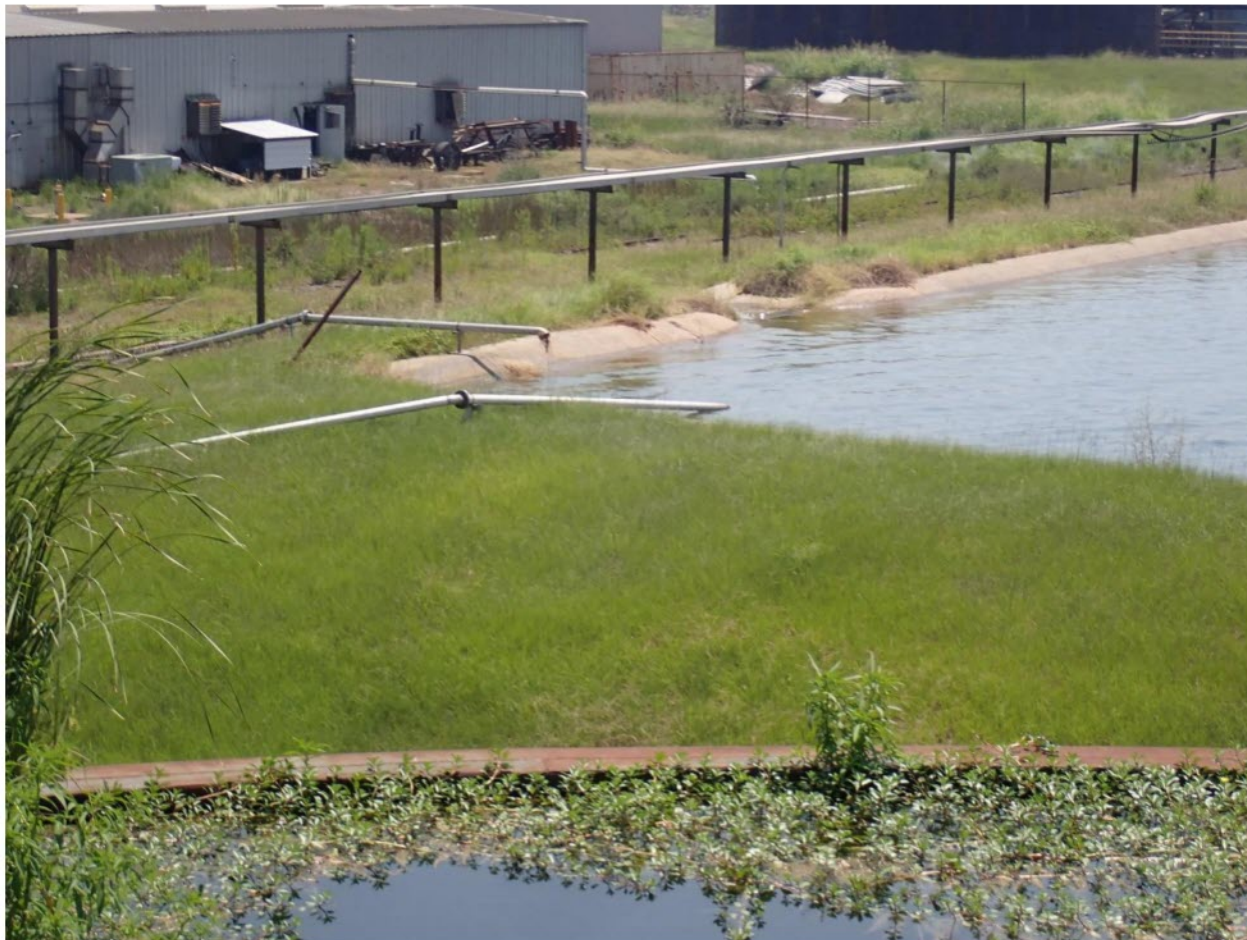
Photo No. 15

The treated water reservoir received water from Toledo Bend Reservoir. The water is treated through two clarifiers (south and north clarifiers) systems and discharge into the treated water reservoir for use in utilities and mill process units. Its main purpose is to provide capacity water to maintain facility operations for specific periods of time. At the time of the inspection, we observed the presence of fish and small formation of algae. Also, we observed large amounts of treated water overflowing (north right corner of

reservoir) from the reservoir directly into a ditch system next to the reservoir area leading to Outfall 003 (See Photo Nos. 12 – 20 in Appendix 1).

This image shows large amounts of treated water overflowing (north right corner of reservoir) from the reservoir directly into a ditch system next to the reservoir area leading to Outfall 003.

4. Facility needs to provide information about the chemical composition of the treated water at the reservoir, wastewater from mill processes redirected and recirculated to the treated water reservoir, and cooling water redirected to the reservoir. This will help to determine the potential

impacts of treated water that was overflowing (north right corner of reservoir) from the reservoir directly into a ditch system next to the reservoir and directed to Outfall 003.

5. Facility needs to provide an explanation of the treated water overflowing and discharging from the reservoir into a ditch system, thence to Outfall 003.
6. Facility needs to provide an updated wastewater flow balance diagram and photos of missing labels or identification tags for external and internal outfalls.
7. Also, facility needs to provide information about the inactivity and potential activation of outfall 201 (under maintenance).
8. Facility needs to provide copies of updated SWPP3 and SPCC plans.

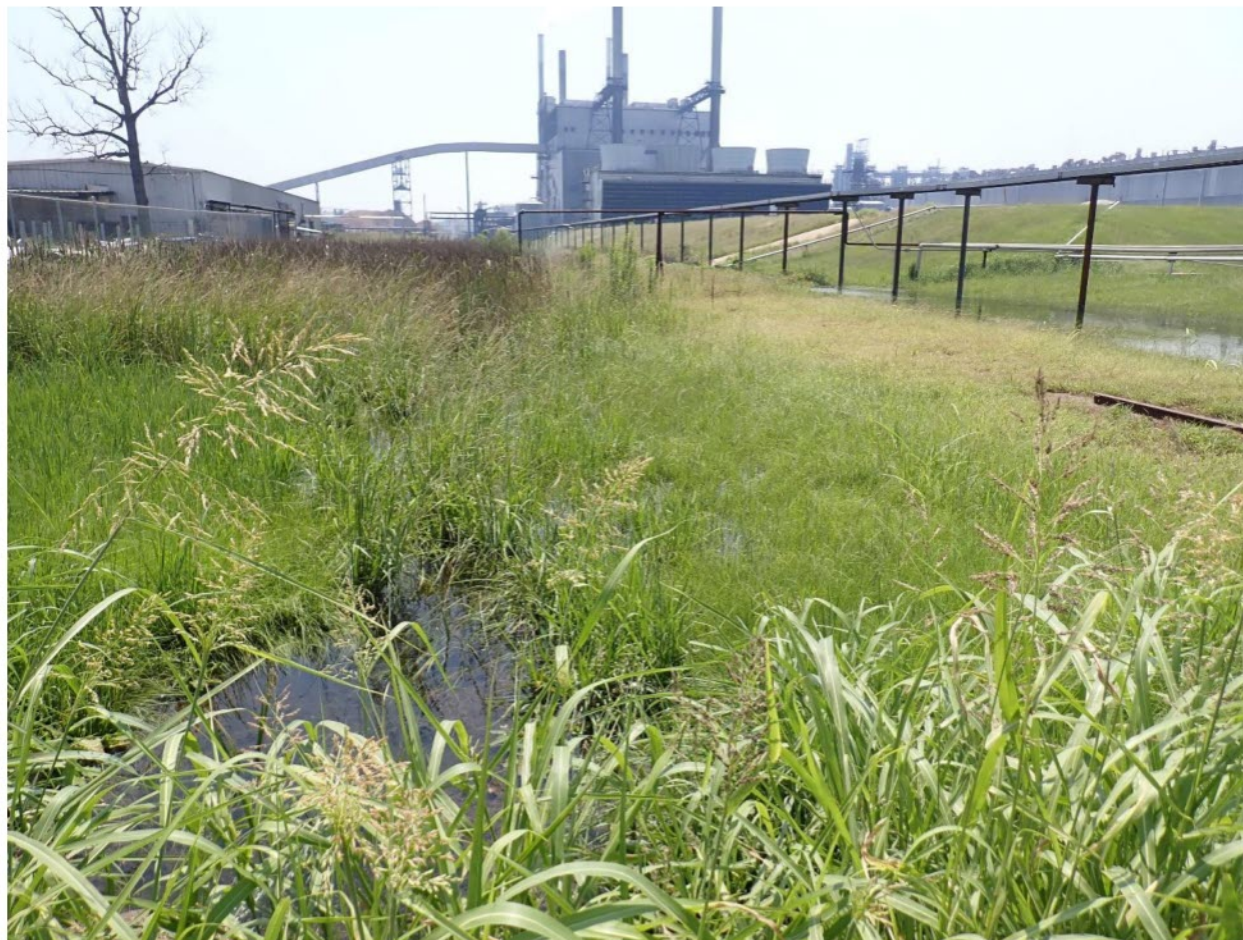
Photograph File Name: P8210091.JPG  
Date of Photograph: 08/21/2024  
Latitude and Longitud: 32.161234 -93.555356  
Orientation: NE  
Map Datum: WGS-84  
Time of Photo: 12:20 PM  
Photographer: Jack Arias  
Description: This image shows the ditch system next to the reservoir area directing treated water to Outfall 003.

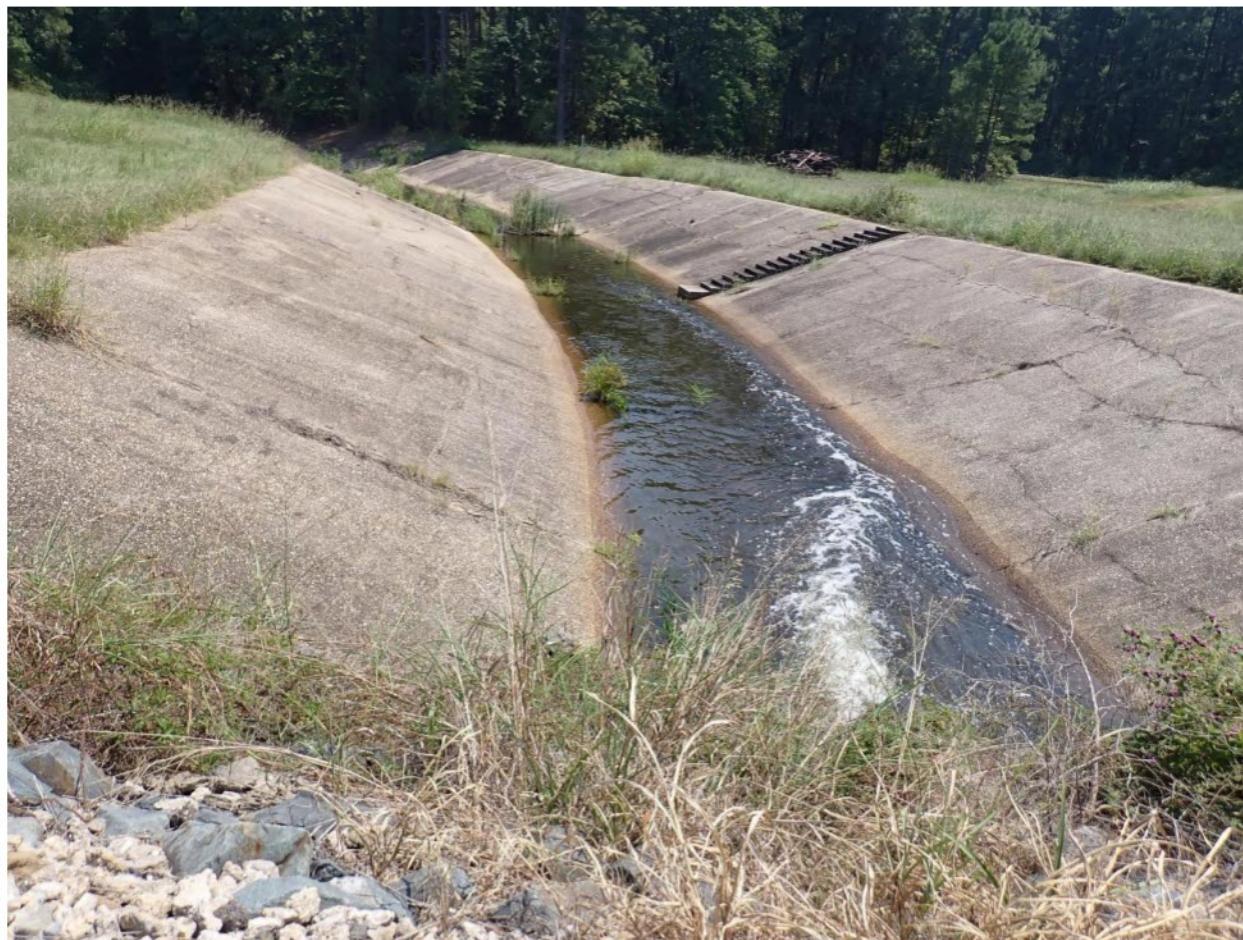
This outfall includes intermittent discharge of low contamination potential stormwater runoff and treated water reservoir overflow. Outfall 003 discharges into Bayou Pierre. At the time of the inspection, we observed large amounts of treated water overflowing and discharging (north right corner of reservoir) from the reservoir into a ditch system next to the reservoir area and directed to Outfall 003. Also, we did not observe the proper label or identification tag. There was flow and discharge into Bayou Pierre (See Photo Nos. 15 - 21 in Appendix 1).

Photograph File Name: P8210111.JPG  
Date of Photograph: 08/21/2024  
Latitude and Longitude: 32.156279 -93.552007  
Orientation: NE  
Map Datum: WGS-84  
Time of Photo: 1:10 PM  
Photographer: Jack Arias  
Description: This image shows a downstream flow and discharge from Outfall 003.

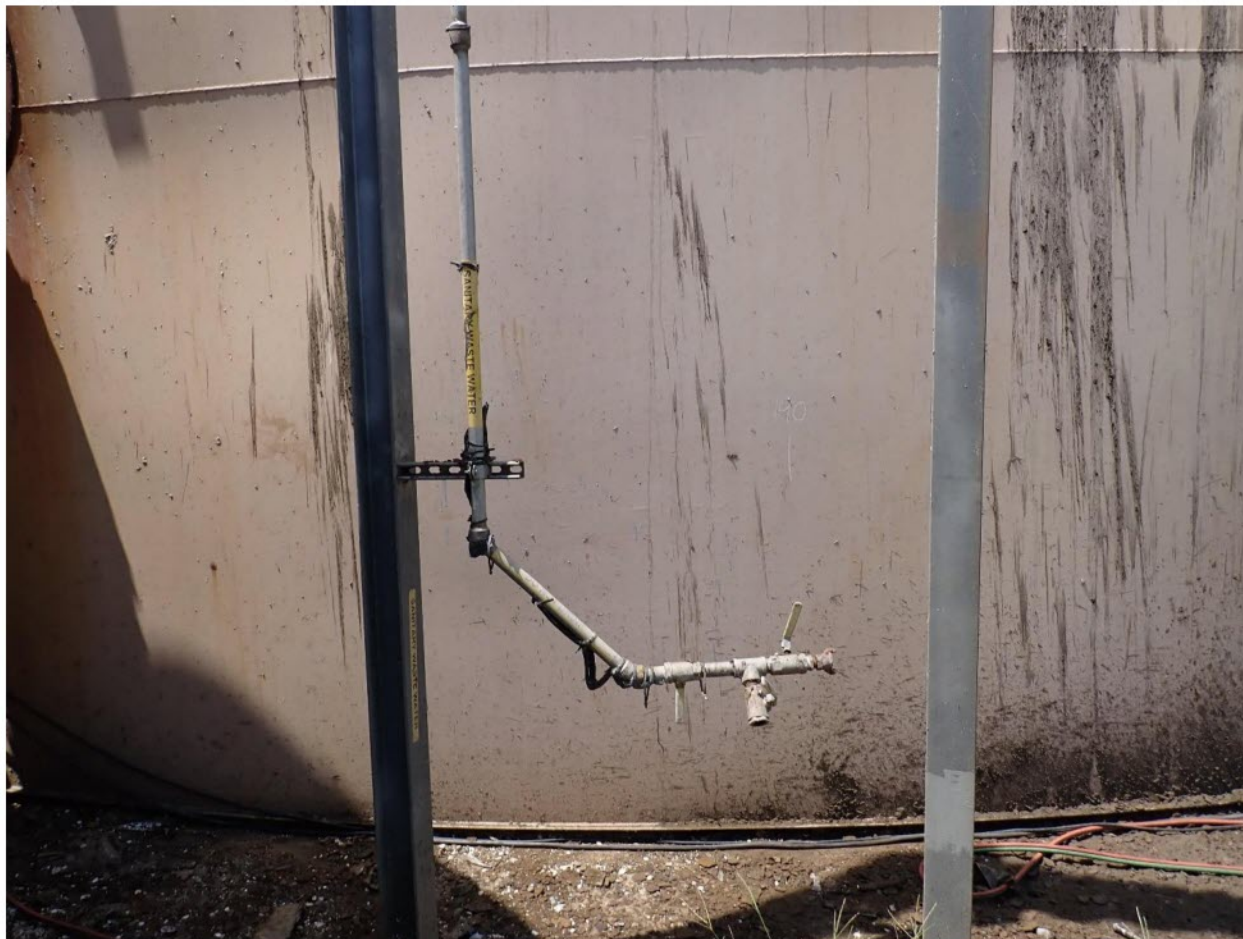
This image shows internal outfall 201 that discharge into lift Pit and is directed to the wastewater treatment system, and thence to outfalls 001 (Red River) and 002 (Bayou Pierre). We did not observe the proper label or identification tag.

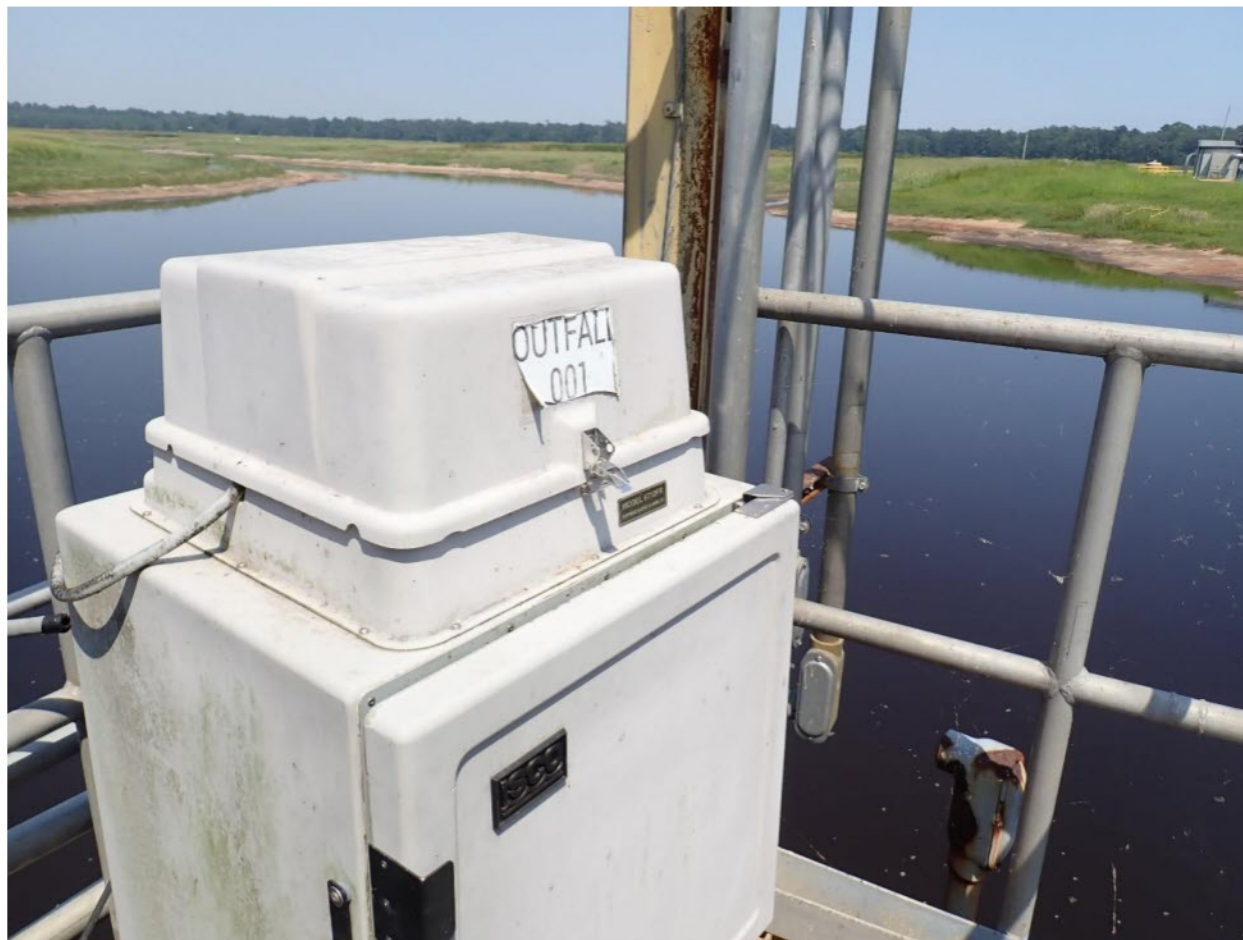
This outfall includes continuous discharge of treated combined process wastewater, process area storm water runoff, landfill leachate, utility wastewater, miscellaneous wastewater, non-process area storm water runoff, and monitored treated sanitary wastewater from internal outfalls 101 and 201. Outfall 001 discharges to Red River. There was flow and discharge at the time of the inspection and the water had a dark brown tint (See Photo No. 29 in Appendix 1).

This image shows outfall 001 that includes continuous discharge of treated combined process wastewater, process area storm water runoff, landfill leachate, utility wastewater, miscellaneous wastewater, non-process area storm water runoff, and monitored treated sanitary wastewater from internal outfalls 101 and 201

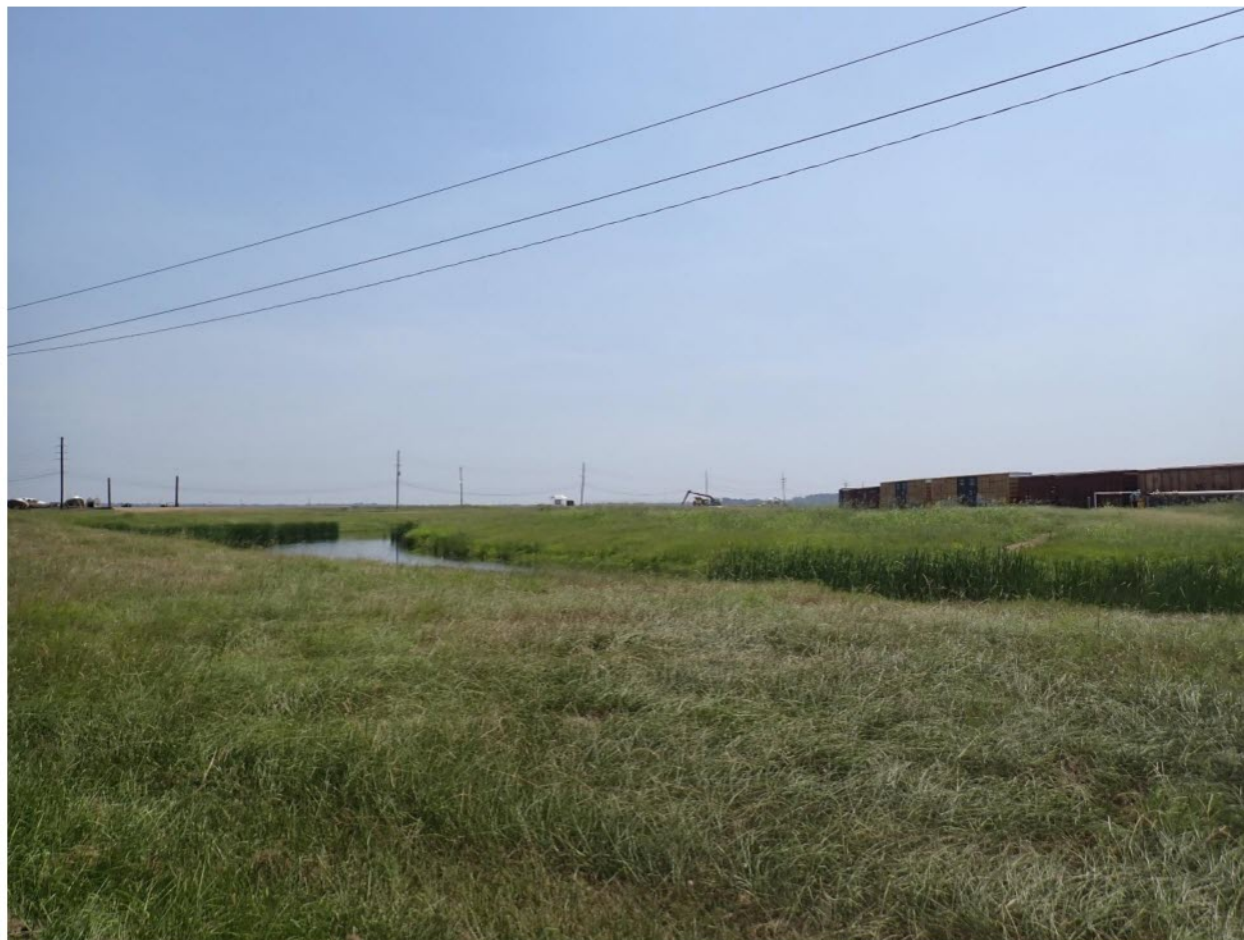
These outfalls 005 and 006 includes intermittent discharge of low contamination potential stormwater runoff from the northern (005) and southern (006) sections of the solid waste disposal facility (low contamination potential stormwater runoff from rail yard and rail tracks in the case of outfall 006). At the time of the inspection, we observed that both outfalls did not have an identification tag (See Photo No. 30 in Appendix 1).

This image shows pathways to outfalls 005 and 006. These outfalls have intermittent discharge of low contamination potential stormwater runoff from the northern (005) and southern (006) sections of the solid waste disposal facility (low contamination potential stormwater runoff from rail yard and rail tracks in the case of outfall 006).
