## REGION 10 Enforcement Division

### INSPECTION REPORT

| <b>Facility or Site Name:</b> | University of Alaska SE Auke Lake Campus | | |

Type of inspection: CEI - Compliance Evaluation Inspection

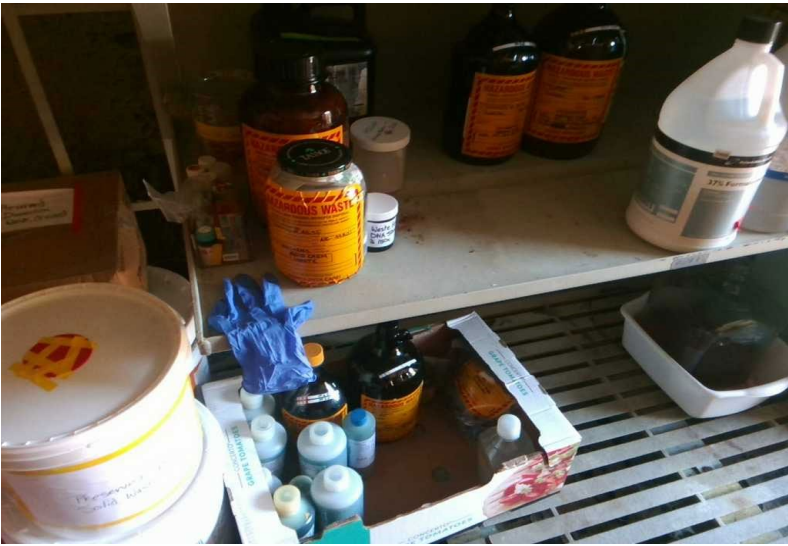
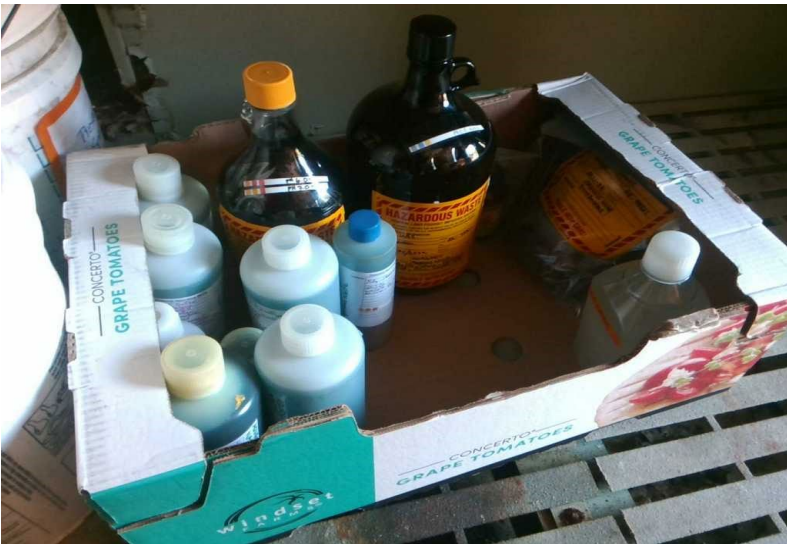
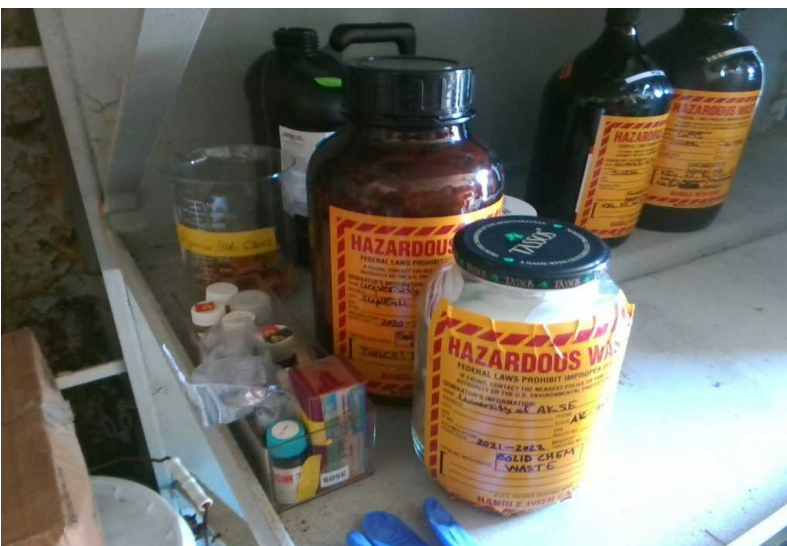
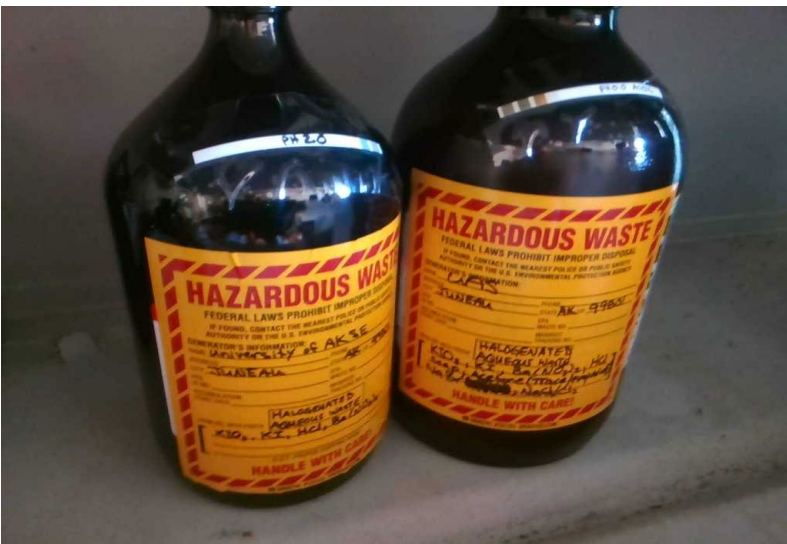
| During the inspection, I inspected the waste being accumulated in the Hazardous Material shed. | |

| View of the waste in the Hazmat shed. | |

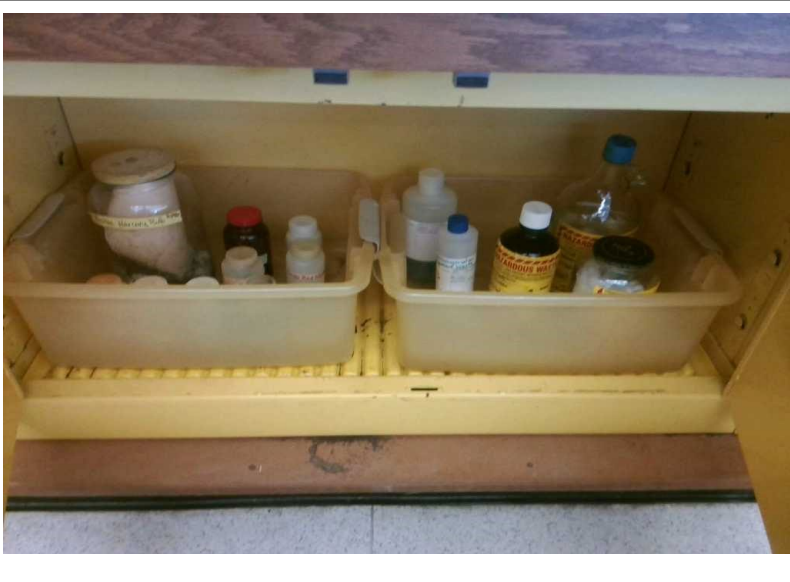
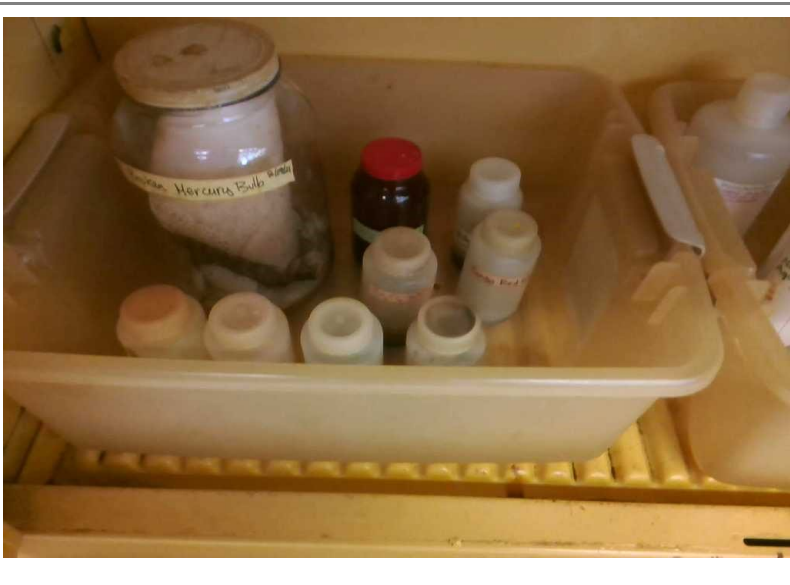
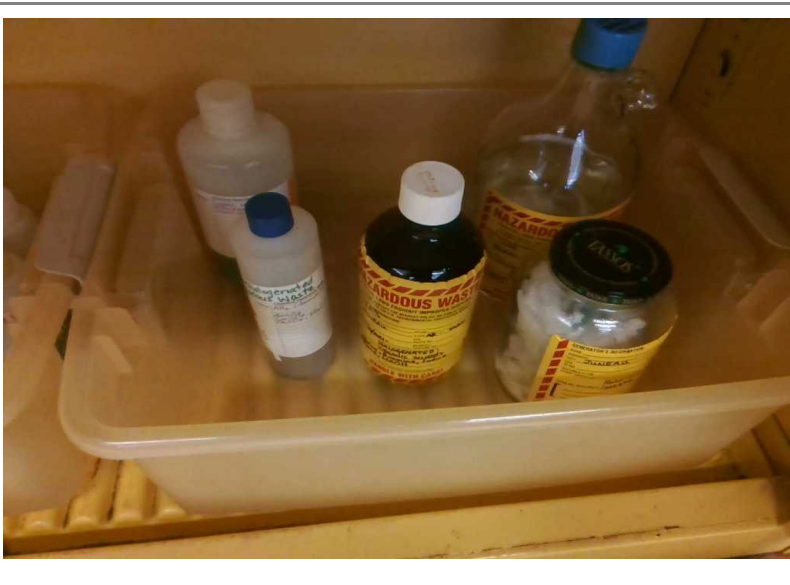
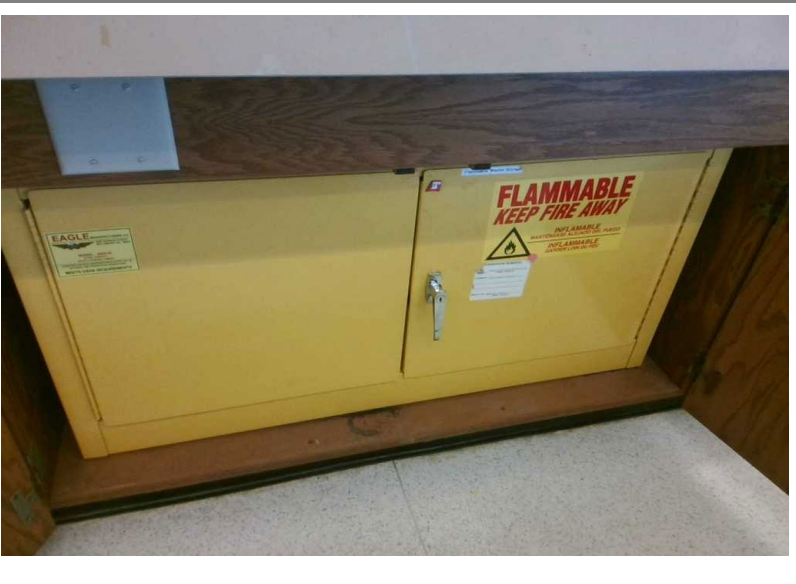
| While inspecting the Anderson Building, I met Ms. Honalee Elkan, Chemistry Lab Technician. Ms. Elkan showed me the waste accumulation areas, as well as the lab chemical storage areas. | |

| <p>[Title]</p> <p>IMG-20220412110054054725546.jpg</p> <p>04/12/2022 11:00 AM (AKT)</p> <p>Jon Jones</p> <p>Anderson Building #15/Room 309</p> <p>No CBI</p> <p>No PII</p> <p>view of the SAA beneath fume hood.</p> | |

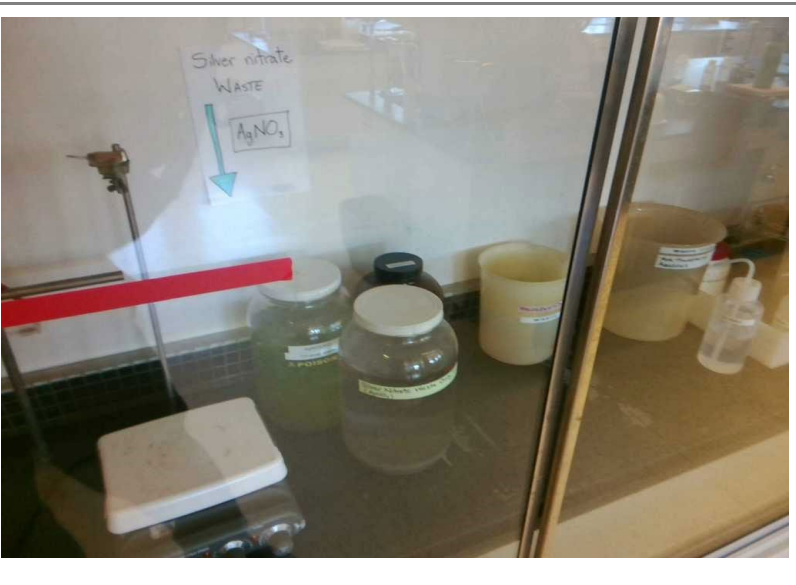
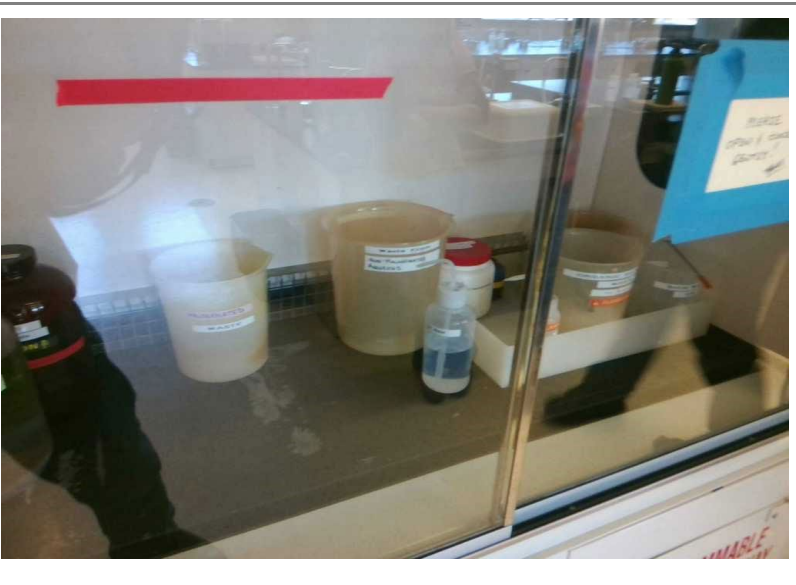
| <p>[Title]</p> <p>IMG-2022041211040545648666.jpg</p> <p>04/12/2022 11:04 AM (AKT)</p> <p>Jon Jones</p> <p>Anderson Building #15/Room 309</p> <p>No CBI</p> <p>No PII</p> <p>View of waste in fume hood.</p> | |

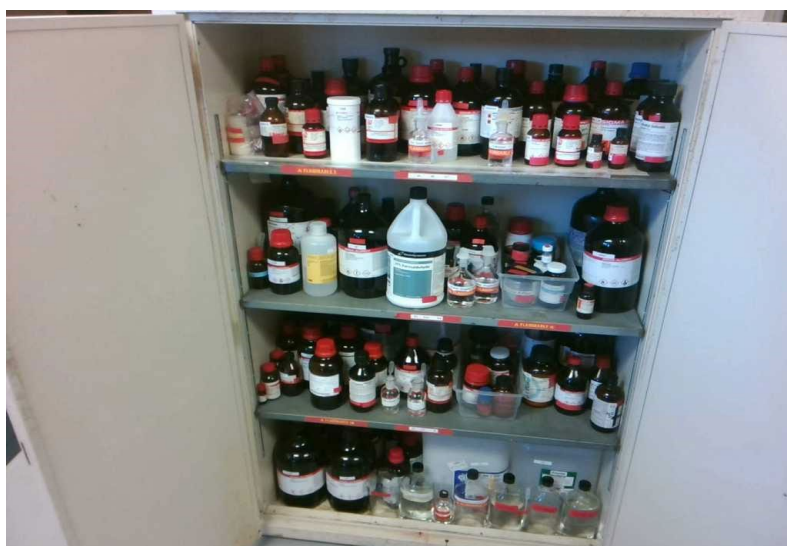
IMG-2022041211070171785325.jpg

View of the chemical storage cabinets.

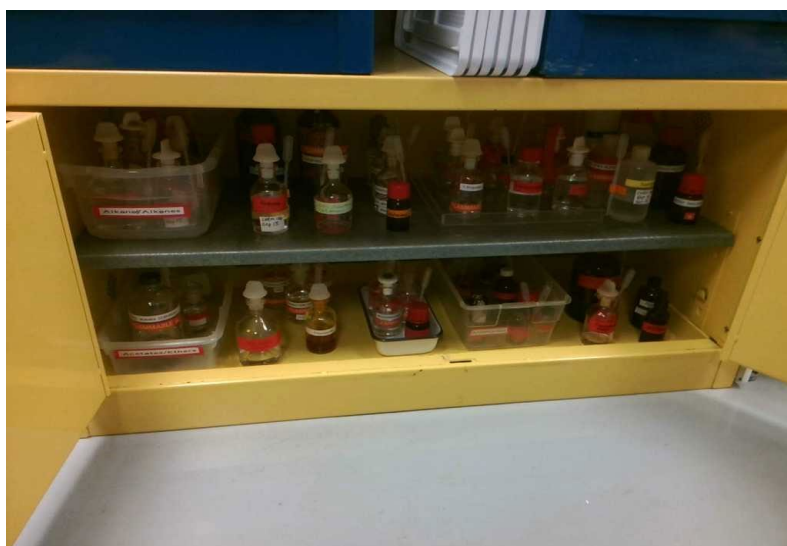
IMG-20220412110743743658762.jpg

View of the chemical storage cabinets.

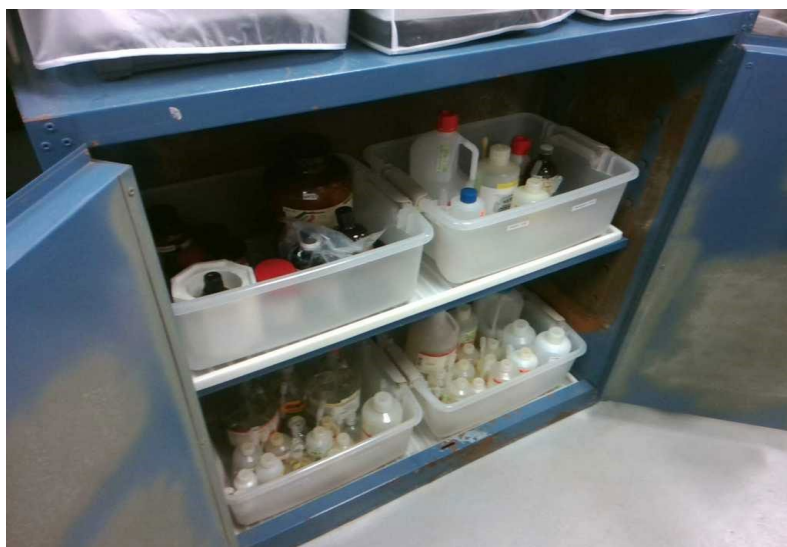
IMG-20220412110810810752626.jpg

View of the chemical storage cabinets.

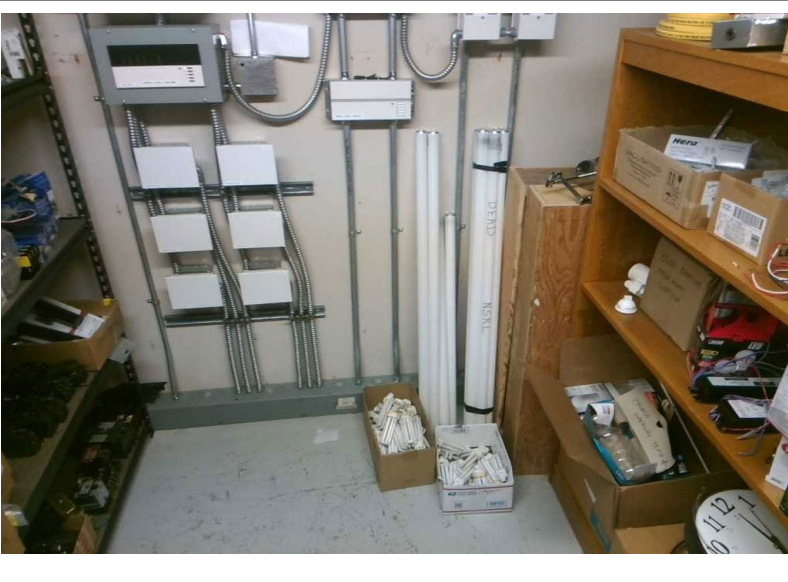
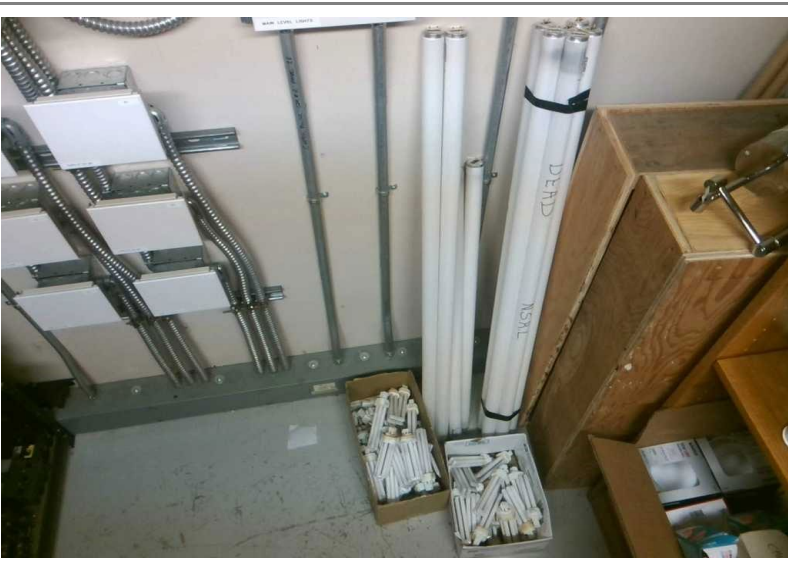
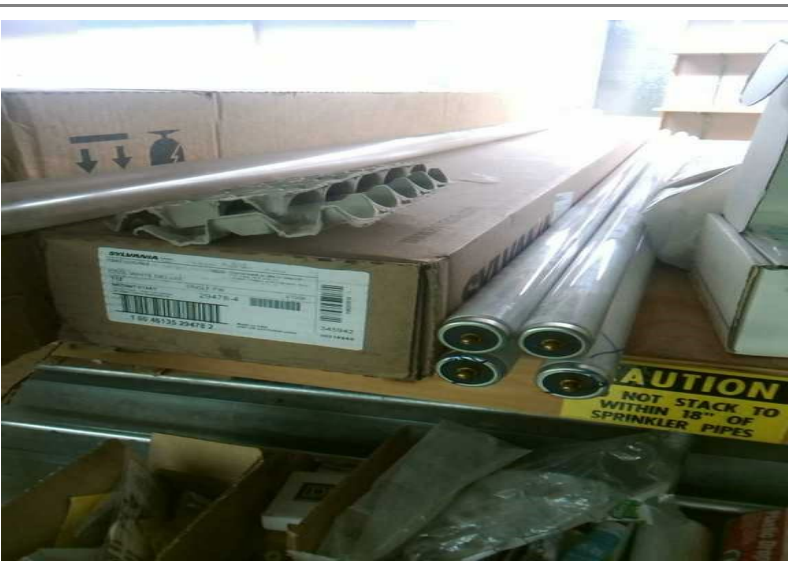
| While in Room 300U1, I inspected the area where waste fluorescent lamps and CFLs were being accumulated. The university does not manage waste lamps as universal waste. | |

| <p>[Title]</p> <p>IMG-202204121035243524909230.jpg</p> <p>04/12/2022 10:35 AM (AKT)</p> <p>Jon Jones</p> <p>Egan Classroom Wing /Room 300U1</p> <p>No CBI</p> <p>No PII</p> <p>Accumulation of waste fluorescent lamps and CFLs.</p> | |

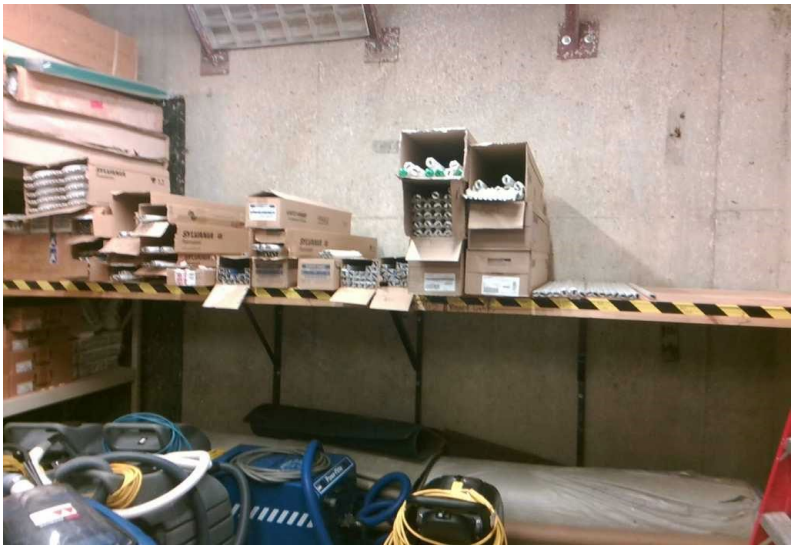
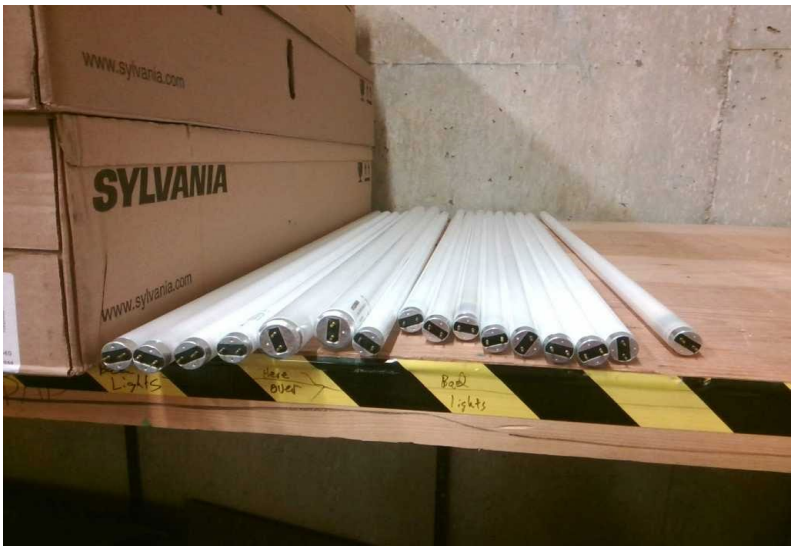
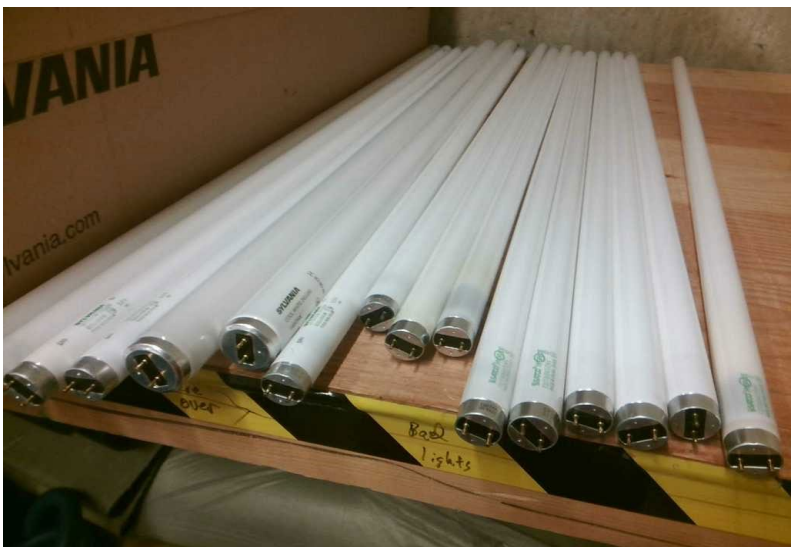
lamps. Mr. Garcia told me that the university does not manage the waste fluorescent lamps as universal waste. During the inspection, I saw 16 waste fluorescent lamps. At least some of the waste lamps were labeled in a green font, which is indicative of lamps that contain a low level of mercury that will pass TCLP testing.

| <p>[Title]</p> <p>IMG-202204121023472347935712.jpg</p> <p>04/12/2022 10:23 AM (AKT)</p> <p>Jon Jones</p> <p>Egan Classroom Wing /Storage 118</p> <p>No CBI</p> <p>No PII</p> <p>During the inspection, I saw 16 waste fluorescent lamps.</p> | |
