# NPDES Compliance Inspection Report

**Darigold – Lynden  
Lynden, Washington**

**Permit #: WAR000564**

**Inspection Date: January 27, 2022**

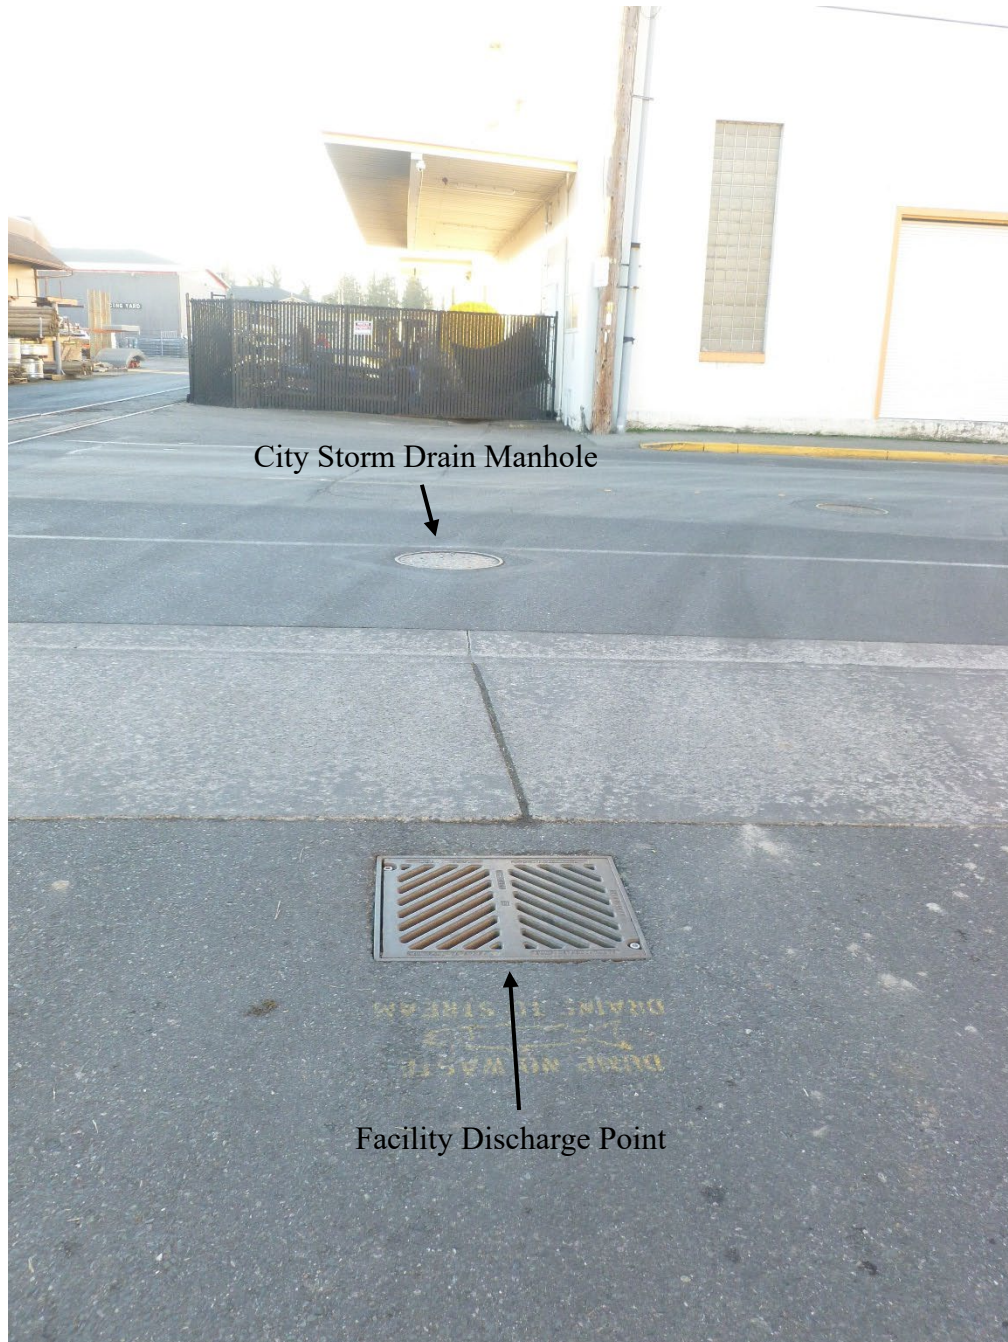
We started the tour at the facility's offices, which were adjacent to, and on the northern side of, Deport Road. We turned to the west and walked to the facility's discharge point near Pine Street (**Photo 1 & 2**). Photo 1 also shows the manhole cover for the City's stormwater conveyance system which leads to the Nooksack River.

**Photo 1 / P1010223** – Discharge Point to City Sewer, facing west

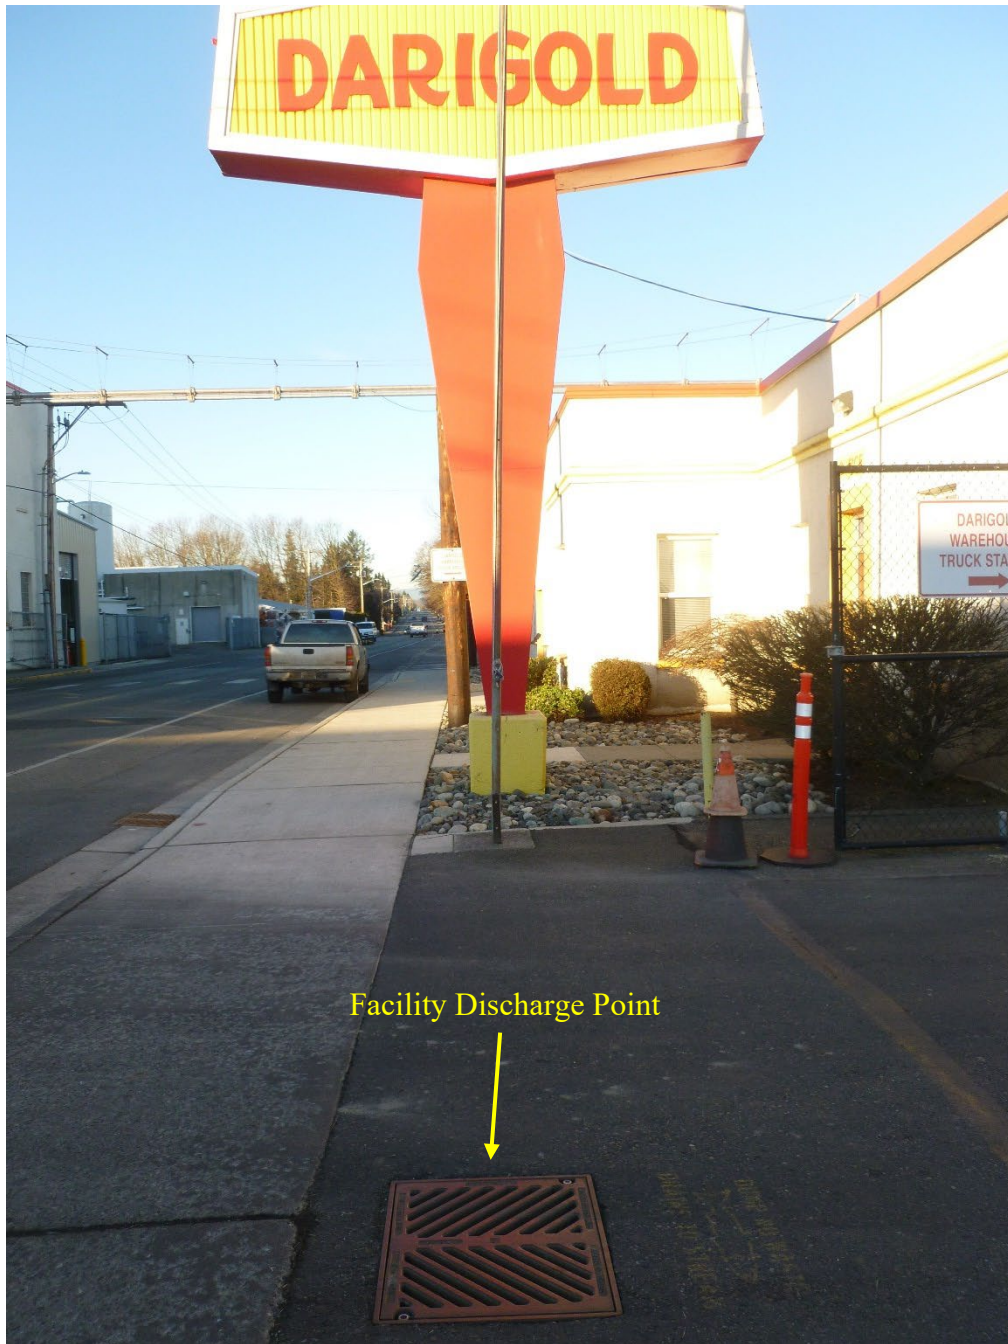
**Photo 2 / P1010224** – Discharge Point to City Sewer, facing north

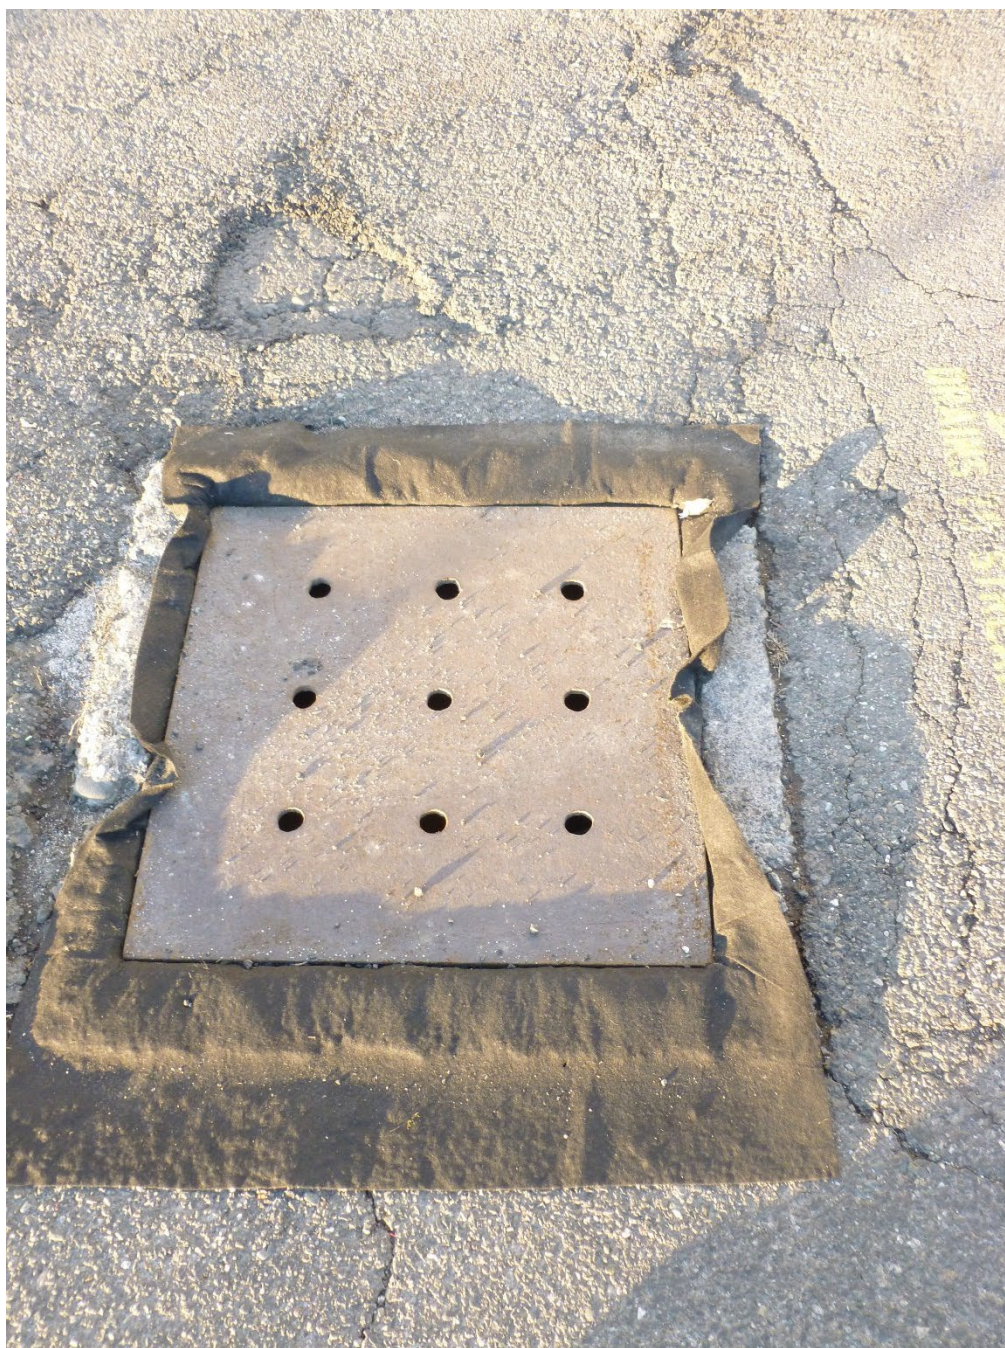
From the discharge point, we turned east and walked to the stormwaterRx™ Filtration System. Per Mr. Jaynes, all stormwater on the site is collected in one of 21 catch basins. The catch basins have a filter to collect oil and debris. The filters are inspected and cleaned monthly and replaced as necessary. After the stormwater has been collected by the catch basins, it is pumped into a 10,000 gallon stormwater holding tank (**Photo 4**). When the holding tank reaches 30% capacity, the water is pumped to a 3,000 gallon tank (**Photo 5**). Once the smaller tank reaches 30% capacity, water is

**Photo 3 / P1010237 – Catch Basin with Filter**

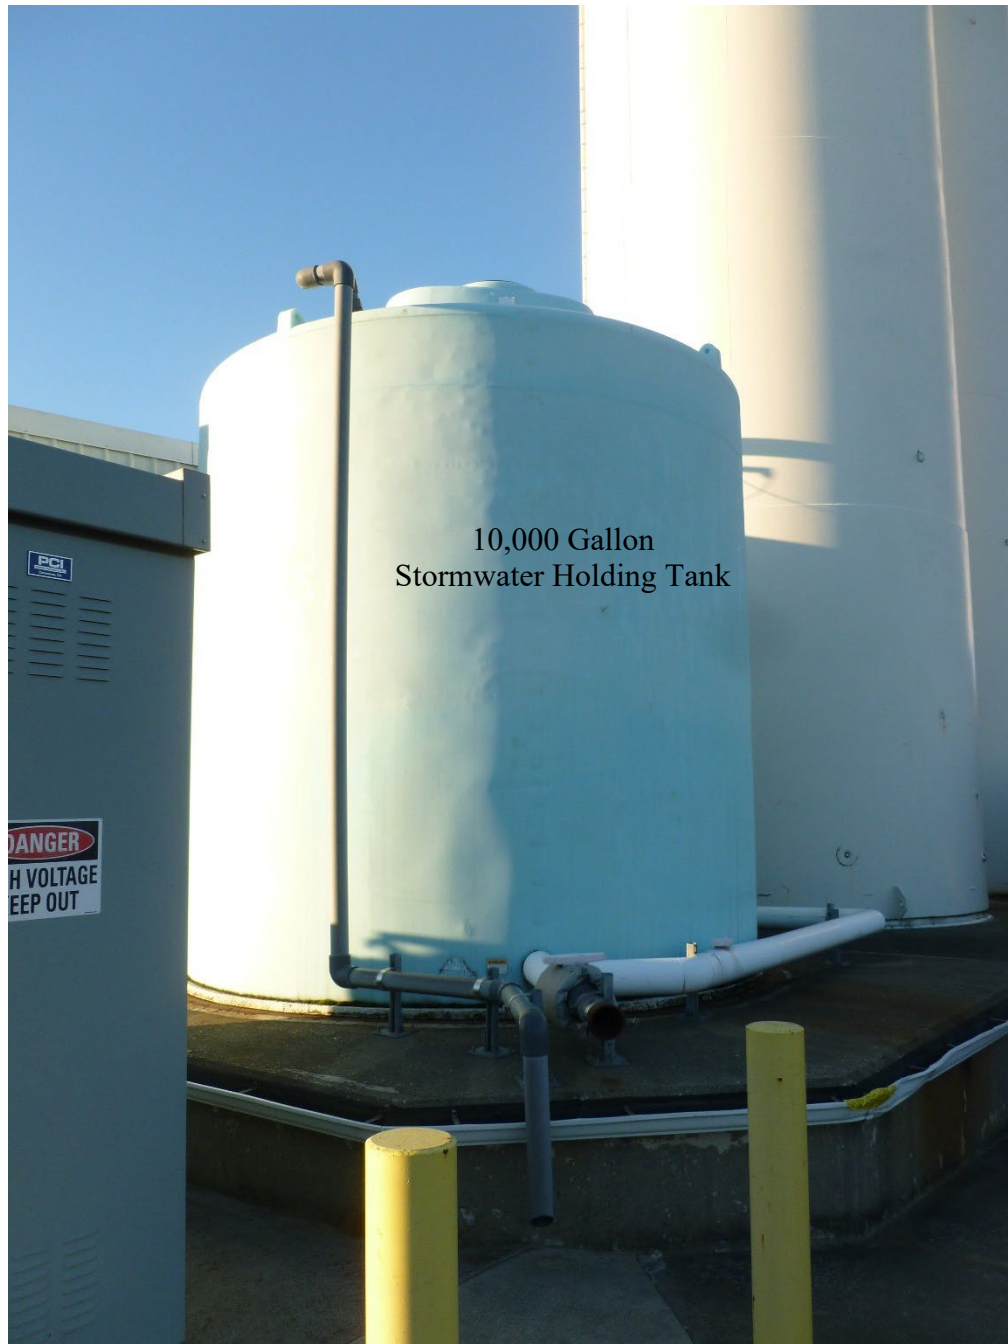
**Photo 4 / P1010227 – 10,000 Gallon Stormwater Tank**

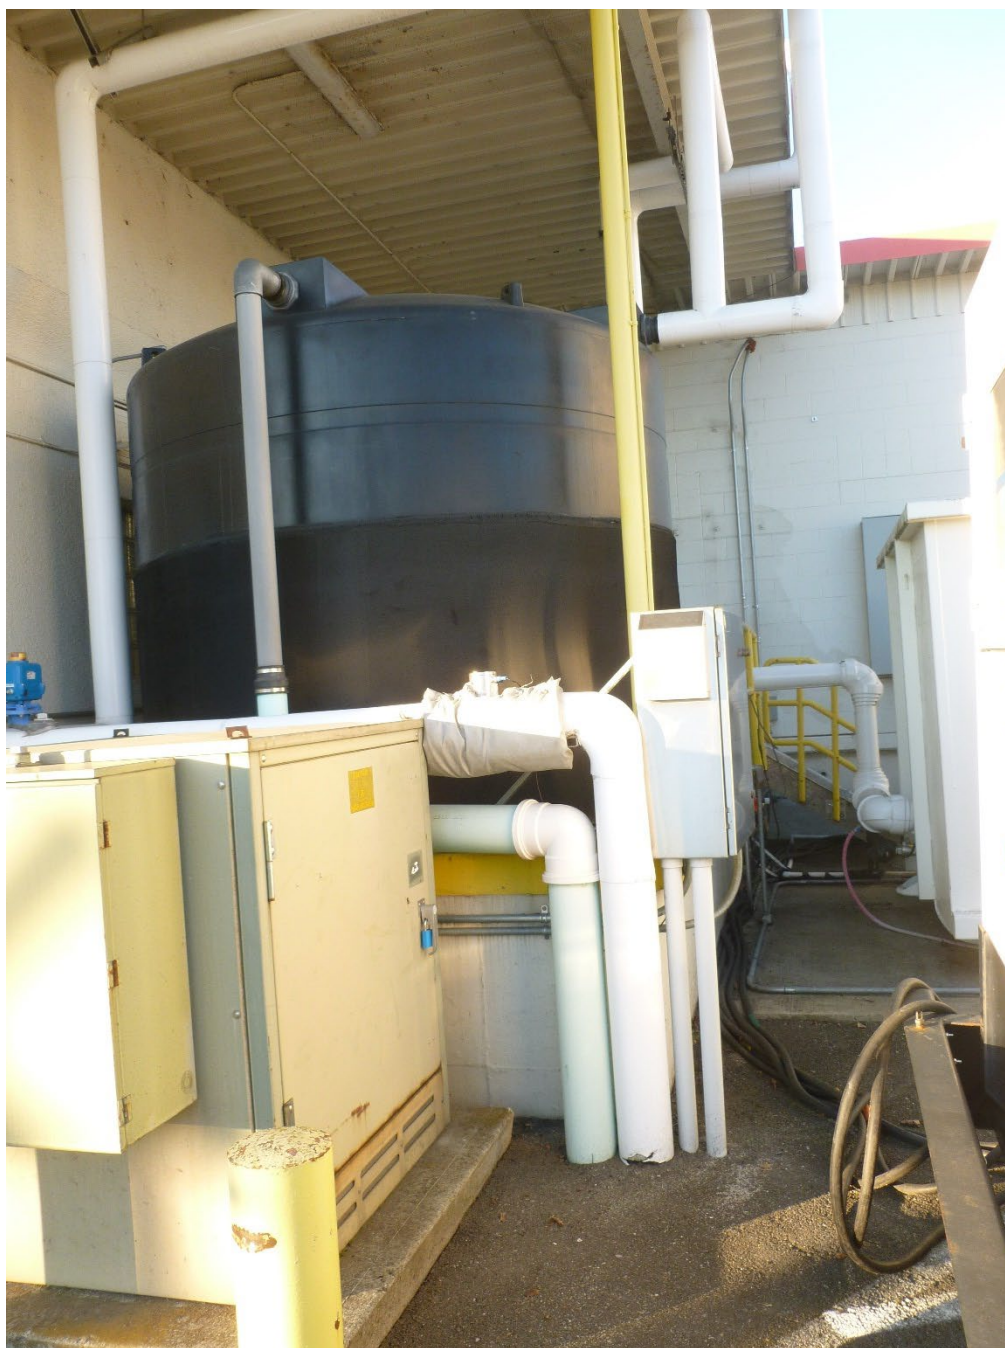
**Photo 5 / P1010230** – 3,000 Gallon Stormwater Tank

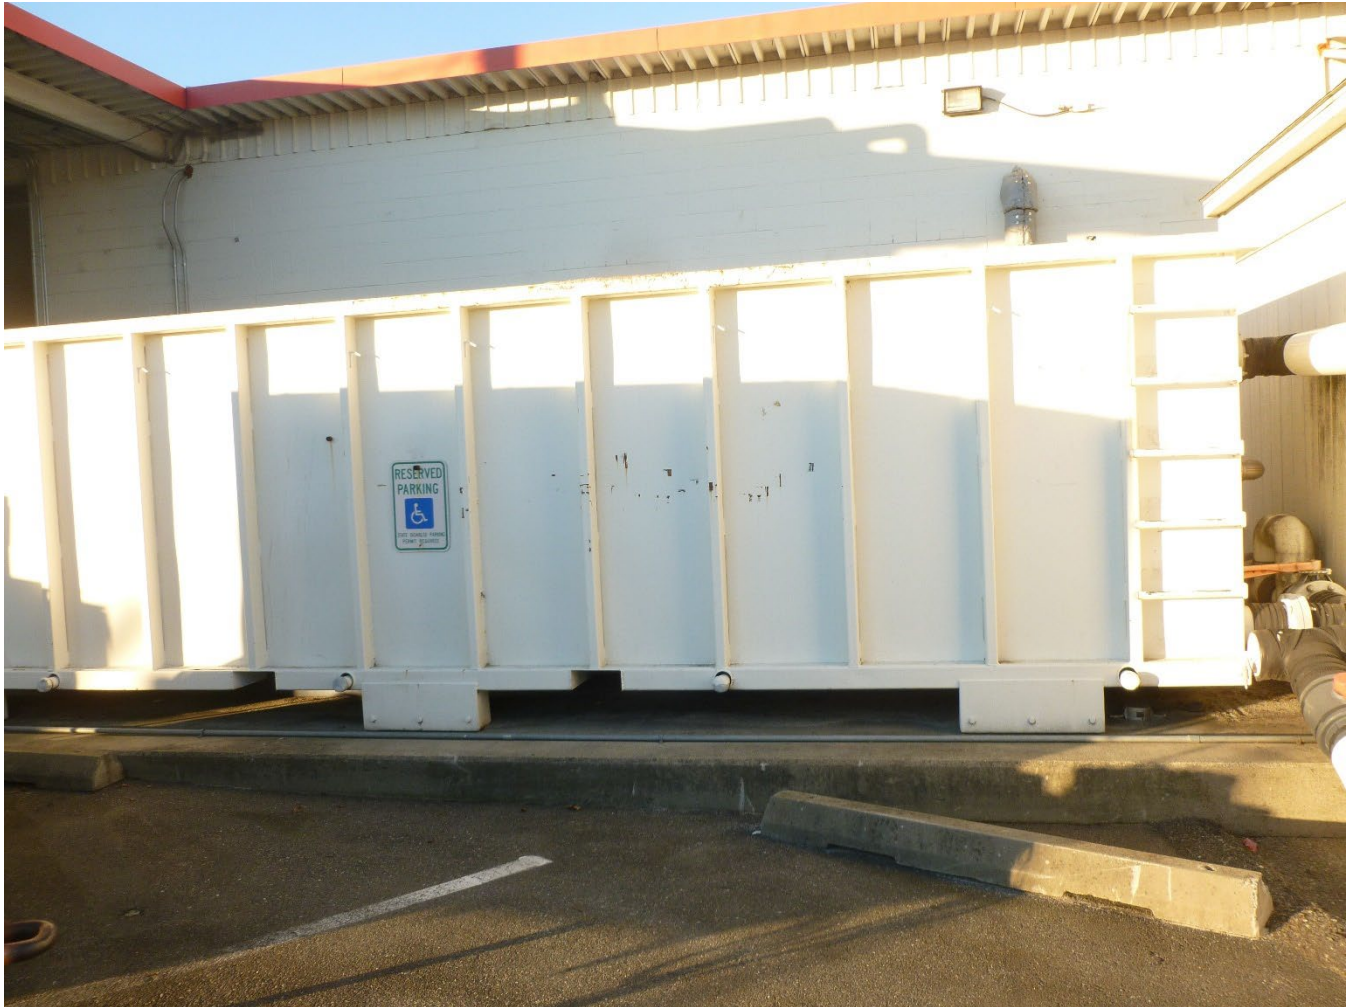
pumped from the tank through a sand/grit pre-filter prior to entering the stormwaterRx™ filtration system (**Photo 6**). Stormwater enters the filtration system through a pvc pipe that is designed to aid in dispersing the water along the length of the system (**Photo 7**). The water infiltrates down through the filtration media.

**Photo 6 / P1010223** – Discharge Point to City Sewer, facing west

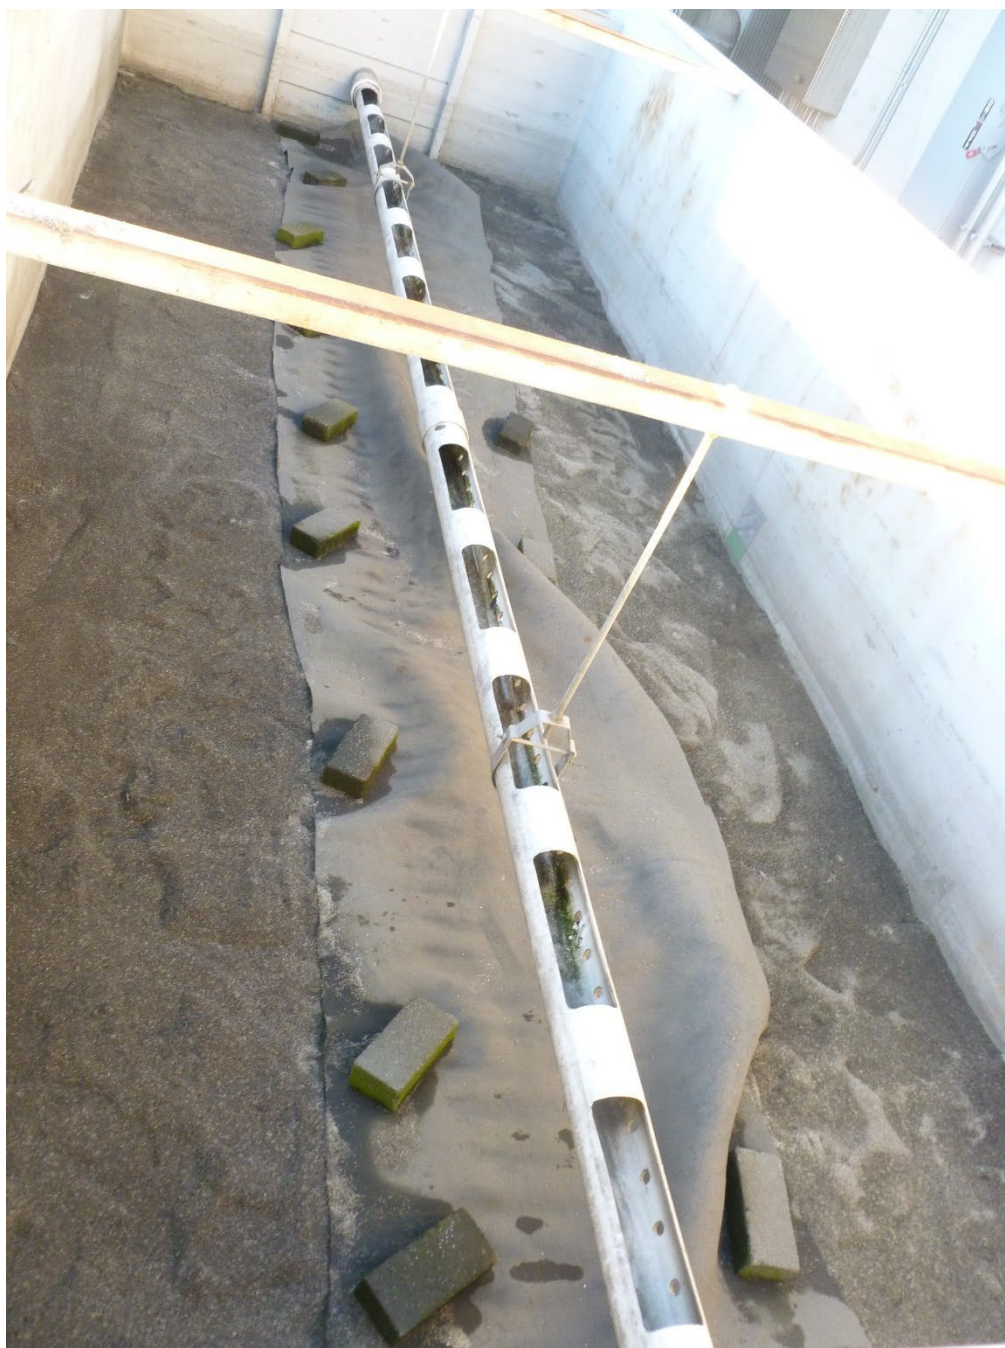
**Photo 7 / P1010233** – Interior of Filtration System with Diffusion Pipe

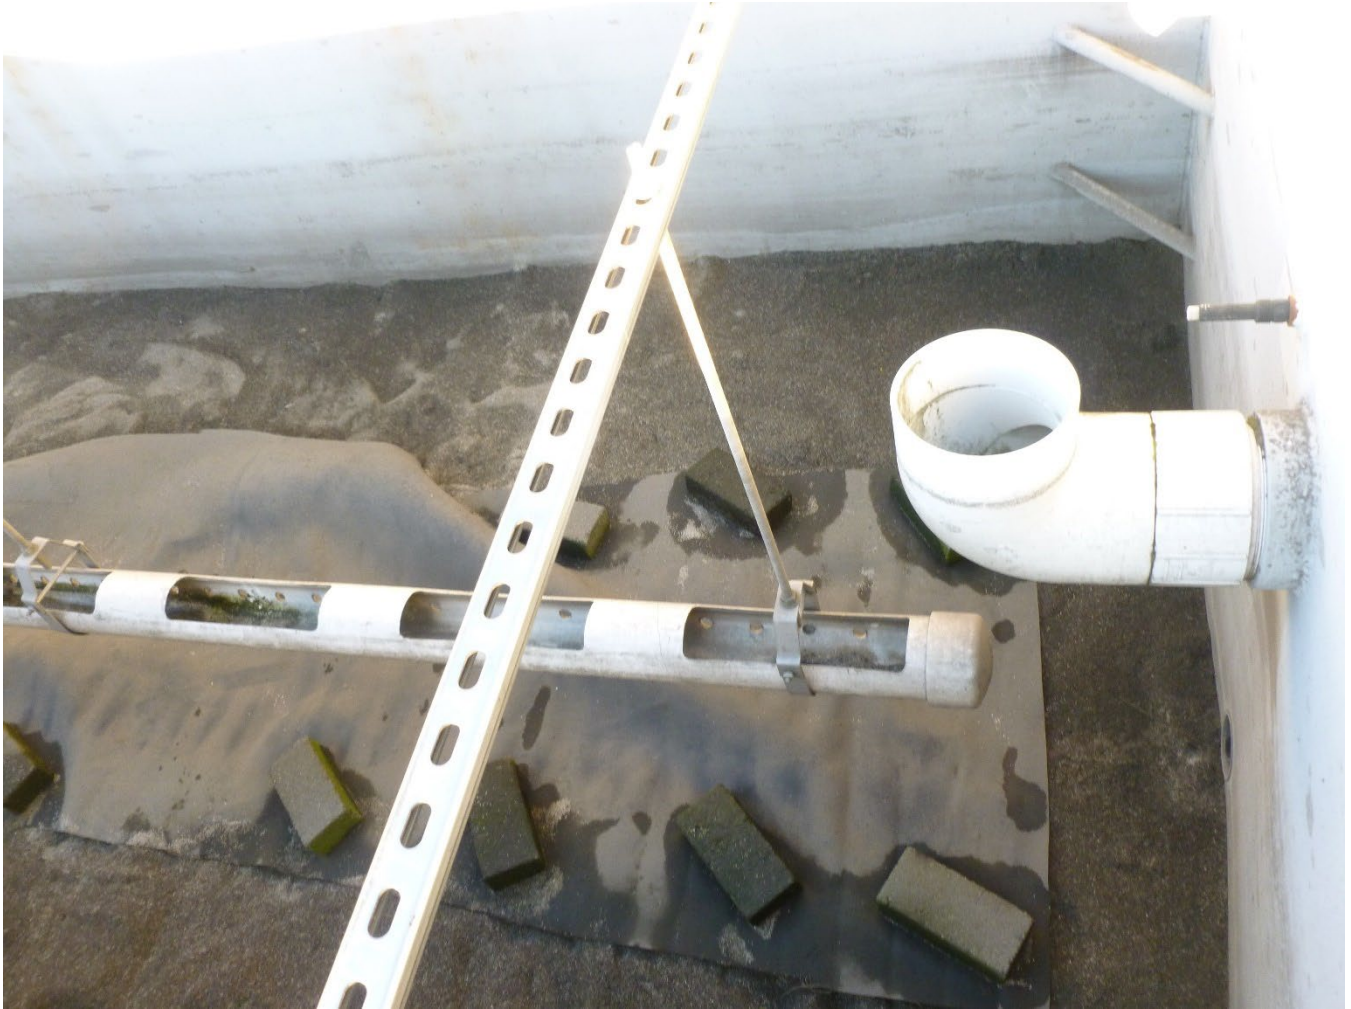
Once the water infiltrates through the media, it percolates back up until it overtops a pvc pipe (**Photo 8**) at the bottom of the system. The pvc pipe carrying the effluent extends outside the filtration system and connects with a horizontal pipe (**Photo 9**) that discharges into a catch basin (**Photo 10 & 11**). The effluent is sampled from the pipe as it discharges into the catch basin.

**Photo 8 / P1010232** – Interior of Filtration System, effluent side

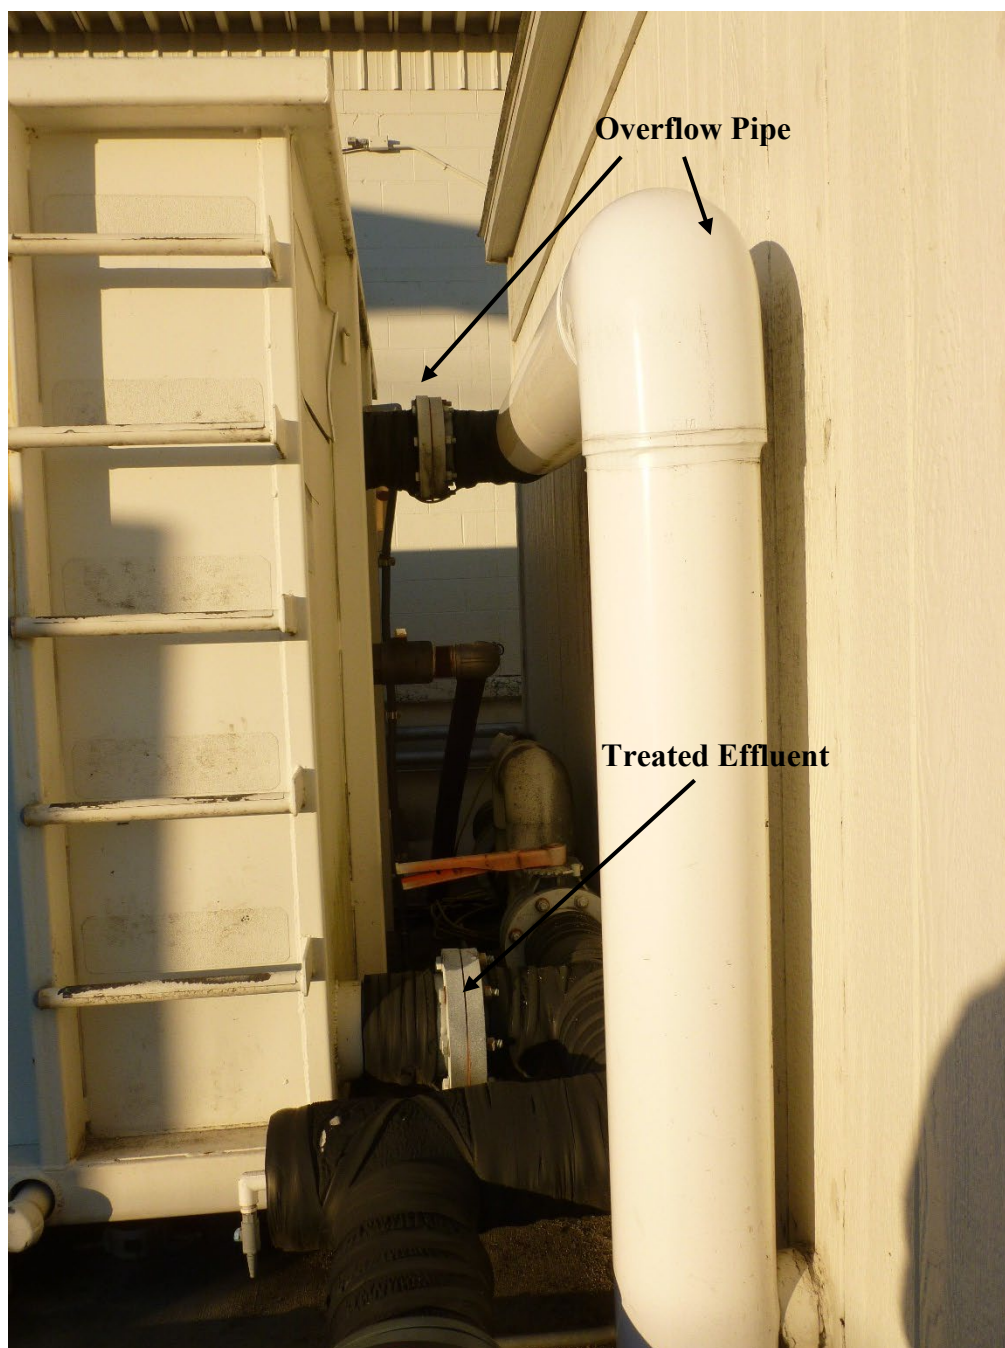
The filtration system is also equipped with an overflow pipe in the event the facility receives a large quantity of stormwater in a short time. The overflow pipe is at the top of the filtration unit. The overflow pipe can be seen in Photo 9. When the filtration unit fills to near capacity, the stormwater overflows into another pvc pipe. Photo 10 shows the untreated stormwater co-mingles with the treated stormwater prior to discharge. During times of overflow, the co-mingled stormwater is sampled.

**Photo 9 / P1010234 – Effluent Side of Filtration System**

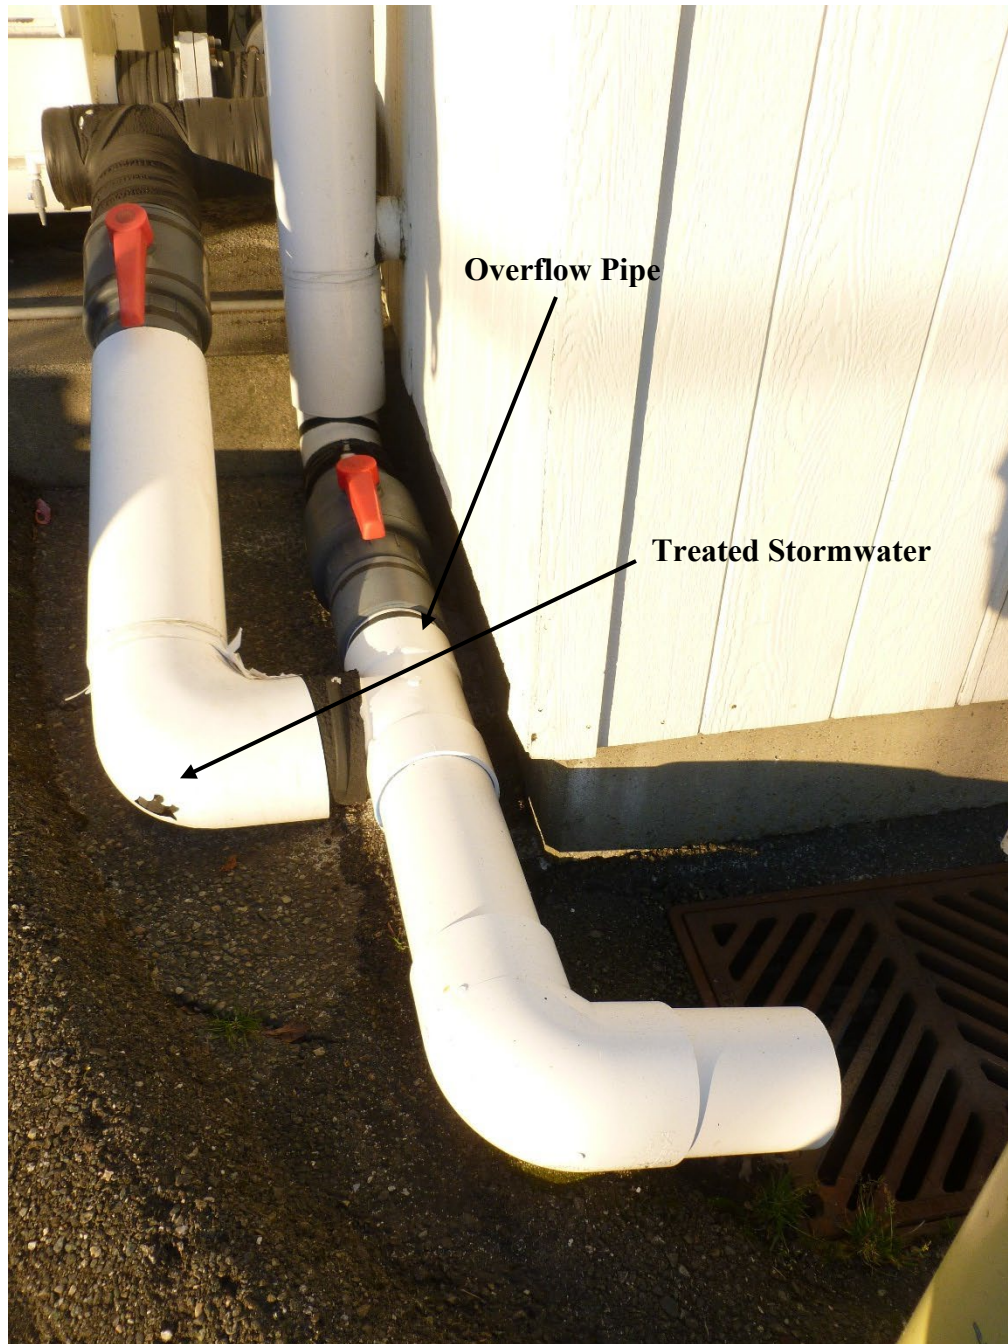
**Photo 10 / P1010235 – Discharge Pipe**

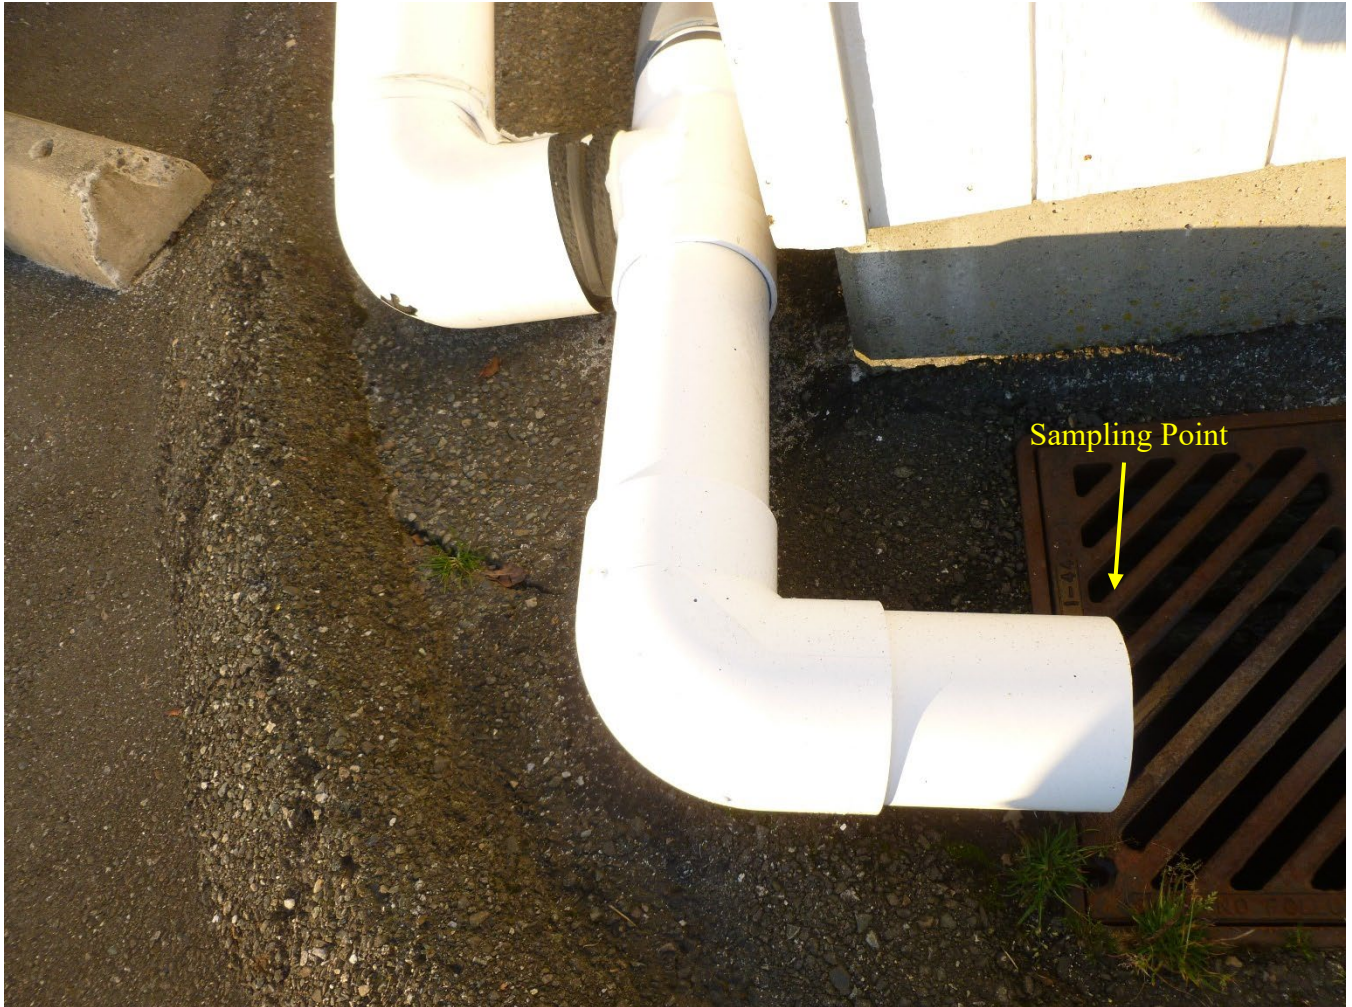
**Photo 11 / P1010236 – Sampling Point**
