## Region 6 - Enforcement & Compliance Assurance Division

### INSPECTION REPORT

| <b>System Name:</b> | San Antonio Water System (SAWS) | |
| <b>PWS ID:</b> | TX0150018 | |

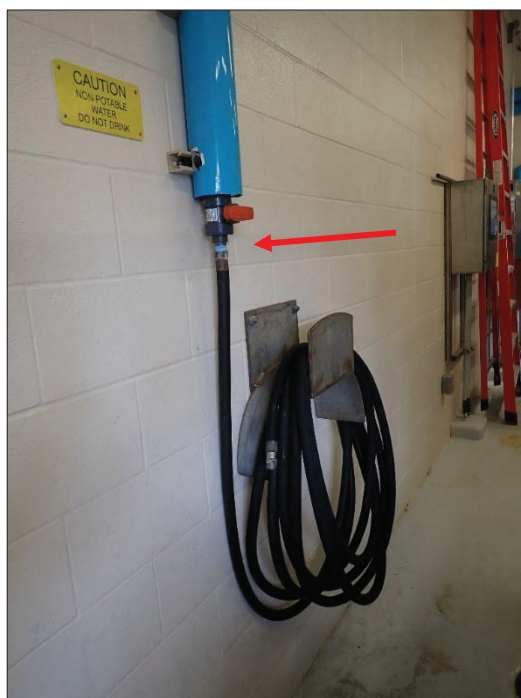
**Photograph 1. 10/23/2025 11:42AM PA240077.JPG**

**Area of Concern 3.** The [REDACTED] OSG room had a hose for cleaning that lacked a vacuum breaker at the spigot (Photograph 1).

**Description:** Cleaning hose in [REDACTED] without a vacuum breaker at the spigot.

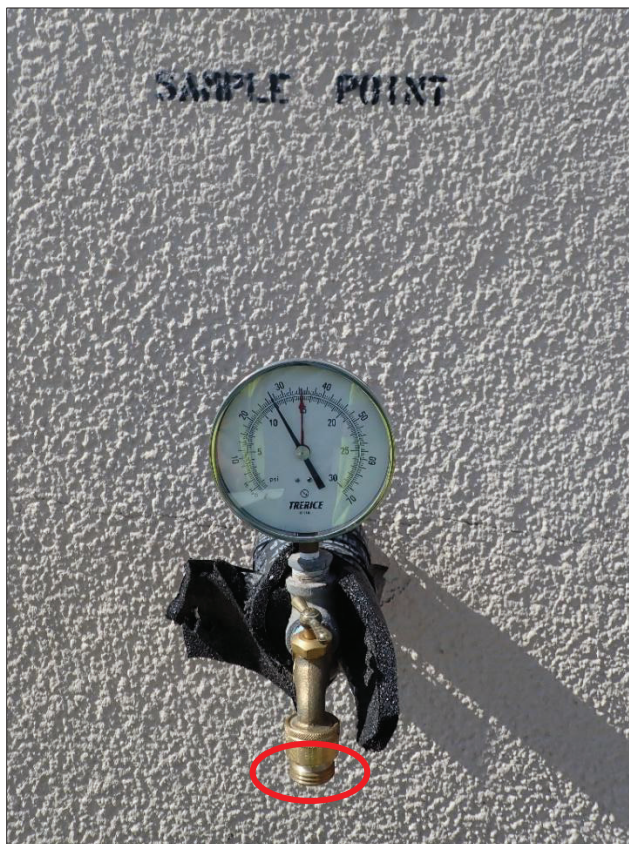
Photograph 2. 10/22/2025 02:59PM PA230001.JPG

Description: Threaded sample tap on [REDACTED] concrete storage tank.

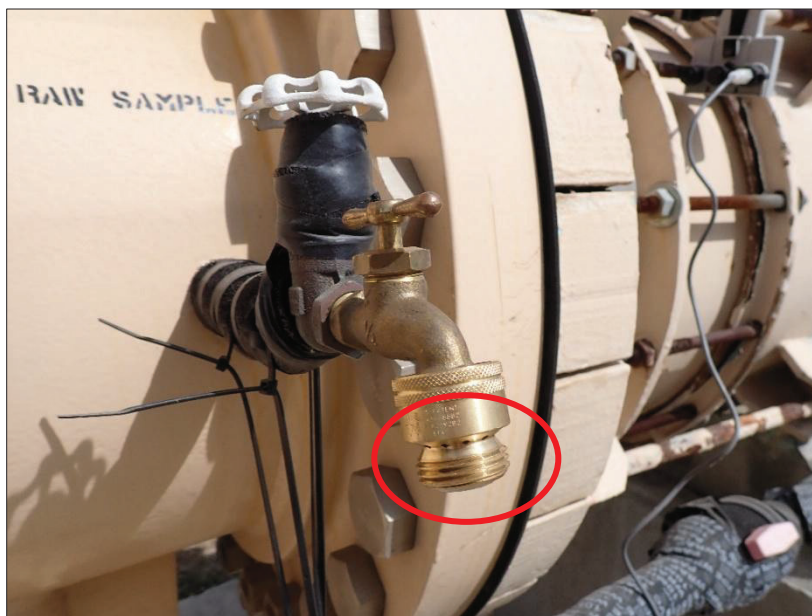
**Photograph 3. 10/23/2025 11:48AM PA240079.JPG**

**Description:** Threaded sample tap on a [REDACTED] discharge piping.

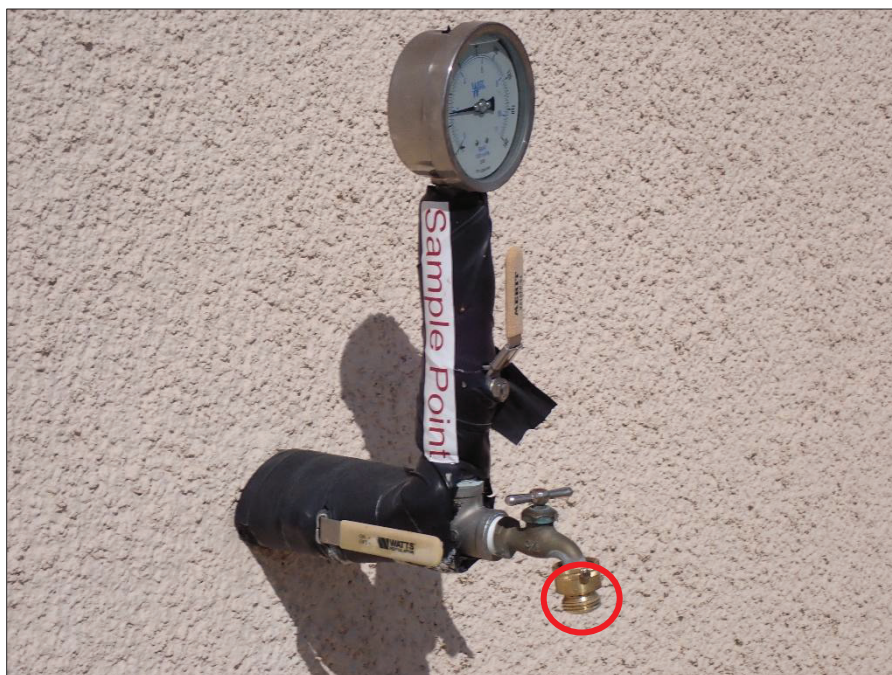
**Photograph 4. 10/23/2025 02:24PM PA240108.JPG**

**Description:** Threaded sample tap on [REDACTED] concrete storage tank.

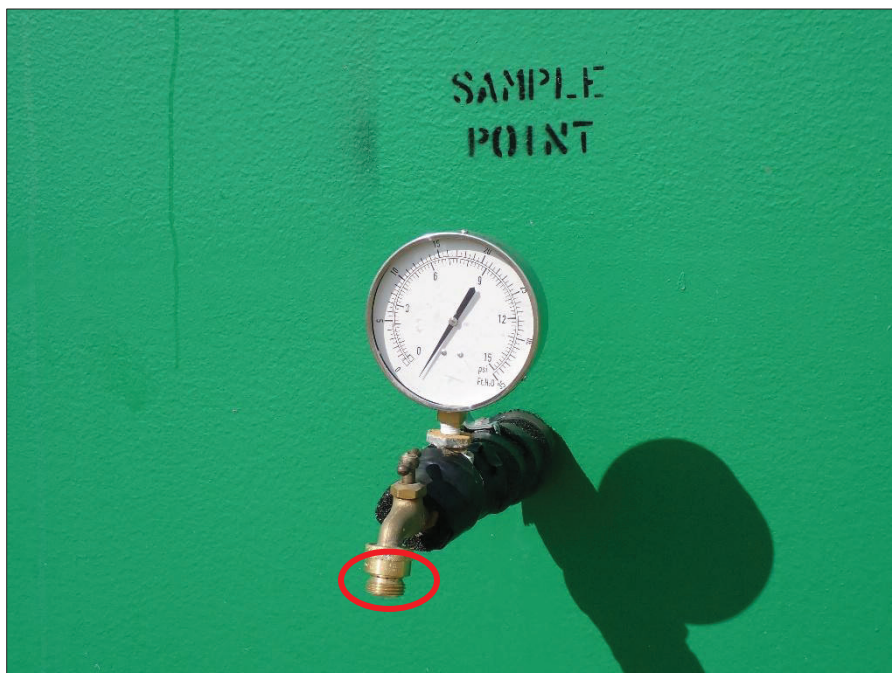
**Photograph 5. 10/23/2025 03:22PM PA240125.JPG**

**Description:** Threaded sample tap on [REDACTED] ground storage tank.

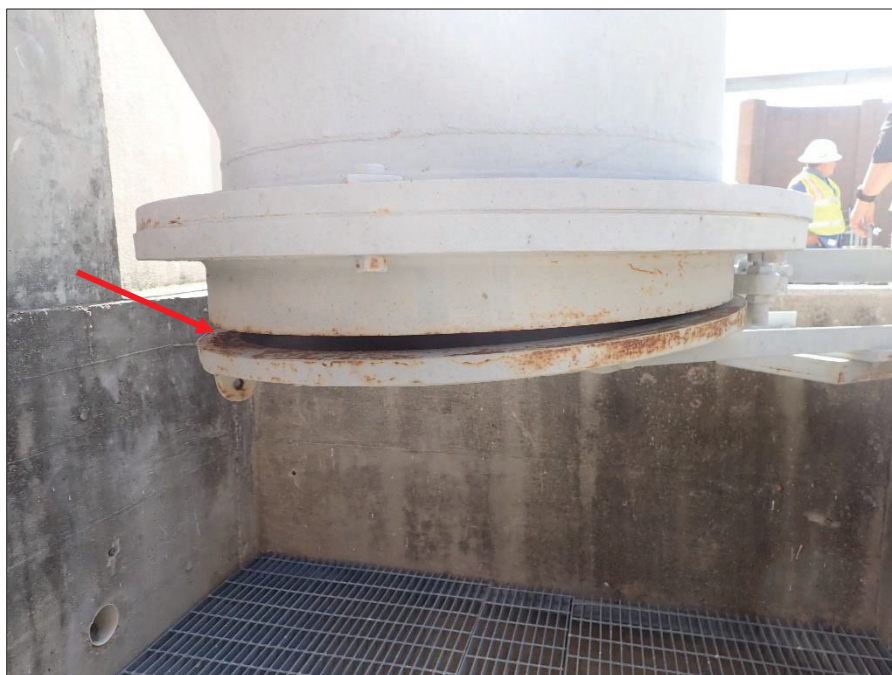
Photograph 6. 10/22/2025 03:07PM PA230008.JPG

Description: [REDACTED] concrete storage tank overflow with unsealed flapper valve.

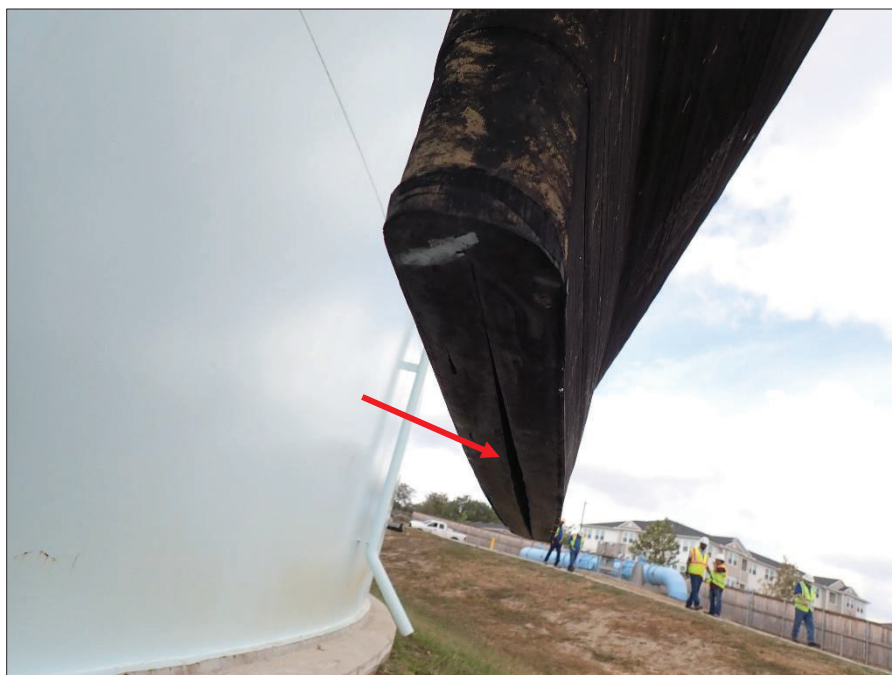
Photograph 7. 10/23/2025 11:58AM PA240081.JPG

Description: [REDACTED] storage tank overflow with an unsealed duckbill valve.

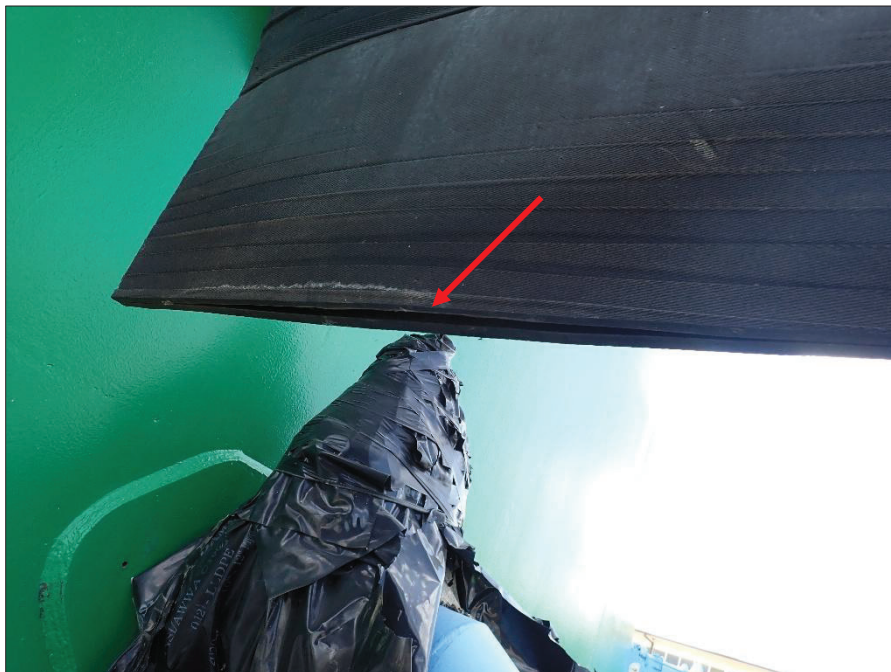
**Photograph 8. 10/23/2025 03:20PM PA240124.JPG**

**Description:** [REDACTED] ground tank overflow with unsealed duckbill valve.

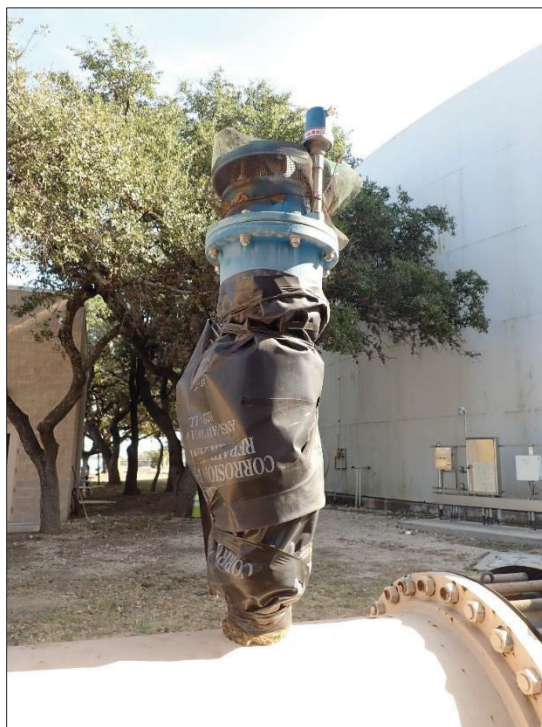
**Photograph 9. 10/22/2025 03:46PM PA230022.JPG**

**Description:** [REDACTED] air relief lacking a downturned port and loosely screened with #16-gauge mesh.

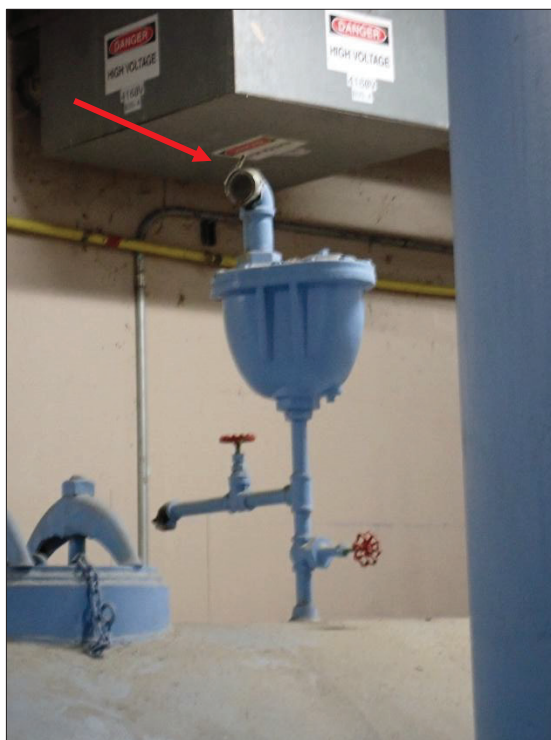
Photograph 10. 10/23/2025 03:15PM PA240121.JPG

Description: [REDACTED] high-service pump without a downturned relief port.

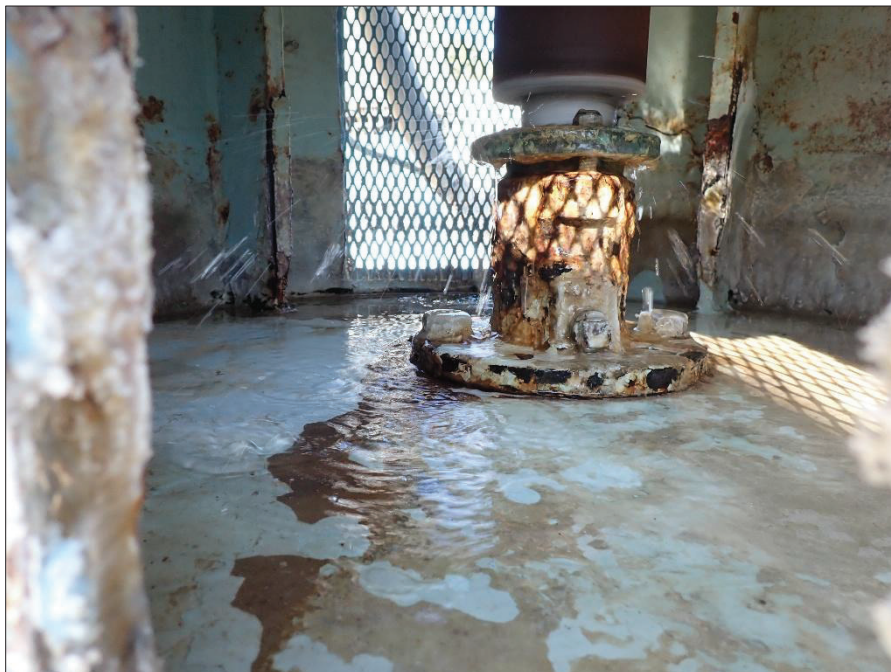
Photograph 11. 10/22/2025 04:02PM PA230048.JPG

- Area of Concern 14.** The motor shaft for the [REDACTED] had excessive water leakage (Photograph 11).
-

Description: [REDACTED] motor shaft with excessive water leakage.

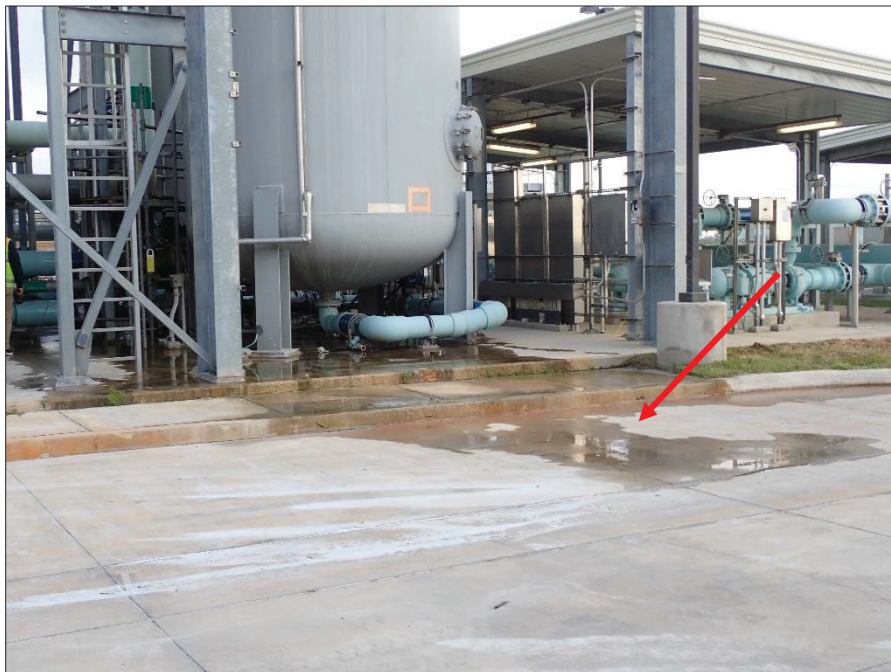
**Photograph 12. 10/23/2025 09:19AM PA230054.JPG**

- Area of Concern 15.** [REDACTED], the calcite contactor had a substantial water leak with water flowing into the driveway (Photograph 12).

**Description:** Water flowing into the driveway from the [REDACTED] calcite contactor leak.

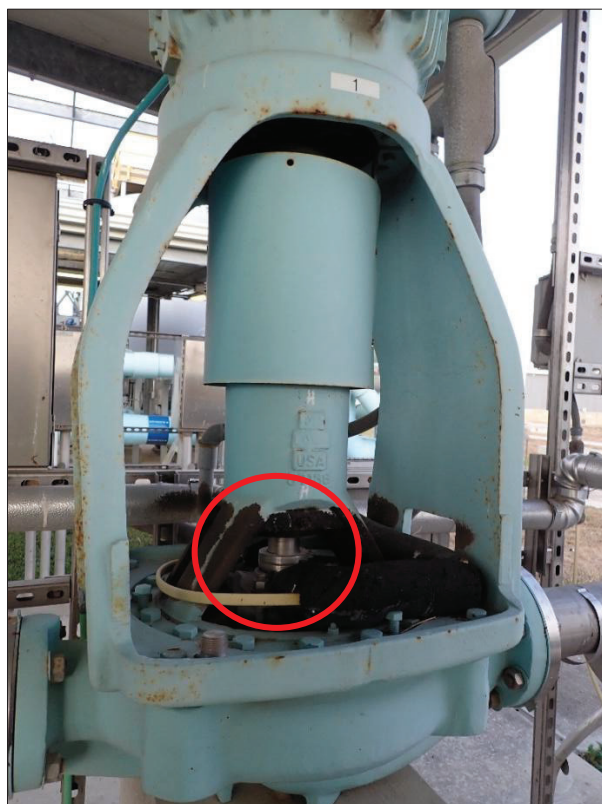
**Photograph 13. 10/23/2025 09:21AM PA230056.JPG**

**Description:** [REDACTED] calcite contactor water feed line pump without protective guard around rotating motor shaft.

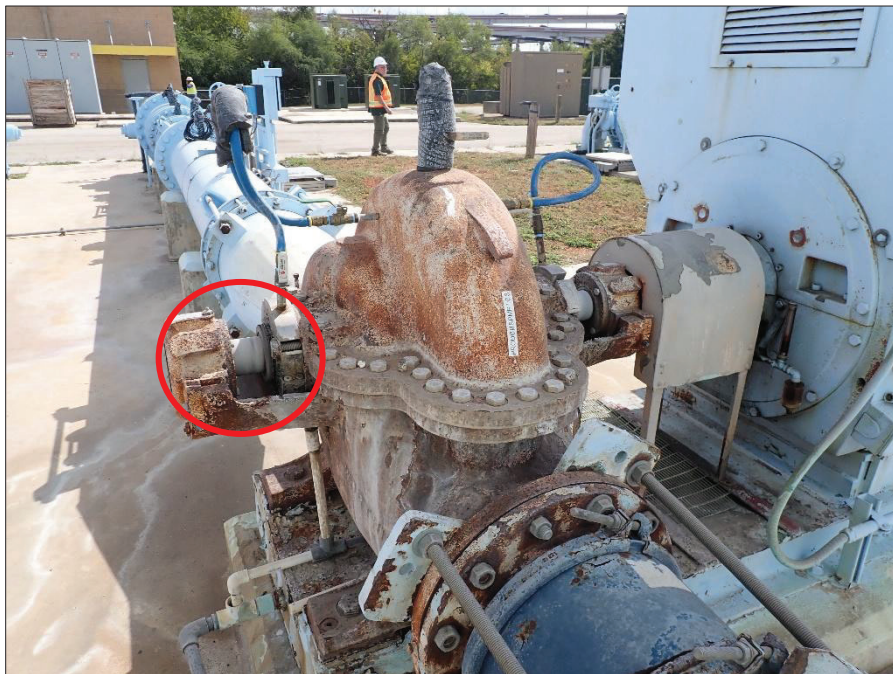
Photograph 14. 10/23/2025 12:00PM PA240085.JPG

Description: [REDACTED] without a protective guard around the rotating pump/motor shaft.

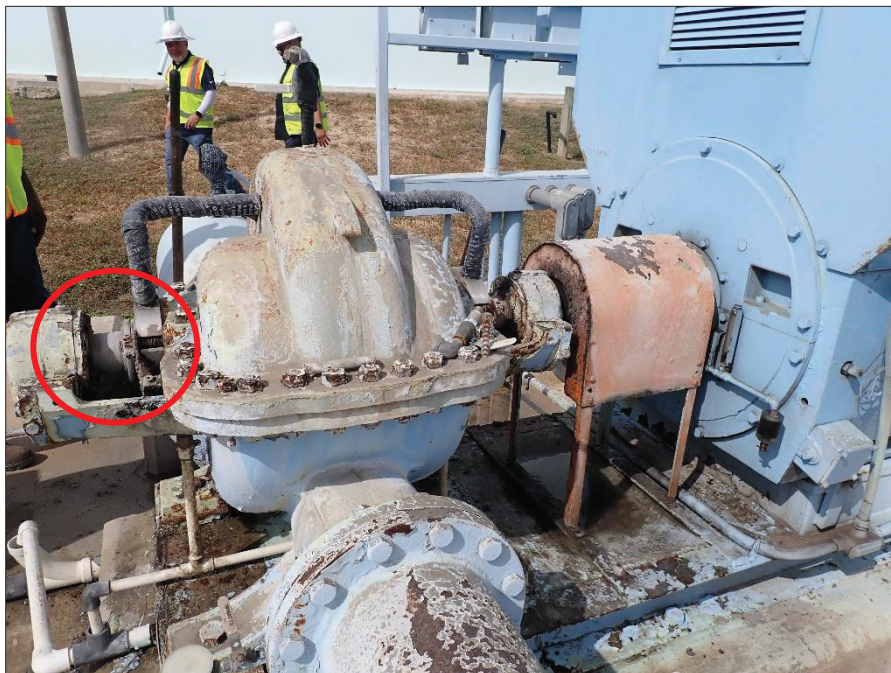
Photograph 15. 10/23/2025 12:01PM PA240086.JPG

Description: [REDACTED] without a protective guard around the rotating pump/motor shaft.

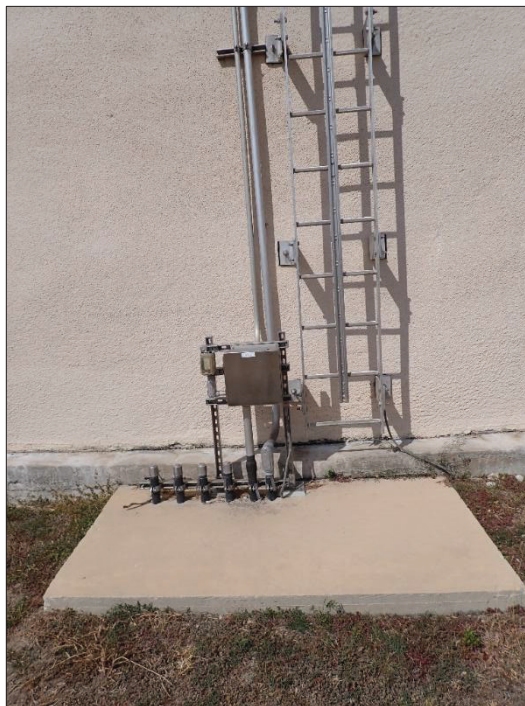
**Photograph 16. 10/23/2025 02:01PM PA240090.JPG**

**Description:** [REDACTED] concrete tank with ladder terminating at ground level and no ladder cage.

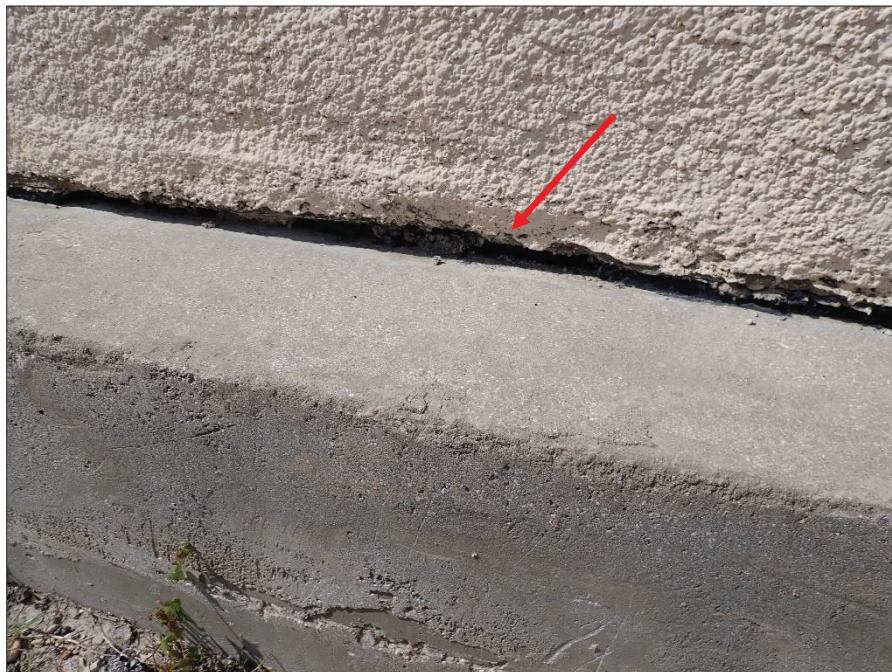
Photograph 17. 10/23/2025 02:00PM PA240088.JPG

**Area of Concern 20.** The seal between the [REDACTED] pre-load concrete tank and foundation was brittle and missing in places (Photograph 17).

Description: Missing seal between the [REDACTED] concrete tank and its foundation.

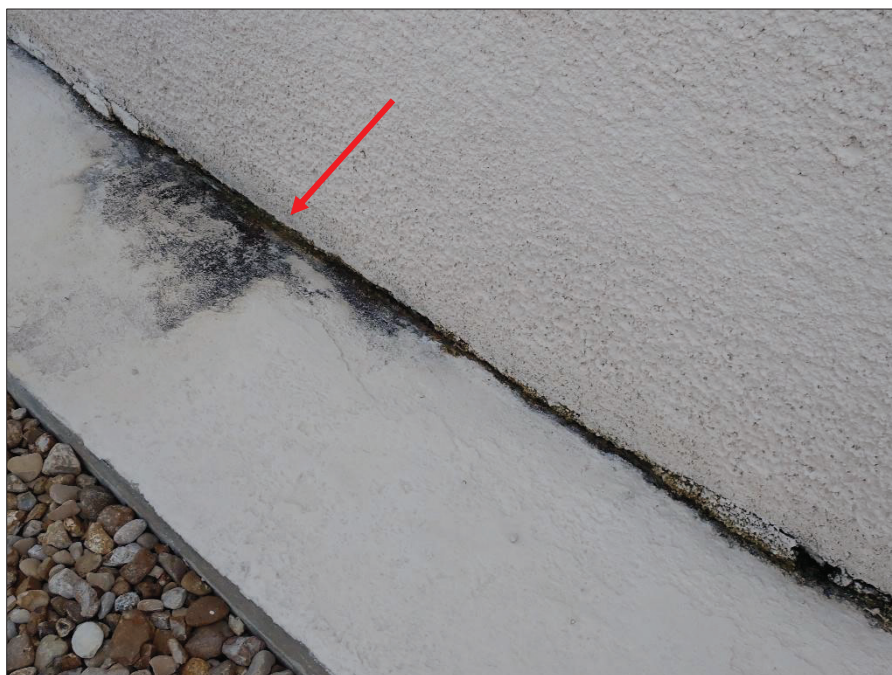
Photograph 18. 10/23/2025 02:26PM PA240110.JPG

**Area of Concern 21.** The EPA inspection team observed small areas of moisture at the foundation seal of the [REDACTED] concrete tank (Photograph 18).

Description: Small areas of moisture at the foundation seal of the [REDACTED] concrete tank.
