**UNITED STATES ENVIRONMENTAL PROTECTION AGENCY
REGION 5
77 WEST JACKSON BOULEVARD
CHICAGO, ILLINOIS 60604**

SUBJECT: CLEAN AIR ACT INSPECTION REPORT
Waste Management – Prairie Hill Landfill, Morrison, Illinois

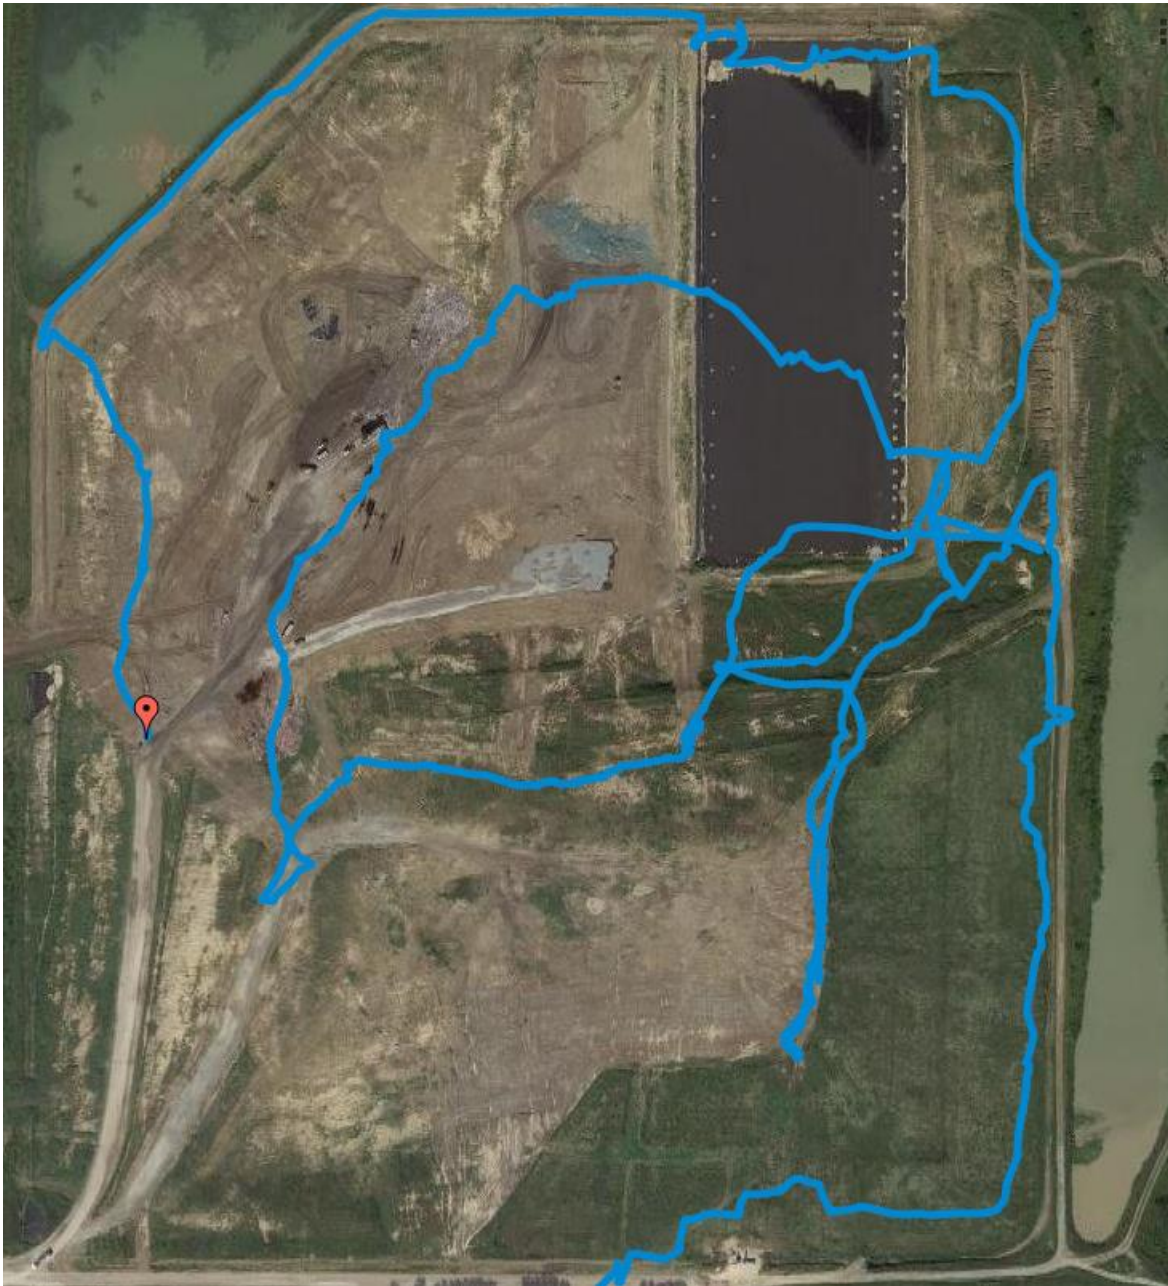
TVA #1 Comparative SEM Path Taken:
(Map data from Google Maps 2021)

Concerns: The SEM path that the EMT SEM technician traverses only covers the closed areas of the Landfill and at specific points in those areas. The technician relayed to EPA that this path and the points monitored are under the instruction of the previous Environmental Manager. The 51 exceedances that EPA detected and the observations listed in the above section, “Data Collected and Observations”, are concerns.

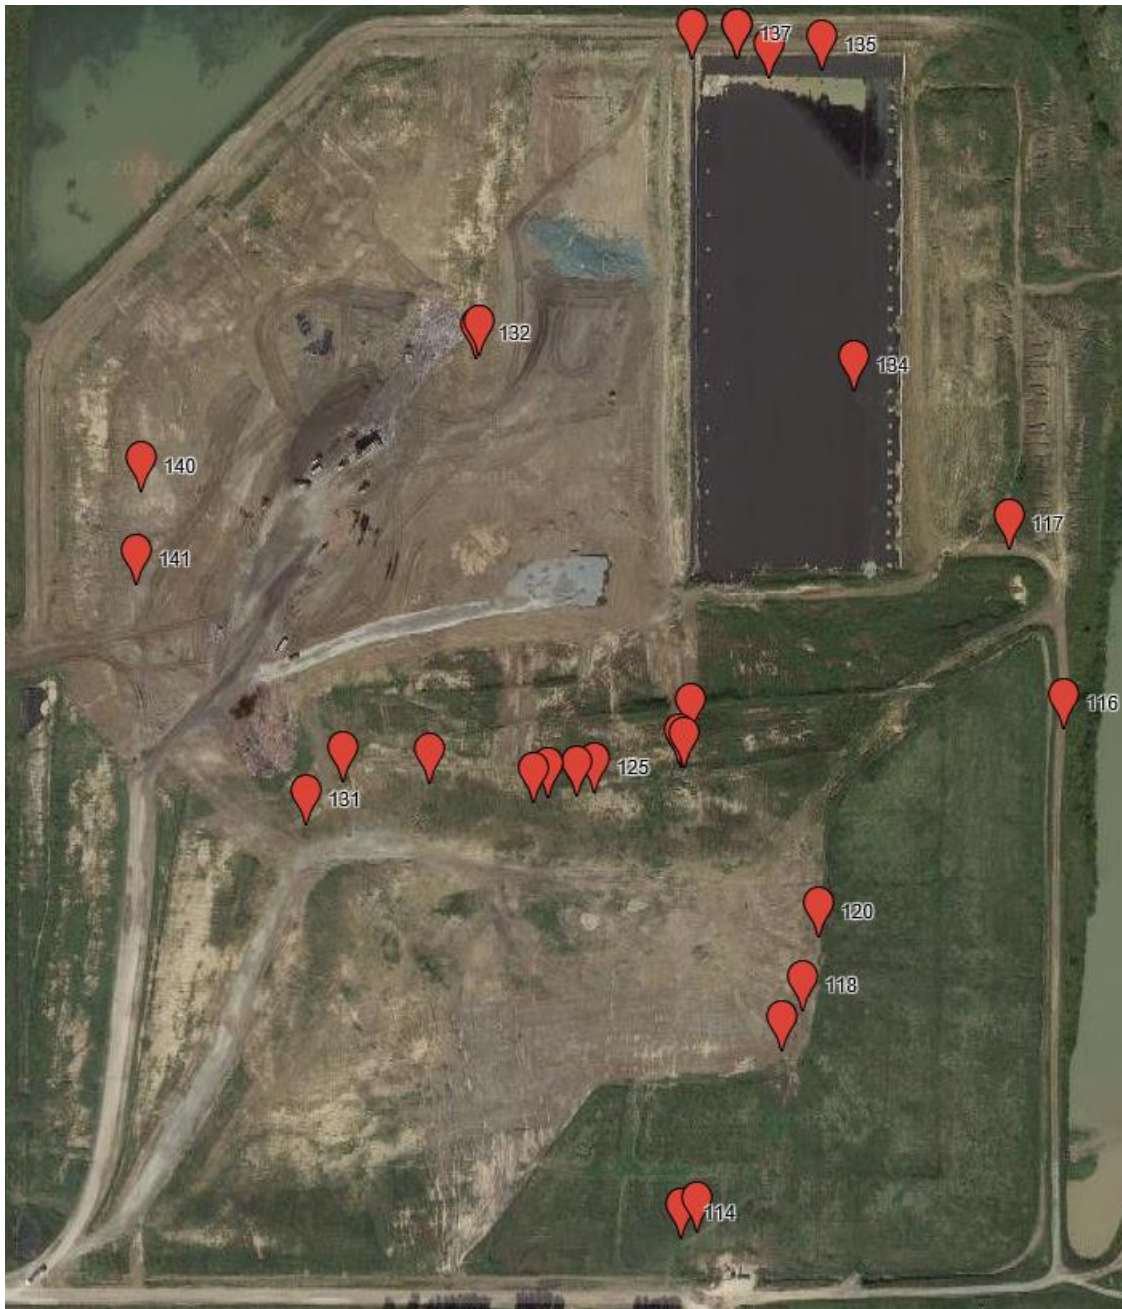
TVA #1 Exceedances Found:
(Map data from Google Maps 2021)

During Comparative SEM conducted by EPA, 51 SEM exceedances above 500 ppm were found. All of the hits, minus one, were confirmed by the Facility's well technician. Large areas of concern and with exceedances include the whole toe of the Landfill by GW-23. The entire side of the slope south of the active area by GW-406 had elevated SEM measurements, exceedance hits, leachate seeps, and exposed waste. The area within a 40 feet radius around GW-33 was elevated. Exposed waste was seen throughout the Landfill in areas that have not been filled for

Exceedance Descriptions		
Exceedance #	Location Description	Observations
1	75 ft West of flare; 50 ft North from road; 90 ft downslope South of GW-23.	Dead vegetation at toe of landfill.
2	20 ft East of Waypoint #114.	Elevated measurements and exceedances found within 20 ft radius.
3		Dead vegetation.
4	50 ft downslope Southeast of GW-70.	Erosion.
5	30 ft North of BC5.	Dead vegetation.
6	GW-70.	Erosion.
7	85 ft North of GW-22R.	Erosion.
8	GW-408.	
9	30 ft West of GW-408.	
10	40 ft upslope of GW-407.	No vegetation.
11	GW-407.	
12	Between GW-407 and GW-406.	
13	110 ft North of GW-70; 100 ft upslope of BC5; in between GW-70 and GW-69.	Erosion trench.
14	GW-406.	
15	50 ft South of GW-406; South of fill area.	Bubbling leachate with audible gas escaping from huge hole. Huge area of side slope with exposed waste and leachate seeps.
16	50' S. of GW-406; South of fill area.	Leachate seep with audible bubbling in another huge hole.

17	50' S. of GW-406; South of fill area.	Audible bubbling in another nearby hole. Whole side of slope with leachate filled holes and elevated methane readings and exceedances within 20 ft radius.
18	Distressed veg + leachate stain/washout	
19	Between GW-406 and GW-33.	
20	10' from EPA Waypoint #125.	
21		Leachate and distressed vegetation.
22	GW-33.

23	20' W. of GW-33.	Many exceedances detected within 40 ft radius of GW-33.
24	Between GW-33 and GW-41.	Exceedance in hole.
25	20' W. of GW-34.	Cracks in washout.
26	40' uphill of GW-40.	Erosion.
27	GW-41.	
28	100' W. of GW-41.	Erosion trench.
29	GW-39.	
30	By the road.	Inactive area with uncovered waste.
31		
32		
33	In what appeared to be auto fluff (central area of top)	
34	HC19.	
35	East slope; 60' W. of GW-68.	Erosion.
36	100' uphill of Southeast Leachate Riser, hole in rivulet	
37		Erosion; elevated measurements within 10 ft radius.
38	30' E of W59 / north slope rivulet	
39	50' S. of road; 100' W. of Leachate-308.	
40	150 ft West of Leachate-308; 50 ft upslope from road on North slope.	
41	Rivulet 40' W of W59	
42	Well 59 (in rivulet)	
43	30' upslope from road and GV-17.	Dried discolored leachate seep.
44	By the exposed mattress immediately beside W58	
45	GW-53.	Strong gas odor.
46	Well 49	
47	Well 52	
48	Unmarked gas well; 100 ft South of GW-52 on West slope.
