**Region 6 - Enforcement & Compliance Assurance Division**  
**INSPECTION REPORT**

| <b>Inspection Date(s):</b> | 02/24/2025 – 02/25/2025 | |
| <b>System Name:</b> | <b>Deming Municipal Water System</b> | |
| <b>PWS ID:</b> | NM3528616 | |

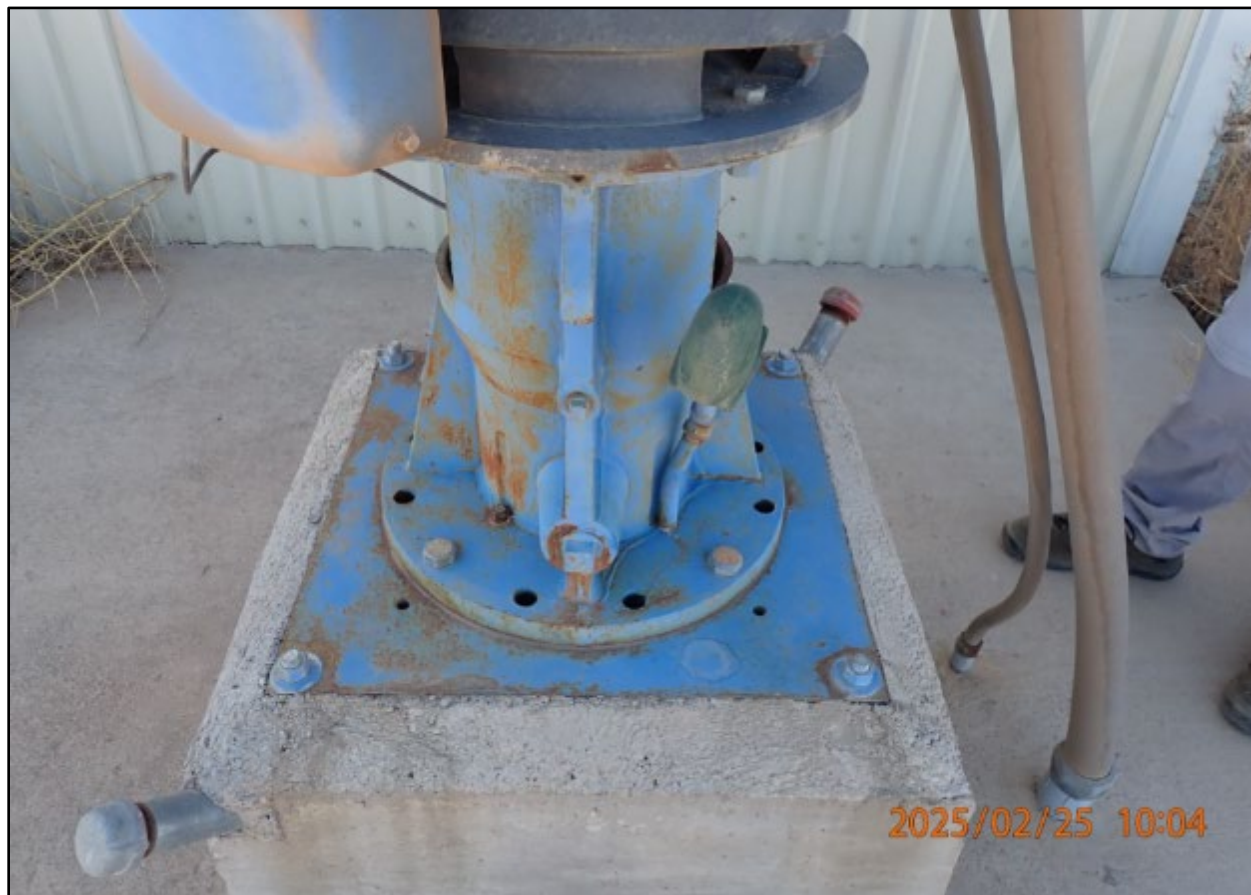
**Photograph 1. 02/25/2025 10:04 P2250344.JPG**

- Well #18 (Refer to Appendix 1, Photographs 1 and 2), that is fully capped with plans to be brought back into service
- Well #11 (Refer to Appendix 1, Photographs 3 and 4), that is not currently in service and not capped.

Description: Inactive Well #18.

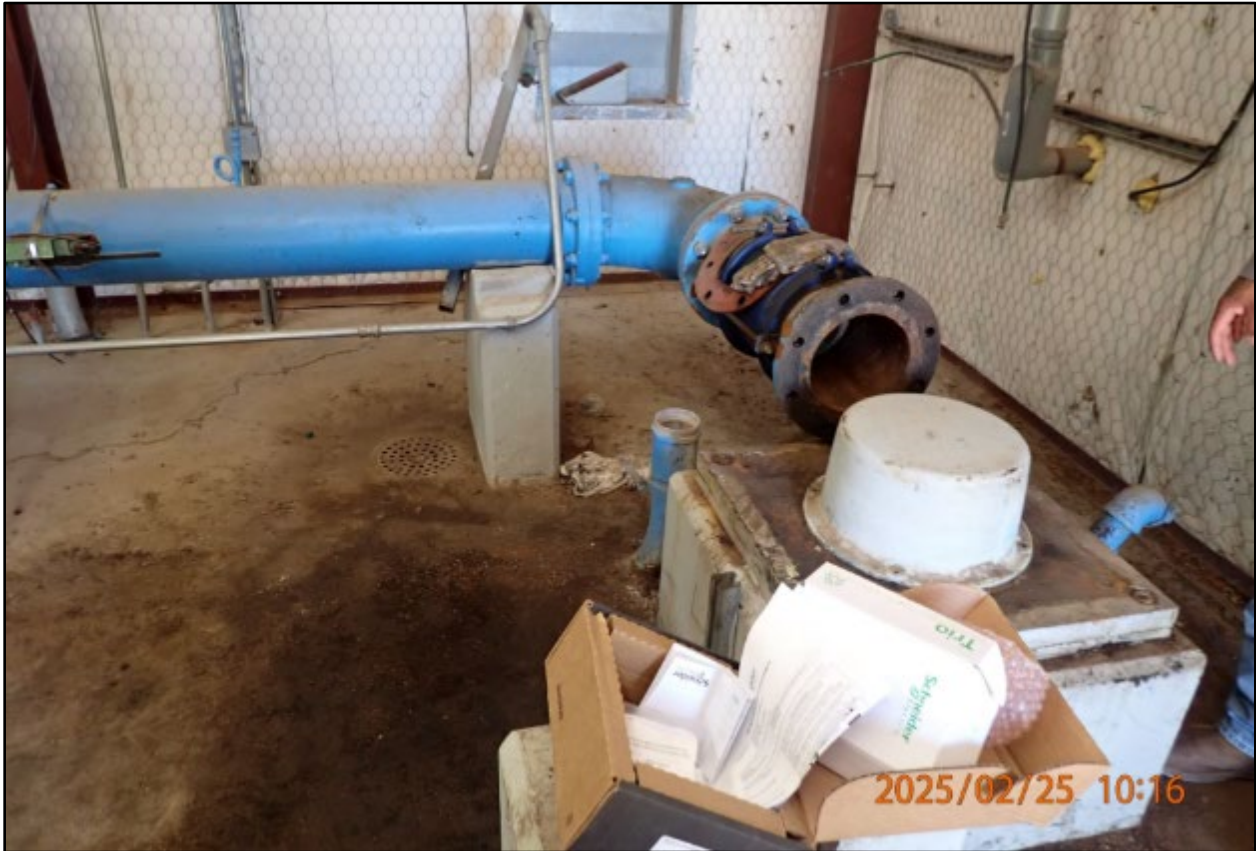
**Photograph 3. 02/25/2025 10:16 P2250339.JPG**

Description: Inactive Well #11 with an unsecured bucket resting on top of the well opening.

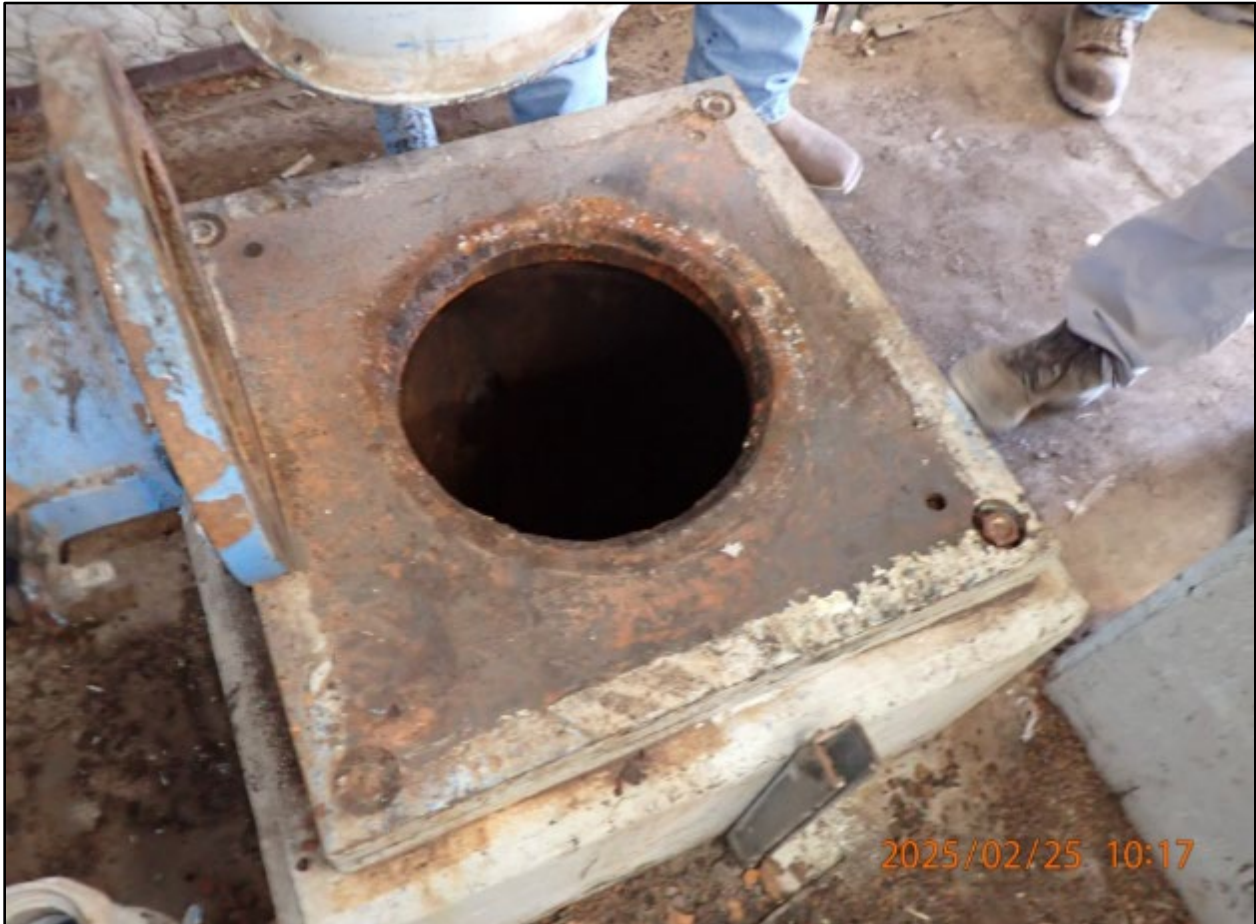
**Photograph 4. 02/25/2025 09:43 P2250339.JPG**

Description: Opening to inactive Well #11; well lacks a secured cover.

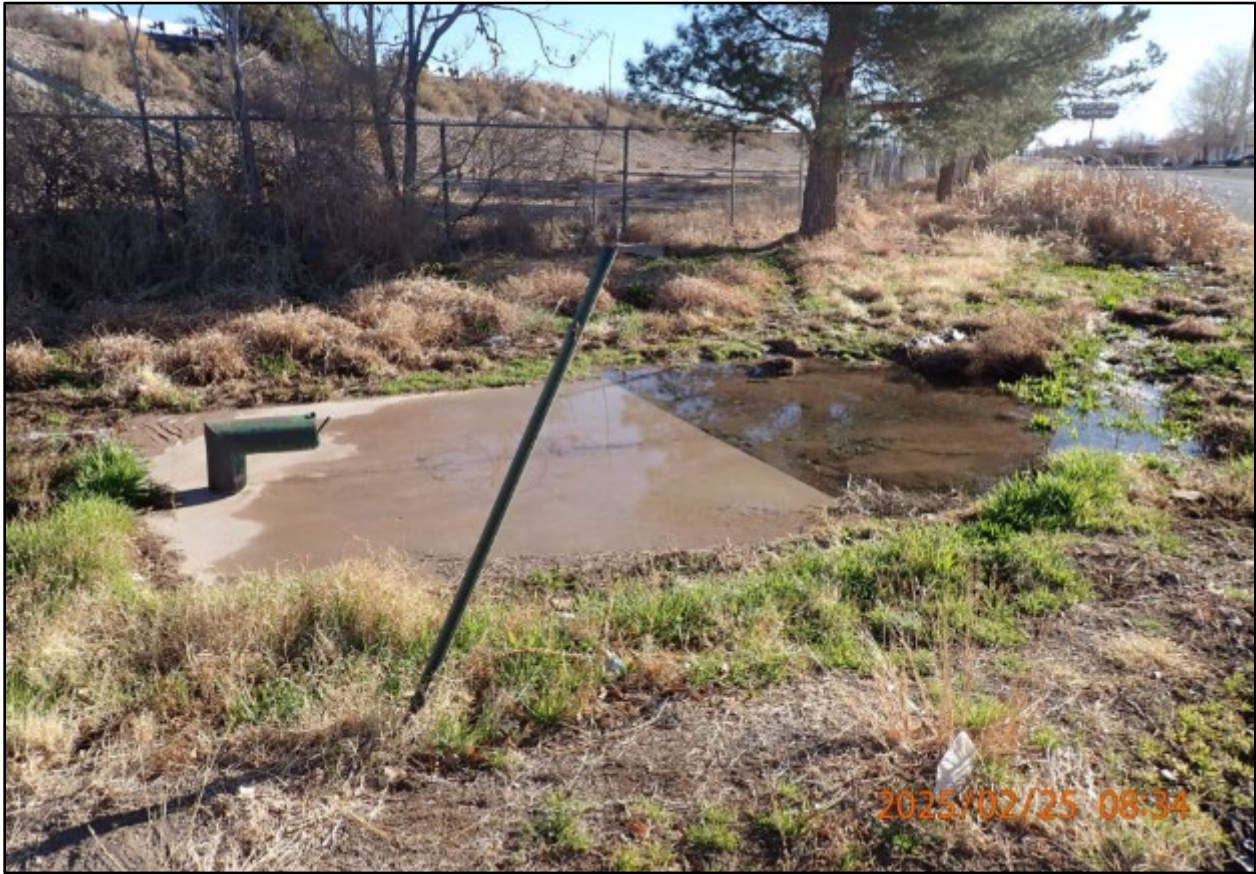
**Photograph 5. 02/25/2025 08:34 P2250285.JPG**

**Observation 8.** The EPA Inspection Team observed that the overflow piping from both Well #1 Tower and Well #11 Tower were connected to the wellhouses' discharge from the de-sanding cleaning process, presenting a potential cross-connection.

Description: Overflow for Well #1 Tower and waste discharge of de-sanding unit at Well #1.

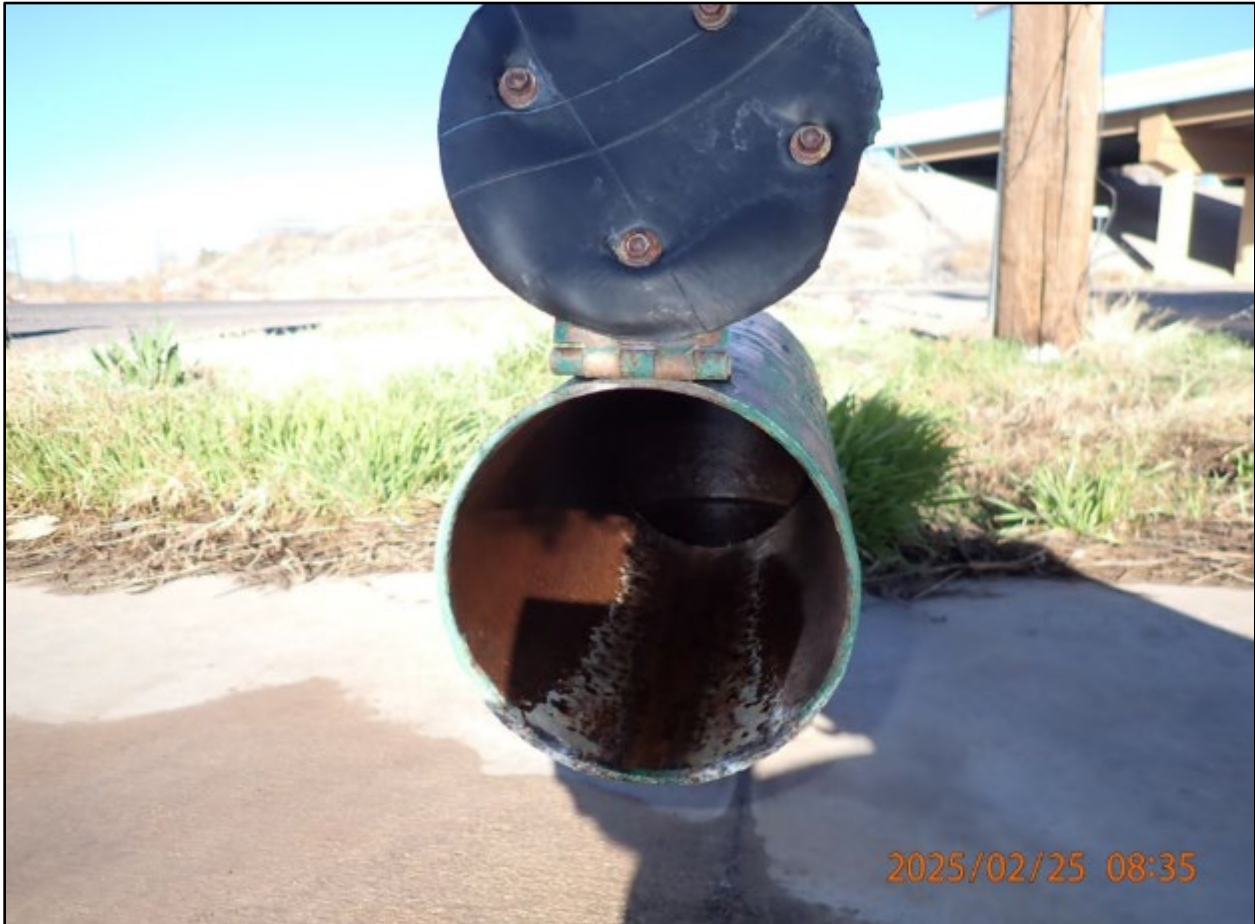
**Photograph 6. 02/25/2025 08:35 P2250286.JPG**

Description: Overflow for Well #1 Tower with a compromised gasket.

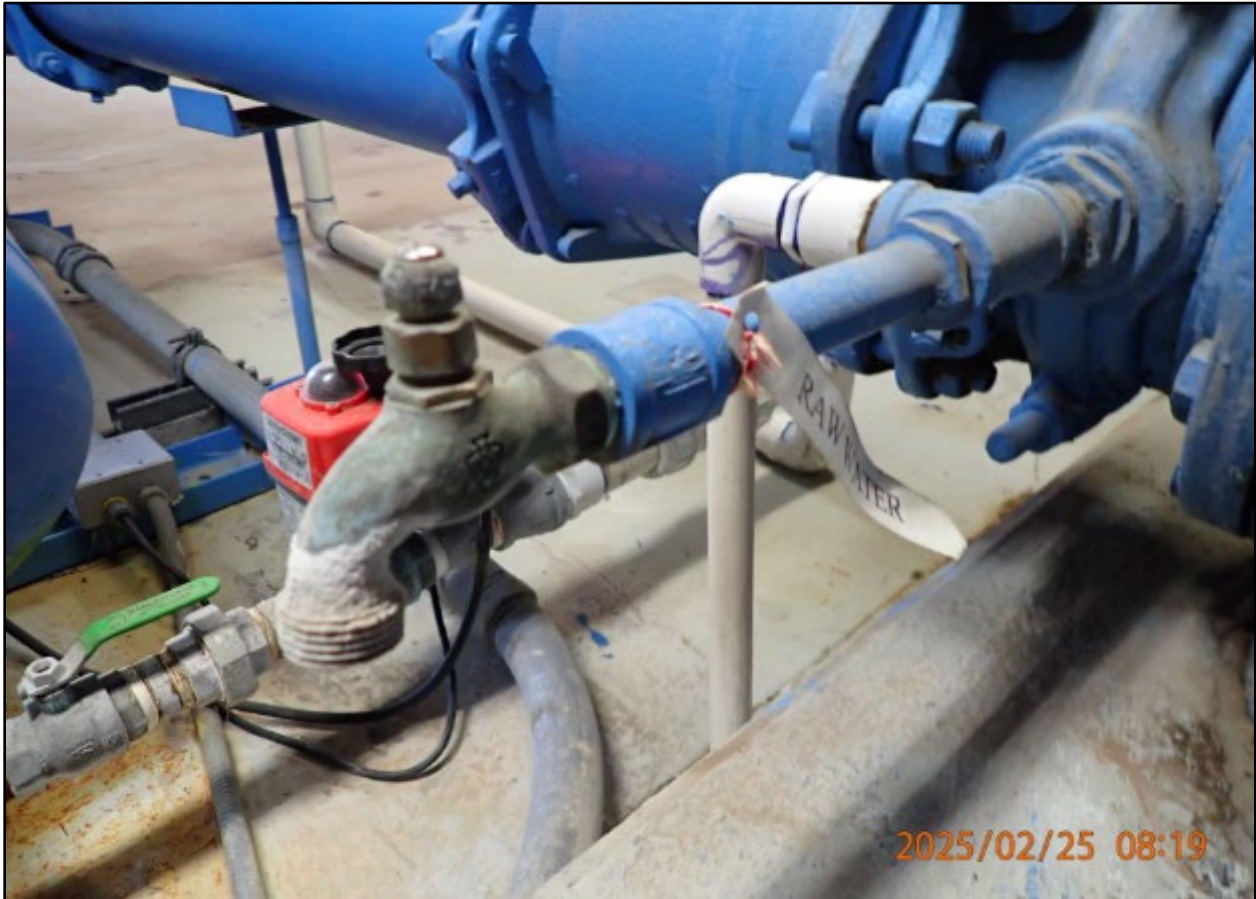
**Photograph 7. 02/25/2025 08:19 P2250267.JPG**

Well #1 Tower and Wellhouse are located within the Water Utility Shop facility, a fenced yard with utility equipment and storage. The 0.5 MG elevated Well #1 Tower was last inspected in 2019 and is scheduled to be recoated in fiscal year 2026. The EPA Inspection Team observed that Well #1 Tower’s overflow pipe (Refer to [Appendix 1, Photographs 5 and 6](#)) was not air-gapped and was plumbed directly to a buried pipe that was also connected to Well #1’s de-sanding unit waste line. The line terminated north of the Shop facility grounds with no screen and a flapper valve that did not rest flush to the pipe, creating a gap for contaminant entry. The EPA Inspection Team also noted a threaded finished water sample tap in the wellhouse (Refer to [Appendix 1, Photograph 7](#)).

**Observation 7.** The EPA Inspection Team observed that sampling taps on the discharge side of the wellhouses' piping were threaded rather than smooth-nosed taps or not equipped with atmospheric vacuum breakers, presenting a potential cross-connection. This issue was noted at Wells #1, #15, #5, #2, #17, and #11 (Refer to [Appendix 1, Photographs 7, 16, 22, and 25](#)). Not all wellhouses were inspected due to time constraints, but system representatives stated that all wellhouses were constructed similarly.

Description: Threaded sample tap on the Well #1 discharge piping.

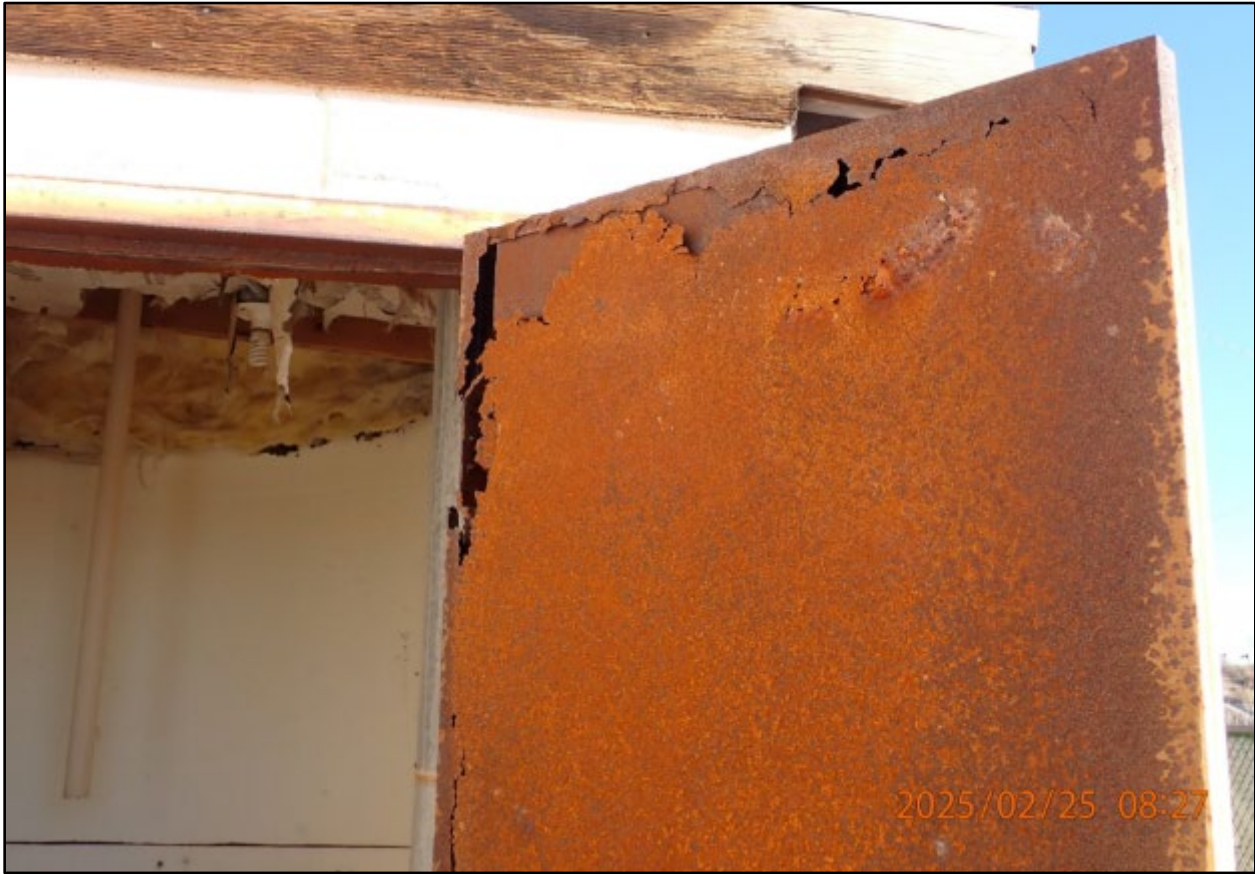
**Photograph 9. 02/25/2025 08:27 P2250279.JPG**

Description: Chlorine room door for Well #1 with excessive corrosion.

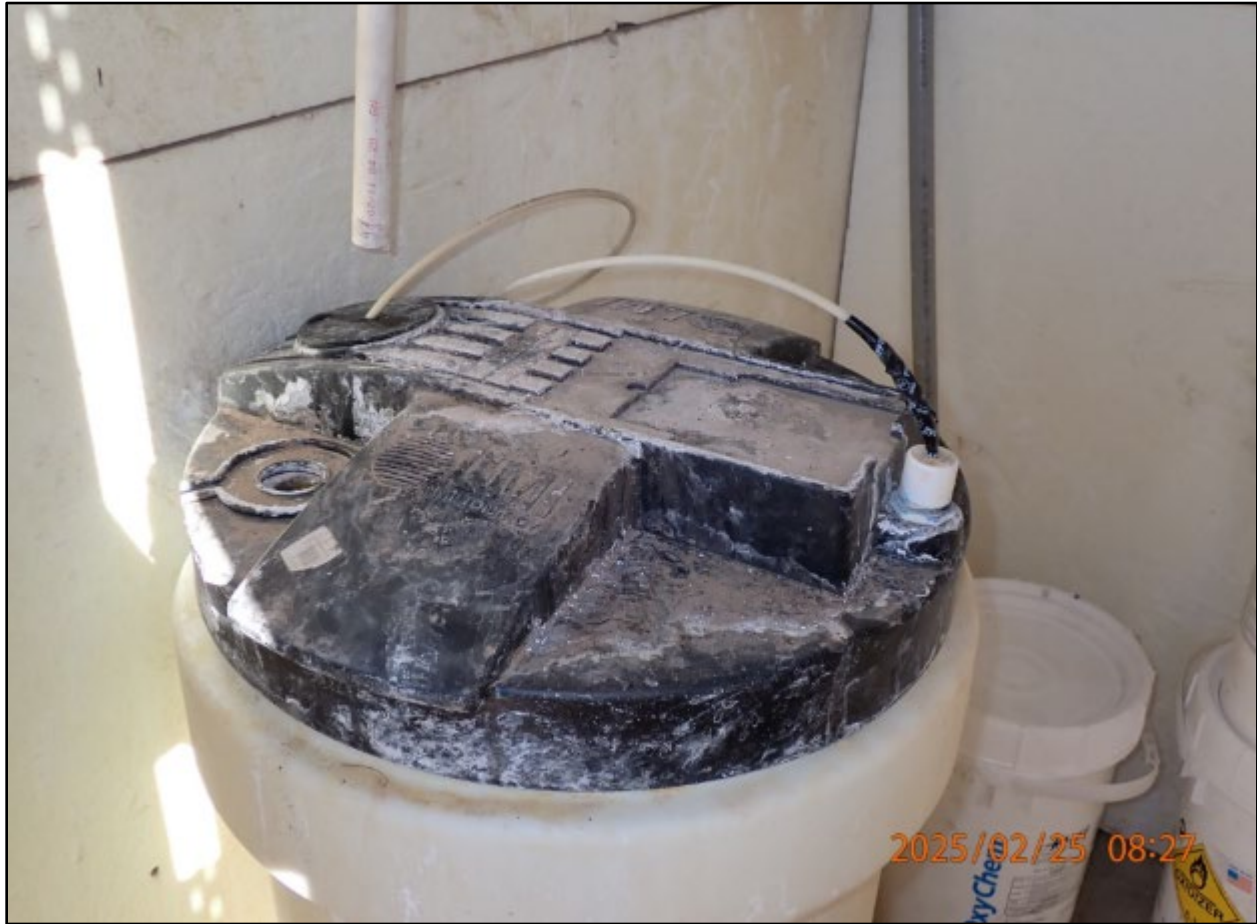
**Photograph 10. 02/25/2025 08:27 P2250280.JPG**

The EPA inspection team observed that the calcium hypochlorite feed room had an open electrical box with exposed wiring, no ventilation (automatic or manual), a chemical container open to atmosphere, and no secondary containment for the chemical tank (Refer to [Appendix 1, Photographs 8, 9, 10, and 11](#)). The eyewash station was inoperable, according to System representatives.

**Observation 11.** The EPA Inspection Team observed that there was no secondary containment for the chemical storage or feed systems in the calcium hypochlorite feed rooms at all inspected well stations (Refer to Appendix 1, Photographs 10, 13, 14, 17, 23, and 24).

**Observation 12.** The EPA Inspection Team observed chemical storage containers with openings and not vented outside of the building in the calcium hypochlorite feed rooms at all inspected well stations (Refer to Appendix 1, Photographs 10, 13, 14, 17, 23, and 24).

Description: Chlorine feed for Well #1 without secondary containment and open to the room atmosphere.

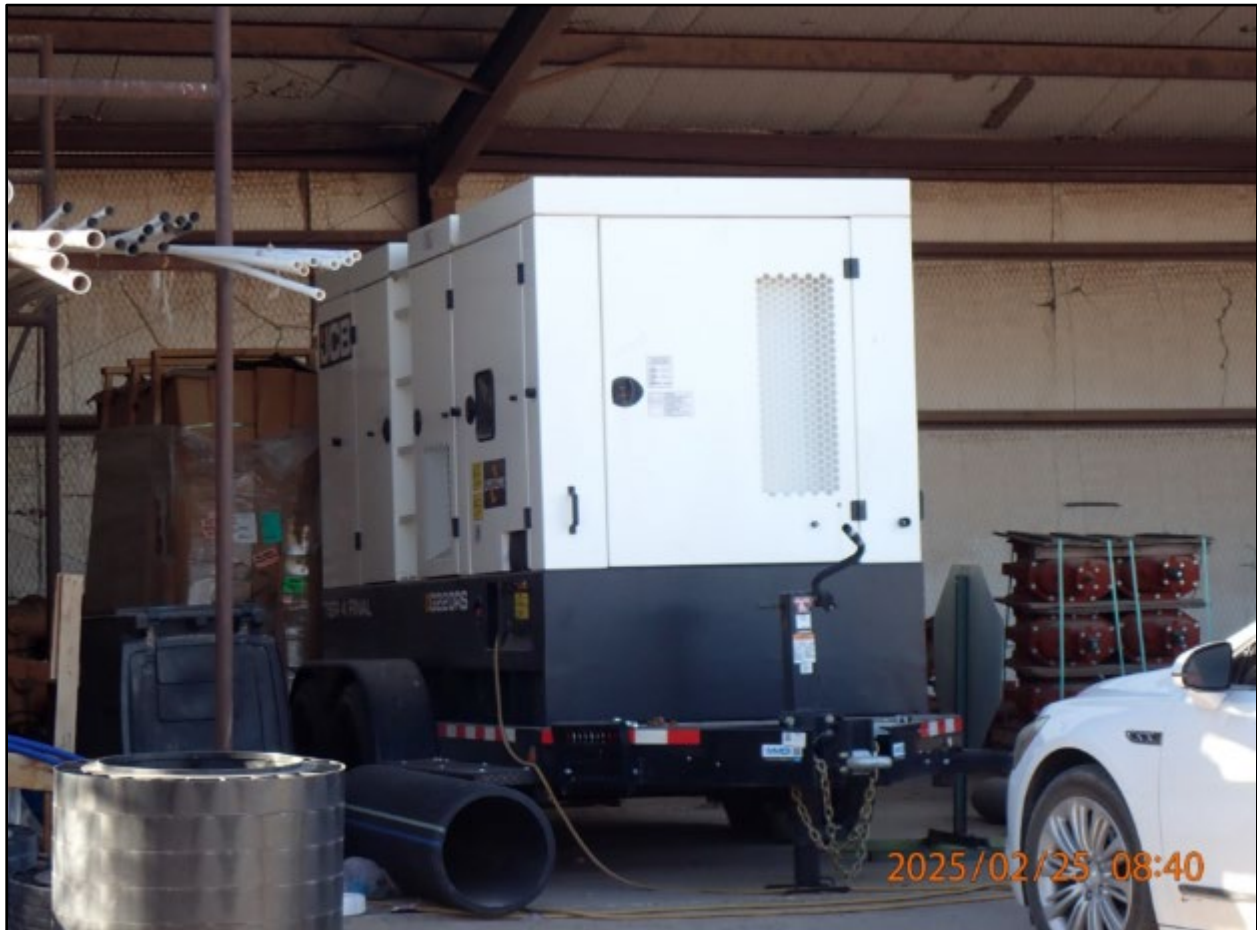
**Photograph 12. 02/25/2025 08:40 P2250291.JPG**  
Description: Portable generator located at Well #1.

A portable generator was stored at the site and was available to be transported to well sites affected by power failures (Refer to [Appendix 1, Photograph 12](#)).

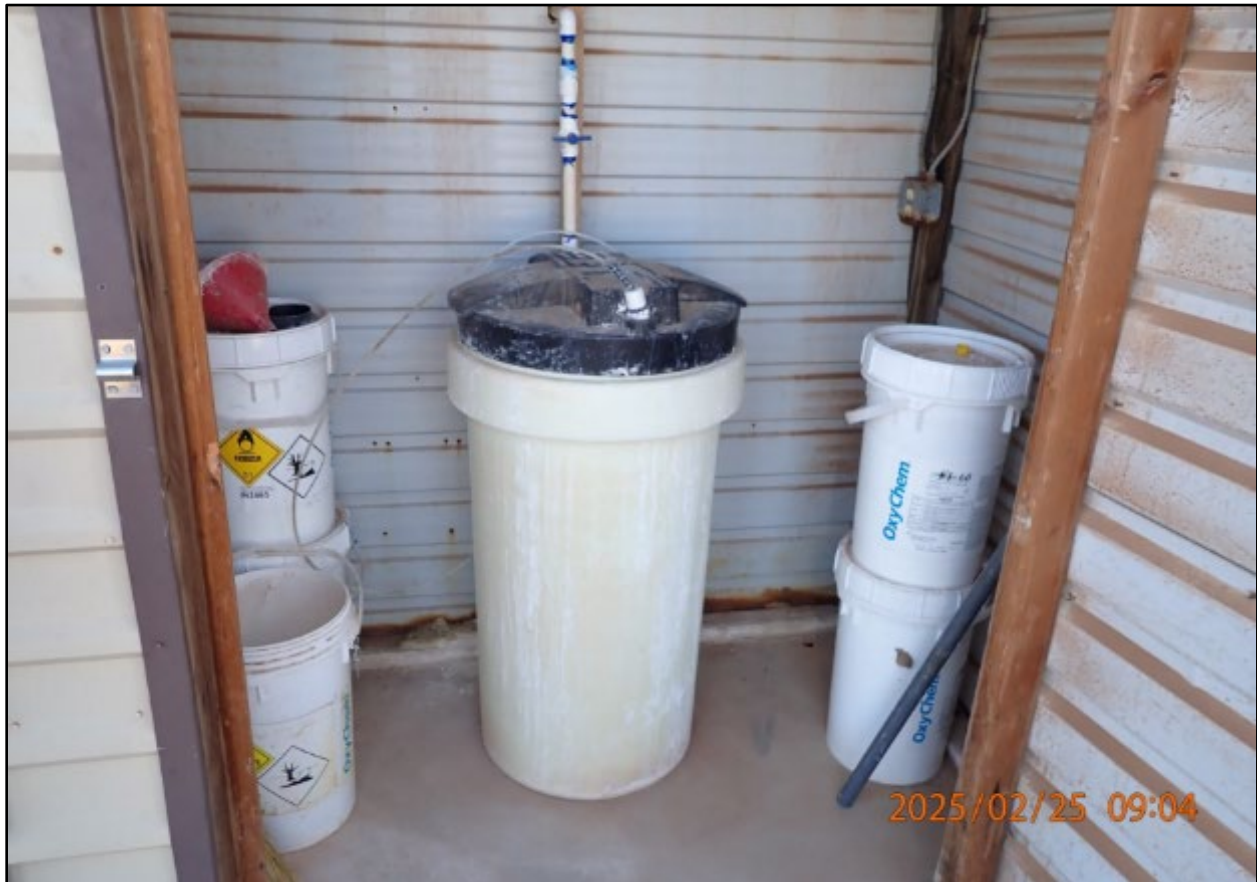
**Photograph 13. 02/25/2025 08:40 P2250291.JPG**

The EPA Inspection Team observed that the calcium hypochlorite feed room had no ventilation (automatic or manual), a chemical container open to room atmosphere, and no secondary containment

Description: Chlorine room for Well #15 with no secondary containment and with openings in the chemical tank.

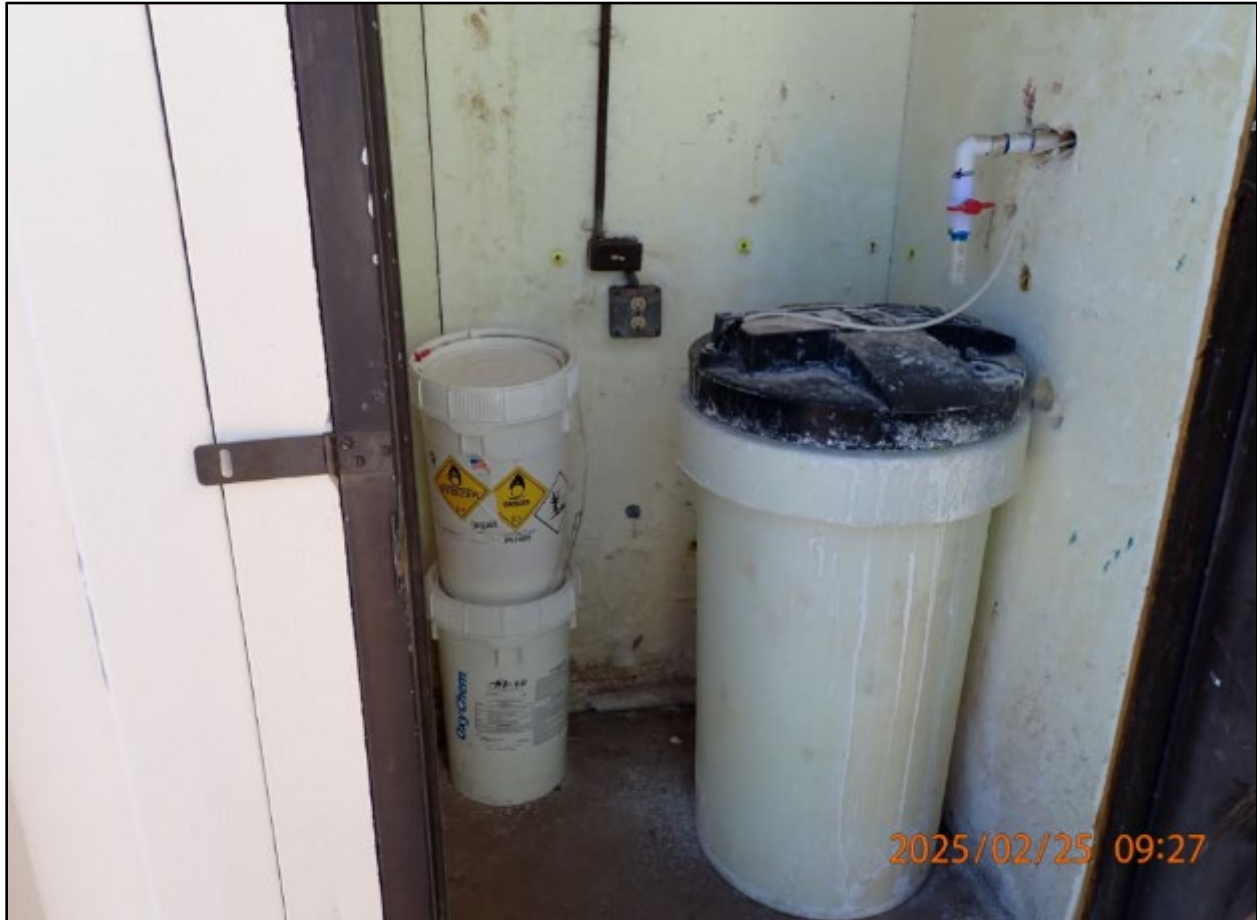
**Photograph 14. 02/25/2025 09:27 P2250317.JPG**

Description: Chlorine room for Well #5 with no secondary containment and with openings in the chemical tank.

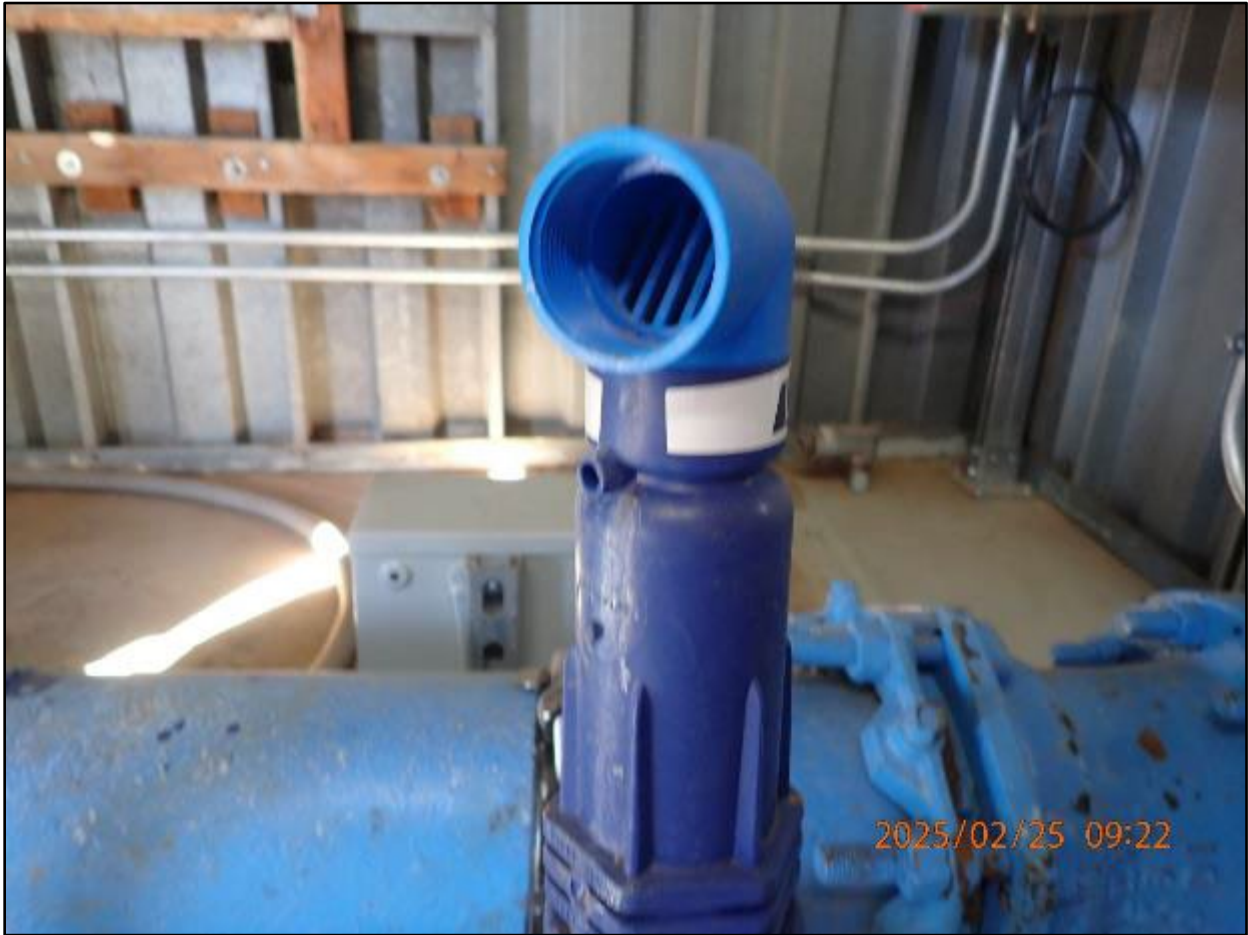
**Photograph 15. 02/25/2025 09:22 P2250321.JPG**

Description: Air relief at Well #5 with no mesh.

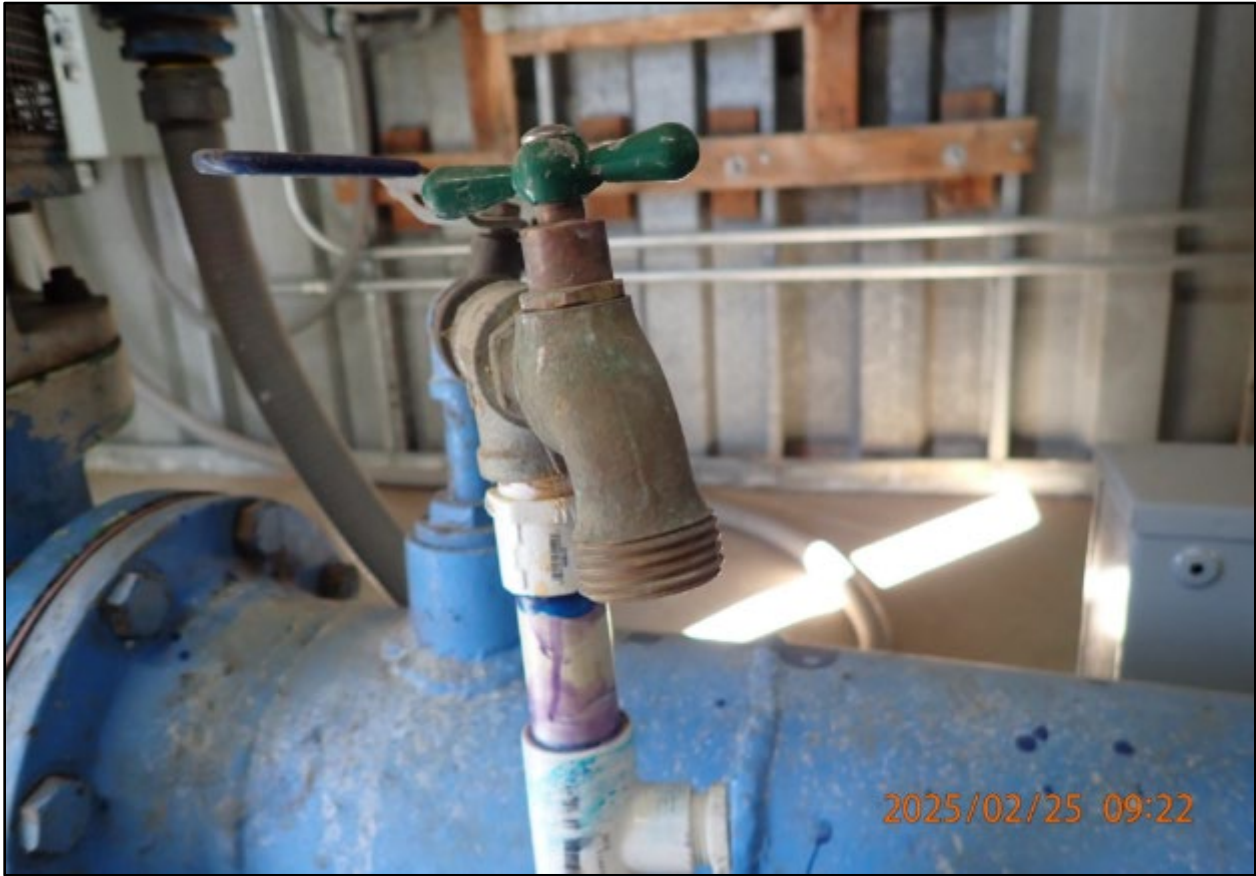
**Photograph 16. 02/25/2025 09:22 P2250309.JPG**

Description: Threaded sample tap on the discharge side of Well #5's piping.

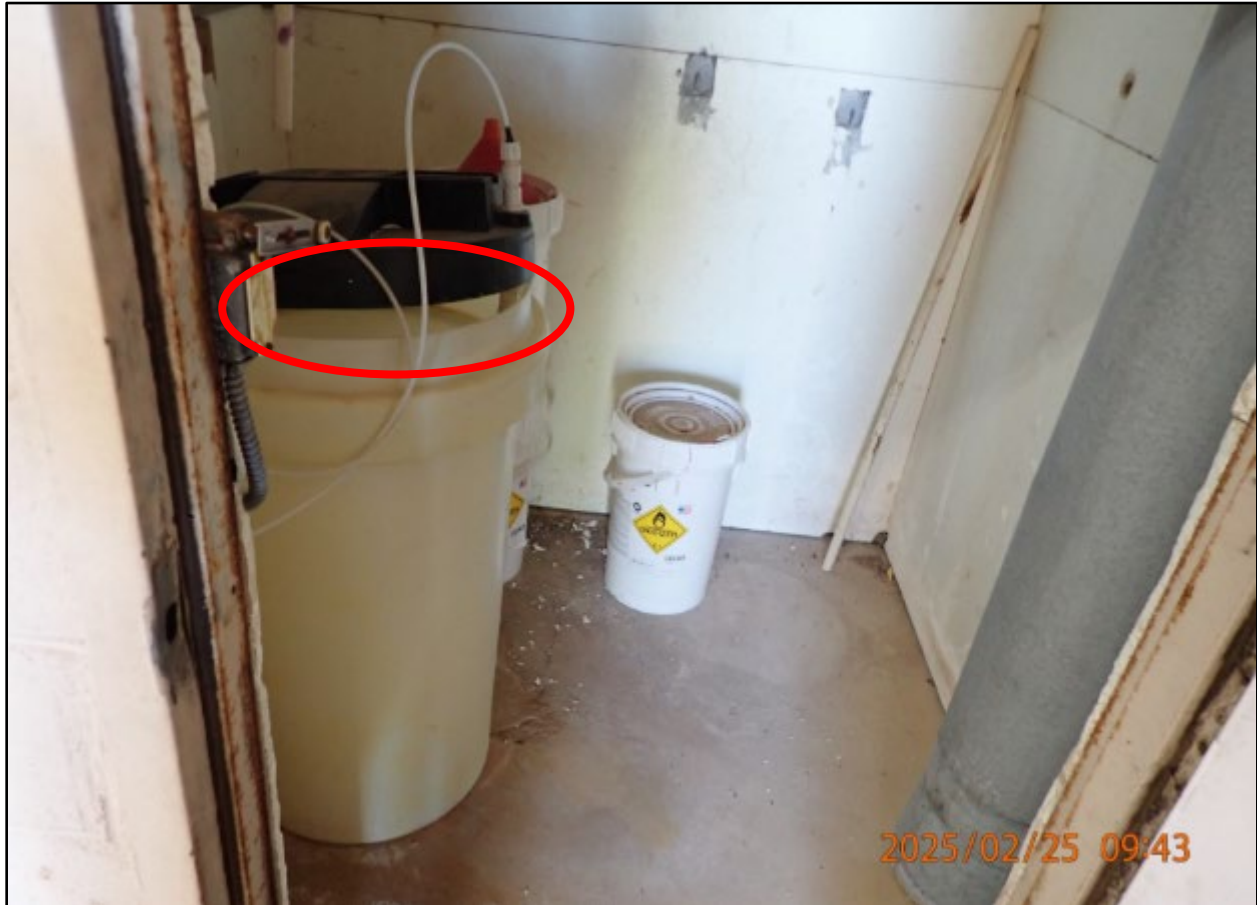
**Photograph 17. 02/25/2025 09:43 P2250336.JPG**

Description: Chlorine room for Well #2 with opening in chemical drum and no secondary containment.

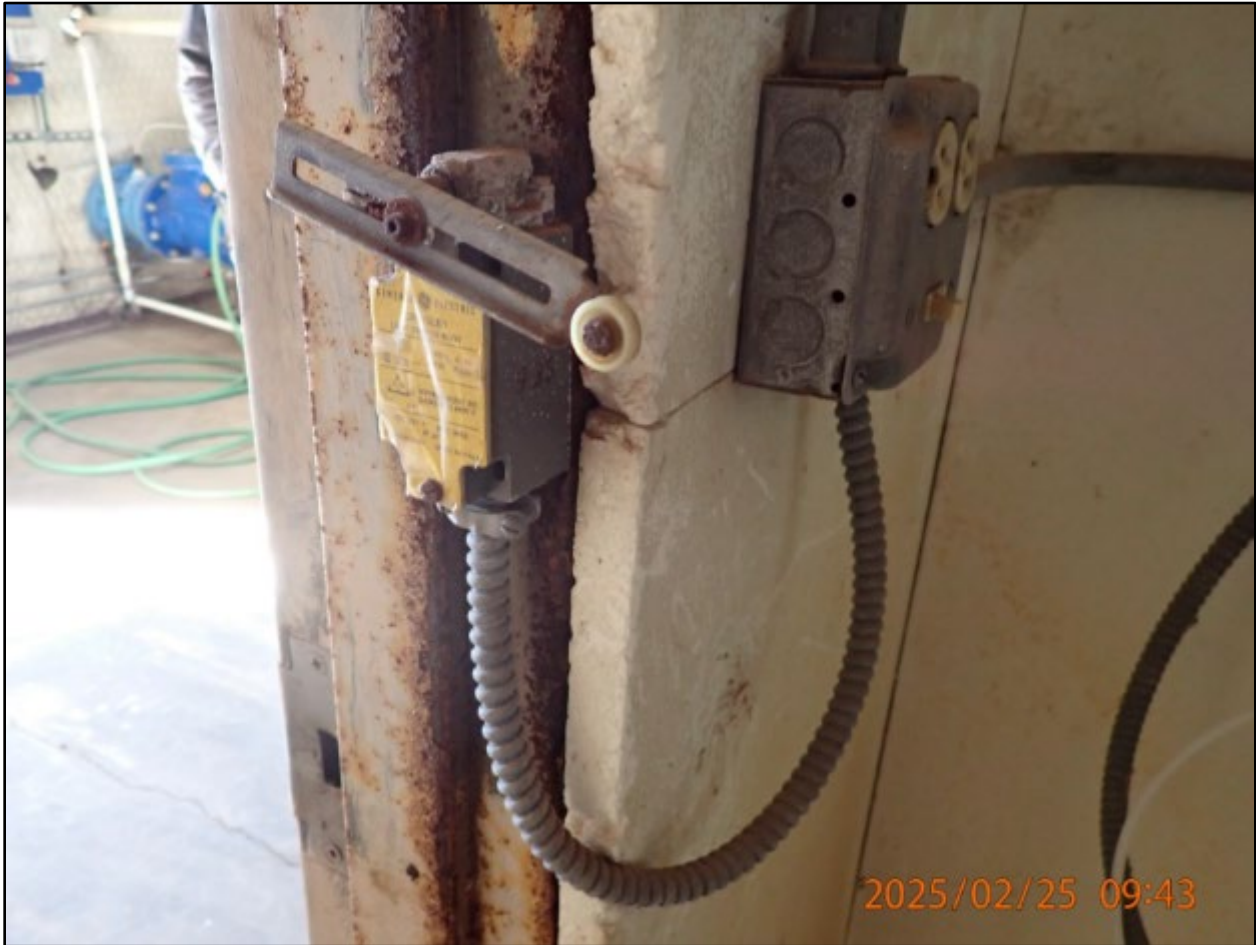
**Photograph 18. 02/25/2025 09:43 P2250339.JPG**

**Observation 10.** The EPA Inspection Team observed that there was no room ventilation initiated by an automatic door switch or manual switch in the calcium hypochlorite feed rooms at all inspected well stations (Refer to Appendix 1, Photograph 18).

Description: Chlorine room non-functional automatic ventilation switch for Well #2.

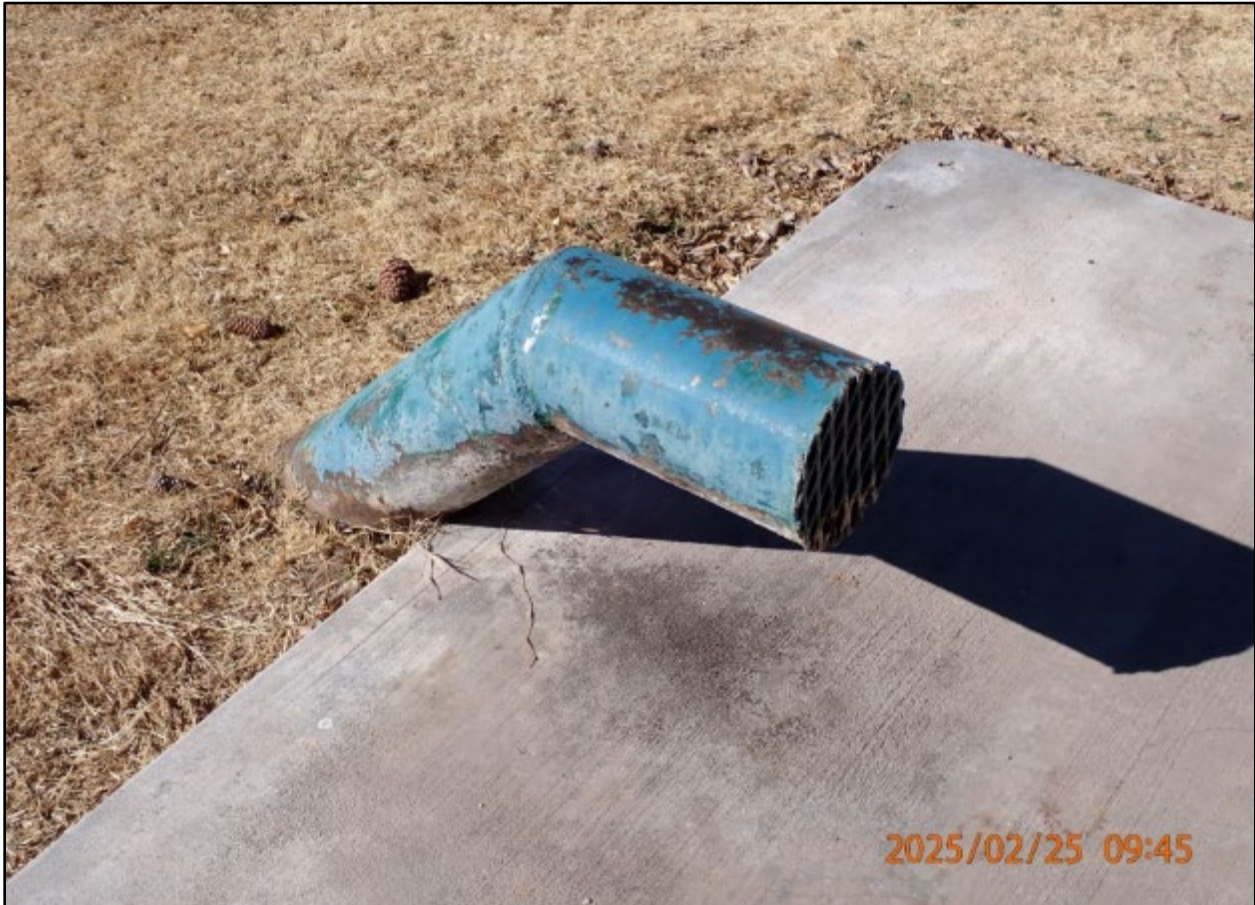
**Photograph 19. 02/25/2025 09:45 P2250341.JPG**

Description: Well #2 pump-to-waste discharge line with coarse mesh.

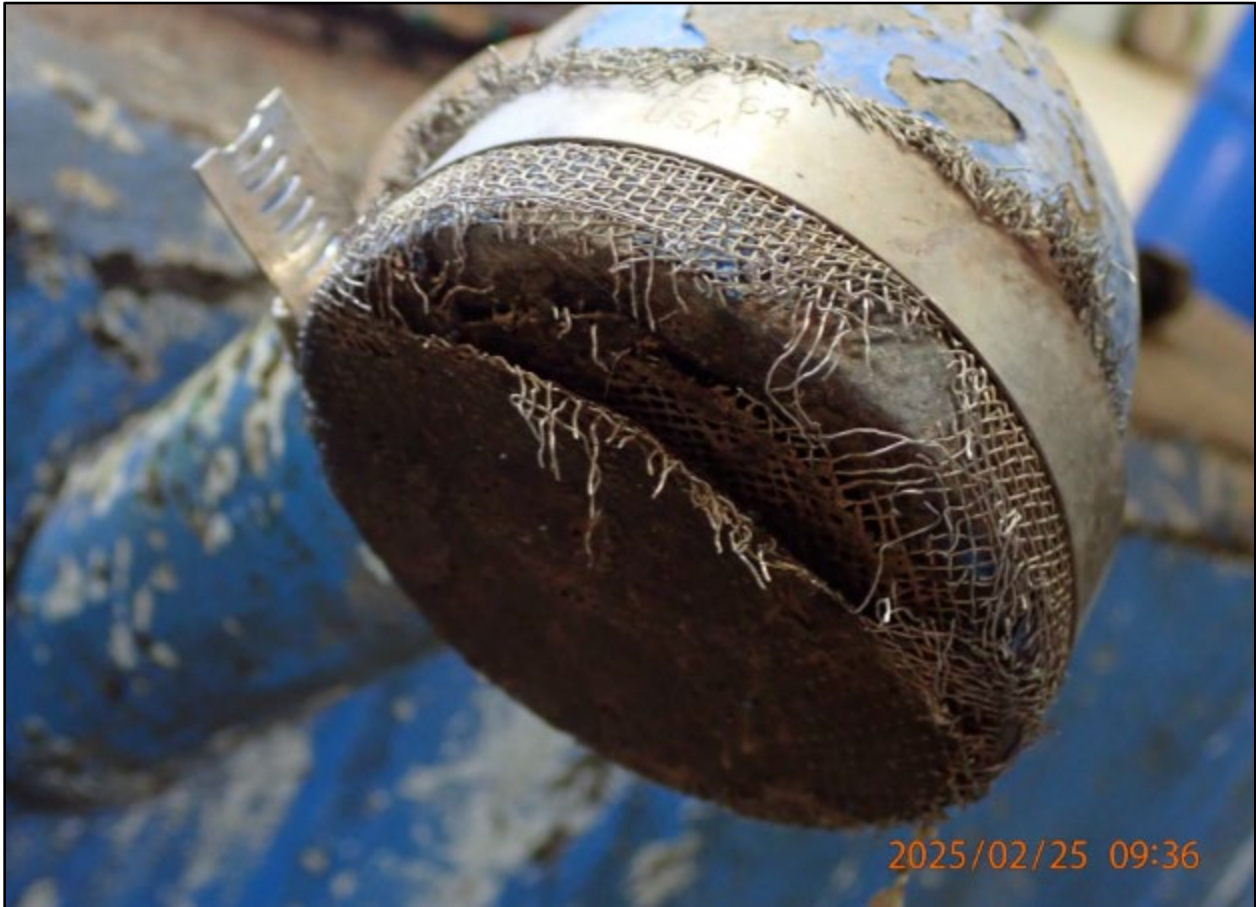
**Photograph 20. 02/25/2025 09:36 P2250331.JPG**  
Description: Well #2 vent screen with torn mesh.

**Observation 13.** The EPA Inspection Team noted that #24 gauge mesh was torn on Well #2 vent (Refer to Appendix 1, Photograph 20).

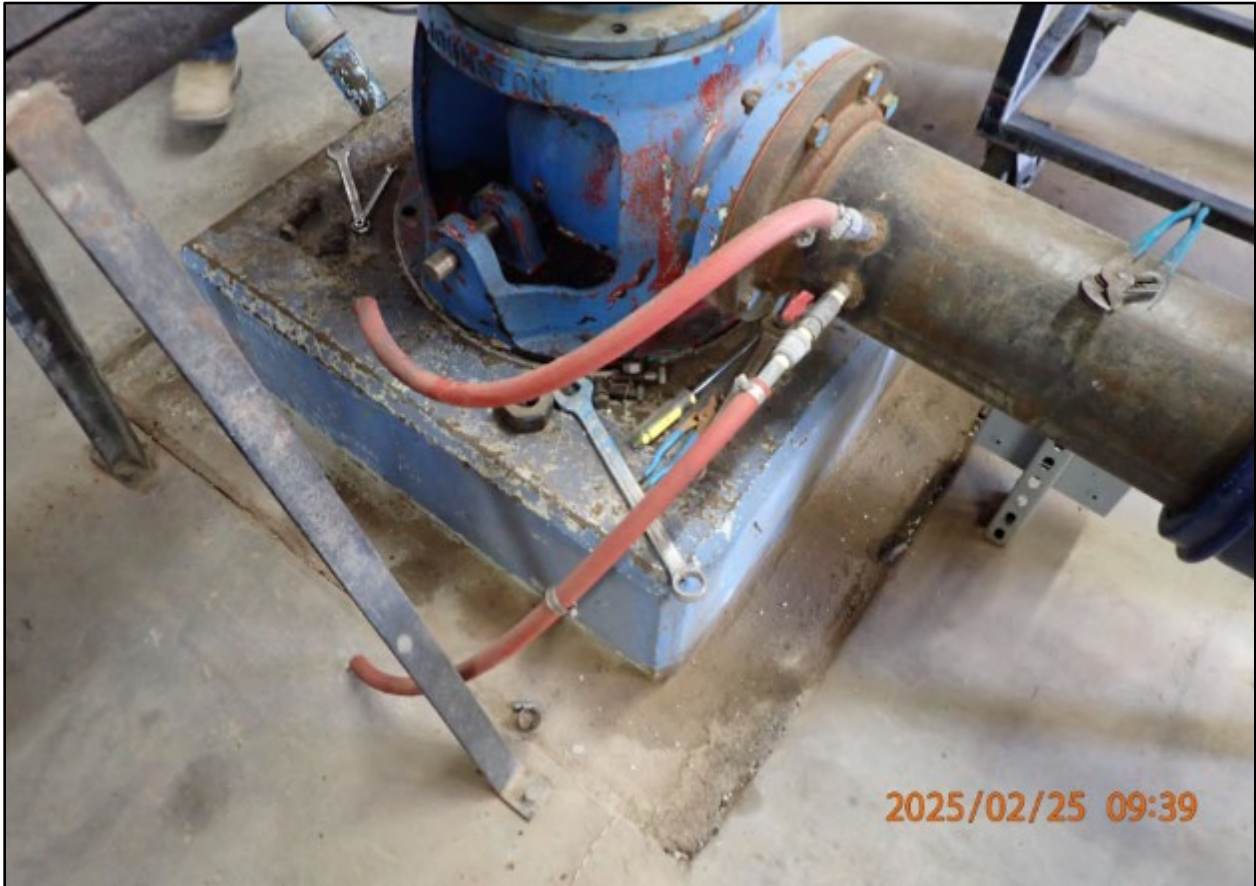
**Photograph 21. 02/25/2025 09:39 P2250334.JPG**

Description: Well #2 with old hose connections.
