**Region 6 - Enforcement & Compliance Assurance Division**  
**INSPECTION REPORT**

| <b>Inspection Date(s):</b> | 02/24/2025 – 02/25/2025 | |
| <b>System Name:</b> | <b>Deming Municipal Water System</b> | |
| <b>PWS ID:</b> | NM3528616 | |

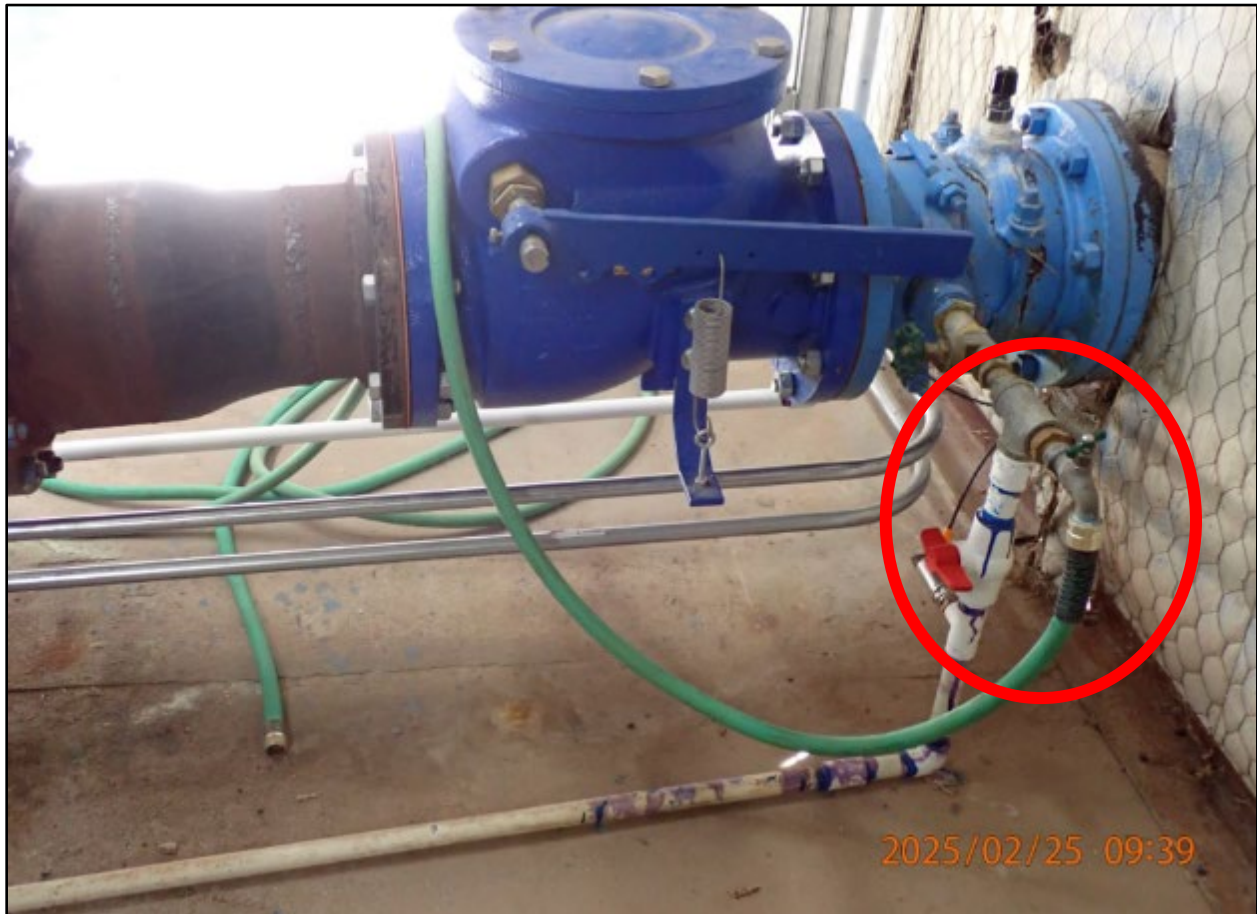
**Photograph 22. 02/25/2025 09:39 P2250335.JPG**

**Observation 7.** The EPA Inspection Team observed that sampling taps on the discharge side of the wellhouses' piping were threaded rather than smooth-nosed taps or not equipped with atmospheric vacuum breakers, presenting a potential cross-connection. This issue was noted at Wells #1, #15, #5, #2, #17, and #11 (Refer to [Appendix 1, Photographs 7, 16, 22, and 25](#)). Not all wellhouses were inspected due to time constraints, but system representatives stated that all wellhouses were constructed similarly.

Description: Well #2 discharge line with threaded sample tap with hose connection.

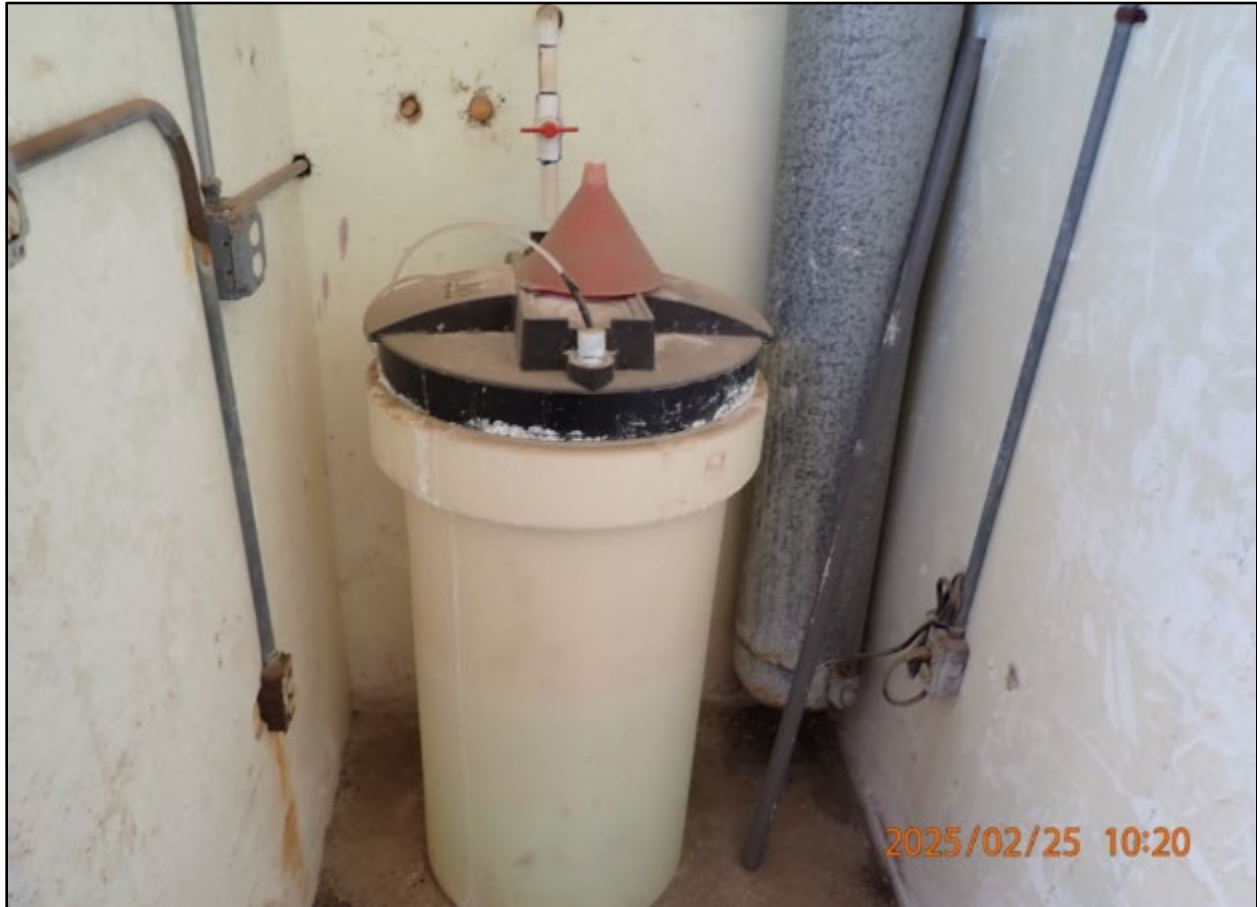
**Photograph 23. 02/25/2025 10:20 P2250363.JPG**

The EPA Inspection Team observed that the calcium hypochlorite feed room had no ventilation (automatic or manual), a chemical container open to room atmosphere, and no secondary containment for the chemical tank (Refer to Appendix 1, Photograph 23).

**Observation 11.** The EPA Inspection Team observed that there was no secondary containment for the chemical storage or feed systems in the calcium hypochlorite feed rooms at all inspected well stations (Refer to Appendix 1, Photographs 10, 13, 14, 17, 23, and 24).

**Observation 12.** The EPA Inspection Team observed chemical storage containers with openings and not vented outside of the building in the calcium hypochlorite feed rooms at all inspected well stations (Refer to Appendix 1, Photographs 10, 13, 14, 17, 23, and 24).

Description: Chlorine room for Well #11 with no secondary containment.

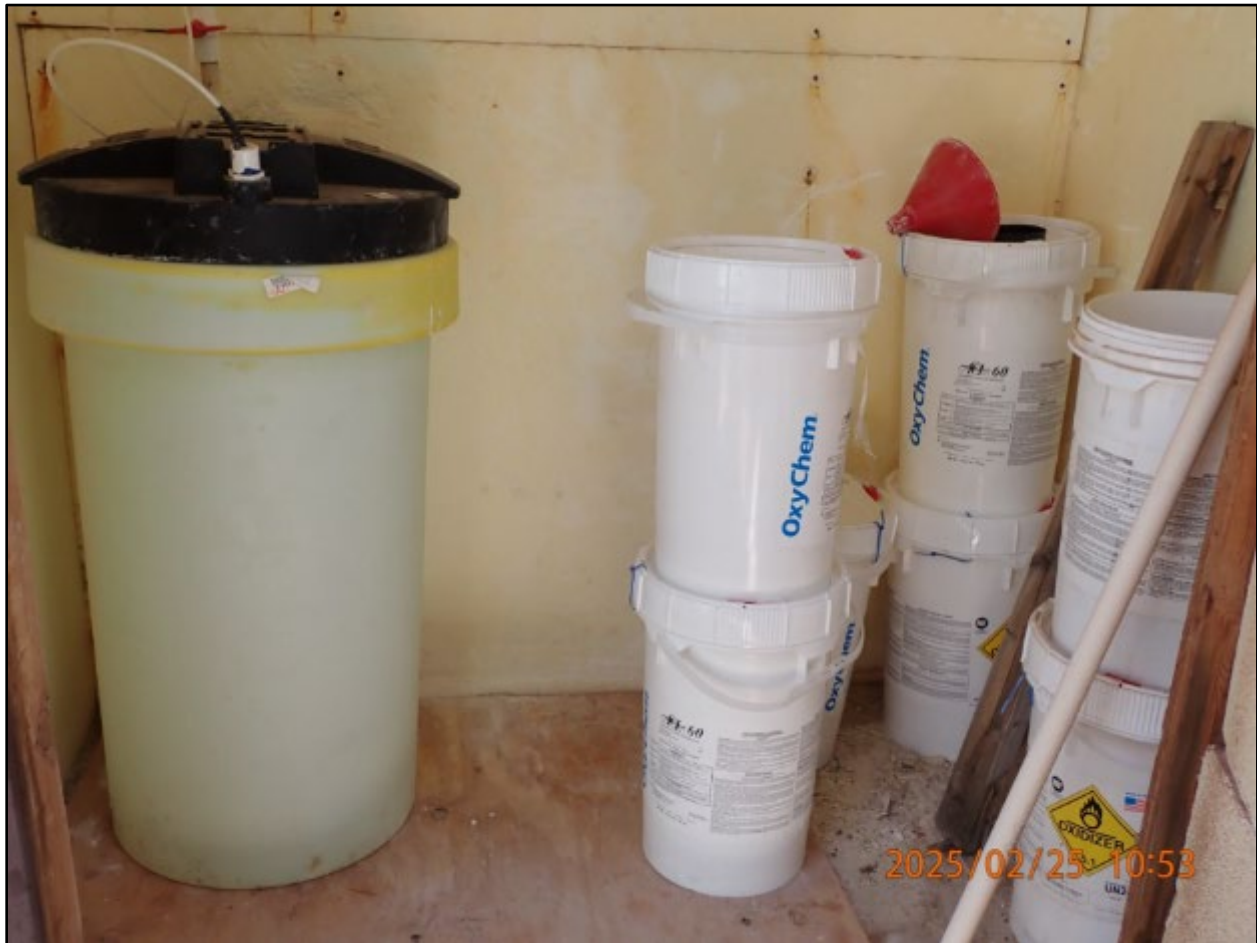
**Photograph 24. 02/25/2025 10:53 P2250387.JPG**

Description: Chlorine room for Well #17 with no secondary containment and liquid chemical tank open to atmosphere.

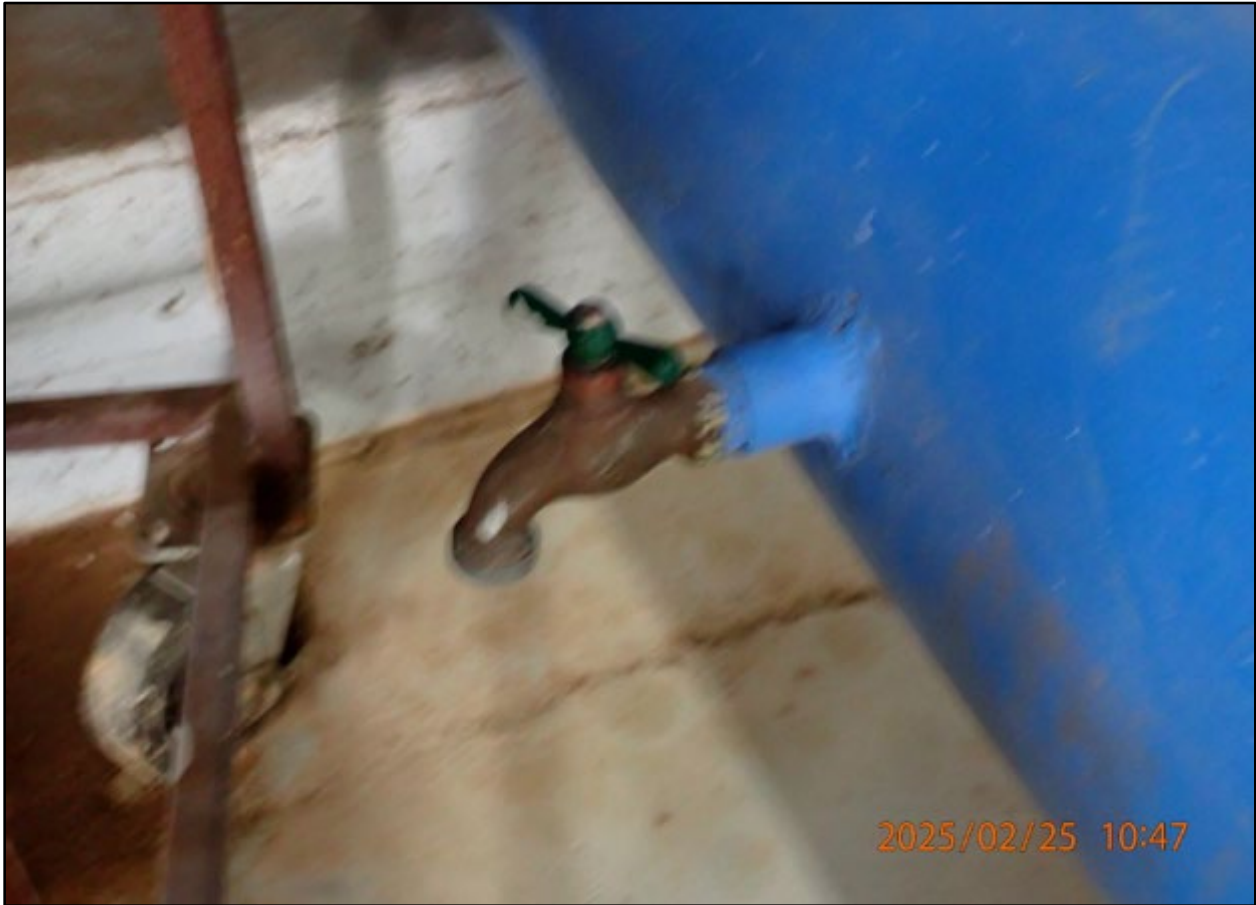
**Photograph 25. 02/25/2025 10:47 P2250383.JPG**  
Description: Threaded sample tap on the Well #17 discharge piping.

The EPA Inspection Team observed that the calcium hypochlorite feed room had no ventilation (automatic or manual), a chemical container open to room atmosphere, and no secondary containment for the chemical tank (Refer to Appendix 1, Photograph 24). A lack of proper screening on the well discharge line was noted by the EPA Inspection Team. Inspectors observed threaded finished water sample taps with no vacuum breakers or smooth-nosed style spigots (Refer to Appendix 1, Photograph 25).

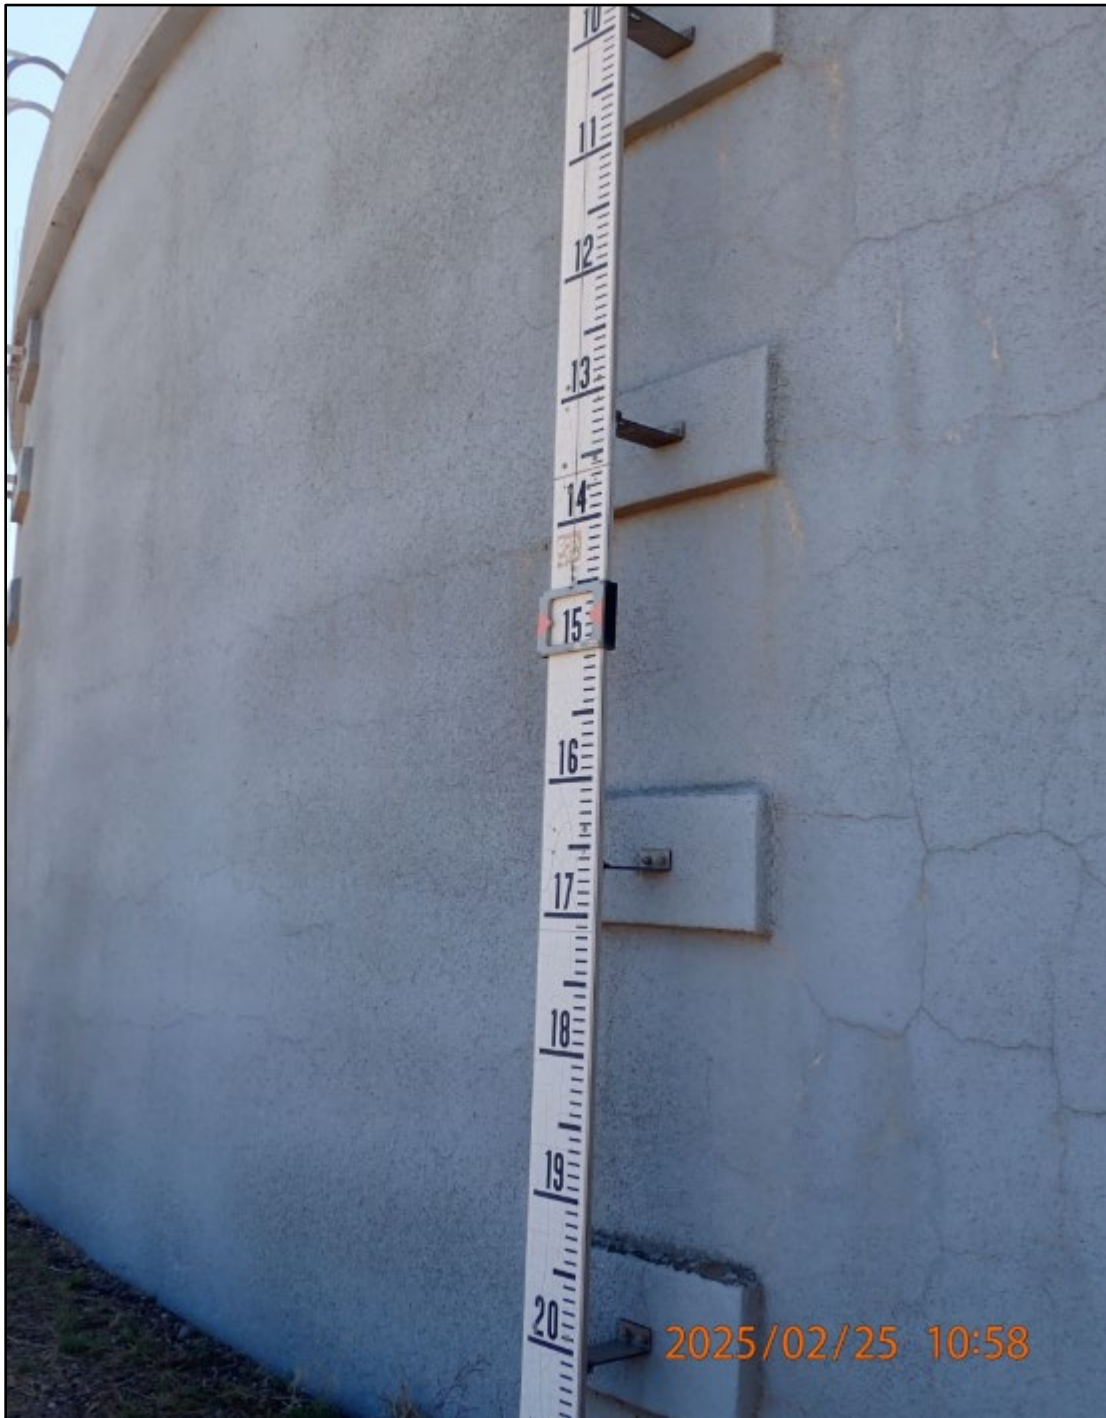
**Photograph 26. 02/25/2025 10:58 P2250397.JPG**  
Description: Minor cracking of 3-MG Storage Tank.

The EPA Inspection Team noted minor cracks in the outer layers of the tank's coating system (Refer to Appendix 1, Photograph 26). According to System representatives, repairs to the coating system were included in the long-term capital plan. The EPA Inspection Team observed that the tank roof access ladder's first rung was less than 12 feet from ground level.

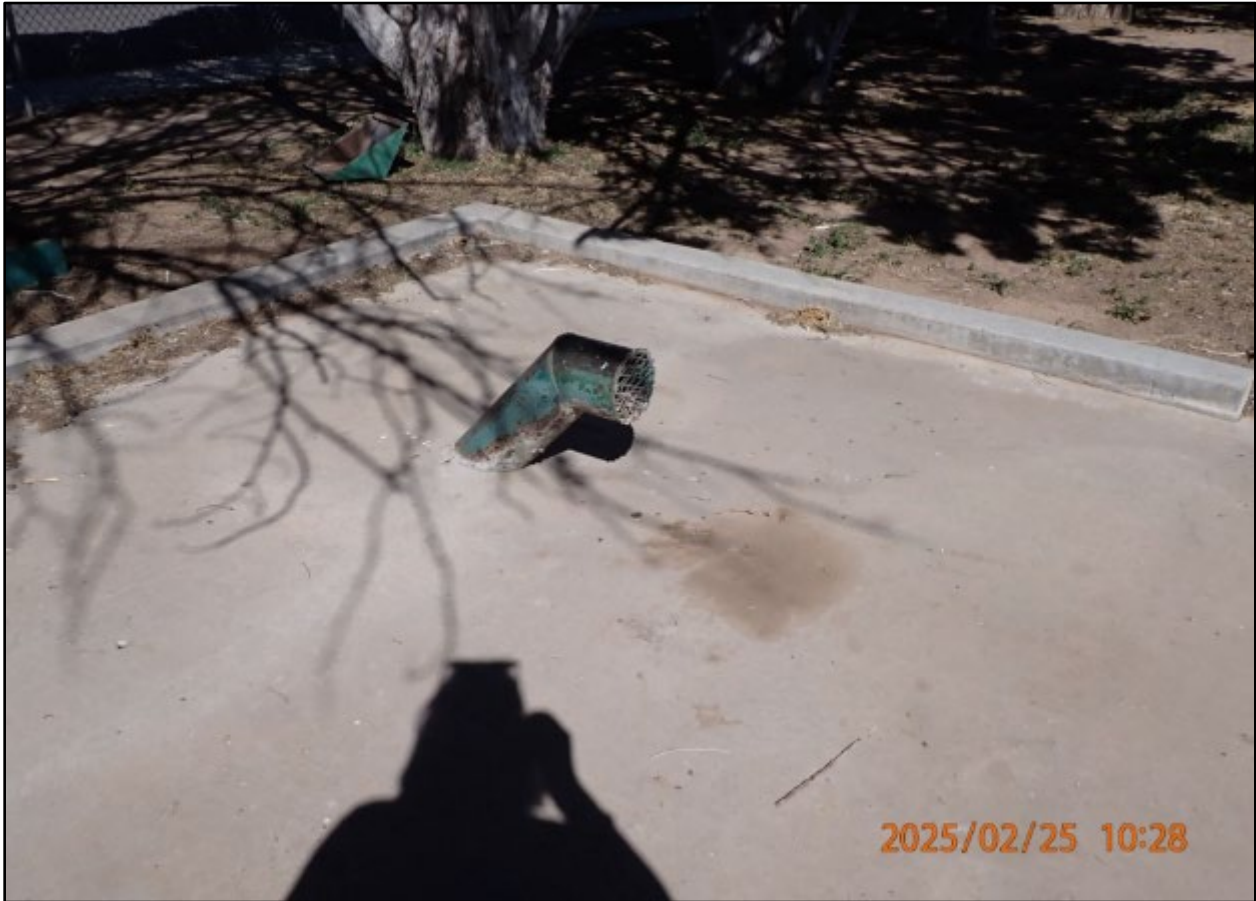
**Photograph 27. 02/25/2025 10:28 P2250370.JPG**

**Observation 8.** The EPA Inspection Team observed that the overflow piping from both Well #1 Tower and Well #11 Tower were connected to the wellhouses' discharge from the de-sanding cleaning process, presenting a potential cross-connection.

Description: Overflow for Well #11 Tower with coarse mesh; Well #11 de-sander waste discharge is connected to the overflow pipe.

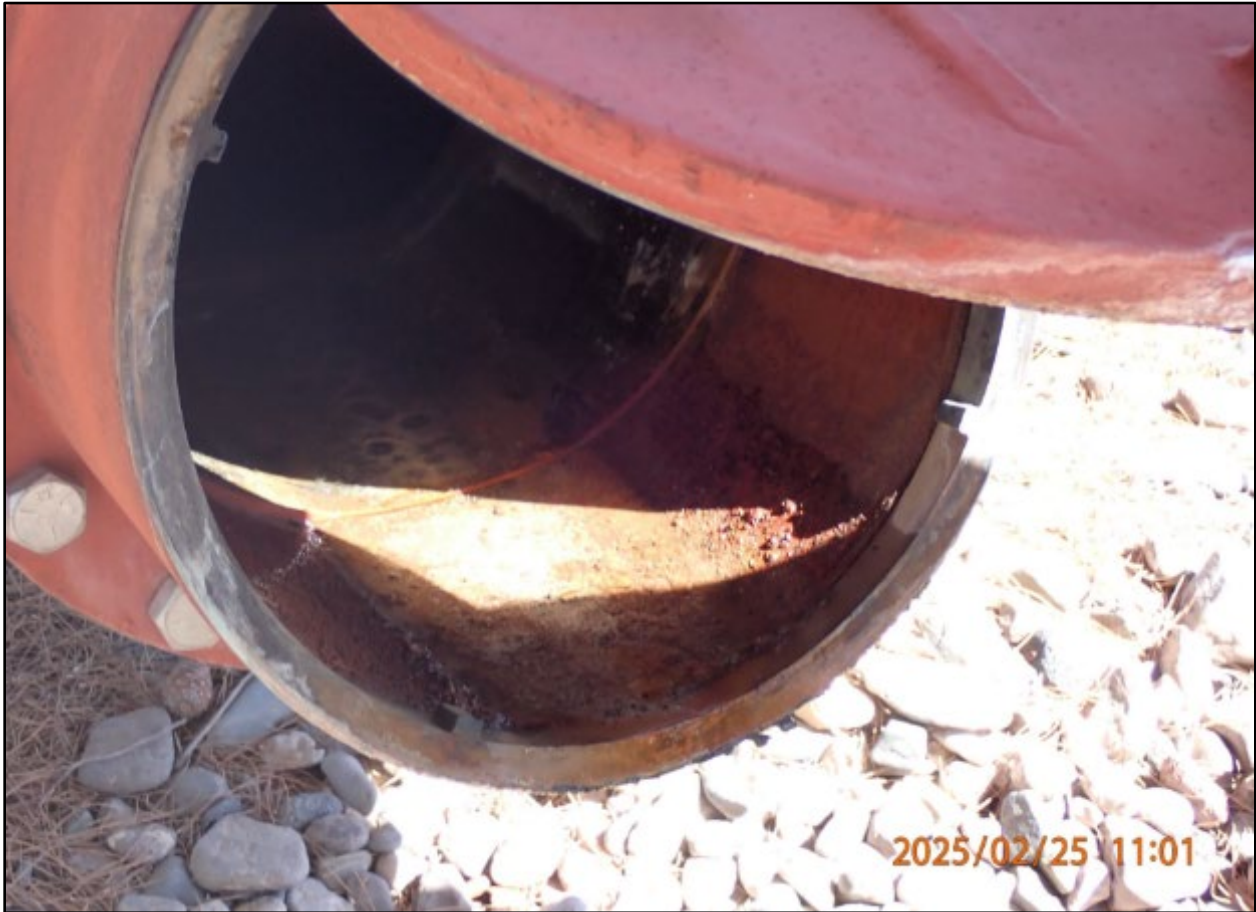
**Photograph 28. 02/25/2025 11:01 P2250402.JPG**

**Observation 15.** The EPA Inspection Team noted that #24-gauge mesh was not installed on the overflow for the 3MG Storage Tank (Refer to [Appendix 1, Photograph 28](#)).

Description: Overflow for 3MG Storage Tank; unsealed flap valve without a mesh screen.

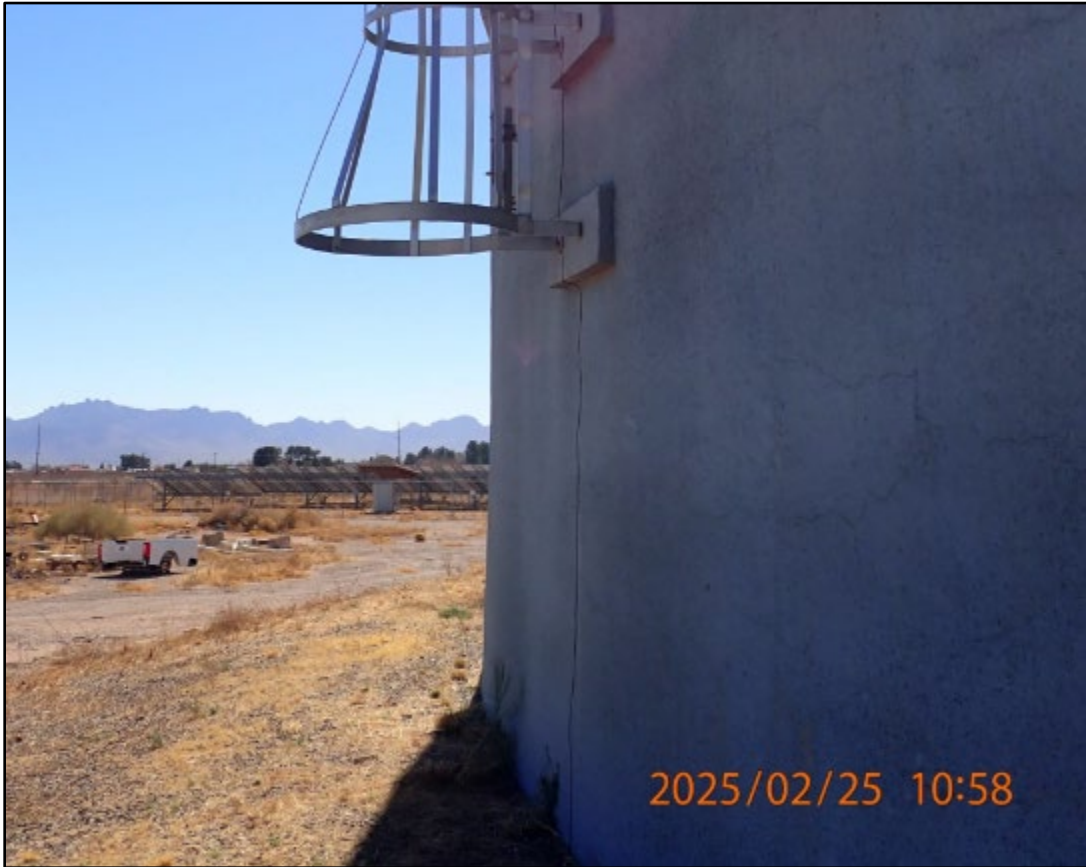
**Photograph 29. 02/25/2025 10:58 P2250398.JPG**

**Observation 17.** The EPA Inspection Team noted that the height to the first ladder rung at the 3-MG Storage Tank was less than 12 feet from ground level, and there was no locked hatch preventing unauthorized access. (Refer to [Appendix 1, Photograph 29](#)).

Description: Ladder for 3-MG Storage Tank less than 12 feet from ground level and no locked hatch preventing unauthorized access.

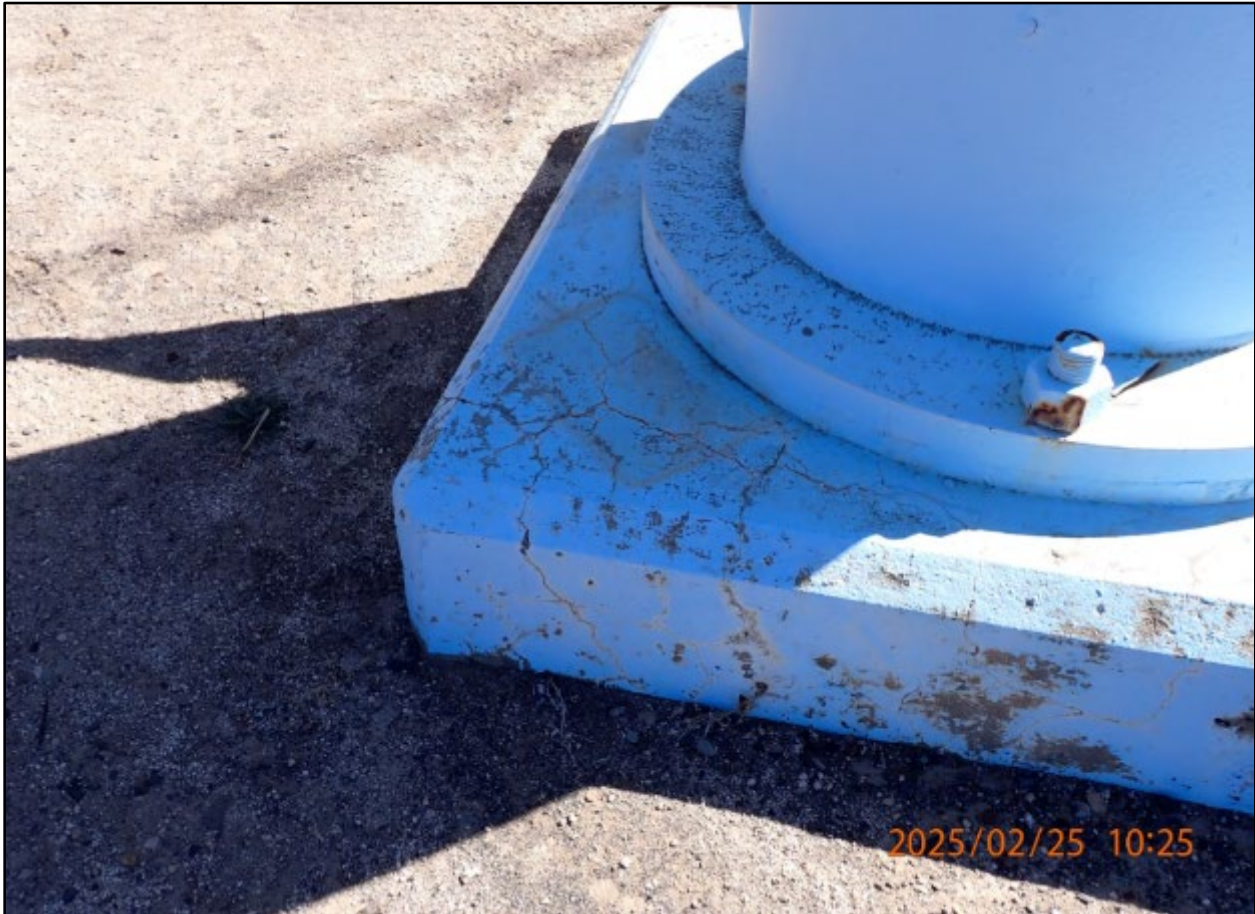
**Photograph 30. 02/25/2025 10:25 P2250369.JPG**  
Description: Cracking foundation of the Well #11 Tower.

**Observation 18.** The EPA Inspection Team noted that the foundation of the Well #11 Tower was showing signs of cracking (Refer to Appendix 1, Photograph 30).
