## Region 6 - Enforcement & Compliance Assurance Division

### INSPECTION REPORT

| Company Name: | <b>Merit Energy Company, LLC</b> | |
| Facility Name: | <b>Ras Fisher No. 3-5</b> | |

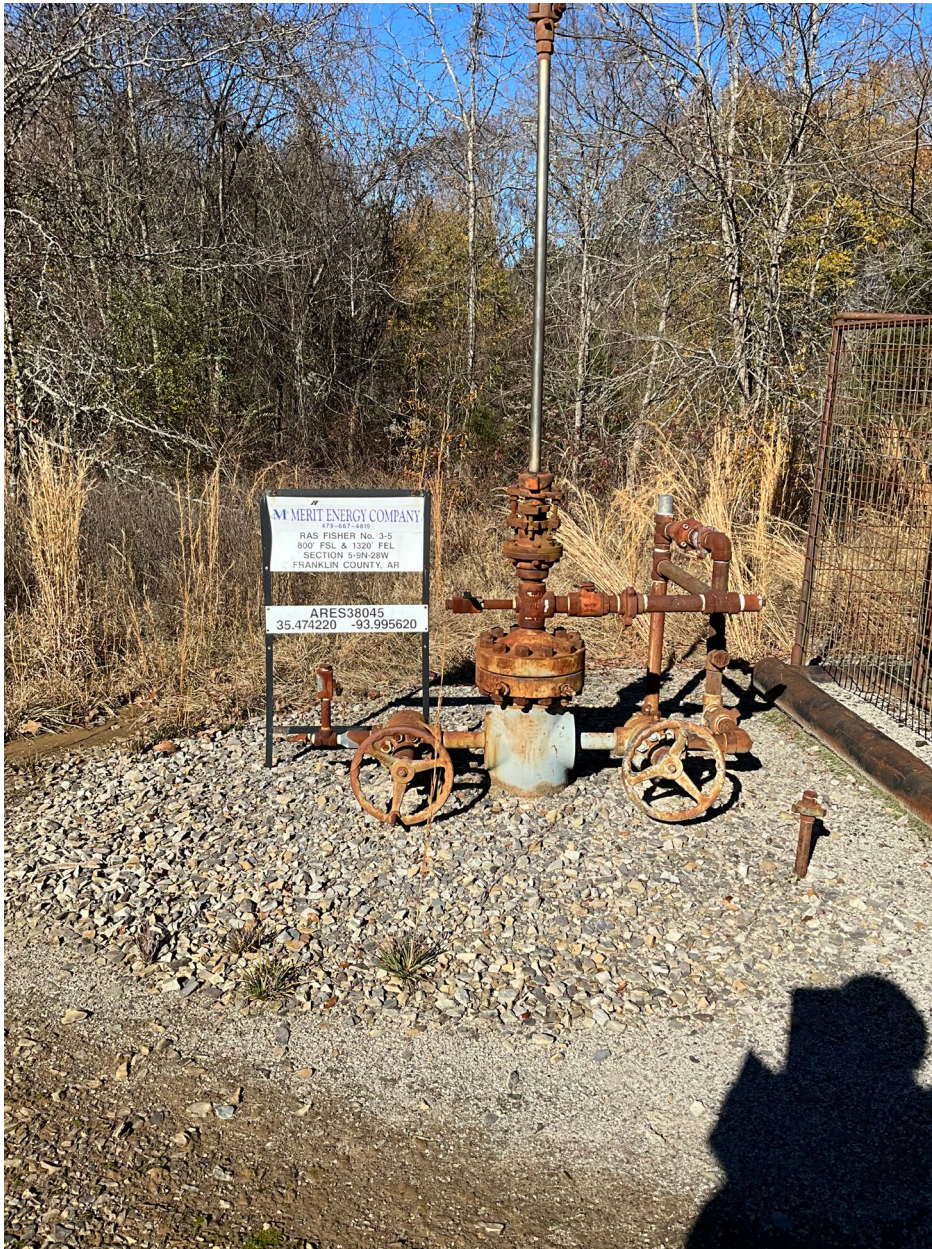
Photo No. 1

**Description:** Looking northwest, this photo shows the sign at the facility.

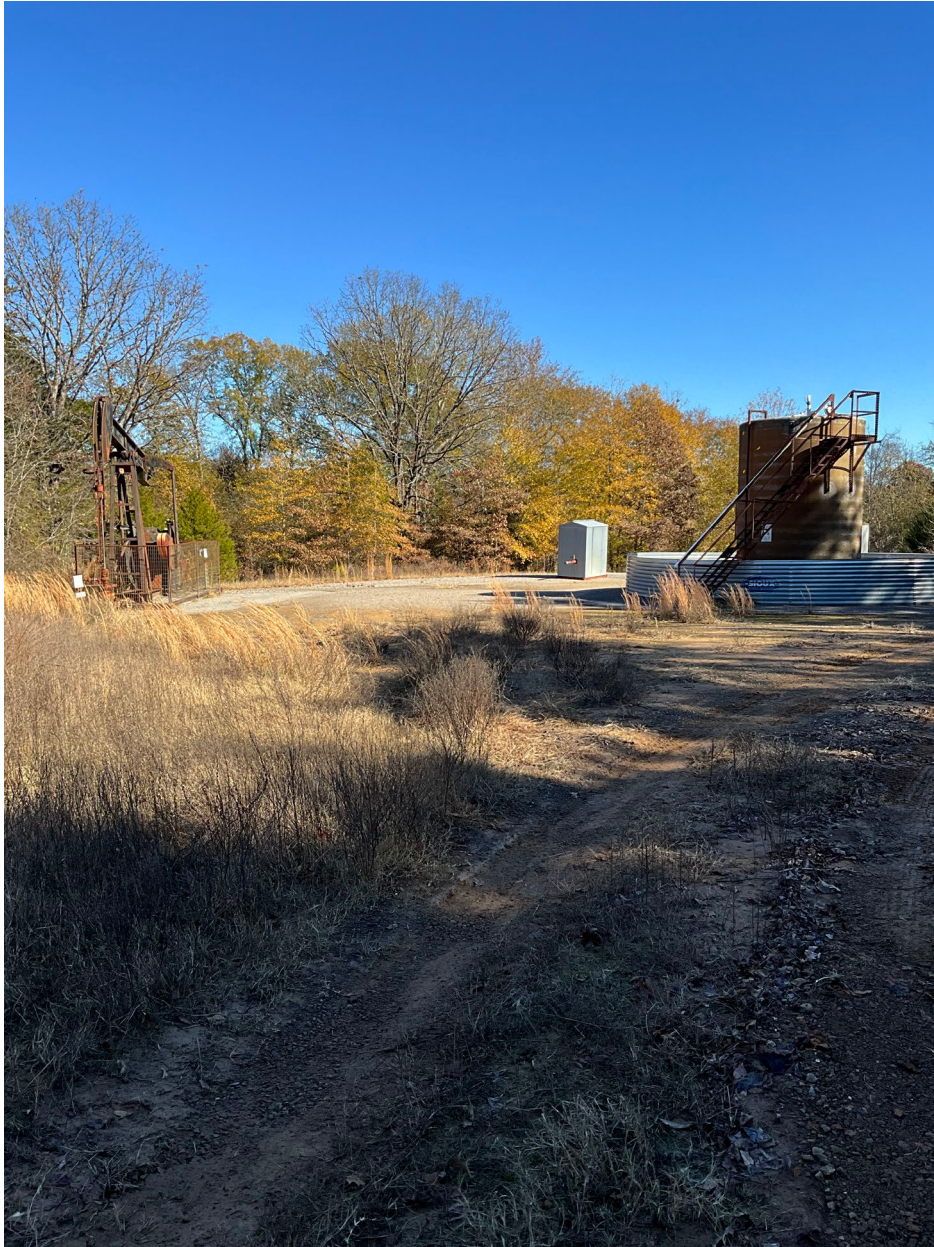
Photo No. 2

**Description:** Looking northwest, this photo shows an overview of the facility.
