Del Oro Dairy  
Inspection Date 06/07/2022

**Region 6 - Enforcement & Compliance Assurance Division**  
**INSPECTION REPORT**

| Regulatory Program(s) | CAFO | |
| Facility Name: | <b>Del Oro Dairy</b> | |

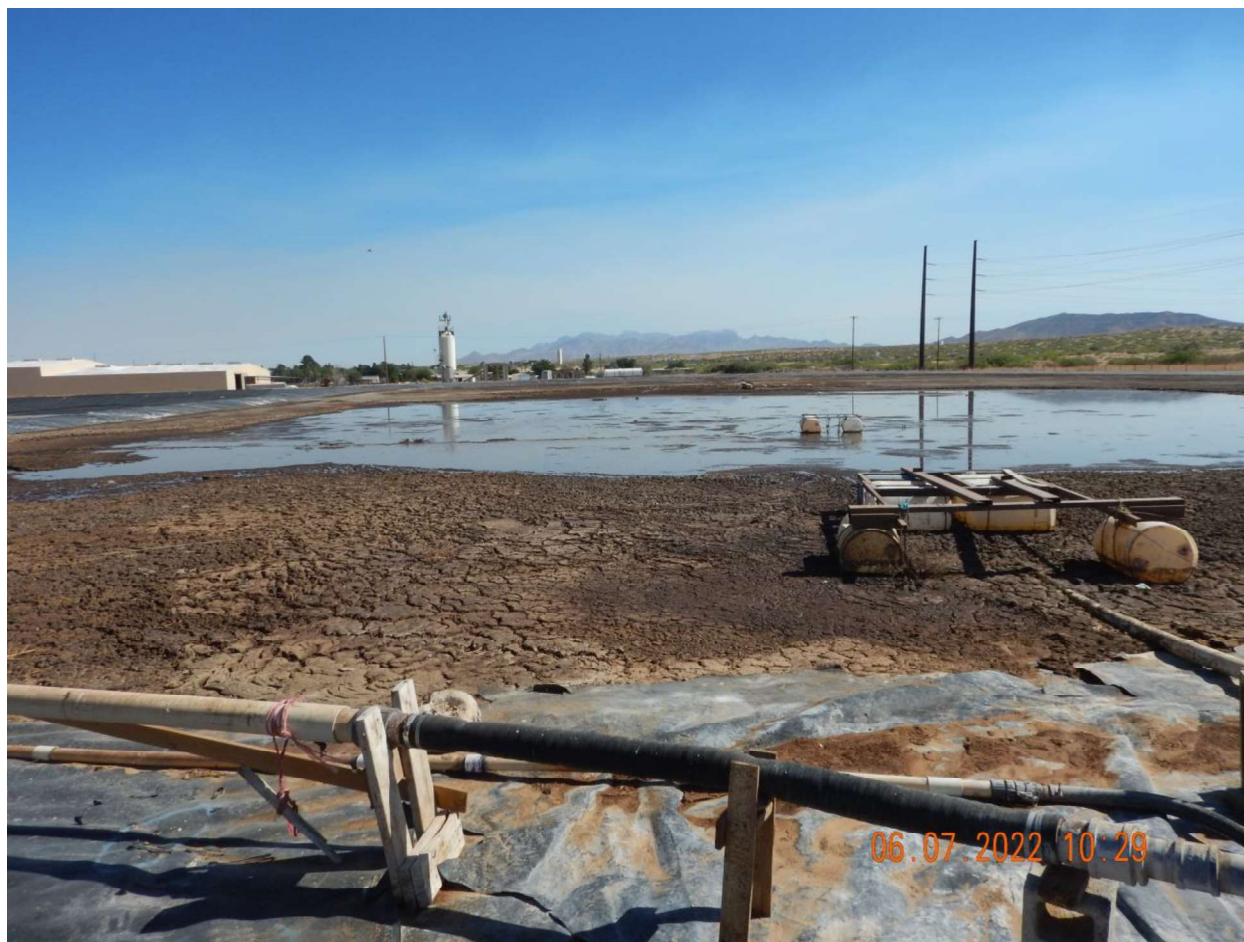
Photo No. 1

There is a significant accumulation of manure solids in RCS A as shown in Photo 1 of Appendix 1 (see AOC 1). There are also two areas where berm maintenance is required to ensure that storm water runoff from the cattle pens is directed into one of the storm water RCSs during the 25-yr/24-hr rain event.

Description: RCS A receives influent flows from the manure screen. This lagoon then overflows into RCS B from which recycle water is drawn to flush the cow holding area prior to the cows going into the milking parlor. RCS A is full of solids and either needs to be assessed by an engineer for wastewater capacity and solids accumulation, or have solids removed from the unit and give them to a third party. The view is toward the north.

AOC 1 - A significant amount of manure solids has accumulated in RCS A. RCS A either needs to be assessed by an engineer to ensure that sufficient wastewater capacity still exists within RCS A and B, and that the solids accumulation has not exceeded the units design limits. Or, the dairy can remove the excess manure solids from the unit and give them to a third party. Part III.A.3.a. of the EPA permit requires “...adequate storage of manure.....including procedures to ensure proper operation and maintenance of the storage facilities. All wastewater and manure containment structures shall at a minimum be designed, constructed, operated, and maintained in accordance with the standards of the Natural Resources Conservation Service, Field Office Technical Guide.” Additionally, Part III.D.2 also requires that “The operator shall restore the storage capacity as soon as possible after any rainfall event or accumulation of wastes reduces such storage capacity...”. This would include manure solids accumulation within an RCS.

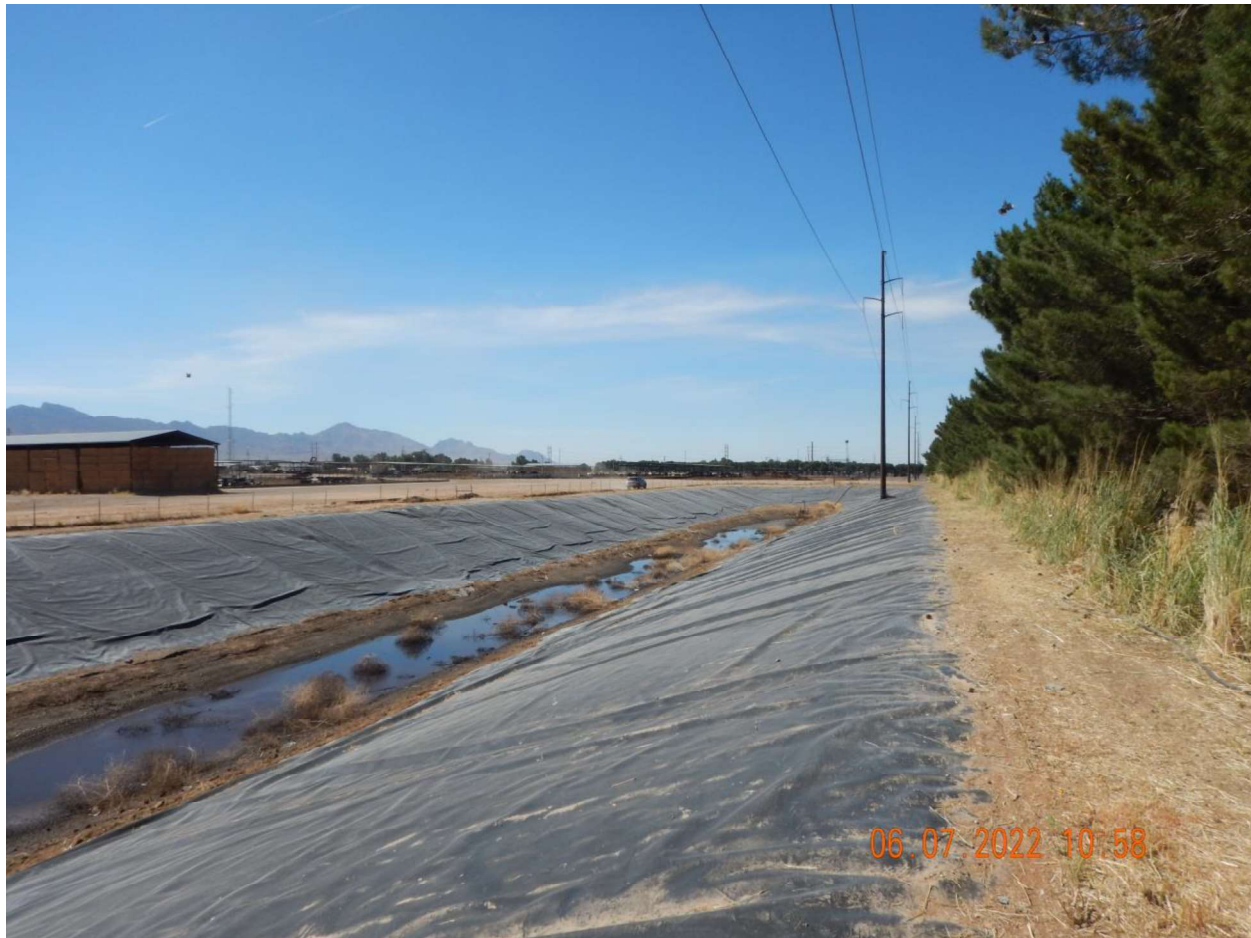
Photo No. 2

Description: RCS C is shown, and RCS D is in the distant background. All the RCS units have depth markers and are fully fenced. The HDPE liners were in good condition with regular annual maintenance. The view is toward the south.

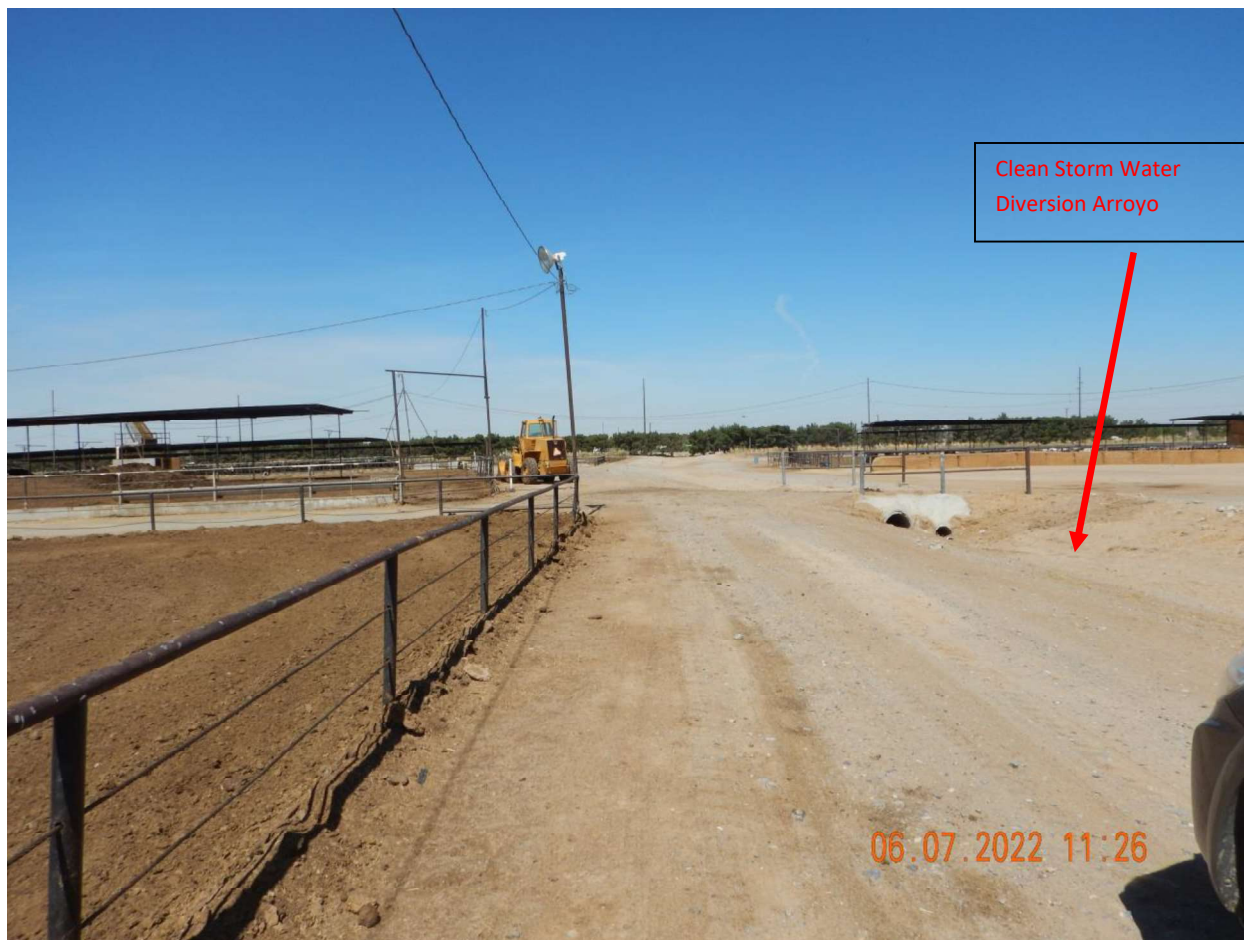
Photo No. 3

The south side of the clean storm water diversion arroyo shown in Photo 3 of Appendix 1 requires berm improvement and maintenance to ensure that pen area runoff does not enter the arroyo, and the other area is at the south-west corner of the cattle pens which should direct production area storm water runoff into RCS D (see AOC 2).

Description: Berm maintenance is needed on the south side of the clean storm water diversion arroyo to ensure that runoff from the 25-yr/24-hr rain event is kept out of the arroyo and that it is channeled to one of the storm water RCSs. The view is toward the west.

AOC 2 - Berm maintenance is required at two locations to ensure that storm water runoff from the cattle pens is directed into one of the RCSs during the 25-yr/24-hr rain event. The south side of the clean storm water diversion arroyo (see Photo 3) requires berm improvement/maintenance to ensure that pen area runoff does not enter the arroyo. The second location is at the south-west corner of the cattle pens which should direct production area storm water runoff into RCS D. The dairy shall prevent any discharge of manure or process wastewater pollutants into waters of the U.S. by ensuring proper design, construction, operation of maintenance to contain all manure and process wastewater from the 25-yr/24-hr storm event as described in Part II.A.1.a.i.
