## **Appendix B**

# **Photograph Log**

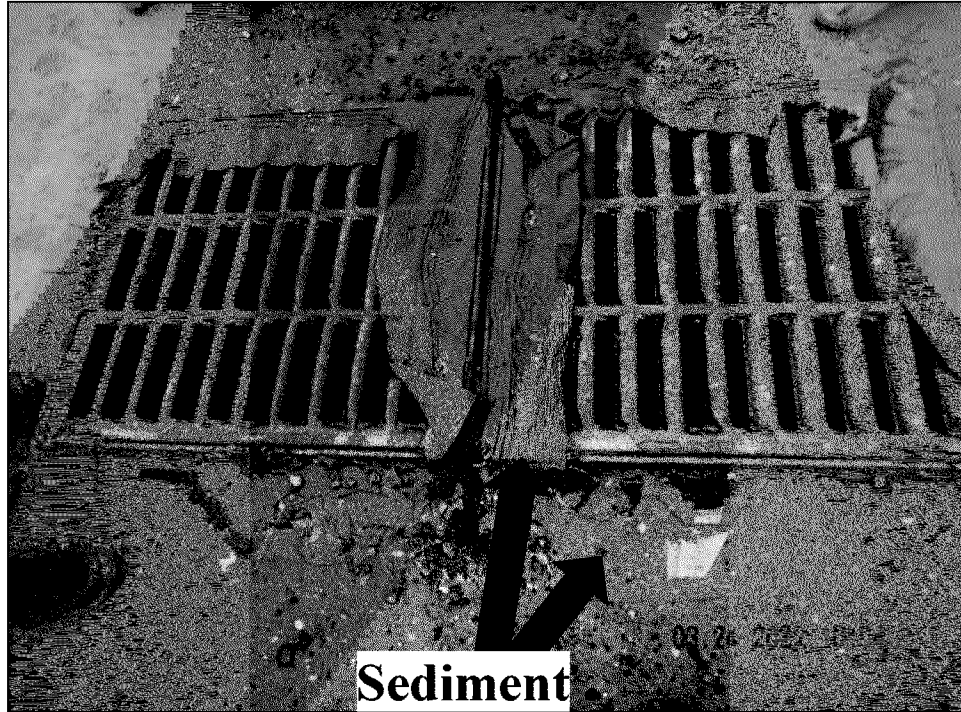
**Photograph 1.** (DSCN3938.JPG) View of stormwater inlets in the south area of the site. Note the sediment adjacent to the stormwater inlets.

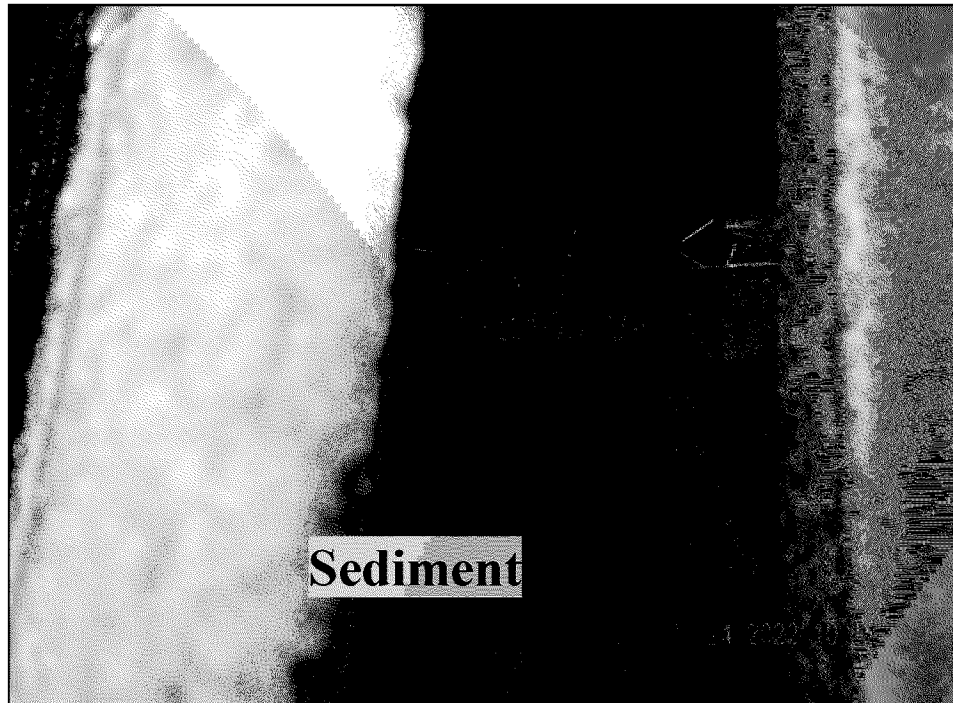
**Photograph 2.** (DSCN3939.JPG) View inside the stormwater inlet shown in Photograph 1 of sediment collected by the filter fabric.

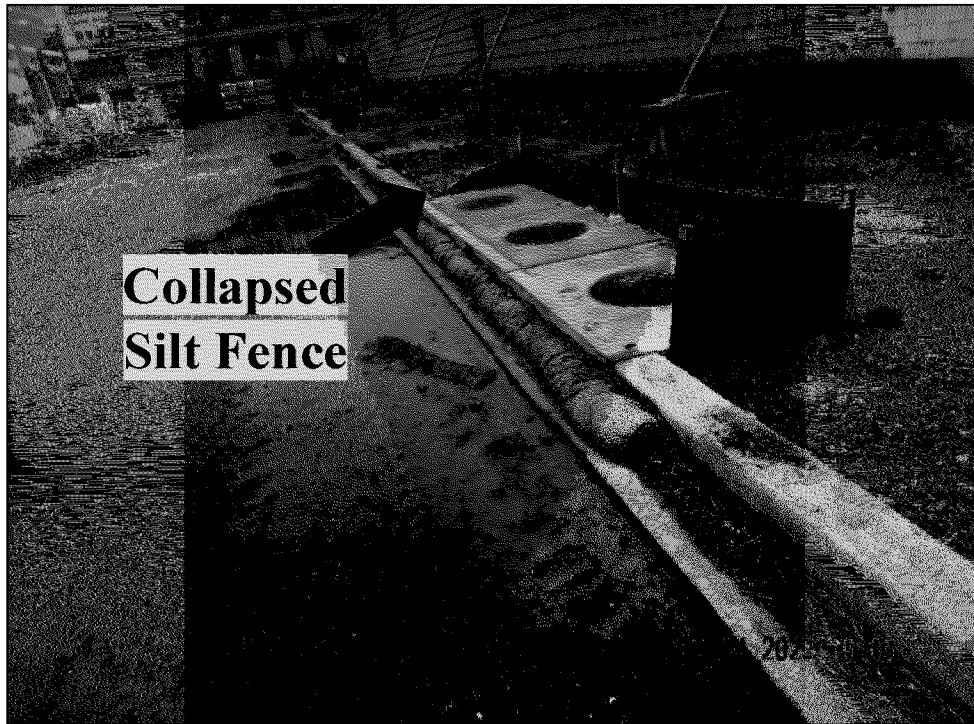
**Photograph 3.** (DSCN3941.JPG) View, facing west, of curb inlets in the south area of the site. Note that the silt fence was collapsed.

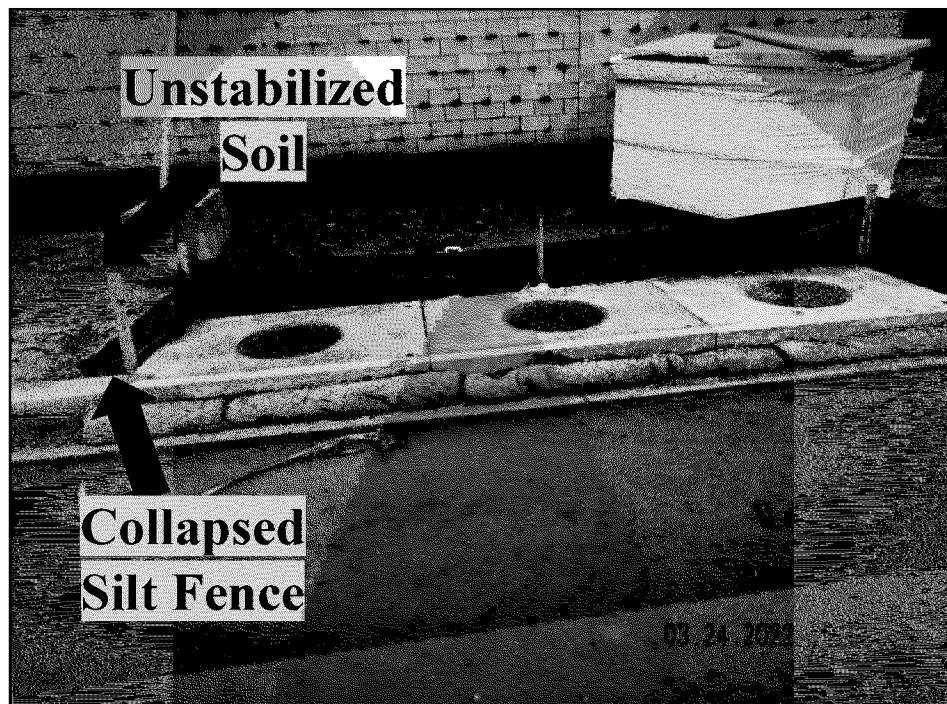
**Photograph 4.** (DSCN3942.JPG) View, facing north, of curb inlets in the south area of the site. Note that the silt fence was collapsed, and surrounding soil was unstabilized.

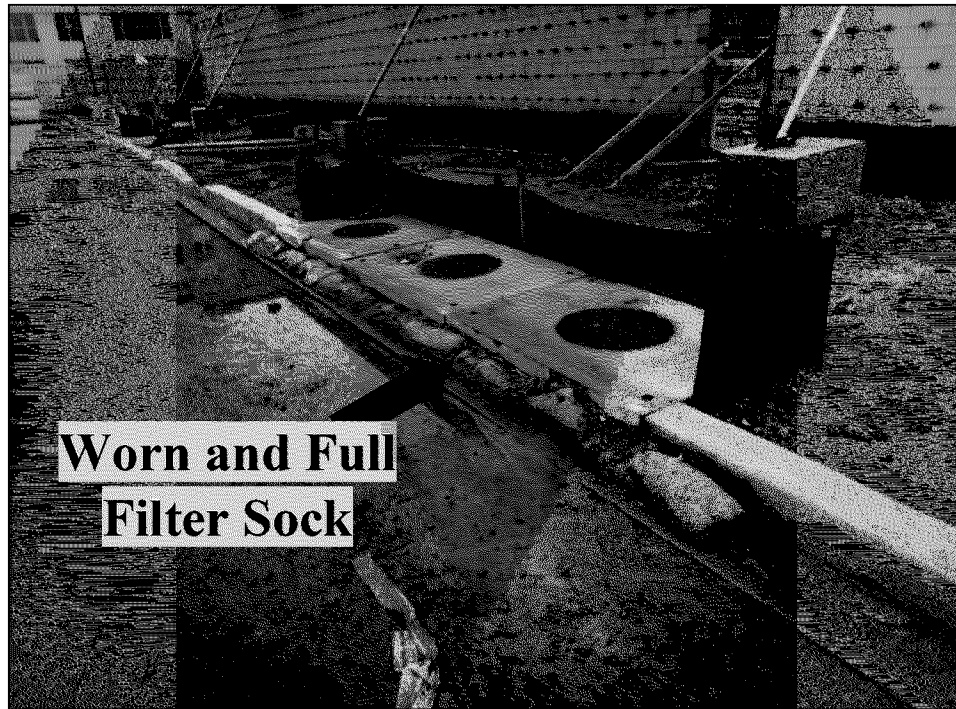
**Photograph 5.** (DSCN3944.JPG) View, facing northwest, of curb inlets in the south area of the site. The filter sock appeared worn and inundated with sediment at the time of the inspection.

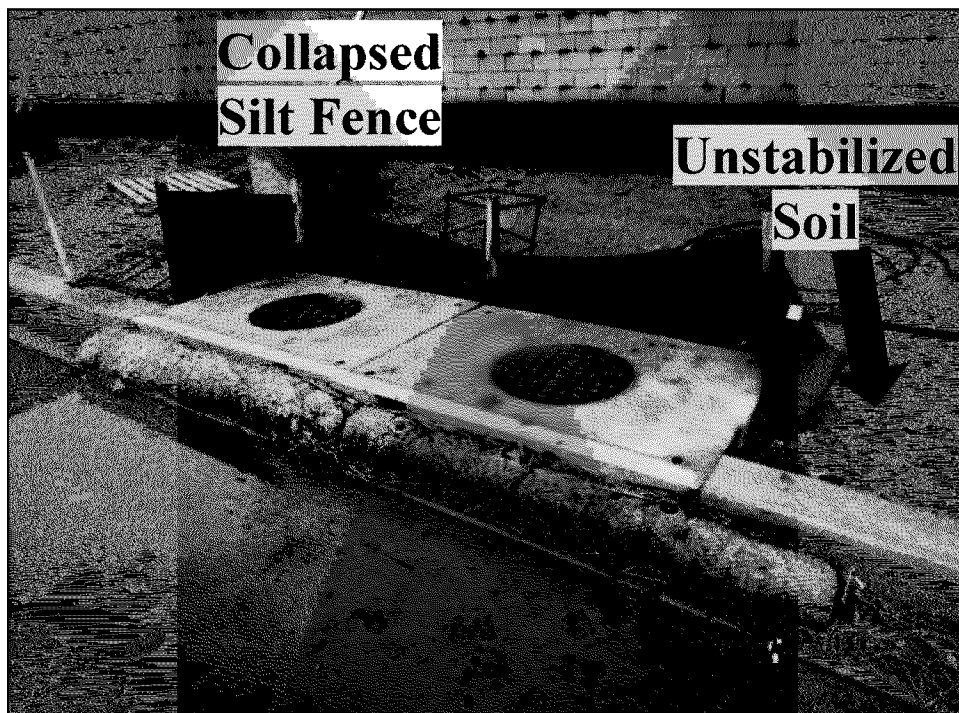
**Photograph 6.** (DSCN3946.JPG) View, facing north, of curb inlets in the south area of the site. The silt fence had collapsed and the surrounding soil was unstabilized.

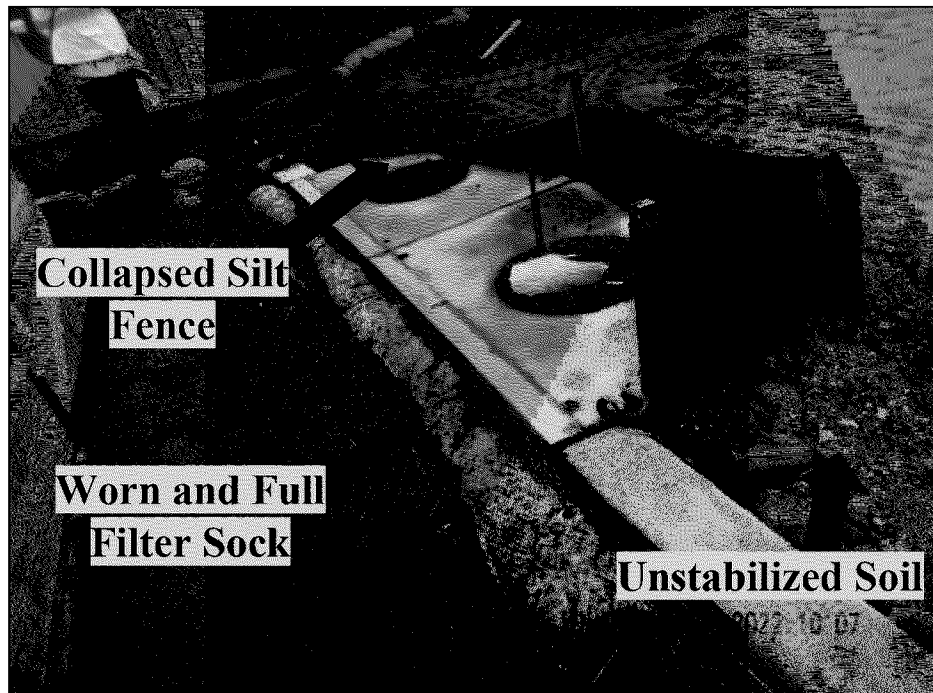
**Photograph 7.** (DSCN3947.JPG) View, facing west, of curb inlets in the south area of the site. The filter sock appeared worn and inundated with sediment, the silt fence had collapsed, and the surrounding soil was unstabilized.

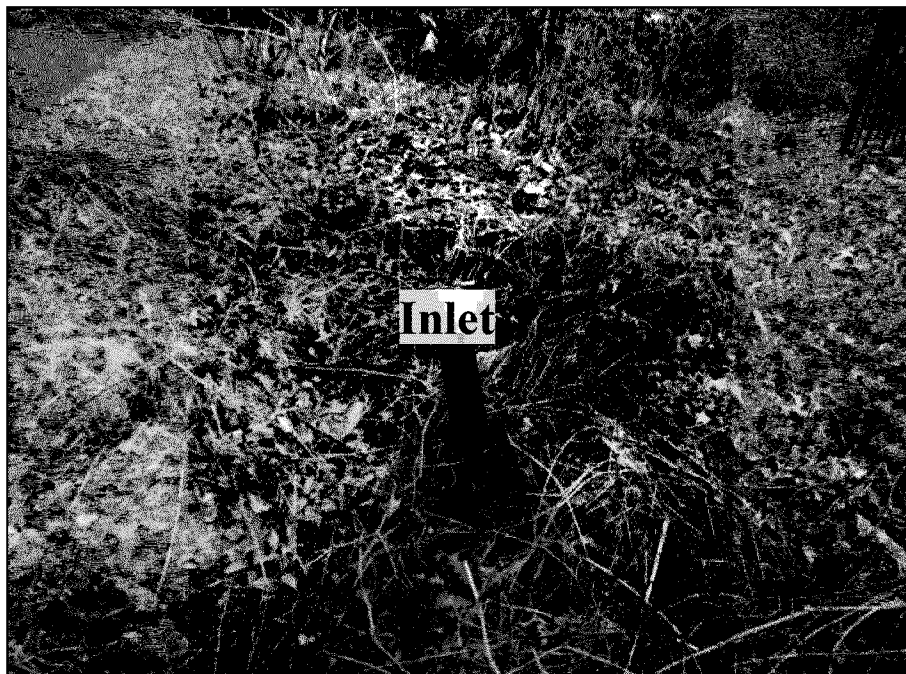
**Photograph 8.** (DSCN4078.JPG) View, facing south, of an inlet north of the site covered in debris. The EPA Inspection Team observed that it appeared to receive runoff from the site. It was unclear where the inlet discharged.

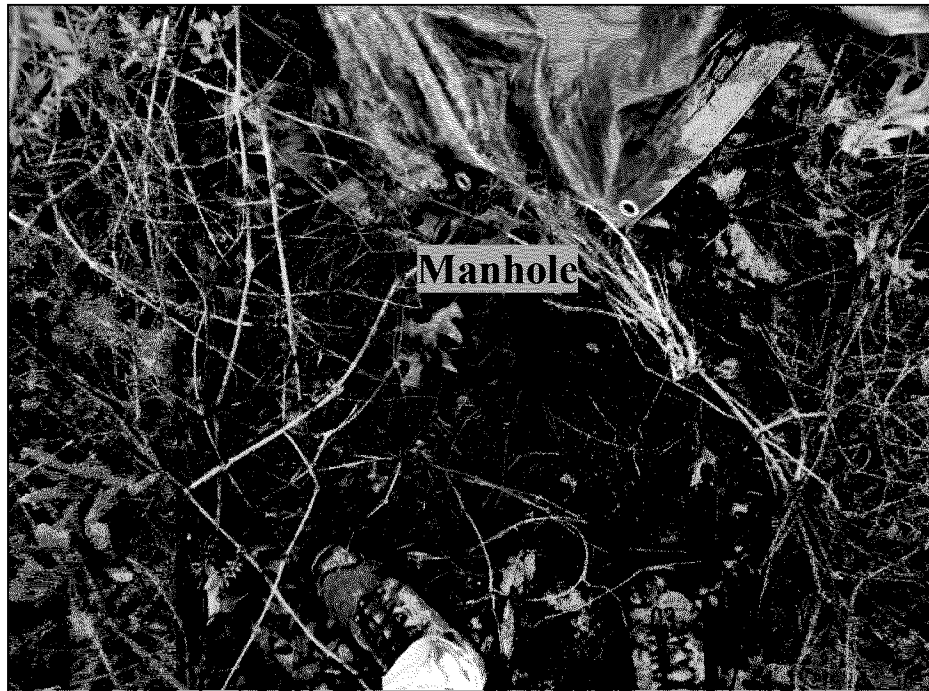
**Photograph 9.** (DSCN4077.JPG) View of a manhole above the inlet shown in Photograph 8 covered in debris north of the site.

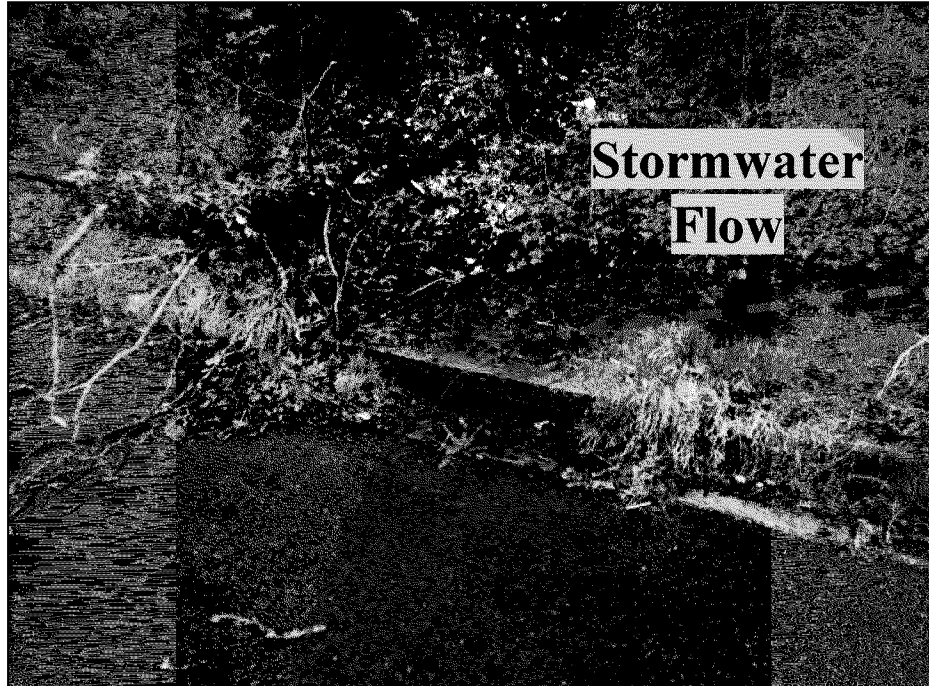
**Photograph 10.** (DSCN4081.JPG) View, facing east, of an inlet north of the site, on 28<sup>th</sup> Street SE, that appeared to receive stormwater from the site. The EPA Inspection Team observed stormwater flow at the time of the inspection. It was unclear where the inlet discharged.

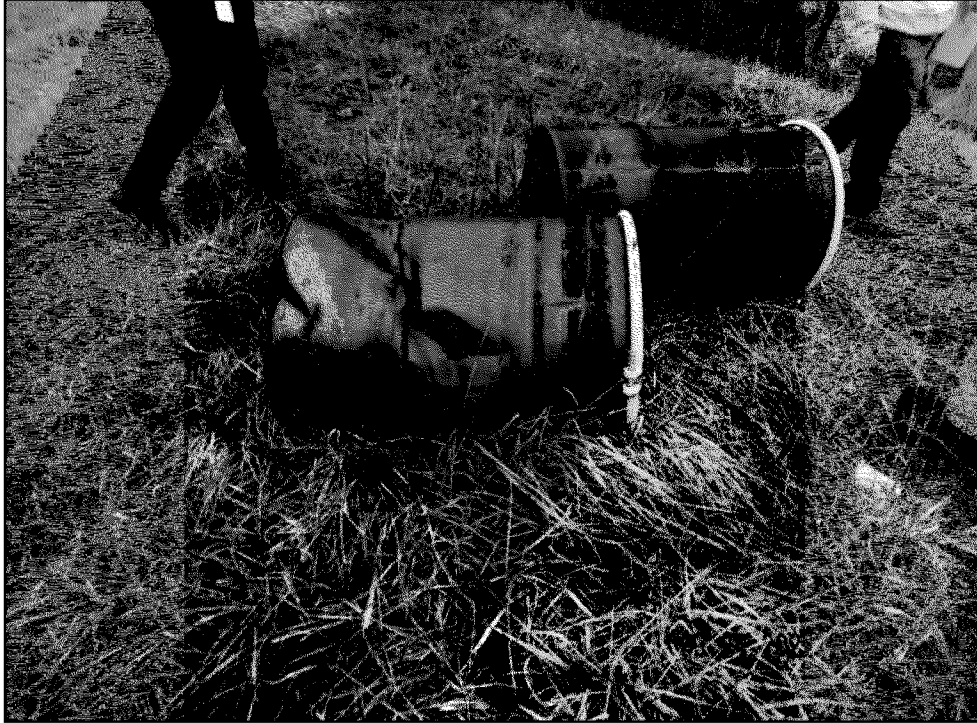
**Photograph 11.** (DSCN3996.JPG) View, facing west, of two full uncovered drums in the north area of the site.

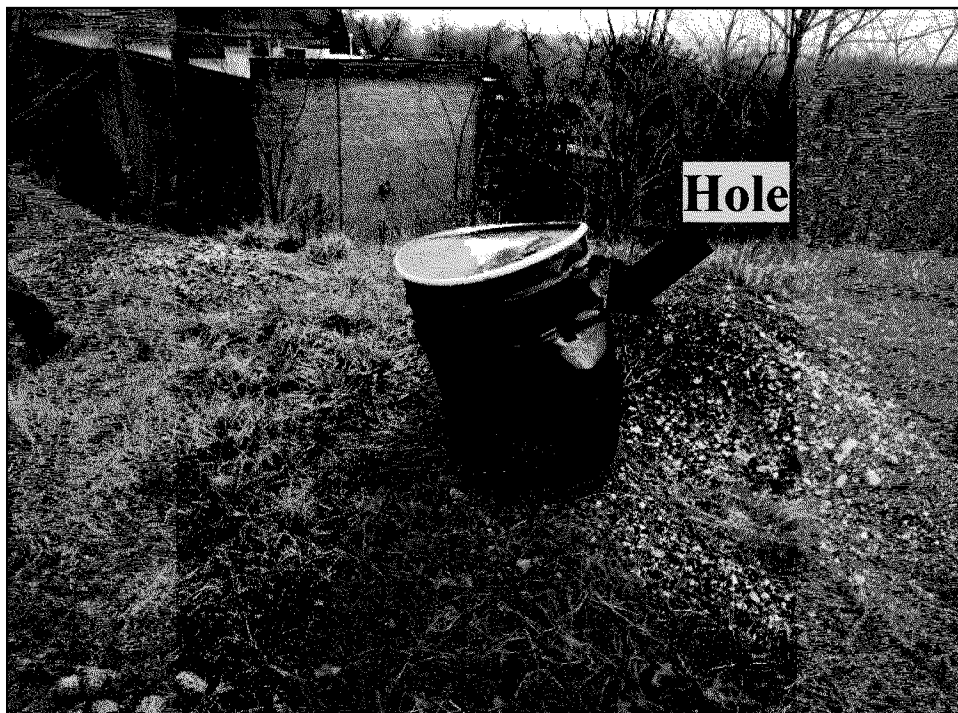
**Photograph 12.** (DSCN3999.JPG) View, facing north, of an uncovered drum in the north area of the site. A rusted hole revealed the drum was filled with soil.

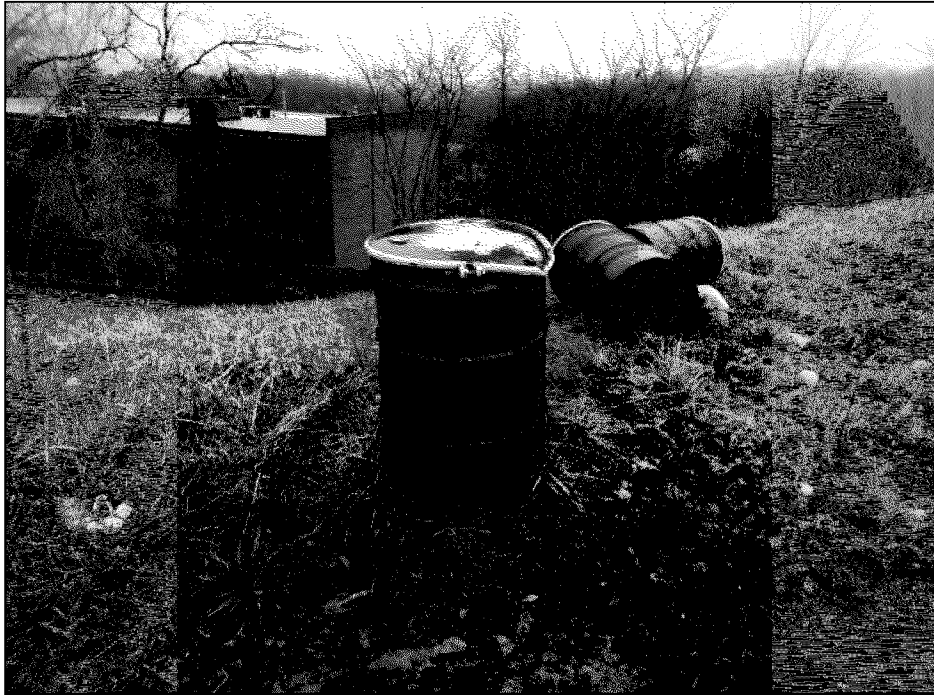
**Photograph 13.** (DSCN4002.JPG) View, facing north, of three full uncovered drums in the north area of the site.

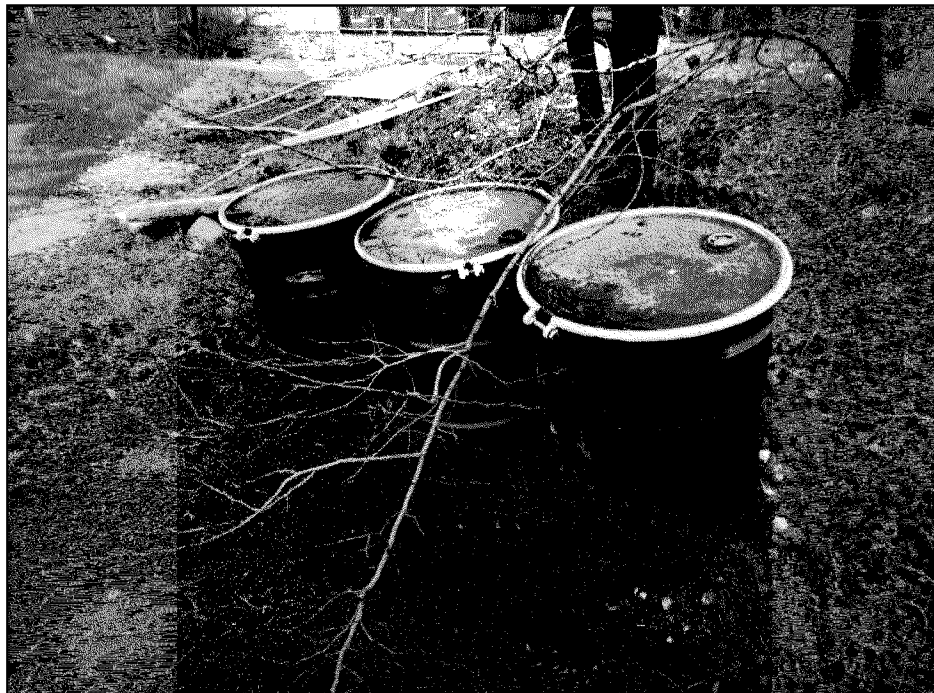
**Photograph 14.** (DSCN4011.JPG) View, facing west, of three full uncovered drums in the north area of the site.

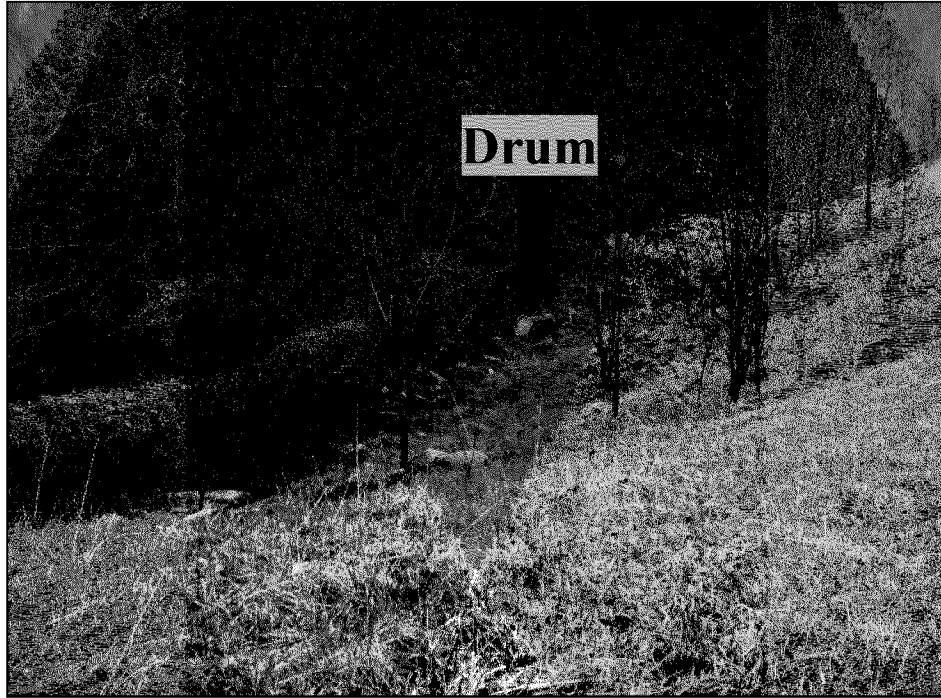
**Photograph 15.** (DSCN7756.JPG) View, facing northeast, of an uncovered drum in the north area of the site.

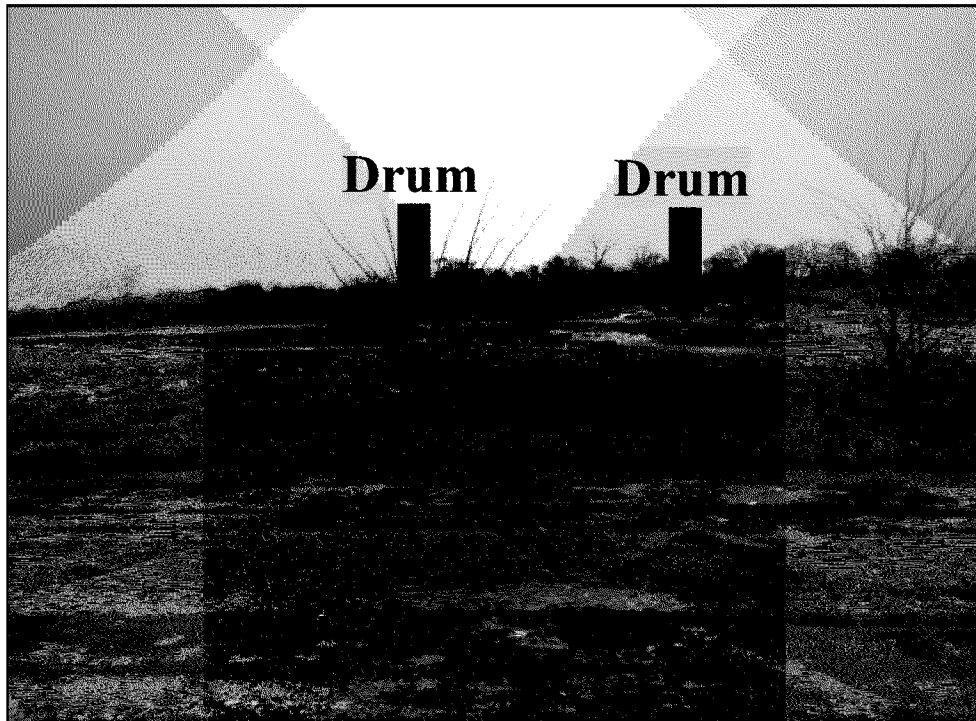
**Photograph 16.** (DSCN4013.JPG) View, facing east, of uncovered drums in the north area of the site.

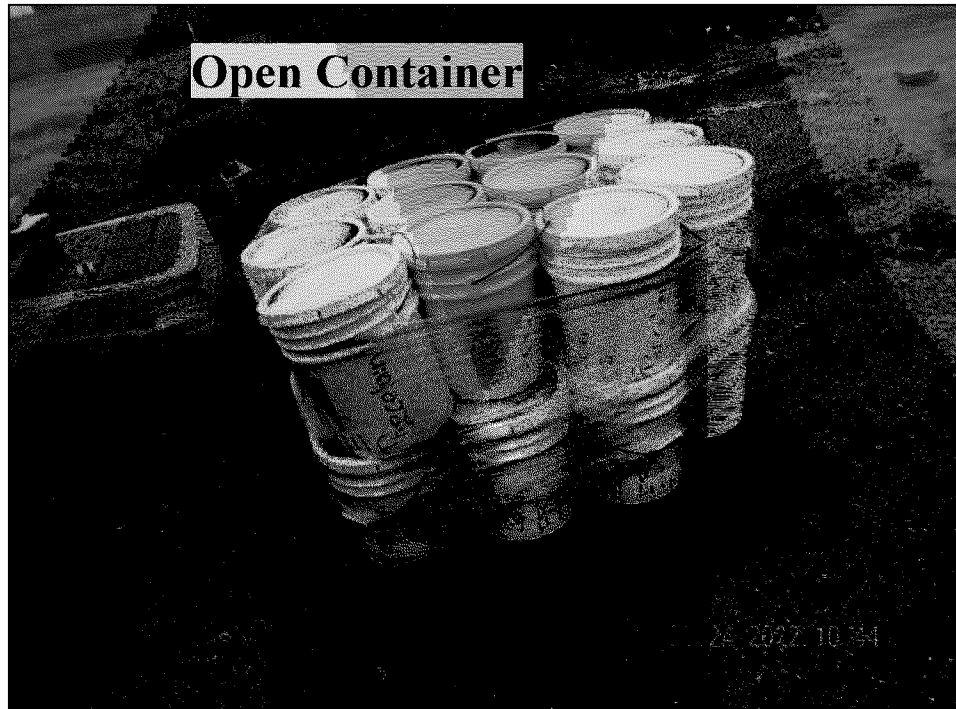
**Photograph 17.** (DSCN4029.JPG) View, facing south, of approximately 24 partially covered containers labeled as porcelain in the north area. One of the containers was open.

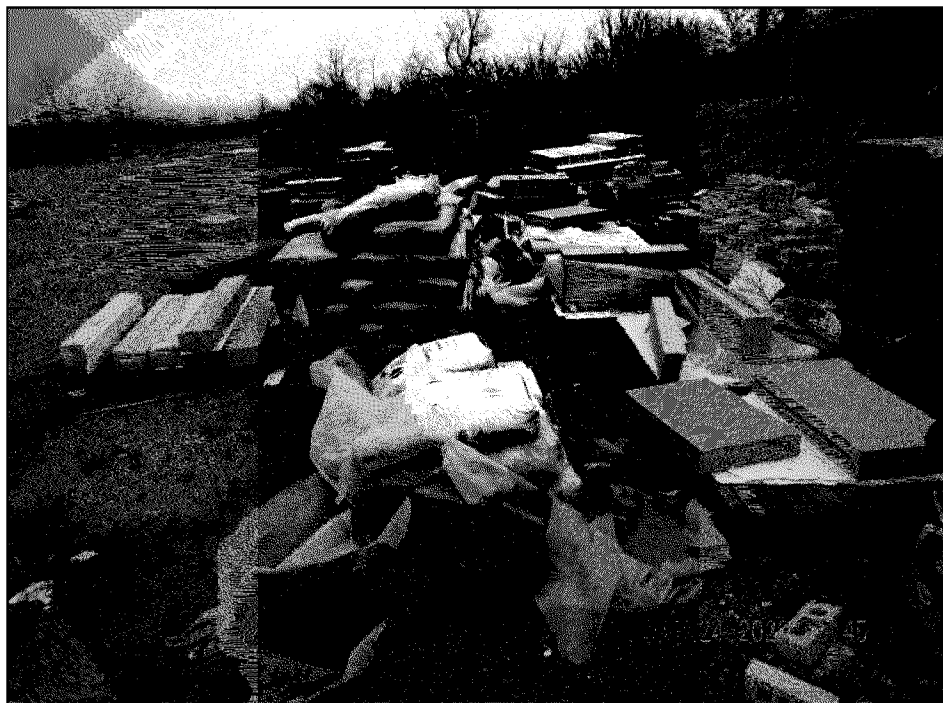
**Photograph 18.** (DSCN4034.JPG) View, facing north, of approximately 30 uncovered bags of cement in the north area of the site. Approximately 8 of the bags were opened.

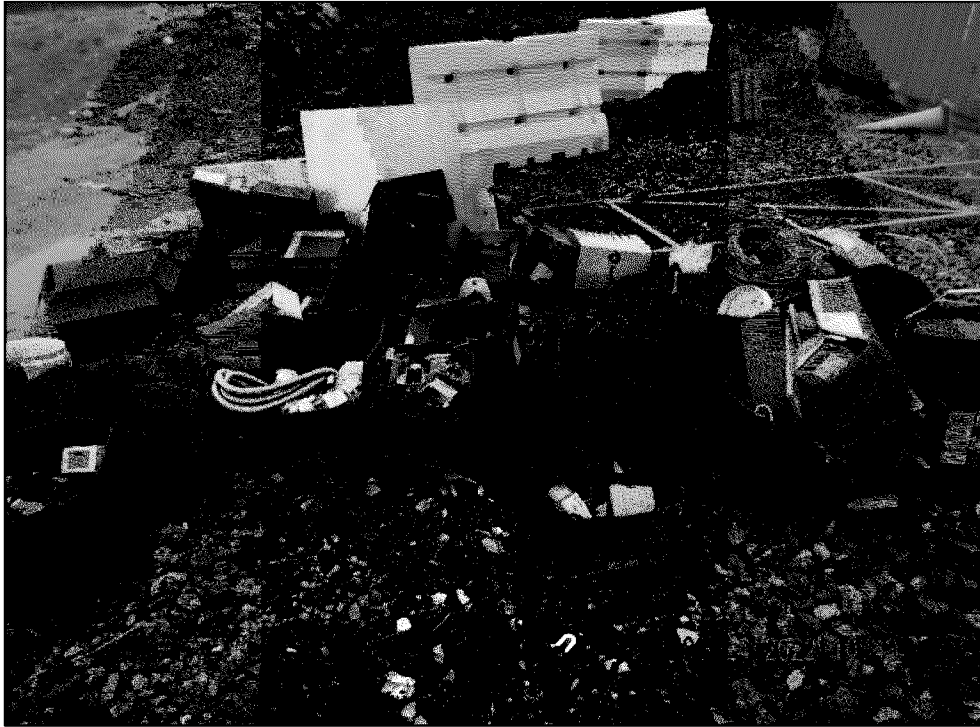
**Photograph 19.** (DSCN4042.JPG) View, facing east, of approximately 15 uncovered boxes and buckets of electronics in the north area of the site.

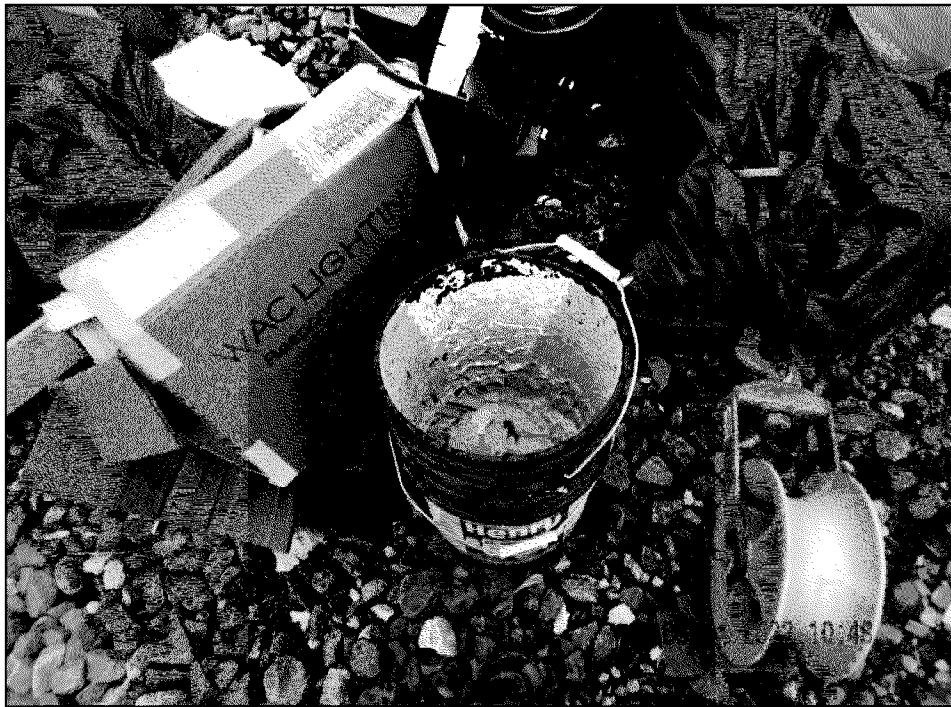
**Photograph 20.** (DSCN4043.JPG) View of a bucket that contained paint residue in the north area of the site.

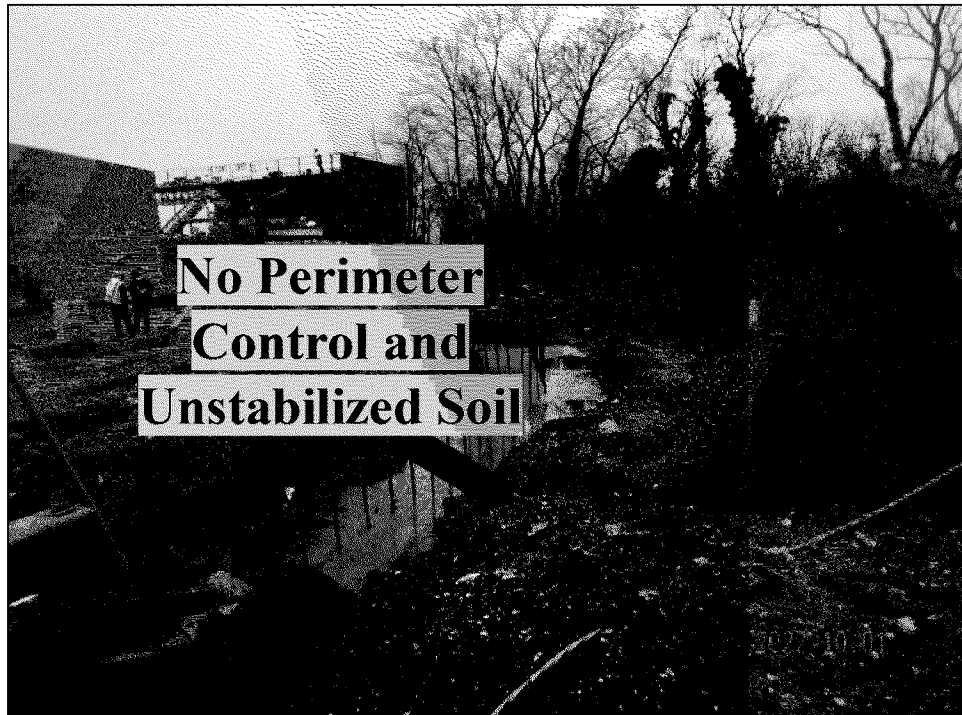
**Photograph 30.** (DSCN3925.JPG) View, facing southeast, of a location that lacked perimeter controls. Pooled stormwater, debris, and sediment were observed downgradient of the location.

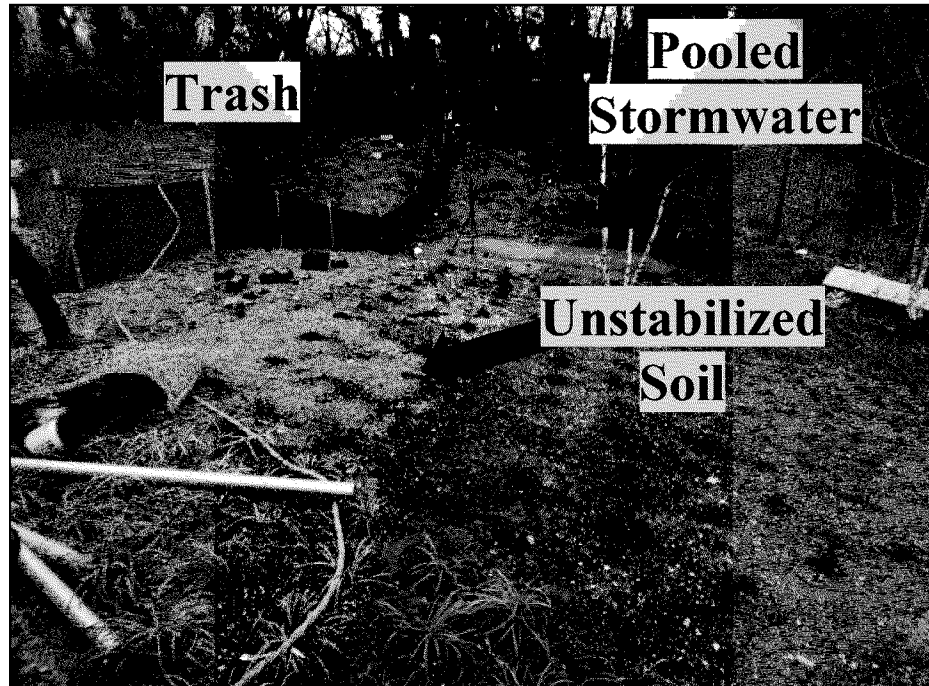
**Photograph 31.** (DSCN3934.JPG) View, facing north, of a location at the southeast corner of the site that lacked perimeter controls. Unstabilized soil was adjacent to the location.

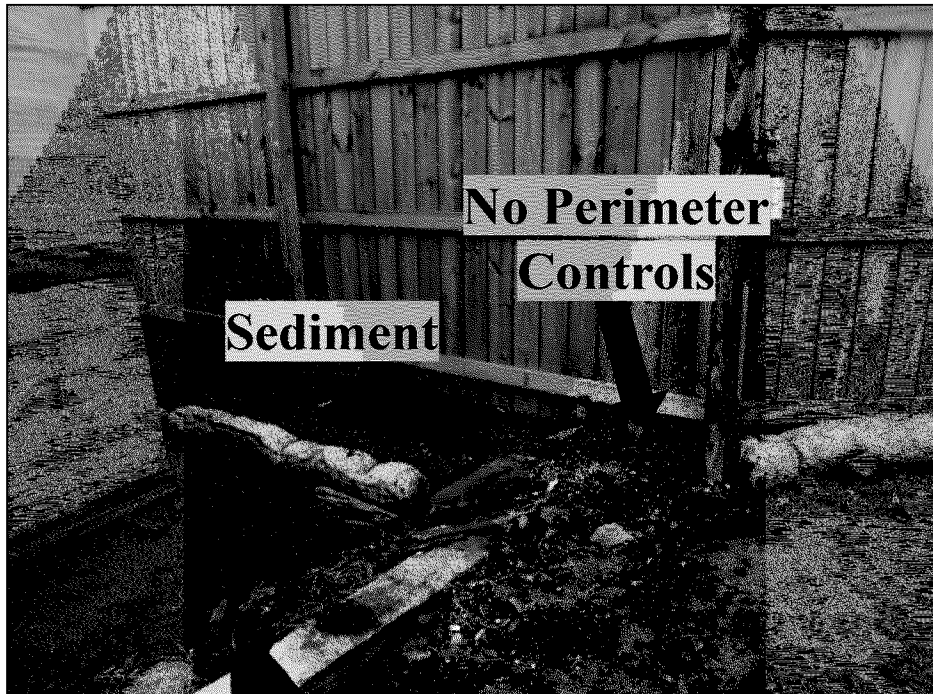
**Photograph 36.** (DSCN3931.JPG) View, facing south, of trash and debris downgradient of the stormwater pooled at the corner of the site. The southeast corner of the site did not have perimeter controls.

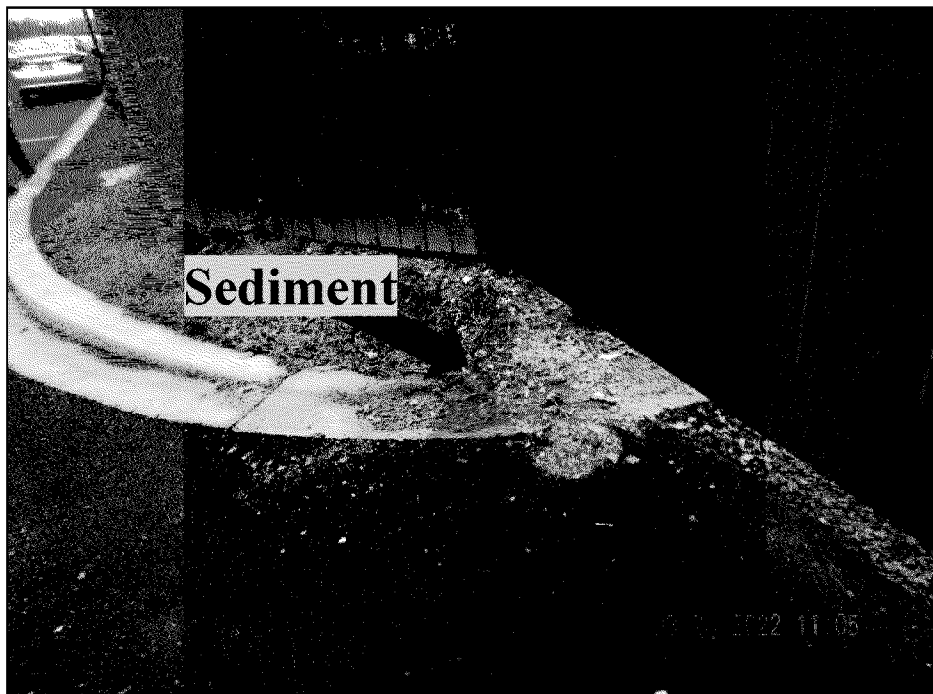
**Photograph 37.** (DSCN4055.JPG) View, facing west, of the west perimeter near the southwest corner that lacked perimeter controls. Note the sediment that traveled off-site.

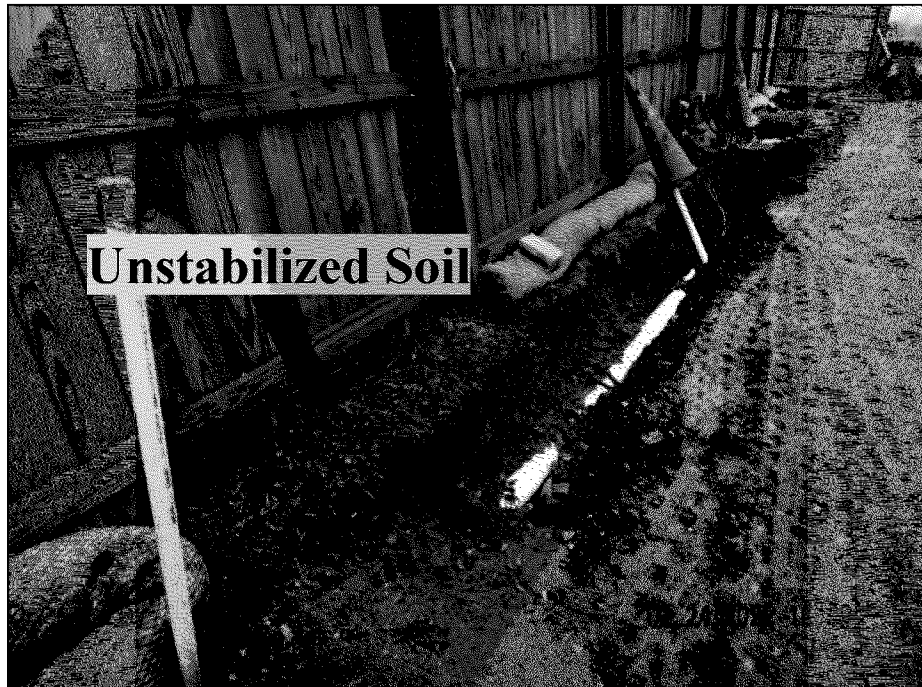
**Photograph 38.** (DSCN4060.JPG) View, facing north, of sediment transported off-site from the west perimeter. The location lacked perimeter controls and is on the other side of the wooden fence of the location shown in Photograph 37.

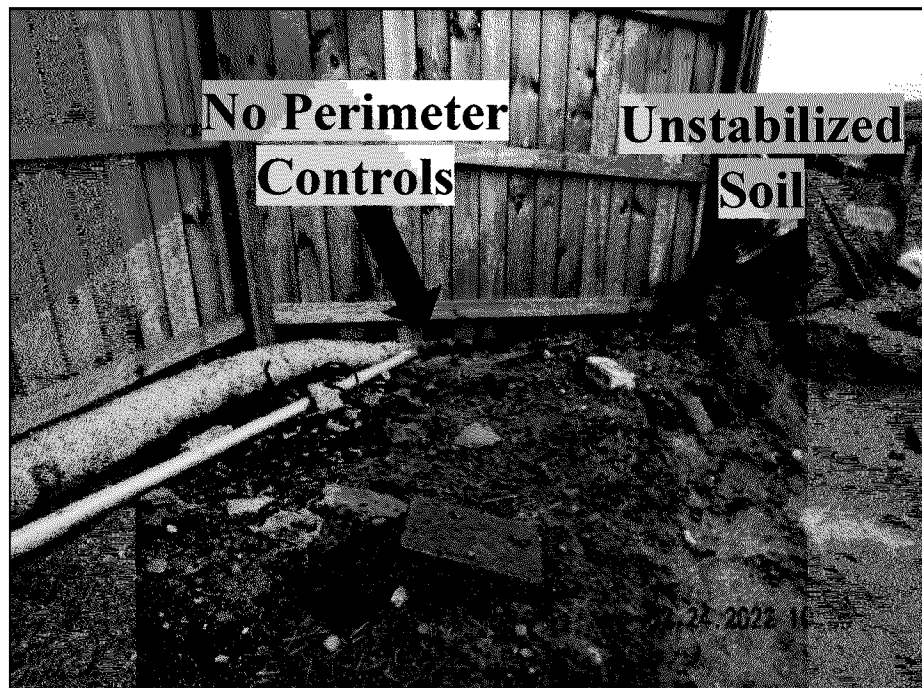
**Photograph 39.** (DSCN3951.JPG) View, facing northwest, of a location along the west perimeter that lacked perimeter controls. Unstabilized soil was adjacent to the perimeter.

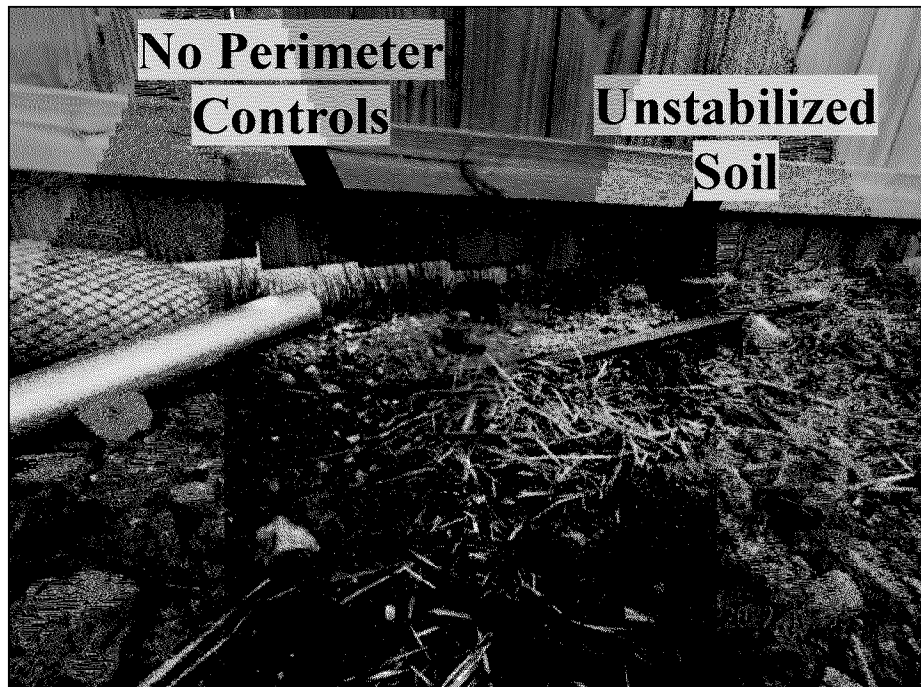
**Photograph 40.** (DSCN3952.JPG) View, facing northwest, of a location along the west perimeter that lacked perimeter controls. Unstabilized soil was adjacent to the perimeter.

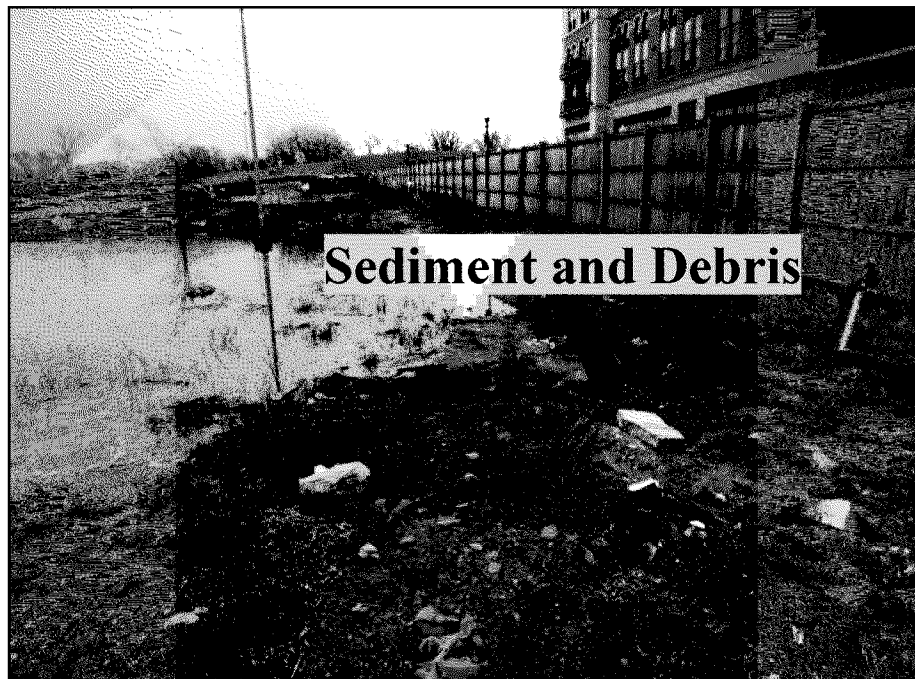
**Photograph 47.** (DSCN4016.JPG) View, facing south, of stormwater pooled adjacent to the mid-west perimeter in the north area of the site. Note the portable toilet adjacent to the mid-west perimeter. The EPA Inspection Team did not observe perimeter controls at this location.

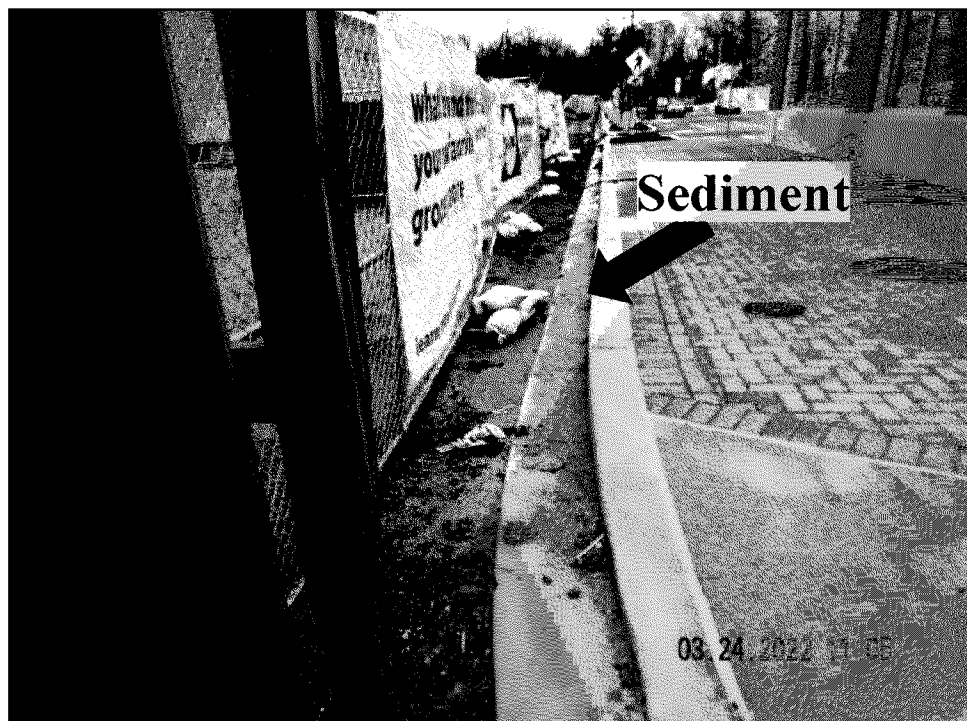
**Photograph 53.** (DSCN4058.JPG) View, facing east, of the south perimeter that lacked perimeter controls. Note the sediment that led offsite.

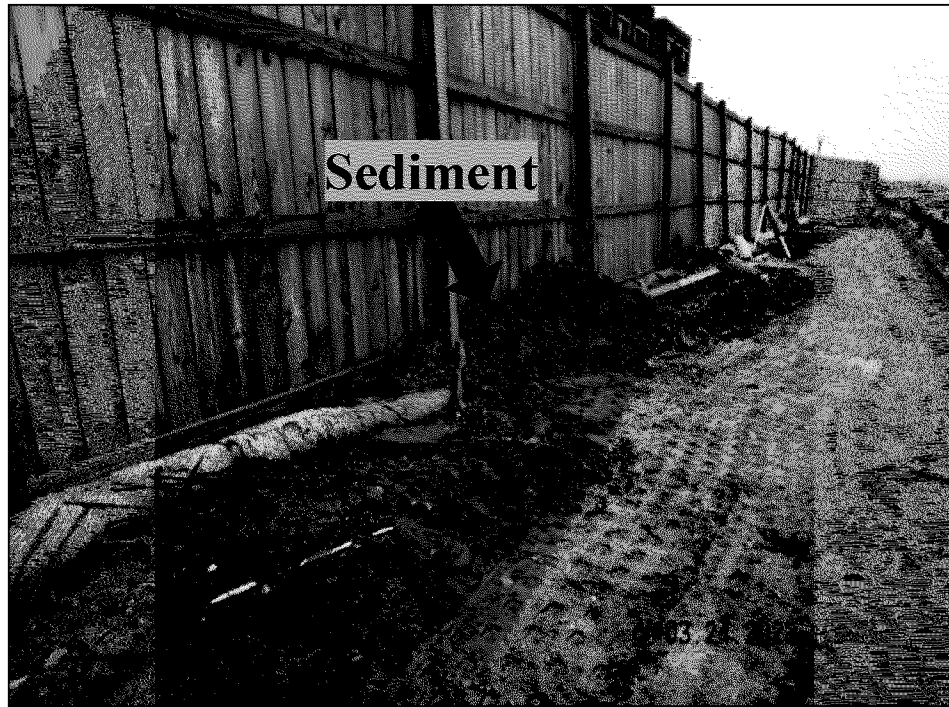
**Photograph 54.** (DSCN4059.JPG) View, facing east, of the south perimeter that lacked perimeter controls. Note the sediment transported offsite. Photograph was taken offsite.

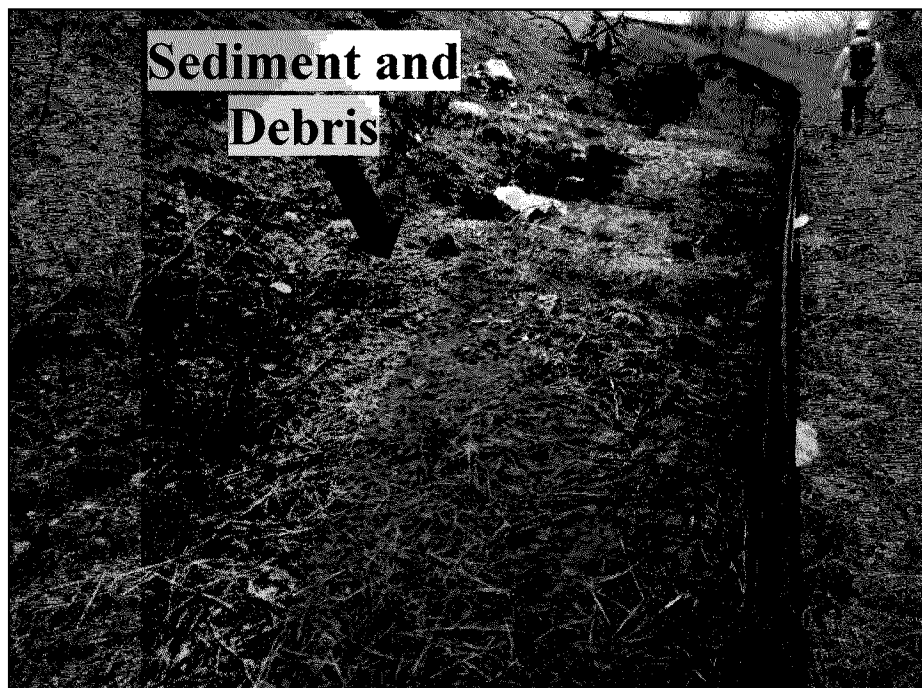
**Photograph 55.** (DSCN3950.JPG) View, facing northwest, of the filter sock along the west perimeter that had accumulated sediment above one-half the height of the filter sock.

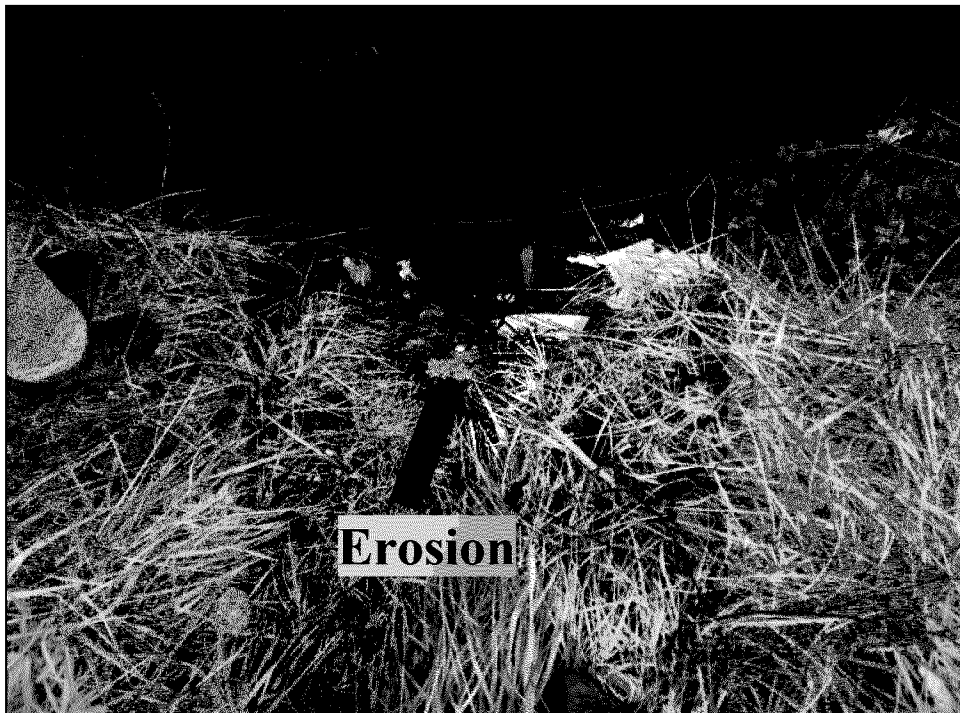
**Photograph 59.** (DSCN3969.JPG) View, facing east, of erosion by the mid-east perimeter. The silt fence was undercut by the erosion.
