## **Appendix B**

# **Photograph Log**

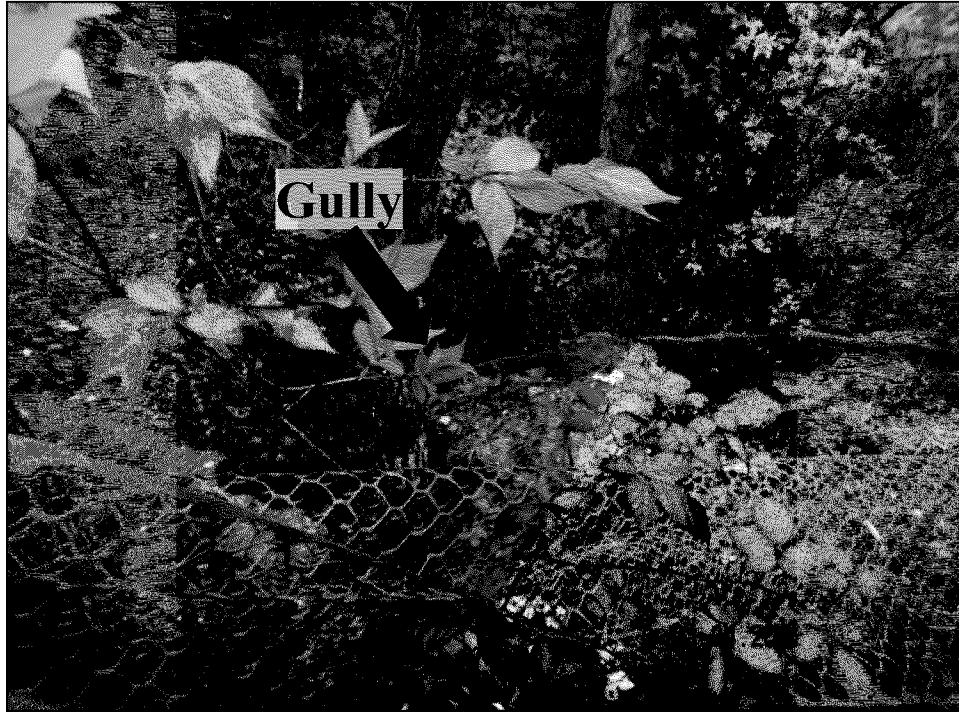
**Photograph 60.** (DSCN3971.JPG) View of erosion underneath the silt fence shown in Photograph 59.

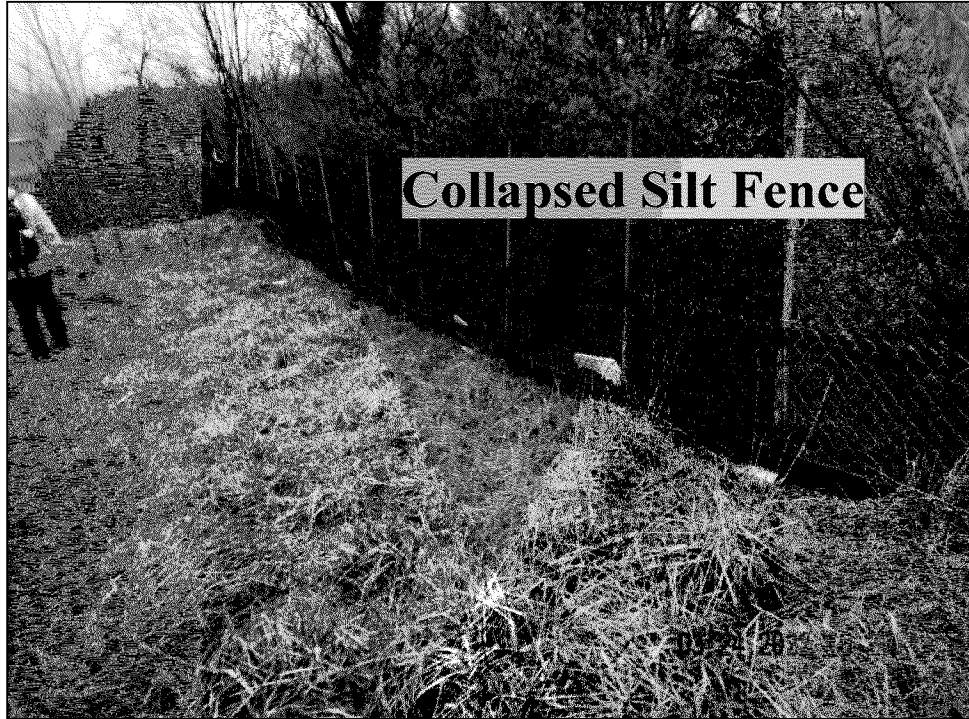
**Photograph 62.** (DSCN3977.JPG) View, facing east, of collapsed silt fencing along the east perimeter.

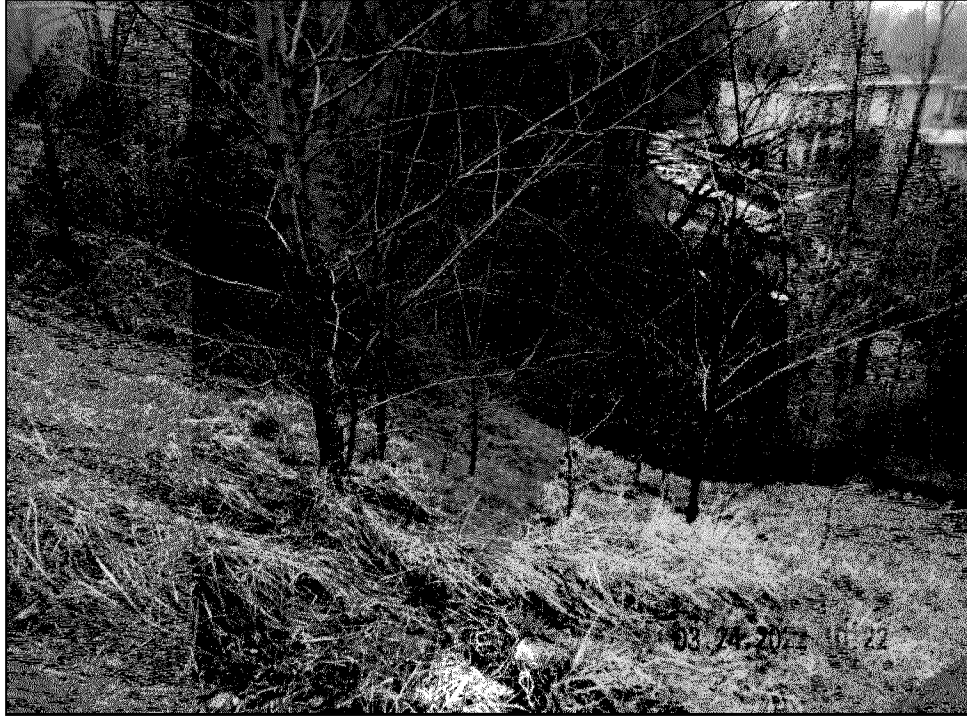
**Photograph 66.** (DSCN3985.JPG) View, facing north, of the steep slope at the north area. Note the collapsed silt fence along the east perimeter.

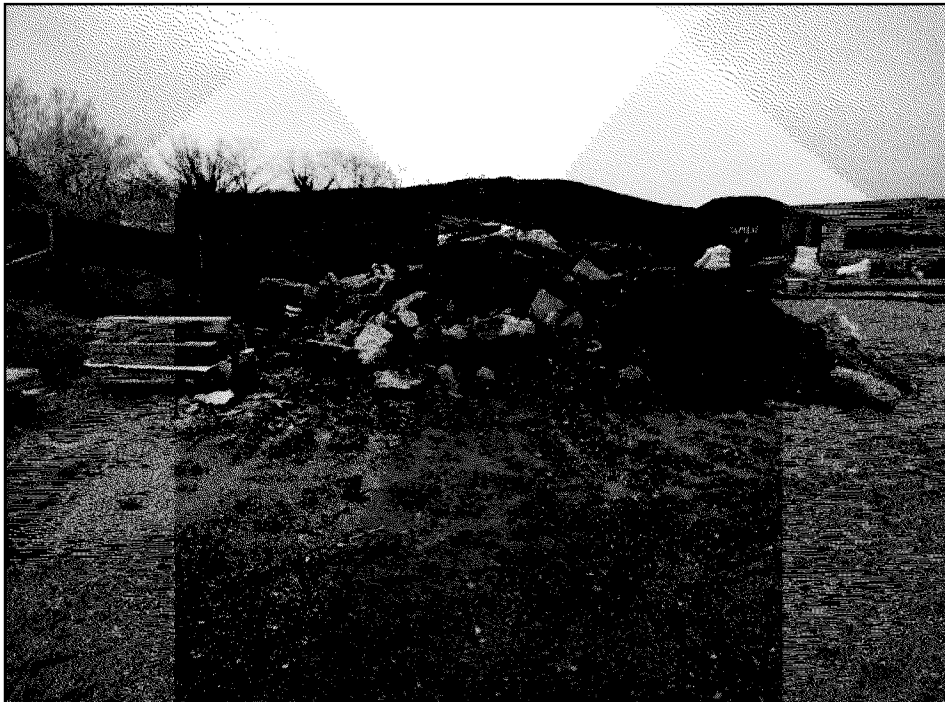
**Photograph 77.** (DSCN4030.JPG) View, facing north, of an unstabilized uncovered stockpile in the north area of the site.

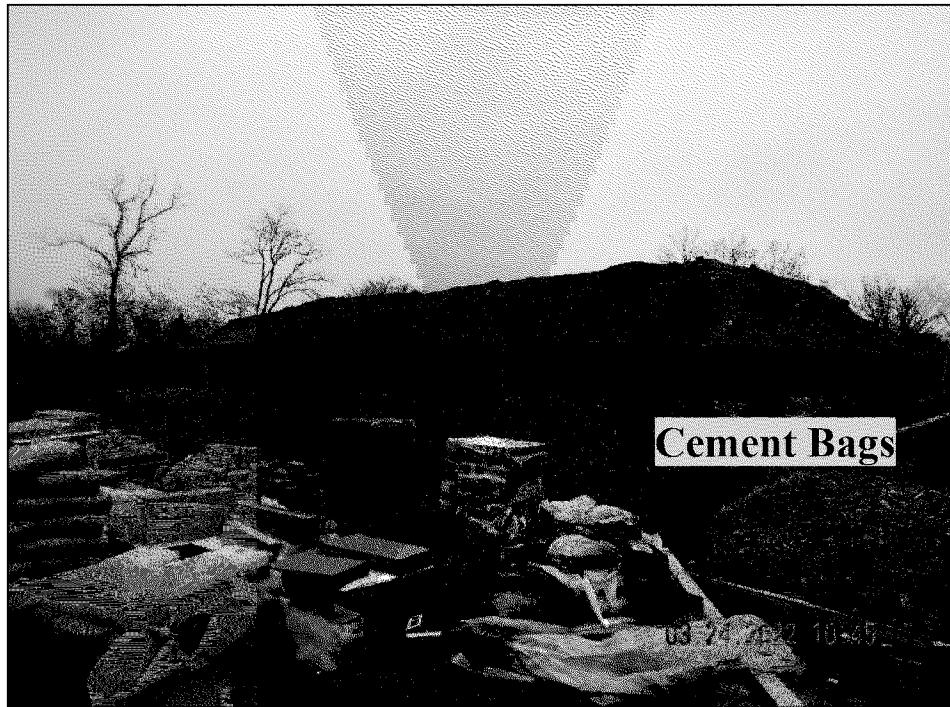
**Photograph 78.** (DSCN4031.JPG) View, facing south, of an unstabilized uncovered stockpile in the north area of the site.
