## Region 6 - Enforcement & Compliance Assurance Division

### INSPECTION REPORT

| Company Name: | McCann Resources, Inc | |
| Facility Name: | Bowring Lease | |

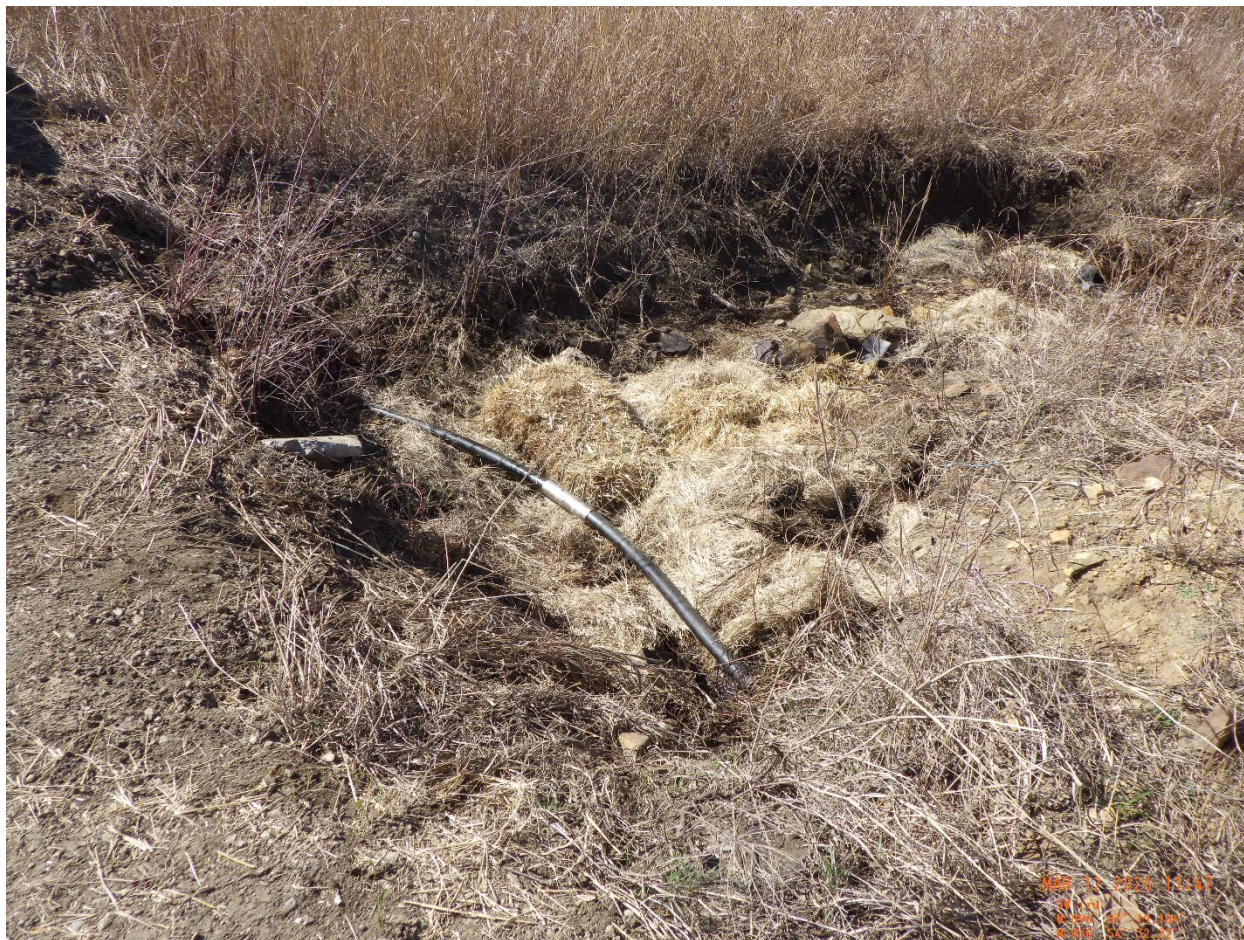
Photo No. 1

I observed the release point and the point of entry (POE) into the unnamed tributary of Hulah Lake. The damaged flowline responsible for the leak had a temporary repair claim installed at the time of the inspection. Straw and straw bales were also present at the release point/POE. See photo No. 1 of the attached photo log. For additional location and photo metadata, see Appendix 1, photo log, which is attached to this report.

**Description:** This was the release point of the spill, a damaged 2" poly flowline crossing over an unnamed tributary of Hulah Lake. The operator had placed straw and straw bales into the tributary to prevent downstream migration of oil.

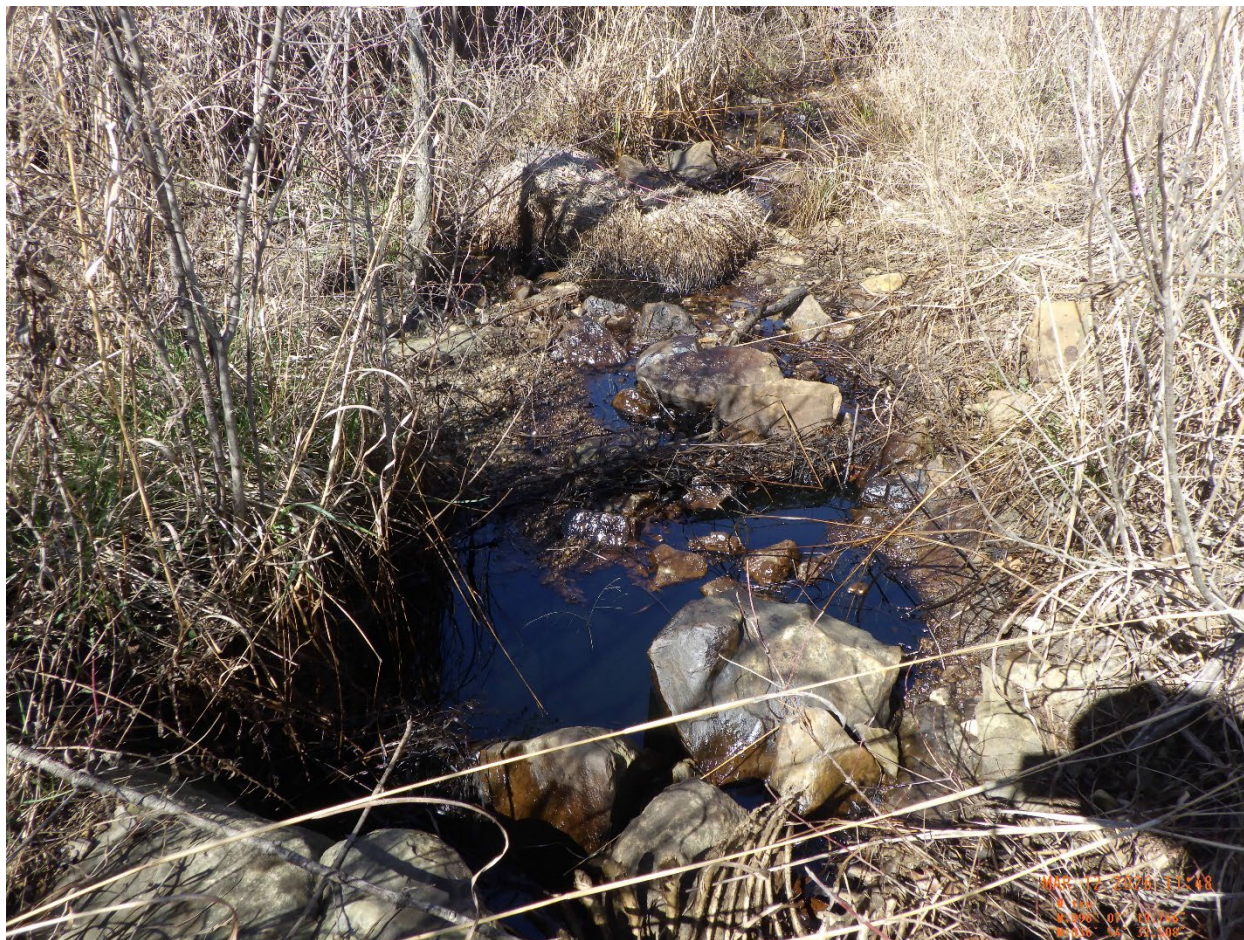
Photo No. 2

Downstream from the POE, I observed oil and straw bales in the main channel of the impacted tributary, see photo No. 2.

**Description:** This was crude oil in the main channel of the unnamed tributary of Hulah Lake. A straw bale which had been placed by the operator was also present at this location. This observation was downstream from the release point.

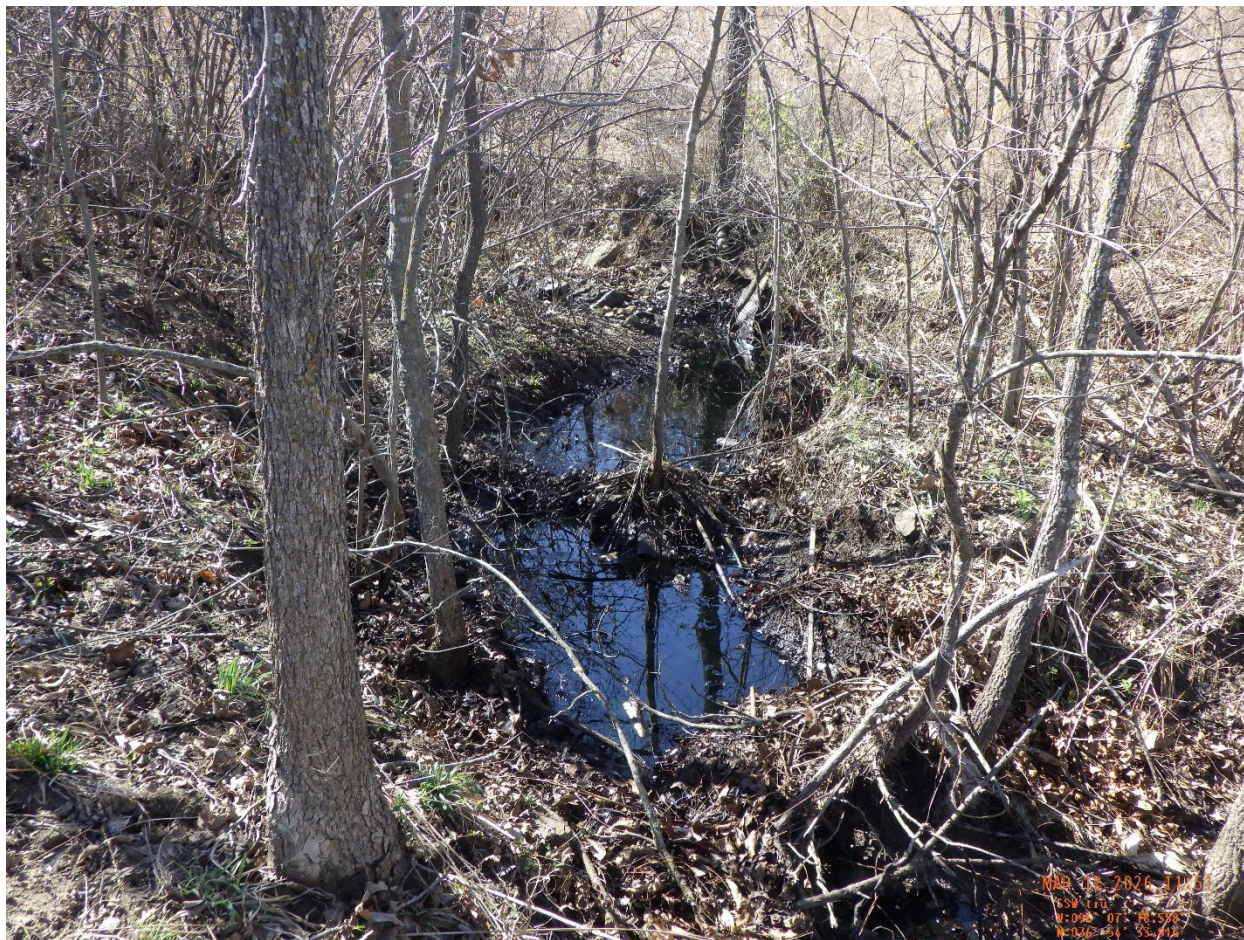
Photo No. 3

Continuing downstream, I observed oil-stained leaves, sticks and soil along the main channel of the impacted tributary. See photo No 3.

**Description:** This was oil, oil-stained leaves, sticks and soil continuing downstream along the impacted tributary.

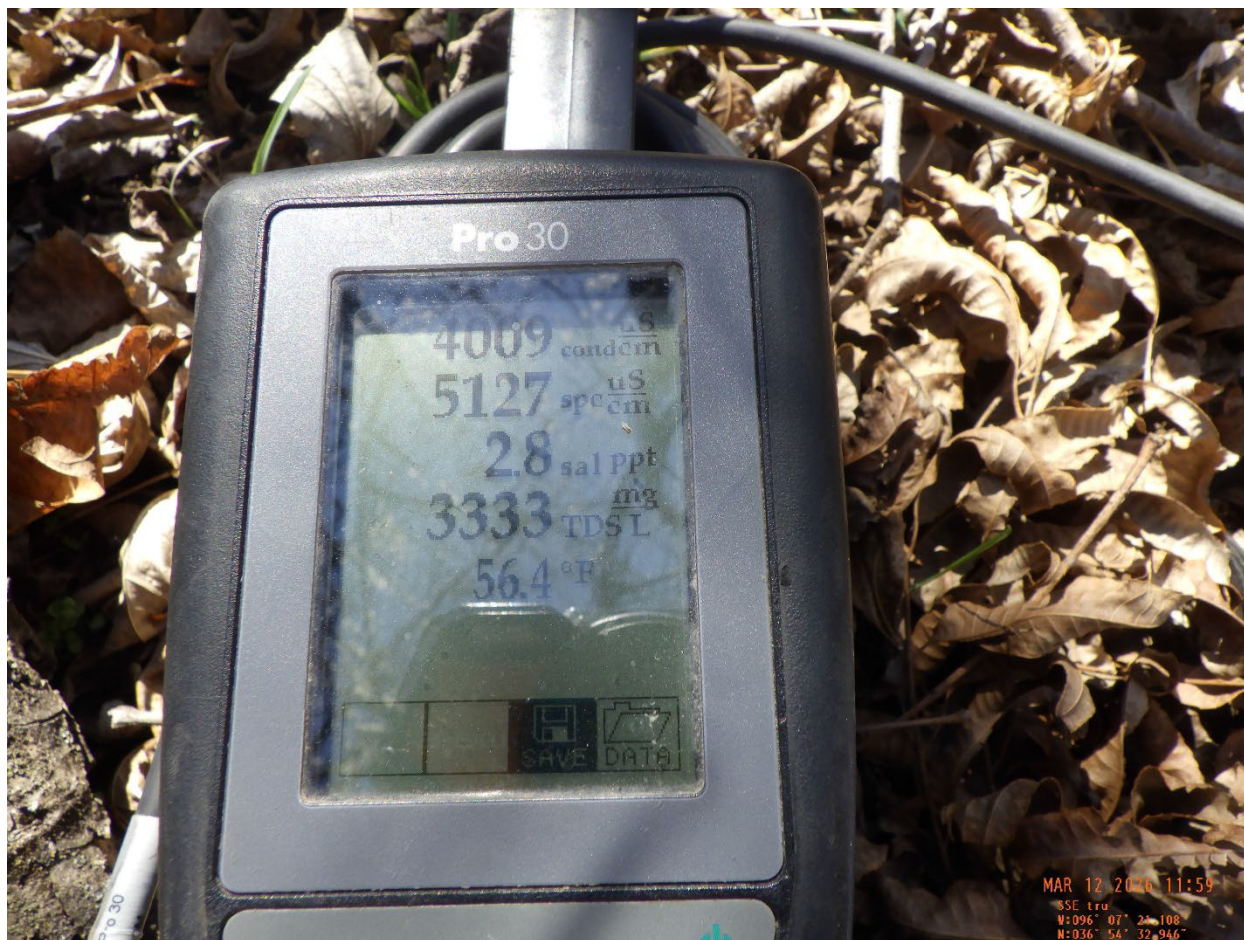
Photo No. 4

I observed an elevated TDS field reading of 3,333 mg/L. At this same location I observed oil floating on the impacted water of the tributary. See photos No. 4 & 5.

**Description:** This was an elevated TDS field reading of 3,333mg/L observed at the first pool of water in the impacted tributary, the first location where oil did not prevent accurate conductivity assessment.

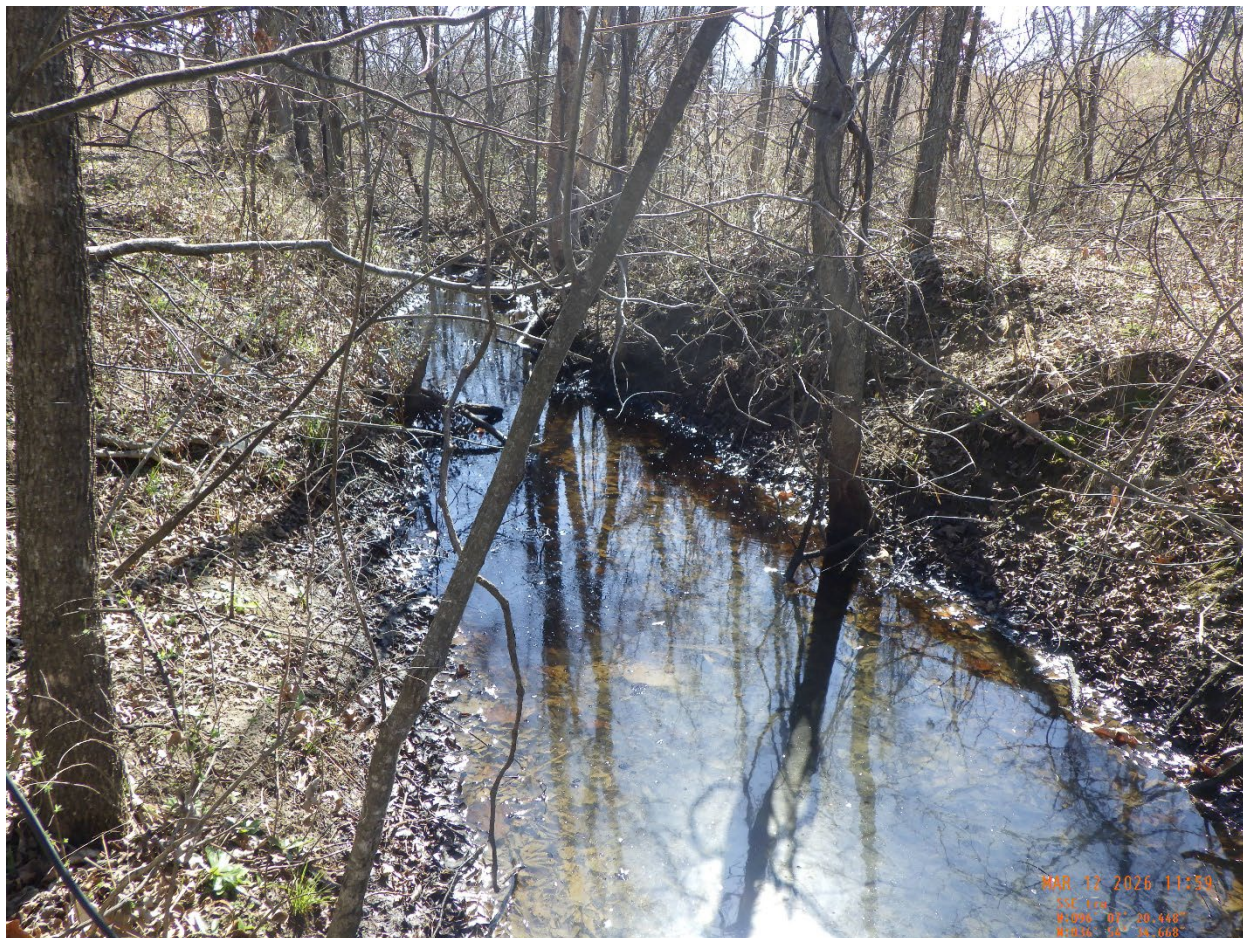
Photo No. 5

**Description:** This was the location where the TDS field reading from photo No. 4 was observed.

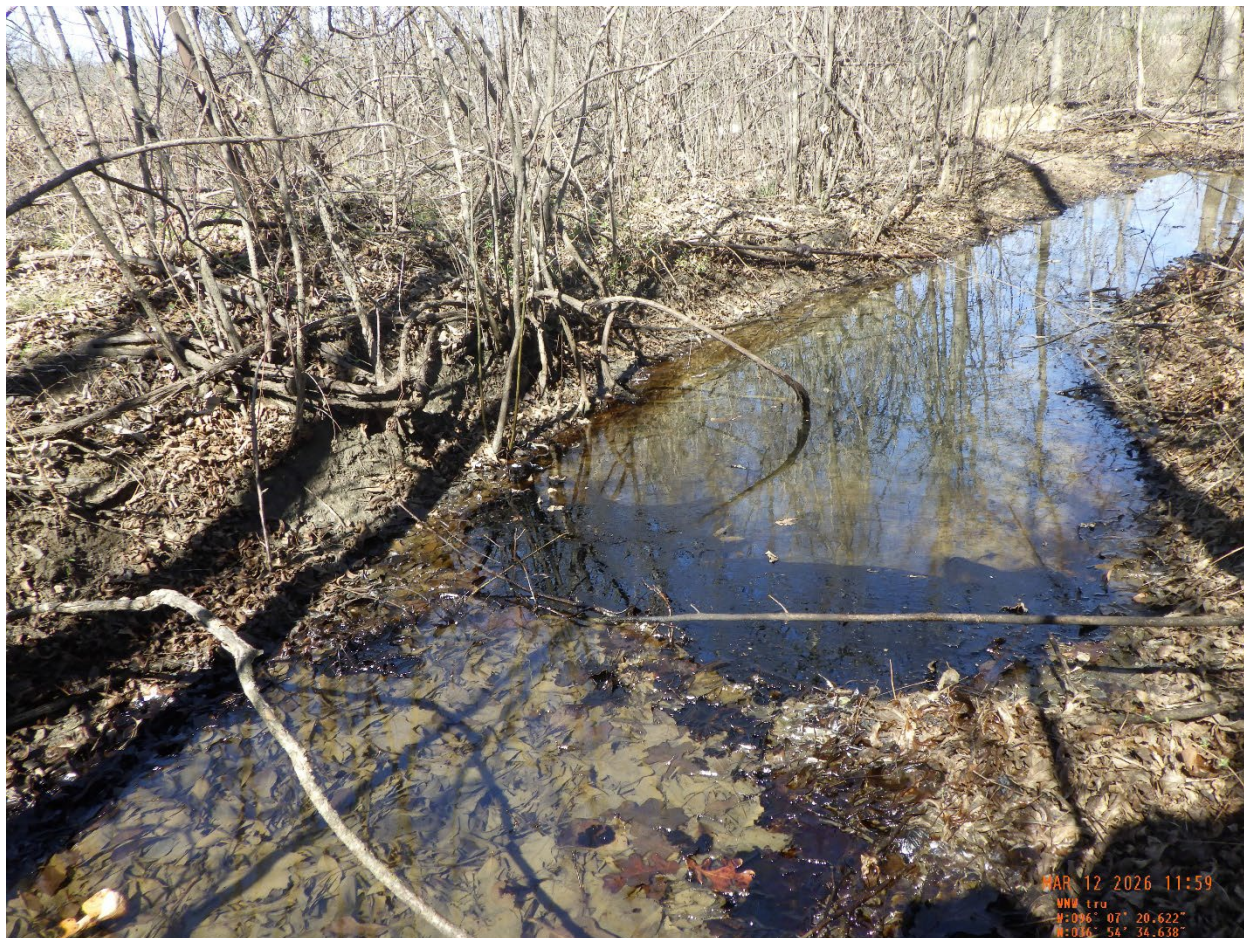
Photo No. 6

Continuing downstream, I observed additional oil floating in the impacted tributary. See photo No. 6.

**Description:** This was oil in the main channel of the impacted tributary as it migrated downstream.

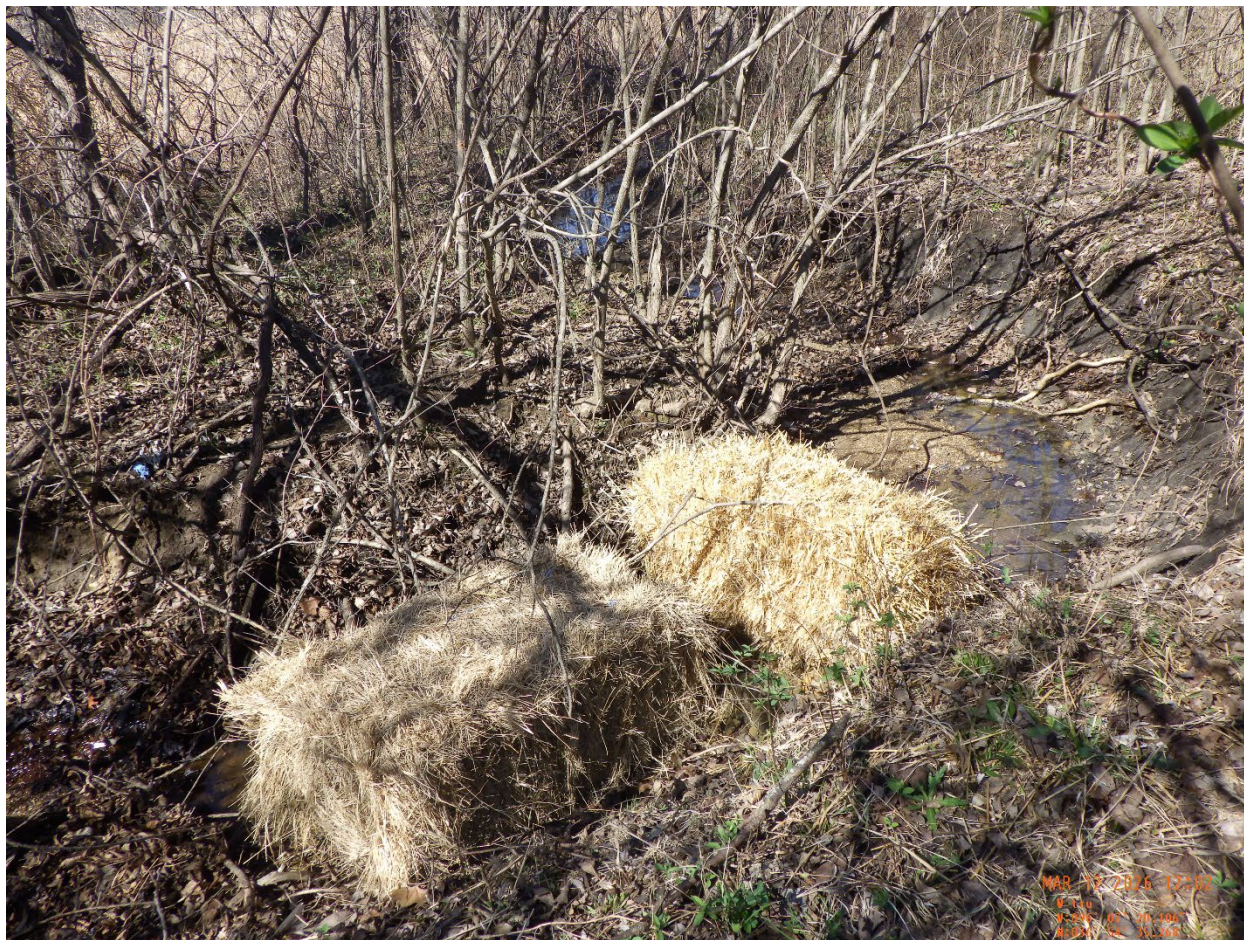
Photo No. 7

Further downstream I observed 2 straw bales placed by the operator. The bales were placed to prevent downstream migration of spill impacts. See photo No. 7.

**Description:** This was two bales of straw placed by the operator to prevent downstream migration of oil.

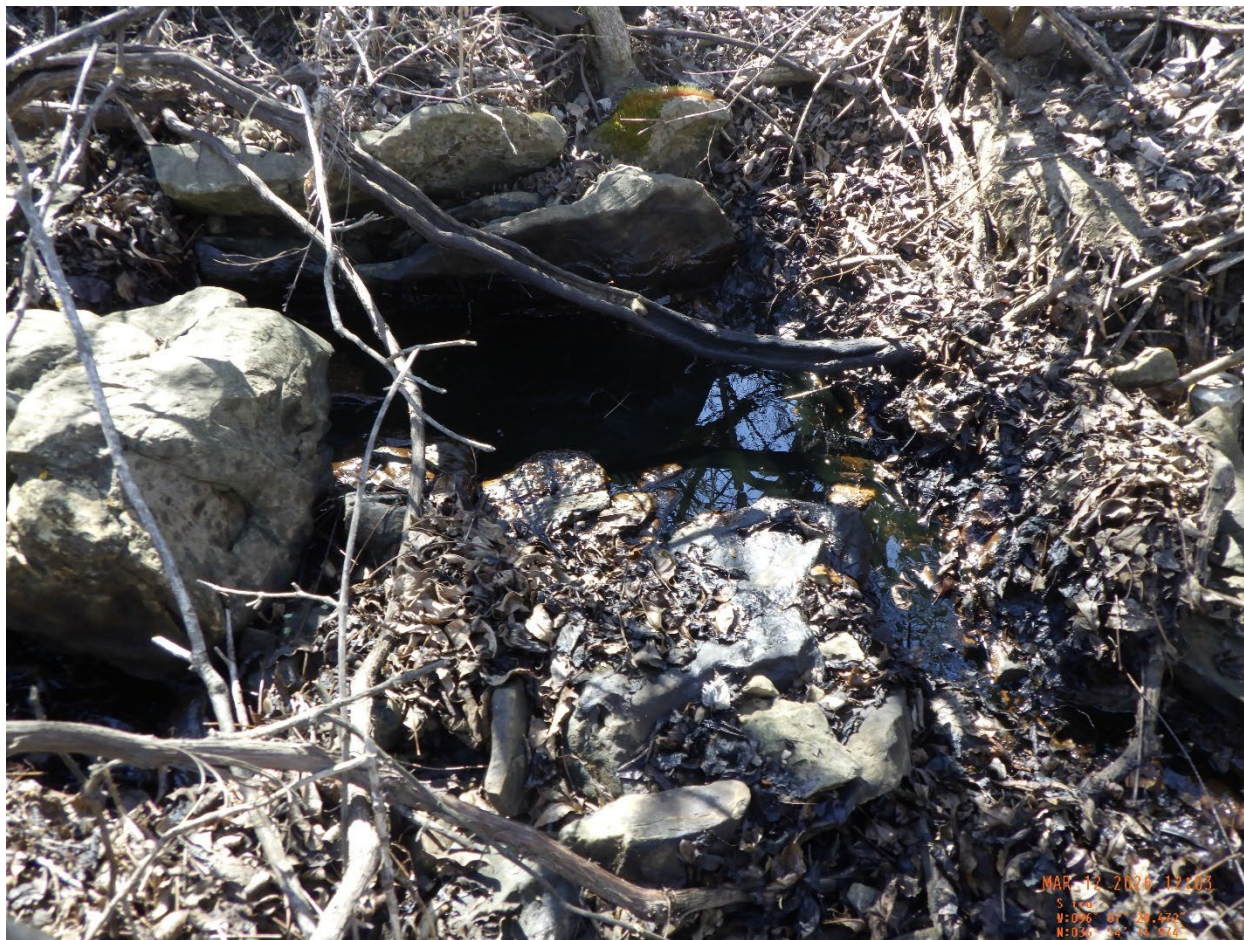
Photo No. 8

Downstream from the straw bales, I observed additional oil in the impacted tributary. See photo No. 8.

**Description:** This was oil in the impacted tributary downstream from the straw bales in photo No. 7.

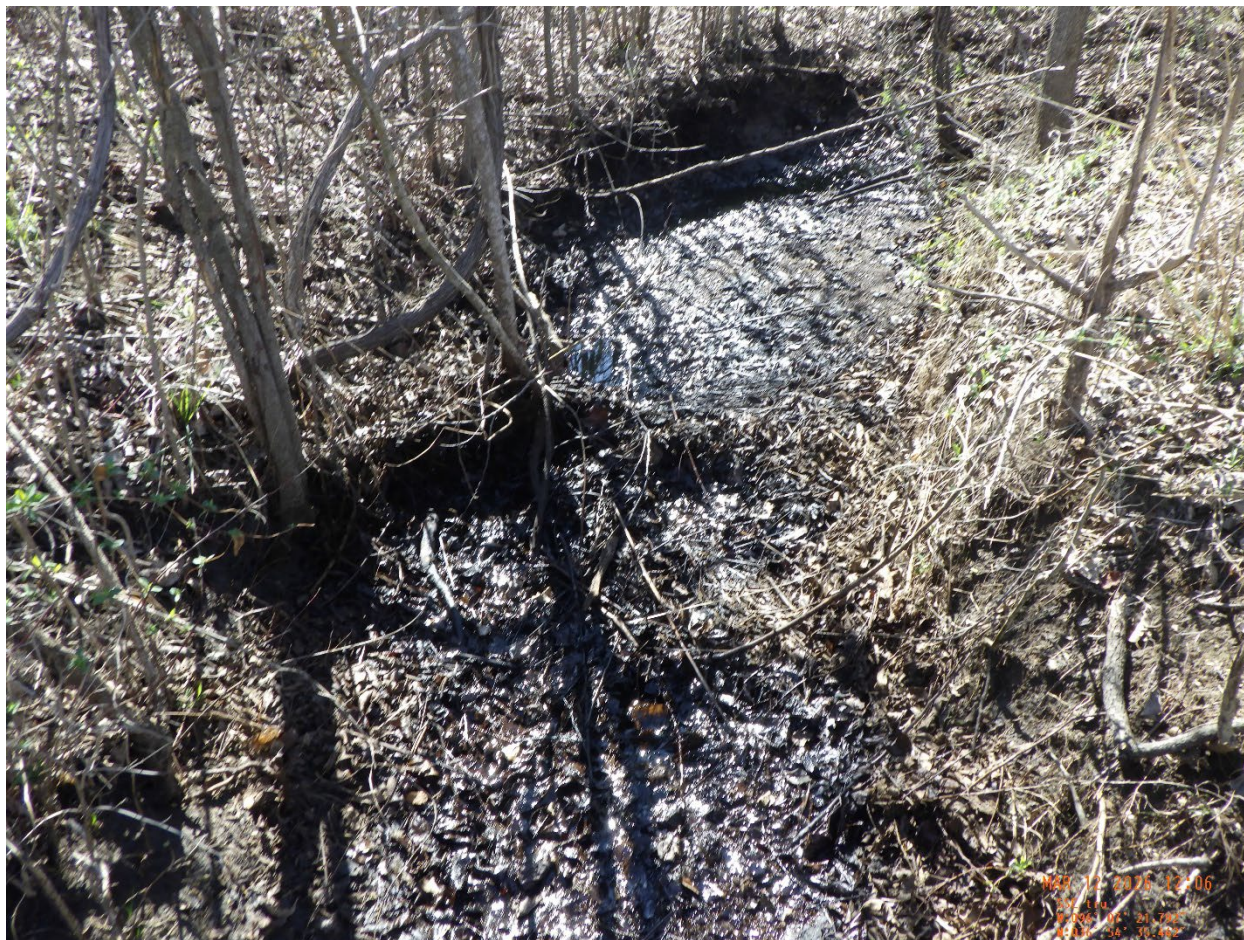
Photo No. 9

Continuing downstream, I observed oil-stained leaves, sticks and soil along the main channel of the impacted tributary. See photo No. 9.

**Description:** This was oil, oil-stained leaves, sticks and soil continuing downstream along the impacted tributary.

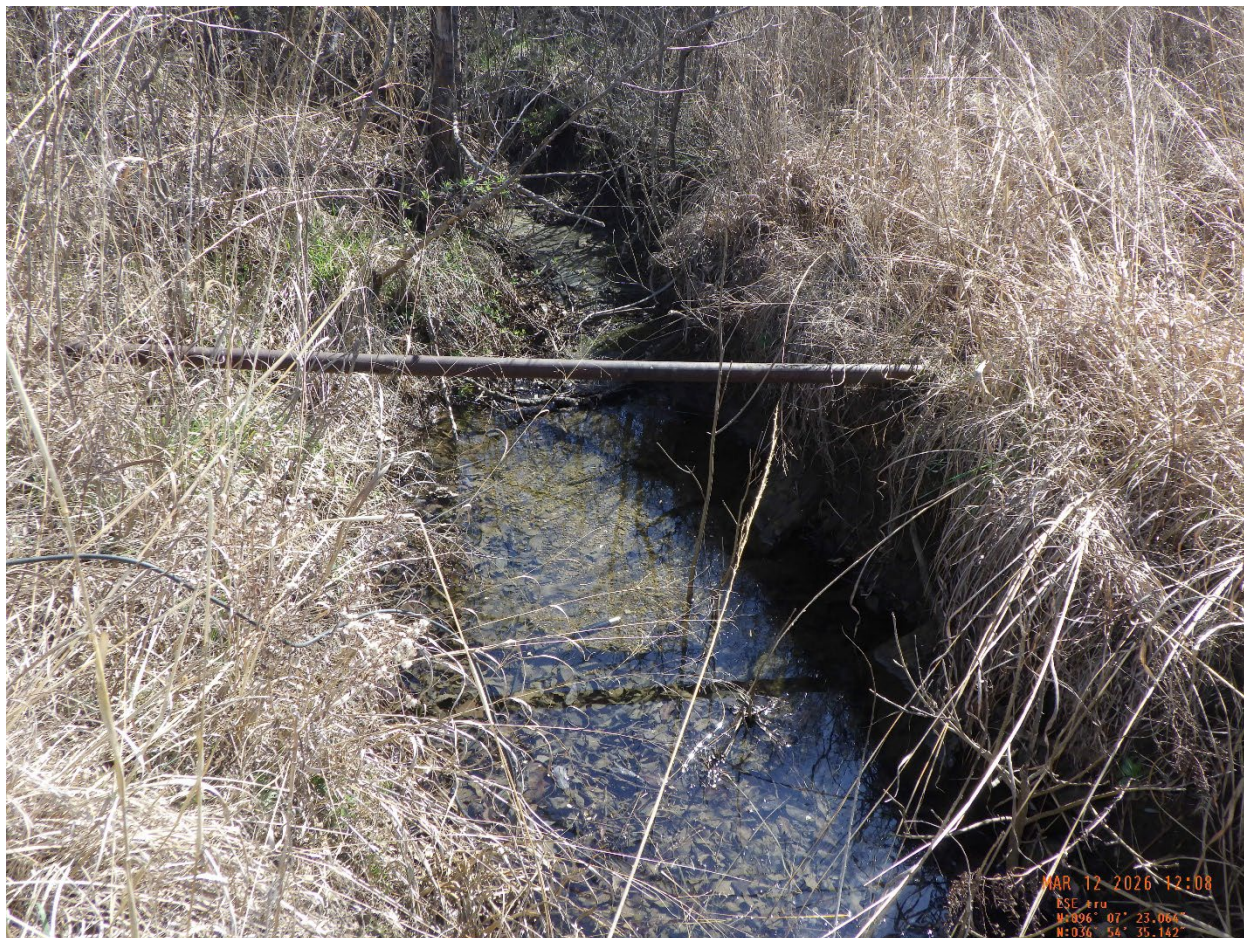
Photo No. 10

Continuing downstream I observed oil sheen and an elevated TDS field reading of 1,956 mg/L. See photos No. 10 & 11.

**Description:** This was the last pool of water which contained oil sheen. An elevated TDS field reading of 1,956 mg/L was observed at this location.

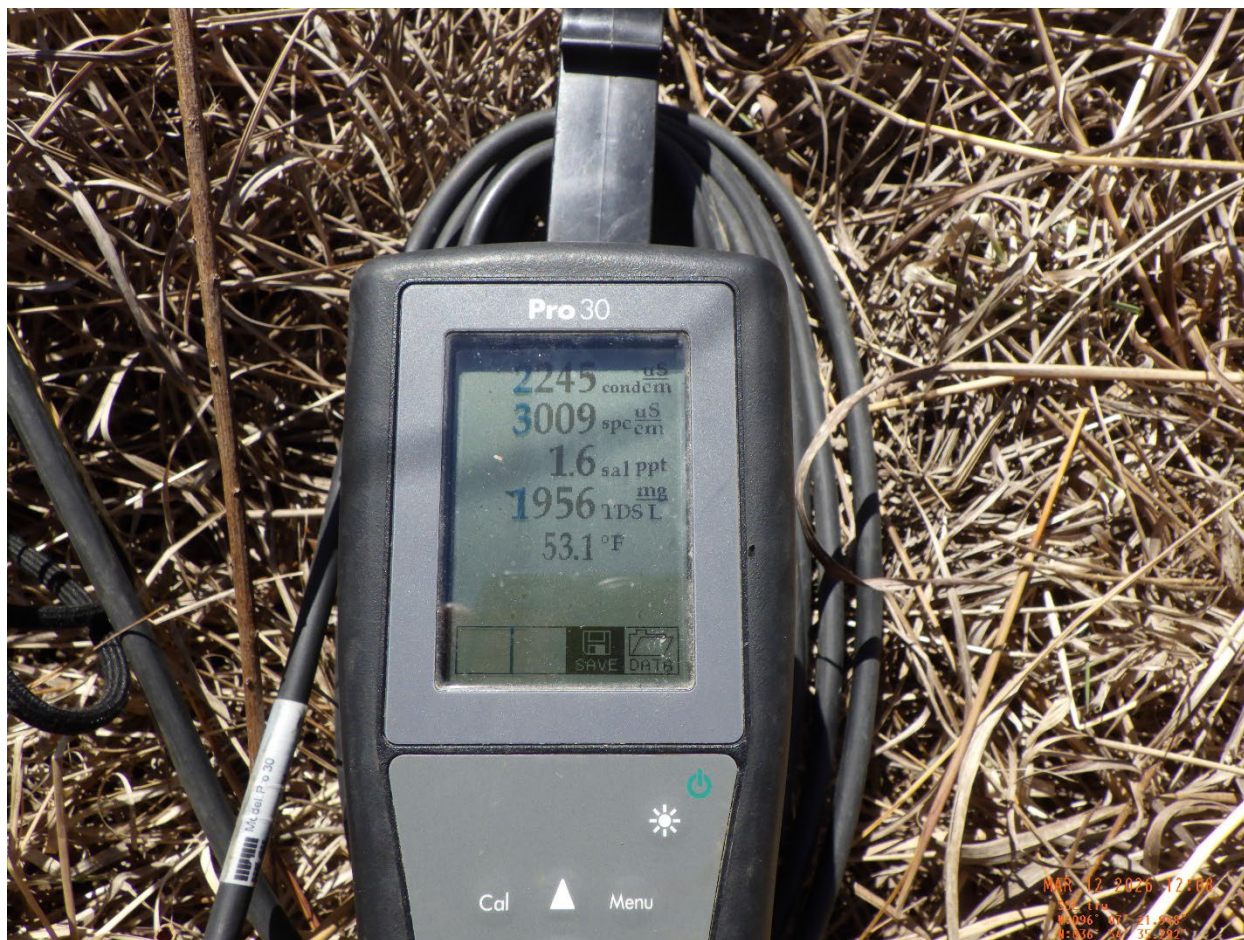
Photo No. 11

**Description:** This was an elevated TDS field reading taken in the main channel of the impacted tributary of Hulah Lake.

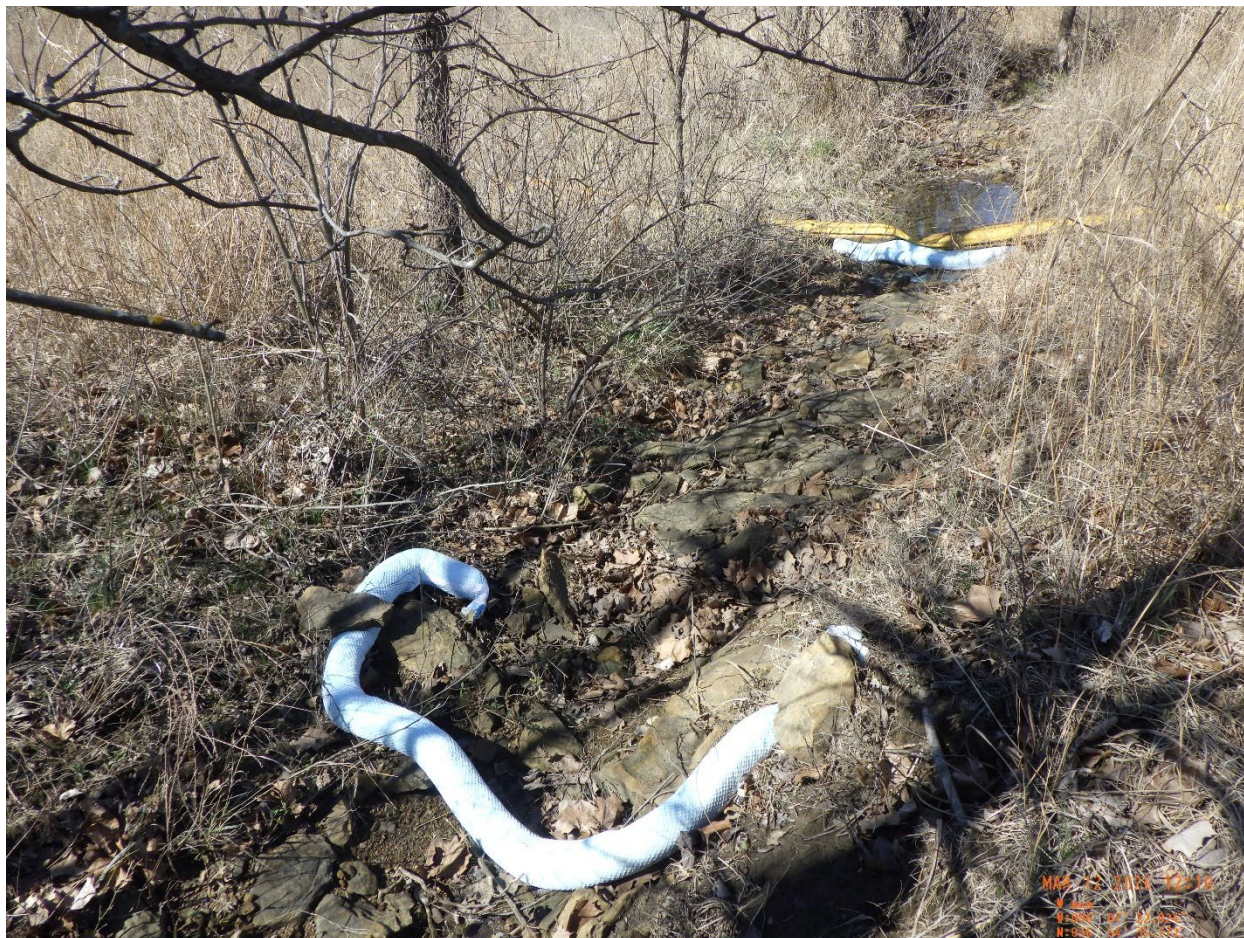
Photo No. 12

At the end of observed spill impacts, I observed floating, oil absorbent containment booms and a floating oil containment boom which had been placed by the operator and US Army Corps of Engineers personnel. At this same location I observed a TDS field reading of 410.2 mg/L which represented “background” TDS levels for the area, indicating the end of spill impacts. There was no oil or sheen observed beyond this point.

**Description:** This was the lowermost containment area. Containment consisted of floating, oil absorbent booms and a floating oil containment boom. This containment was placed by the operator and U.S. Army Corps of Engineers personnel.

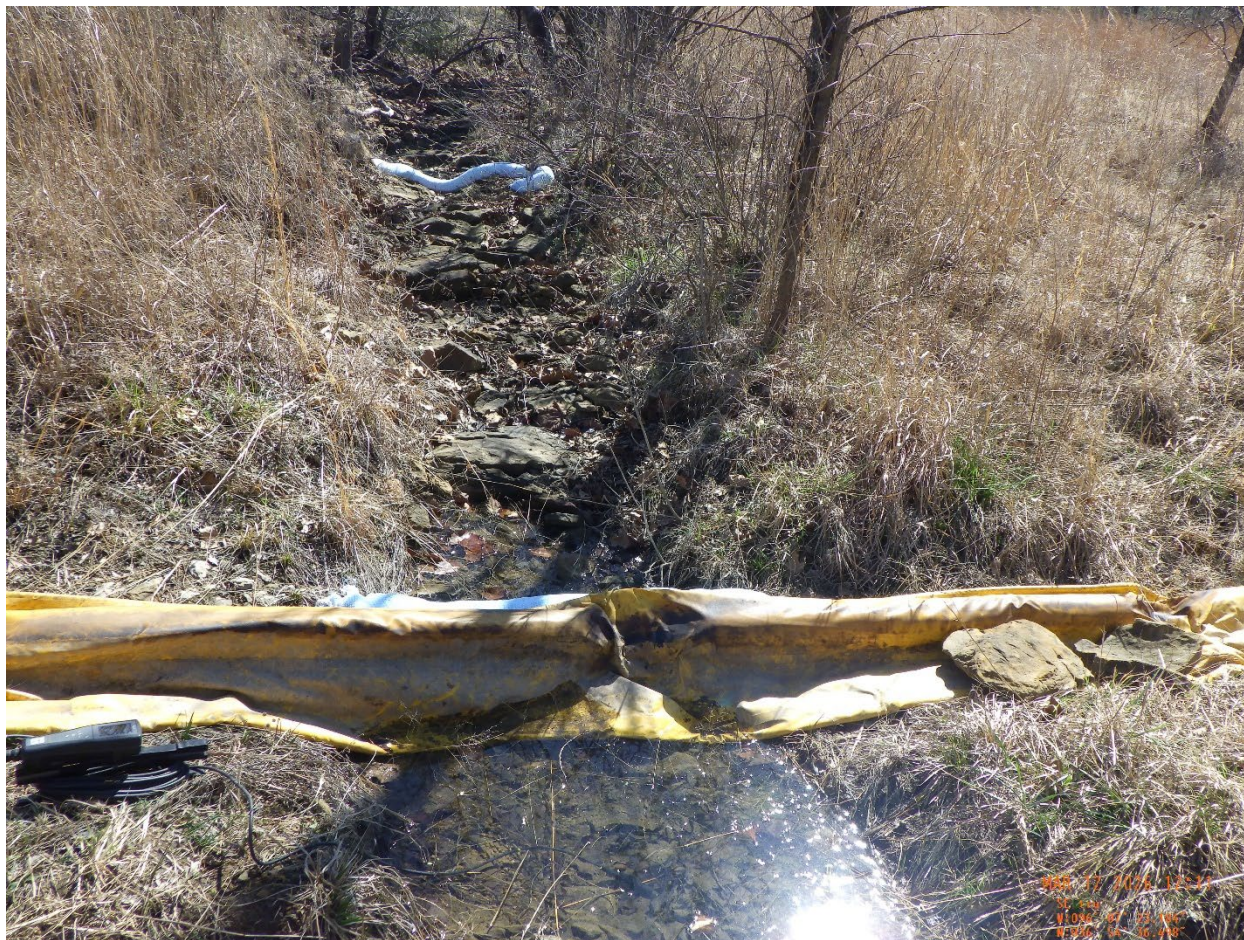
Photo No. 13

**Description:** This was the lowermost containment area with booms installed.

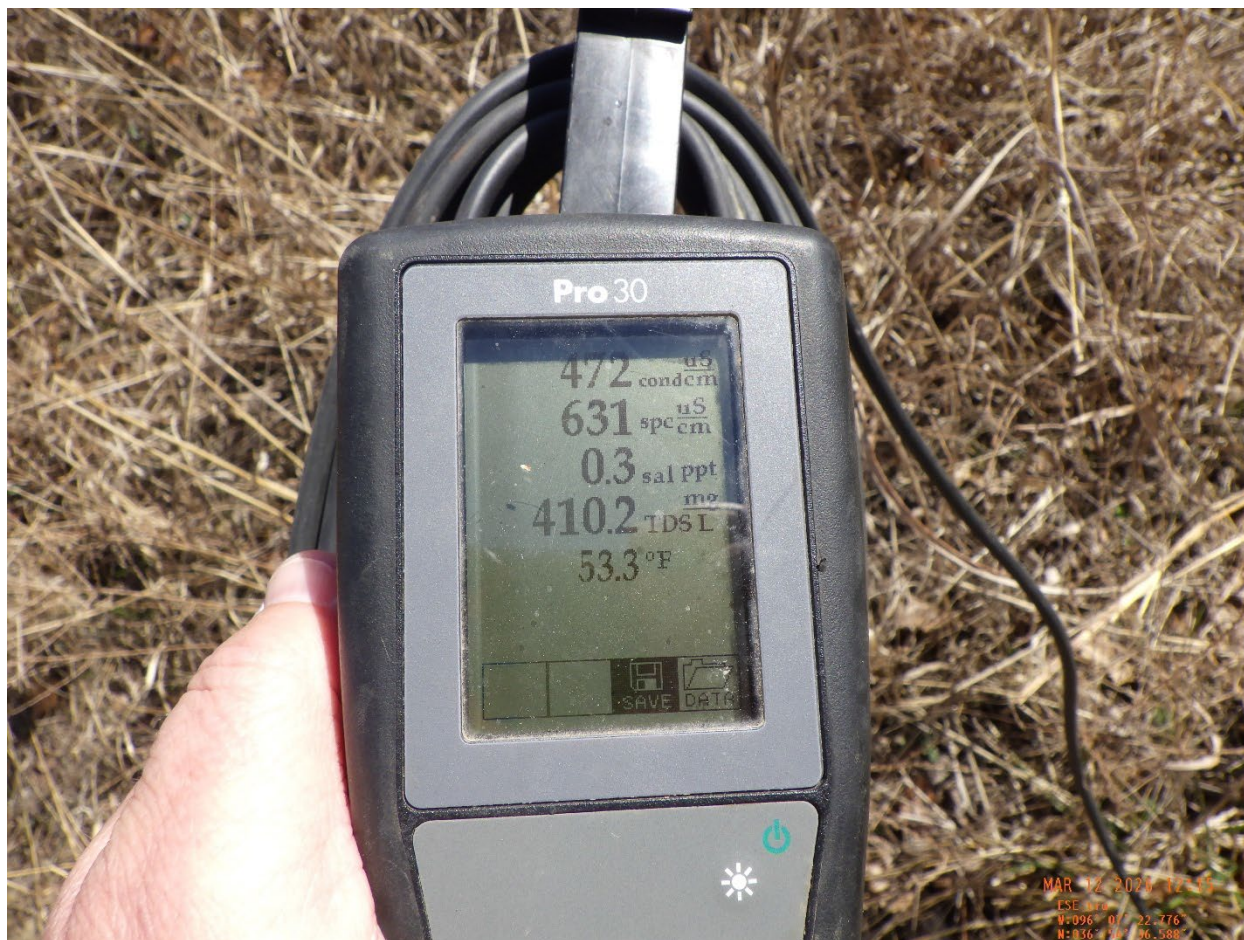
Photo No. 14

**Description:** This was a TDS field reading of 410 mg/L taken in the same pool where the lowermost containment booms were placed. This is representative of "background" TDS levels in the area. This was the end of observed spill impacts.
