## Interoffice Communication

To J. A. DeBernardi  
From J. W. Ware  
Date September 17, 1980  
Subject Unexpected VCM Release - September 11, 1980

### Summary

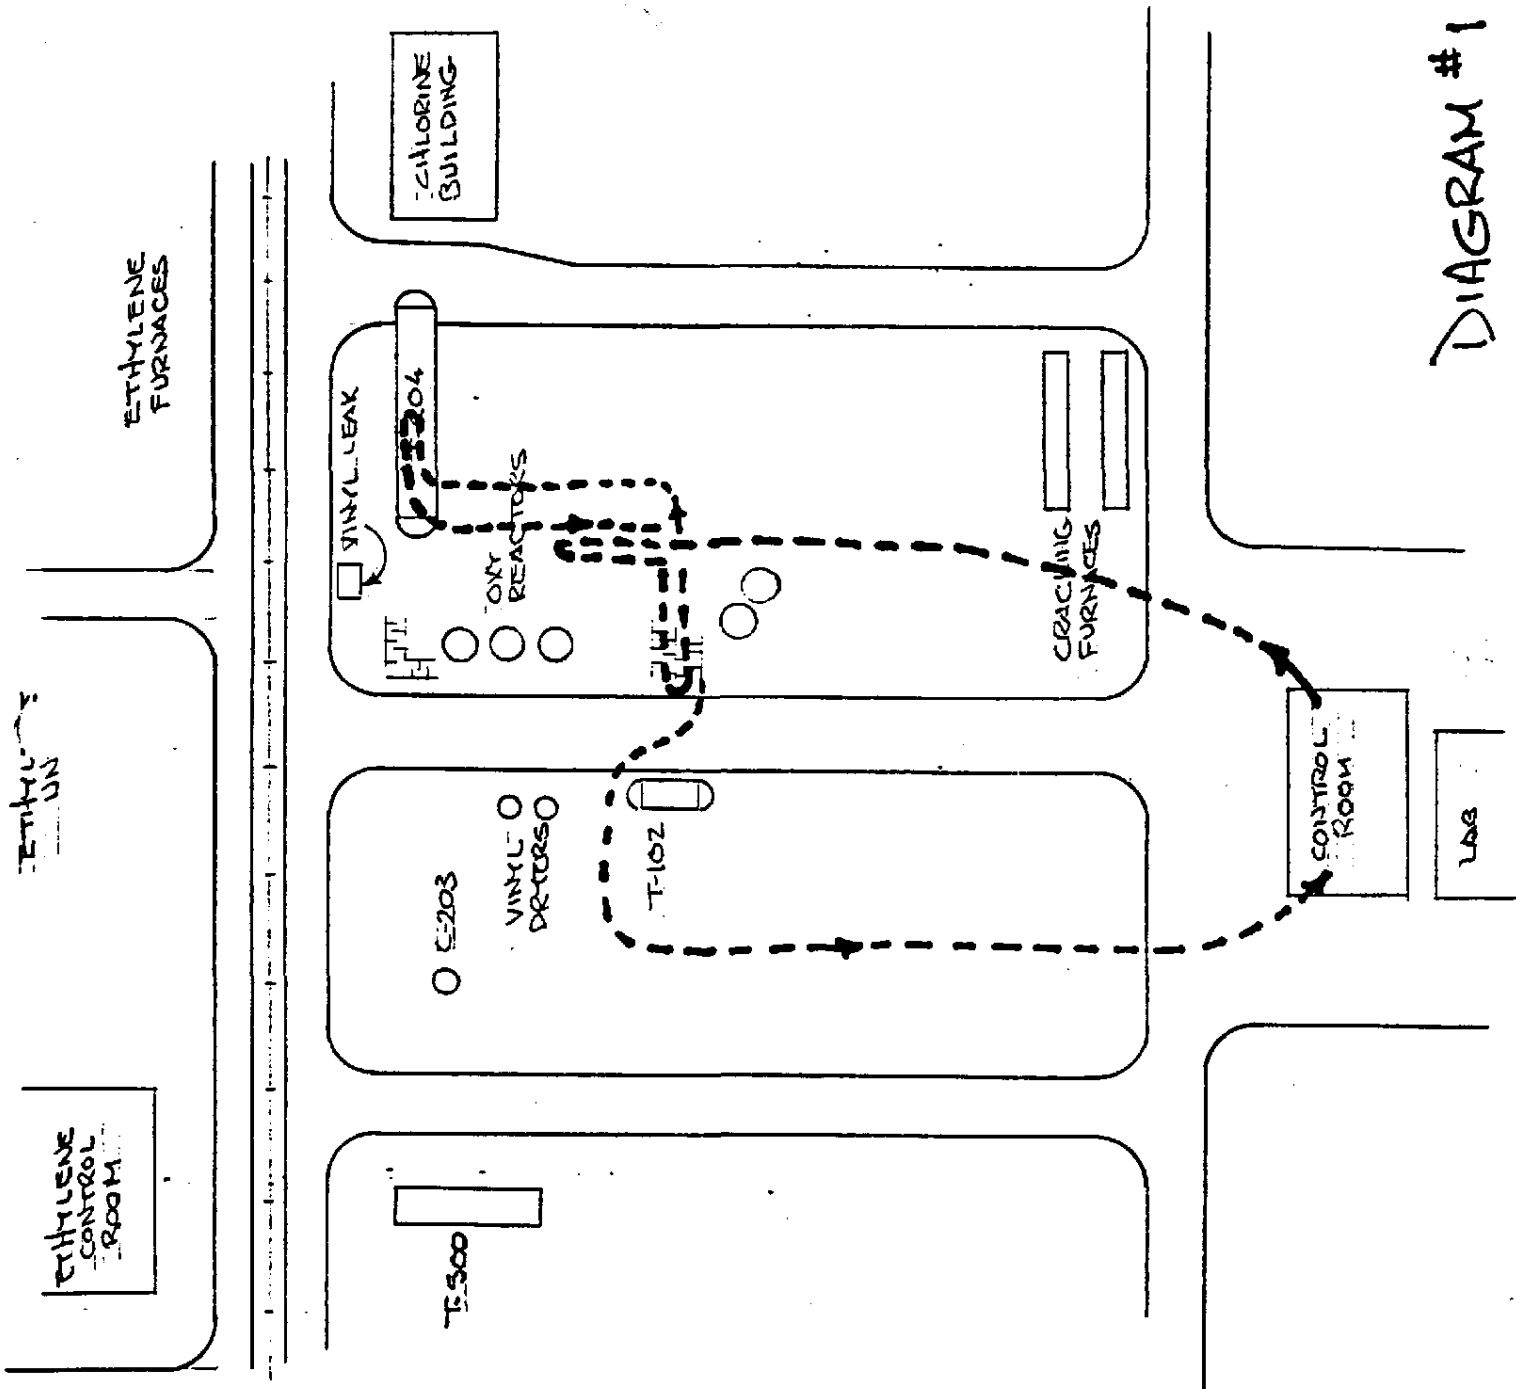
DIAGRAM #1

Ware and Turner joined Henry in the control room. A preliminary survey of the plant indicated that a satisfactory evacuation had been accomplished. TLV analysis indicated that control room levels of vinyl chloride did not require breathing air use. Turner donned a Scott Air Pak and retrieved a Drager analyzer from atop T-204. Henry utilized this unit to back up the TLV and confirm that the control room levels of vinyl chloride were indeed acceptable. While retrieving the Drager analyzer Turner surveyed the process unit with a TLV and found various concentrations of vinyl chloride ranging from 1200+ ppm in Block II to 300 ppm atop T-204 (see Diagram #1, Appendix C).

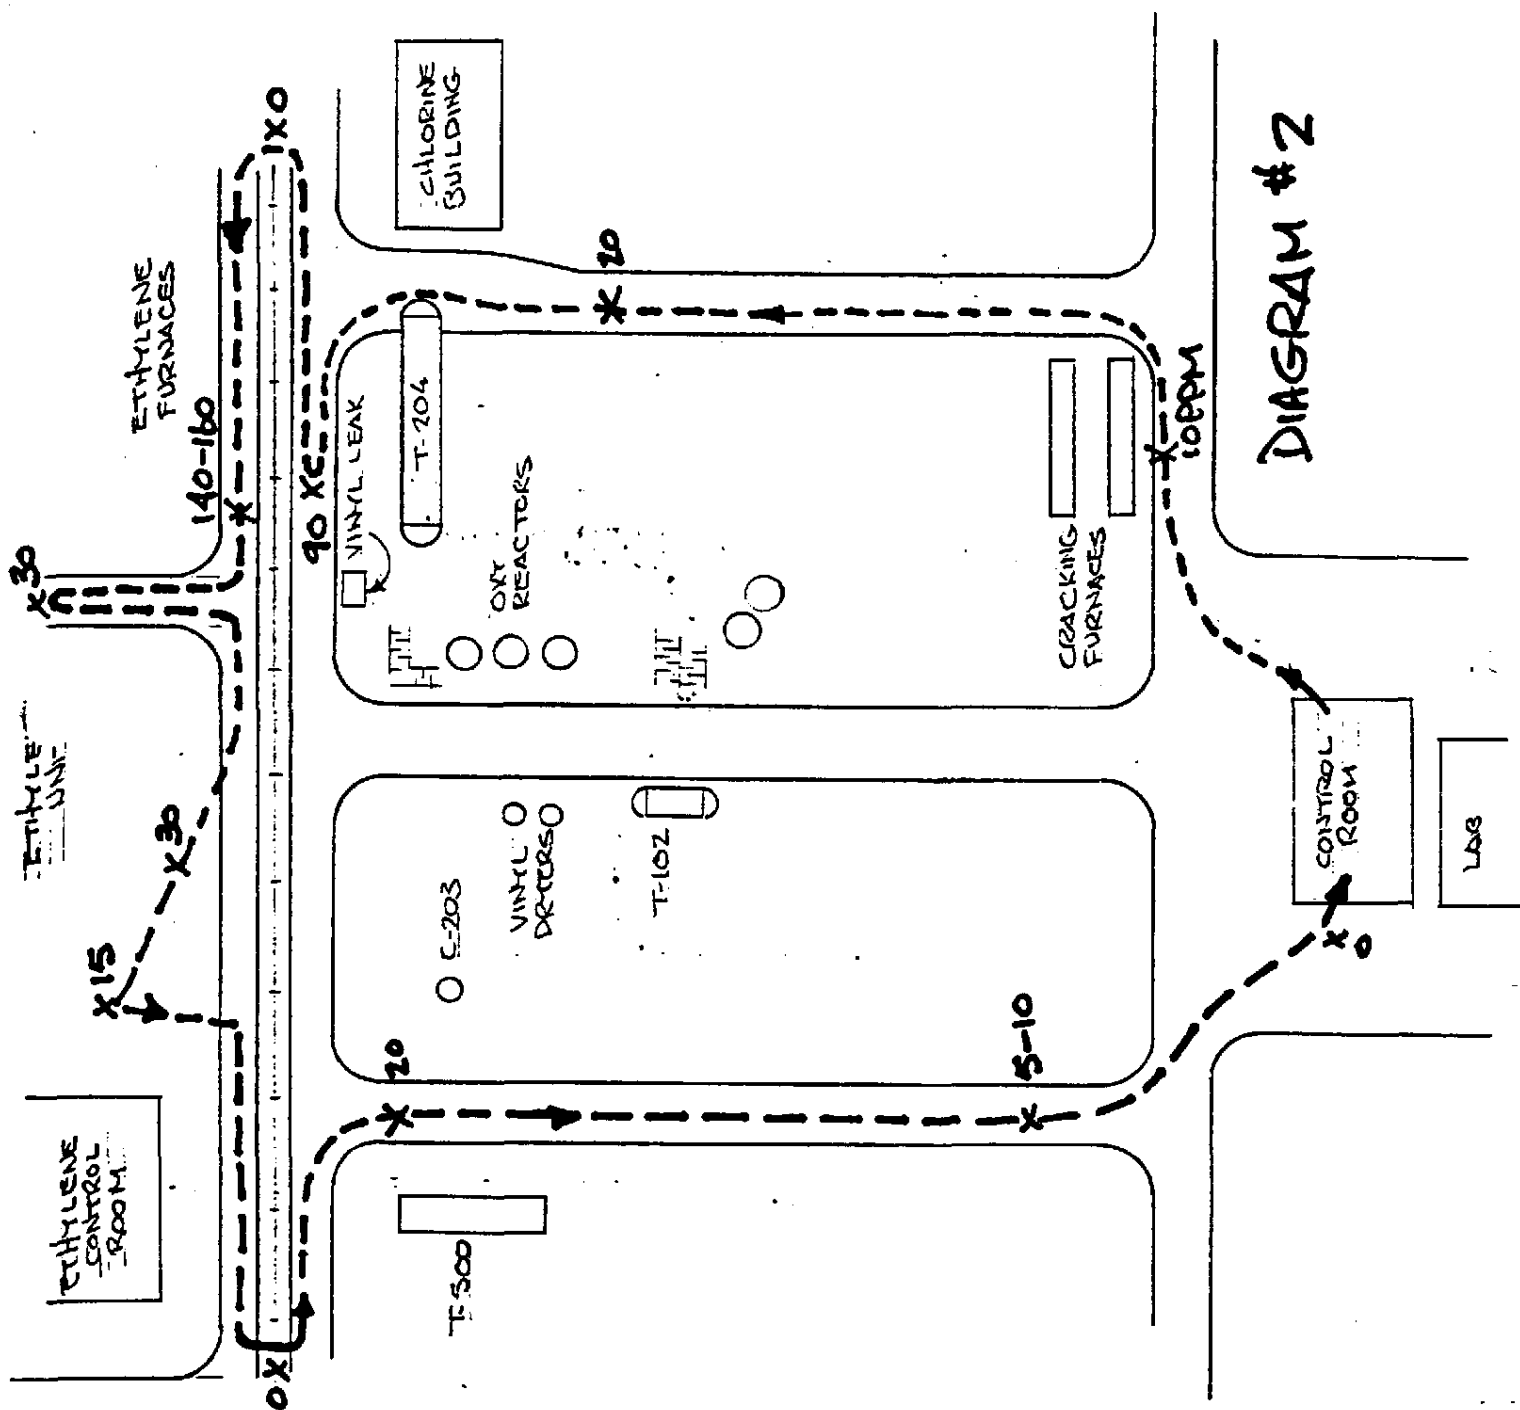
At 1430 hours Turner donned a second Scott Air Pak and surveyed in detail the entire unit to determine the extent of the area affected by high vinyl chloride concentrations (see Diagram #2, Appendix C). The ethylene unit foreman was then contacted by Ware and informed that no one should enter his unit without respiratory protection. The foreman stated that he would call all of his people to the control room. Vinyl chloride levels in the ethylene area was monitored during the incident with the results being that shown in Appendix D.

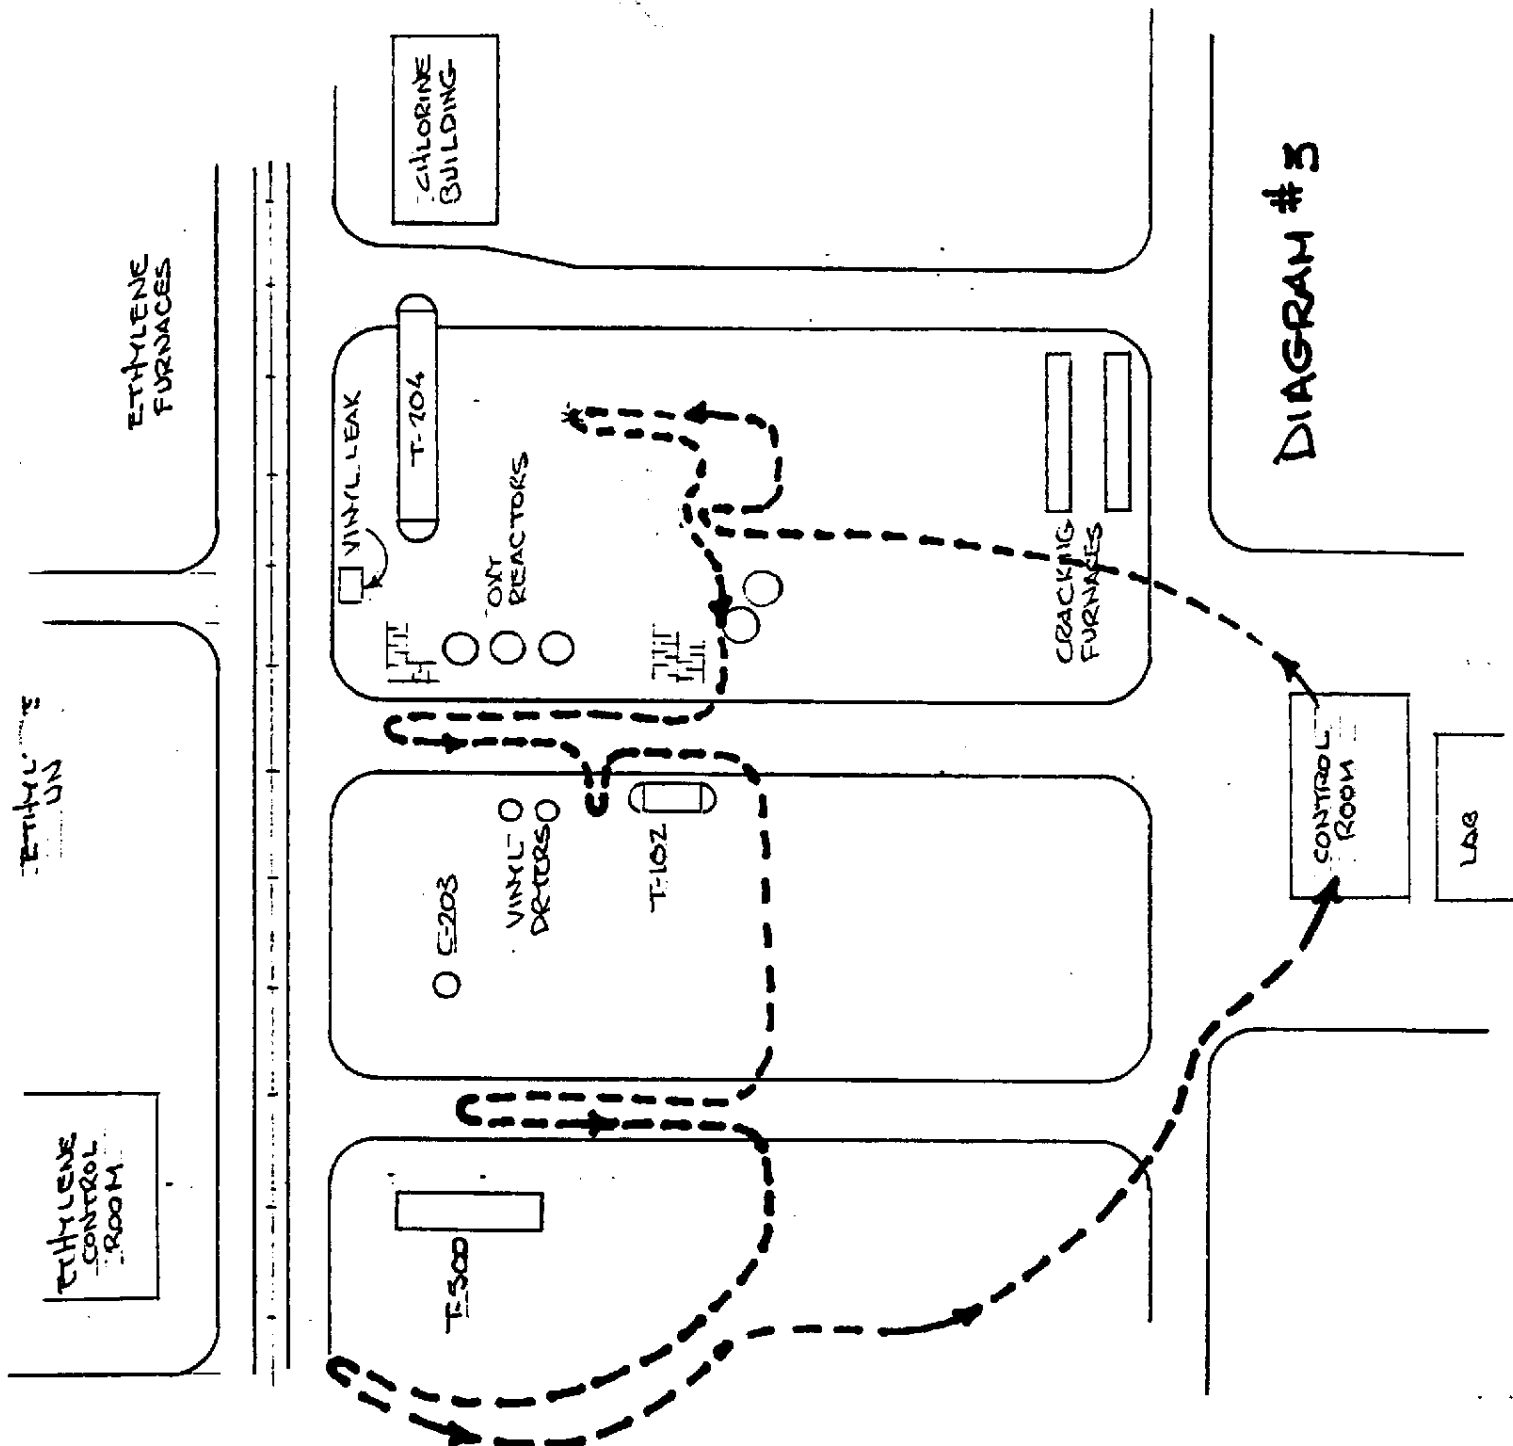
DIAGRAM #3

The vinyl chloride levels were then monitored in the unit using the fixed point monitor system in the control room. When, according to this system, vinyl chloride levels had lowered to 1 ppm or less, Turner was sent out with a TLV unit (without breathing air) and instructed not to trespass in an area which showed a reading approaching 5 ppm (see Diagram #3, Appendix C).

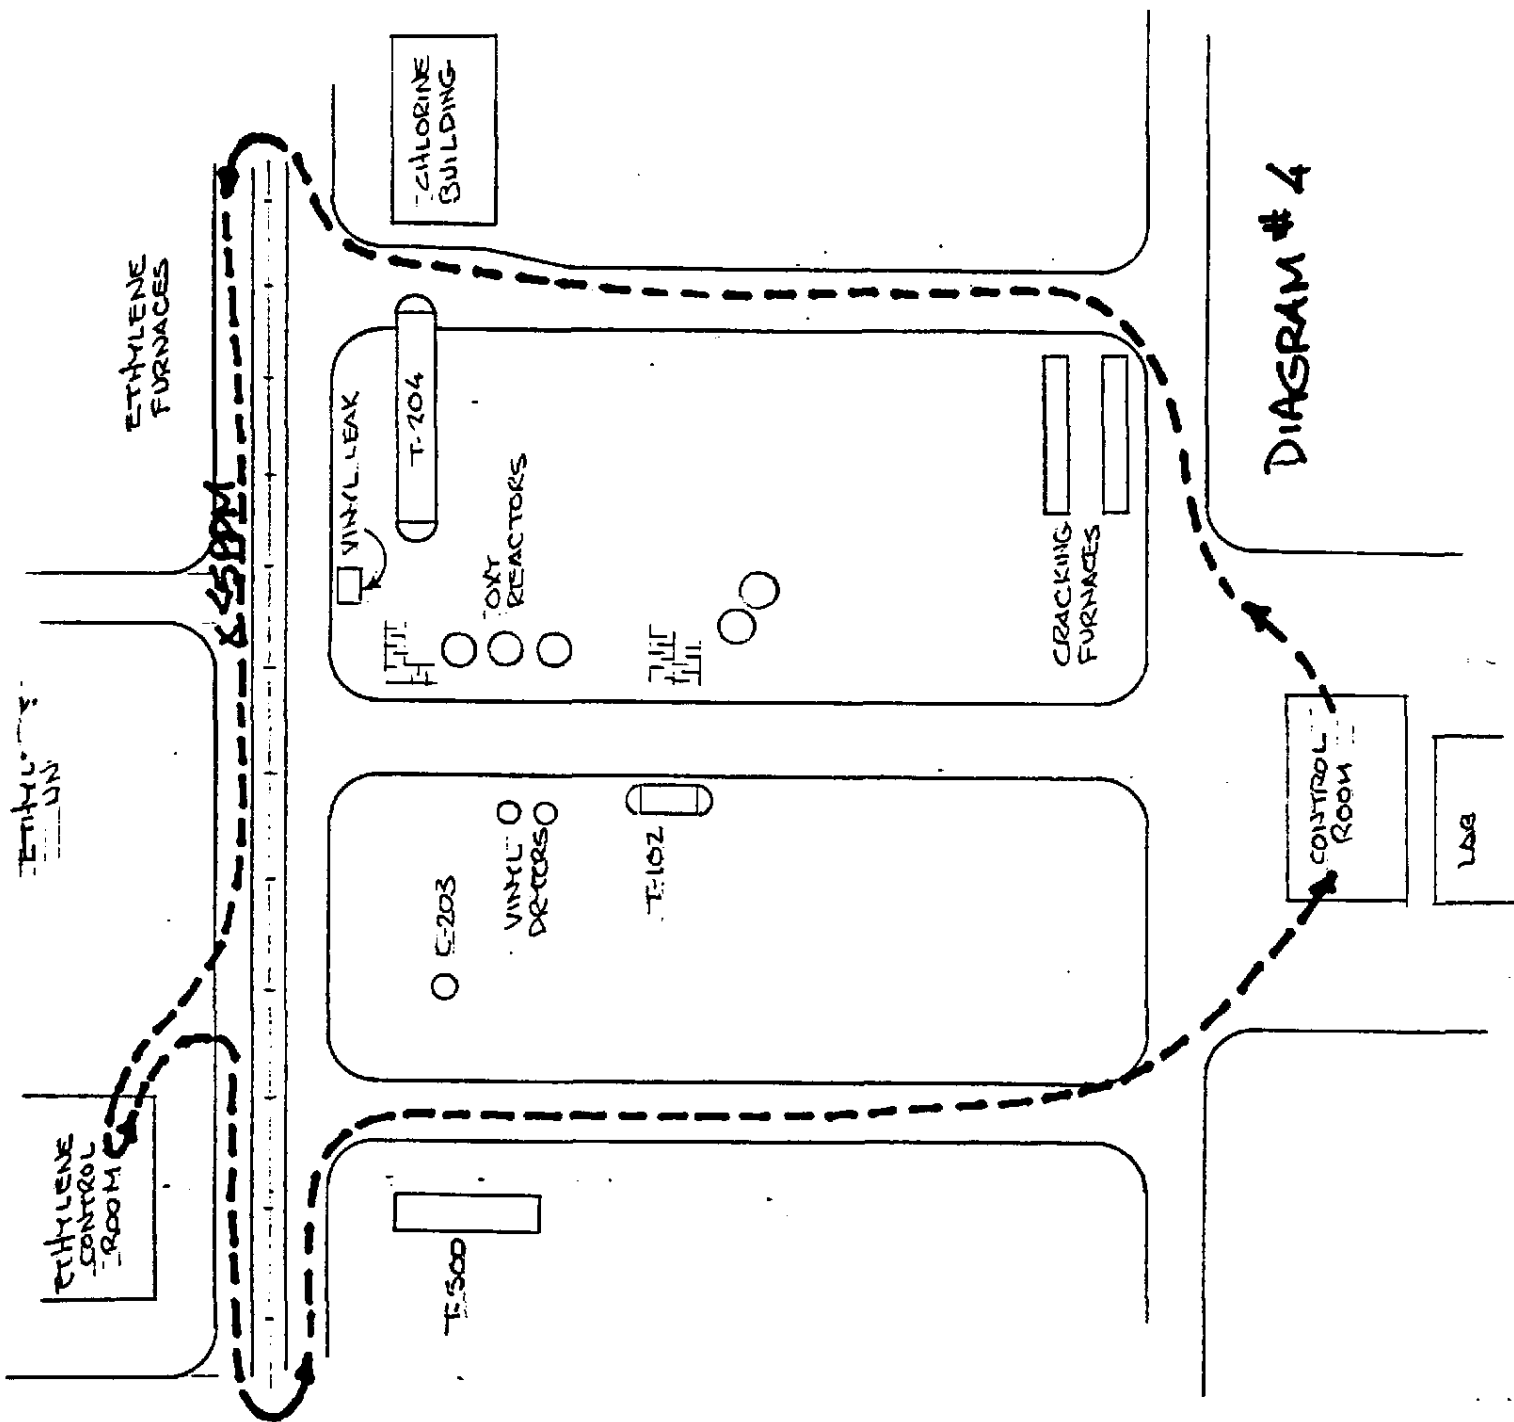
Diagram #4, Appendix C shows a fourth survey conducted by Turner.
