RCRA Compliance Branch INSPECTION REPORT

Inspection Date(s):	5/20/2024	Inspection Announced: No
Facility or Site Name: Safety-Kleen A Clean Harbors Company		
Facility/Site Physical Location: 1200 Sylvan St		
(city, state, zip code) Linden, NJ 07036-6418		
Mailing address (if different from above):		
(city, state, zip code)		
Facility/Site Contact:	David D. Cornell	Sr. Environmental Compliance Manager
	David.cornell@safety-kleen.com	
	934.777.1175	
RCRA ID Number: NJD002182897		
Facility/Site Personnel Participating in Inspection:		
David D. Cornell	Above	Above
William Greenlaw	Facility Manager II	greenlaw.william@cleanharbors.com
Inspector(s):		
William Chernes	WILLIAM CHERNES

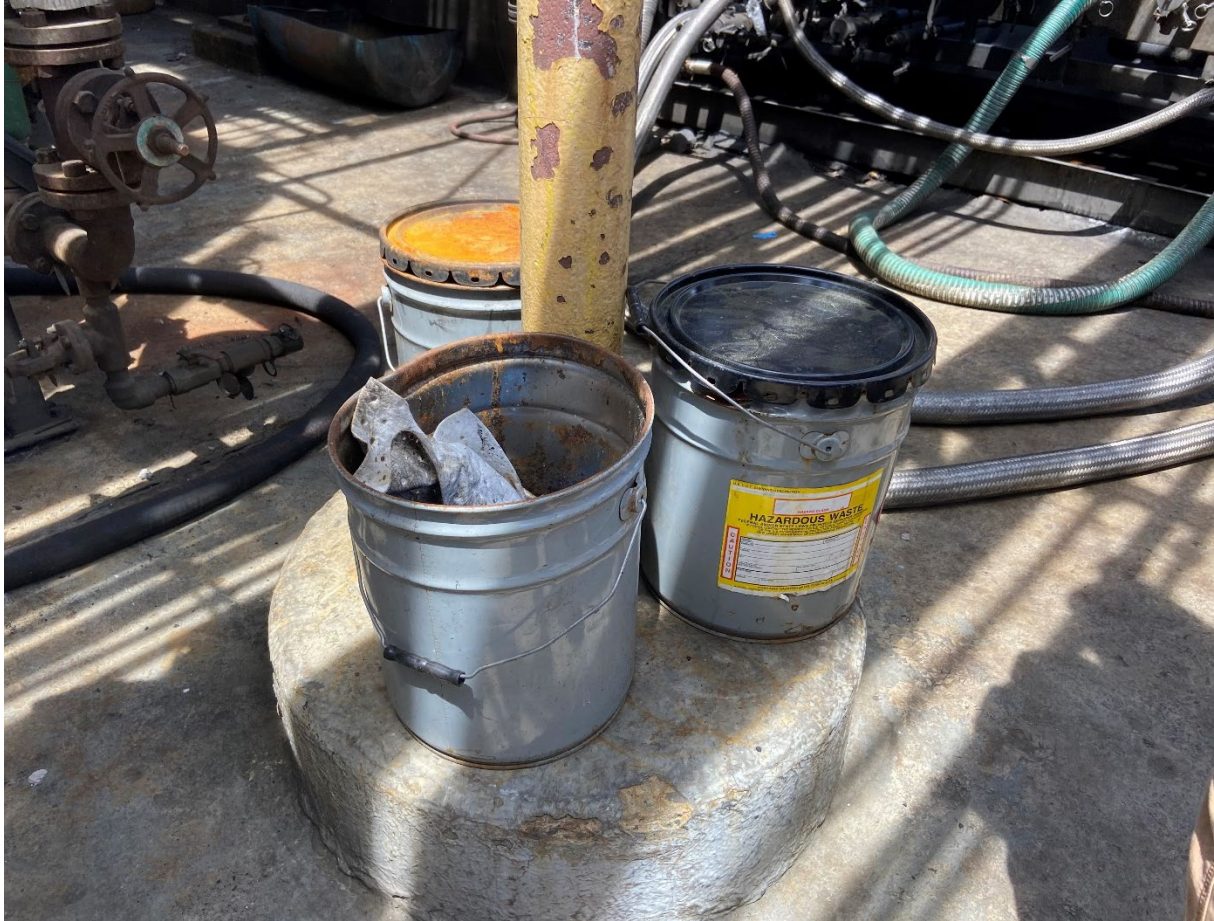
The Column Pad contained two distillations columns (CT-1 & CT-2) and one wastewater tank (T-75). The wastewater tank is non-hazardous. In the area, there were four leaking pumps that had not been red tagged. Three 5-gallon satellite drums were not properly labeled with the hazards of their contents, and two of the drums were not properly closed, shown in Figure 1. There were 14 bleeders that did not have double closed valves. EPA inspectors witnessed a facility representative add a large cap to one of the valves immediately after the concern was identified. Cut Tanks 1 & 2 had four open-ended BB lines. Several lines of mixed solvents were leaking into a trough in the area, and an unidentifiable vial was found knocked over without a cap, shown in Figure 2. EPA inspectors witnessed facility representatives begin to clean the spill immediately after the concern was identified. Tank 75 was missing a valve cap and had corrosion

7. Pursuant to 40 C.F.R. § 262.34(a)(3), as incorporated by reference in N.J.A.C. 7:26G-6.1 (a) states that a container must be labeled with the words “Hazardous Waste” and “[a]n indication of the hazards of the contents”.
 - a. At the time of the inspection, three 5-gallon satellite drums in the Column Pad were not labeled with an indication of the hazards of the contents.
 - b. At the time of the inspection, there was one 55-gallon hazardous waste drum just outside the Column Pad that did not contain labeling that indicated the hazards of the contents.
 - c. At the time of the inspection, one 5-gallon hazardous waste satellite drum in Tank Farm #4 did not contain labeling that indicated the hazards of the contents.

At the time of the inspection, two 5-gallon satellite drums in the Column Pad were not fully closed.

Figure 1: Three 5-gallon satellite hazardous waste drums were not properly labeled in the Column Pad. Two of the drums were also not properly closed.

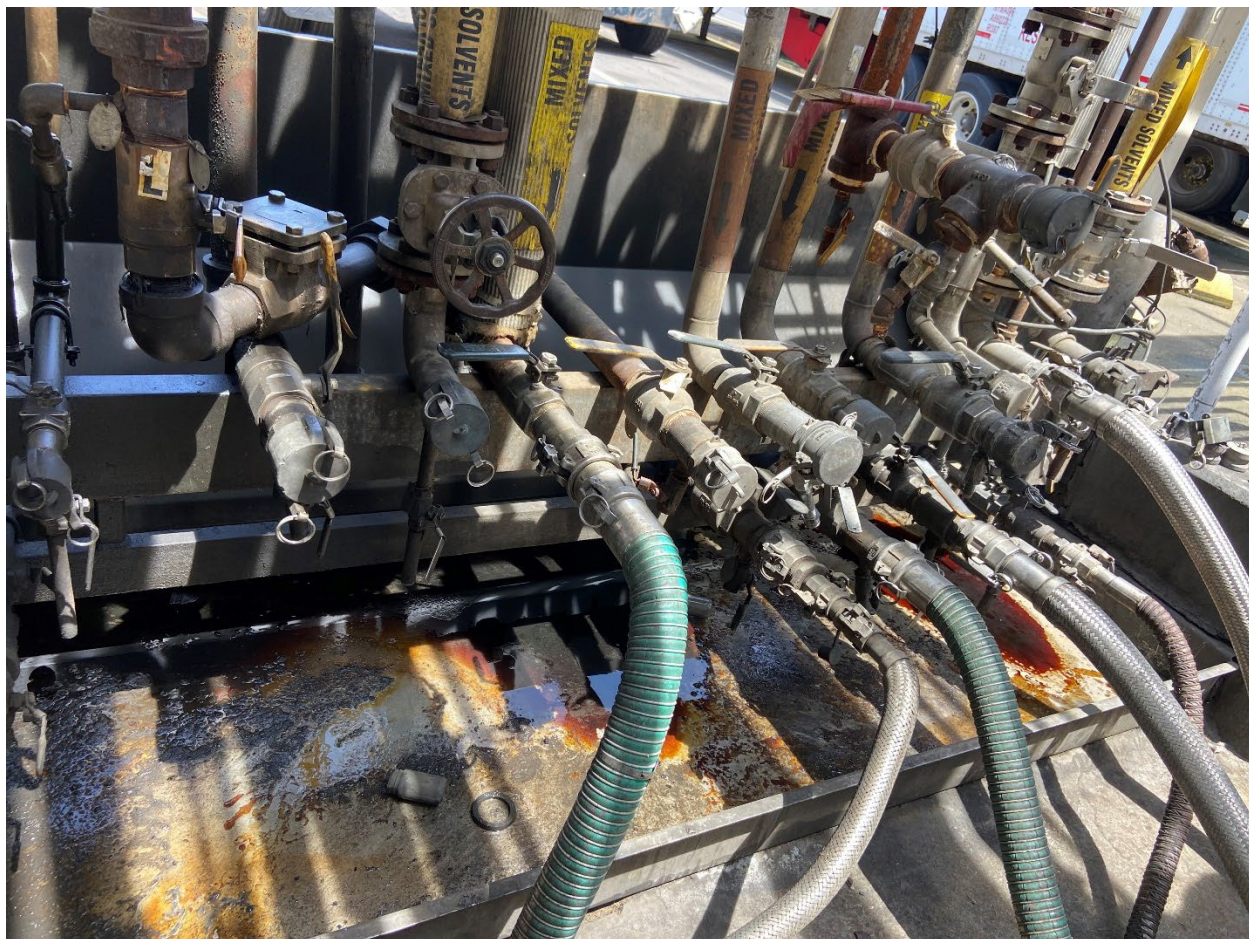
- b. At the time of the inspection, several lines of mixed solvents had been leaking into a trough in the Column Pad, and an unidentifiable open vial was also found knocked over in the area.

Figure 2: Trough in the Column Pad containing leakage from solvent pipes and an unidentifiable open vial on its side.

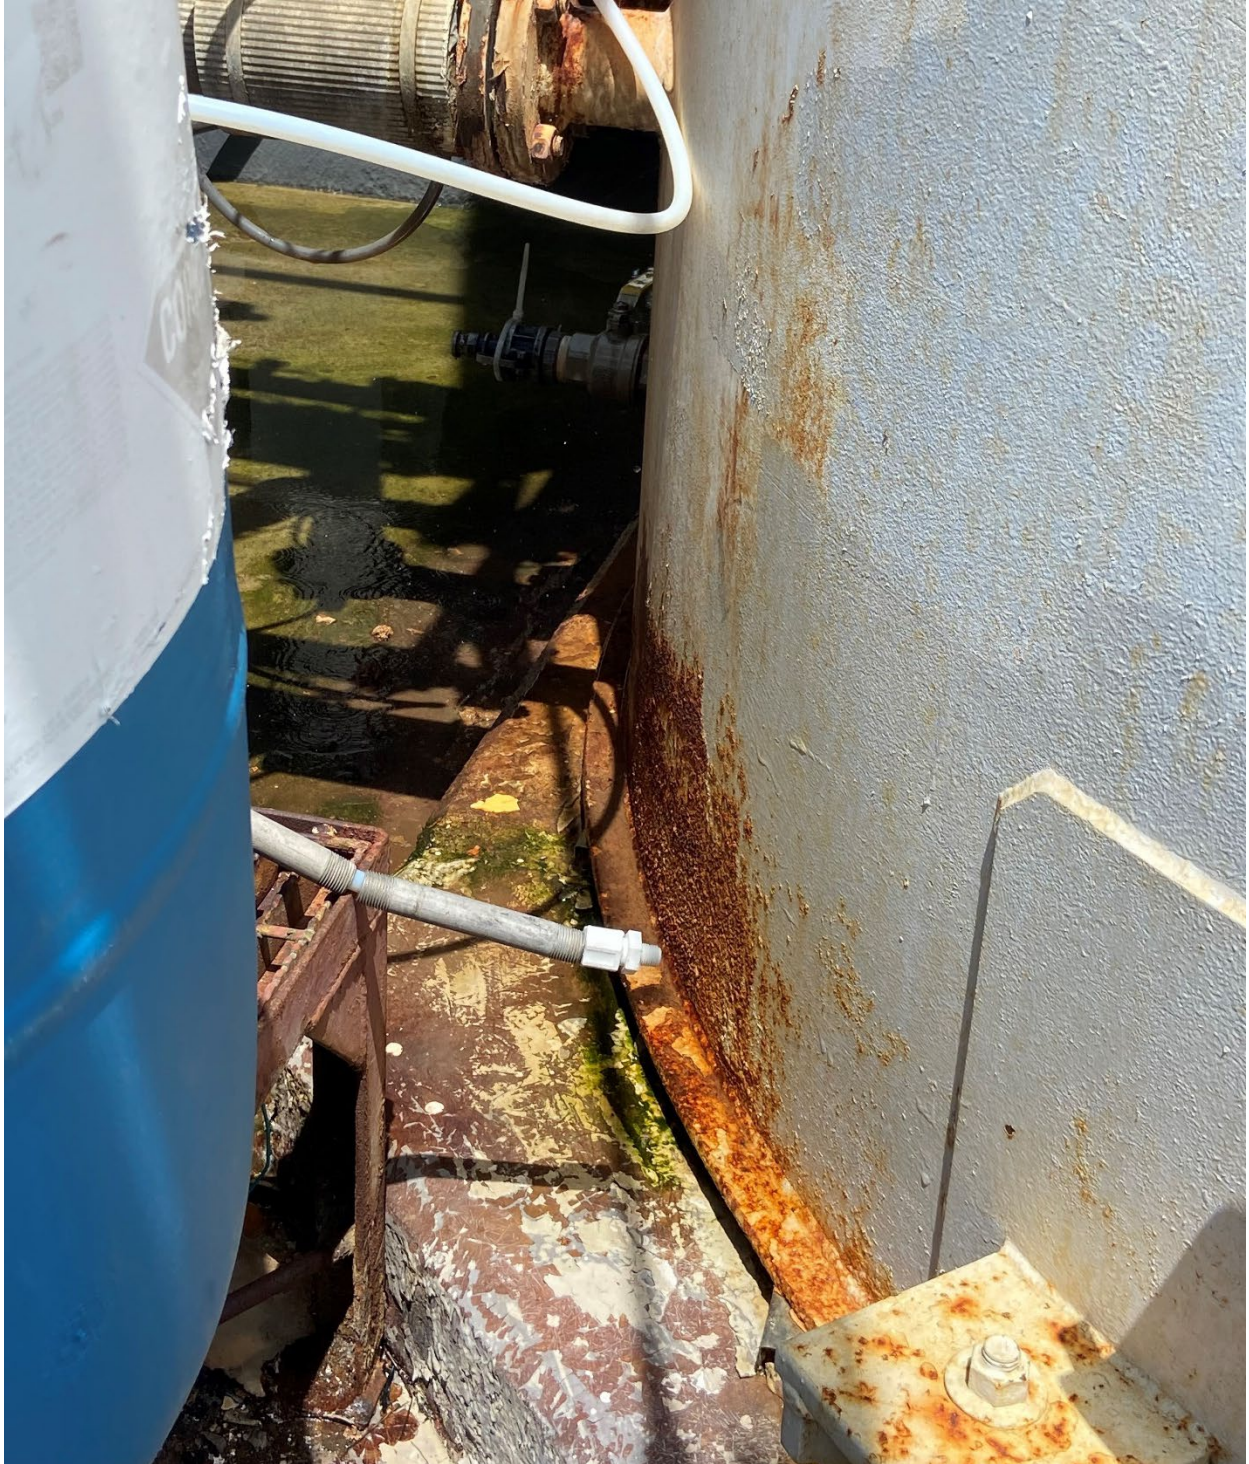
on the exterior, shown in Figures 3 & 4. There were cracks in the secondary containment surrounding the tank. There was one 55-gallon hazardous waste drum just outside the Column Pad that was corroded and did not contain labeling that indicated the hazards of the contents, shown in Figure 5.

At the time of the inspection, Tank 75, which contained non-hazardous wastewater, was missing a valve cap, and had corrosion on the exterior.

Figure 3: Corrosion and open valve on wastewater Tank 75 in the Column Pad.

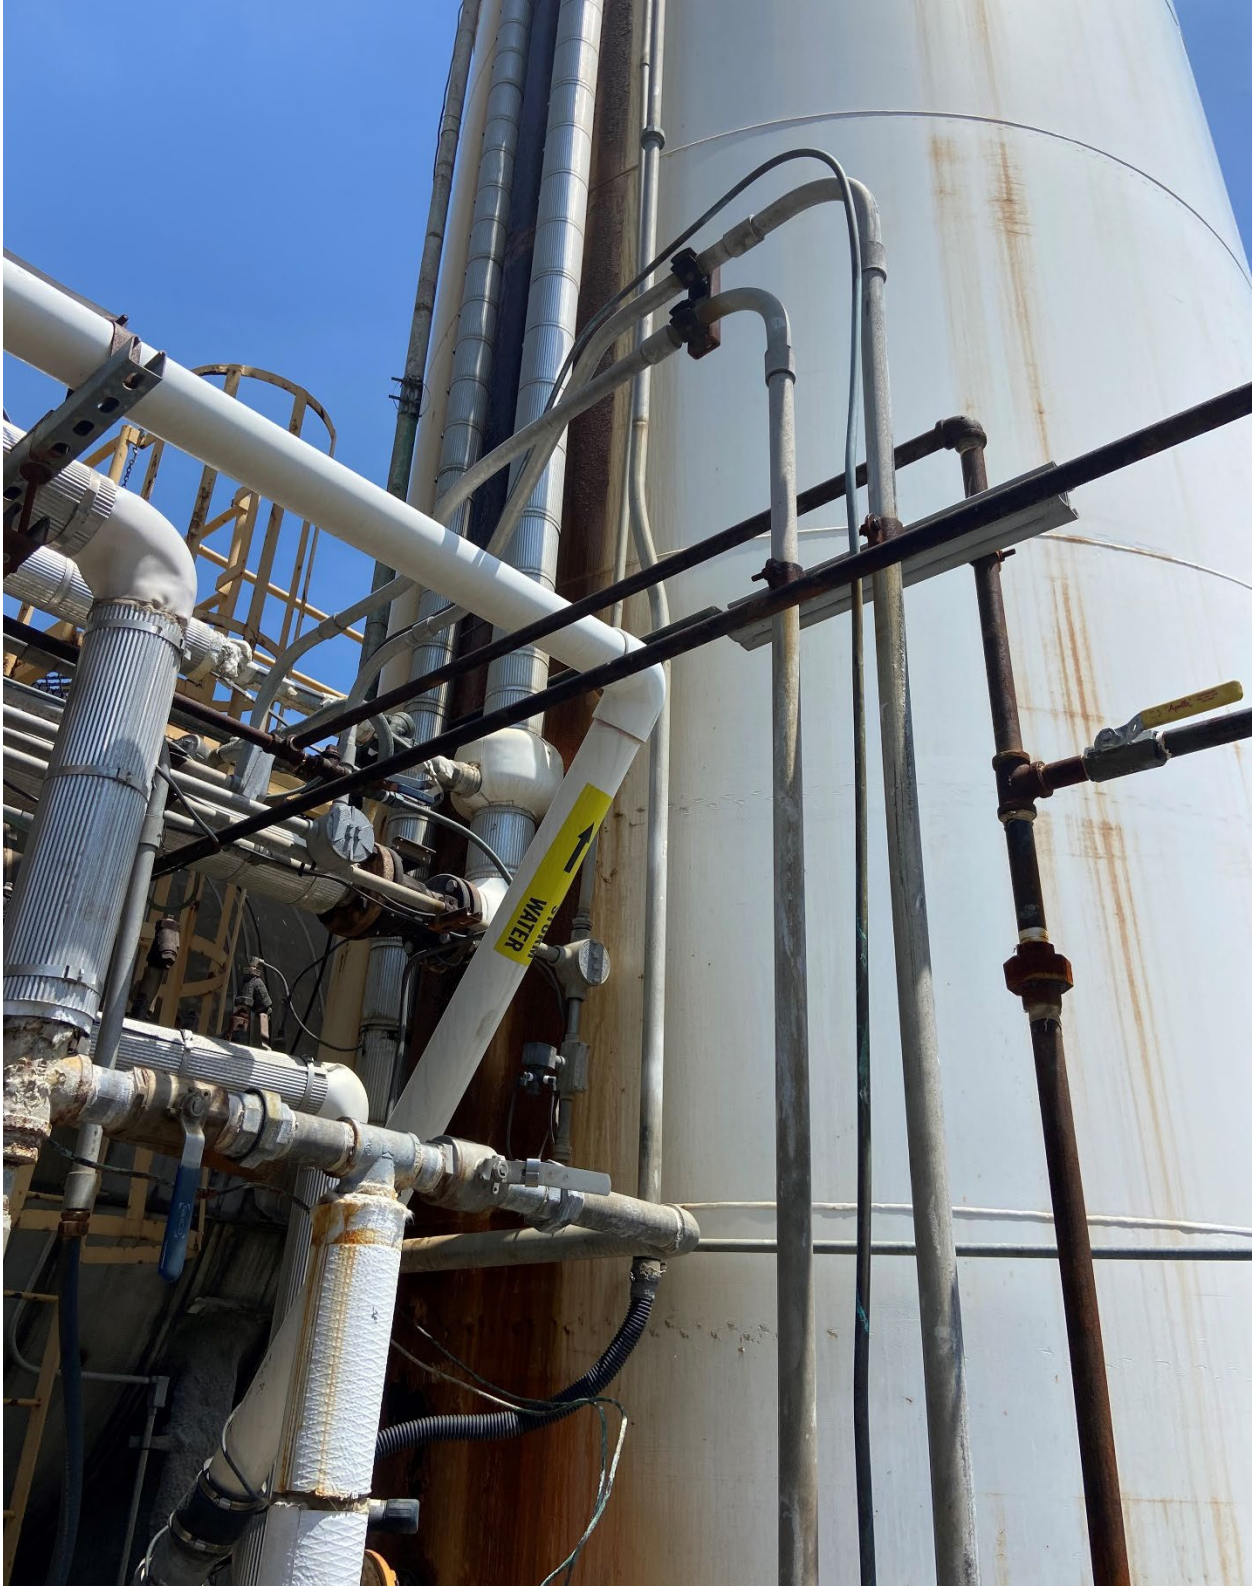
Figure 4: Corrosion along the side of Tank 75 in the Column Pad.

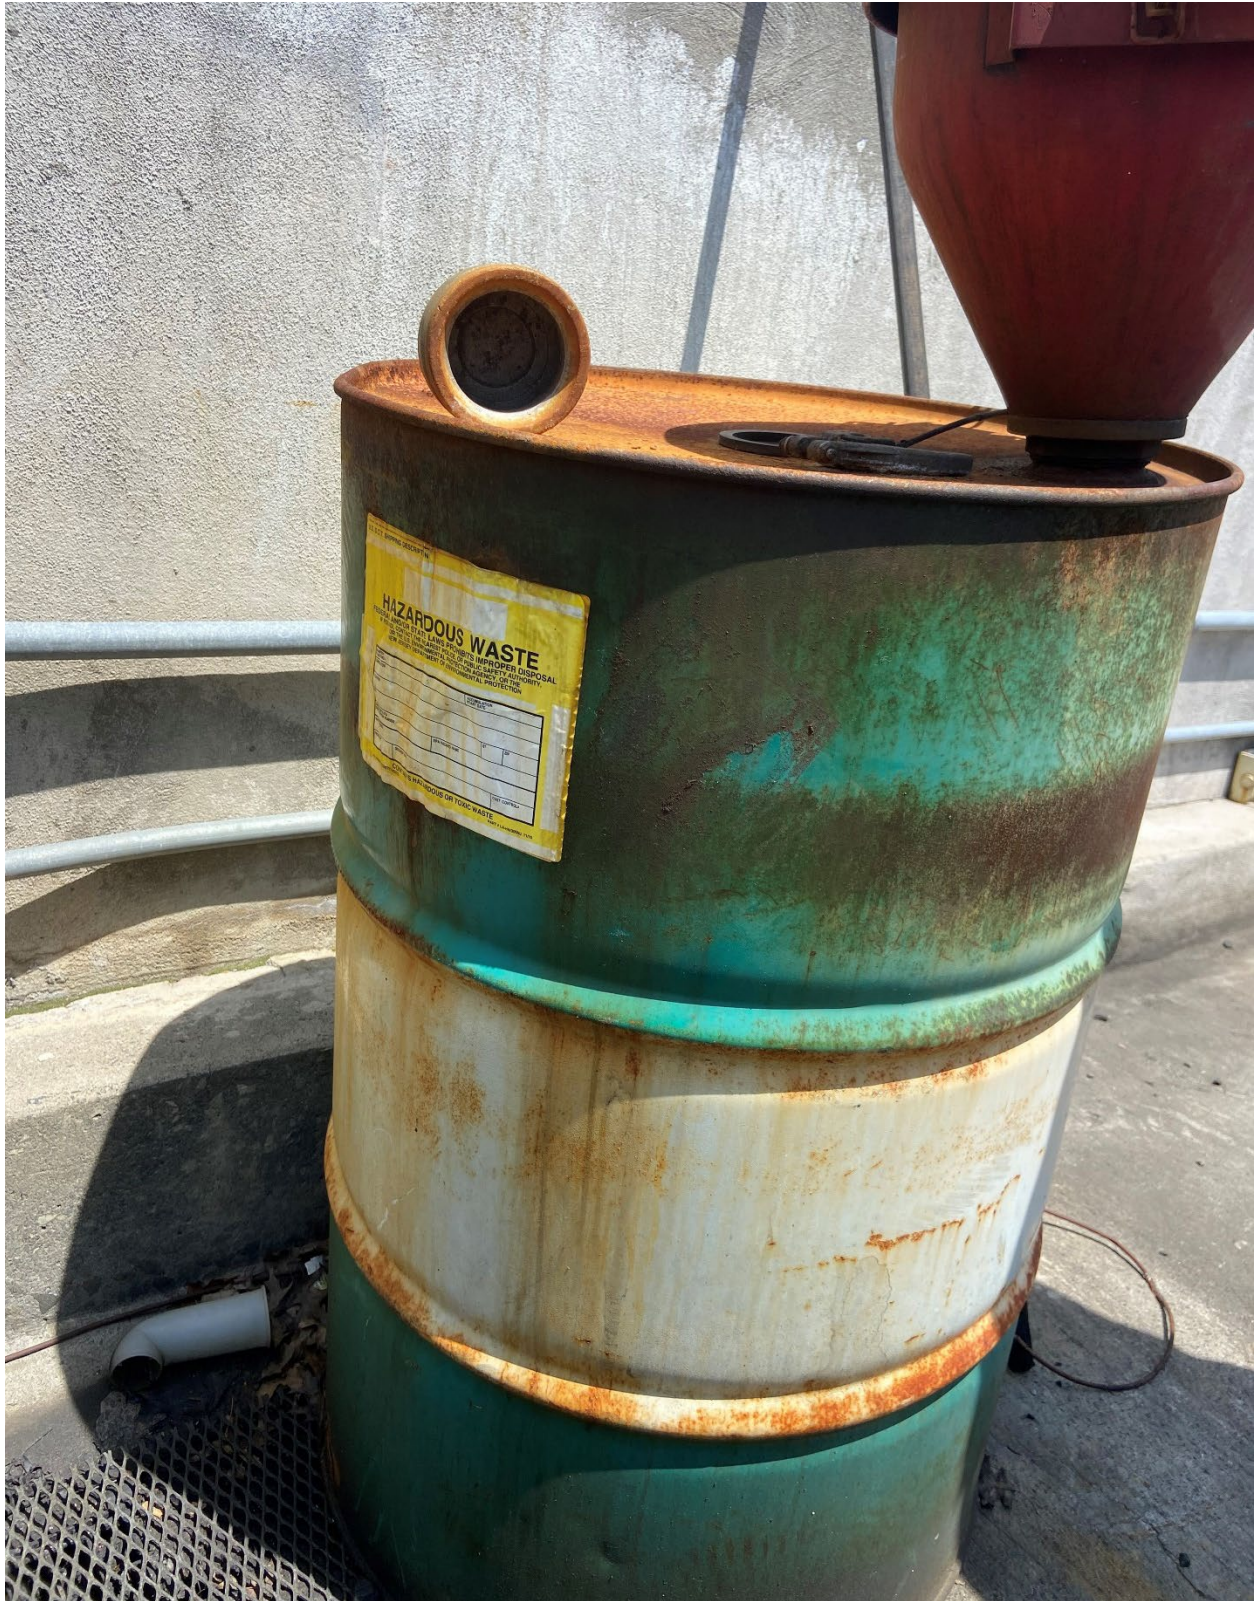
Figure 5: Corrosion and improper labeling on 55-gallon hazardous waste drum outside the Column Pad.

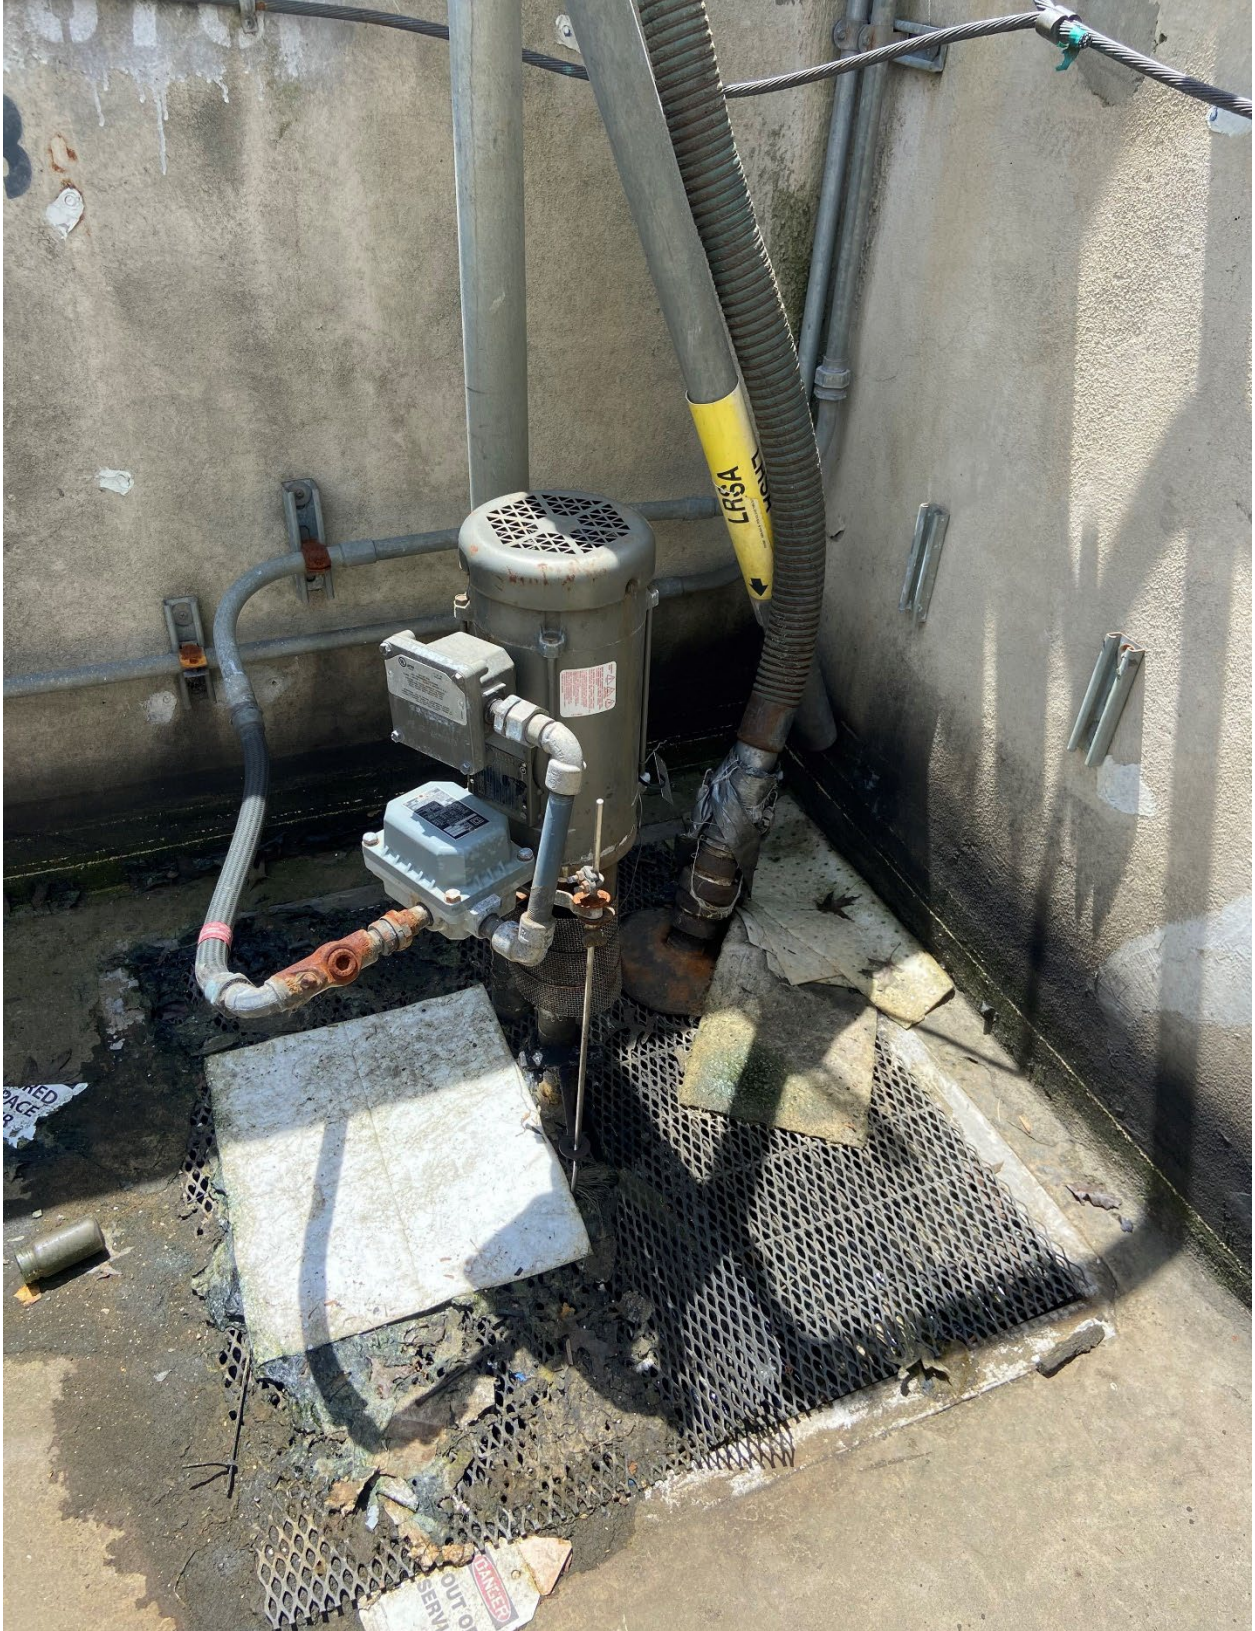
The floor of the tank farm had no secondary containment lining. EPA inspectors noticed soiled rags left on the floor, appearing to have been used to clean up a spill. There was also an unidentifiable open vial knocked over on the floor near the rags, shown in Figure 6. A 5-gallon hazardous waste satellite drum in the area was corroded and did not contain labeling that indicated the hazards of the contents, shown in Figure 7. Tank 4403 was pitting near the base, shown in Figure 8. There was also pitting on the floor under the staircase leading into the tank farm, shown in Figure 9.

- c. At the time of the inspection, in Tank Farm #4, soiled rags had been identified within the secondary containment on the ground, appearing to have been used to clean up a spill. There was also an unidentifiable open vial knocked over on the floor near the rags.

Figure 6: Soiled rags and open vial on its side on the floor inside Tank Farm #4.

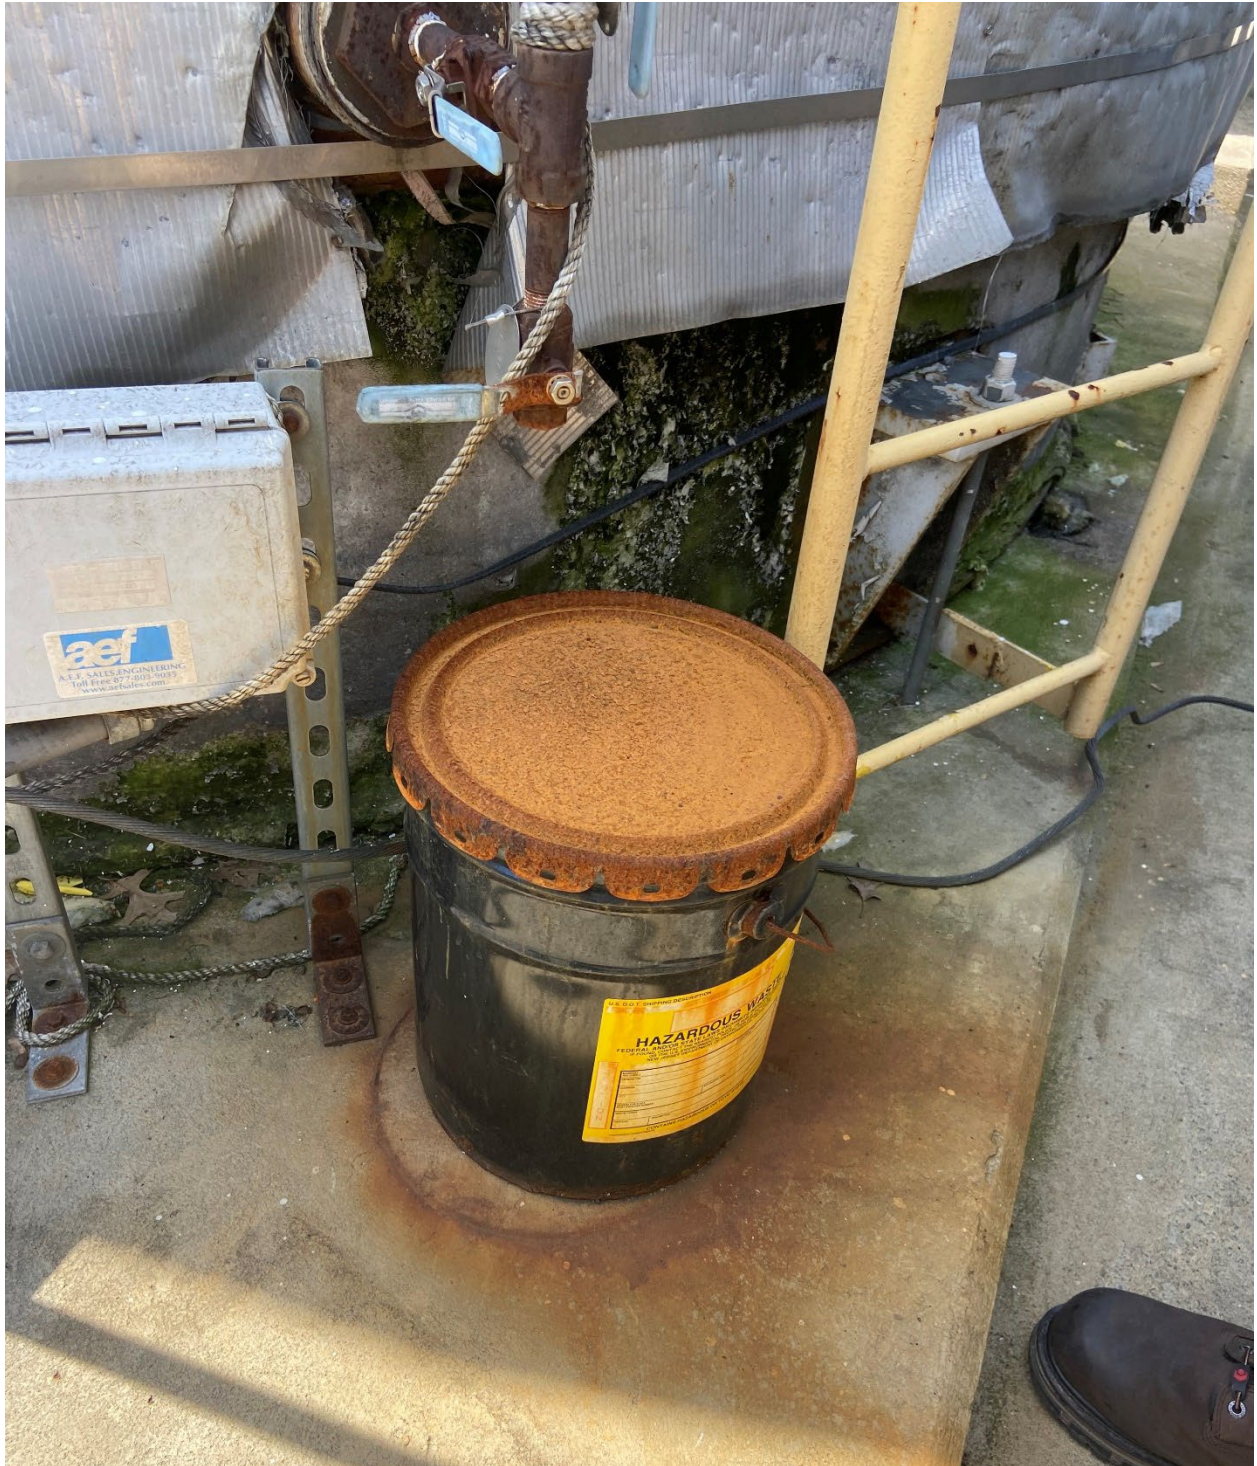
4. Pursuant to 40 C.F.R. § 262.15(a)(1), as incorporated by reference in N.J.A.C. 7:26G-6.1 (a) states that if a container holding hazardous waste is not in good condition, or if it begins to leak, the generator must immediately transfer the hazardous waste from this container to a container that is in good condition and does not leak, or immediately transfer and manage the waste in a central accumulation area operated in compliance with [§ 262.16\(b\)](#) or [§ 262.17\(a\)](#).
 - a. At the time of the inspection, there was one 55-gallon hazardous waste drum just outside the Column Pad that was corroded.
 - b. At the time of the inspection, one 5-gallon hazardous waste satellite drum in Tank Farm #4 was corroded.

Figure 7: Corroded 5-gallon satellite hazardous waste drum with improper labeling inside Tank Farm #4.

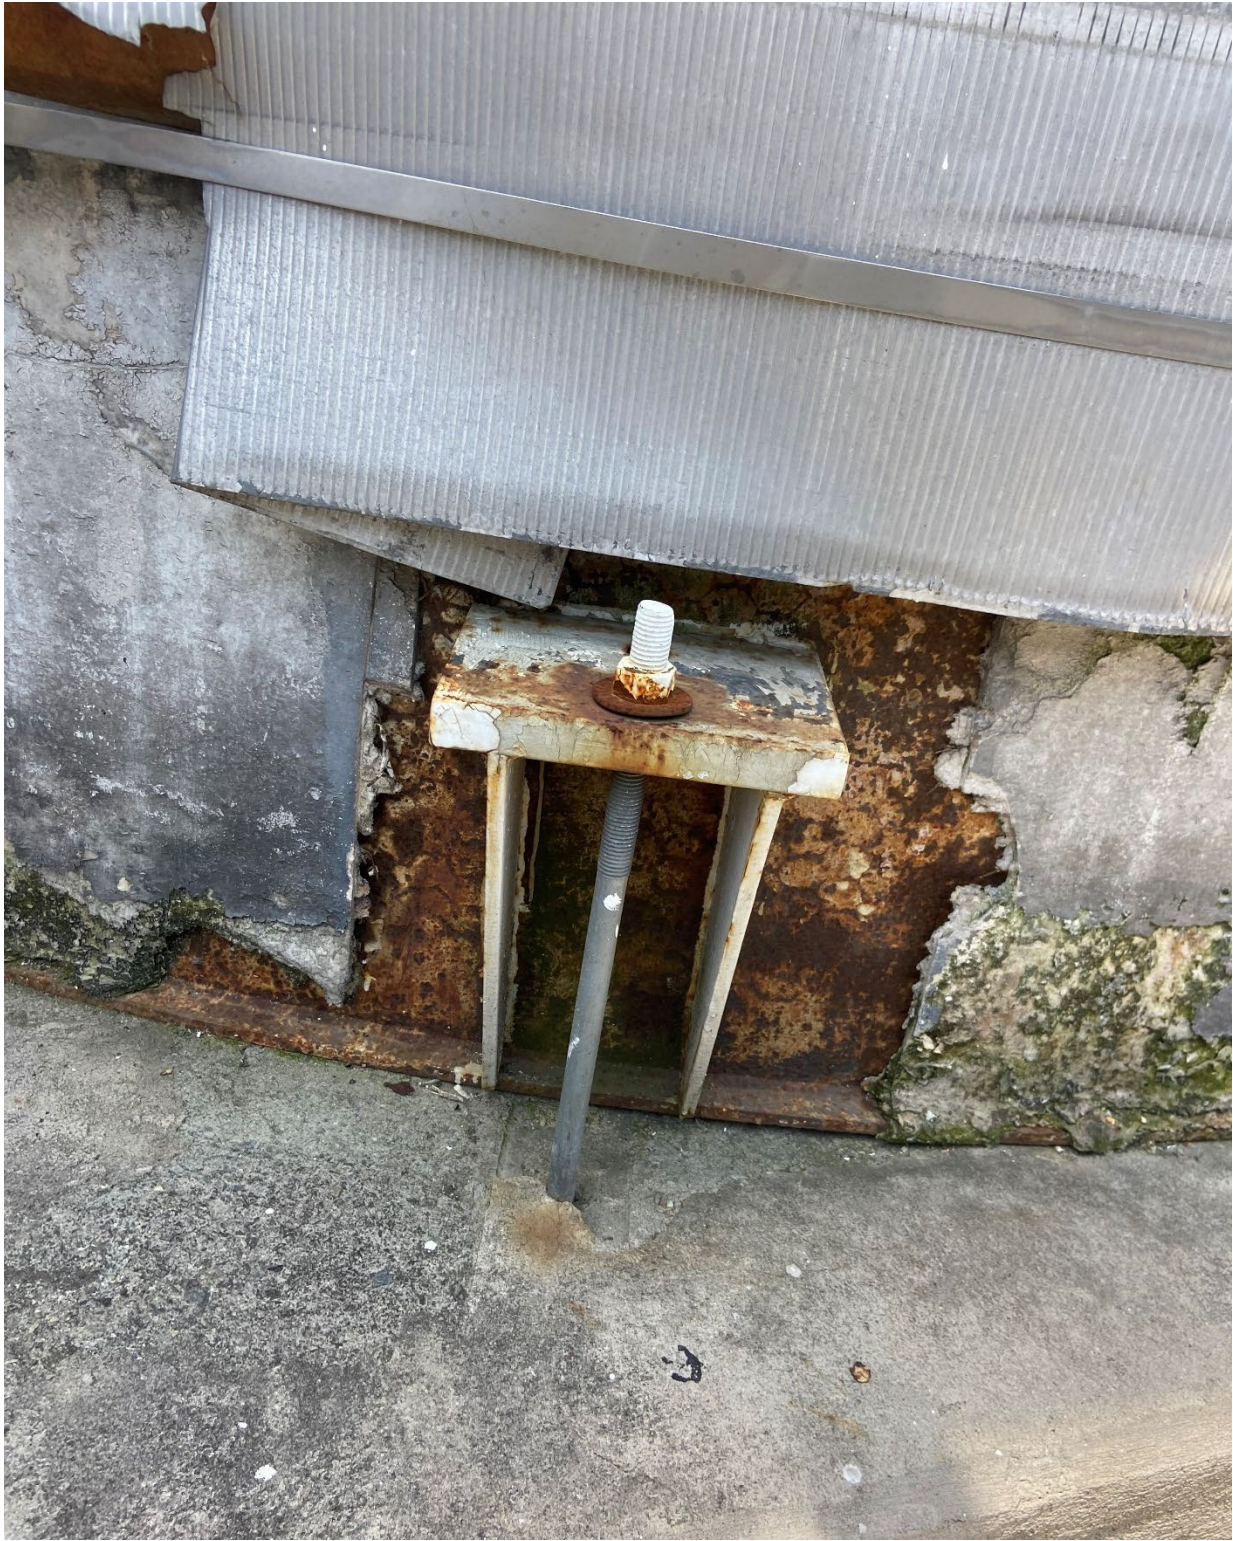
At the time of the inspection, Tank 4403 in Tank Farm #4 was pitting near the base.

Figure 8: Pitting at the base of Tank 4403 in Tank Farm #4.

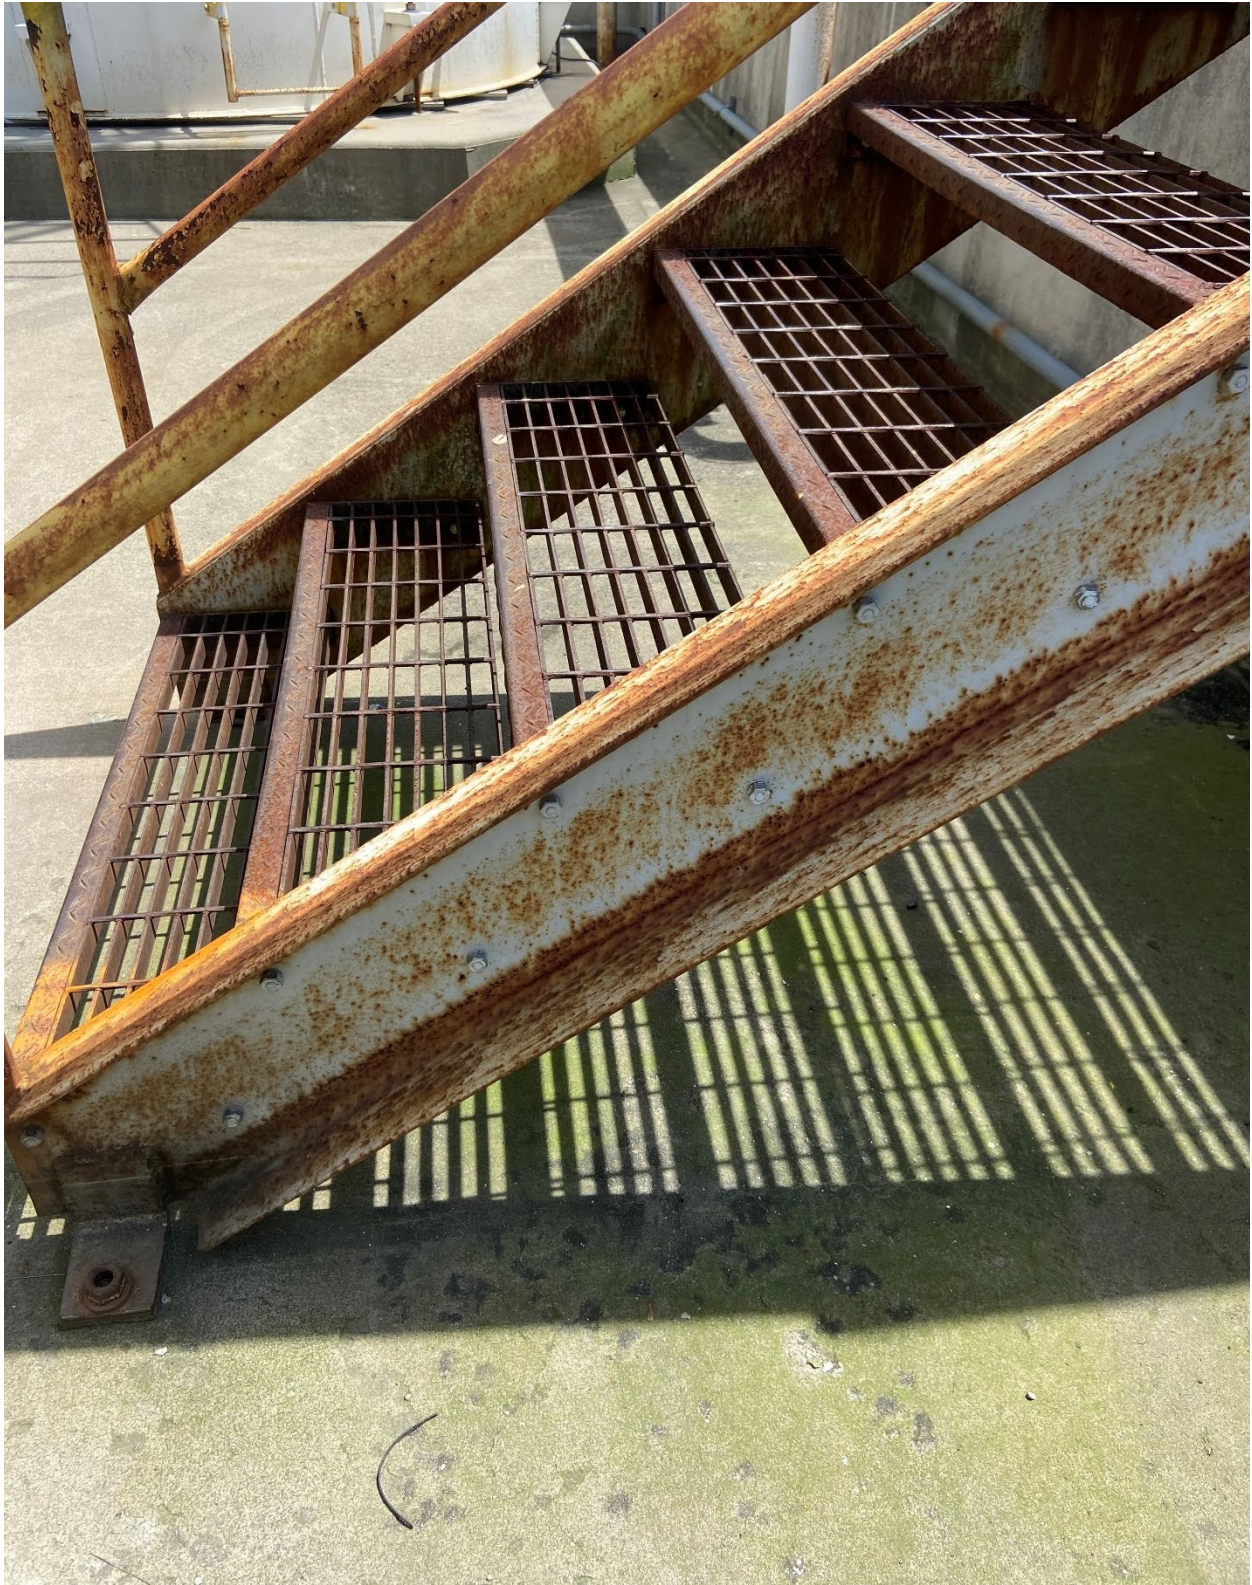
- a. At the time of the inspection, the secondary containment inside Tank Farm #2 (T201-T215) had several cracks and the previously applied epoxy liner had eroded in many locations.
- b. At the time of the inspection, the epoxy liner in the secondary containment inside Tank Farm #2 (T40 & T41) had eroded in many locations.
- c. At the time of the inspection, there were cracks in the secondary containment surrounding Tank 75 in the Column Pad.
- d. At the time of the inspection, the floor inside Tank Farm #4 had no secondary containment lining.
- e. At the time of the inspection, there was pitting in the secondary containment under the staircase leading into Tank Farm #4.

Figure 9: Pitting beneath the staircase leading into Tank Farm #4.
