## REGION 10 Enforcement Division

### INSPECTION REPORT

| <b>Company Name:</b> | Hilcorp North Slope, LLC | | |
| <b>Facility or Site Name:</b> | HILCORP NORTH SLOPE PRUDHOE BAY UNIT | | |

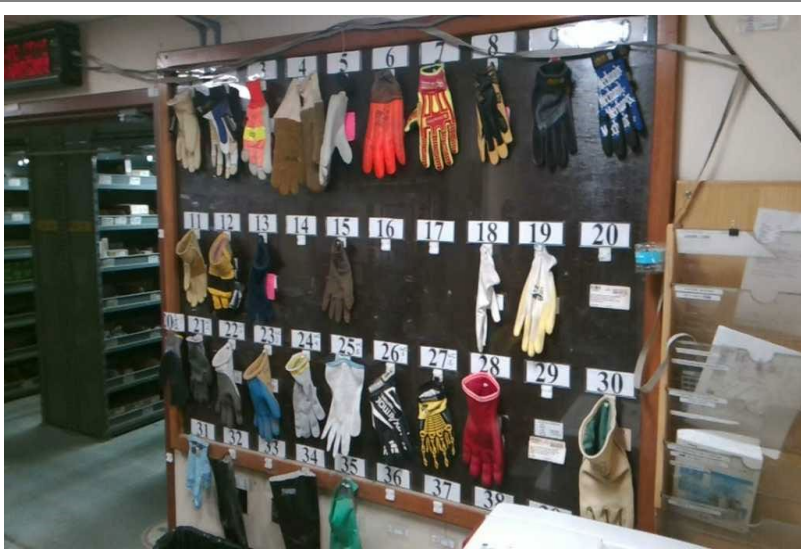
| <p>While at the C Pad Warehouse, I saw a board that was used to display the various work gloves that are issued to Hilcorp workers at the North Slope facility. At the time of the inspection, there were several styles of gloves that were leather and some that contained leather parts. According to Mr. Shannon there has been no waste determination made for the waste leather gloves that are generated when worn out or damaged.</p> | |

| According to Mr. Shannon, not waste determination has been made on waste leather gloves that are generated when damaged or worn out. | <b>Citations:</b> | <b>Sections:</b> |

| <div>[Title]</div> <div>06/17/2021 11:54 AM (AKT)</div> <div>Jon Jones</div> <div>C Pad Warehouse</div> <div>No CBI</div> <div>No PII</div> <div>A view of the various styles of gloves that are provided to Hilcorp employees and contractors at the Prudhoe Bay Unit.</div> | |

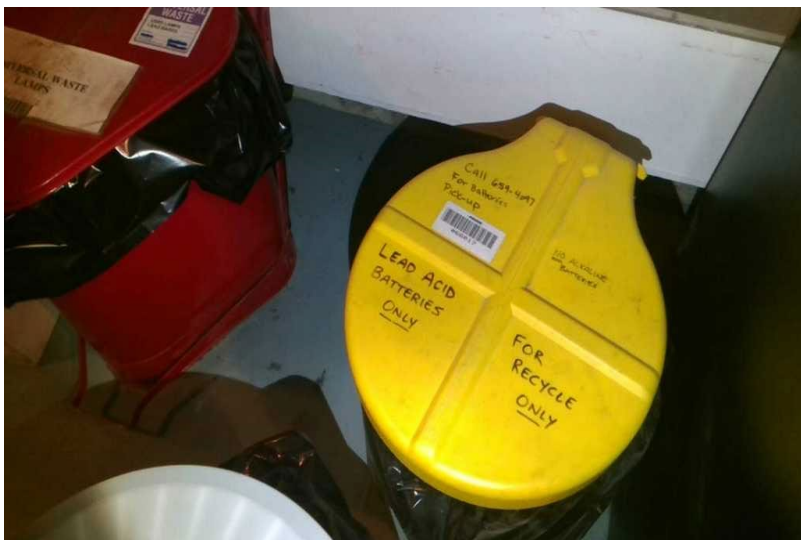
| <div>[Title]</div> <div>06/16/2021 11:28 AM (AKT)</div> <div>Jon Jones</div> <div>Central Power Station (CPS)/Hallway 128</div> <div>No CBI</div> <div>No PII</div> <div>View of a yellow poly step-can that, according to the labeling, held lead acid batteries.</div> | |

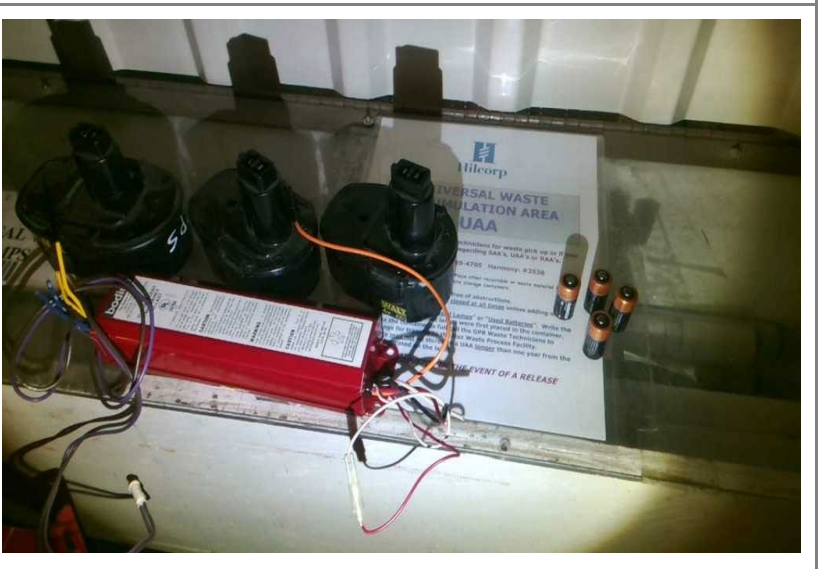
| View looking into the same yellow poly step-can, showing that the container held three NiCad batteries, a fluorescent light ballast that contained a NiCad battery, and four small lithium batteries. | |

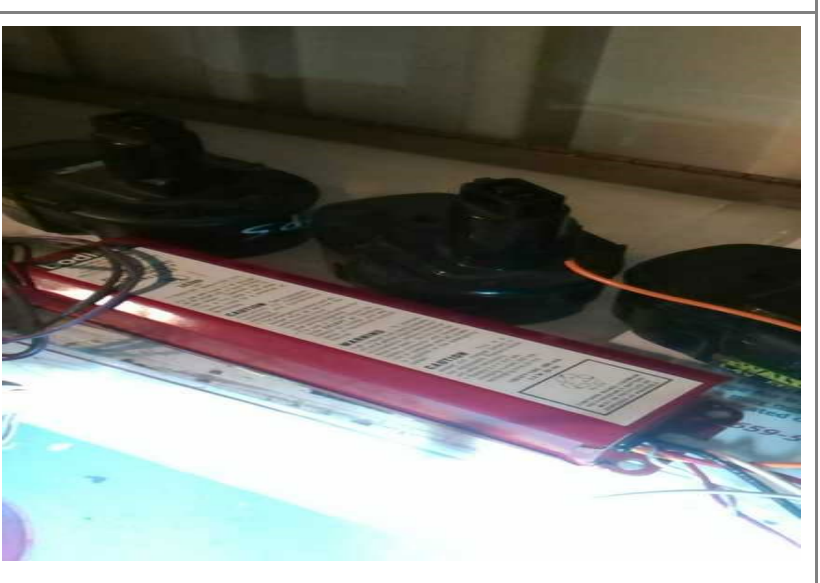
| View of the NiCad and lithium batteries after Mr. Shannon removed them from the yellow step-can. | |

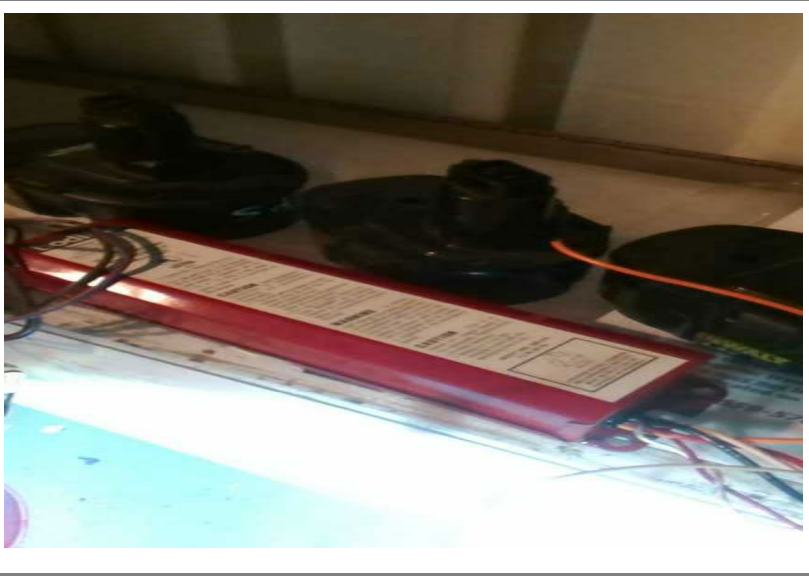
| <p>[Title]</p> <p>06/16/2021 11:33 AM (AKT)</p> <p>Jon Jones</p> <p>Central Power Station (CPS)/Hallway 128</p> <p>No CBI</p> <p>No PII</p> <p>Another view of NiCad batteries that were not labeled as UW.</p> | |

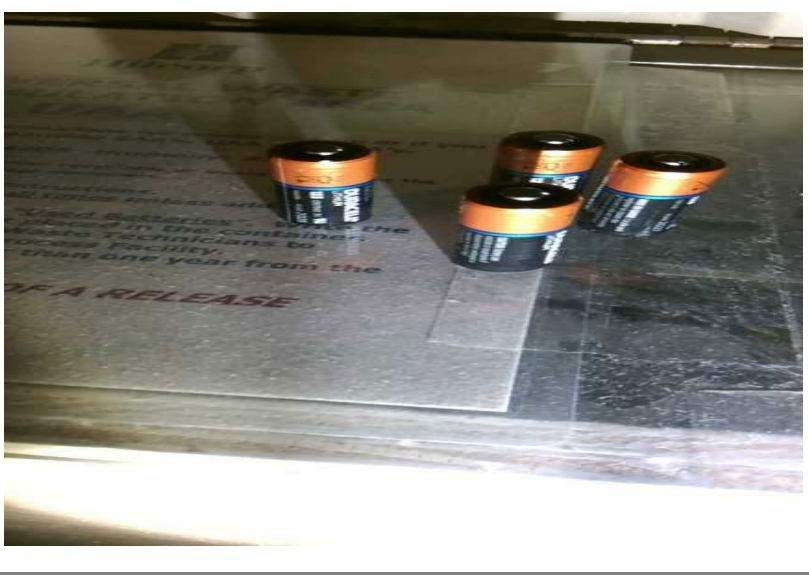
| <p>[Title]</p> <p>06/16/2021 11:34 AM (AKT)</p> <p>Jon Jones</p> <p>Central Power Station (CPS)/Hallway 128</p> <p>No CBI</p> <p>No PII</p> <p>View of lithium batteries that were not labeled as UW.</p> | |

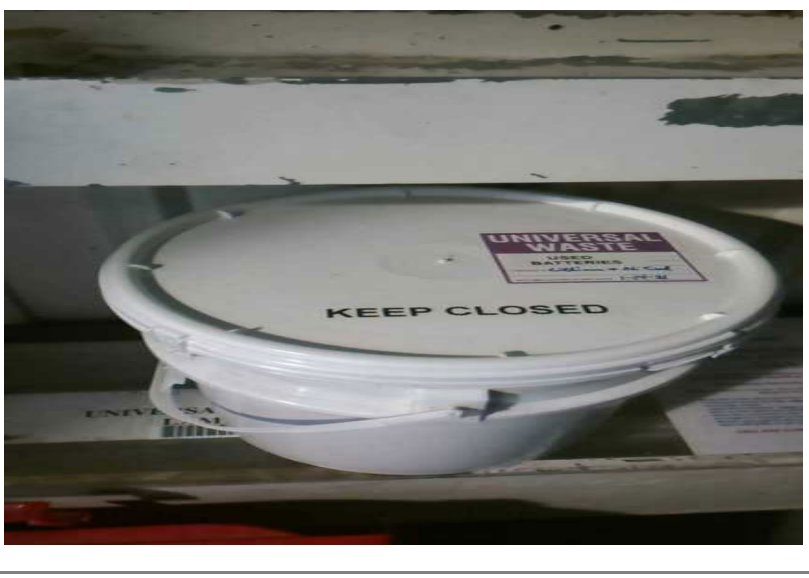
| <p>[Title]</p> <p>06/16/2021 11:45 AM (AKT)</p> <p>Jon Jones</p> <p>Central Power Station (CPS)/Hallway 128</p> <p>No CBI</p> <p>No PII</p> <p>View of the UW container that Mr. Shannon used to repackage the NiCad and lithium batteries during the inspection.</p> | |

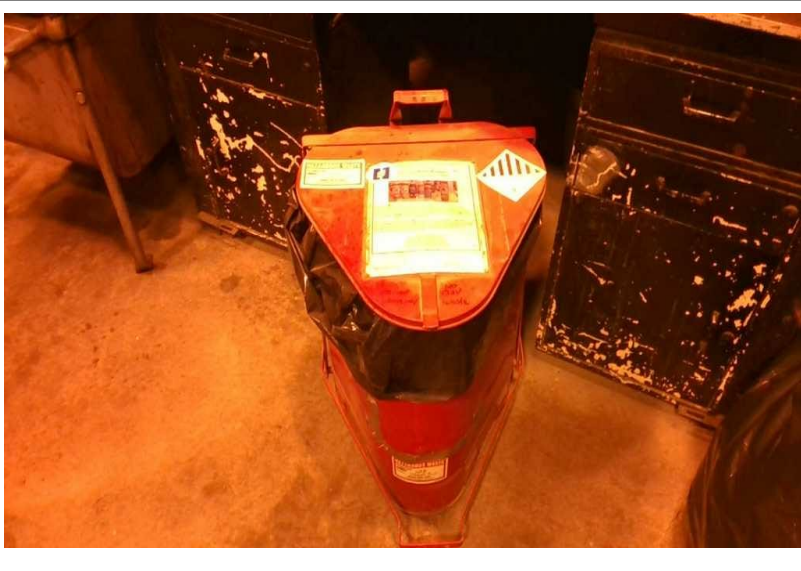
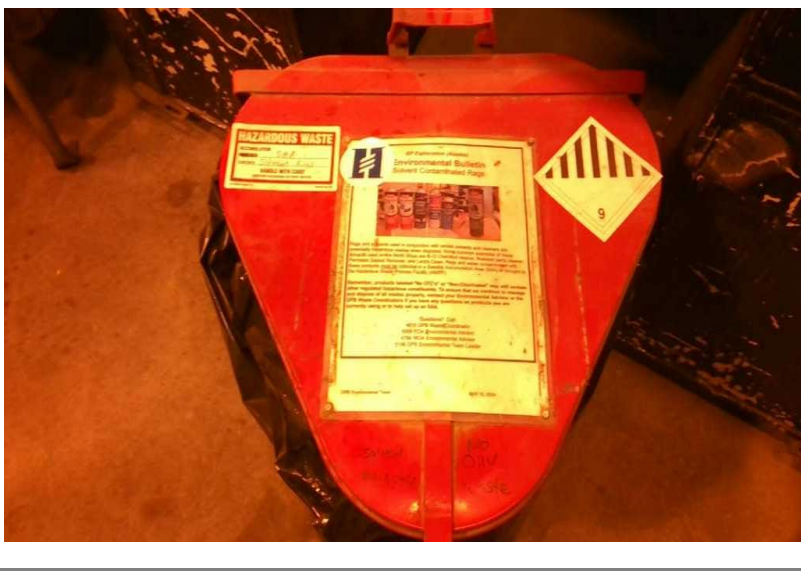
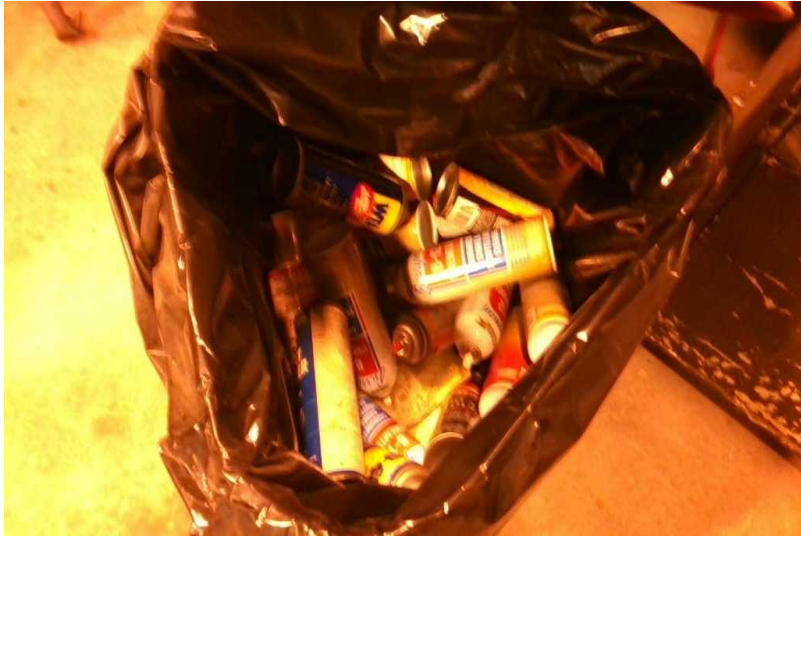
While inspecting the maintenance mod I saw a red step-can that was labeled, "Hazardous Waste - Solvent rags." The step-can was being utilized as a SAA container for solvent rags. At the time of the inspection, the container lid was not making a complete seal with the container when closed. This is a common problem when using step-cans. When we opened the lid to see what was inside, I saw that it contained waste aerosols. The hazard indicator was a Department of Transportation (DOT) Class 9 N.O.S. label for solvent rags instead of a Class 3 ignitable hazard indicator. Upon further inspection I saw a few waste rags inside the container and approximately 20- 25 waste aerosol cans.

| <b>Building:</b> Gathering Center 3 (GC3) | <b>Area:</b> Skid 7 | <b>Sub-area:</b> |
|---|---|---|
| <p>There was step-can being utilized as a SAA container for waste solvent rags that was not closed. At the time of the inspection, the container lid was not making a complete seal with the container when closed. When we opened the lid to see what was inside, I saw that it contained waste aerosols. The hazard indicator was a Class 9 label for solvent rags instead of a Class 3 ignitable hazard indicator. Upon further inspection I saw a few waste rags inside the container and approximately 20- 25 waste aerosol cans.</p> | <b>Citations:</b> | <b>Sections:</b> |

| <p>[Title]</p> <p>06/16/2021 10:57 AM (AKT)</p> <p>Jon Jones</p> <p>Gathering Center 3 (GC3)/Skid 7</p> <p>No CBI</p> <p>No PII</p> <p>View of a red SAA step-can that was labeled, "Hazardous Waste - Solvent rags." The container lid was not making a complete seal with the container when closed.</p> | |
| <p>[Title]</p> <p>06/16/2021 10:58 AM (AKT)</p> <p>Jon Jones</p> <p>Gathering Center 3 (GC3)/Skid 7</p> <p>No CBI</p> <p>No PII</p> <p>Close-up view of the same SAA container seen in the previous photo.</p> | |
| <p>[Title]</p> <p>06/16/2021 10:58 AM (AKT)</p> <p>Jon Jones</p> <p>Gathering Center 3 (GC3)/Skid 7</p> <p>No CBI</p> <p>No PII</p> <p>Another view of the same SAA container seen in the previous two photos. After being opened, I saw that it contained waste aerosols. The hazard indicator was a Class 9 label for solvent rags instead of a Class 3 ignitable hazard indicator. Upon further inspection I saw a few waste rags inside the container and approximately 20- 25 waste aerosol cans.</p> | |

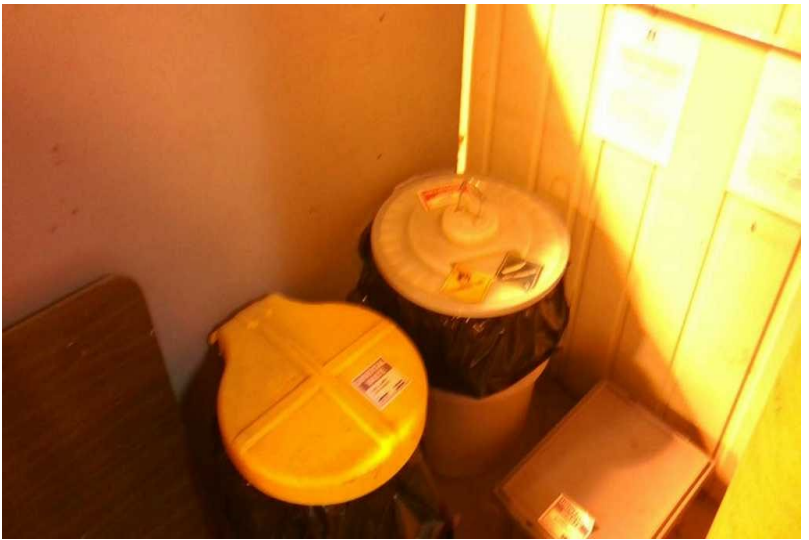
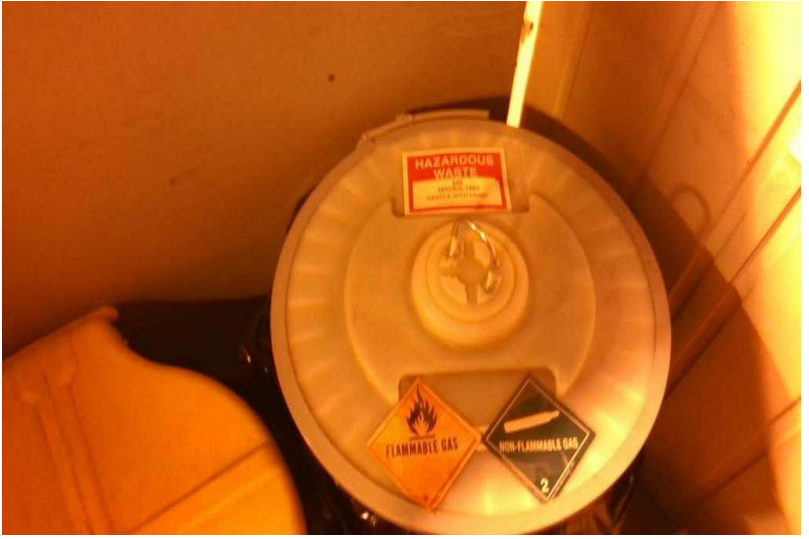
| <p>[Title]</p> <p>06/16/2021 11:05 AM (AKT)</p> <p>Jon Jones</p> <p>Gathering Center 3 (GC3)/Skid 7</p> <p>No CBI</p> <p>No PII</p> <p>Mr. Shannon removed the waste aerosol cans from the waste solvent rags SAA and placed them inside of the waste aerosol SAA, that was located just upstairs, during the inspection. This is a view of that waste aerosol SAA seen here to the right of the yellow step-can.</p> | |
| <p>[Title]</p> <p>06/16/2021 11:05 AM (AKT)</p> <p>Jon Jones</p> <p>Gathering Center 3 (GC3)/Skid 7</p> <p>No CBI</p> <p>No PII</p> <p>Close-up view of the waste aerosol SAA seen in the previous photo.</p> | |

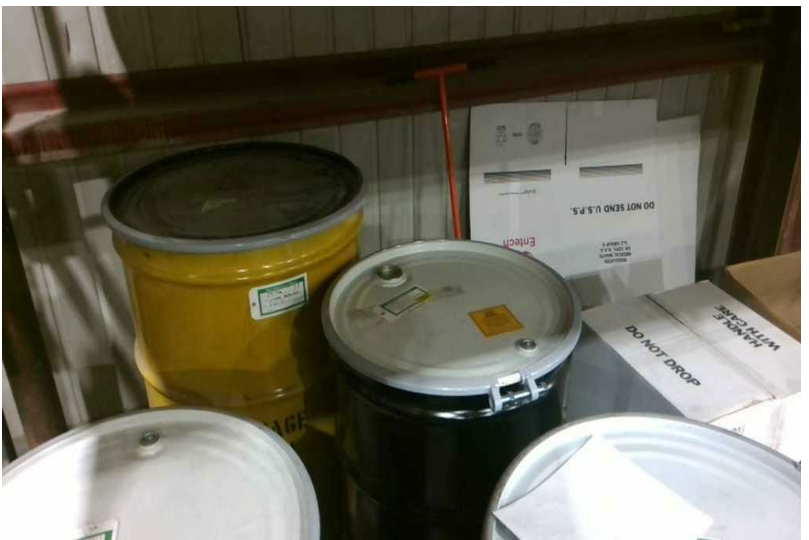
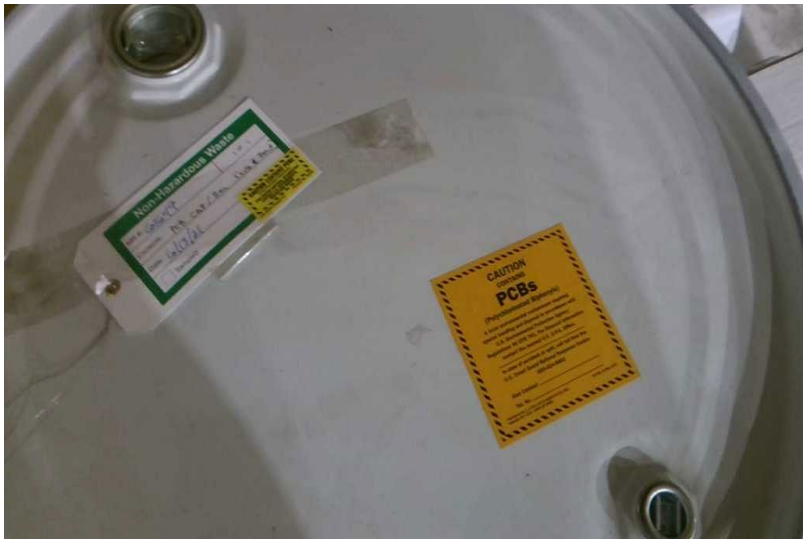
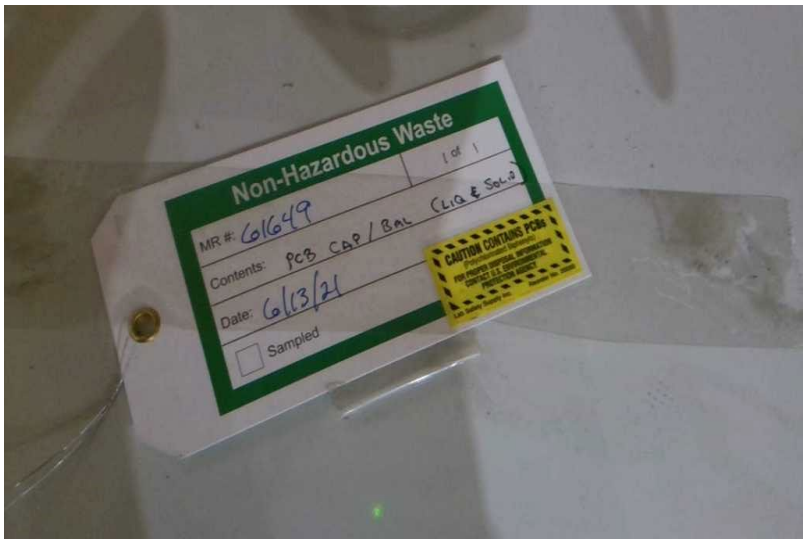
While inspecting the HWPf, I saw a 55-gallon container located in the area on the floor adjacent to storage area CS-5 and just beneath Pallet 08. The container had a label on it that was marked with the words "Non-Hazardous Waste." The label had an additional description of, "PCB CAP/BAL (LIQ & SOLID), it was dated 6/13/21 and the MR# 61649, and it was also marked with the words, "Caution Contains PCBs." Another label

| <p>[Title]</p> <p>06/16/2021 09:06 AM (AKT)</p> <p>Jon Jones</p> <p>Hazardous Waste Process Facility (HWPF)</p> <p>No CBI</p> <p>No PII</p> <p>View of black 55-gallon container of PCB ballasts adjacent to CS-5 and just beneath pallet 08.</p> | |

| <p>[Title]</p> <p>06/16/2021 09:07 AM (AKT)</p> <p>Jon Jones</p> <p>Hazardous Waste Process Facility (HWPF)</p> <p>No CBI</p> <p>No PII</p> <p>Close-up view of the same black 55-gallon container of PCB ballasts seen in the previous photo.</p> | |
| <p>[Title]</p> <p>06/16/2021 09:07 AM (AKT)</p> <p>Jon Jones</p> <p>Hazardous Waste Process Facility (HWPF)</p> <p>No CBI</p> <p>No PII</p> <p>Close-up view of the labeling on the 55-gallon container of PCB ballasts.</p> | |

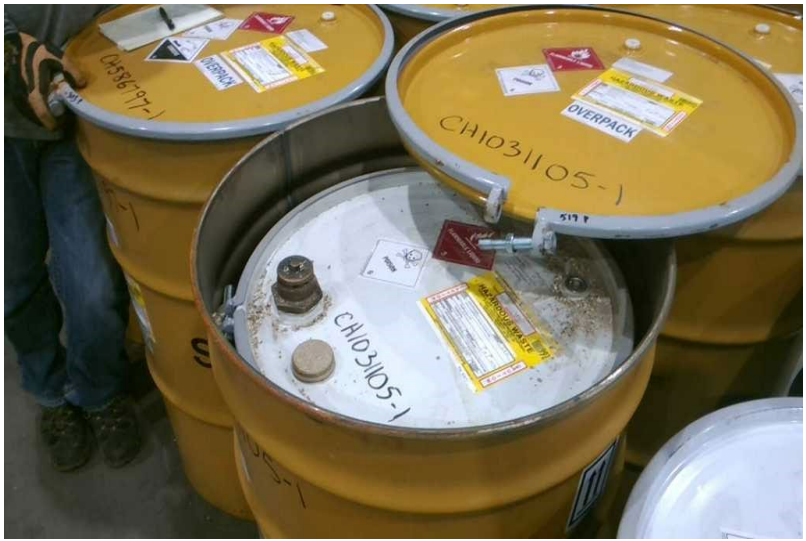
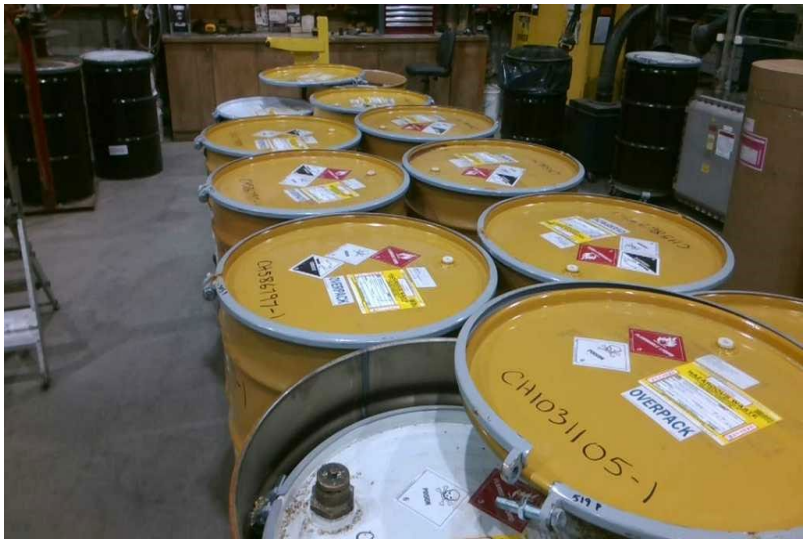
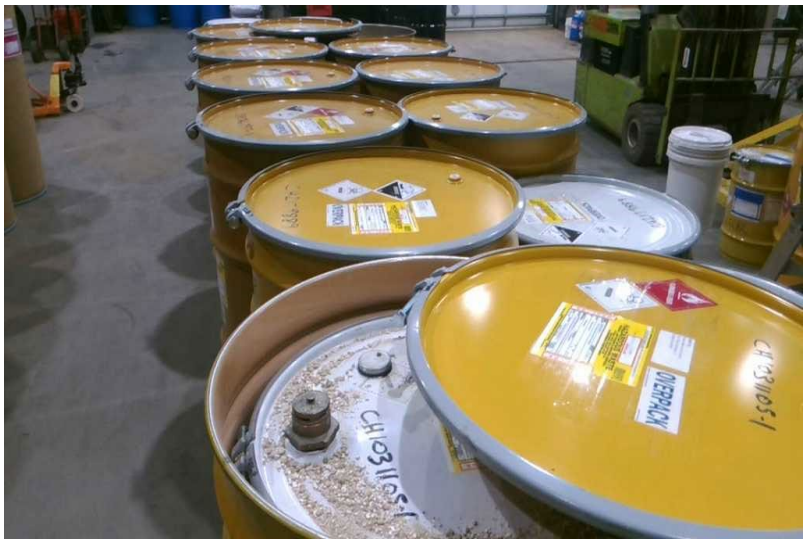
At the time of the inspection, while in the HWPF, I saw an 85-gallon overpack drum with a drum ring that was not fully closed. According to the labeling on the overpack, it held "PAINT AND THINNERS/FUEL W/EMPTY AEROSOLS." According to Mr. Laskey, they overpack all of their hazardous waste liquids and this container held aerosol can residues. He said that the containers holding the aerosol can residue have vented bung caps installed to relieve any pressure. He said that just prior to being shipped, the overpack lids are closed with a lid that has a plastic bung installed so that, if needed, the pressure can be relieved by the transporter while the container is in transit. There were two of these overpacks that contained the same waste and had these venting valves.

| <p>[Title]</p> <p>06/16/2021 09:37 AM (AKT)</p> <p>Jon Jones</p> <p>Hazardous Waste Process Facility (HWPF)</p> <p>No CBI</p> <p>No PII</p> <p>View of vented, overpacked container of waste aerosol residue in storage at the HWPF.</p> | |

| <p>[Title]</p> <p>06/16/2021 09:37 AM (AKT)</p> <p>Jon Jones</p> <p>Hazardous Waste Process Facility (HWPF)</p> <p>No CBI</p> <p>No PII</p> <p>View of a second vented container of the same waste aerosol residue, seen here at the top of the photo.</p> | |
| <p>[Title]</p> <p>06/16/2021 09:38 AM (AKT)</p> <p>Jon Jones</p> <p>Hazardous Waste Process Facility (HWPF)</p> <p>No CBI</p> <p>No PII</p> <p>Close-up view of the same container seen in the previous photo.</p> | |

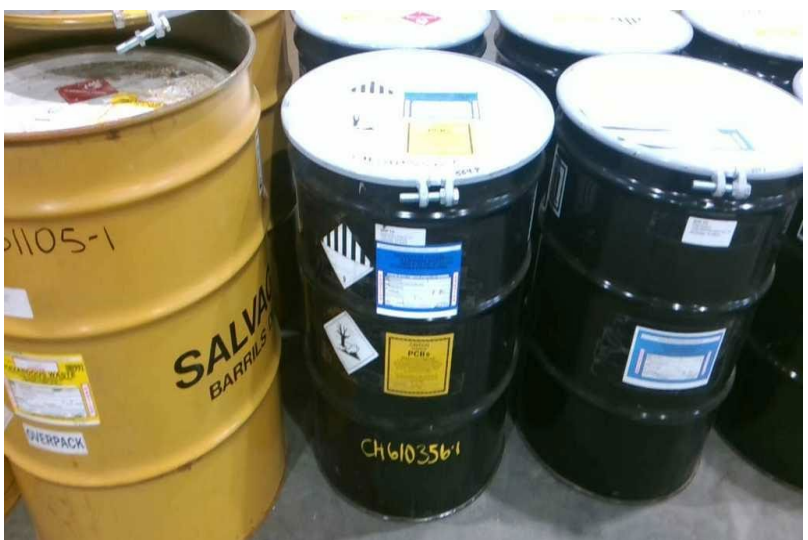
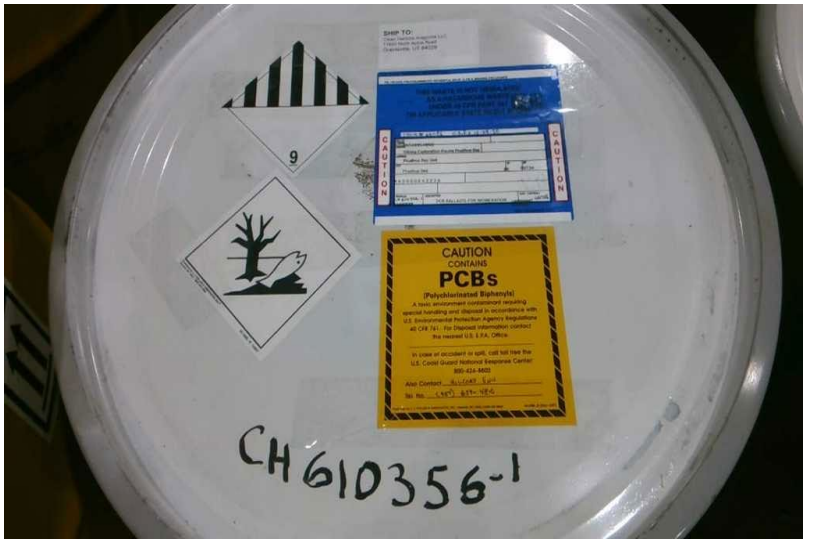
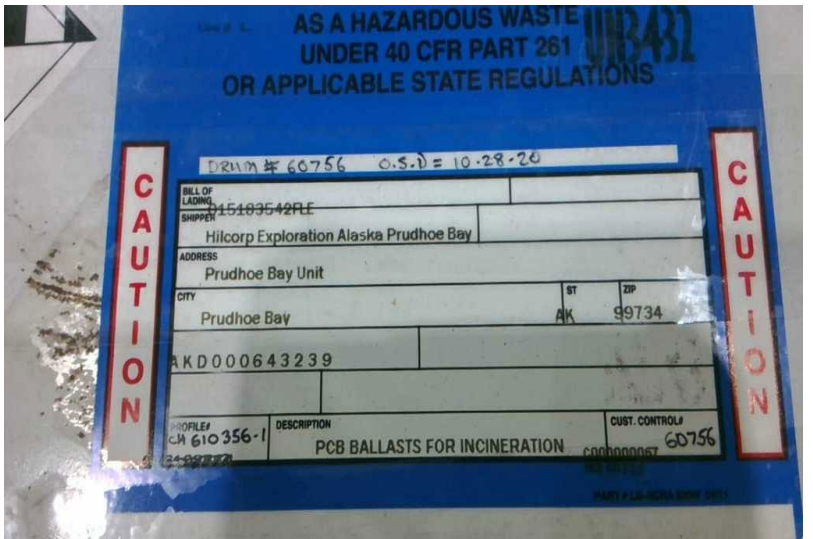
At the time of the inspection, I observed a second container that held PCB ballasts for incineration.

| <p>[Title]</p> <p>06/16/2021 09:42 AM (AKT)</p> <p>Jon Jones</p> <p>Hazardous Waste Process Facility (HWPF)</p> <p>No CBI</p> <p>No PII</p> <p>View of another container that held PCB ballasts for incineration that was located in the HWPF.</p> | |

| <p>[Title]</p> <p>06/16/2021 09:42 AM (AKT)</p> <p>Jon Jones</p> <p>Hazardous Waste Process Facility (HWPF)</p> <p>No CBI</p> <p>No PII</p> <p>View of the labeling on top of the PCB container, seen in the previous photo.</p> | <p>The image shows the top of a white cylindrical container. It features a diamond-shaped hazard label with a tree and a bird, a yellow label with 'CAUTION CONTAINS PCBs' and 'Polychlorinated Biphenyls', and a blue label with 'AS A HAZARDOUS WASTE UNDER 40 CFR PART 261 OR APPLICABLE STATE REGULATIONS'. Handwritten text 'CH 610356-1' is visible on the lid.</p> |
| <p>[Title]</p> <p>06/16/2021 09:42 AM (AKT)</p> <p>Jon Jones</p> <p>Hazardous Waste Process Facility (HWPF)</p> <p>No CBI</p> <p>No PII</p> <p>Close-up view of the labeling on top of the PCB container, seen in the previous photo.</p> | <p>A close-up of the blue hazardous waste label. It includes the text 'AS A HAZARDOUS WASTE UNDER 40 CFR PART 261 OR APPLICABLE STATE REGULATIONS'. The label contains fields for 'BILL OF LADING', 'SHIPPER', 'ADDRESS', 'CITY', 'ST', 'ZIP', 'AKD000643239', 'DESCRIPTION', and 'CUST. CONTROL#'. The description is 'PCB BALLASTS FOR INCINERATION' and the control number is '60756'.</p> |

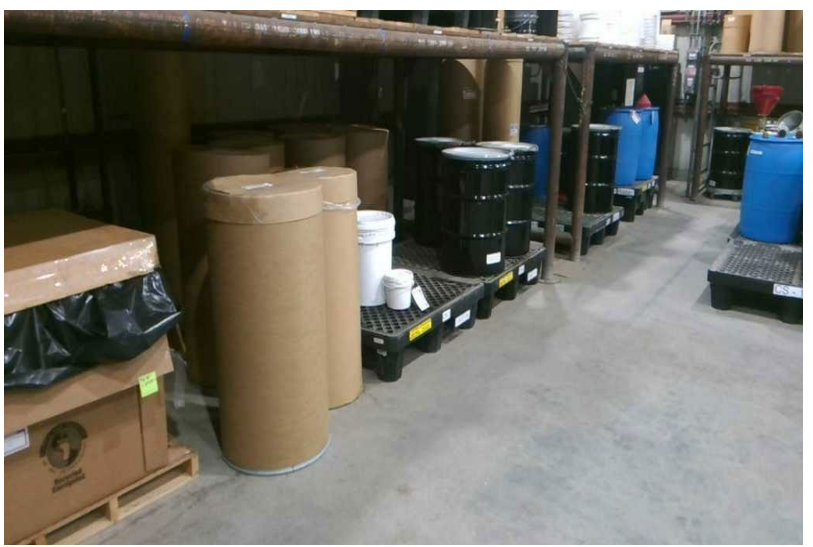
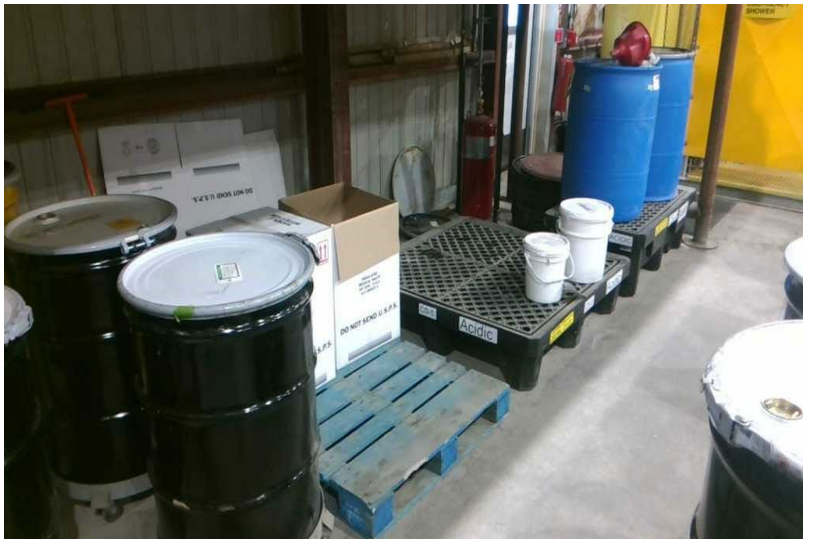
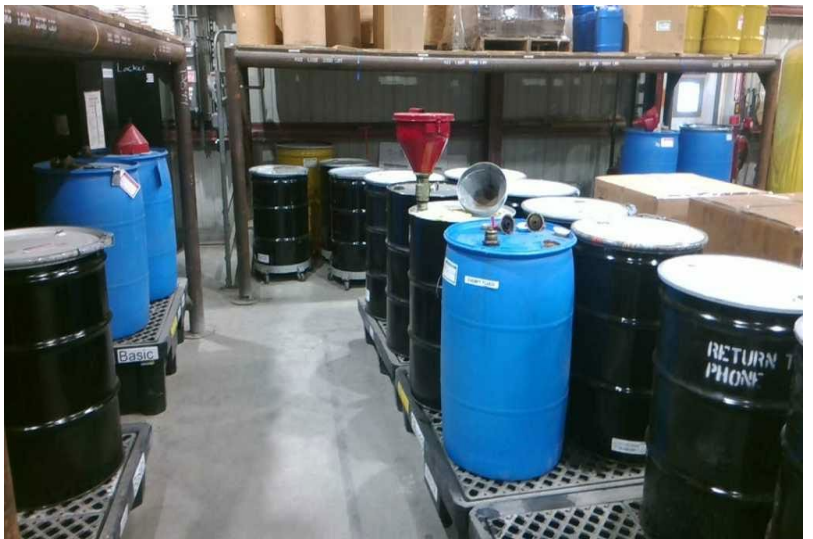
While in the HWPF I observed that the facility was now using spill pallets as secondary containment since removal of the large white storage bins.

| <p>[Title]</p> <p>06/16/2021 09:47 AM (AKT)</p> <p>Jon Jones</p> <p>Hazardous Waste Process Facility (HWPF)</p> <p>No CBI</p> <p>No PII</p> <p>View of the secondary containment spill pallets being used in place of the large white storage bins that were removed on 11/2/20.</p> | <p>The image shows a warehouse interior with several large, brown, cylindrical spill pallets stacked on a wooden pallet. In the background, there are blue and black storage bins and other industrial equipment.</p> |

| <p>[Title]</p> <p>06/16/2021 09:47 AM (AKT)</p> <p>Jon Jones</p> <p>Hazardous Waste Process Facility (HWPF)</p> <p>No CBI</p> <p>No PII</p> <p>Another view of the secondary containment spill pallets being used in place of the large white storage bins that were removed on 11/2/20.</p> | |
| <p>[Title]</p> <p>06/16/2021 09:48 AM (AKT)</p> <p>Jon Jones</p> <p>Hazardous Waste Process Facility (HWPF)</p> <p>No CBI</p> <p>No PII</p> <p>Another view of the secondary containment spill pallets being used in place of the large white storage bins that were removed on 11/2/20.</p> | |

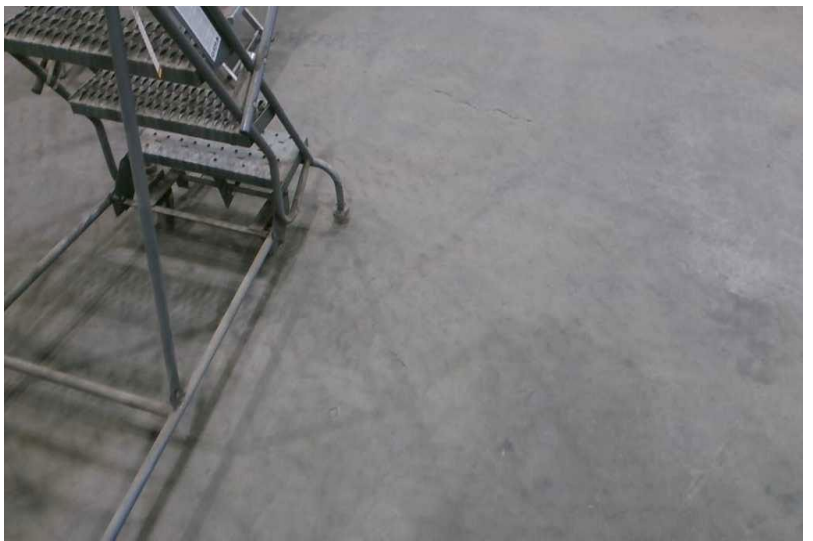
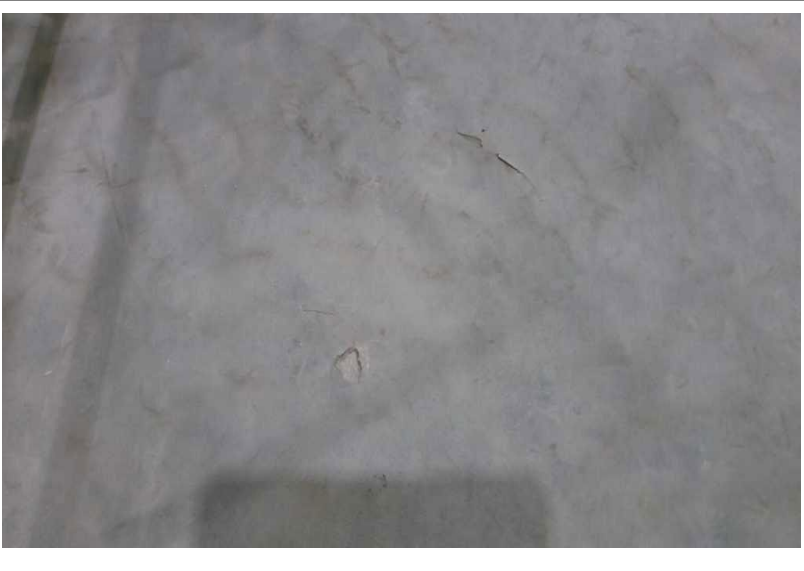
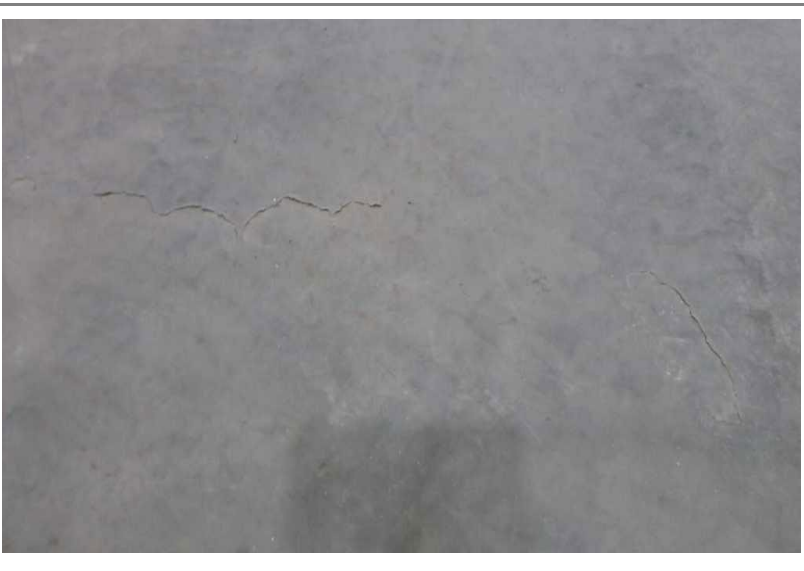
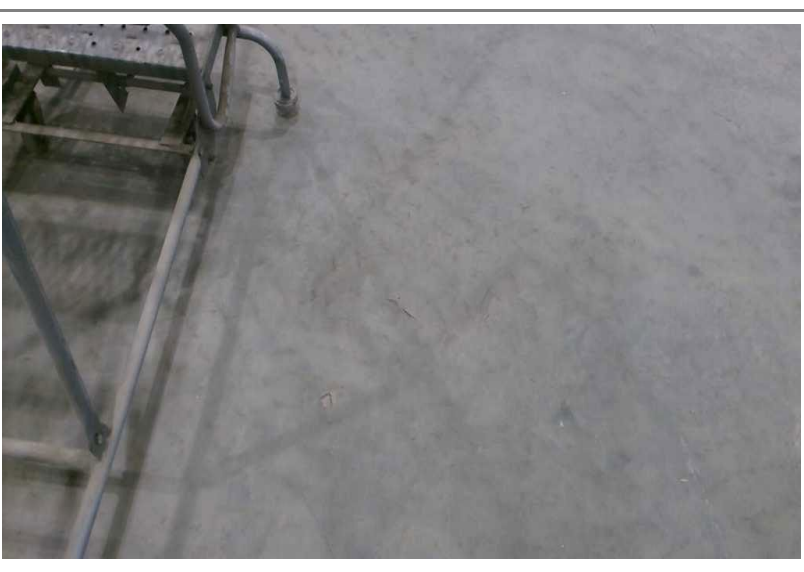
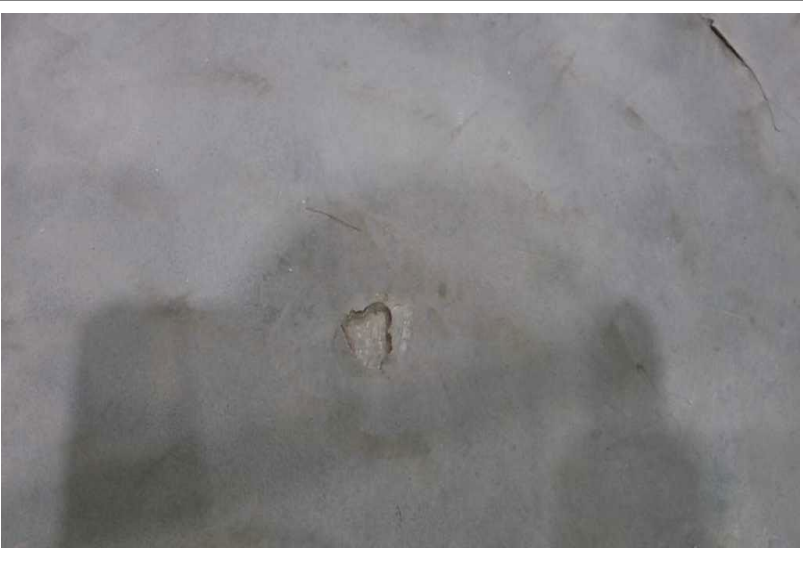
There were several areas where it looked as though there was some damage to the coating on the floor of the HWPF. Mr. Laskey said it looked as though there was still some coating underneath some of the damaged areas; however, I observed that concrete was visible in the smaller of two holes, as shown in photograph # (you need to figure out which photo this is since the title is missing in the photo log, but it's the 5<sup>th</sup> photo in the lineup so probably 6880) . The size of the smaller hole in the coating was approximately the size of a quarter.

During the inspection, I reviewed the facility's weekly inspection logs and saw that the facility was not inspecting the integrity of the sealed concrete floor in the HWPF. There were several areas on the HWPF floor where the seal on the concrete floor had been damaged and were showing the bare concrete. There were also several areas on the HWPF floor that were damaged when the hazardous waste storage cabinets were removed. Some of the pins that anchored the cabinets to the floor had been ripped out of the floor, revealing obvious damage to the floor seal as well as the concrete. According to annotations on the weekly inspection log, floor integrity was not being checked/inspected prior to the 6/16/21 RCRA CEI.

| <b>Building:</b> Gathering Center 3 (GC3) | <b>Area:</b> Skid 7 | <b>Sub-area:</b> |
|---|---|---|
| <p>There were several areas where it looked as though there was some damage to the coating on the floor inside of the HWPF. Mr. Laskey said it looked as though there was still some coating underneath the damaged areas however, concrete was visible in a smaller hole that was approximately the size of a quarter.</p> <p>I observed another tear in the coating adjacent to the CS-4 pallet which contained drums holding waste corrosives-basic. Mr. Laskey viewed the tear in the coating and commented that it was exposed concrete beneath the tear.</p> | <b>Citations:</b> | <b>Sections:</b> |

| <div data-bbox="65 1314 715 1366" data-label="Text">[Title]</div> <div data-bbox="65 1366 715 1424" data-label="Text">06/16/2021 09:59 AM (AKT)</div> <div data-bbox="65 1424 715 1482" data-label="Text">Jon Jones</div> <div data-bbox="65 1482 715 1541" data-label="Text">Hazardous Waste Process Facility (HWPF)</div> <div data-bbox="65 1541 715 1599" data-label="Text">No CBI</div> <div data-bbox="65 1599 715 1657" data-label="Text">No PII</div> <div data-bbox="65 1657 715 1881" data-label="Text">View of several areas on the floor where there was some damage to the coating on the floor inside of the HWPF.</div> | |

| Close-up view of several areas on the floor where there was some damage to the coating on the floor inside of the HWPF. | |
| Another view of several areas on the floor where there was some damage to the coating on the floor inside of the HWPF. | |
| Another view of several areas on the floor where there was some damage to the coating on the floor inside of the HWPF. | |

| <p>[Title]</p> <p>06/16/2021 10:03 AM (AKT)</p> <p>Jon Jones</p> <p>Hazardous Waste Process Facility (HWPF)</p> <p>No CBI</p> <p>No PII</p> <p>Close-up view of a smaller hole where the concrete was visible.</p> | A close-up photograph of a small, irregular hole in a light-colored concrete floor. The hole is roughly circular with jagged edges, and some darker material is visible inside it. |

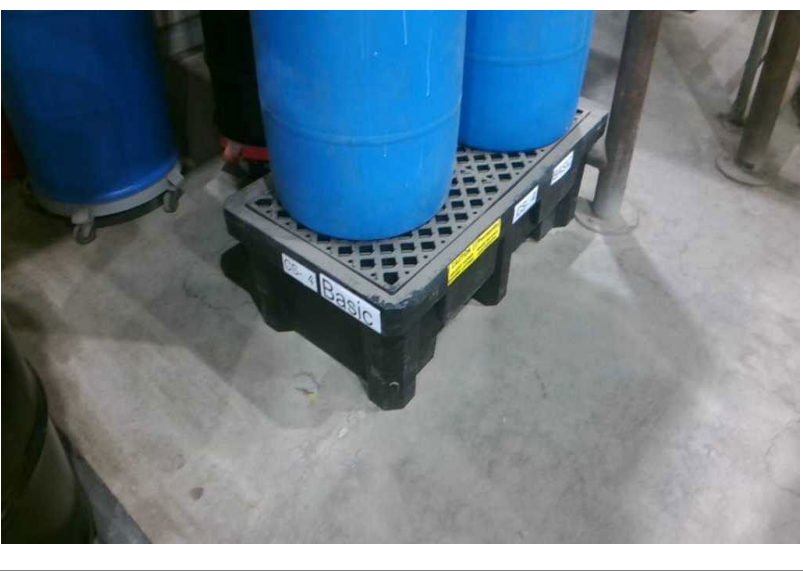
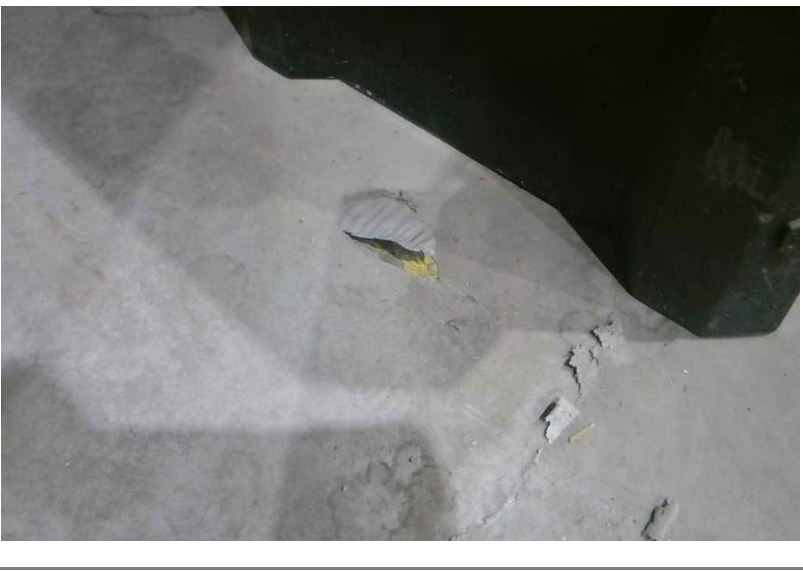
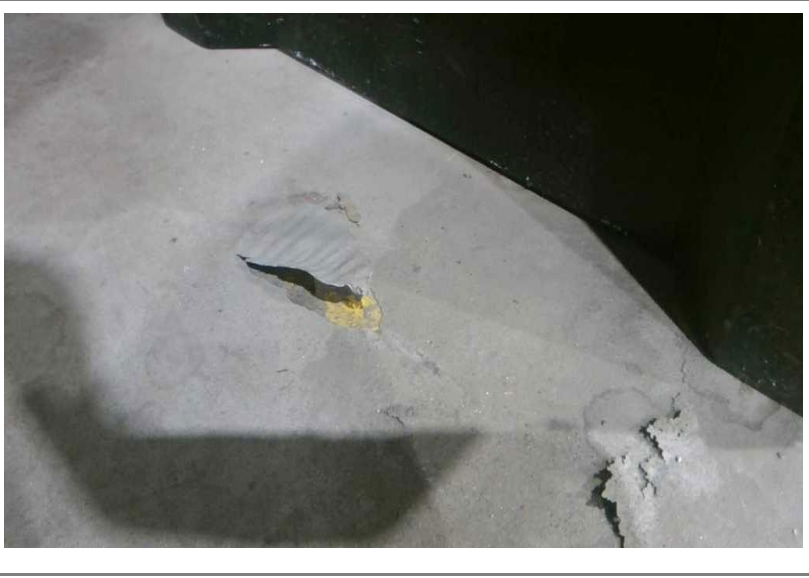
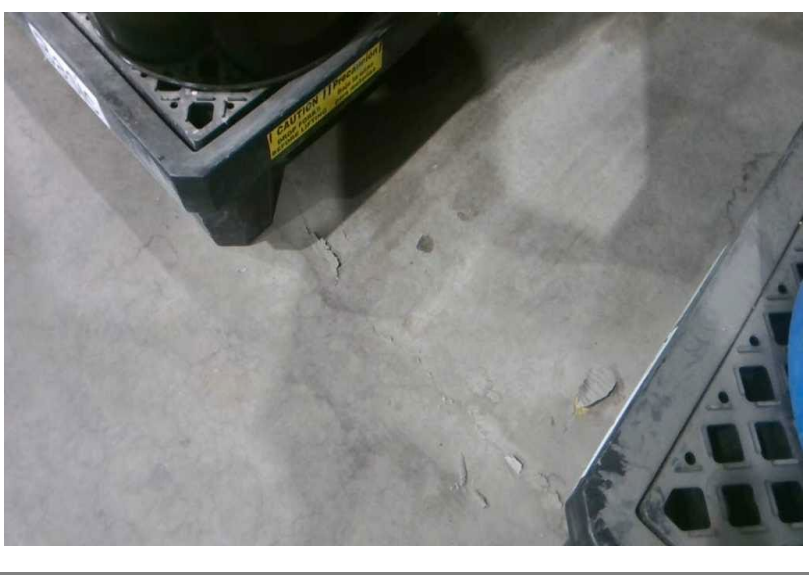
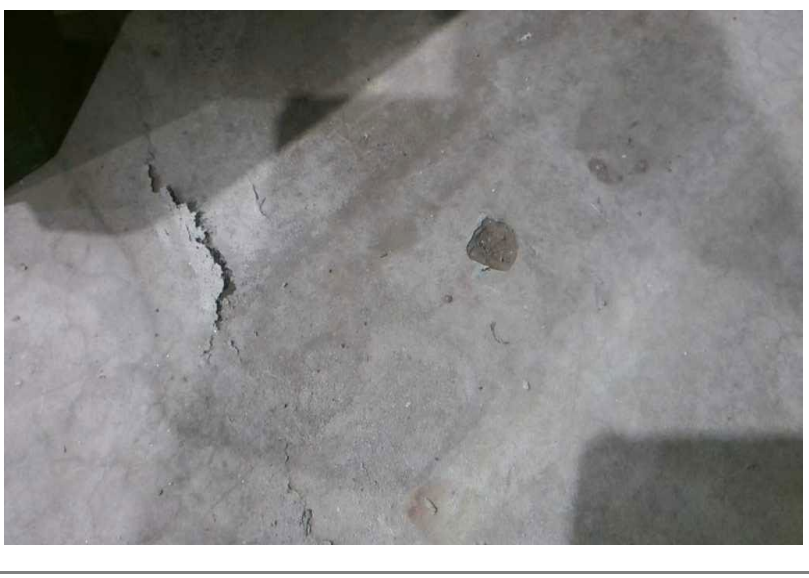
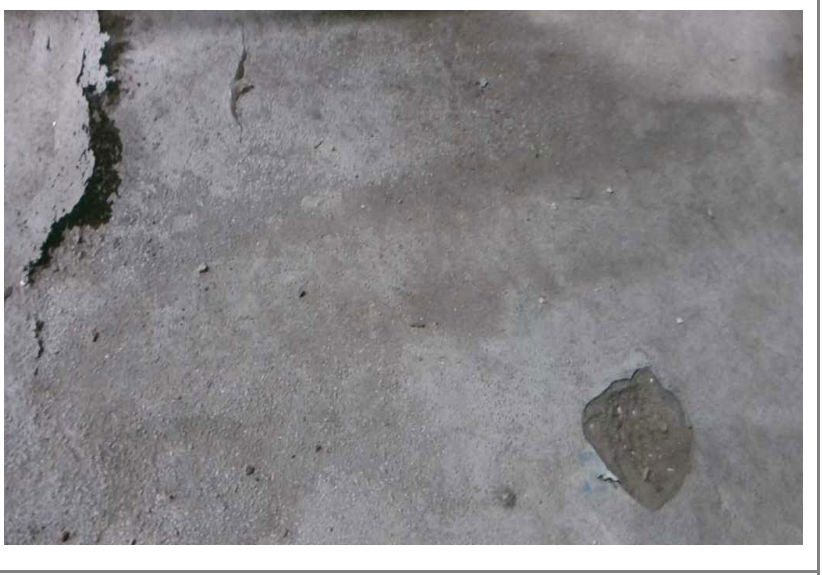
I observed another tear in the coating adjacent to the CS-4 pallet which contained drums holding waste corrosives-basic. Mr. Laskey viewed the tear in the coating and commented that there was exposed concrete beneath the tear. There was another area right next to the tear where one of the storage bins used to be bolted down to the floor, just between pallets CS-3 and CS-4, both holding containers of waste corrosives-basic. Some of the pins that anchored the cabinets to the floor had been ripped out of the floor, revealing obvious damage to the floor seal as well as the concrete.

| <p>[Title]</p> <p>06/16/2021 10:07 AM (AKT)</p> <p>Jon Jones</p> <p>Hazardous Waste Process Facility (HWPF)</p> <p>No CBI</p> <p>No PII</p> <p>View of another tear in the coating adjacent to the CS-4 pallet which contained drums holding waste corrosives-basic.</p> | A photograph showing a black plastic pallet with a yellow label that says "Basic" on it. The pallet is holding several blue drums. The floor is concrete, and there is a visible tear in the coating near the pallet. |
| <p>[Title]</p> <p>06/16/2021 10:07 AM (AKT)</p> <p>Jon Jones</p> <p>Hazardous Waste Process Facility (HWPF)</p> <p>No CBI</p> <p>No PII</p> <p>Close-up view of the tear in the coating, from the previous photo, adjacent to the CS-4 pallet which contained drums holding waste corrosives-basic.</p> | A close-up photograph of a tear in the concrete coating. The tear is a jagged, irregular crack in the light-colored concrete, revealing a darker material underneath. It is located near a dark, possibly black, object. |

| <div data-bbox="70 165 711 221" data-label="Text"><i>[Title]</i></div> <div data-bbox="70 221 711 277" data-label="Text">06/16/2021 10:08 AM (AKT)</div> <div data-bbox="70 277 711 333" data-label="Text">Jon Jones</div> <div data-bbox="70 333 711 389" data-label="Text">Hazardous Waste Process Facility (HWPF)</div> <div data-bbox="70 389 711 445" data-label="Text">No CBI</div> <div data-bbox="70 445 711 501" data-label="Text">No PII</div> <div data-bbox="70 501 711 741" data-label="Text">Another close-up view of the damage to the floor seen in the previous photo.</div> | |
| <div data-bbox="70 741 711 797" data-label="Text"><i>[Title]</i></div> <div data-bbox="70 797 711 853" data-label="Text">06/16/2021 10:14 AM (AKT)</div> <div data-bbox="70 853 711 909" data-label="Text">Jon Jones</div> <div data-bbox="70 909 711 965" data-label="Text">Hazardous Waste Process Facility (HWPF)</div> <div data-bbox="70 965 711 1021" data-label="Text">No CBI</div> <div data-bbox="70 1021 711 1077" data-label="Text">No PII</div> <div data-bbox="70 1077 711 1317" data-label="Text">Another close-up view of the damage to the floor seen in the previous photo.</div> | |
| <div data-bbox="70 1317 711 1373" data-label="Text"><i>[Title]</i></div> <div data-bbox="70 1373 711 1429" data-label="Text">06/16/2021 10:14 AM (AKT)</div> <div data-bbox="70 1429 711 1485" data-label="Text">Jon Jones</div> <div data-bbox="70 1485 711 1541" data-label="Text">Hazardous Waste Process Facility (HWPF)</div> <div data-bbox="70 1541 711 1597" data-label="Text">No CBI</div> <div data-bbox="70 1597 711 1653" data-label="Text">No PII</div> <div data-bbox="70 1653 711 1892" data-label="Text">Another close-up view showing damage to the floor and exposed concrete.</div> | |

| <p>[Title]</p> <p>06/16/2021 10:14 AM (AKT)</p> <p>Jon Jones</p> <p>Hazardous Waste Process Facility (HWPF)</p> <p>No CBI</p> <p>No PII</p> <p>Another close-up view showing damage to the floor and exposed concrete seen in the previous photo.</p> | |

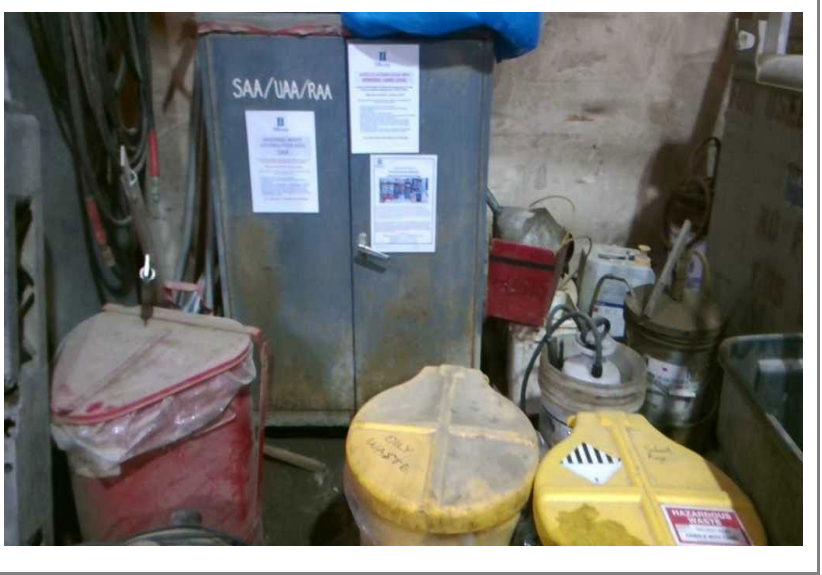
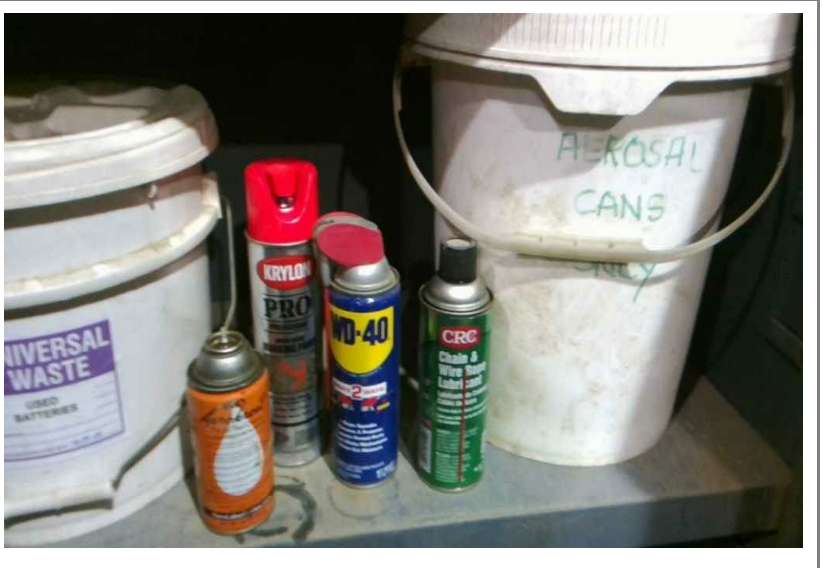
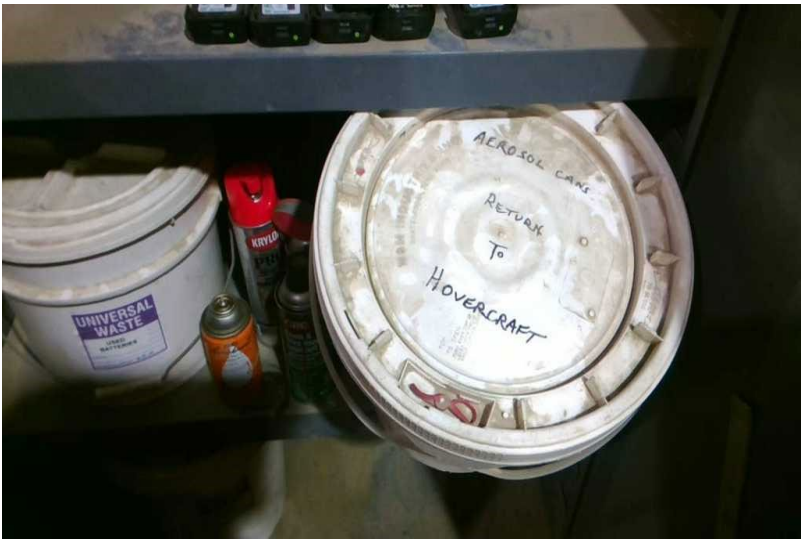
The four waste aerosol cans were not containerized, not labeled as hazardous waste (HW), and were not marked with a hazard indicator. The facility manages aerosols as hazardous waste rather than universal waste.

aerosol cans and was empty. I saw that the other side of the container was labeled as HW and had hazard indicators for both Flammable and Non-flammable gases. Mr. Shannon placed the waste aerosol cans into the container during the inspection.

| <b>Building:</b> Hover craft hangar | <b>Area:</b> | <b>Sub-area:</b> |
|---|---|---|
| While inspecting the hovercraft hanger, I saw four waste aerosol cans were not containerized, not labeled as HW, and were not marked with a hazard indicator. | <b>Citations:</b> | <b>Sections:</b> |

| <p>[Title]</p> <p>06/17/2021 08:50 AM (AKT)</p> <p>Jon Jones</p> <p>Hover craft hangar</p> <p>No CBI</p> <p>No PII</p> <p>View of a cabinet marked as an SAA/UAA/RAA.</p> | |
| <p>[Title]</p> <p>06/17/2021 08:51 AM (AKT)</p> <p>Jon Jones</p> <p>Hover craft hangar</p> <p>No CBI</p> <p>No PII</p> <p>View inside the cabinet, seen in the previous photo. Photo shows four waste aerosol cans on the shelf adjacent to the SAA container for waste aerosols.</p> | |

| <div>[Title]</div> <div>06/17/2021 08:51 AM (AKT)</div> <div>Jon Jones</div> <div>Hover craft hangar</div> <div>No CBI</div> <div>No PII</div> <div>View of the labeling on the SAA container.</div> | |
