## REGION 10 Enforcement Division

### INSPECTION REPORT

| <b>Company Name:</b> | Hilcorp North Slope, LLC | | |
| <b>Facility or Site Name:</b> | HILCORP NORTH SLOPE PRUDHOE BAY UNIT | | |

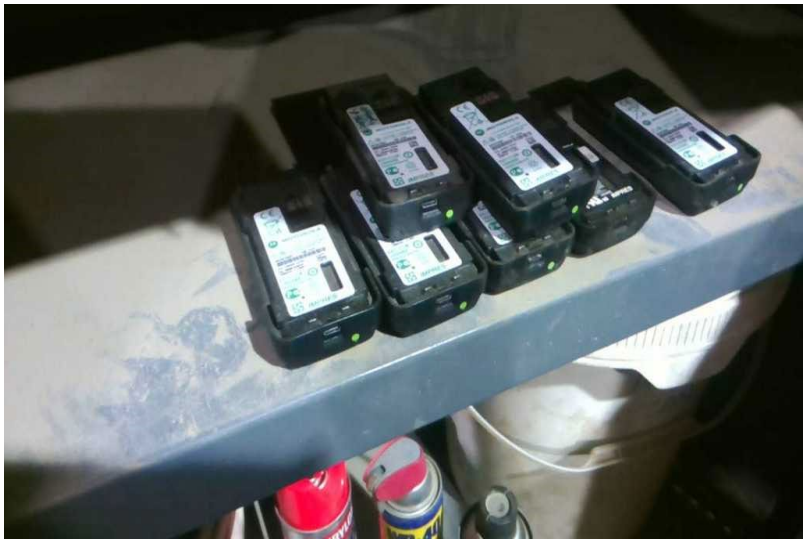
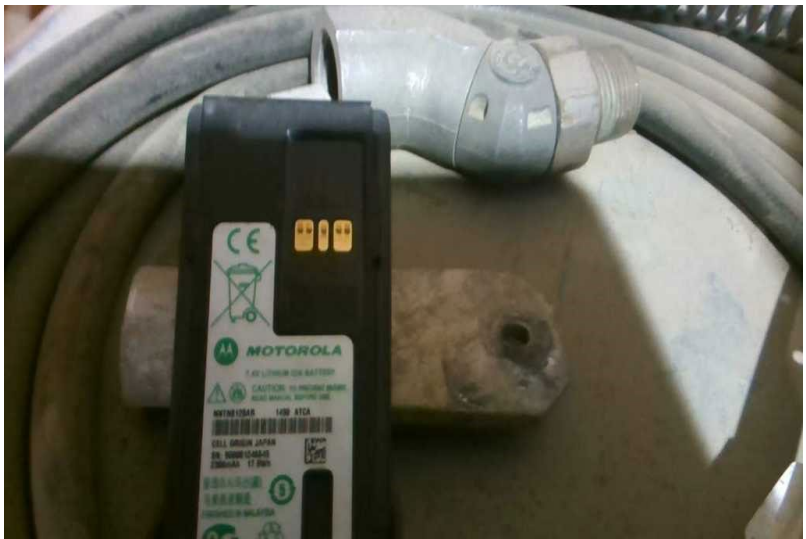
| <p>[Title]</p> <p>06/17/2021 08:57 AM (AKT)</p> <p>Jon Jones</p> <p>Hover craft hangar</p> <p>No CBI</p> <p>No PII</p> <p>View of seven waste lithium batteries on the top shelf of the same gray cabinet seen in the previous photo. The waste batteries were not labeled as UW batteries.</p> | |
| <p>[Title]</p> <p>06/17/2021 09:00 AM (AKT)</p> <p>Jon Jones</p> <p>Hover craft hangar</p> <p>No CBI</p> <p>No PII</p> <p>Close-up view of one of the seven waste lithium batts that were not labeled as UW.</p> | |

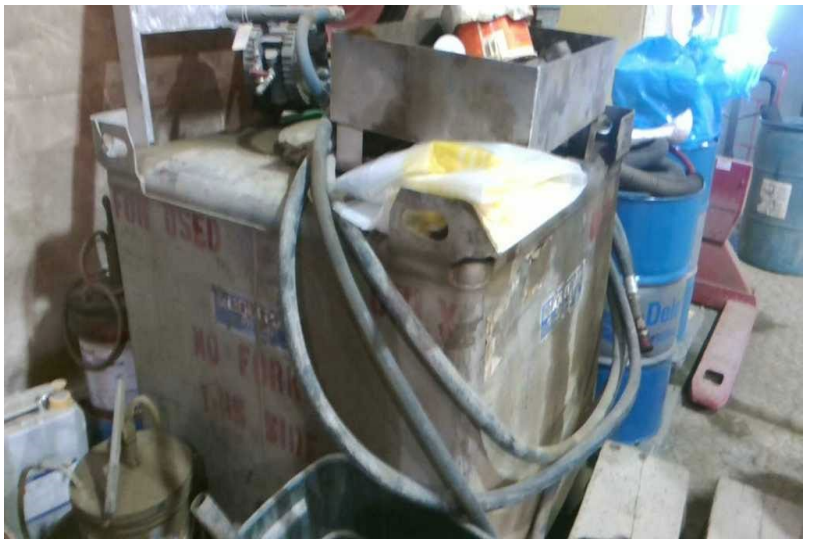
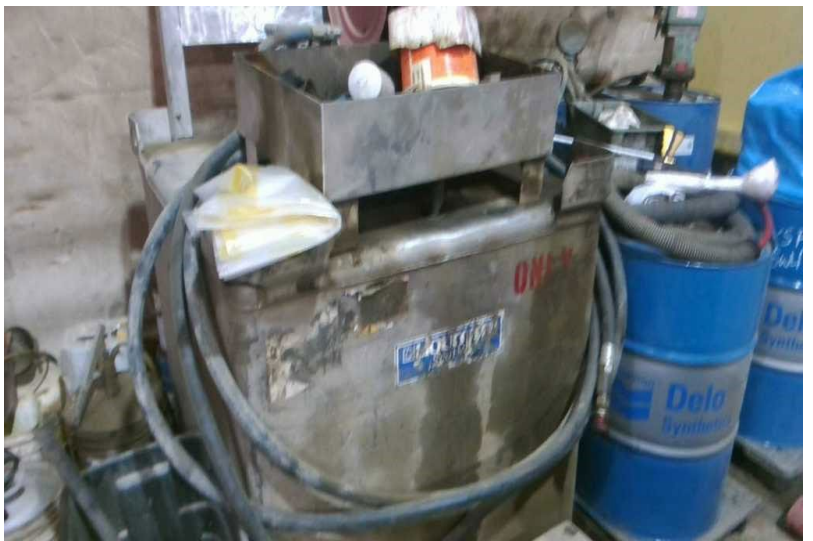
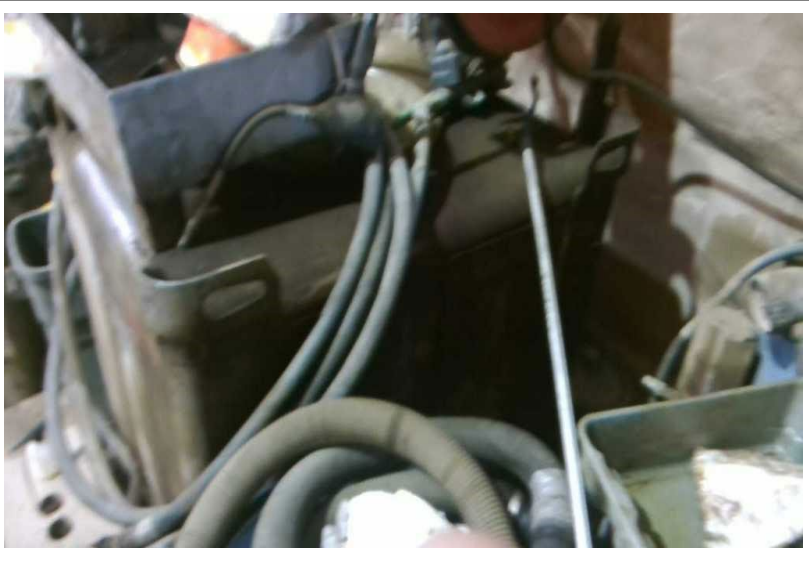
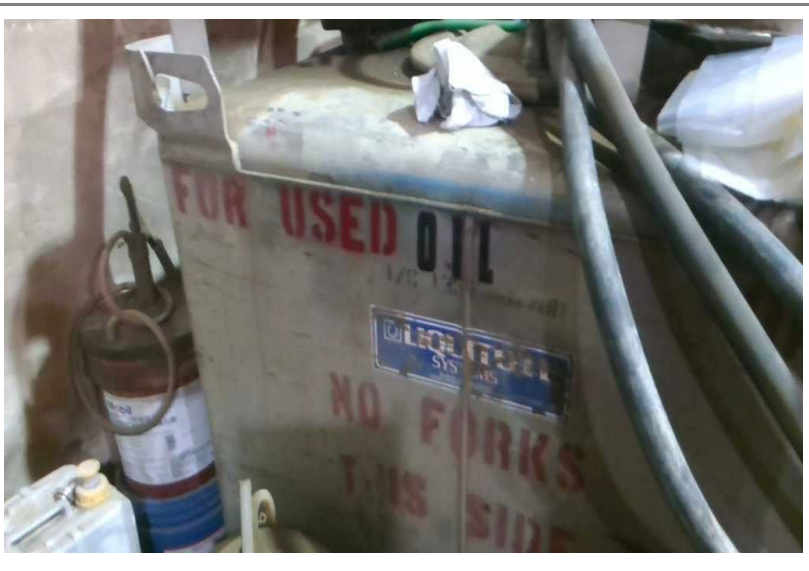
| <div>[Title]</div> <div>06/17/2021 09:17 AM (AKT)</div> <div>Jon Jones</div> <div>Hover craft hangar</div> <div>No CBI</div> <div>No PII</div> <div>View of a 250-gallon steel tote containing used oil that is not labeled with the words "Used Oil."</div> | |
| <div>[Title]</div> <div>06/17/2021 09:17 AM (AKT)</div> <div>Jon Jones</div> <div>Hover craft hangar</div> <div>No CBI</div> <div>No PII</div> <div>Another view of a 250-gallon steel tote containing used oil that is not labeled with the words "Used Oil."</div> | |

| <div data-bbox="70 165 711 219" data-label="Text">[Title]</div> <div data-bbox="70 219 711 277" data-label="Text">06/17/2021 09:18 AM (AKT)</div> <div data-bbox="70 277 711 336" data-label="Text">Jon Jones</div> <div data-bbox="70 336 711 394" data-label="Text">Hover craft hangar</div> <div data-bbox="70 394 711 452" data-label="Text">No CBI</div> <div data-bbox="70 452 711 510" data-label="Text">No PII</div> <div data-bbox="70 510 711 734" data-label="Text">Another view of a 250-gallon steel tote containing used oil that is not labeled with the words "Used Oil."</div> | |
| <div data-bbox="70 734 711 792" data-label="Text">[Title]</div> <div data-bbox="70 792 711 851" data-label="Text">06/17/2021 09:22 AM (AKT)</div> <div data-bbox="70 851 711 909" data-label="Text">Jon Jones</div> <div data-bbox="70 909 711 967" data-label="Text">Hover craft hangar</div> <div data-bbox="70 967 711 1025" data-label="Text">No CBI</div> <div data-bbox="70 1025 711 1084" data-label="Text">No PII</div> <div data-bbox="70 1084 711 1303" data-label="Text">View of the 250-gallon steel tote containing used oil after being labeled with the words "Used Oil."</div> | |

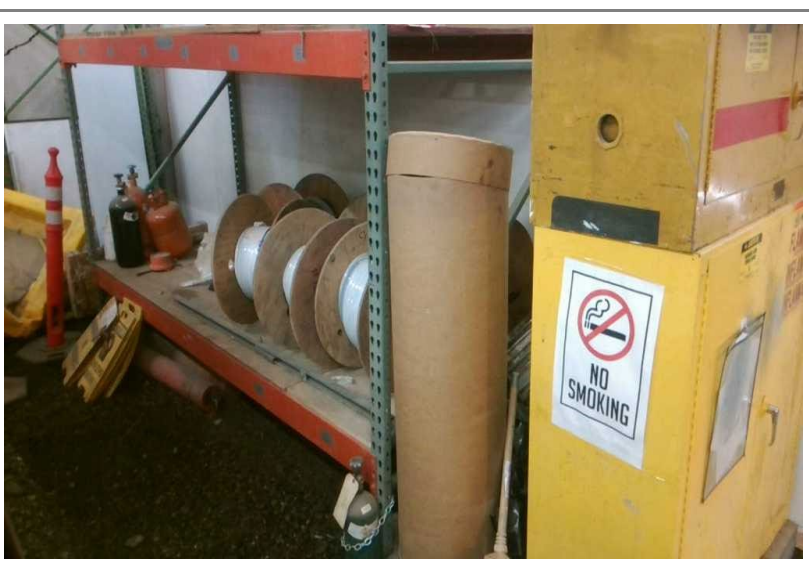
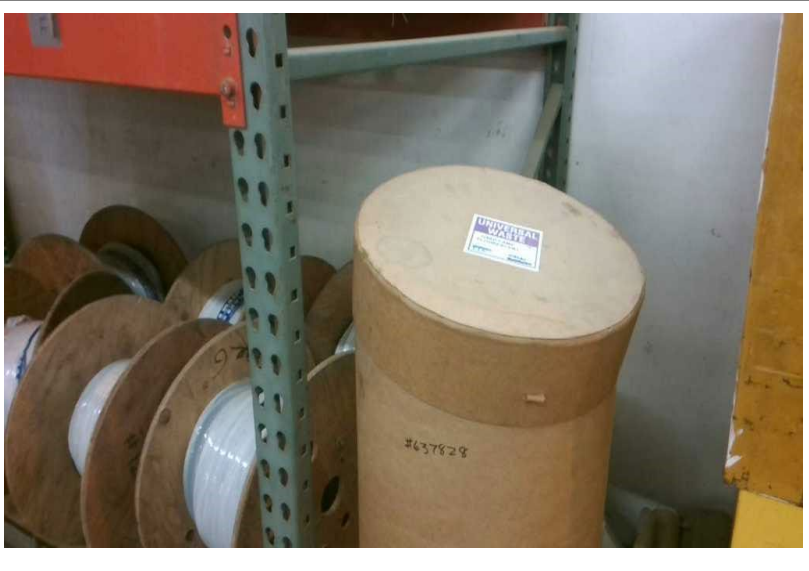
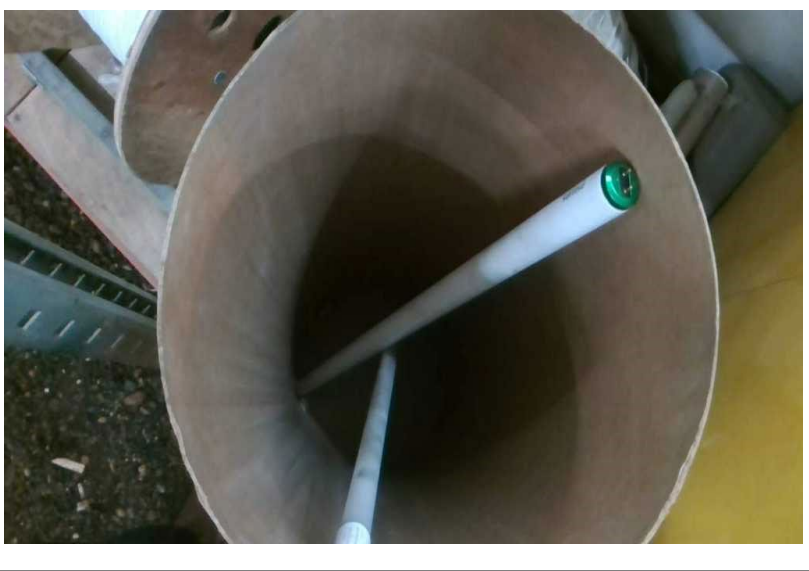
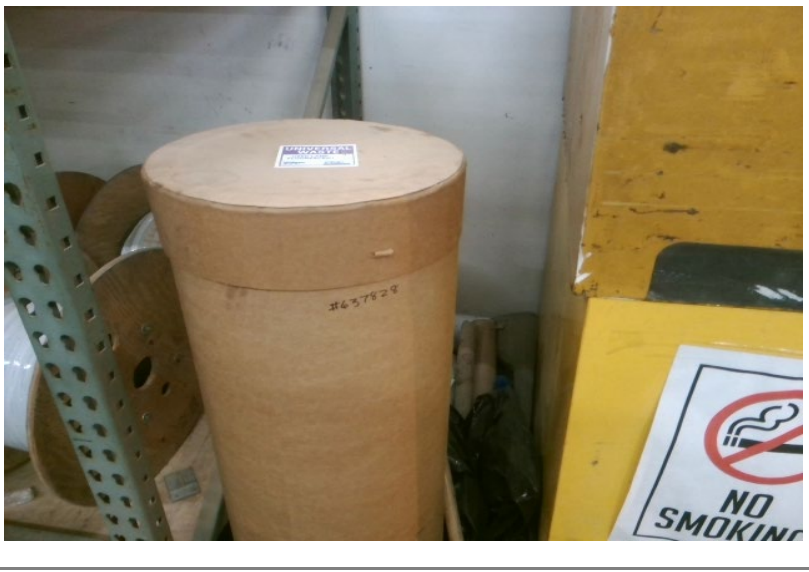
| <div data-bbox="70 1303 711 1361" data-label="Text">[Title]</div> <div data-bbox="70 1361 711 1420" data-label="Text">06/16/2021 01:08 PM (AKT)</div> <div data-bbox="70 1420 711 1478" data-label="Text">Jon Jones</div> <div data-bbox="70 1478 711 1536" data-label="Text">U11 - I&amp;E</div> <div data-bbox="70 1536 711 1594" data-label="Text">No CBI</div> <div data-bbox="70 1594 711 1653" data-label="Text">No PII</div> <div data-bbox="70 1653 711 1872" data-label="Text">View of container of UW lamps that is not closed.</div> | |

| <p>[Title]</p> <p>06/16/2021 01:09 PM (AKT)</p> <p>Jon Jones</p> <p>U11 - I&amp;E</p> <p>No CBI</p> <p>No PII</p> <p>Another view of container of UW lamps that is not closed.</p> | |
| <p>[Title]</p> <p>06/16/2021 01:09 PM (AKT)</p> <p>Jon Jones</p> <p>U11 - I&amp;E</p> <p>No CBI</p> <p>No PII</p> <p>View of the waste lamps inside the container.</p> | |
| <p>[Title]</p> <p>06/16/2021 01:12 PM (AKT)</p> <p>Jon Jones</p> <p>U11 - I&amp;E</p> <p>No CBI</p> <p>No PII</p> <p>View of the UAA container of waste lamps after being closed.</p> | |
