**Region 6 - Enforcement & Compliance Assurance Division**  
**INSPECTION REPORT**

| Inspection Date(s): | 5/14/2025 - 5/15/2025 | |
| Company Name: | <b>Nemaha Environmental Services, LLC</b> | |
| Facility Name: | <b>Gray Commercial Mud Disposal, SWD, and Reclamation Facility</b> | |

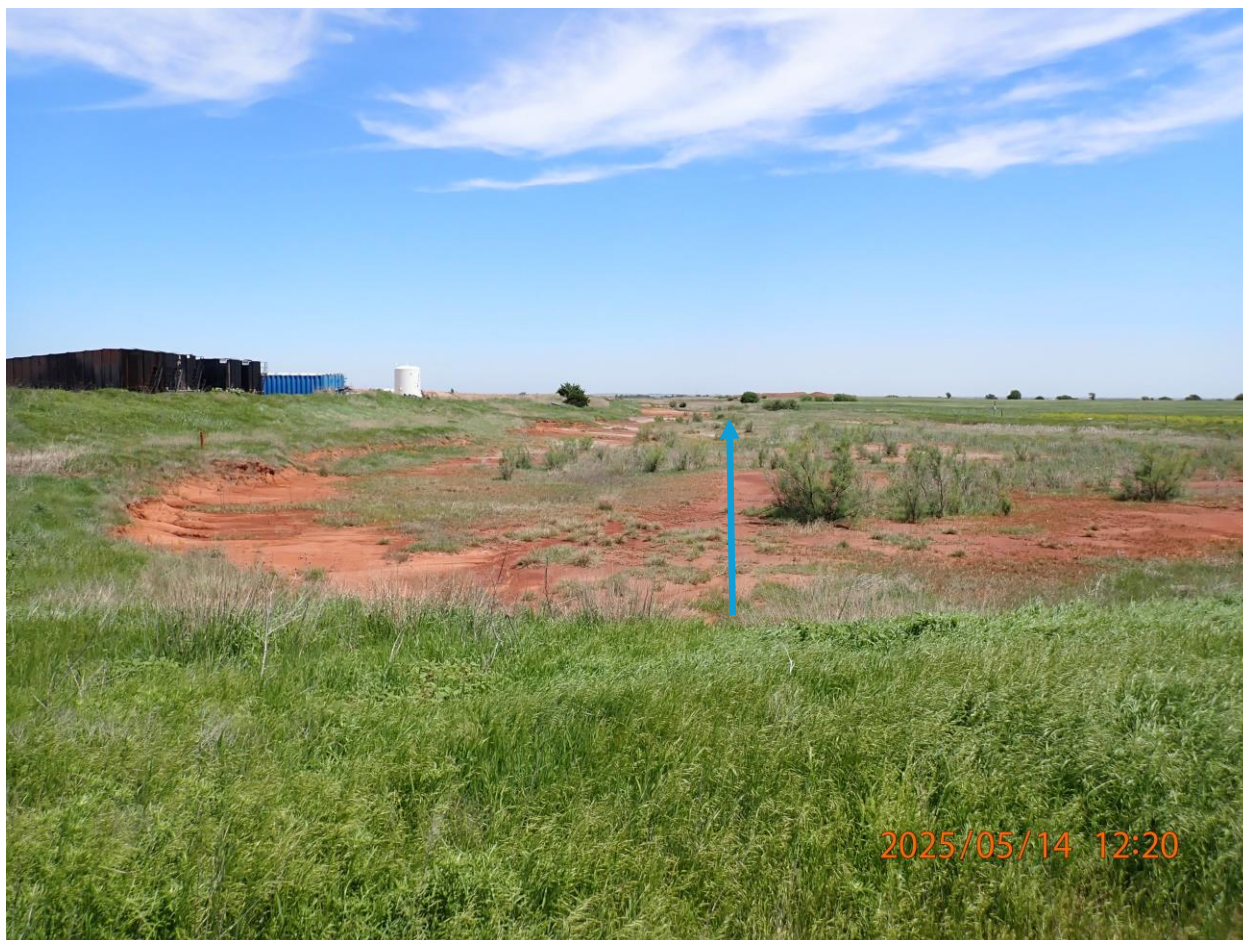
Photo No. 1

I observed the beginning of the unnamed tributary that goes through the Nemaha Environmental Services, LLC's property. The beginning of the unnamed tributary was dry for approximately 100 to 200 yards, see photo No. 1.

**Description:** This photo was taken looking NE and shows the starting point of the unnamed tributary that goes through the property. The starting point of the unnamed tributary in this photo is directly behind Pit No. 9. At the time of inspection, this section of the unnamed tributary was dry. The arrow shows the flow direction the unnamed tributary would have with water present.

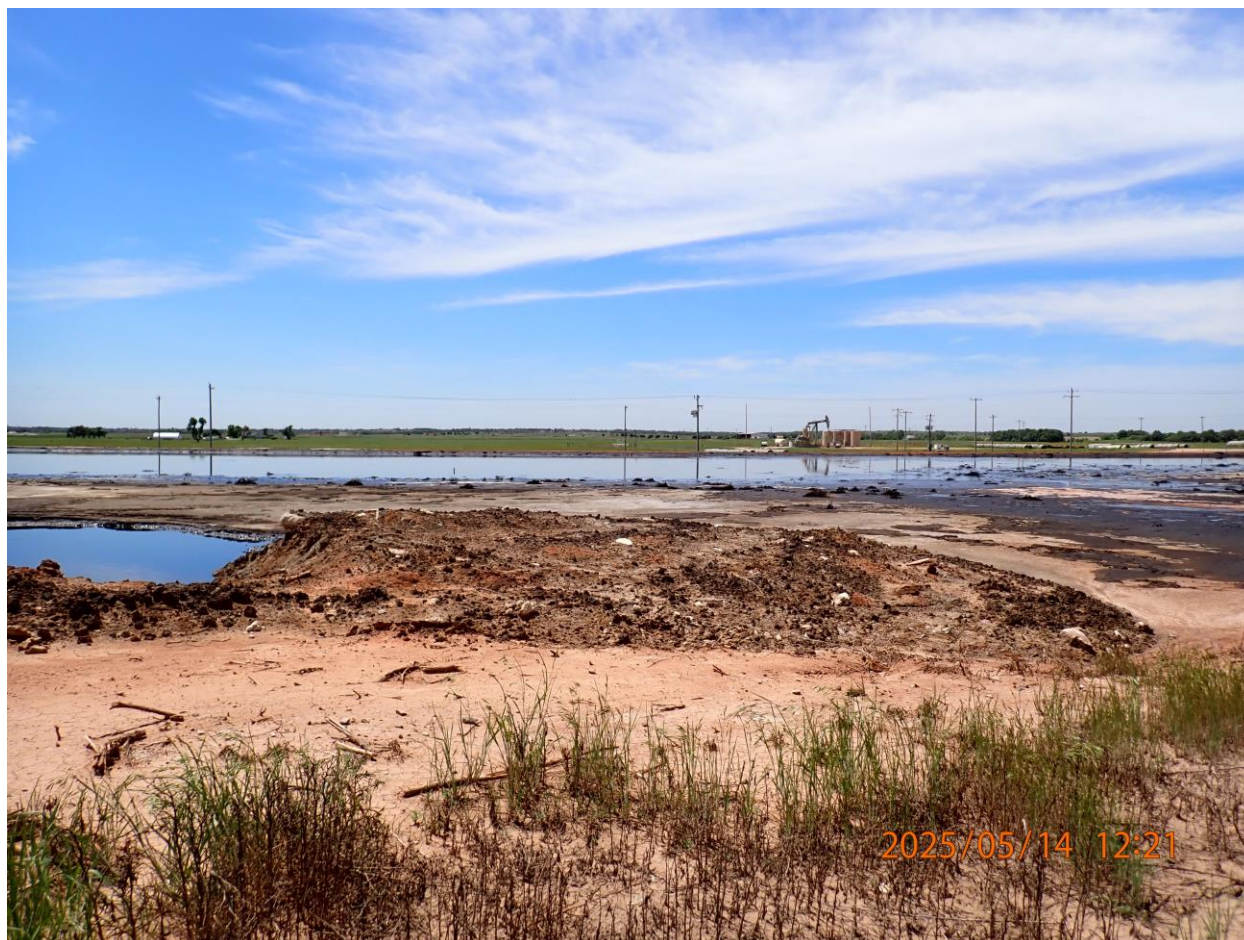
Photo No. 2

I observed Pit No. 9 behind the beginning of the unnamed tributary, see photo No. 2. This pit is closest to West Keowee Road.

**Description:** This photo was taken looking S and shows Pit No. 9, which is the pit closest to West Keowee Road.

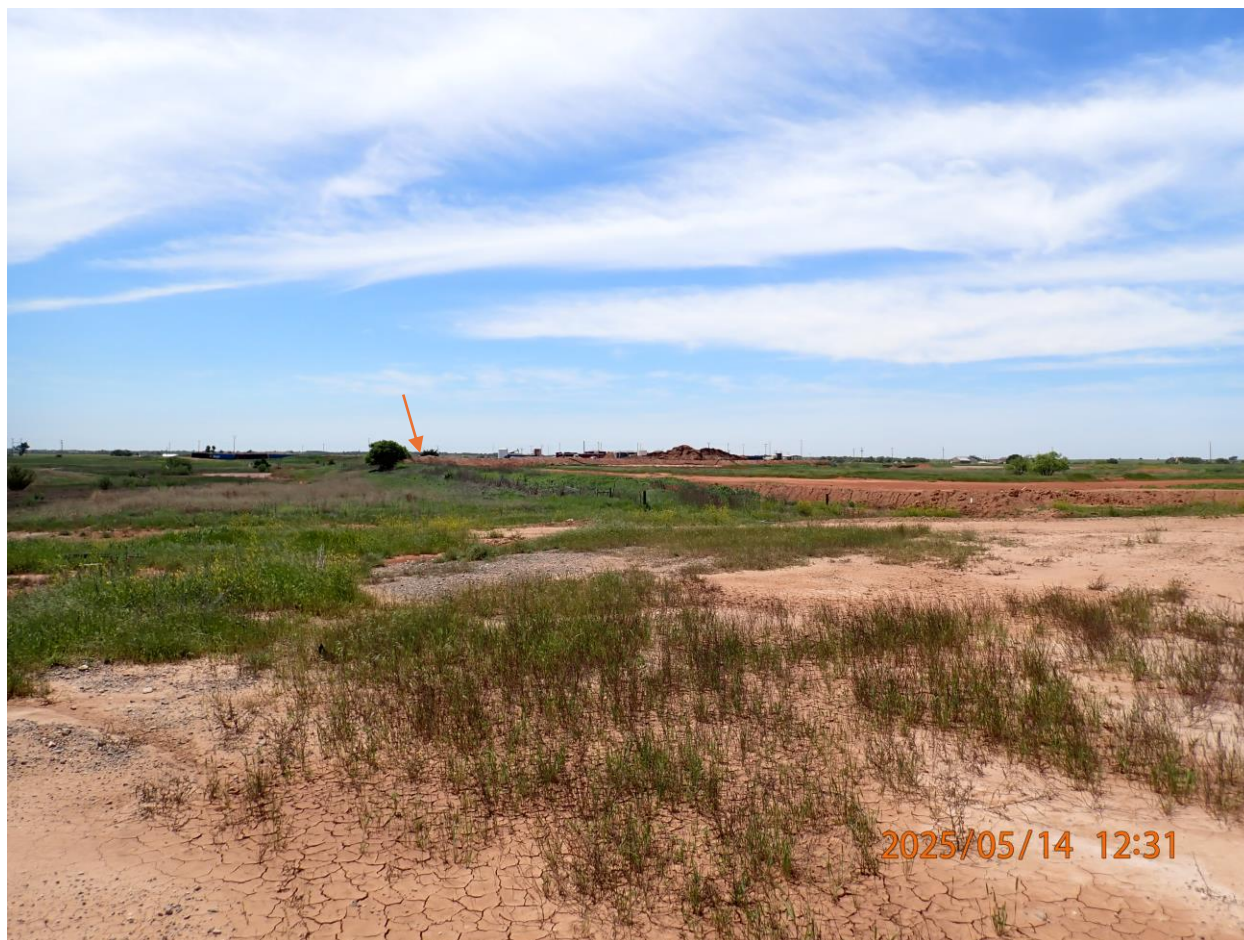
Following the unnamed tributary downstream, I observed the berm from which a spill occurred on June 3, 2023, see photo No. 3.

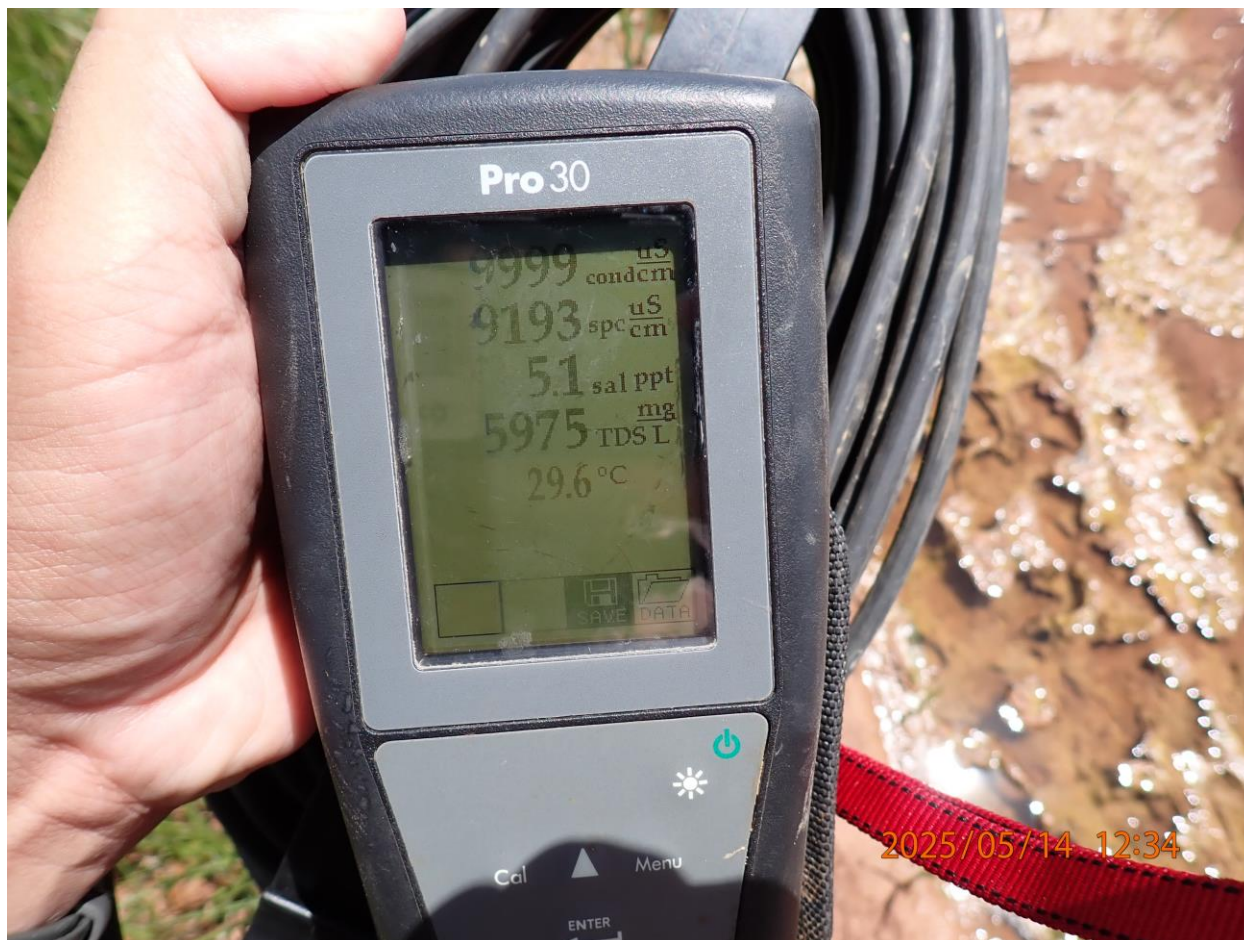
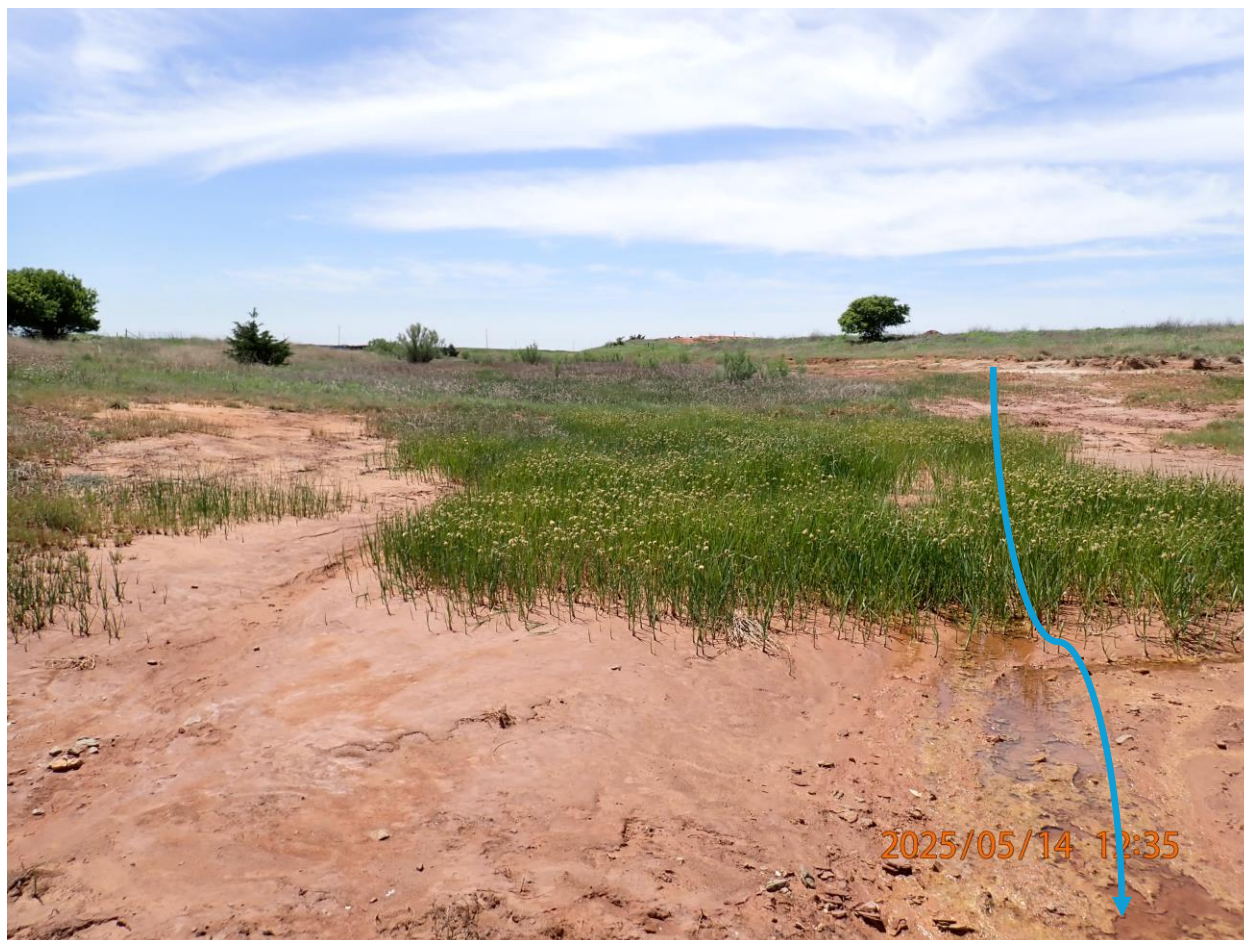
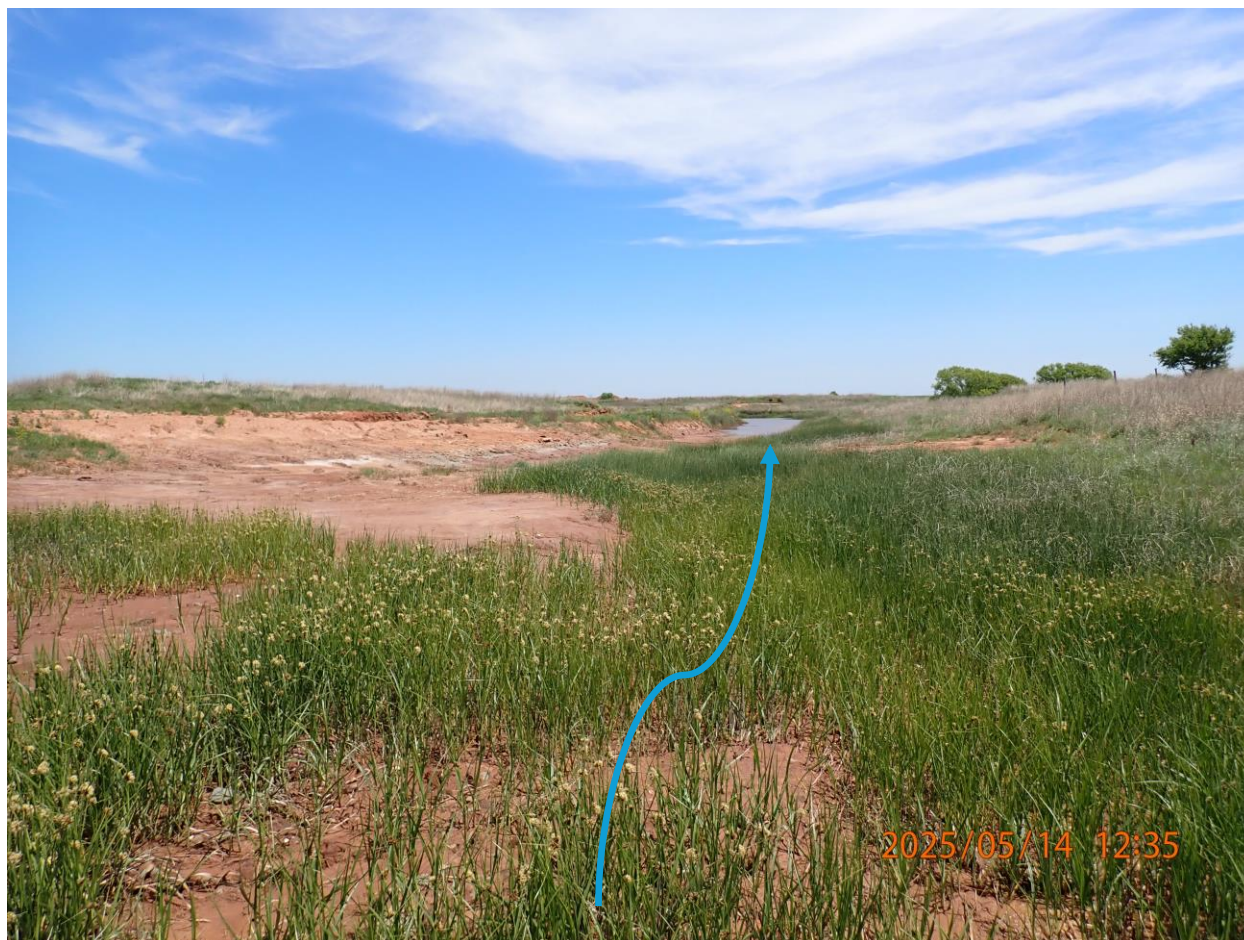
I observed the first spot in the unnamed tributary that had water and had a TDS reading of 5,975 mg/L. I also observed the flow path, bed and banks, and vegetation of the unnamed tributary upstream and downstream of the TDS reading, see photo No. 4 through photo No. 6.

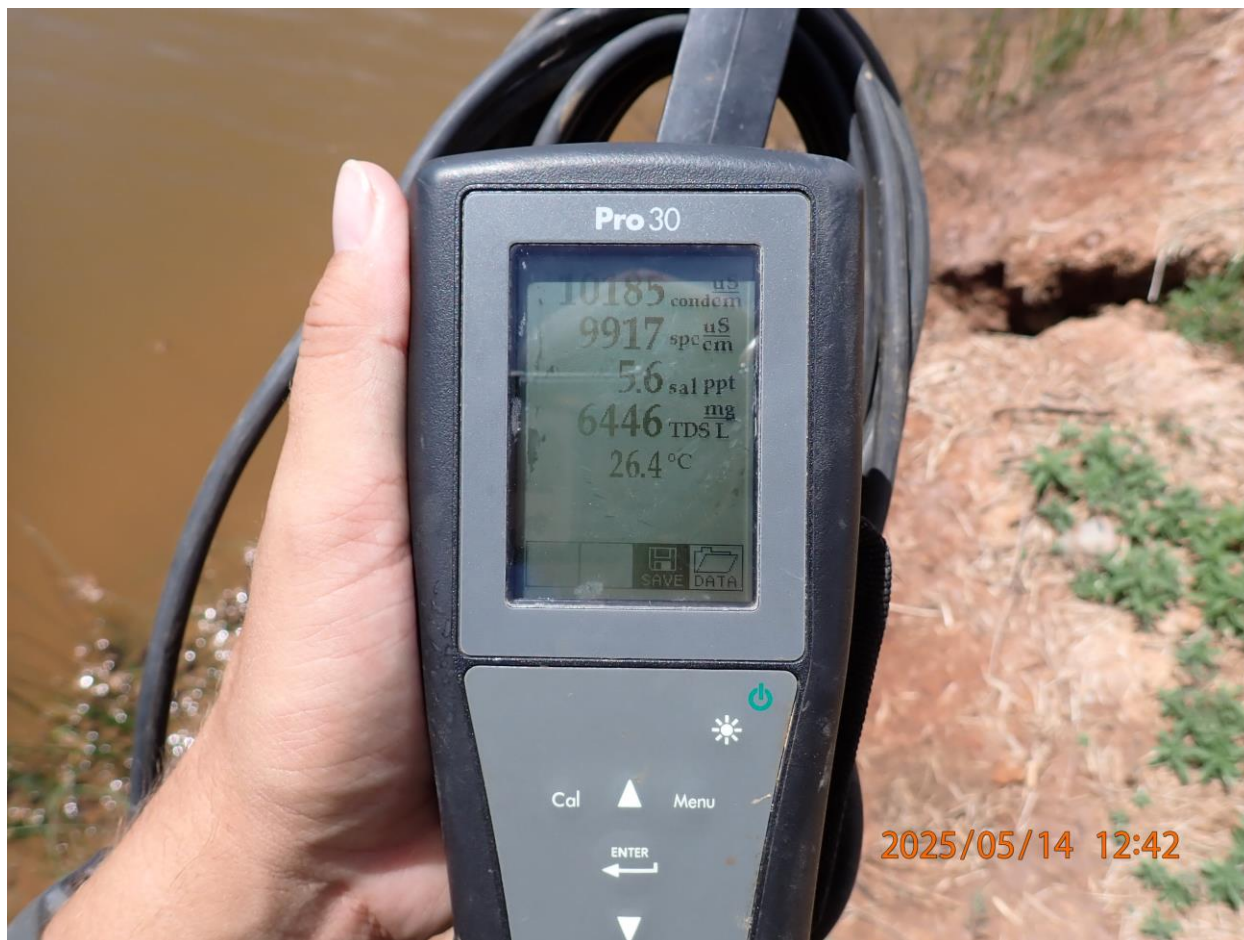
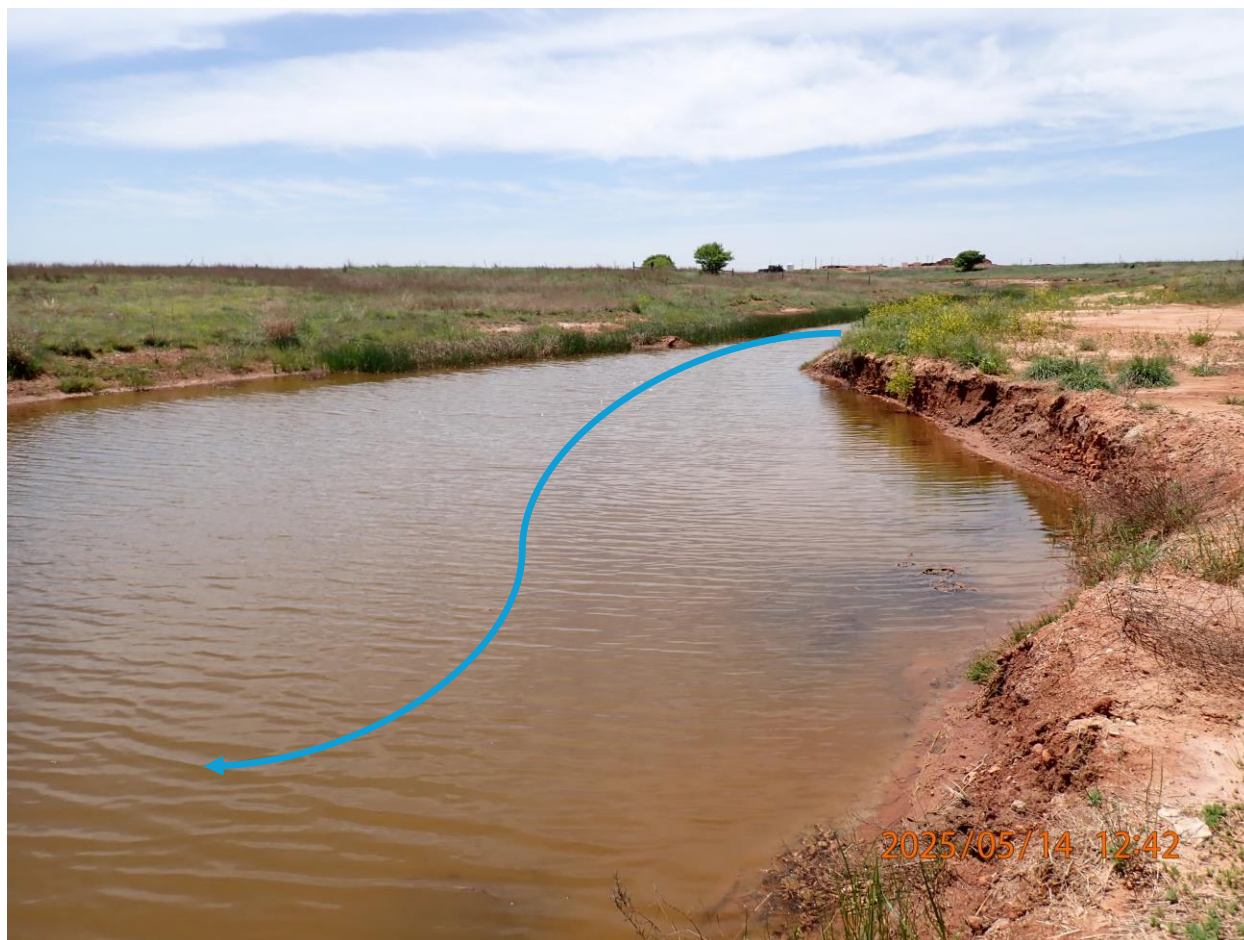
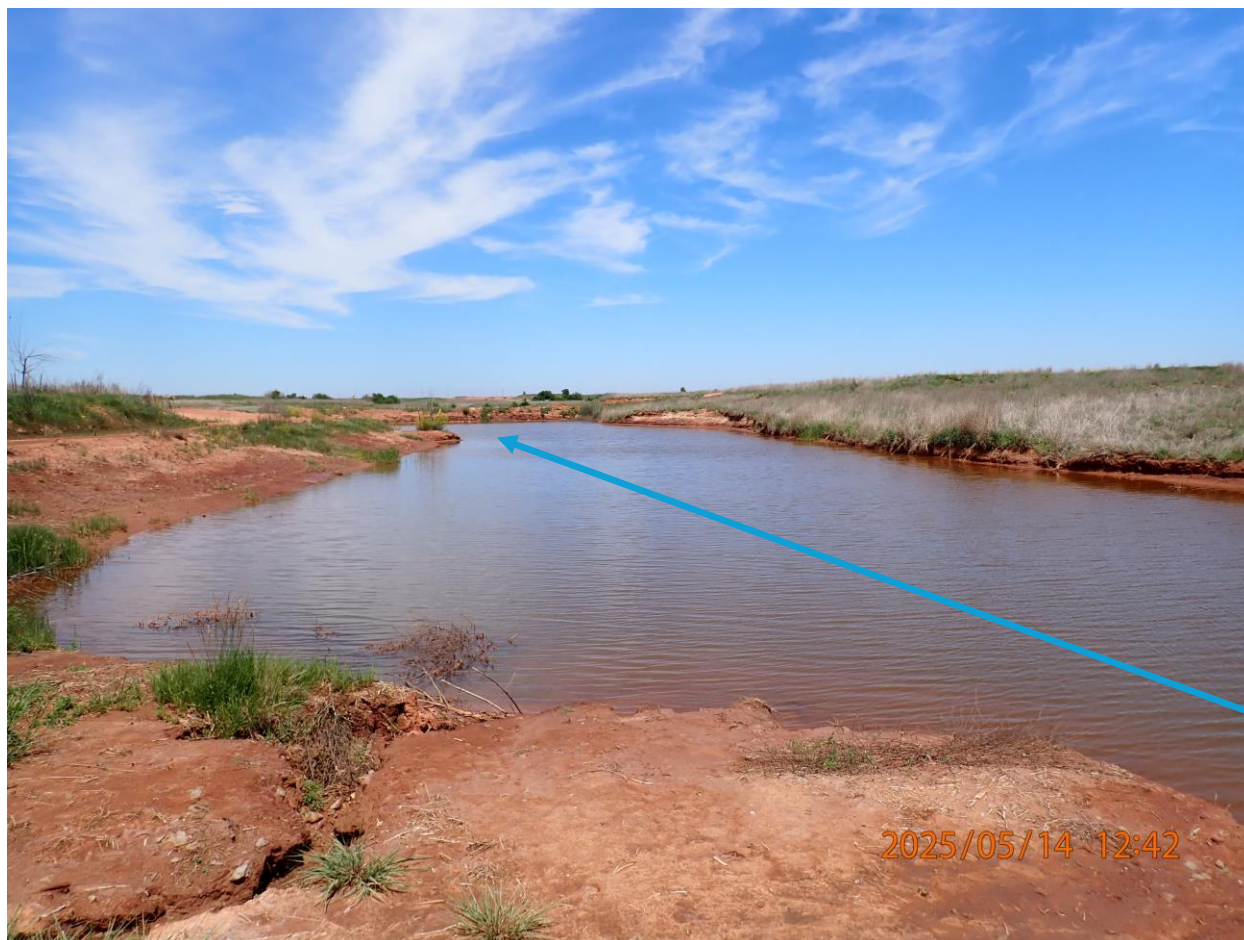
Working downstream, I observed a (TDS) reading of 6,446 mg/L near a dammed area of the unnamed tributary. I also observed the flow path, bed and banks, and vegetation of the unnamed tributary upstream and downstream of the TDS reading, see photo No. 7 through photo No. 9.

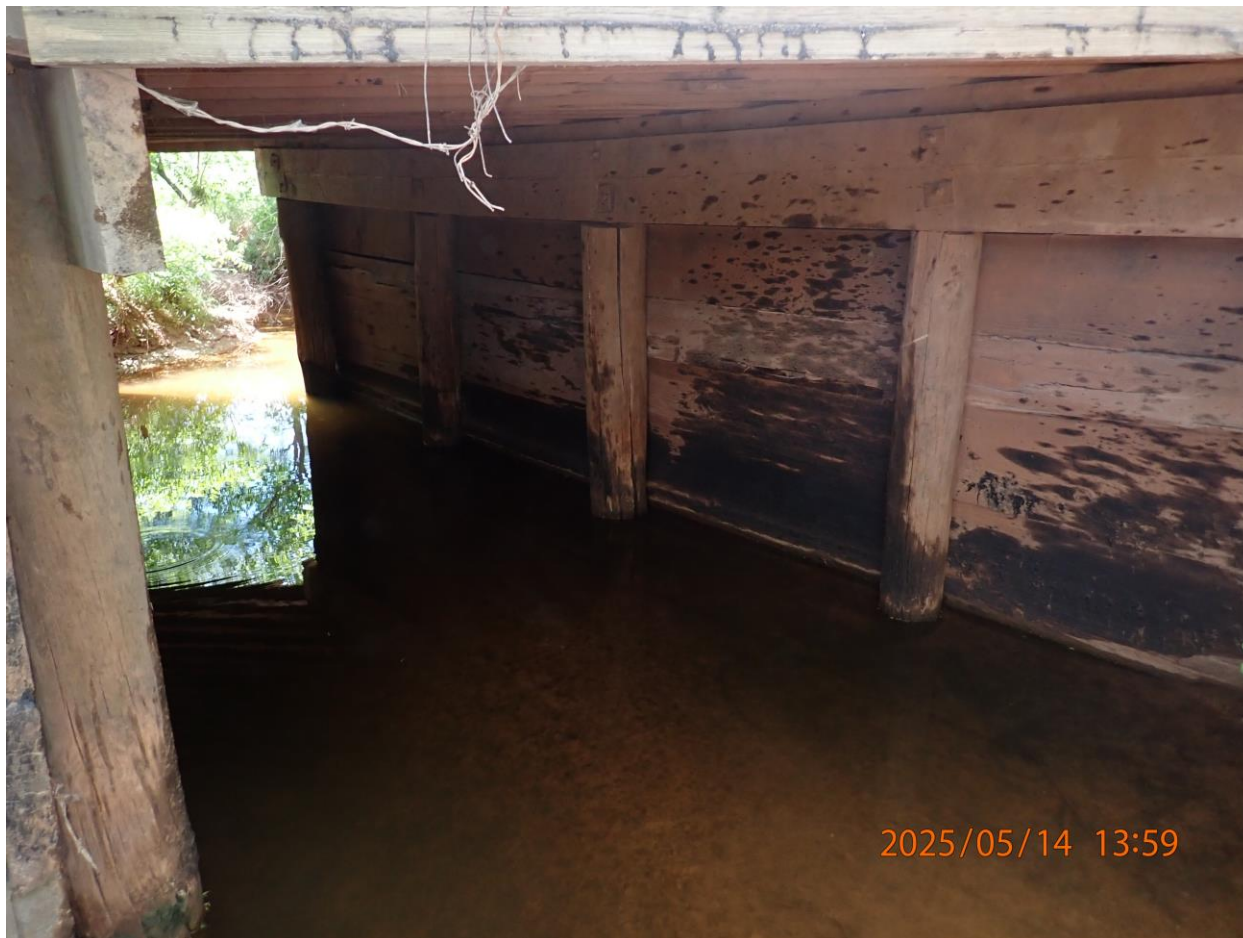
Under a road crossing on North Oakwood Road, I observed oil staining on the wooden wall supports, see photo No. 25.

**Description:** This photo was taken looking W showing oil staining on the wood supports under the road crossing on North Oakwood Road.

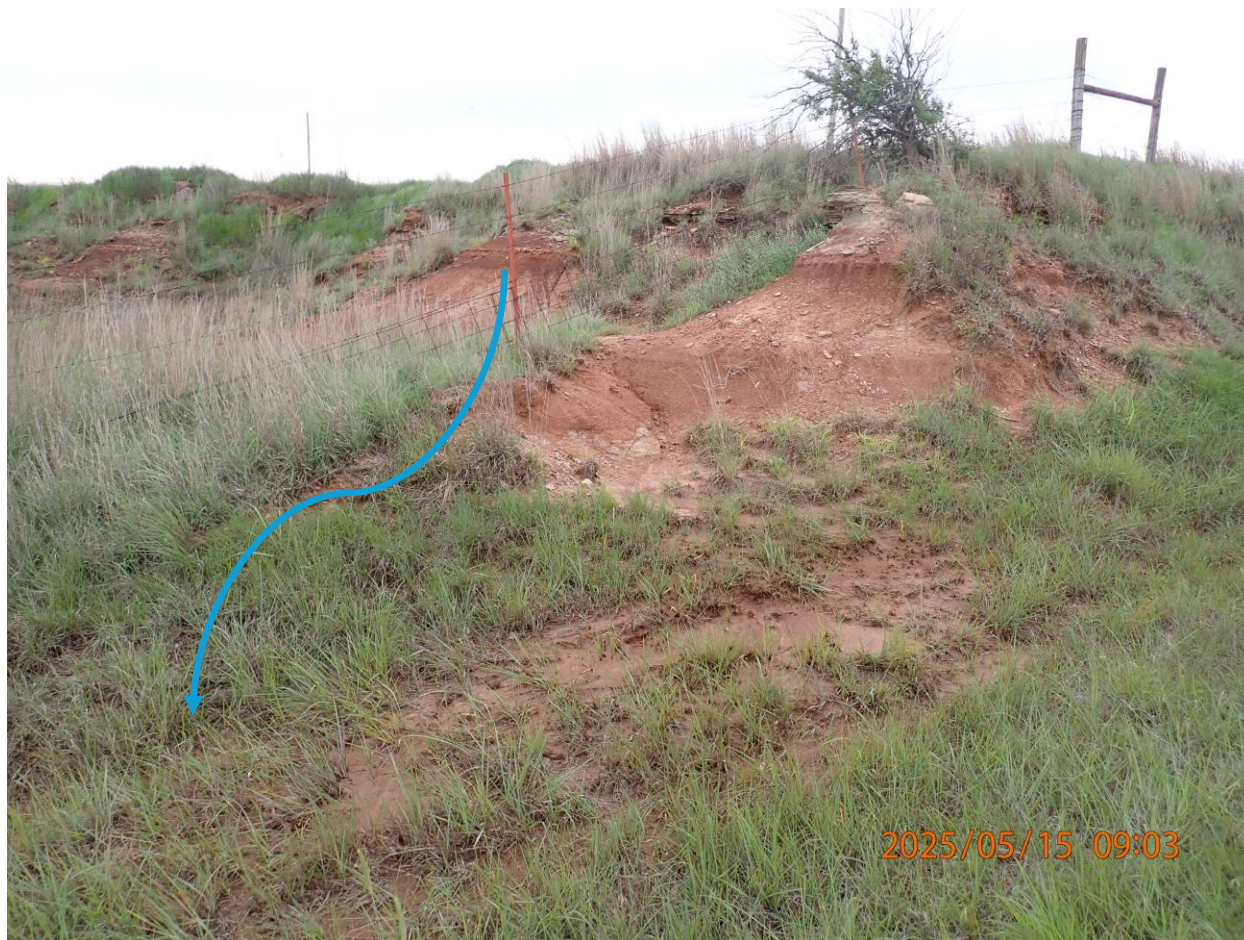
Off N Garland Road, I observed a wet spot on the backside of a berm, see photo No. 59.
