**U.S. ENVIRONMENTAL PROTECTION AGENCY  
REGION 5**

**Purpose:** Pretreatment and Industrial Storm Water Compliance Evaluation Inspection

**Facility:** Metalex North  
700 Liberty Drive  
Libertyville, IL 60048

**Date of Inspection:** December 14, 2022

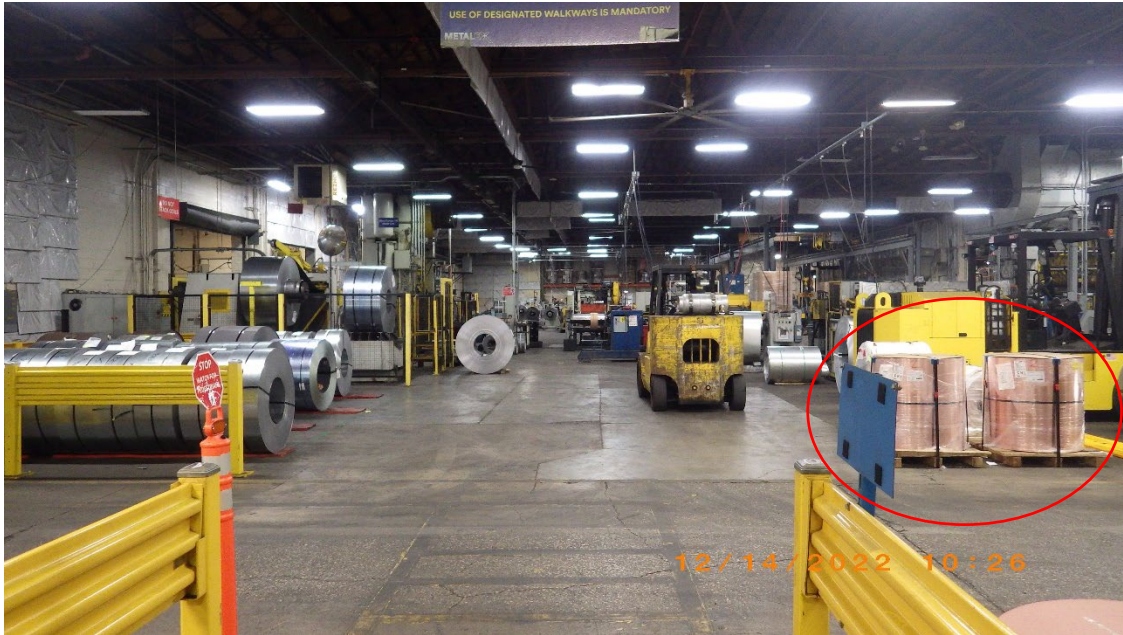
1: RIMG0105

Description: Overview of Stamping Department. Note copper spools of raw material in red circle.

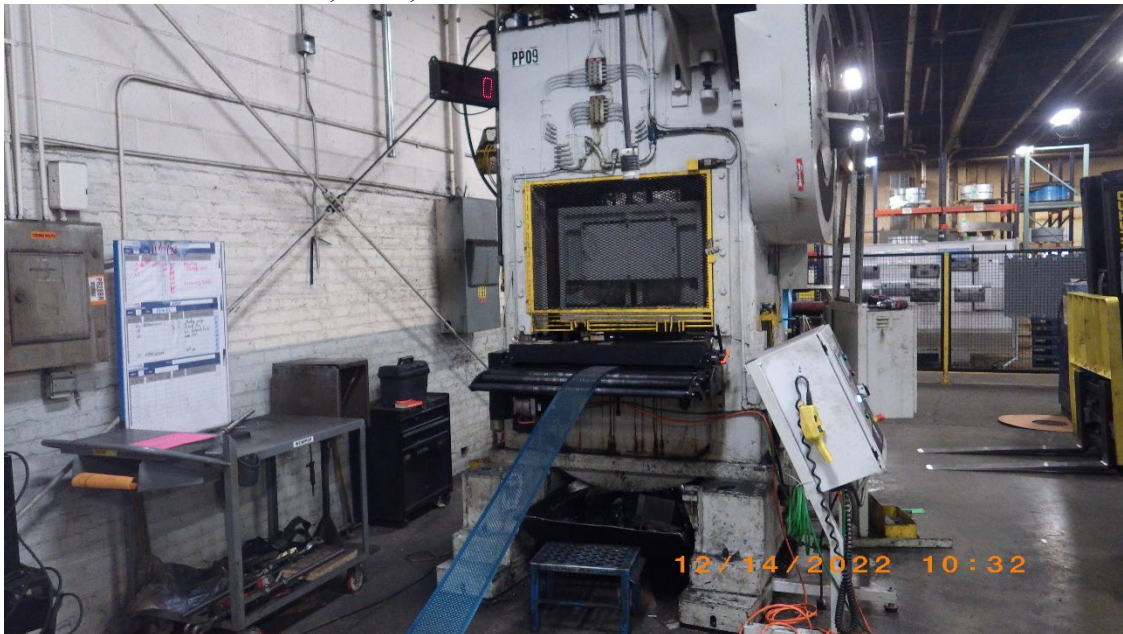
2: RIMG0106

Description: Perforation machine. Blue material in foreground is exiting the machine and is coated in vanishing oil.

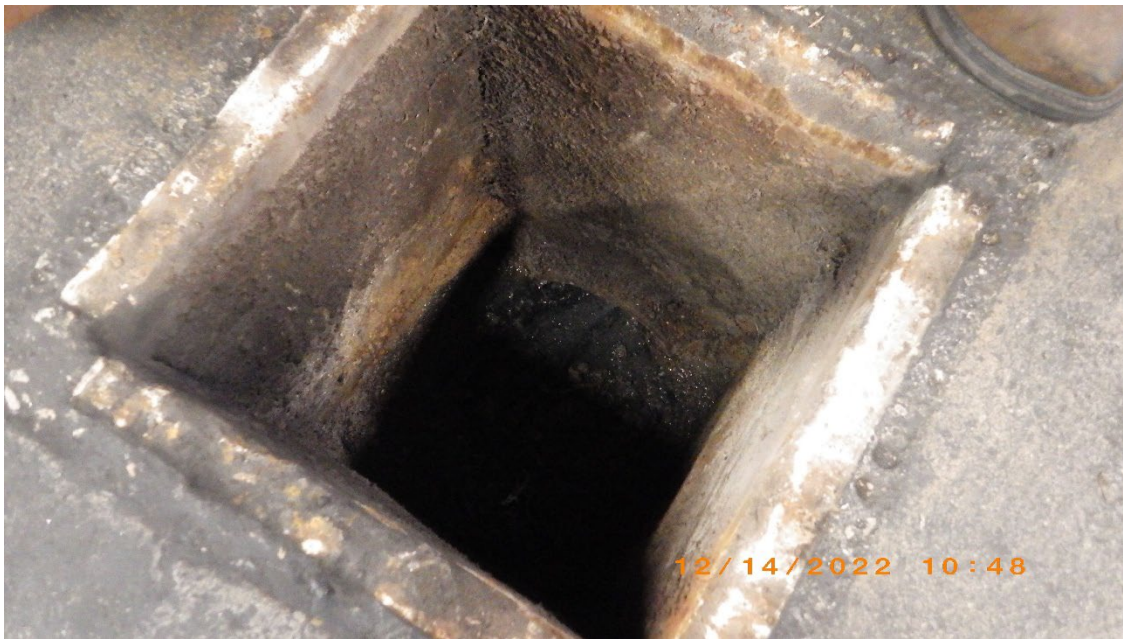
7: RIMG0111

Description: Sewer clean out with cap removed. Flash off. Depth is approximately 2 feet.

Location: Adjacent to Machine 182. Noted presence of oil and grease.

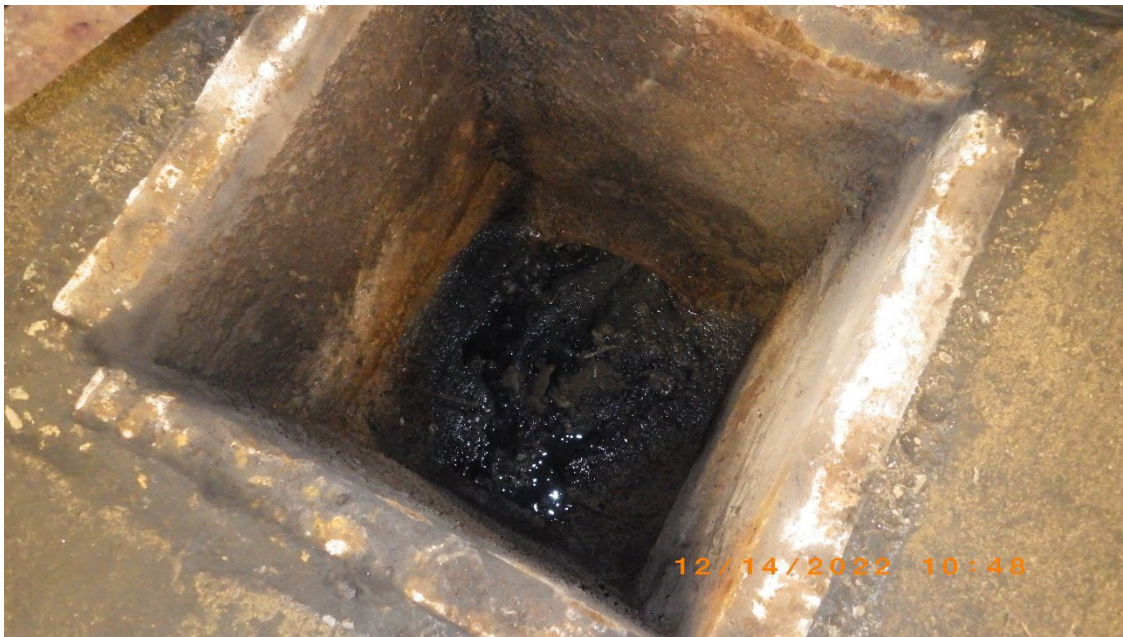
8: RIMG0112

Description: Additional photo of sewer clean out depicted in Photo 7 with cap removed. Flash on. Depth is approximately 2 feet. Note presence of oil and grease.

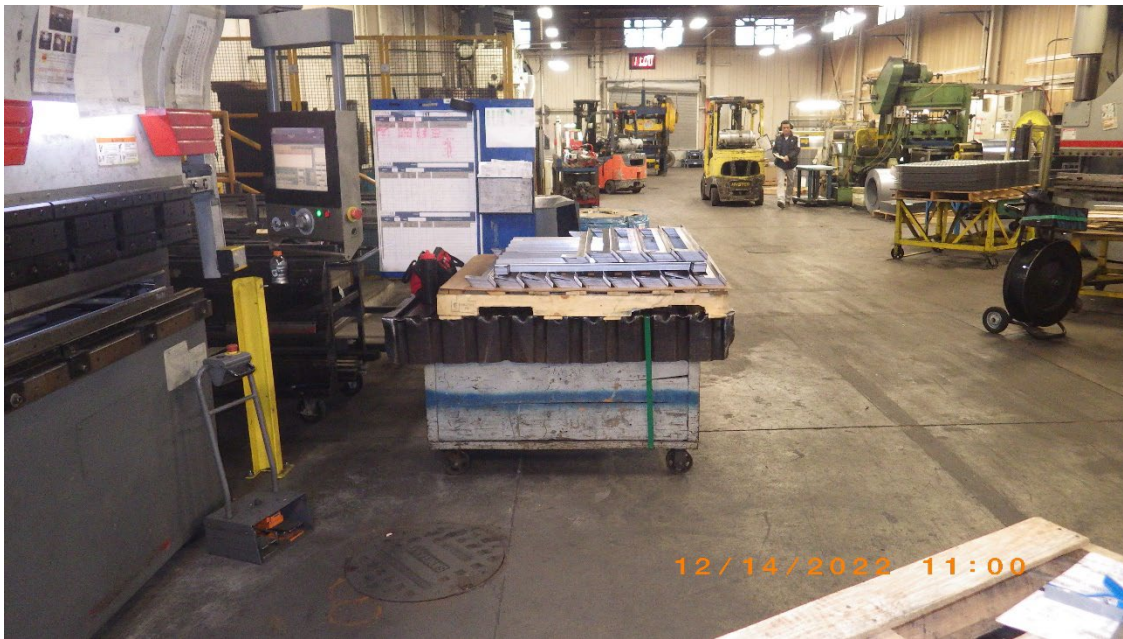
13: RIMG0117

Description: Overview of manhole which was labeled “Sanitary Sewer.”

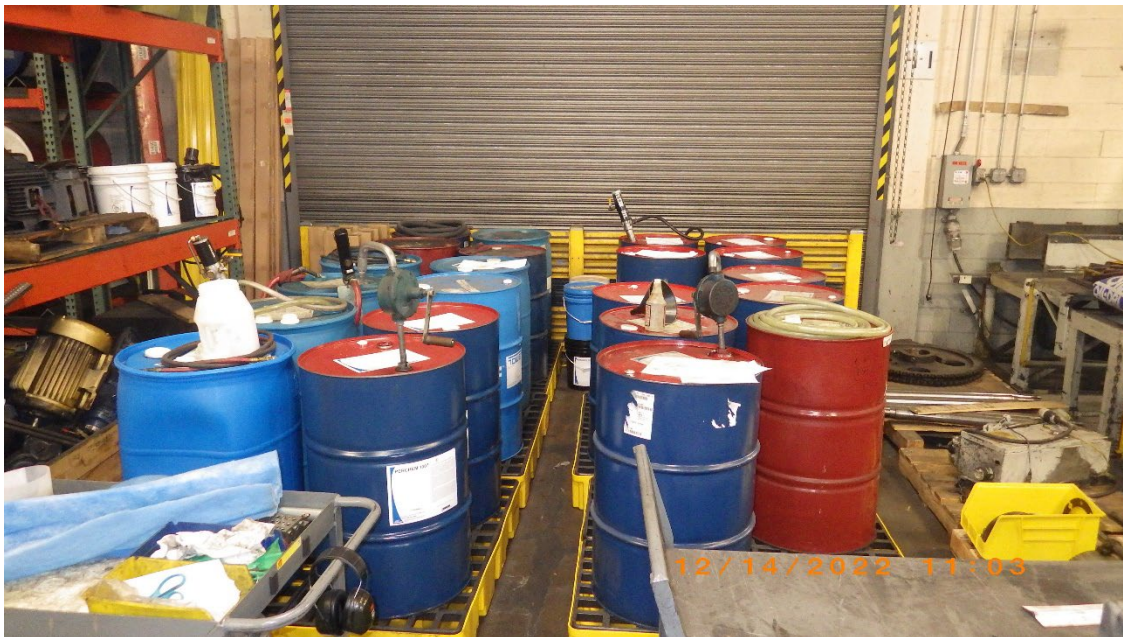
14: RIMG0118

Description: Overview of new oil storage 55 gal tanks with secondary containers.

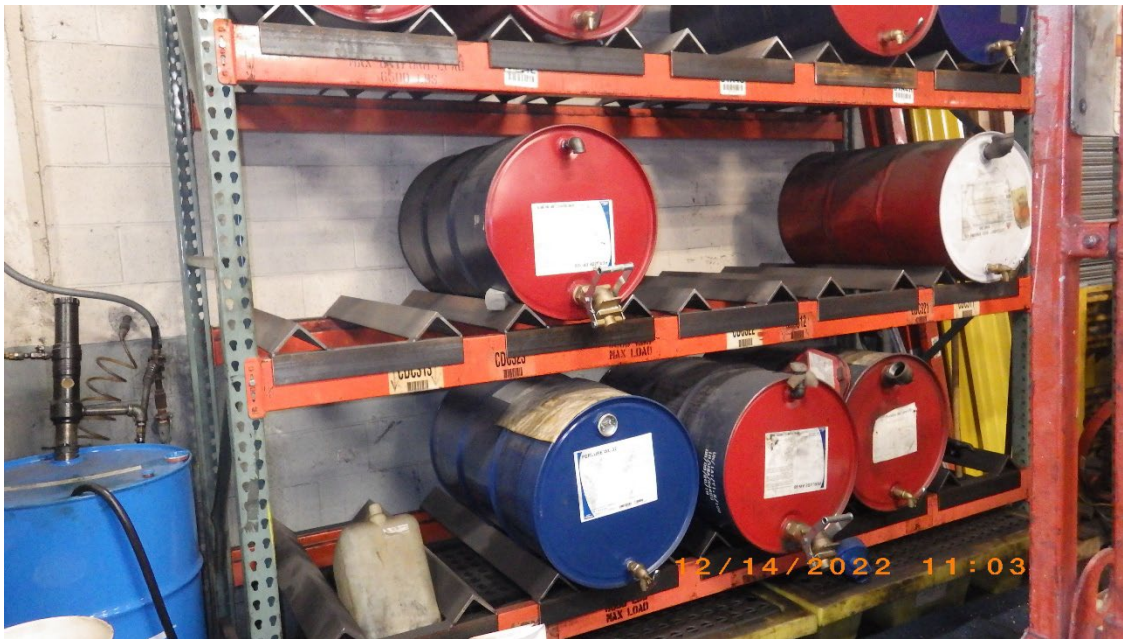
15: RIMG0119

Description: Overview of new oil storage of 55 gal tanks.

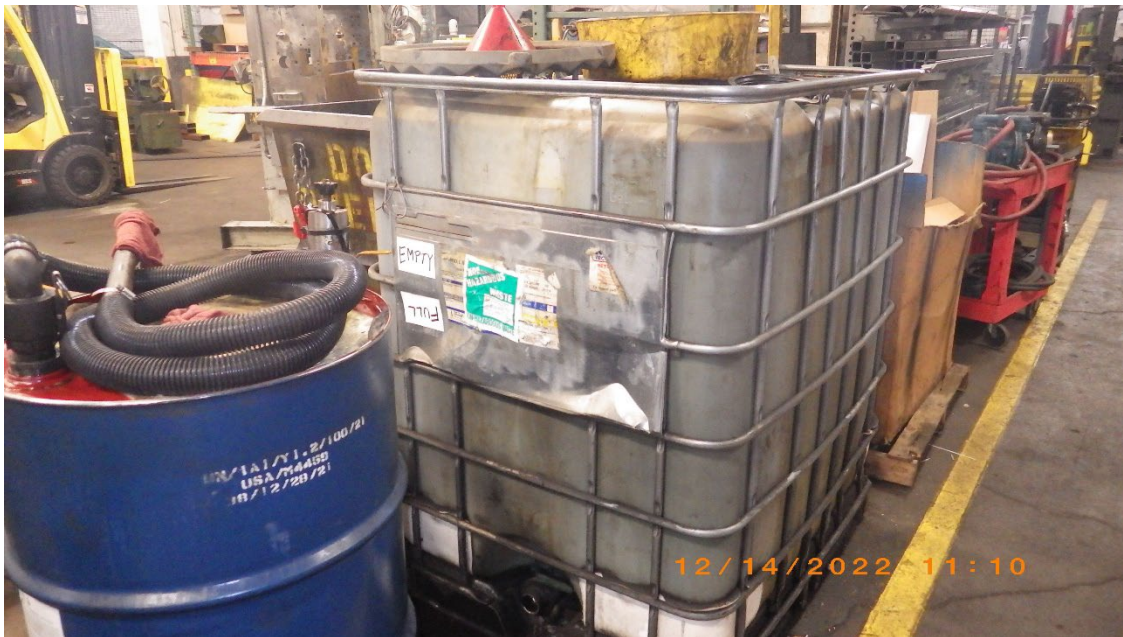
16: RIMG0120

Description: Tote full of used oil.

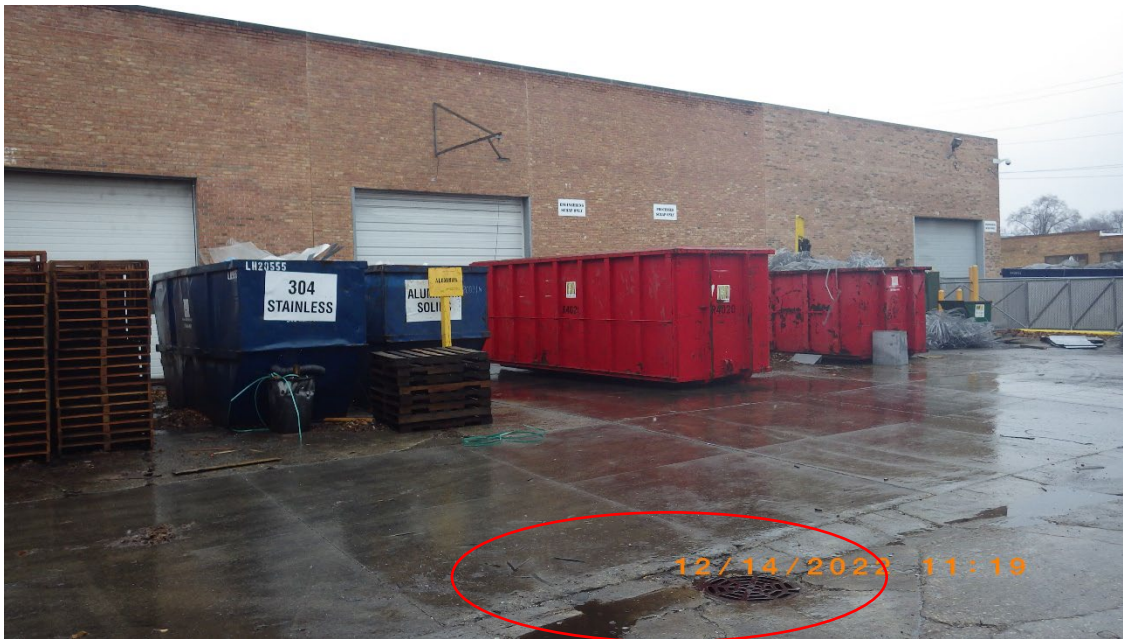
17: RIMG0121

EPA observed open dumpsters with scrap metal (waste materials associated with industrial activity), scrap metal on the ground exposed to stormwater, and flow of discolored storm water entering the storm drain (Photos #17 and #18).

Description: Overview of dumpsters used for engineered scrap metal storage. Note active rain during inspection and the flow of discolored storm water entering the storm drain in the red circle.

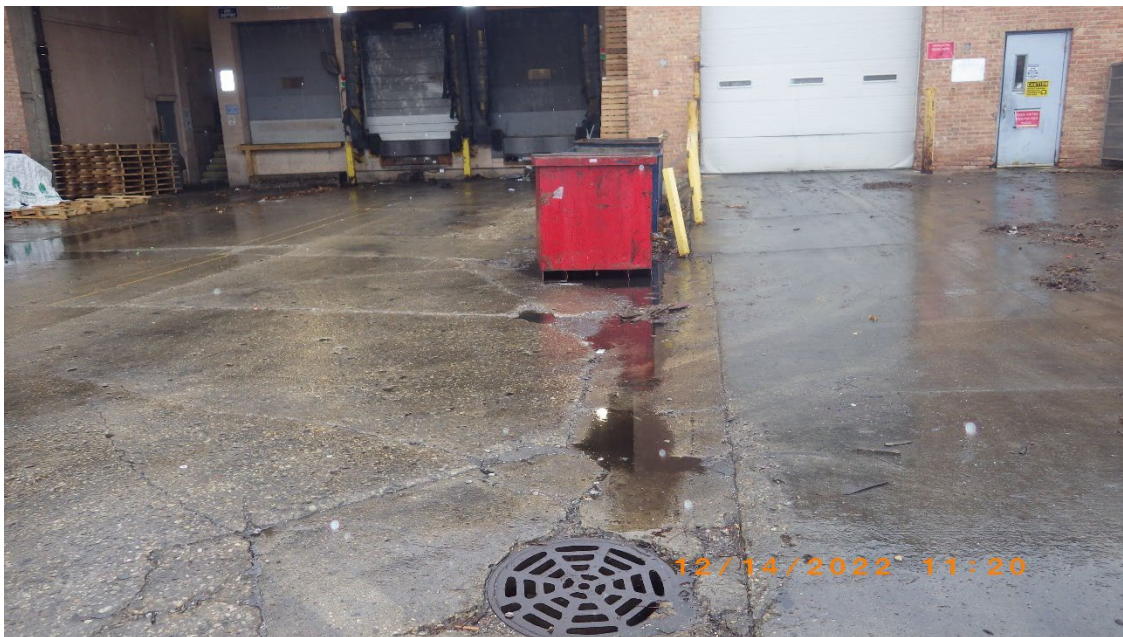
18: RIMG0122

Description: Discolored storm water entering storm drain adjacent to engineered scrap metal storage. Same storm drain depicted in Photo 17.
