# ECHLIN *Ignition* SERVICE BULLETIN

FEBRUARY 1977

## TIMING THE '77 OLDS TORONADO

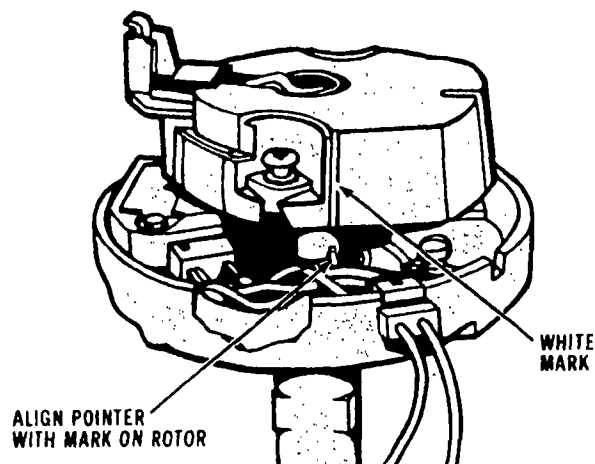
Next, look at the rotor. You will notice that it has a white mark down the left side which should be lined up with a pointer located on the inside base of the distributor. If not, loosen the distributor and adjust until the pointer is in line with the white mark on the rotor. (See Illustration)

Retighten the distributor bolt. This is the final distributor position and the distributor should not be moved or changed when setting the timing.
