**Region 6 - Enforcement & Compliance Assurance Division**  
**INSPECTION REPORT**

| Media Program: | Water | |
| Regulatory Program(s) | SDWA-PWS | |
| Company Name: | <b>Rocky Creek Park 1</b> | |

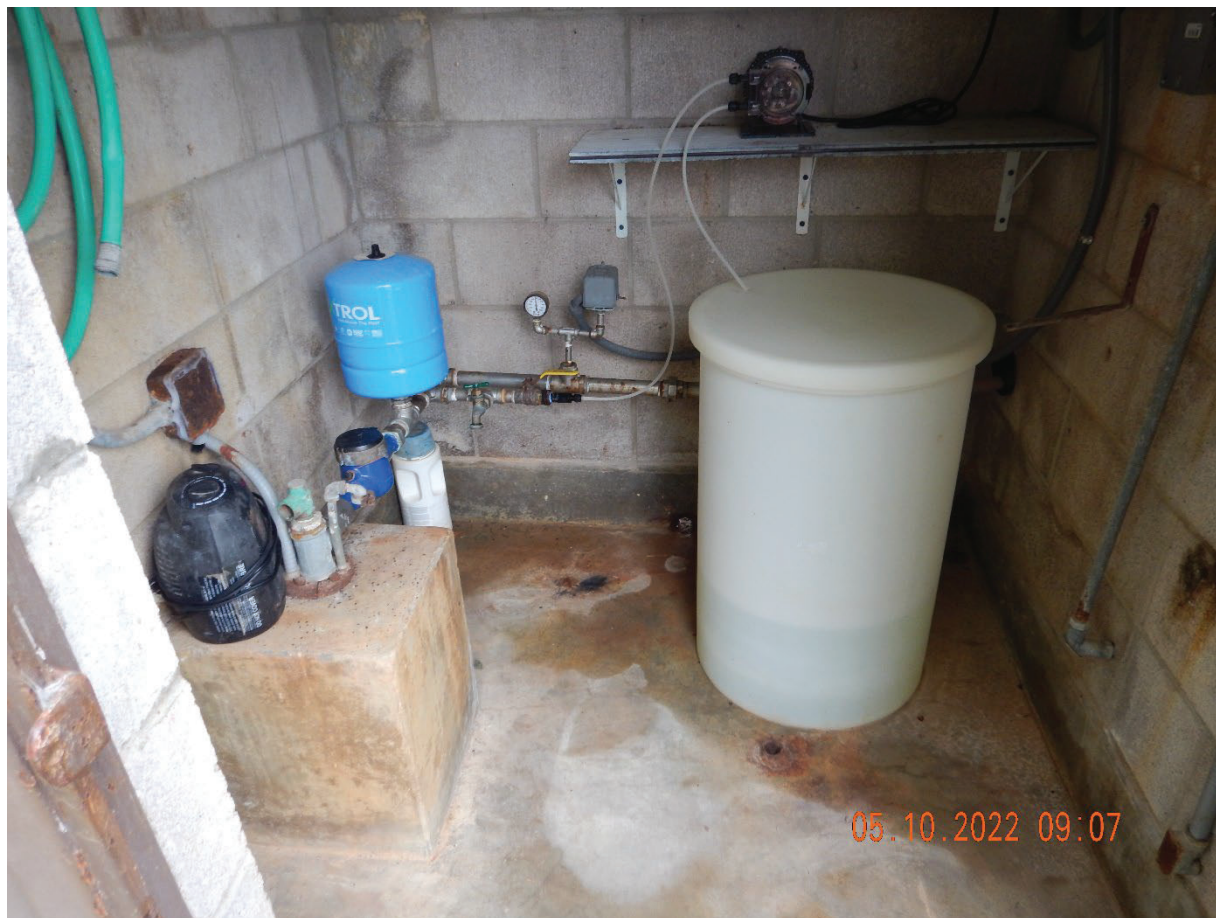
Photo No. 1

- Wellhouse is cinderblock building with metal door with lock
- Wellhouse generally clear of debris (Photo 1)
- Small animal nest located above electrical box (Photo 2)
- Liquid chlorine storage tub missing label (Photo 3)
- Liquid chlorine fed by peristaltic pump (Photo 4)
- Wellhead has new seal and vent is covered with metal mesh (Photo 5)
- Small hole without cover where liquid chlorine is fed (Photo 6)
- Pressure maintained in system by 500-gallon hydropneumatic tank inside security fencing (Photo 7-9)
- Hydropneumatic tank replaced in 2020 as part of modernization effort (Photo 10)
- Well house secured by padlock (Photo 11)

Description: Cinderblock well house with liquid chlorine and pressure tank.

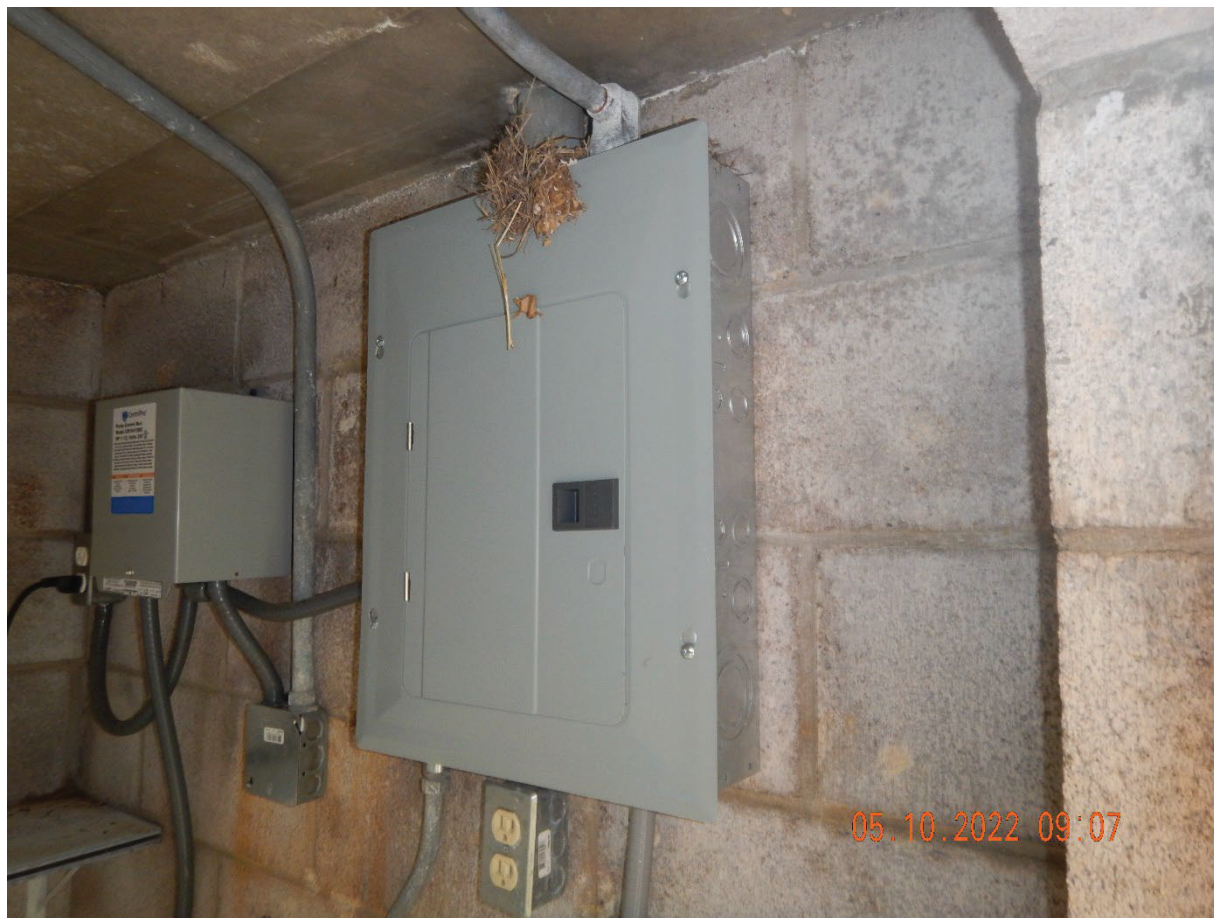
Photo No. 2

Description: Electrical Panel with animal nest

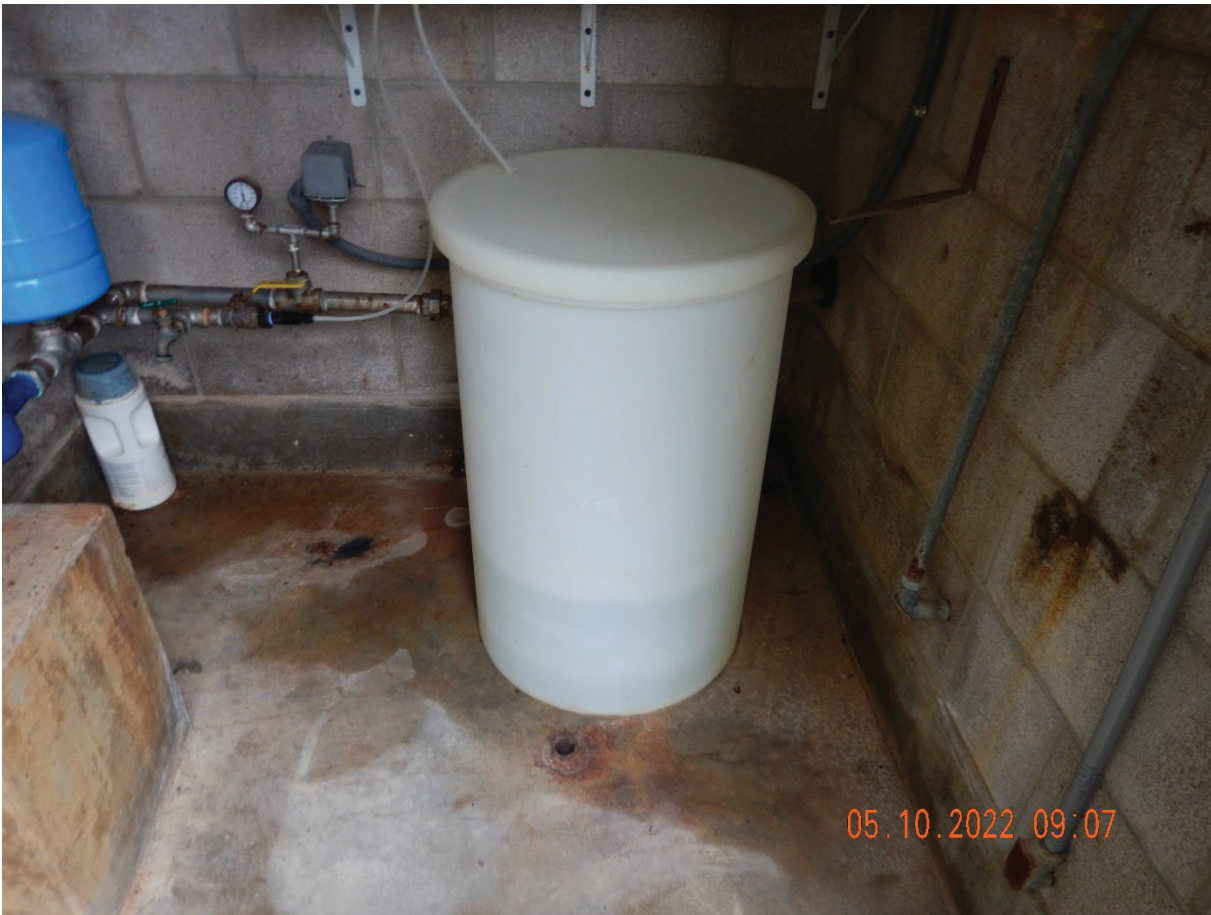
Photo No. 3

- The liquid chlorine container was unlabeled
- The liquid chlorine container had an open hole where the tubing is located

Description: Liquid chlorine container, not labeled

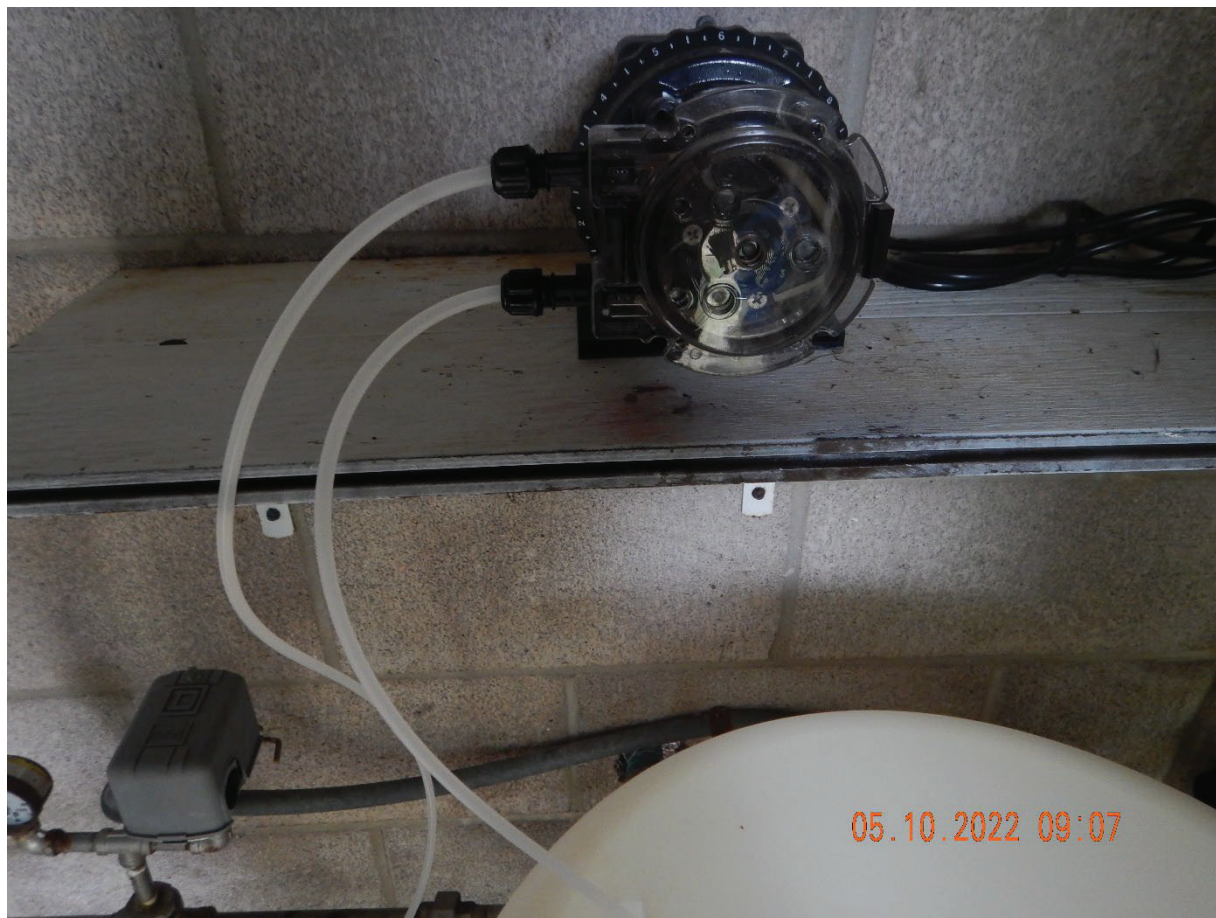
Photo No. 4

Description: Liquid chlorine container and peristaltic pump

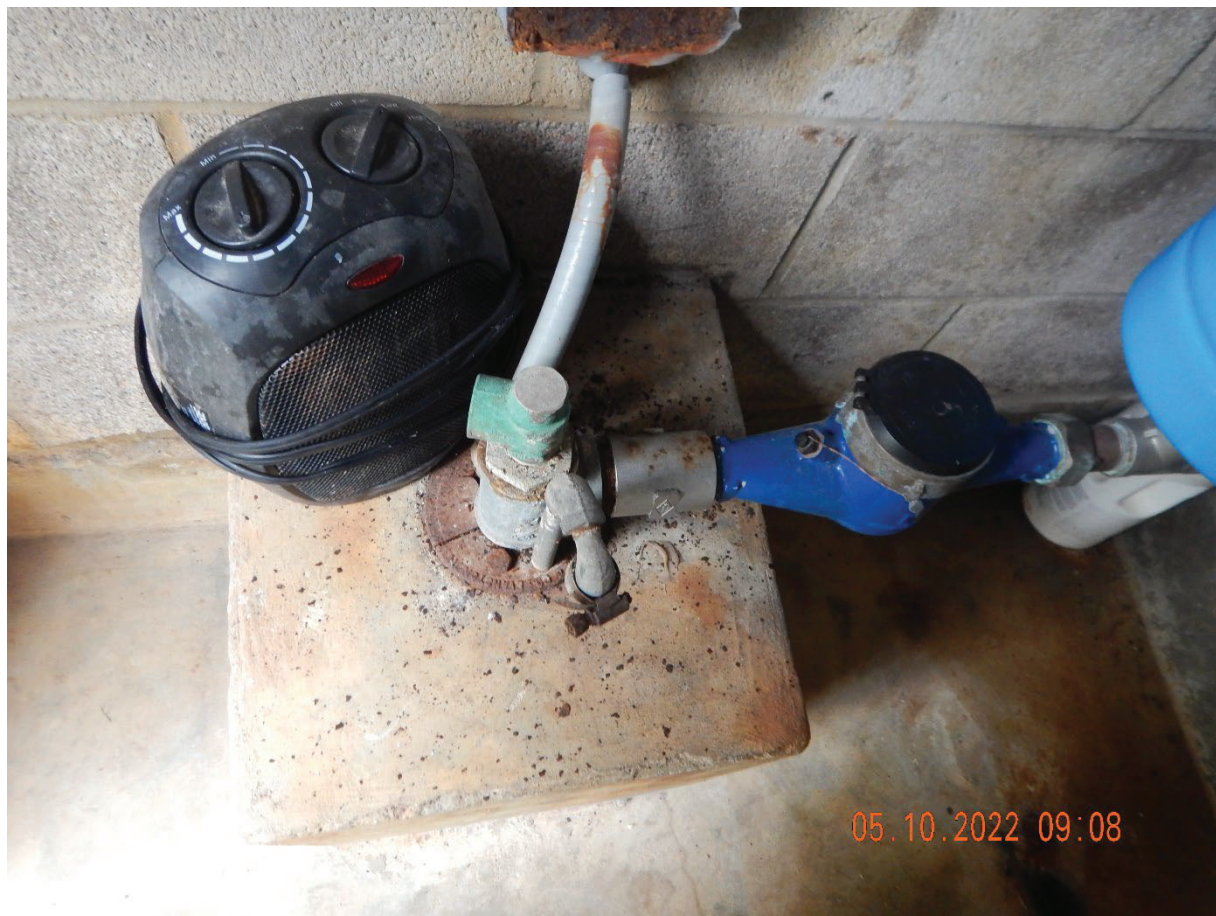
Photo No. 5

Description: Wellhead and vent.

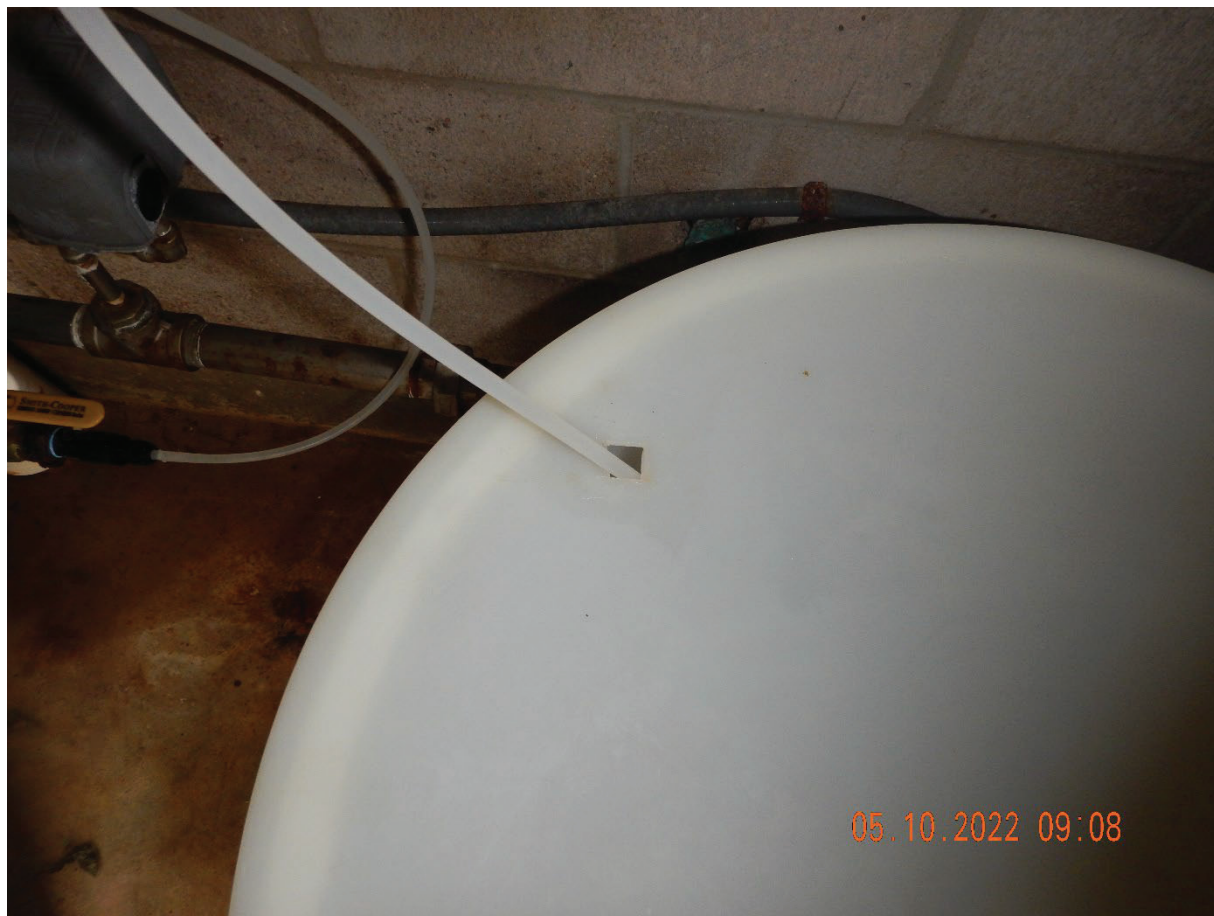
Photo No. 6

Description: Open hole for tubing on chlorine tank

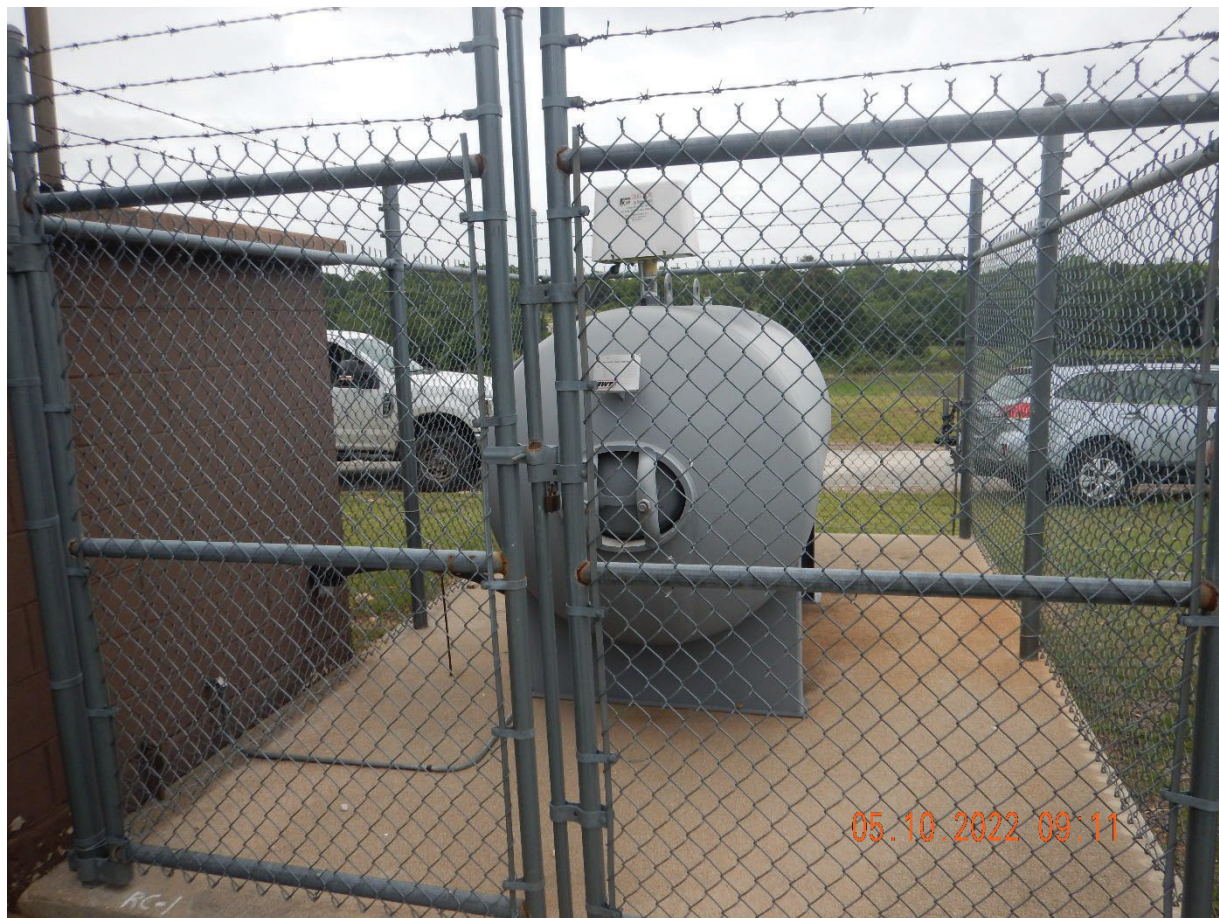
Photo No. 7

Description: Hydropneumatic tank 500 gallon

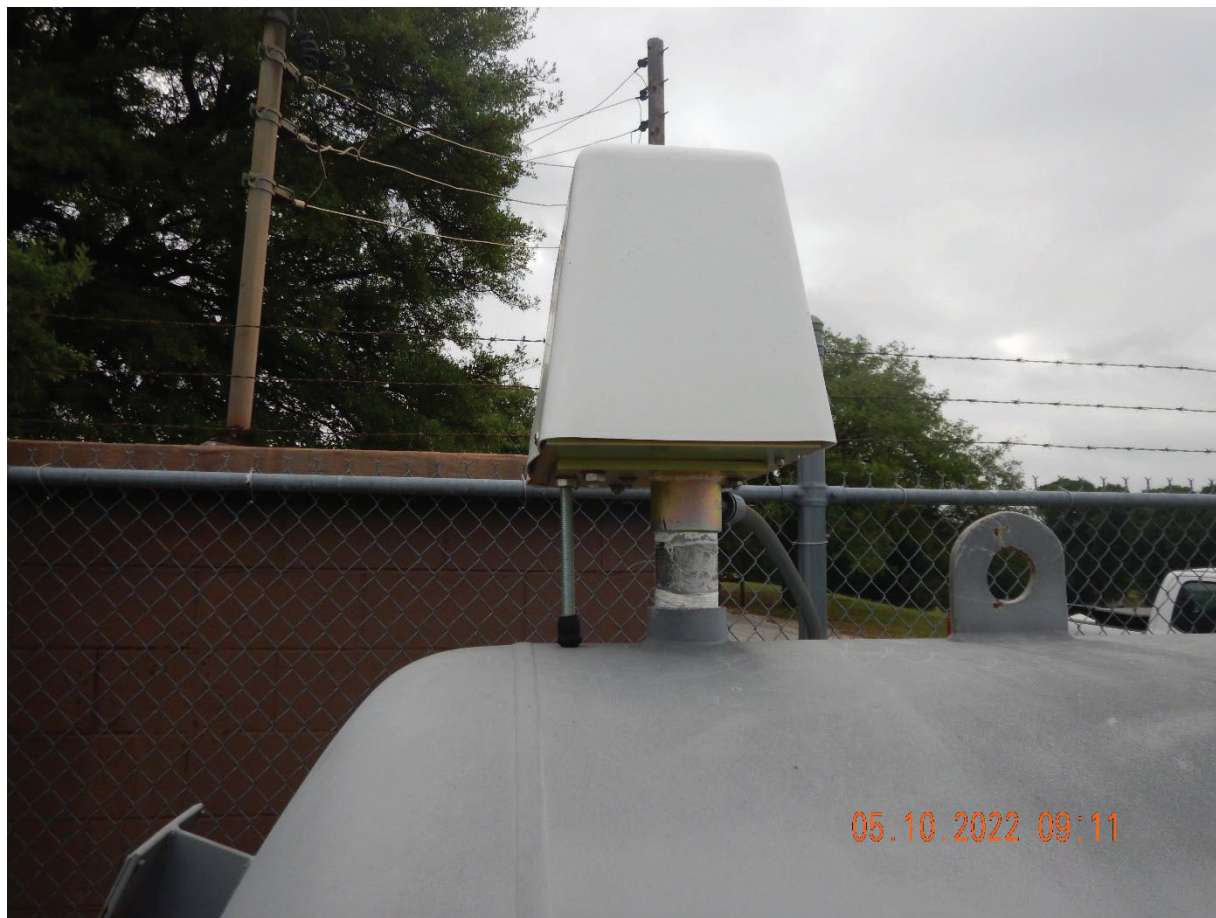
Photo No. 8

Description: Overflow on tank

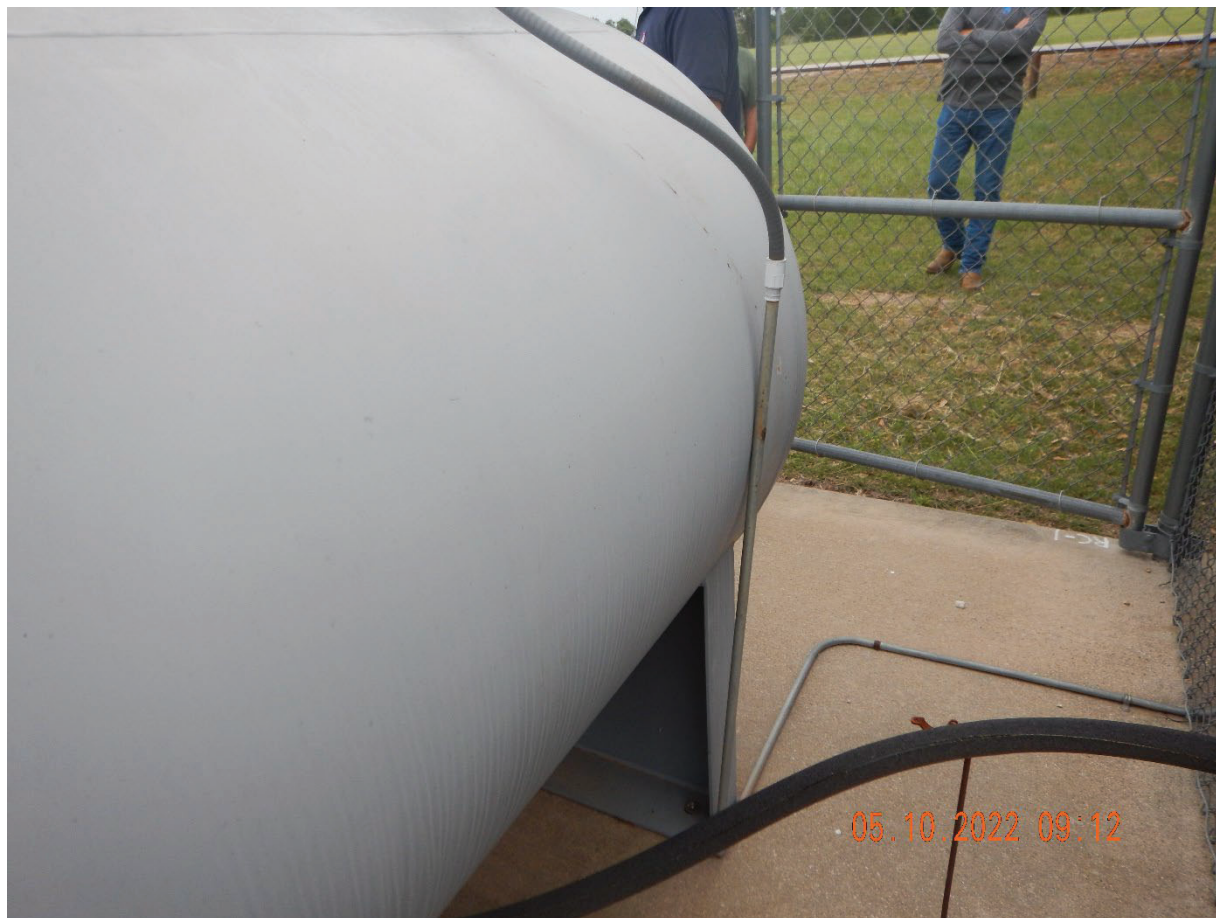
Photo No. 9

Description: Hose for relief valve on tank

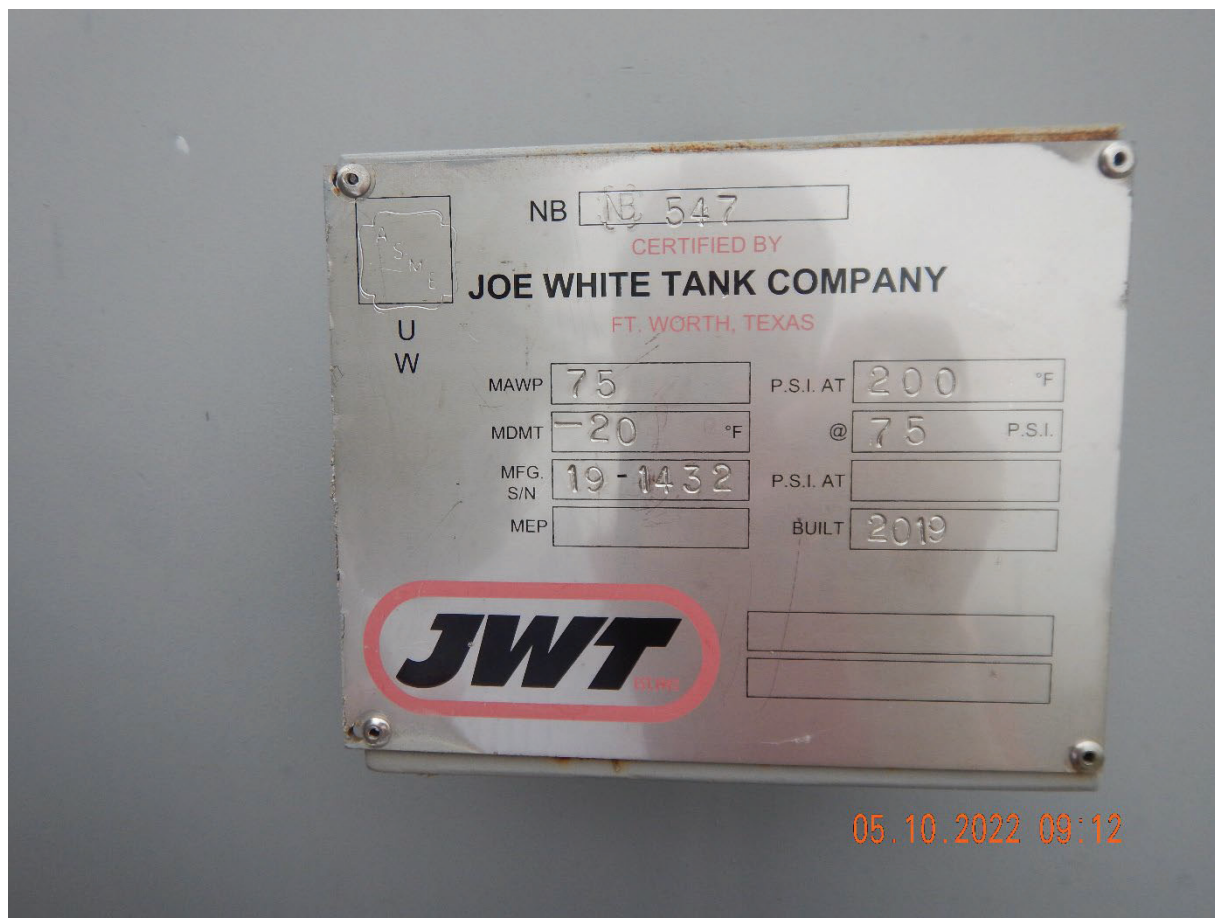
Photo No. 10

Description: Tab label. New in 2020.

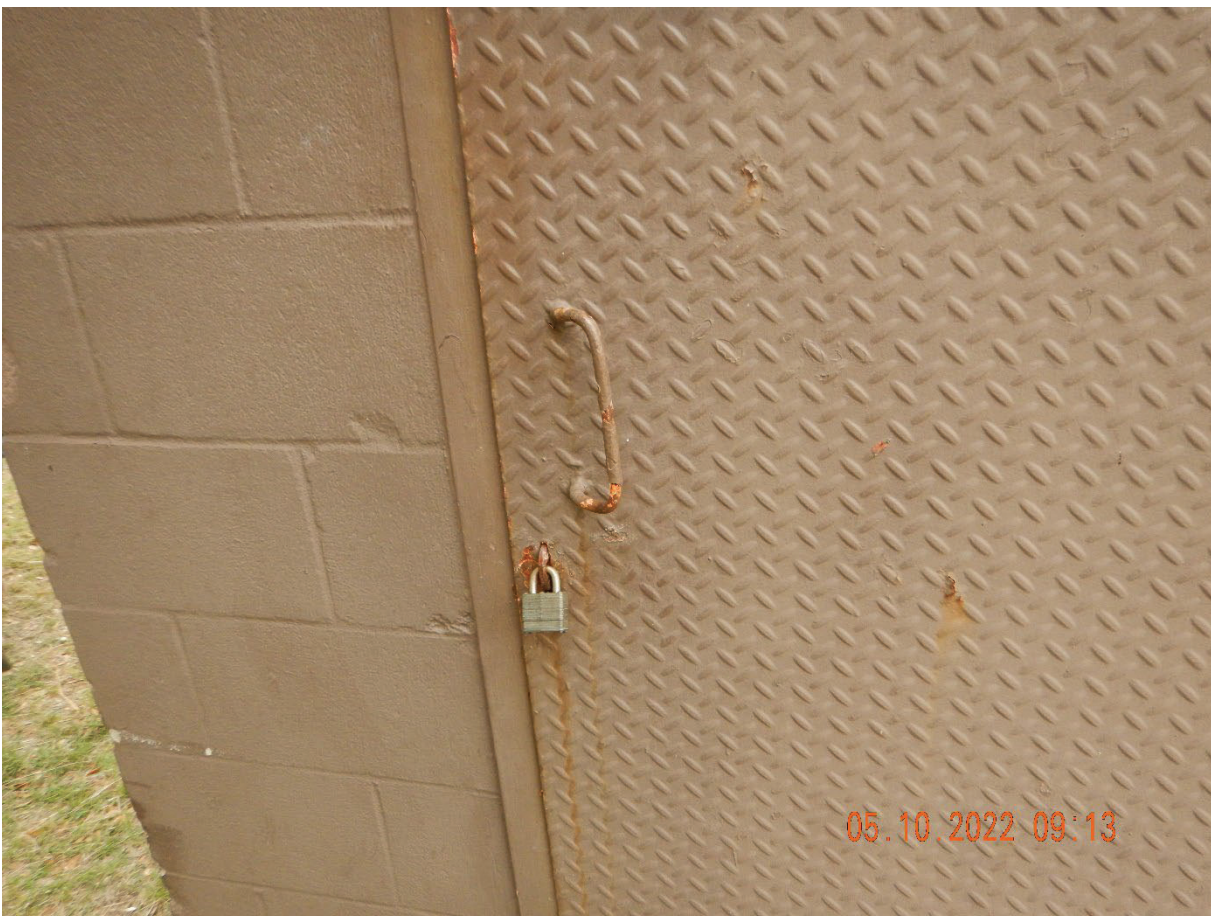
Photo No. 11

Description: Lock on wellhouse.
