**Region 6 - Enforcement & Compliance Assurance Division**  
**INSPECTION REPORT**

| Inspection Date(s): | 11/08/2024 | |
| Company Name: | <b>SMI Operating Company, LLC</b> | |
| Facility Name: | <b>Walker-Gregory #6 &amp; #8 Tank Battery</b> | |

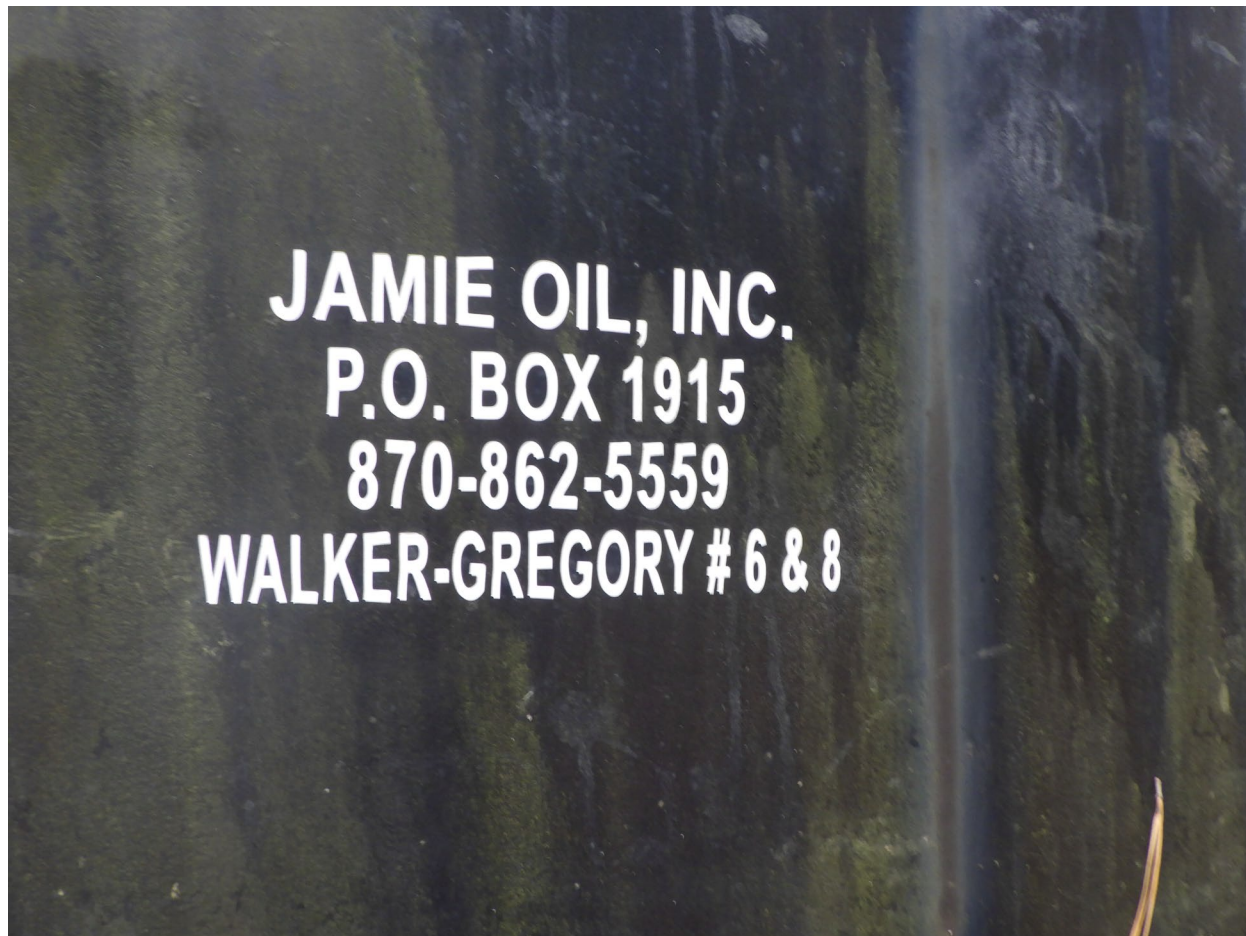
I observed the SMI Operating Company, LLC / Walker-Gregory #6 & #8 Tank Battery facility and associated secondary containment, storage tanks, and separator/heater treater; see Appendix 1 (Photograph Log), Photo No. 1 and No. 2. For additional GPS location and photo metadata, see Appendix 1.

**Description:** Looking ESE, this photo shows the signage at the facility.

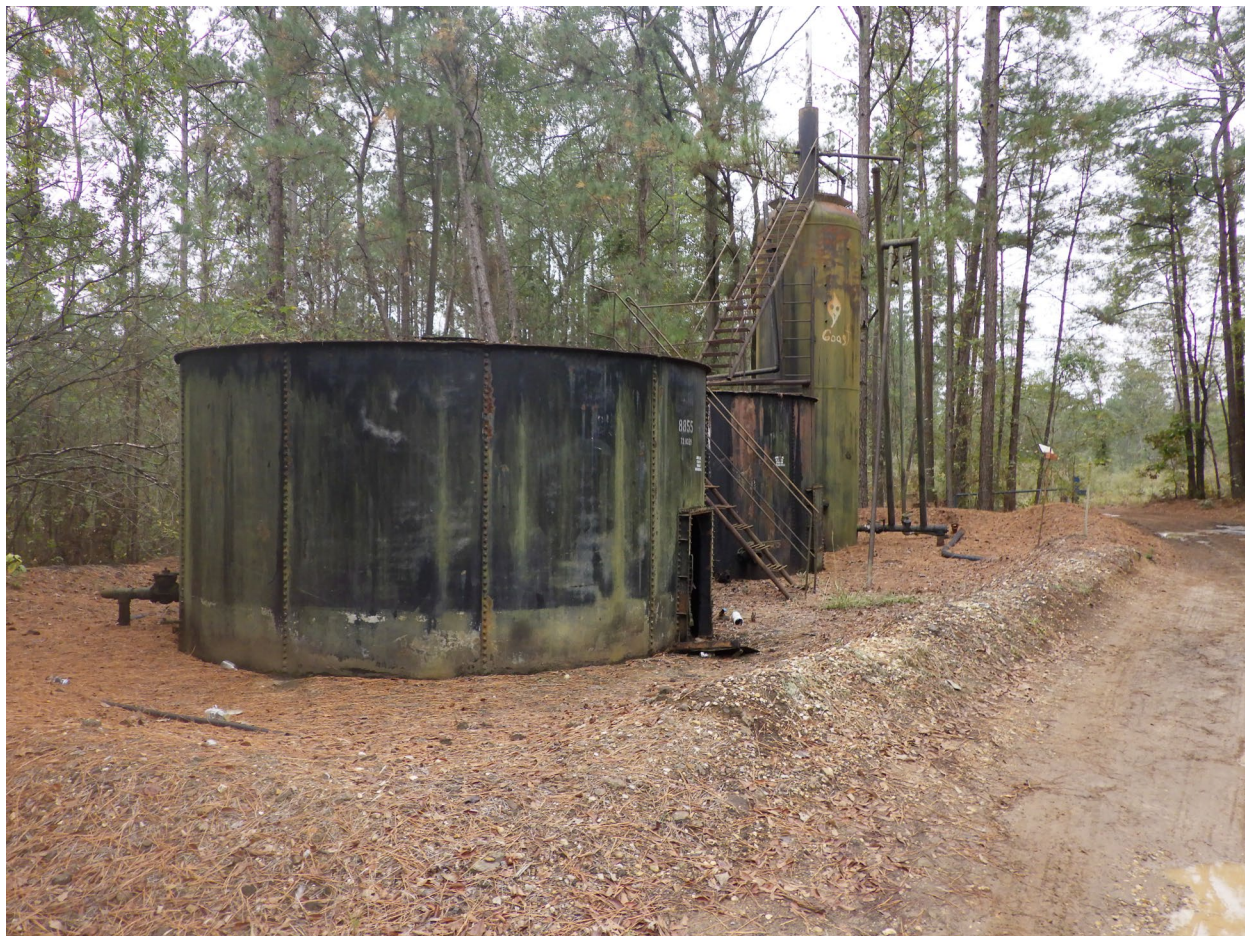
Photo No. 2

**Description:** Looking SSE, this photo shows an overview of the facility.

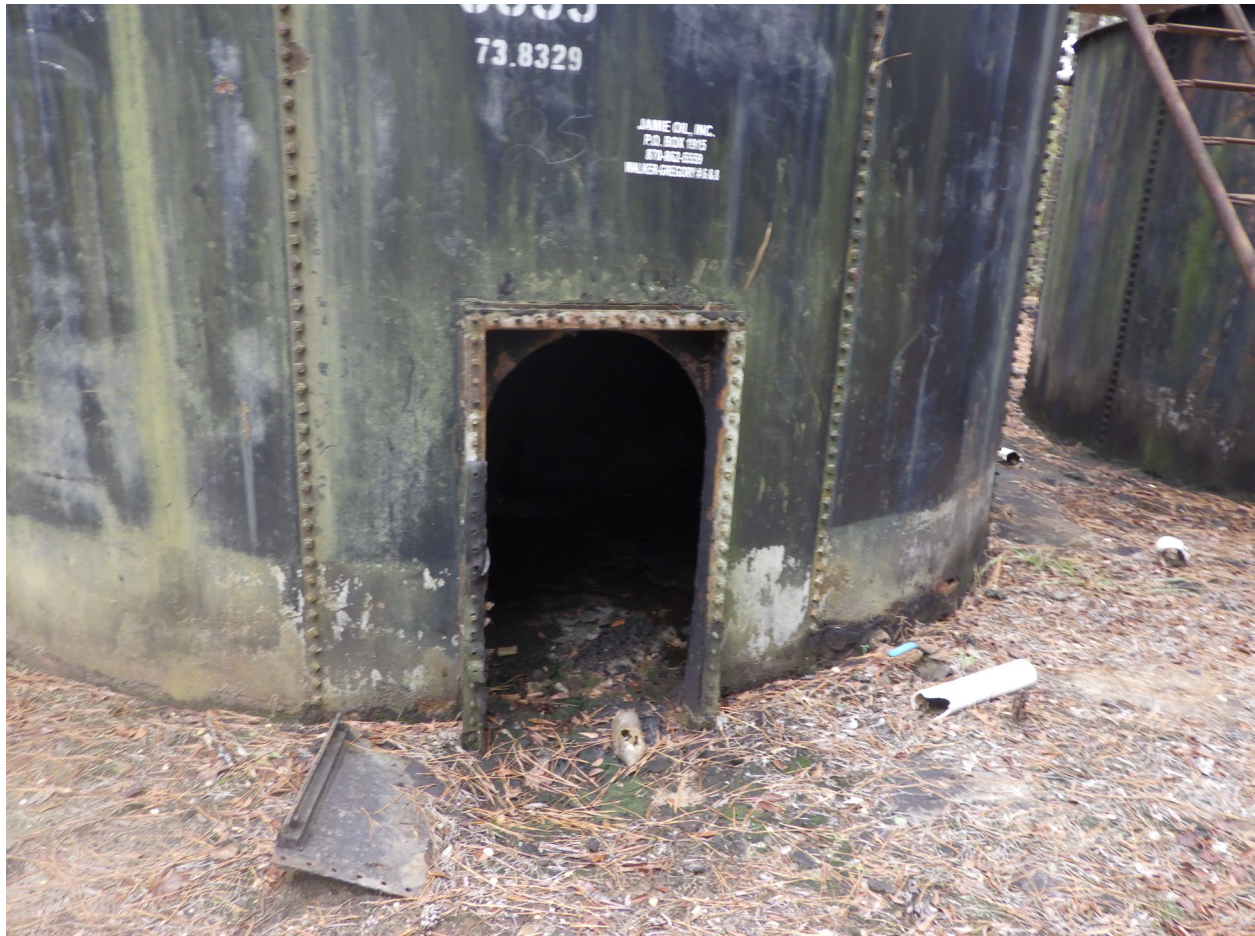
Photo No. 3

I observed one (1) tank with an open hatch, see Photo No. 3.

**Description:** Looking ESE, this photo shows an opened hatch on one of the tanks inside secondary containment.

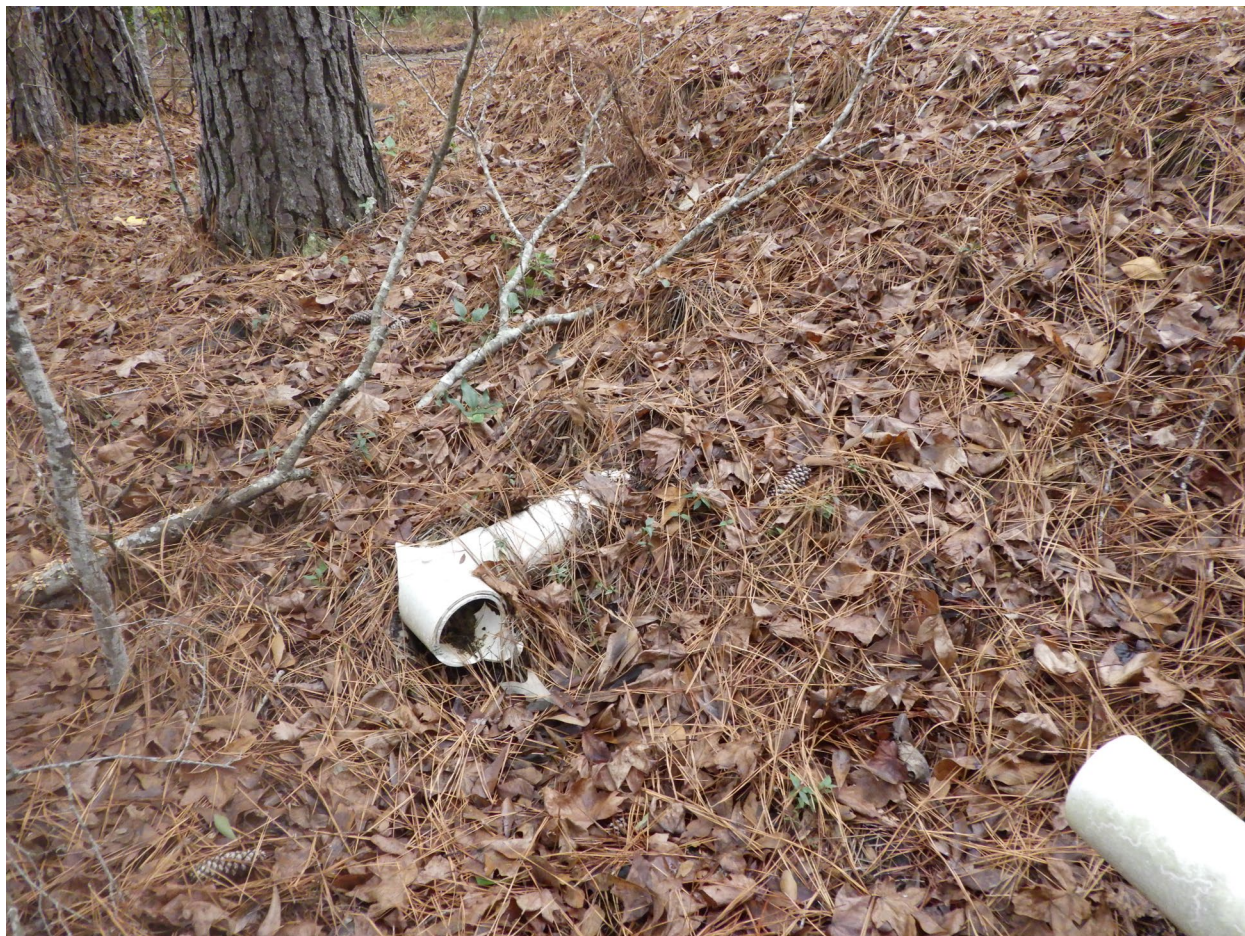
Photo No. 4

I observed the drainpipe for secondary containment to be broken and opened outside containment, see Photo No. 4.

**Description:** Looking NNW, this photo shows the broken and opened drainpipe outside secondary containment.

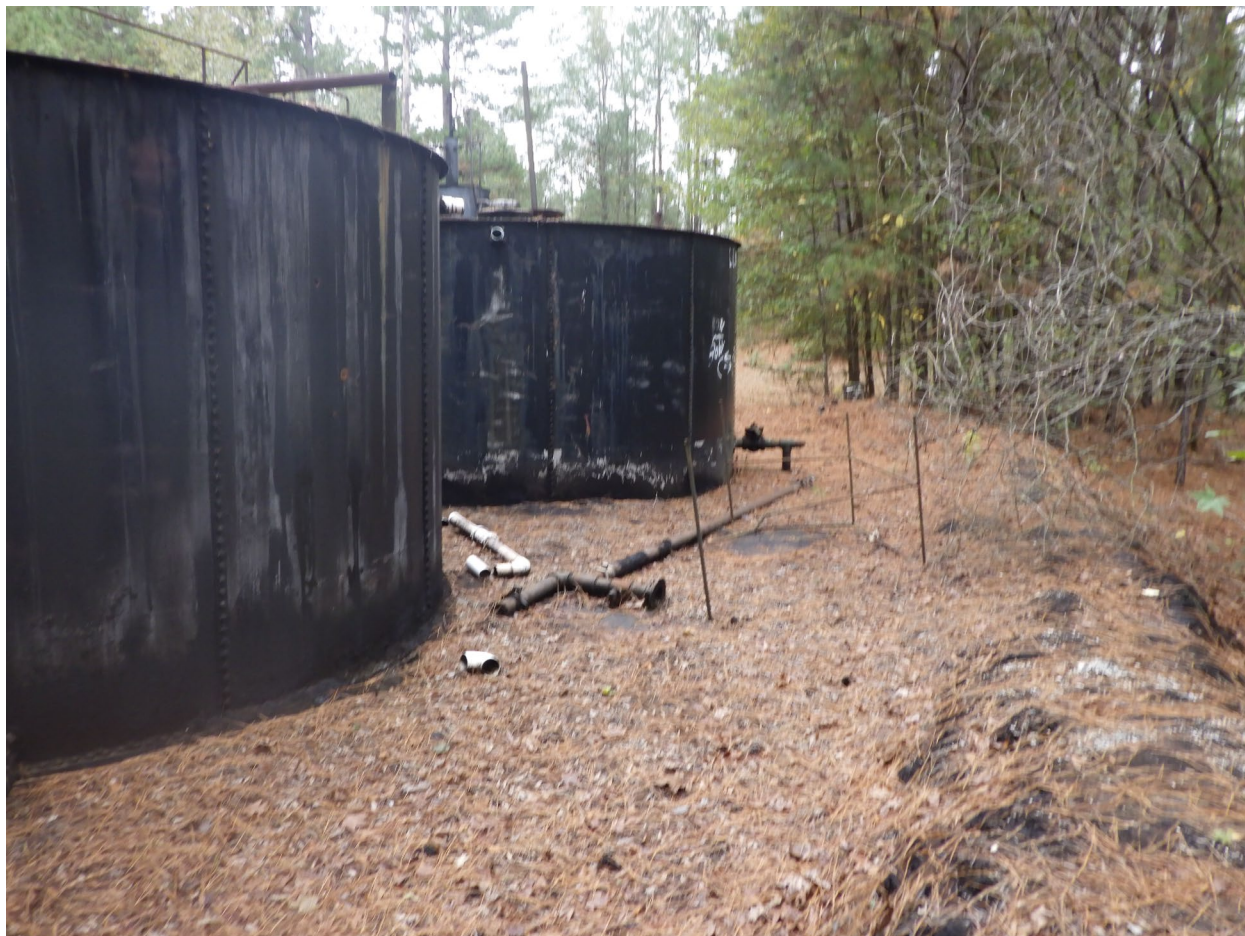
Photo No. 5

I observed tank bottom crude oil and solids used on the secondary containment berms, see Photo No. 5.

**Description:** Looking NNE, this photo shows tank bottom crude oil and solids applied to the berms for secondary containment.
