U.S. Environmental Protection Agency Region 5

Purpose: Industrial User Pretreatment Compliance Inspection

Facility: Manasek Acquisition Company, LLC d/b/a Warner Bodies
11700 North SR37
Elwood, Indiana 46036

Inspection Date: April 14 and 15, 2021

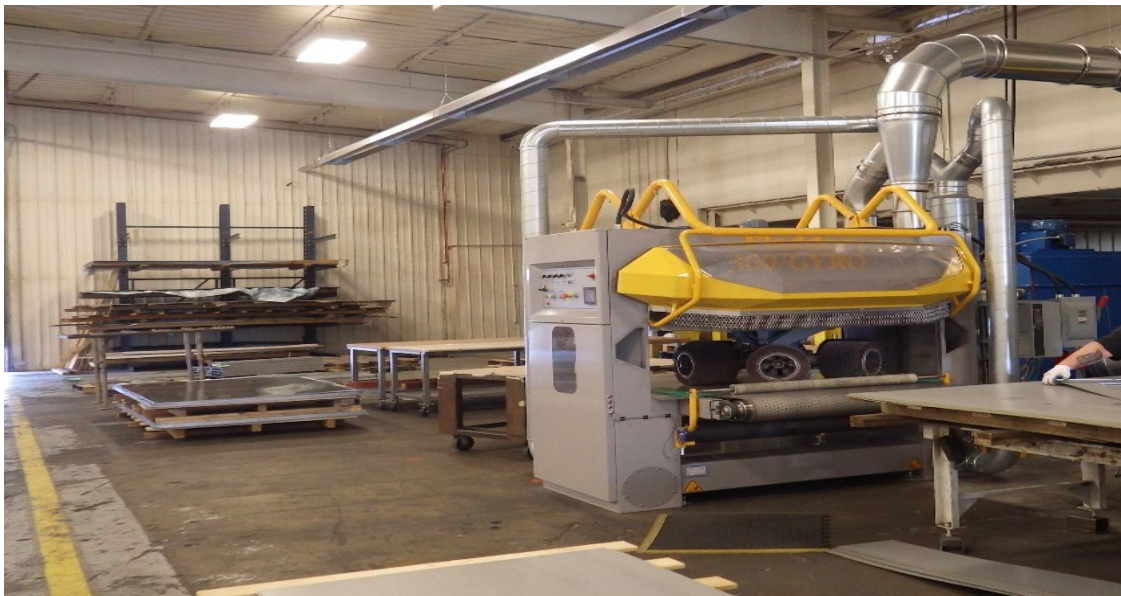
2: RIMG0002

We then proceeded to inspect the newly installed deburring machine used for smoothing the metal sheets (photo 2). This machine is equipped with a dust collection system designed to further remove fine metal particles formed as a result of deburring. Mr. Lapp stated that the dust collection is also expected to capture and reduce the amount of zinc from the recently cut metal sheets and hence it would reduce zinc loading in the facility wastewater prior to pretreatment. The facility stopped using the sandblasting machine they used in the past and installed the deburring machine for effective smoothing and capturing fine metal particles from entering the environment.

Description: Newly installed deburring machine with dust collection. Facility representatives stated that they hoped the dust collection would reduce zinc loading in wastewater.

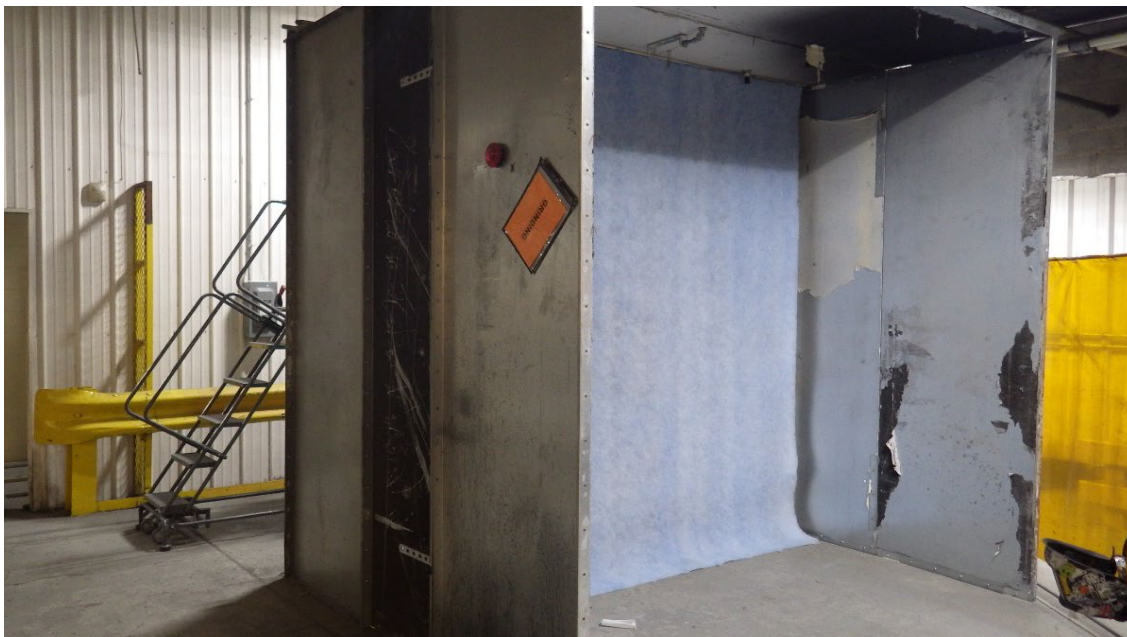
12: RIMG0012

Description: Dust collection with no external vent.

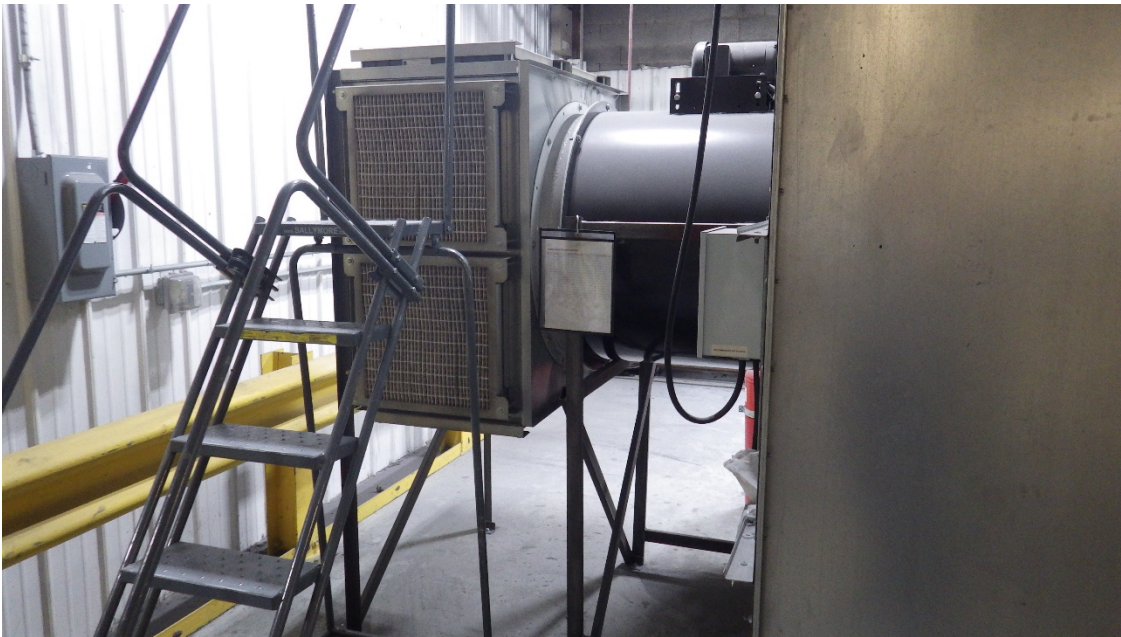
13: RIMG0013

Description: Dust collection with no external vent.

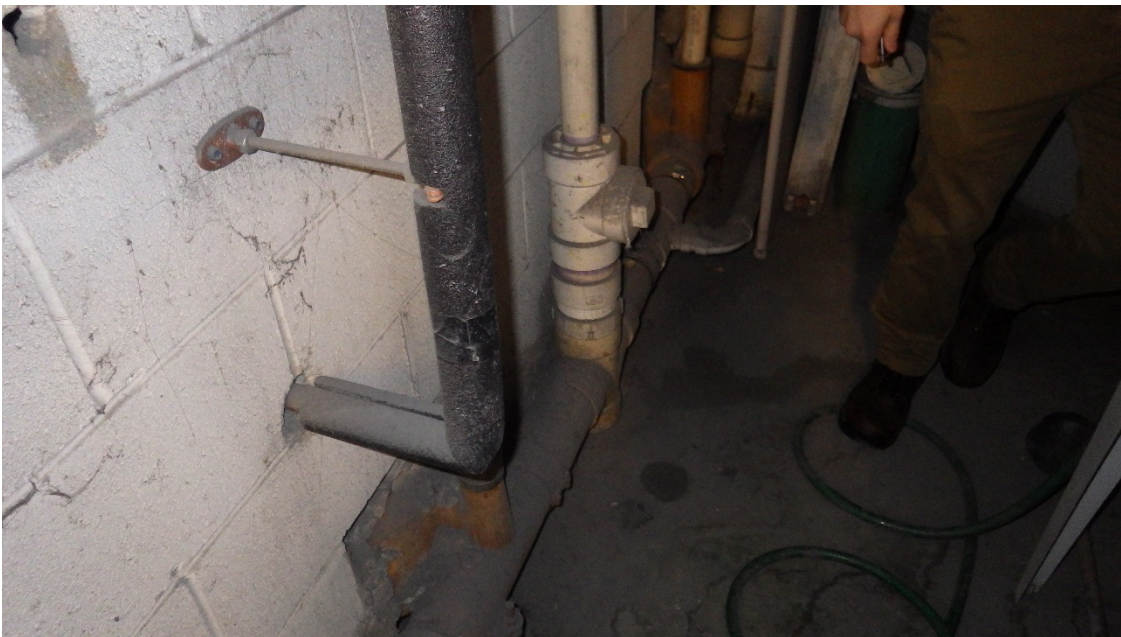
14: RIMG0014

Description: Processwaster connection to sewer line.

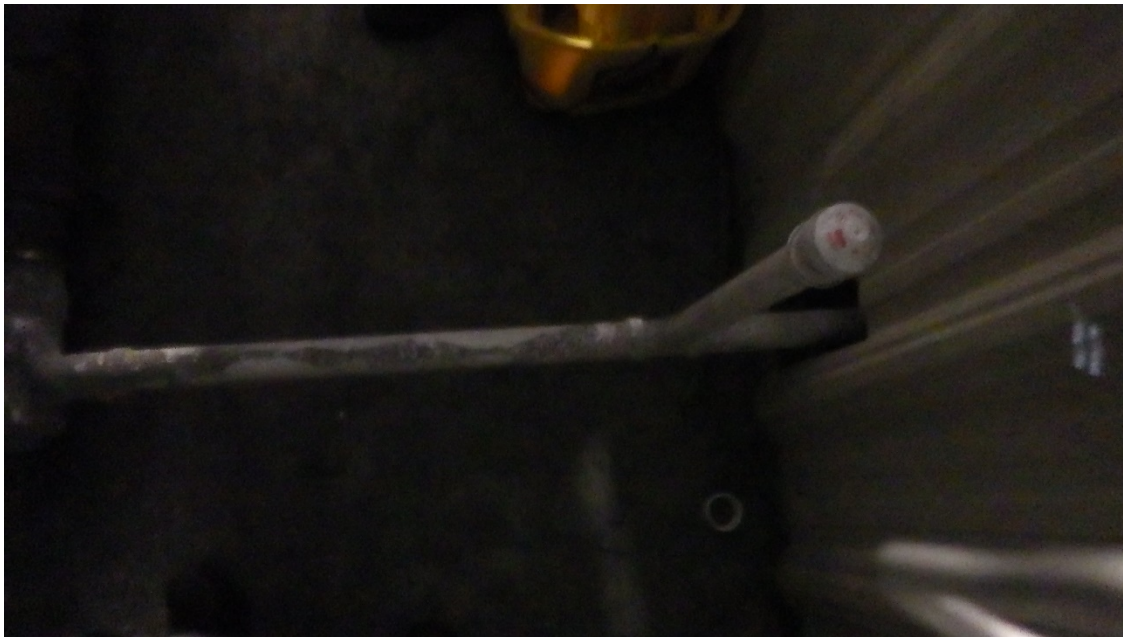
15: RIMG0015

Description: Pipe coming through the western wall and joining sewer line.

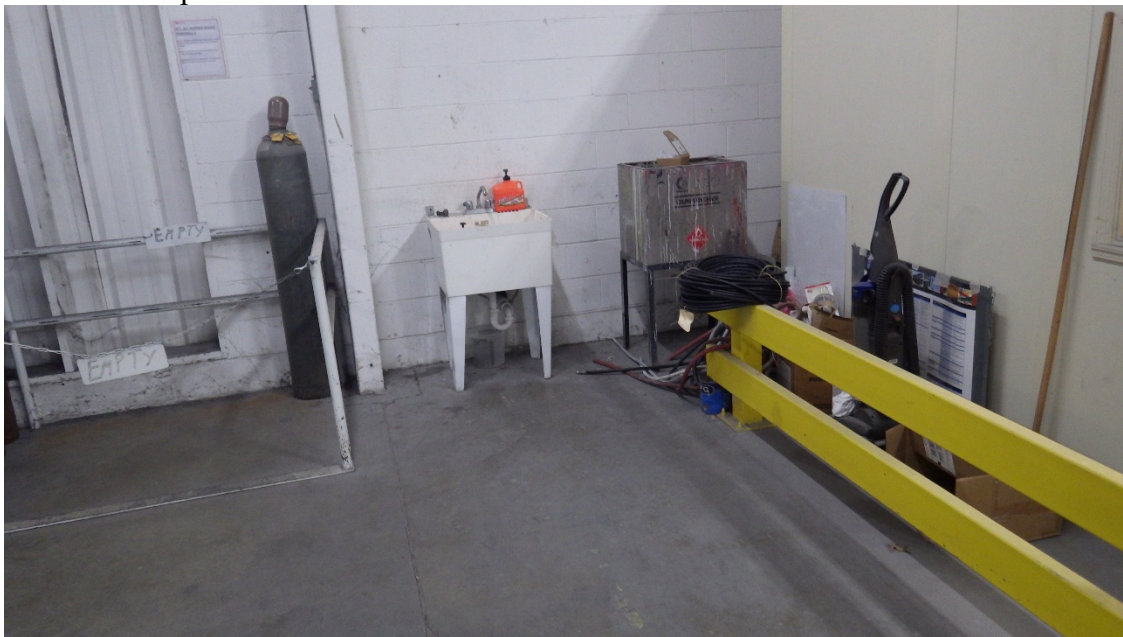
16: RIMG0016

We asked Mr. Lapp to show us the process wastewater connection to the sewer line (photo 14). We noticed a pipe coming through the western wall and joining sewer line (photo 15). That pipe is connected to the sink on the west side of the wall (photo 16). Mr. Lapp stated that the facility staff use that sink to wash their hands during breaks and at the end of their shift.

Description: Sink on the west side of the wall seen in photo 15. Source of pipe identified in photo 15.

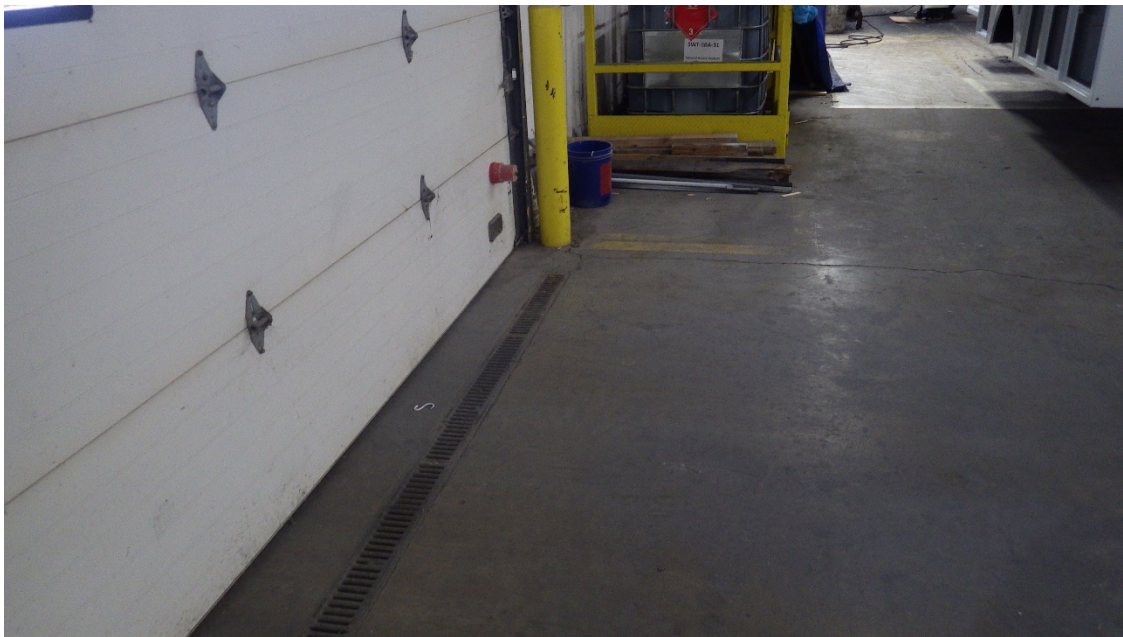
25: RIMG0025

Description: Floor drain by exterior door west of undercoating area.

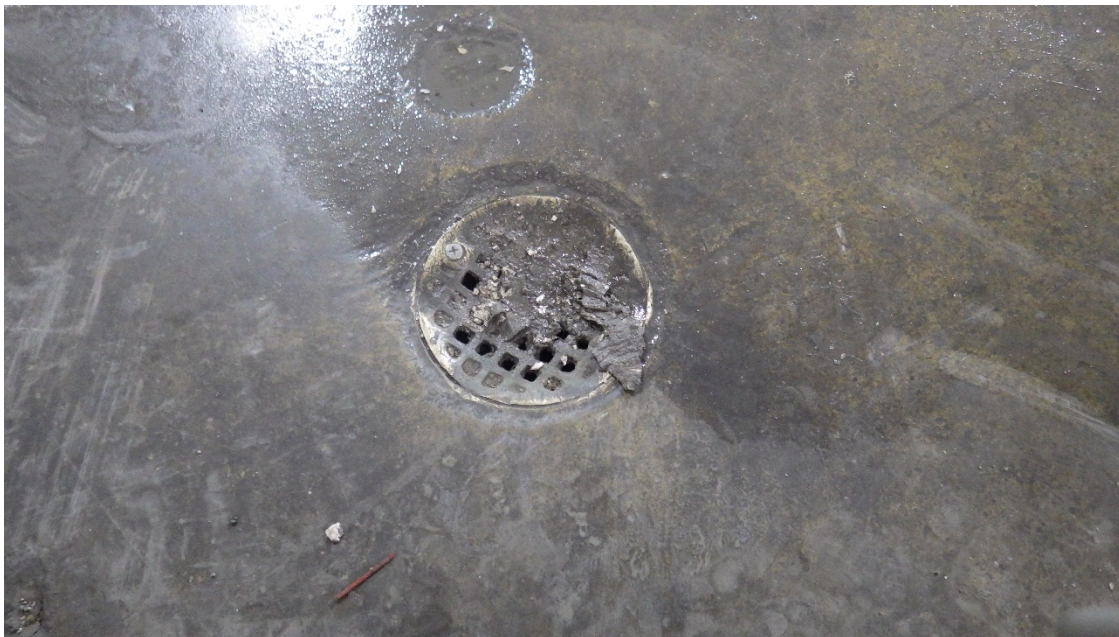
27: RIMG0027

Description: Round floor drain south of parts wash area.

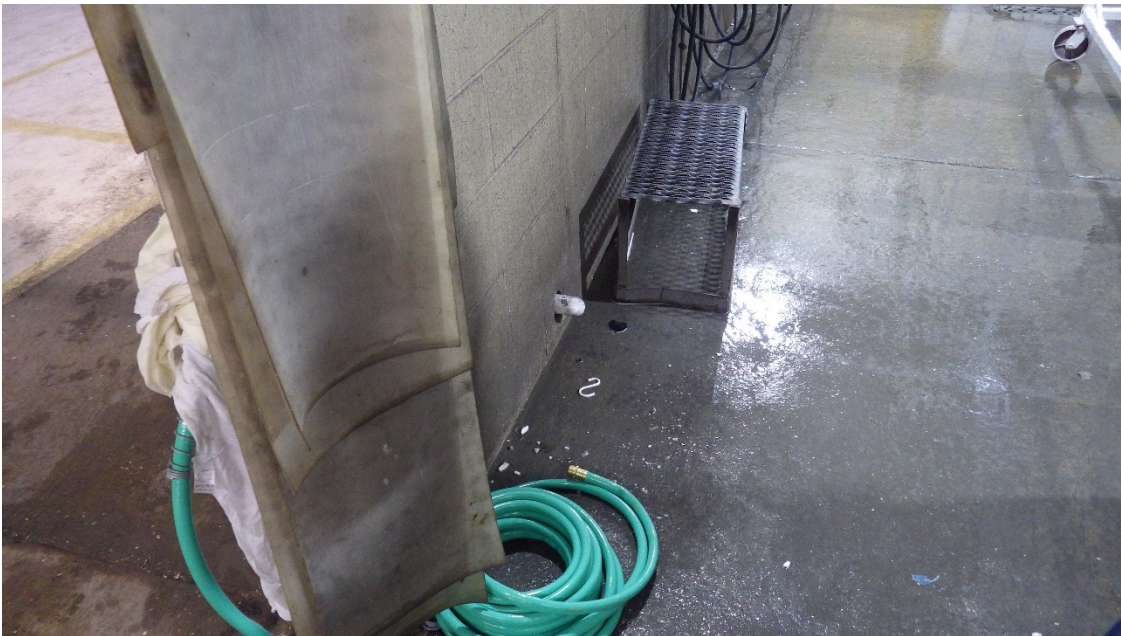
29: RIMG0029

We proceeded to the parts washing area (photos 26 & 44). Mr. Lapp stated that the round floor drain south of the parts washing area (photo 27) and the main floor drain collecting all the wash water from the parts washing area (photo 28) drains to the underground holding tanks covered by a storage shed located immediately west of the washing area (on the outside). There was an eye wash station on the west side of the west wall of the parts washing area (photo 30). There was also a capped pipe protruding into the parts washing area (photo 29).

Description: West wall of parts wash area with pipe protruding from the west.

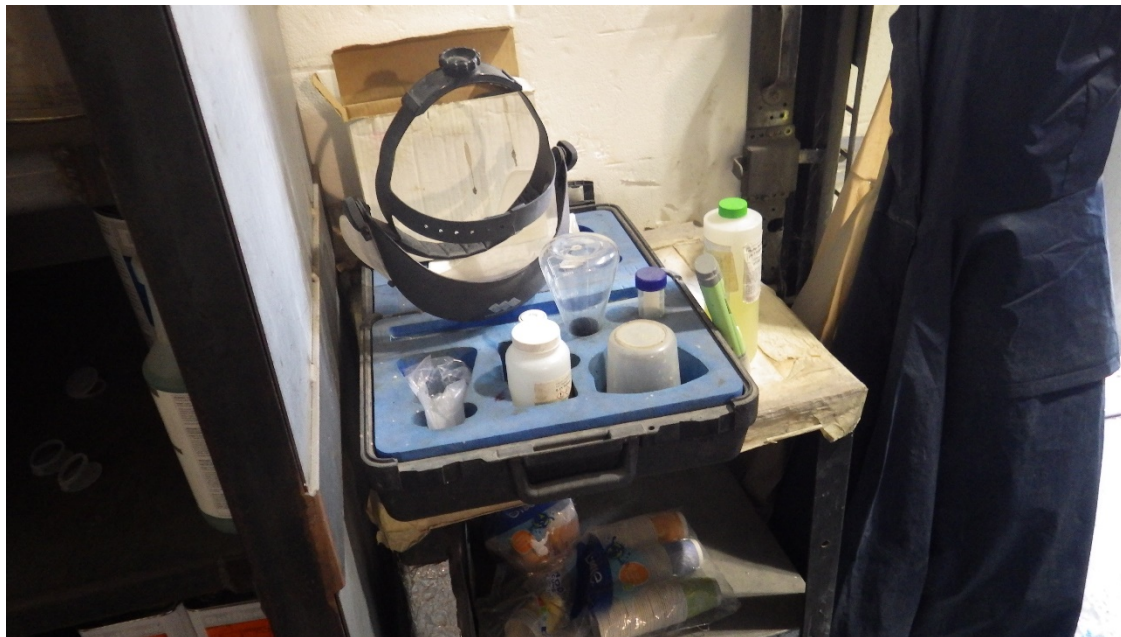
40: RIMG0040

Description: pH meter calibration kit. Note only one buffer, pH 7, was used for calibration.

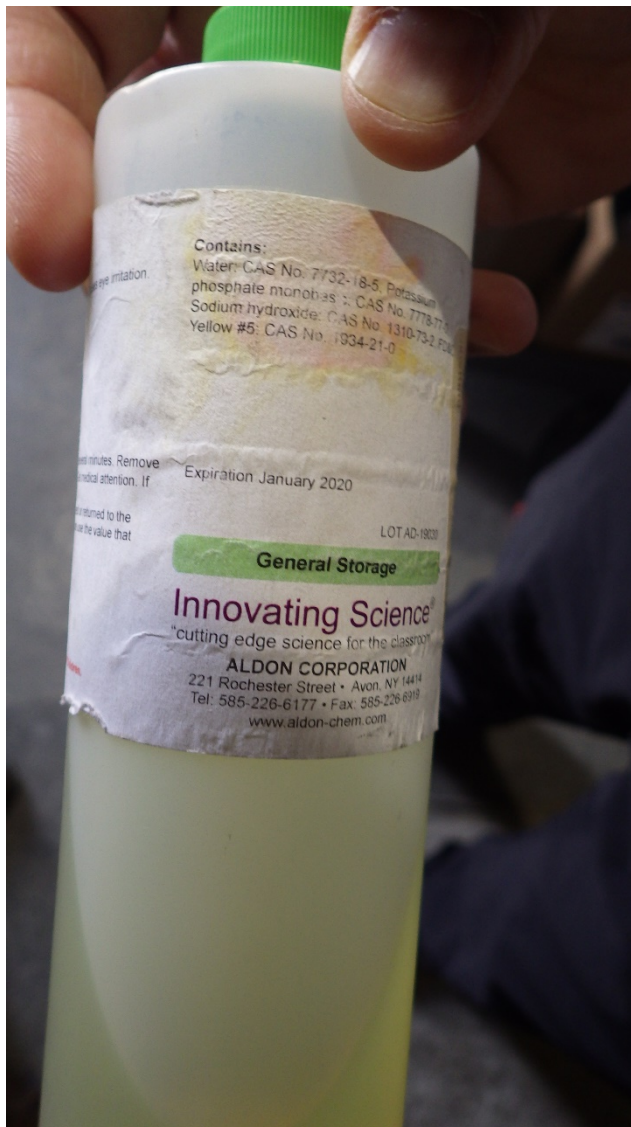
41: RIMG0041

Description: Bottle of expired pH probe calibration buffer solution.

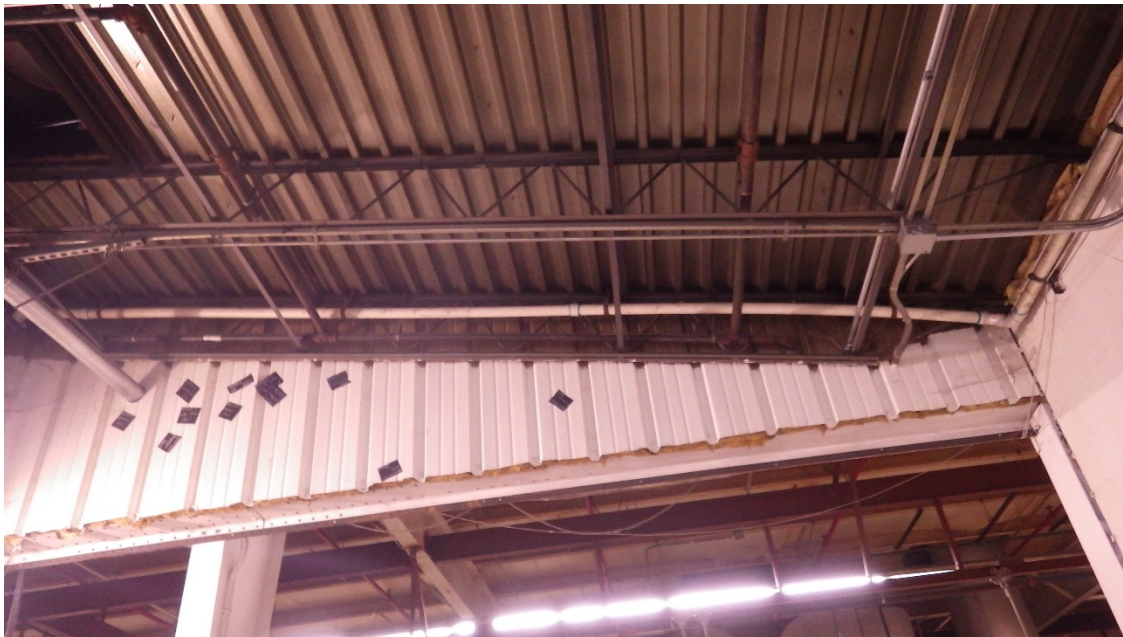
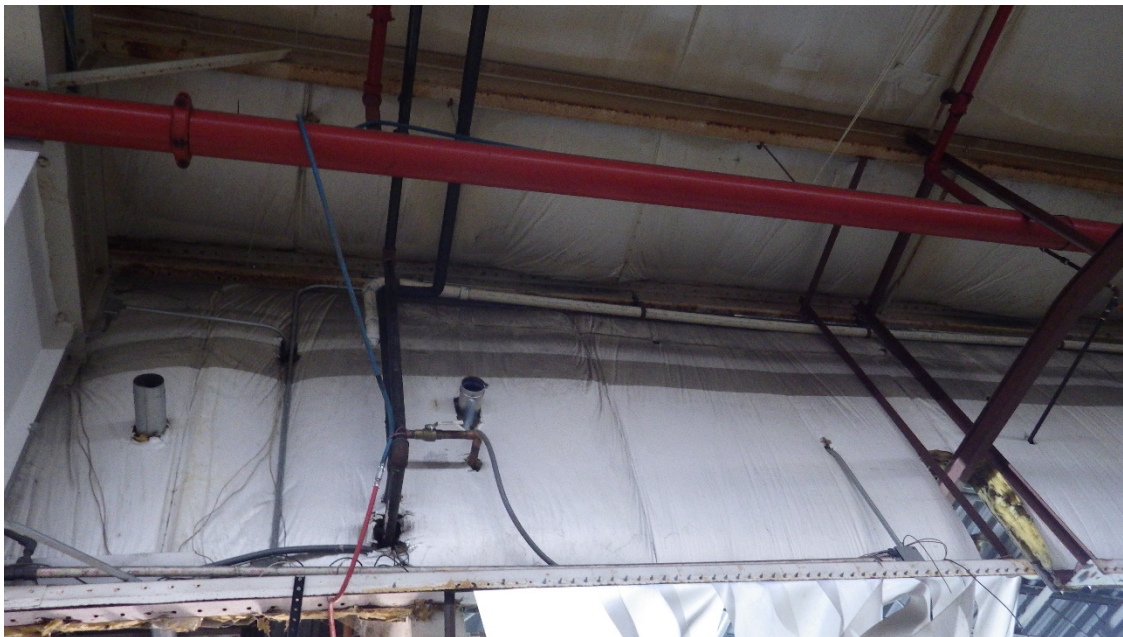
At the time of the visit, the facility did not have any mechanism in place to collect 24-hour flow based composite samples for the metal sample analysis as required by 40 CFR 403.12(g)(3). Mr. Lapp stated that the facility has only used the “grab” sampling method to collect wastewater sampling to date. Grab water samples are collected from the discharge sampling spigot (photos 46 & 47) prior to discharge from outfall 001. The discharge spigot is located just above the discharge flow meter (photo 45). The discharge pipe is routed close to the ceiling of a room south of the parts washing area (photos 48 & 49).

Description: Discharge pipe routing.

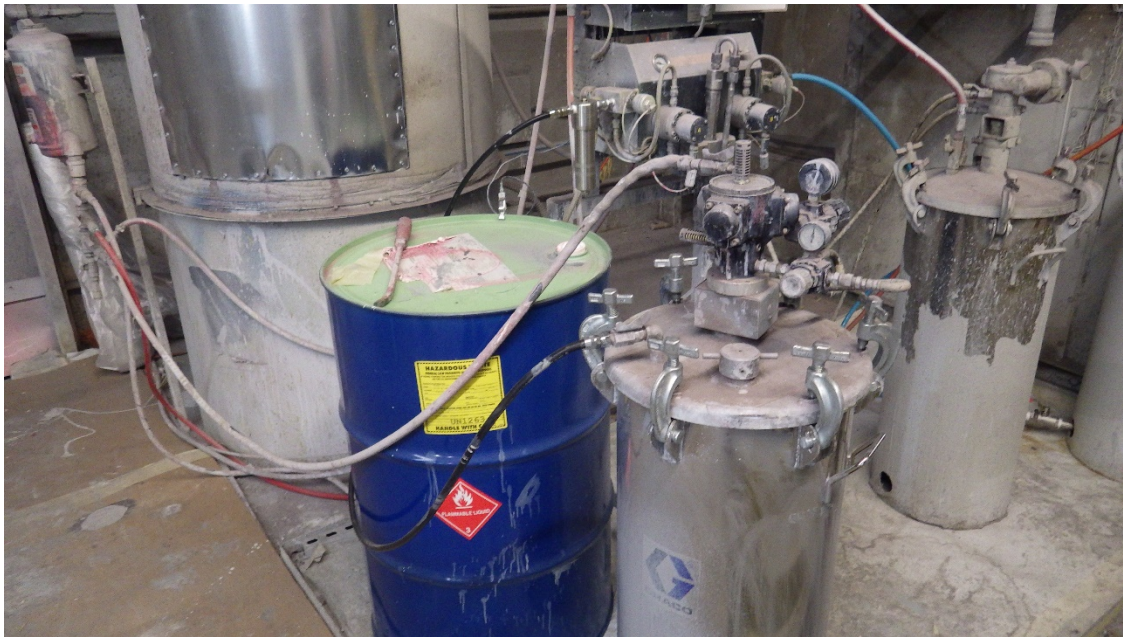
The inspection continued to the side of the wet paint booth where we noticed a 55-gallon metal drum (photos 50-52) of lacquer thinner (cleaner). Mr. Lapp stated that the cleaner is used to clean paint equipment (photo 53). Spent cleaning liquid is collected in waste drums, which are hauled off site quarterly (photos 54 & 55). Storage for back up of chemicals used in the facility operations is located in the northwest corner of the western portion of the facility (photo 56) – where the 55-gallon drums are placed on wooden crates. I asked Mr. Lapp if the facility has had any such product spillage in the facility and he confirmed that the facility has not had any spill since it opened in 2014.

50: RIMG0050
 Description: Wet paint equipment and cleaner.
 Location: South of wash area.
 Camera Direction: South.
 Date/Time: April 15 2021 11:24 AM EST

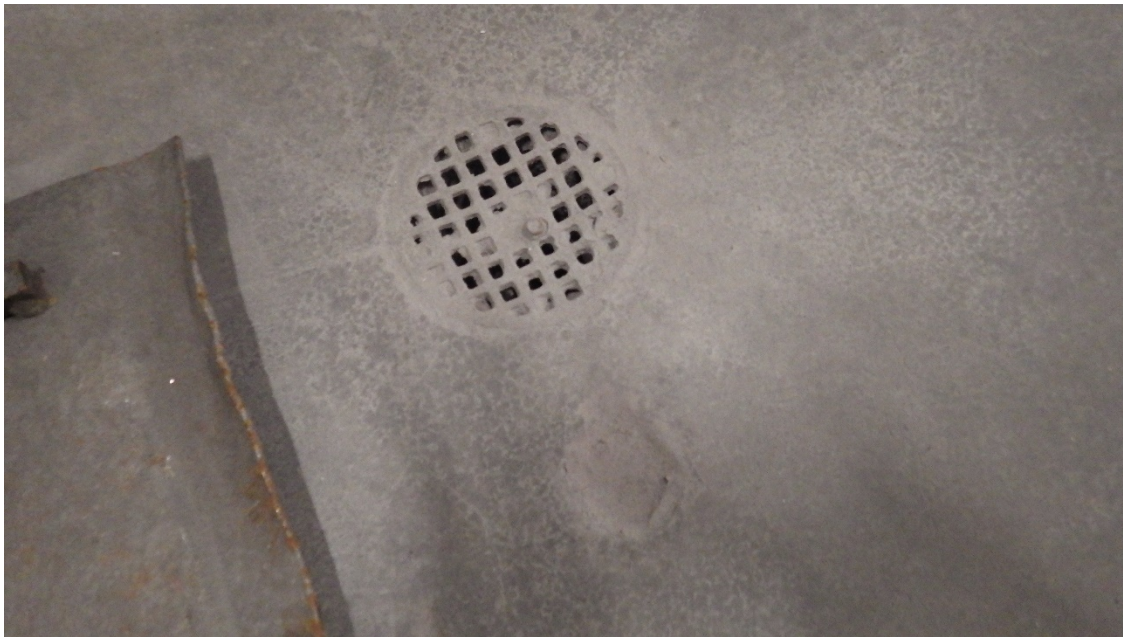
64: RIMG0064

We noticed one drain south of the powder coating area (photo 64). Mr. Lapp confirmed that the drain is non-functional and it is not connected to the sewer. We also noticed a small bucket of black paint and acetone in the bedliner area ((photo 65). Mr. Lapp mentioned that the black paint and acetone are used in small quantities for the fire truck bodies.

Description: Nonfunction flood drain south of powder coat area.
