## TROPICAL SHIPPING-CONTAINER PORT, NPDES Stormwater Reconnaissance Inspection (RI) Photo Album; 3-29-2023 Walkthrough

### A. Observations that revealed potential non-compliance with regulations implementing the CWA and TPDES Stormwater Rules during the RI

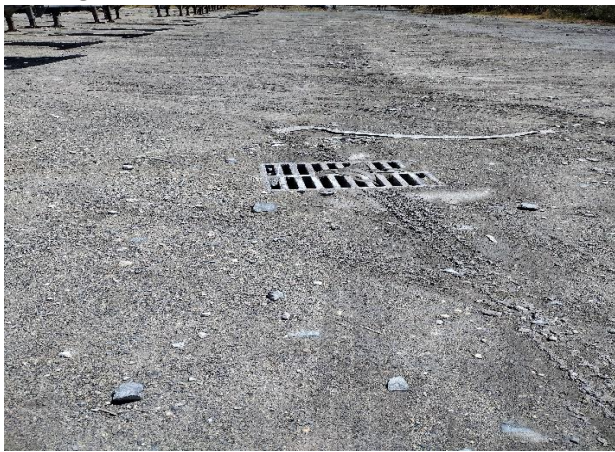
**IMG 5058**-Partially clogged storm inlet midway of unpaved south section of CommUserArea 1.

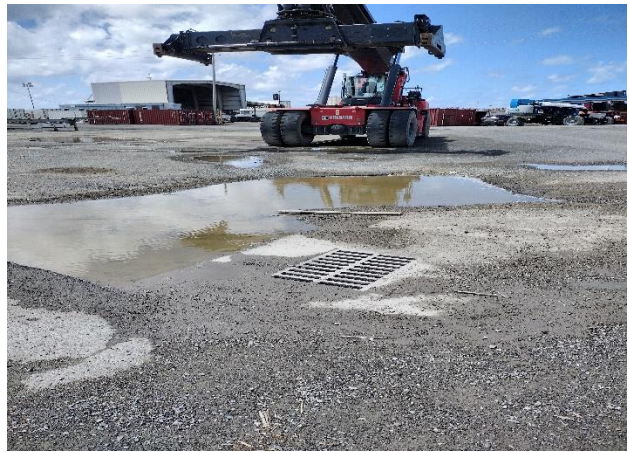
**IMG 2816**-Retention area where stormwater runoff from the unpaved south section of CommUserArea 1 is collected and drained-off. Inlets are unprotected.

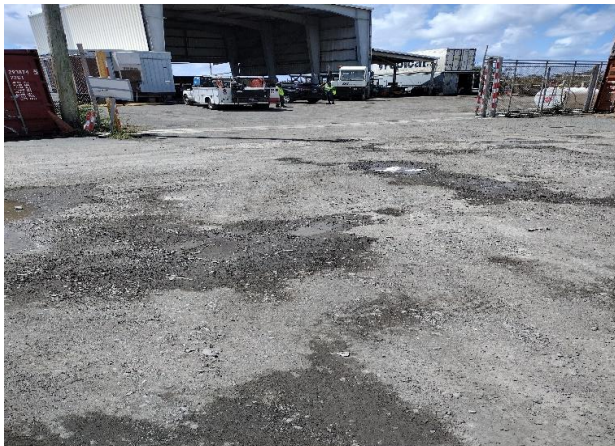
**IMG 0179**-Sloped entrance into maintenance shed, where Tropical's vehicle fleet and equipment are regularly serviced. Potential for transport of sediments and gravel into stormwater catch basin.

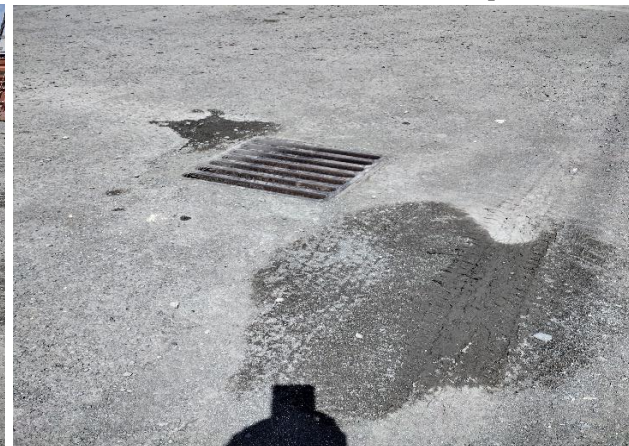
**IMG 3660**-Accumulated sediment at base of sloped entrance into the Facility's maintenance shed area. Storm inlet unprotected from transport of sediment by stormwater runoff into stormwater catch basin.

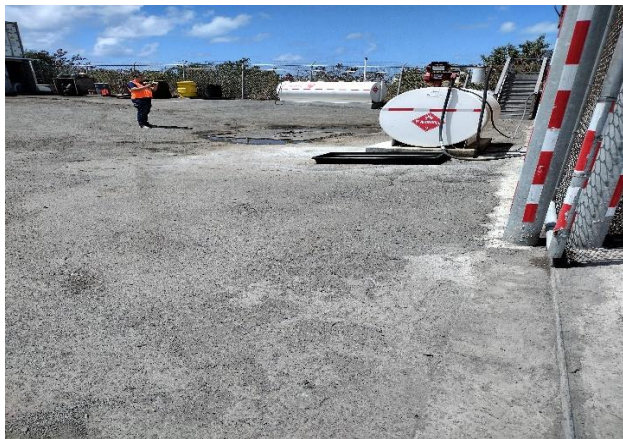
**IMG 5366**-Fueling terminal unit within fenced area of Tropical's maintenance shed. Yard surface slopes toward large stormwater catch basin.

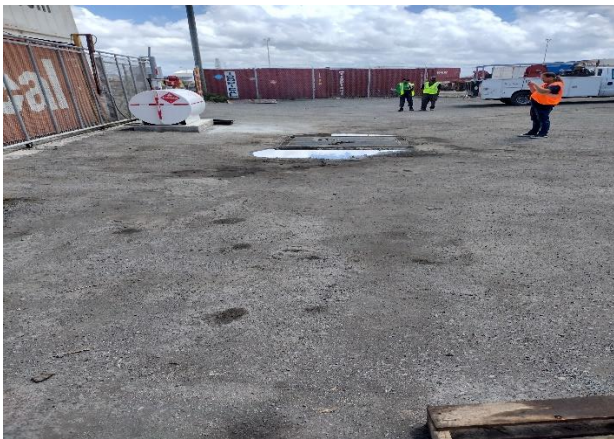
**IMG 5320**-Sloped yard surface towards large stormwater catch basin within the fenced area of the maintenance shed. Basin not within a containment.

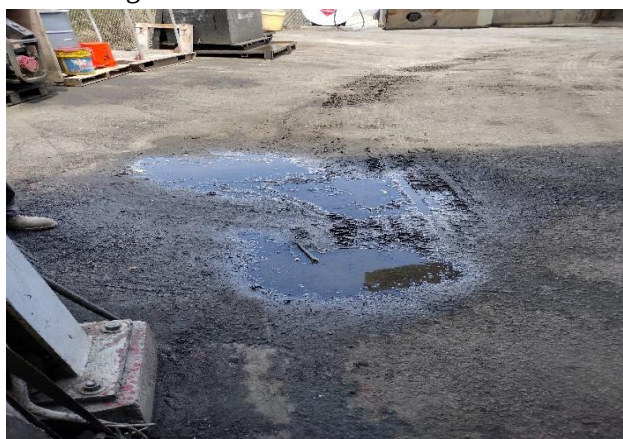
**IMG 1616**-Stormwater runoff path observed from front of the shed flowing downhill towards a large stormwater catch basin at the low-point in the yard.

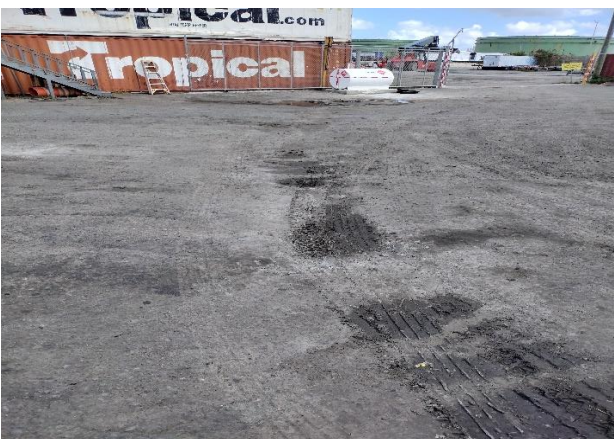
**IMG 2768**-Close-up of stormwater runoff path that appeared saturated with oil patches along the stormwater path towards the stormwater catch basin.

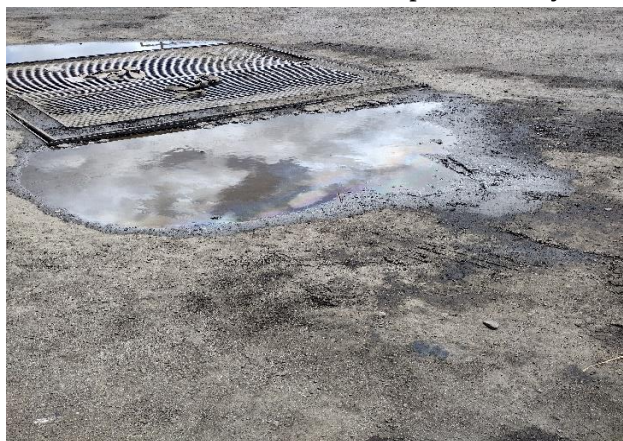
**IMG 8118**-View of the large stormwater catch at low point in the yard of the maintenance shed. Oil spills patches next to the puddles observed.

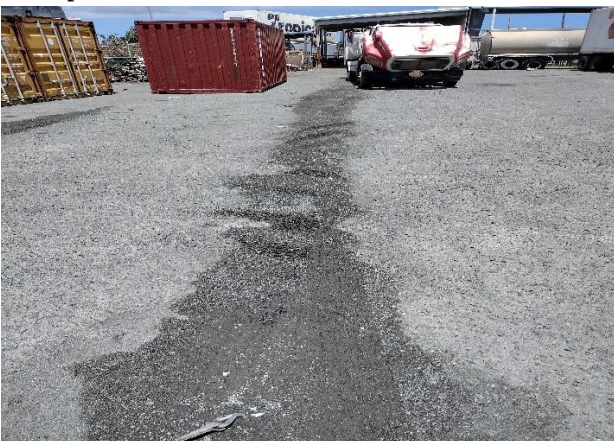
**IMG 0111**-Evidence of stormwater runoff flow path from rear side of the maintenance shed, that runs across paved yard area.

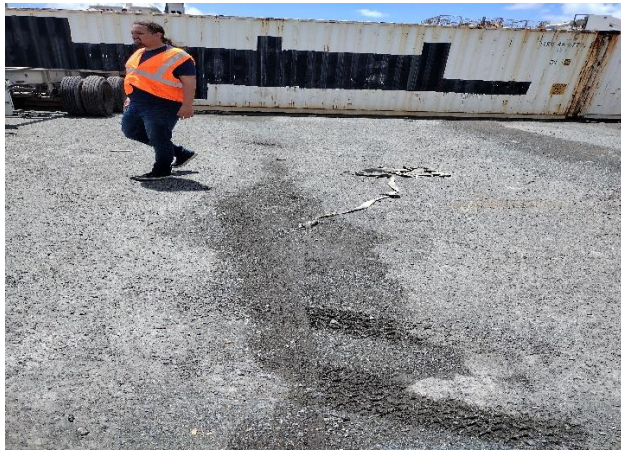
**IMG 6966**-Flow path of stormwater flow in the rear yard area of the maintenance shed.

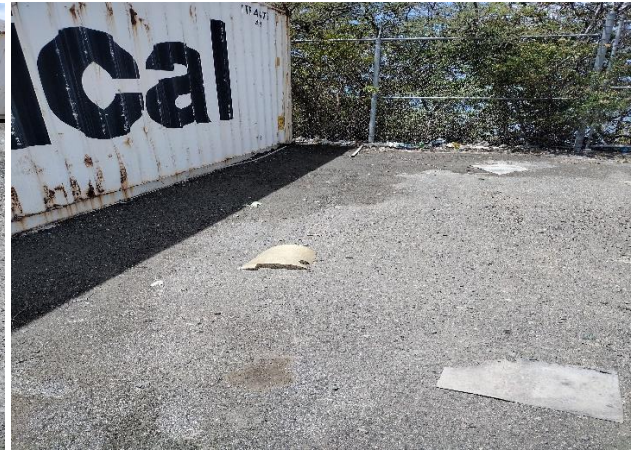
**IMG 1793**-Evidence observed that stormwater flow within the rear yard area drains off at the western fence line of the Facility.

**IMG 1793**-Discharge point where storm water from the rear yard area of the maintenance shed reaches the a point along the western fence line of the Facility, and drains into Lime Tree Bay.

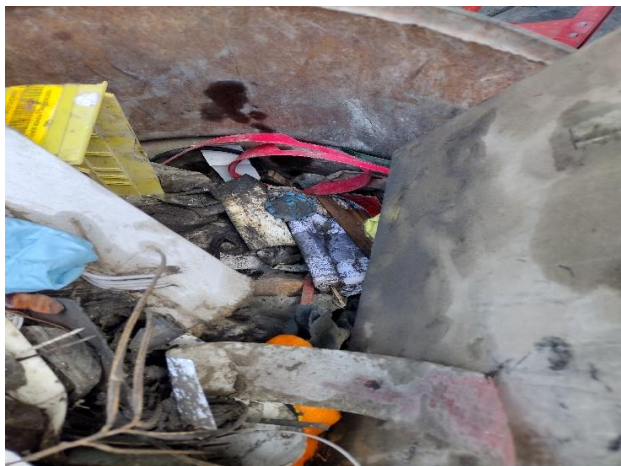
**IMG 4022**-View of oil-soaked rags, crushed tube casing of chemical materials and paint residues discarded among regular garbage.

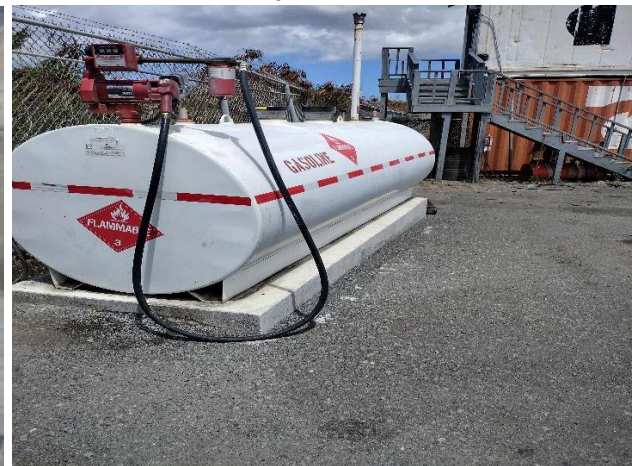
**IMG 9911**-Closeup of fueling terminal unit with no containment around the system. Oil-soaked spot next to the tank, and exposed to stormwater runoff.

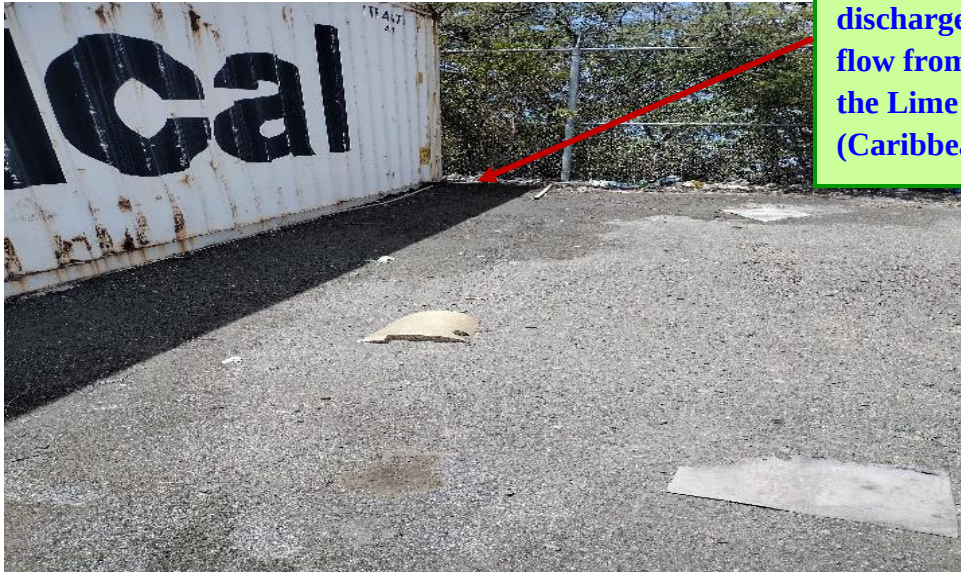
**Outfall 1**

**Outfall 1 – Official point of discharge of storm water flow from the Facility into the Lime Tree Bay (Caribbean Sea)**
