INSPECTION REPORT

| Type of Inspection | Focused Compliance Inspection (FCI) | | | |
| Facility or Site Name | Gibson Energy Infrastructure, LLC | | | |
| Type of Operation | Gibson Energy is a crude oil storage and export terminal. | | | |

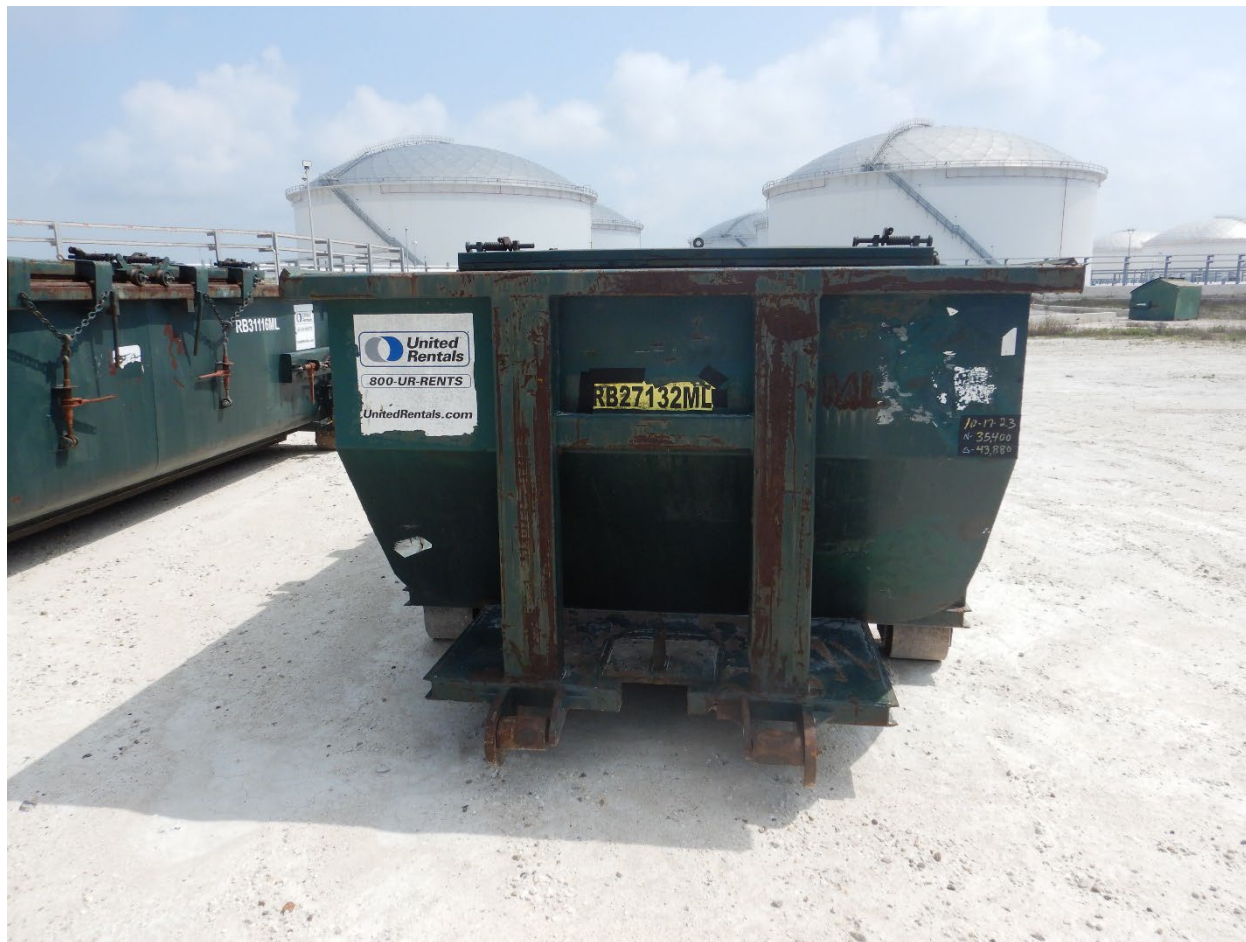
Photo No. 1

Description: A roll-off container with hydrocarbon contaminated debris in Gibson's dock area dated 10/17/23.

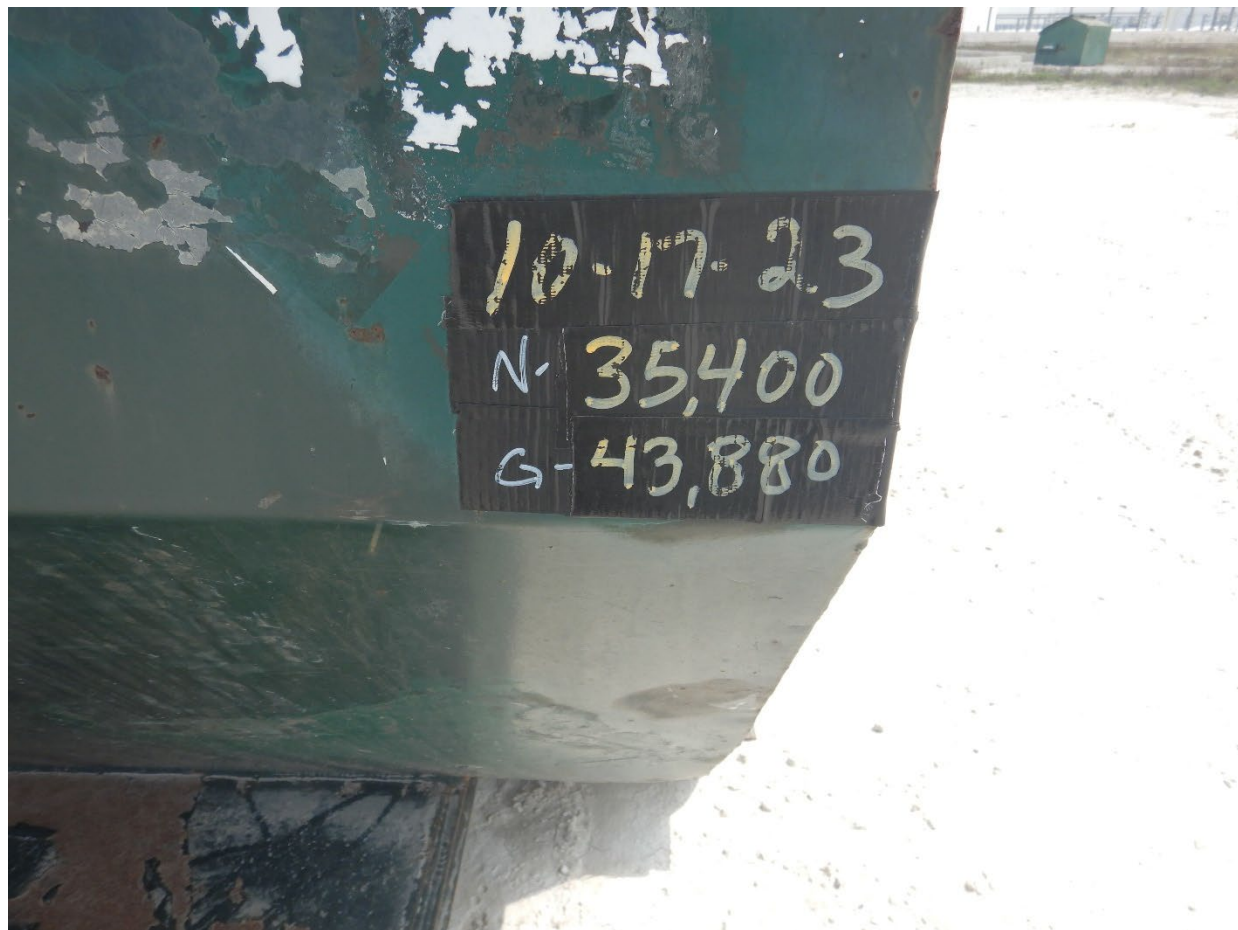
Photo No. 2

Description: Close-up of the label on the roll-off container in Photo No. 1 in Gibson's dock area.

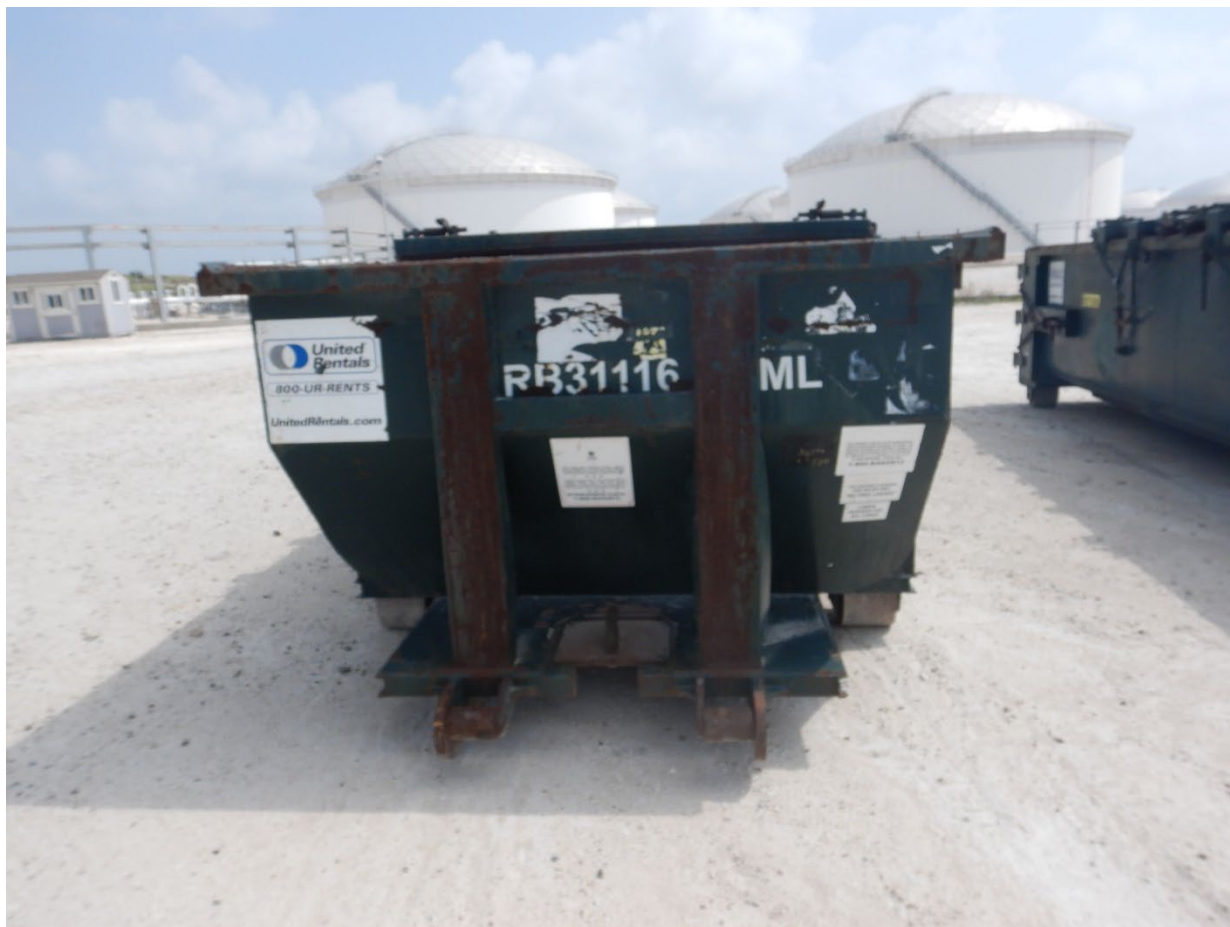
Photo No. 3

Description: Roll-off container with hydrocarbon contaminated debris that did not have a label and had a smudged date in Gibson's dock area.

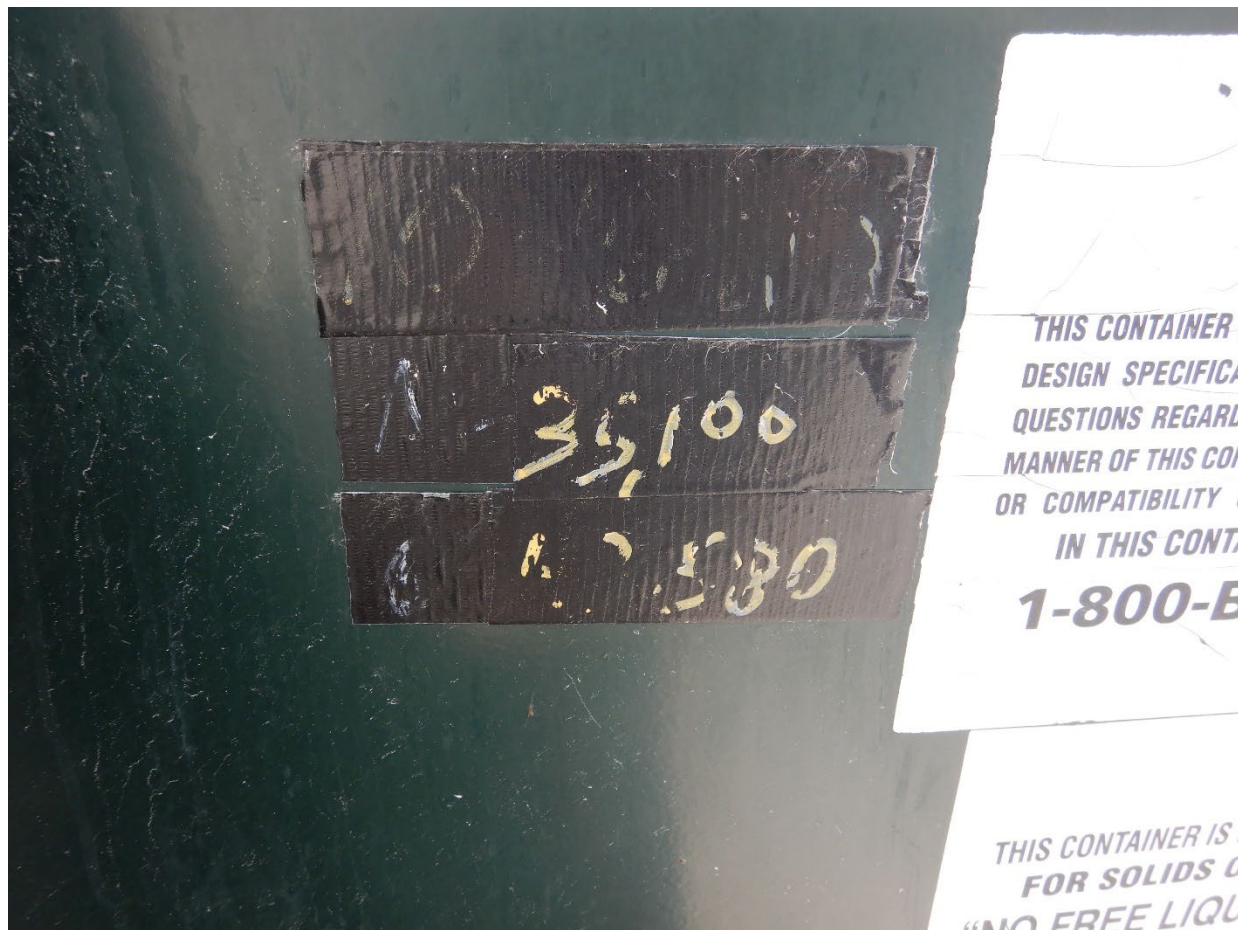
Photo No. 4

Description: Close-up of the label on the roll-off container in Photo No. 3 in Gibson's dock area.

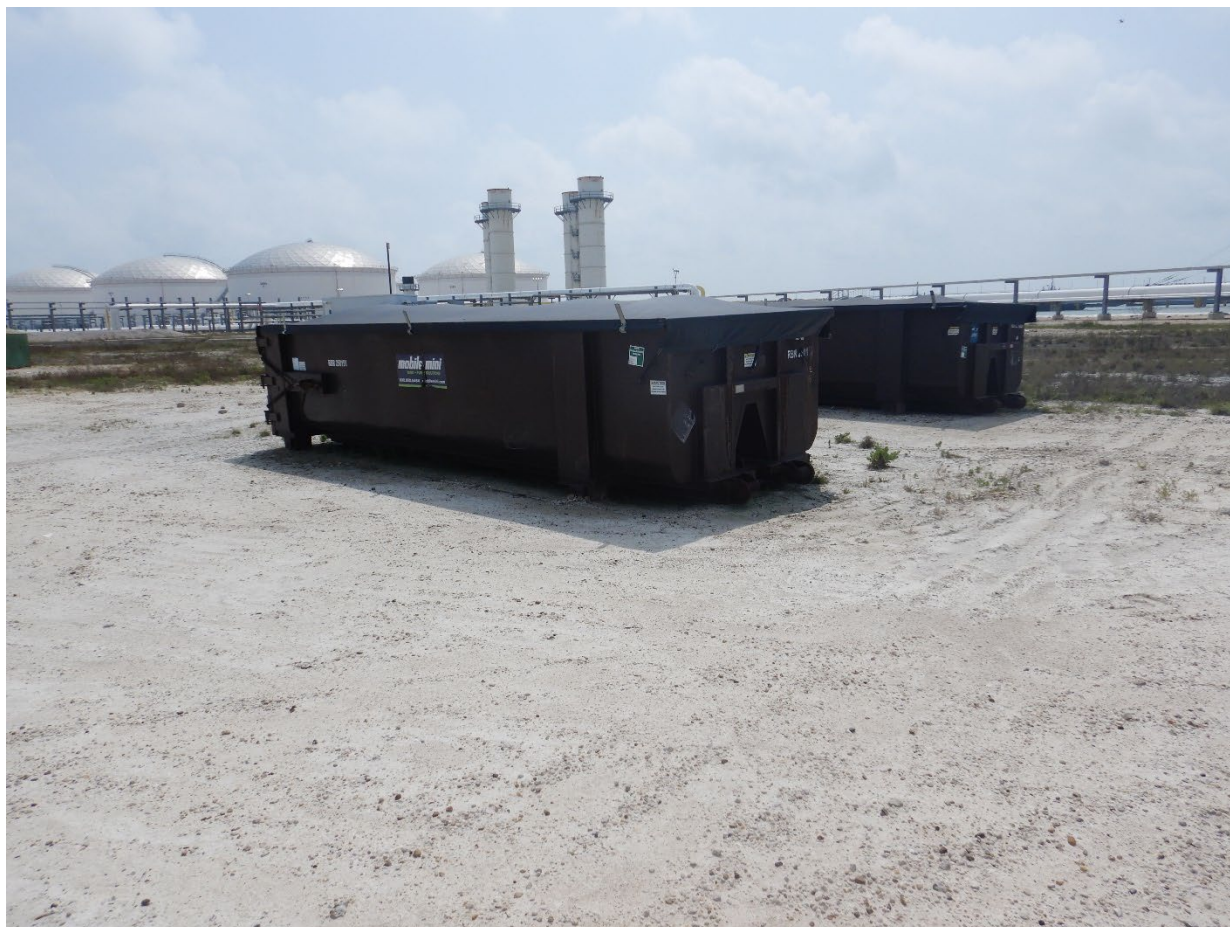
Photo No. 5

Description: Two roll-off containers with hydrocarbon contaminated debris in Gibson's dock area.

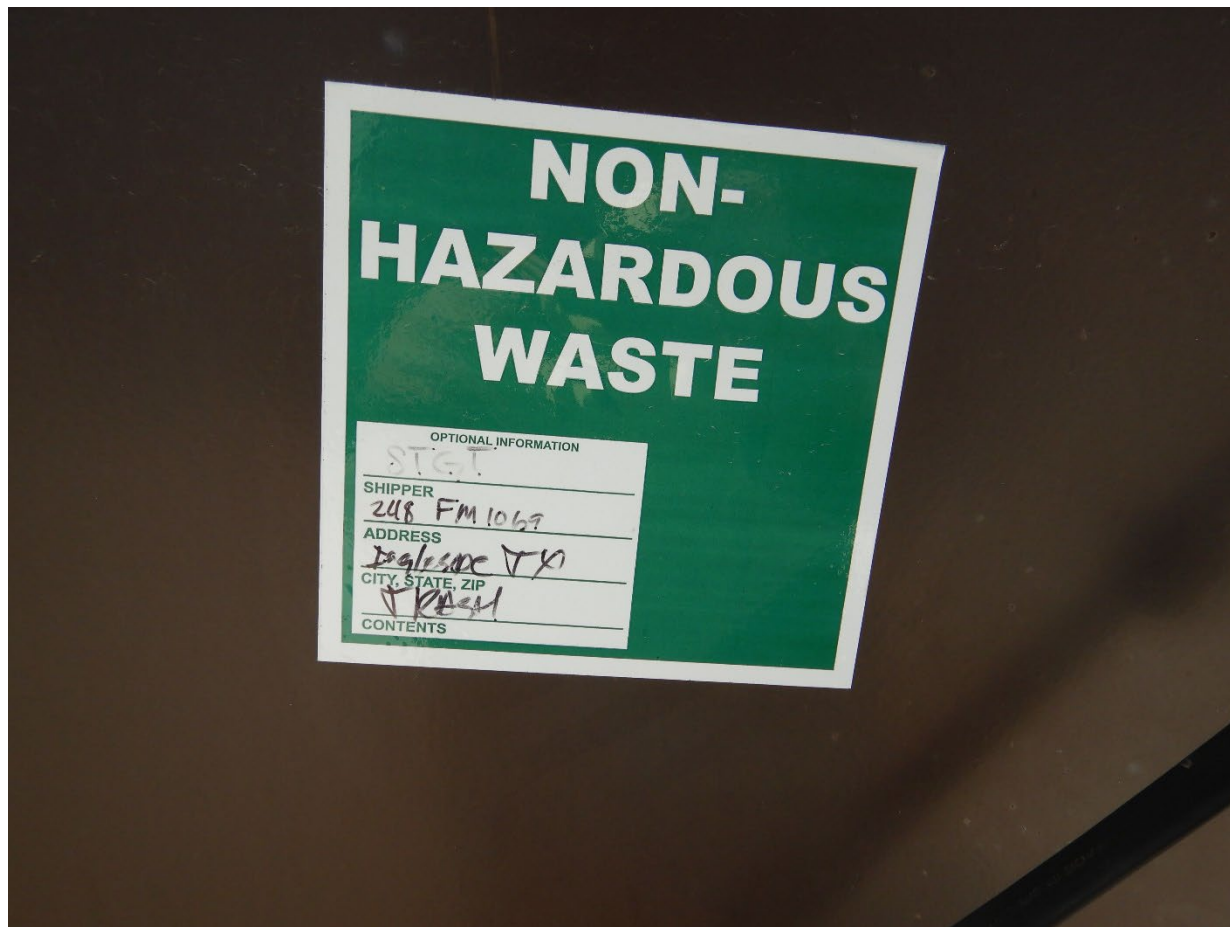
Photo No. 6

Description: Close-up of the label on one of the roll-off containers in Photo No. 5 in Gibson's dock area.

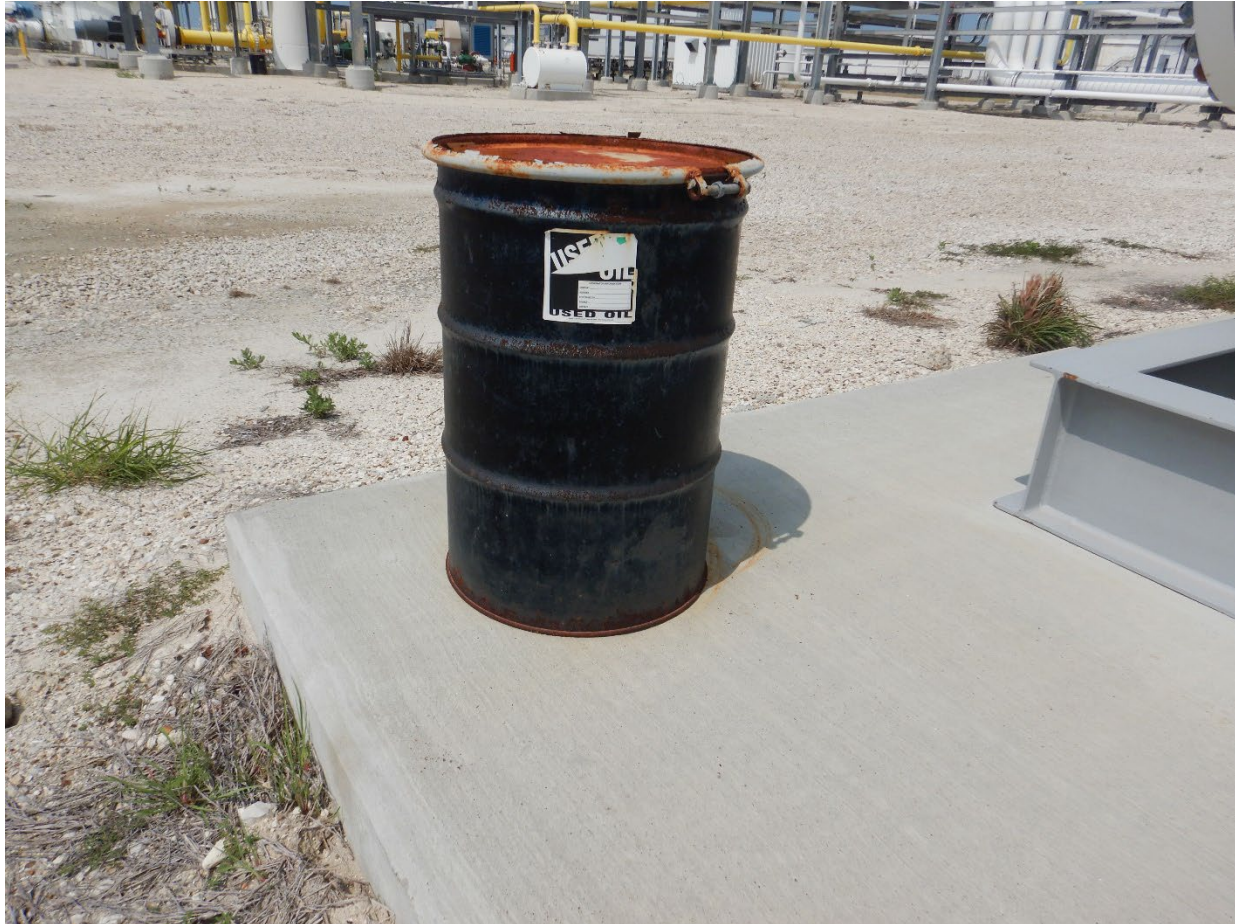
Photo No. 7

The inspection team observed one 55-gallon drum in the skid area that was labeled as used oil but contained an unknown waste. The drum had reportedly been onsite since at least the end of 2023 (see Appendix 1 – Photo 7). A hazardous waste determination was not performed for this waste, and it was not labeled “hazardous waste, pending analysis” until a determination was made [**AOC #1** – *Gibson did not make an accurate determination as to whether its waste is a hazardous waste in order to ensure wastes are properly managed according to applicable RCRA regulations. – 40 CFR 262.11*].

| <b>Tenant:</b> Gibson Energy Infrastructure, LLC | | |
|---|---|---|
| <b>AOC #1</b> – Gibson did not make an accurate determination as to whether its waste is a hazardous waste in order to ensure wastes are properly managed according to applicable RCRA regulations. | <b>Citation:</b> 40 CFR 262.11 | <b>Section:</b> 2.1 |

Description: 55-gallon drum in Gibson's skid area that was labeled as used oil but contained an unknown waste. The drum had been onsite since at least the end of 2023.

- All roll-off containers have been labeled
- The contents of the 55-gal drum (located at the skid area and labeled "used oil") were transferred to a new drum to ensure good container integrity. The new drum has been labeled "Hazardous Waste, pending analysis" and moved to the waste management area. The previous drum is now empty and has been labeled as such. We determined that the contents of the original drum were not used oil, but crude oil from a previous drain-up with debris mixed in. We'll plan to sample this drum in the near future and dispose of as hazardous waste.

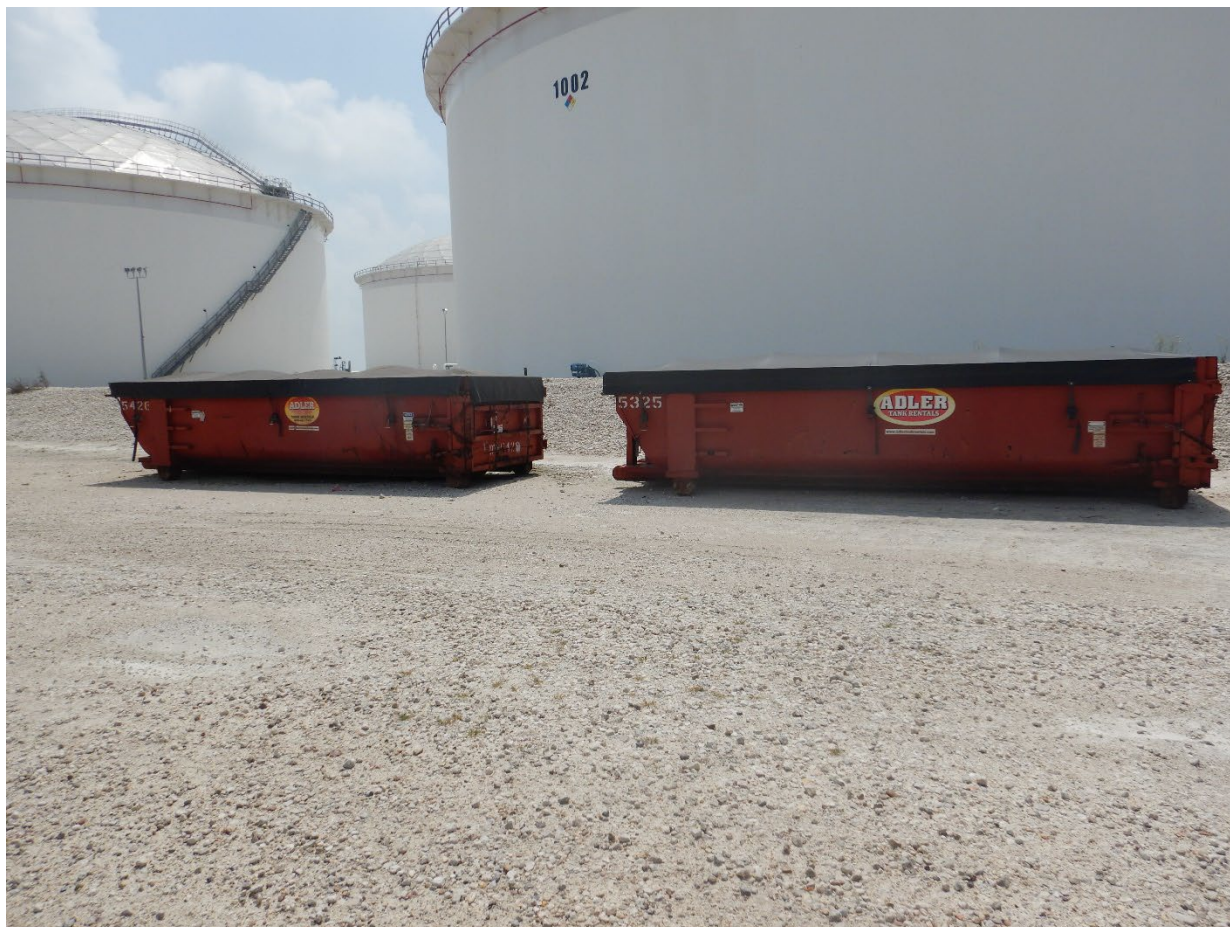
Photo No. 8

In the Northside area, the inspection team observed two unlabeled roll-offs that supposedly contained hydrocarbon contaminated used seals (see Appendix 1 – Photo 8). The inspection team also observed five roll-offs that contained hydrocarbon contaminated debris, which were not labeled as to their contents (see Appendix 1 – Photo 9). The inspection team observed Gibson’s non-hazardous accumulation area in the Northside area and found no issues (see Appendix 1 – Photo 10).

Description: Two unlabeled roll-off containers that supposedly contained hydrocarbon contaminated used seals in Gibson's Northside area.

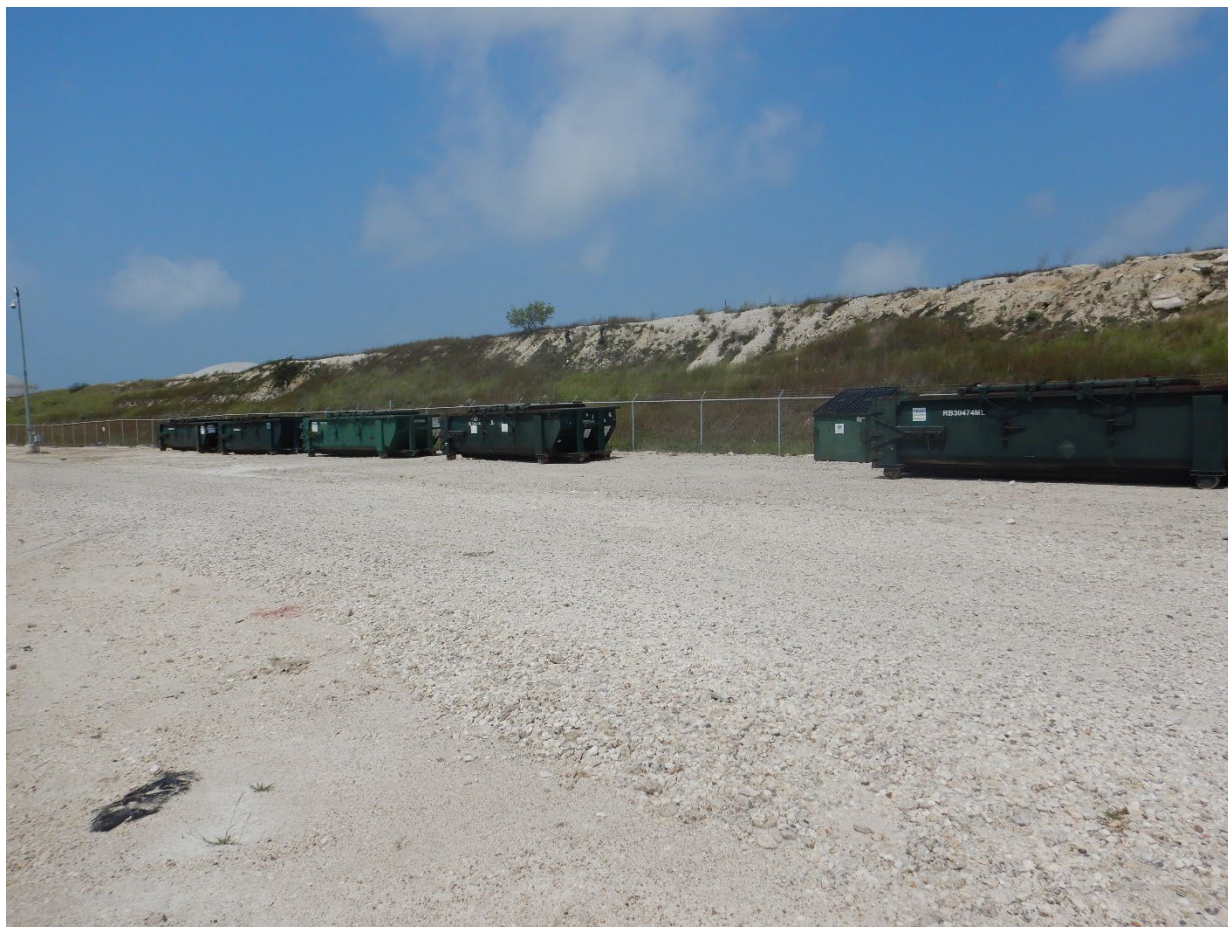
**Photo No. 9**

Description: Five roll-off containers that supposedly contained hydrocarbon contaminated debris in Gibson's Northside area.

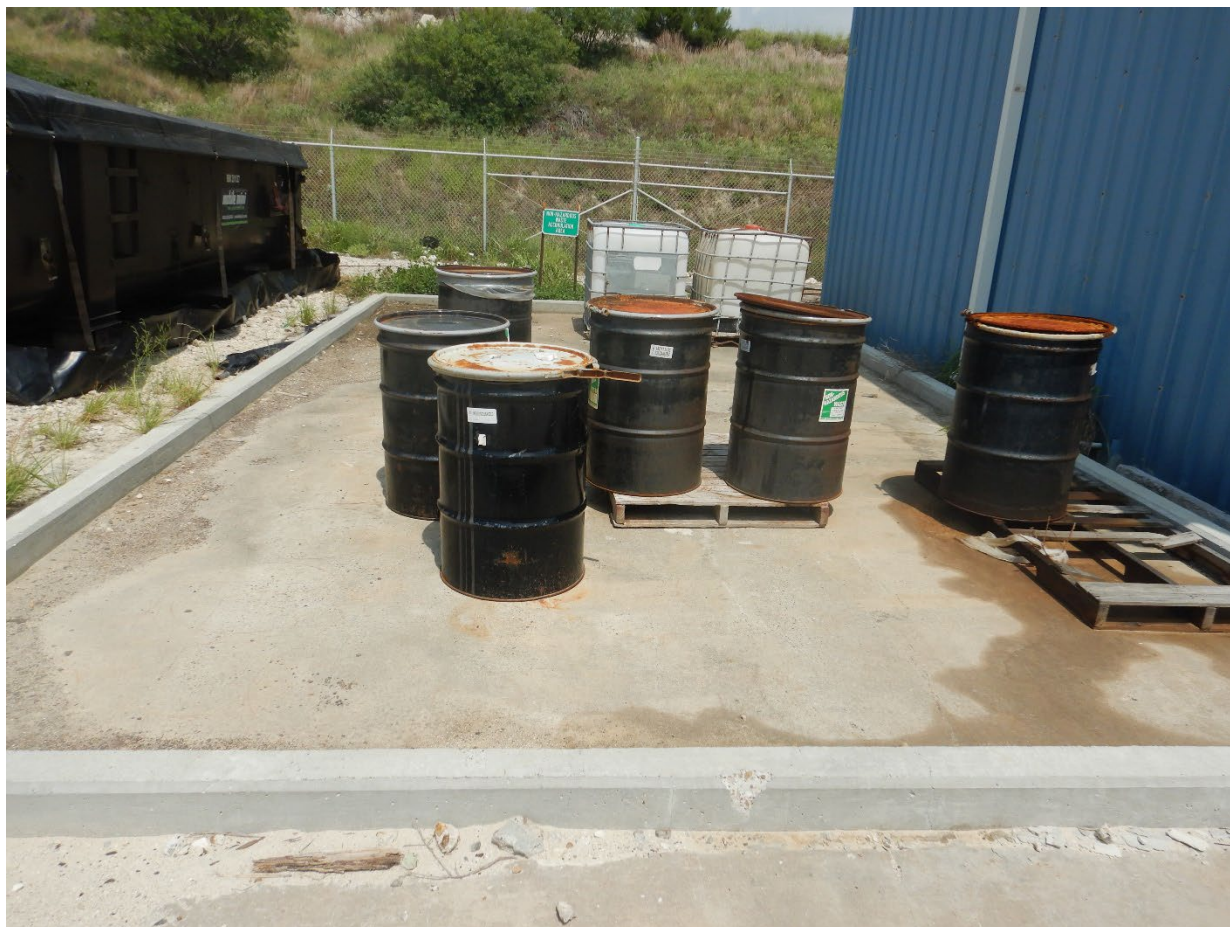
Photo No. 10

Description: Gibson's non-hazardous waste accumulation area in Gibson's Northside area (observed).

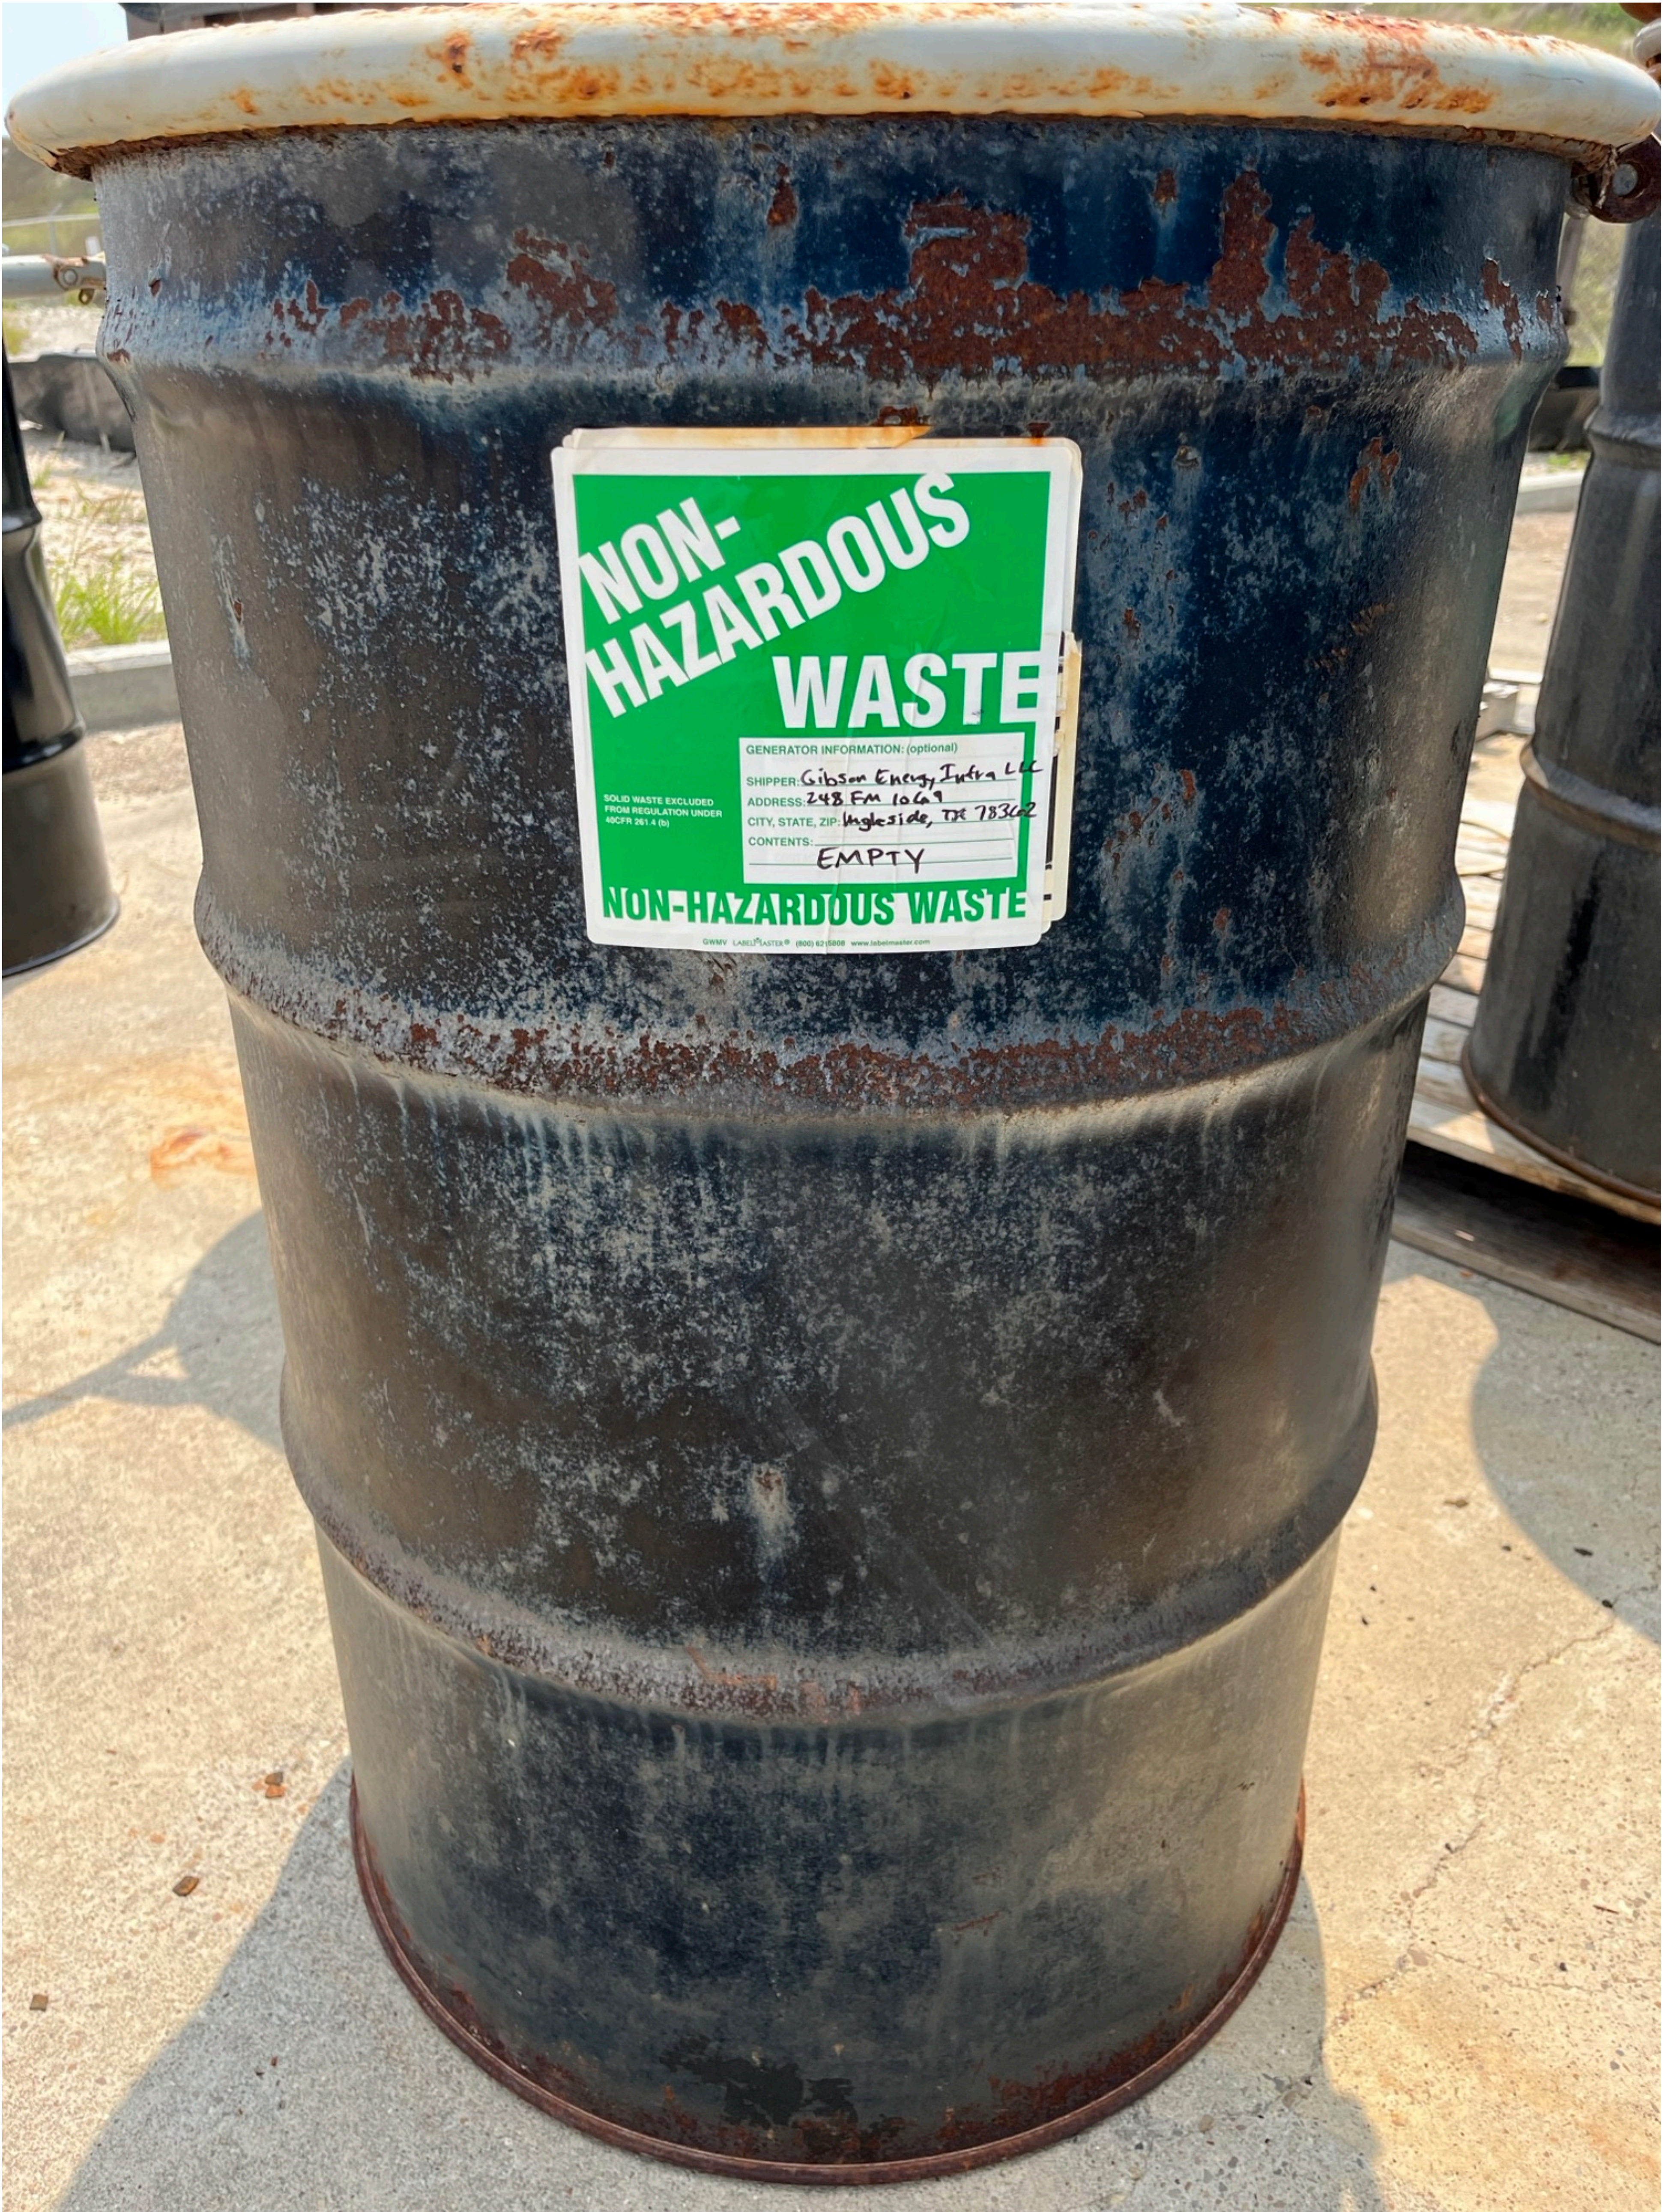
Hazardous  
Waste

\* Pending Analysis

Crude Oil  
& Debris
