**Region 6 - Enforcement & Compliance Assurance Division**  
**INSPECTION REPORT**

| Inspection Date(s): | 12/6/2023 | |
| Company Name: | NEW MEXICO WATER SERVICE | |
| Facility Name: | Rio Del Oro Wastewater Treatment Plant | |

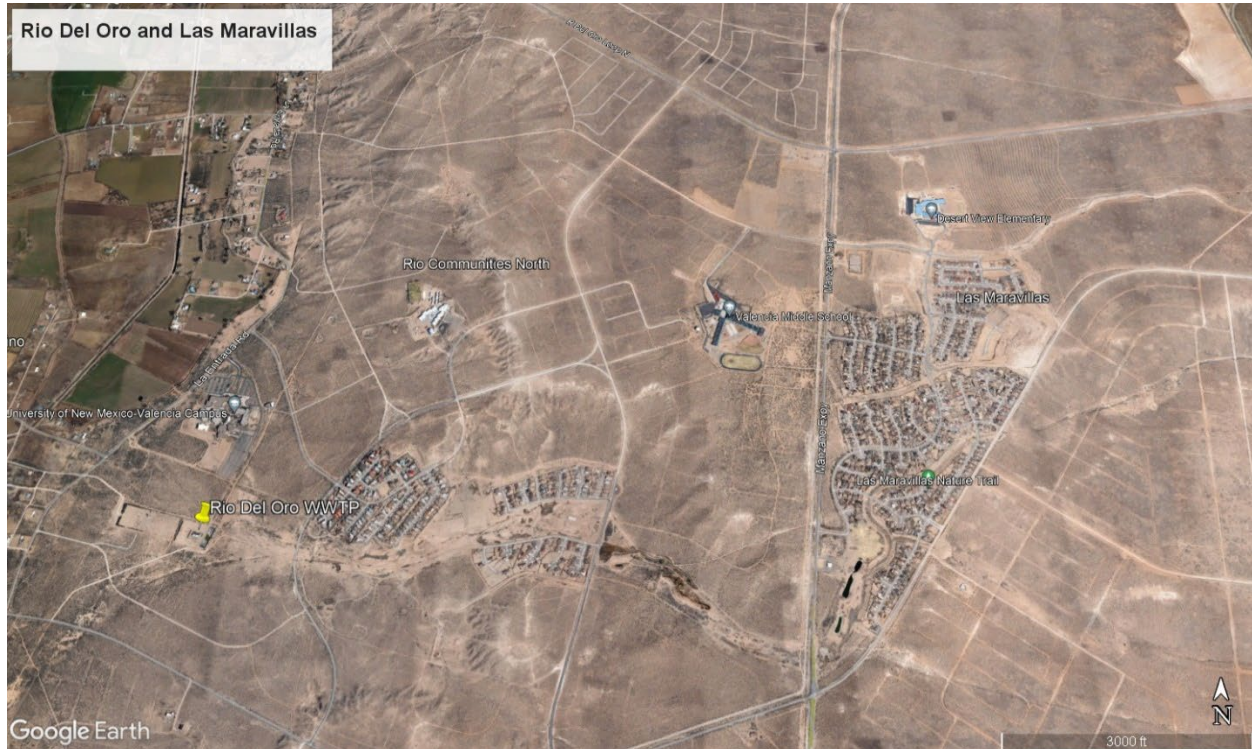
- The observed affixed thermometer within the sample storage refrigerator did not exhibit any visible evidence of proper and timely calibration of temperature recording devices (thermometers). In response to the Request for Information (RFI) dated December 7, 2023 (**Appendix 3 Request for Information (RFI)**). The WWTP simply responded “none”. Therefore, the integrity or stability of the collected samples cannot be guaranteed; thus, the results could be inaccurate or in error.
- The WWTP description of Outfall 001 states the discharge is to an arroyo named La Cañada de la Loma de Arena thence to La Constancia Ditch, and finally to Rio Grande (**Aerial Image #2**). However, if the statement of the closed conduit discharge to the Las Maravillas Homeowner’s Association lagoon is correct (**Aerial Image #3**) this is contrary to the permitted outfall location.

**Aerial Image #3** View of the Rio Del Oro WWTP (yellow pin) and the stated discharge to the Las Maravillas Subdivision (green pin) located approximately 1-mile east of the WWTP.

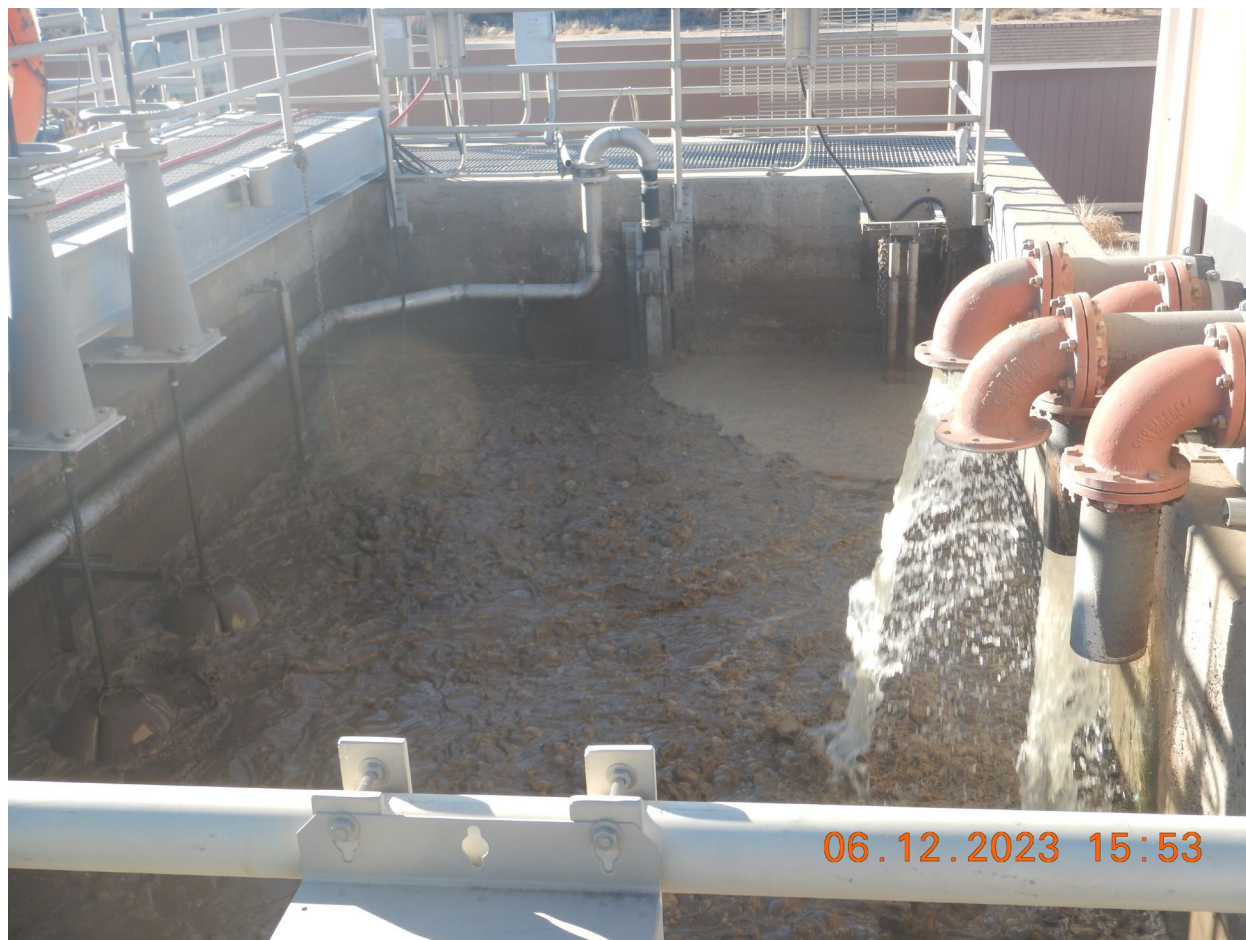
Photo No. 1

View of WWTP's pre-air basin. Bar screen and entrance headworks on right side of photograph. (DSCN2678). Photographed by D. Esparza

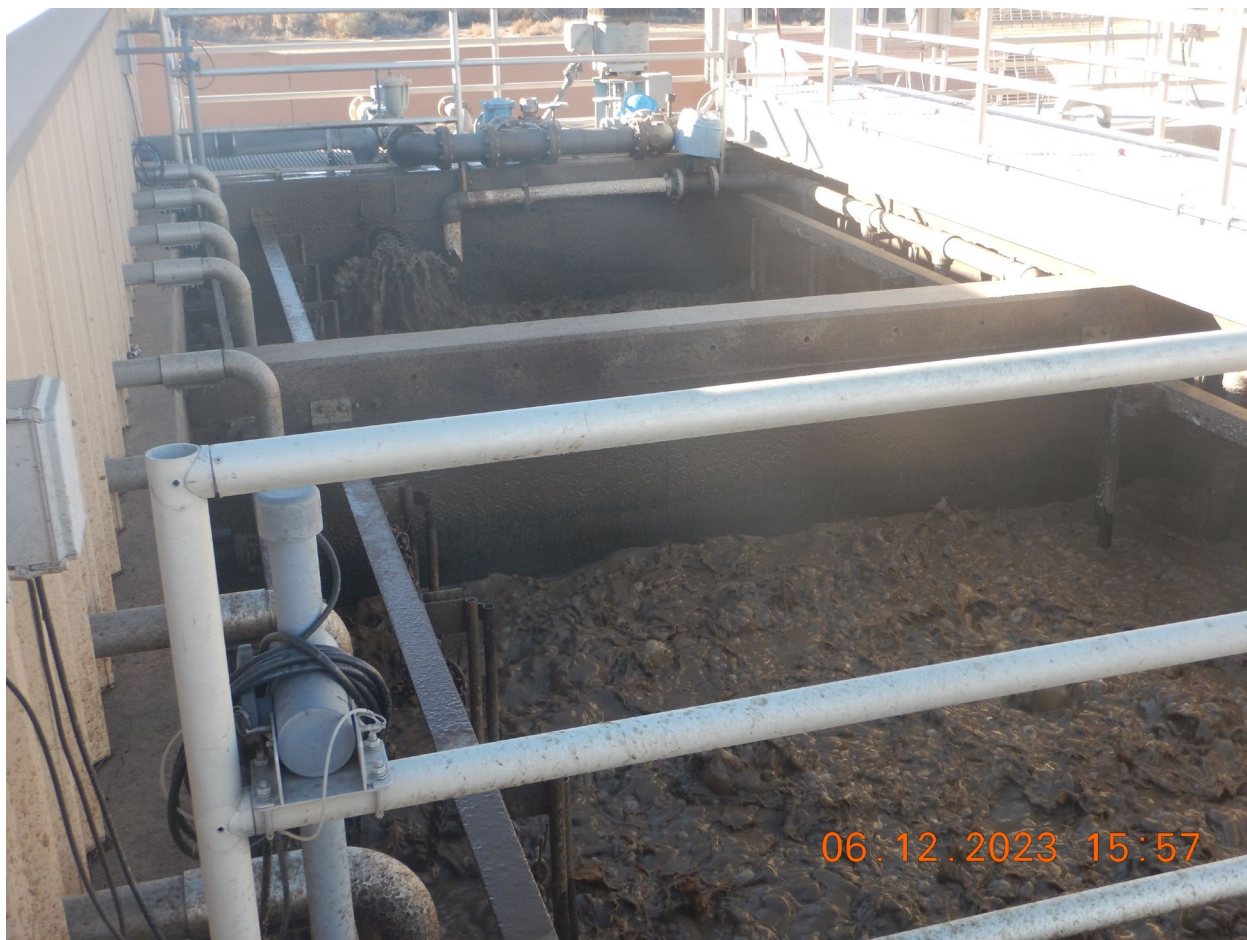
Photo No. 2

View of the bioreactors. (DSCN2681). Photographed by D. Esparza

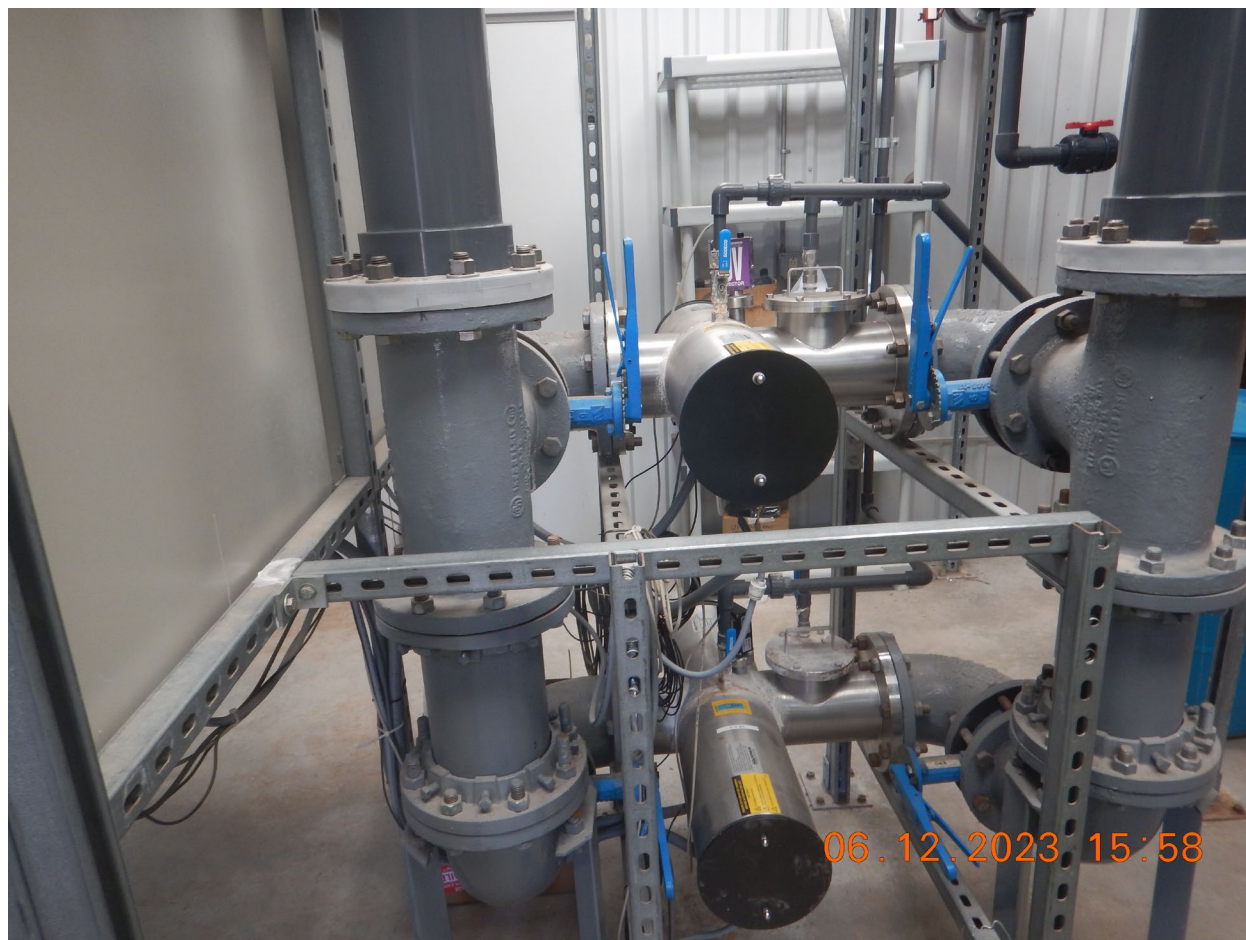
Photo No. 3

View of the ultraviolet (UV) disinfection treatment system. (DSCN2682). Photographed by D. Esparza

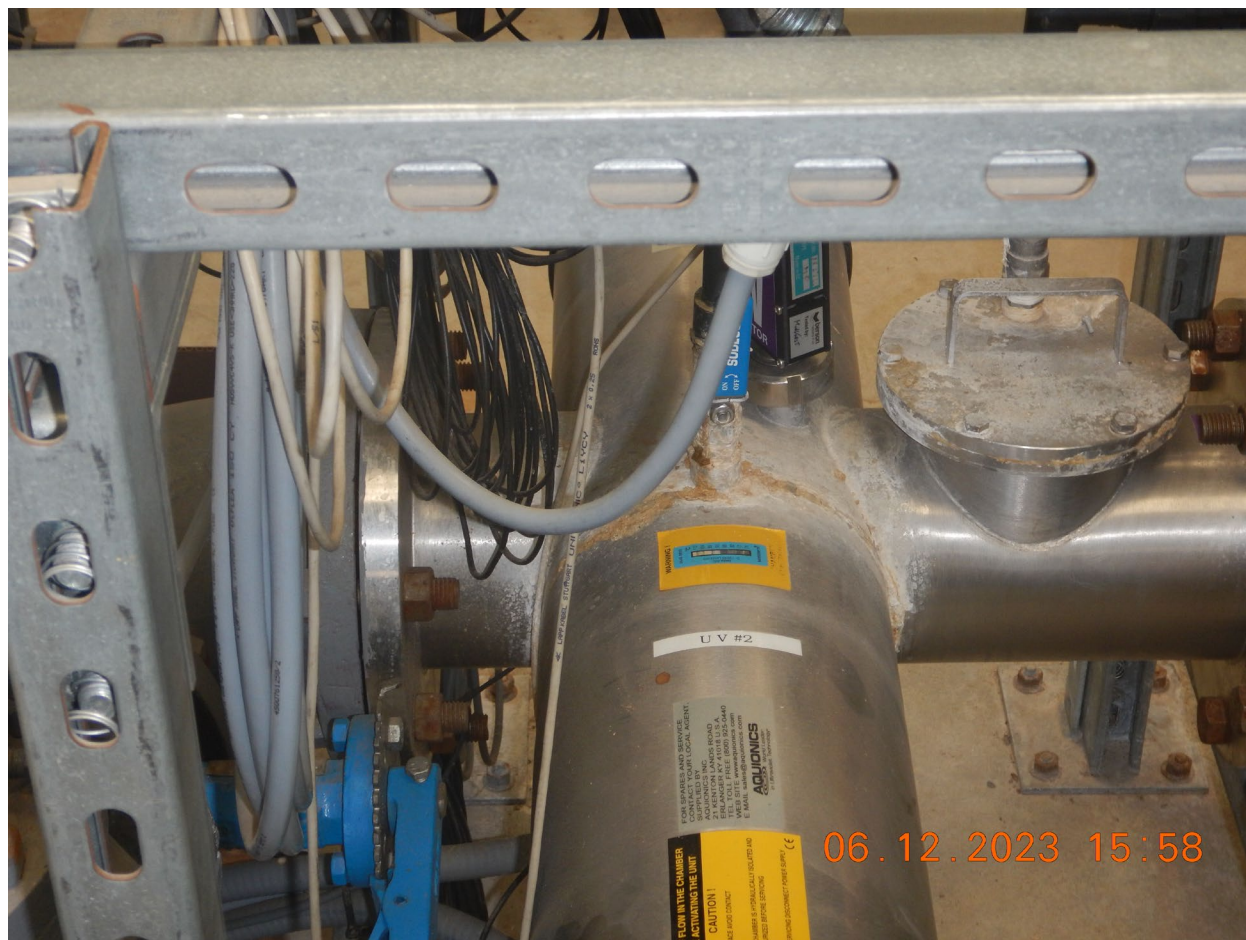
Photo No. 4

View of the one (1) of the ultraviolet (UV) disinfection treatment systems (UV-2) injection ports exhibiting corrosion. (DSCN2683). Photographed by D. Esparza

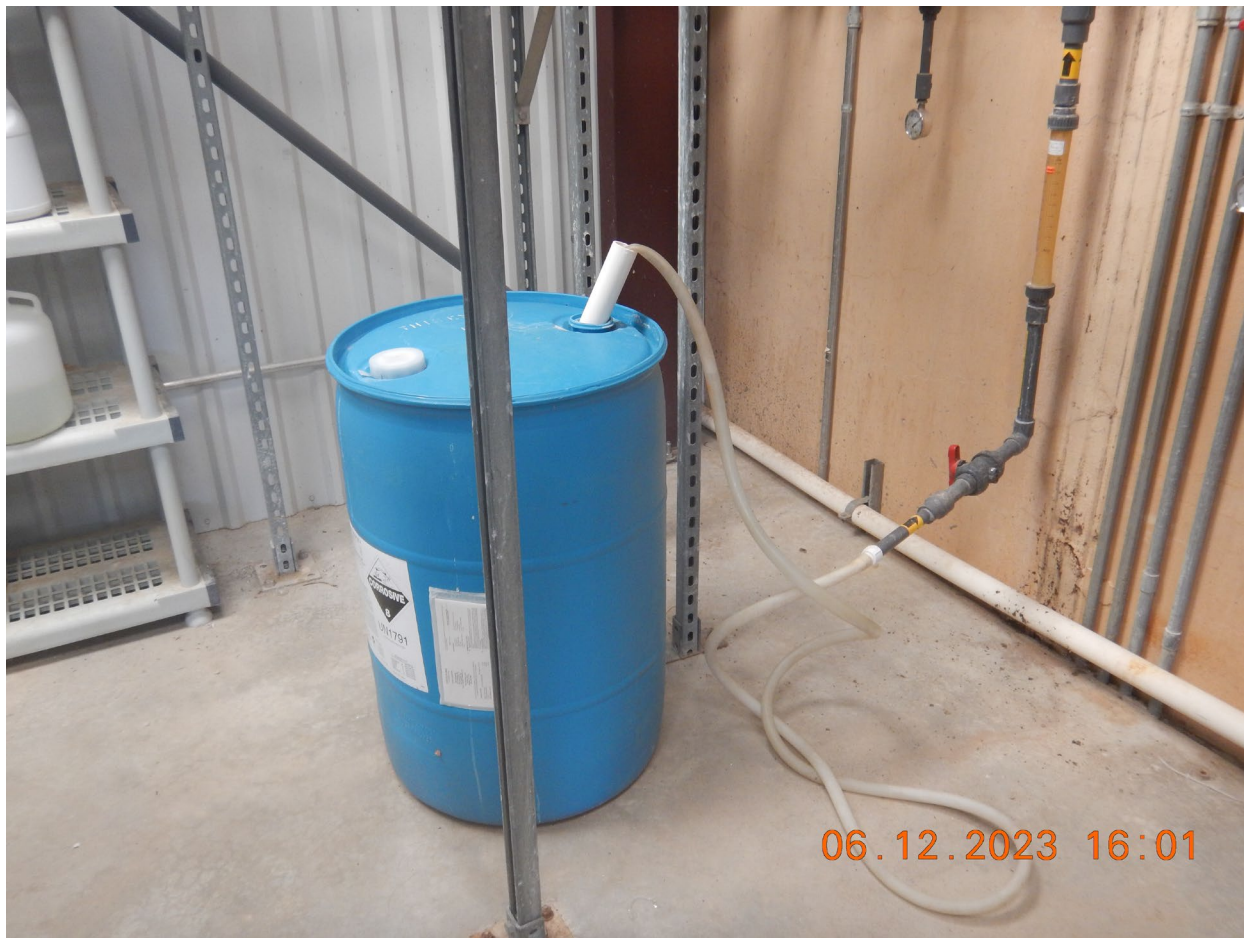
Photo No. 5

View of the sodium hypochlorite (UN1791) un-restrained drum. (DSCN2684). Note: not clear why the sodium hypochlorite (typically used in wastewater treatment as an oxidizing and disinfection agent) and the UV are plumbed into the system. Photographed by D. Esparza

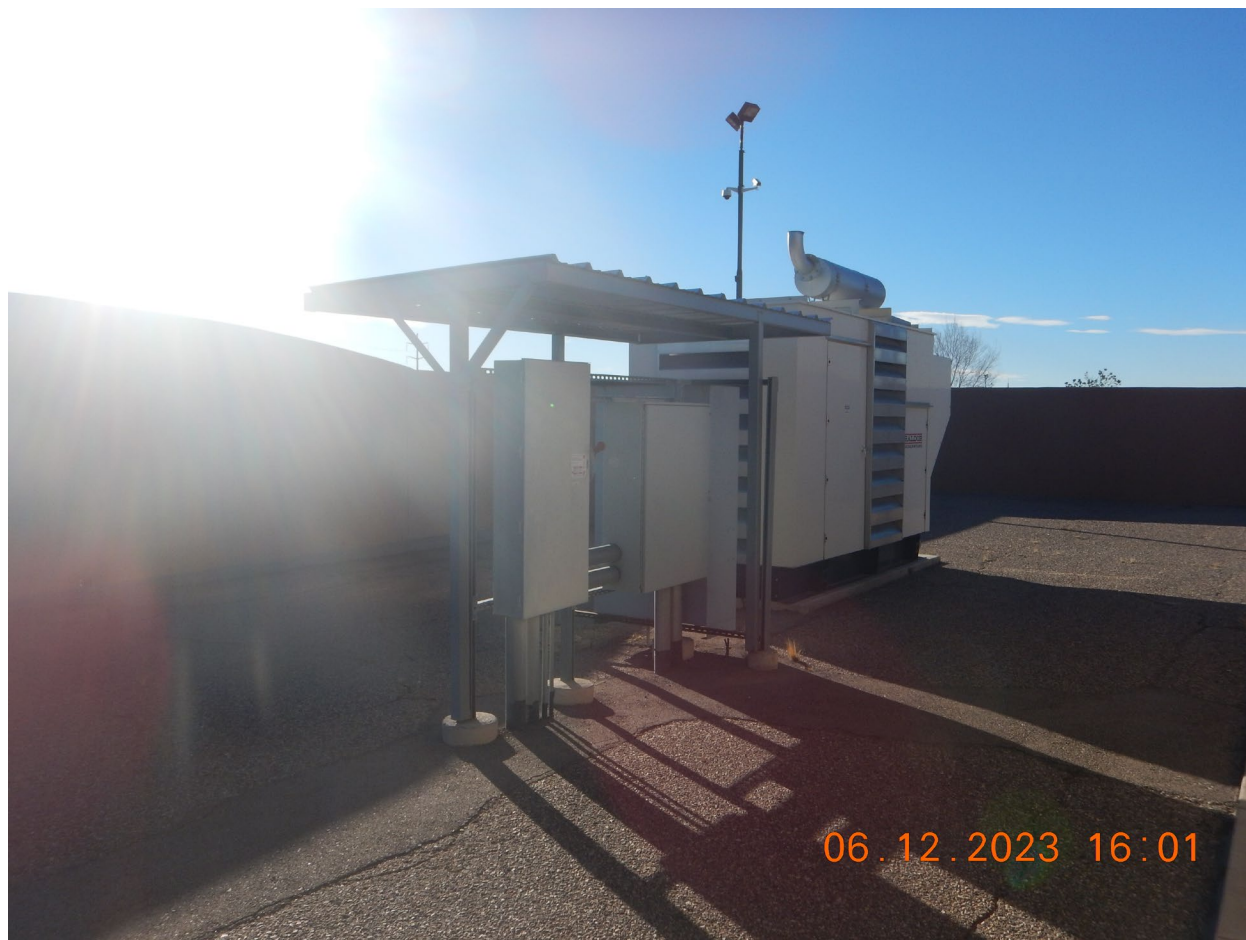
Photo No. 6

View of the onsite back-up generator. (DSCN2685). Photographed by D. Esparza

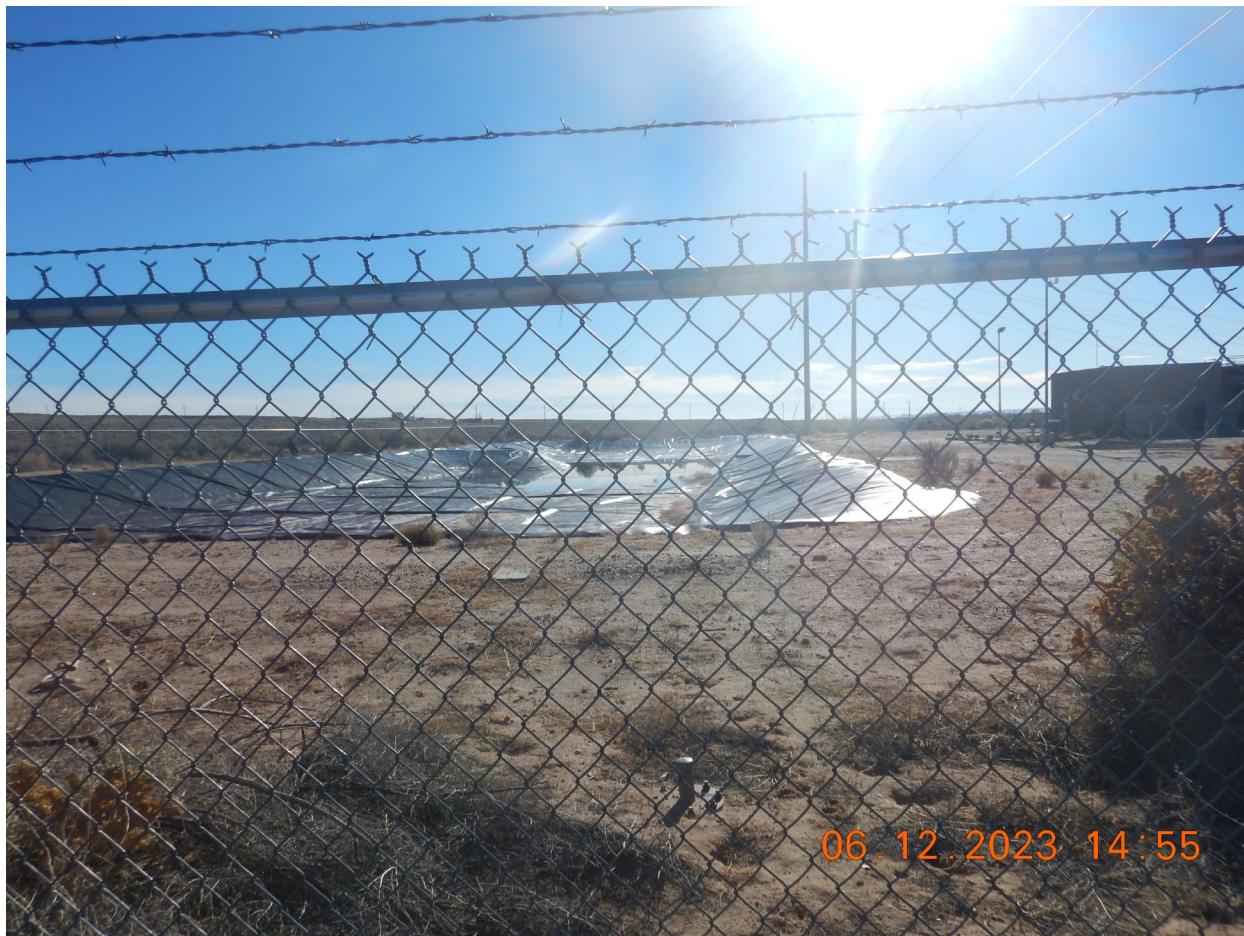
Photo No. 7

View looking south of the 500K-gallon emergency storage lagoon. (DSCN2675). Photographed by D. Esparza

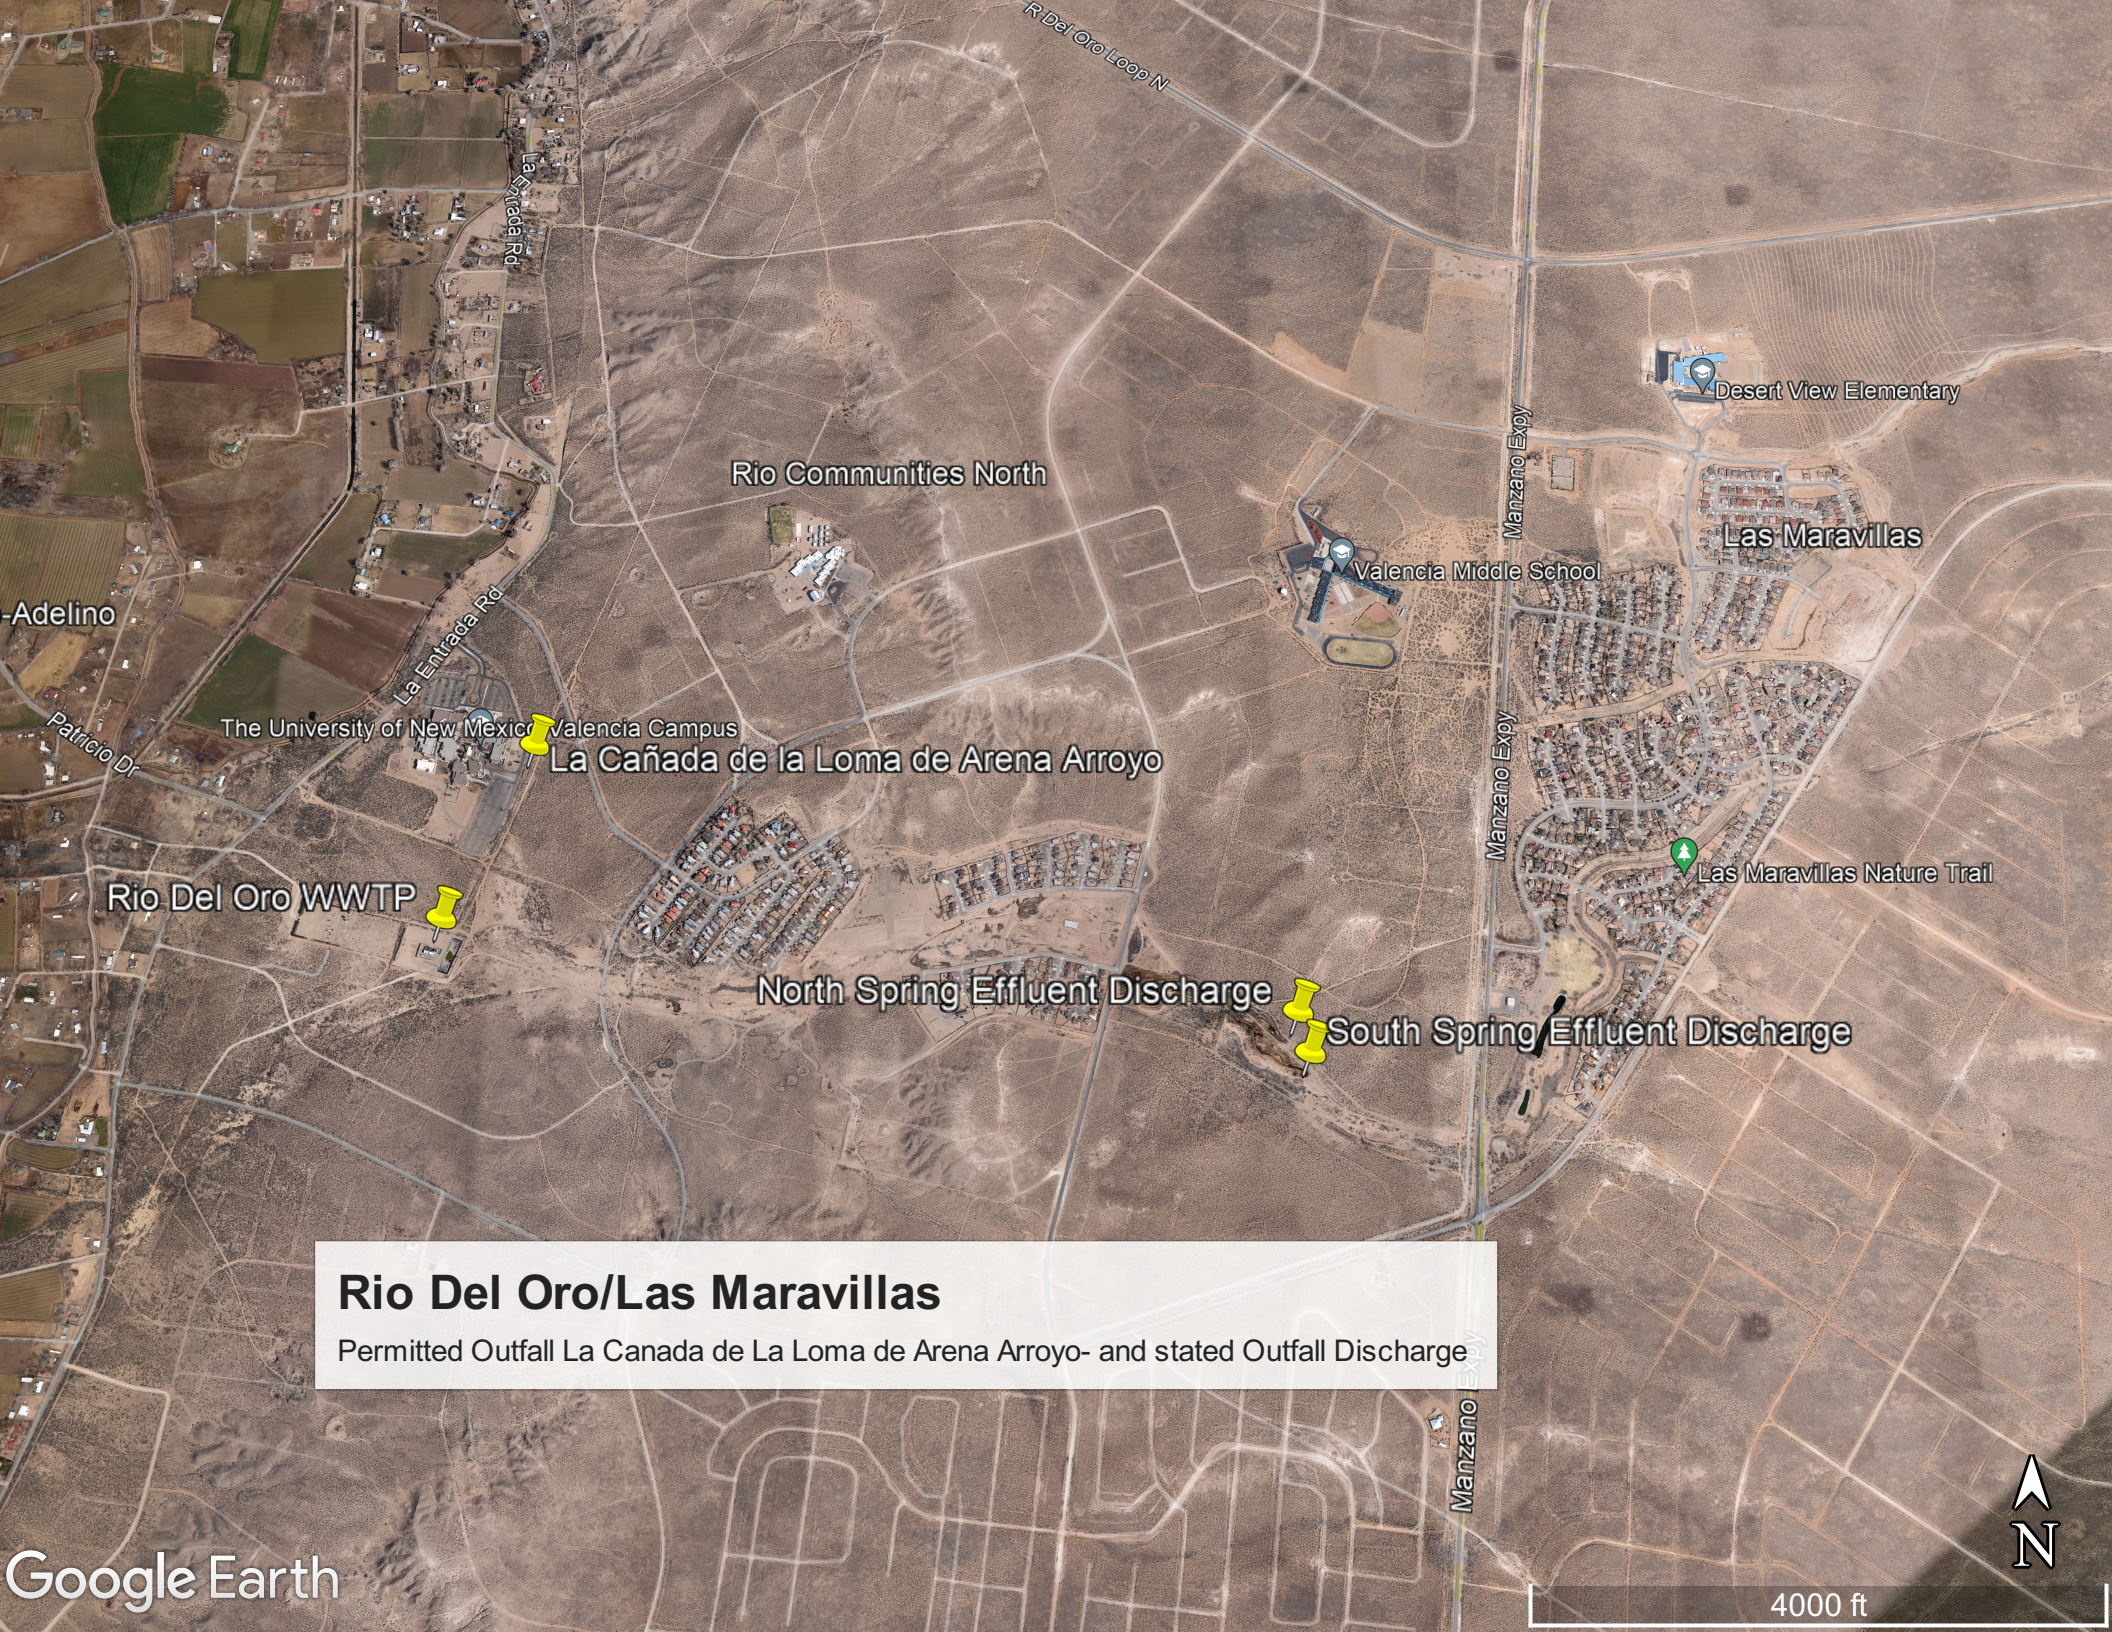
# Rio Del Oro/Las Maravillas

Permitted Outfall La Canada de La Loma de Arena Arroyo- and stated Outfall Discharge
