# **DTE ELECTRIC COMPANY MONROE POWER PLANT CLEAN WATER ACT (CWA) INSPECTION**

**Monroe, Michigan**

**Permit #: MI0001848**

**Inspection Date: August 29 and 30, 2023**

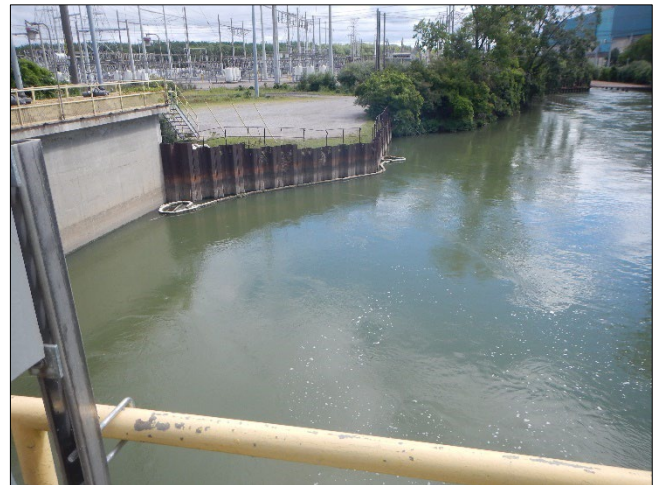
The Inspection Team observed that booms placed in the cooling water channel, upstream from Outfall 001A, were parallel to the flow instead of perpendicular to flow which could allow floatable material to reach Outfall 001A.

Photograph 84. DTE - Monroe Plant DSCN0170.JPG  
Description: General view, facing west, of the cooling water discharge canal from 001A. Booms (circled) were parallel to flow instead of perpendicular.

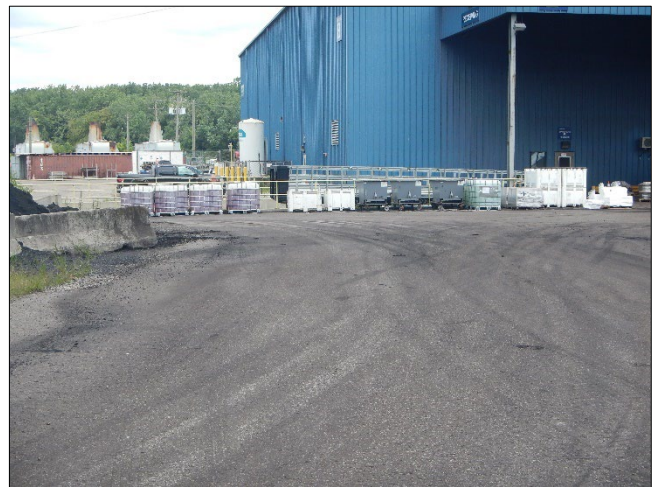
The Inspection Team observed chemical totes and hoppers stored outside without cover or containment on the east side of Warehouse B (Photographs 92, 94, and 95). The Inspection Team observed accumulated stormwater in the hoppers (Photograph 96).

Photograph 92. DTE - Monroe Plant DSCN0178.JPG  
Description: View, facing north, of Warehouse B with totes and hoppers stored outside without cover or containment.

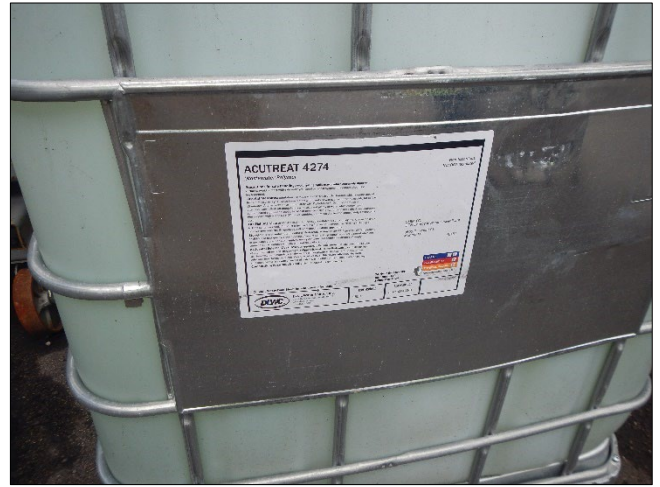
Photograph 95. DTE - Monroe Plant DSCN0181.JPG  
Description: Up-close view of totes seen in Photograph 92.

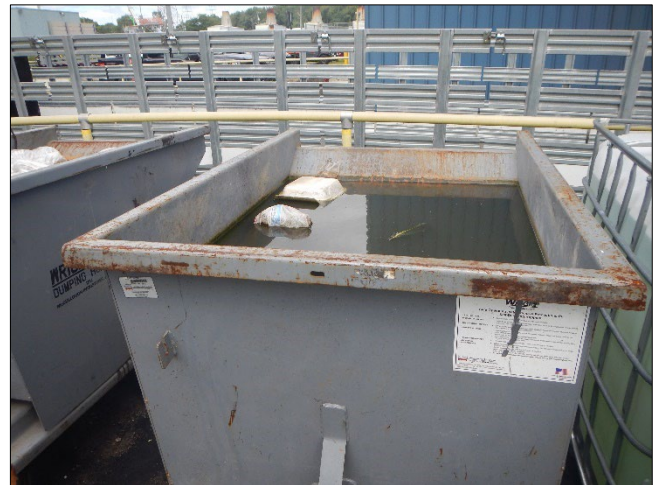
Photograph 96. DTE - Monroe Plant DSCN0182.JPG  
Description: Up-close view of hoppers seen in Photograph 92.

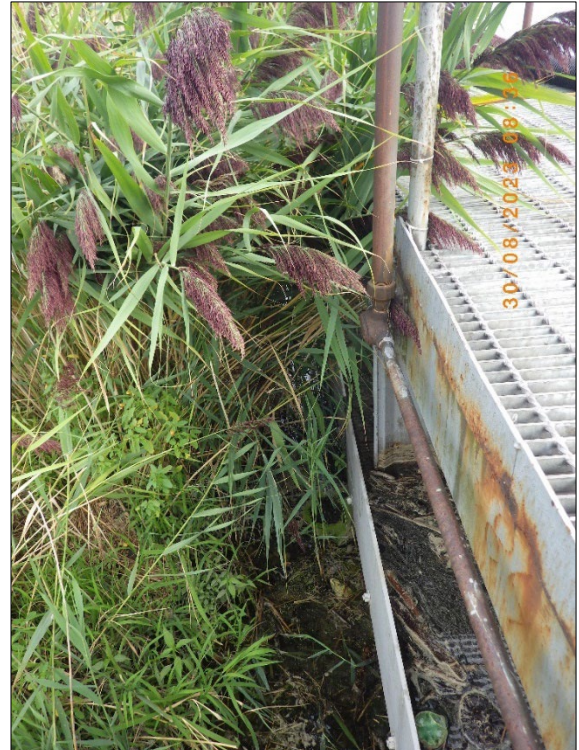
MP 001B is the discharge point for the Inactive Bottom Ash Basin; however, Facility representatives stated that the Inactive Bottom Ash Basin does not discharge. The Inspection Team observed a float was placed on the upgradient side of the basin containment wall to retain process wastewater in the Inactive Bottom Ash Basin (Photograph 39). However, the Inspection Team observed leaks in the containment wall between the Inactive Bottom Ash Basin and the Discharge Channel on August 29, 2023. Members of the Inspection Team returned to the Inactive Bottom Ash Basin on August 30, 2023 and photo documented that the Inactive Bottom Ash Basin was leaking through the containment wall to the Discharge Channel at several locations near the MP 001B (Photographs 116, 117, 118, 119, 120, 121, and 122).

Photograph 116. DTE - Monroe Plant RIMG3193.JPG  
Description: View of standing water on the drainage canal side of the inactive bottom ash basin.

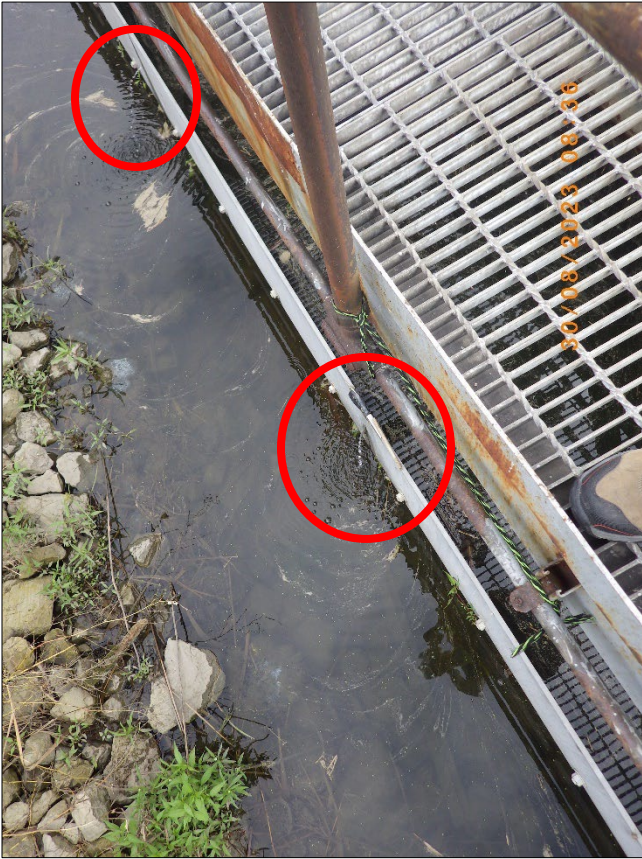
Photograph 117. DTE - Monroe Plant RIMG3194.JPG  
Description: View of additional leaks in the containment wall on the western side of the inactive bottom ash basin.

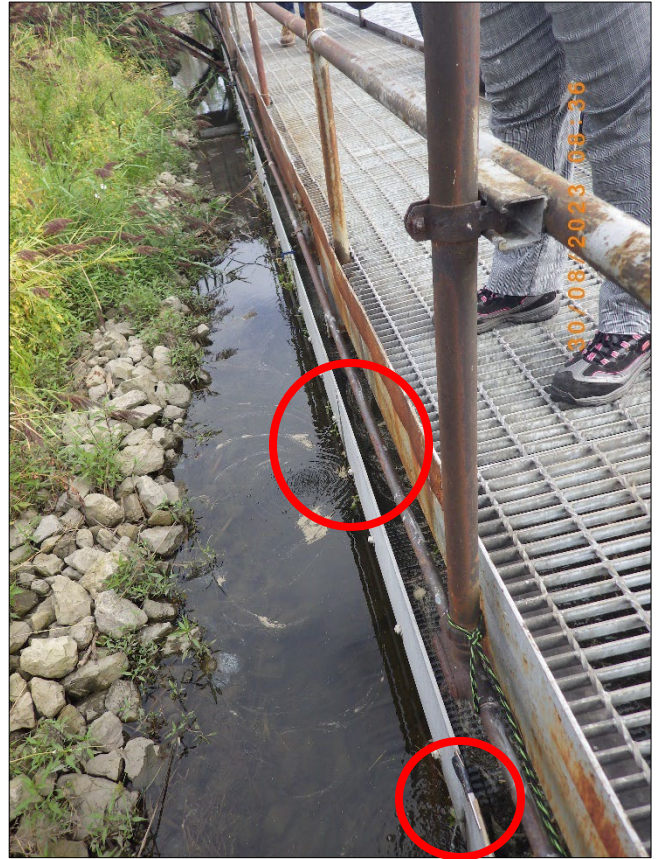
Photograph 118. DTE - Monroe Plant RIMG3195.JPG  
Description: View of additional leaks in the containment wall on the western side of the inactive bottom ash basin.

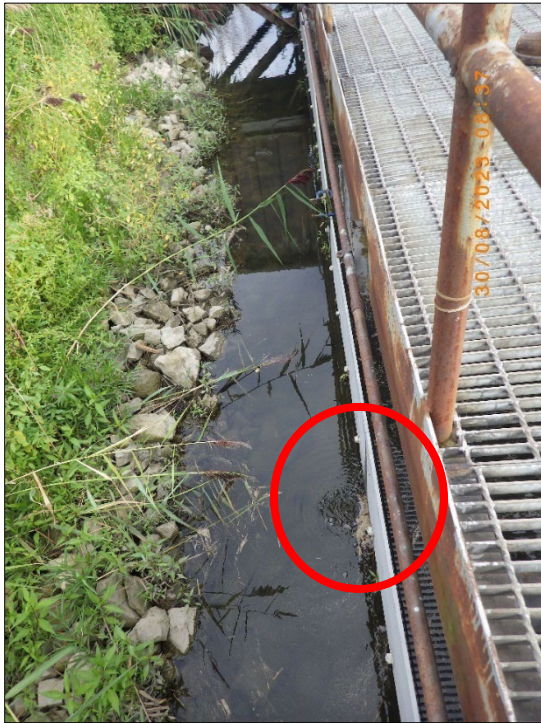
Photograph 119. DTE - Monroe Plant RIMG3196.JPG  
Description: View of additional leaks in the containment wall on the western side of the inactive bottom ash basin.

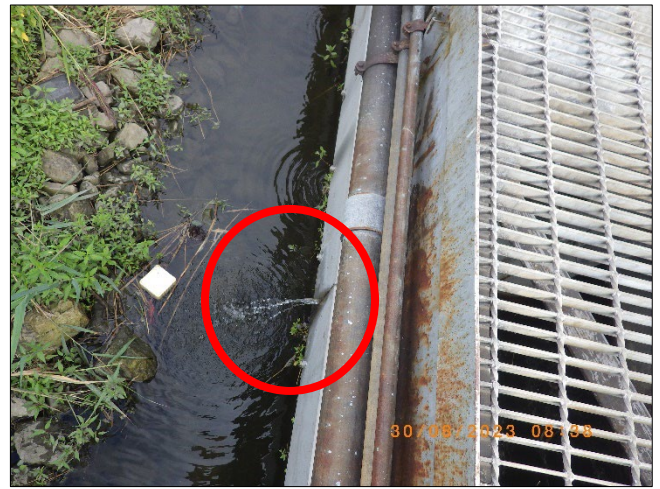
Photograph 121. DTE - Monroe Plant RIMG3198.JPG  
Description: View of additional leaks in the containment wall on the western side of the inactive bottom ash basin.

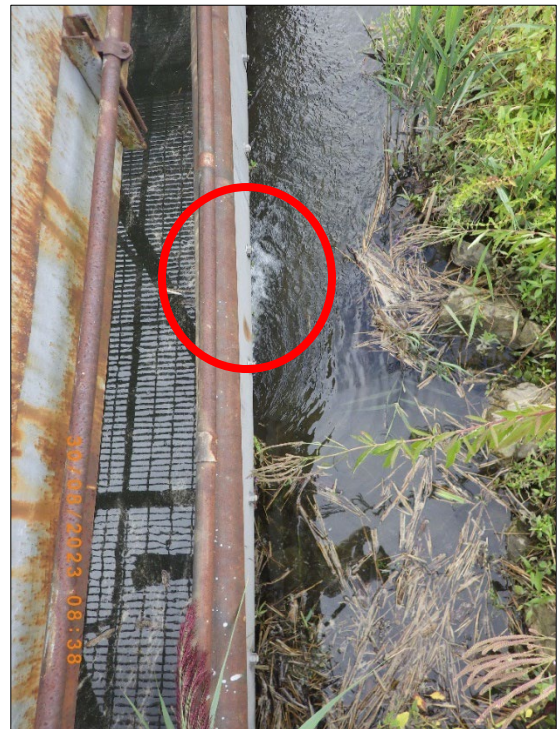
Photograph 122. DTE - Monroe Plant RIMG3199.JPG  
Description: View of additional leaks in the containment wall on the western side of the inactive bottom ash basin.

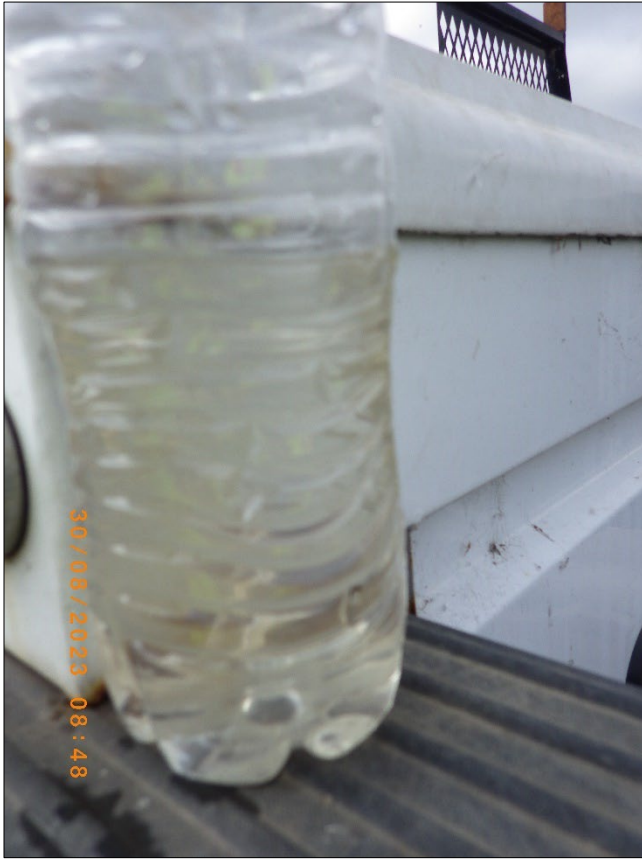
The Inspection Team observed a dark plume in the Discharge Channel immediately downstream of MP 001H on August 29 (Photographs 31 and 32) and 30 (Photograph 125). On August 30, 2023, a Facility representative used a plastic water bottle to collect a sample from the plume as well as by Outfall 001. Facility representatives suggested that the plume resulted from recent storm events that stirred up sediment in the Discharge Channel at MP 001H (Photographs 123, 124, and 126).

Photograph 123. DTE - Monroe Plant RIMG3200.JPG  
Description: View of water collected by a facility representative using a plastic bottle for a visual aid regarding the darker colored water in discharge canal by 001H. Note this is not the bottle or sampling method that would be used for NPDES compliance samples.

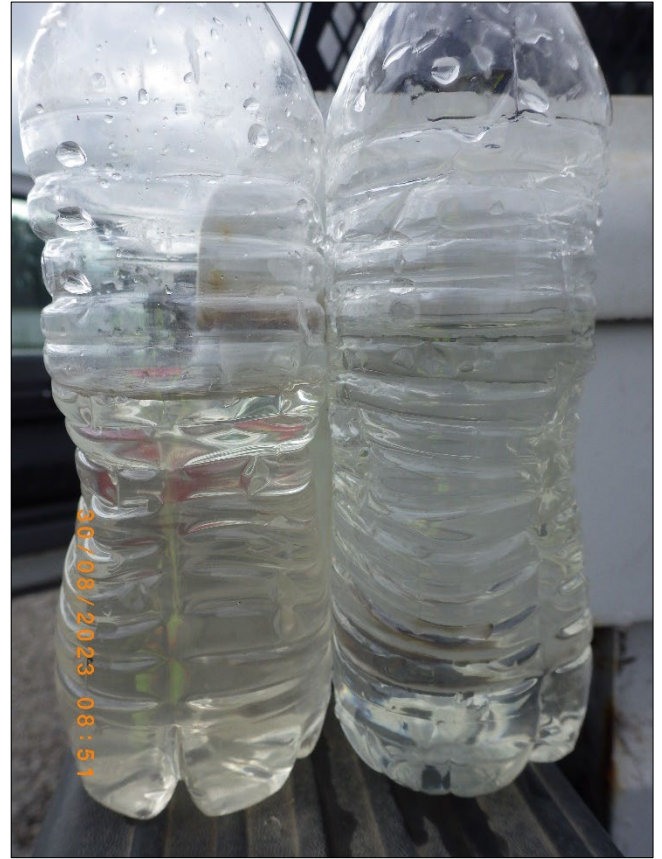
Photograph 124. DTE - Monroe Plant RIMG3201.JPG  
Description: View of water collected from the dark colored water in the discharge canal by 001H on the left and downstream by 001 on the right. The water was collected by a facility representative for a visual aid during the inspection, these are not the bottles or sampling method that would be used for NPDES compliance samples.

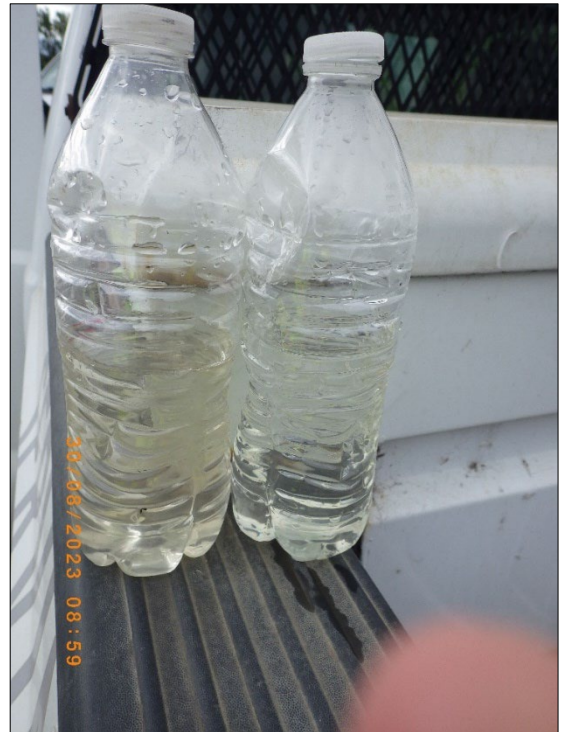
Photograph 126. DTE - Monroe Plant RIMG3203.JPG  
Description: View of water collected from the dark colored water in the discharge canal by 001H on the left and downstream by 001 on the right. The water was collected by a facility representative for a visual aid during the inspection, these are not the bottles or sampling method that would be used for NPDES compliance samples.
